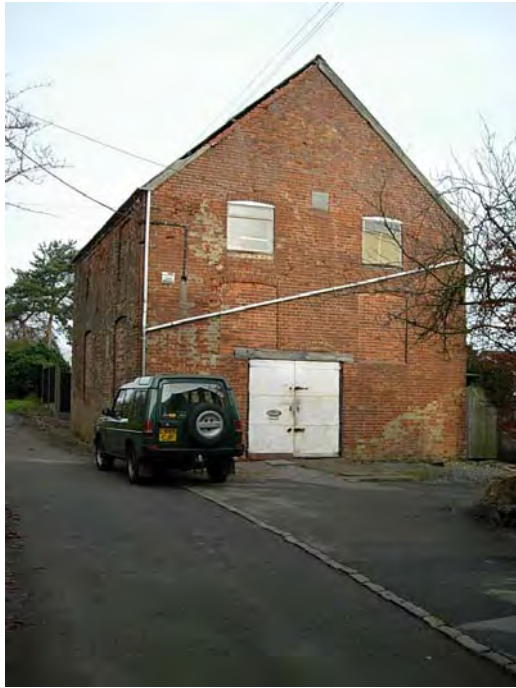
The former Methodist Chapel built 1811. Although the property's interior has been cleared and is now used for car repairs, the shell of the building is still of considerable visual and historical importance at the northern end of The Green.

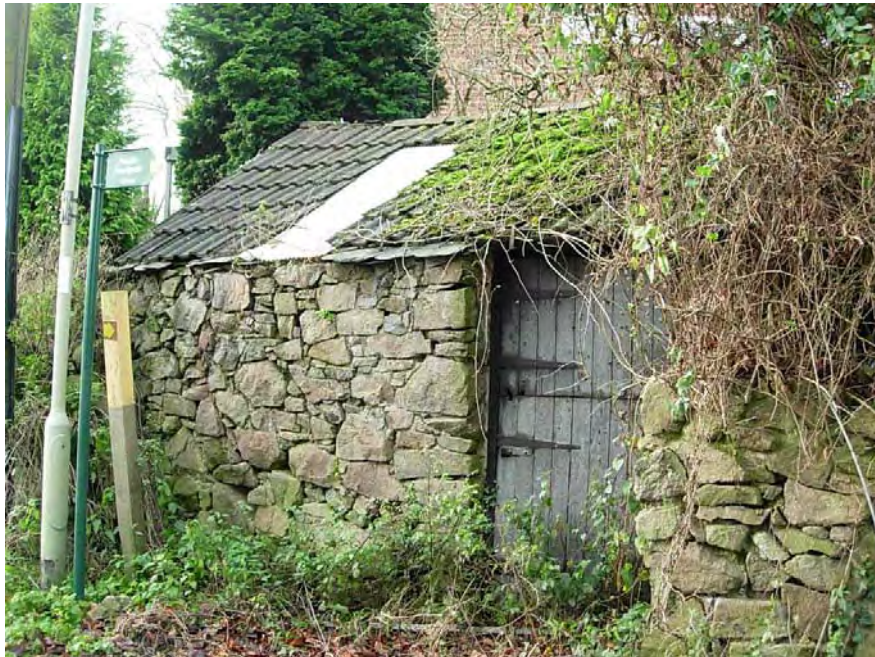
This quaint granite outhouse enhances the rugged character of The Green at its northern end and should be retained and repaired utilizing traditional materials.

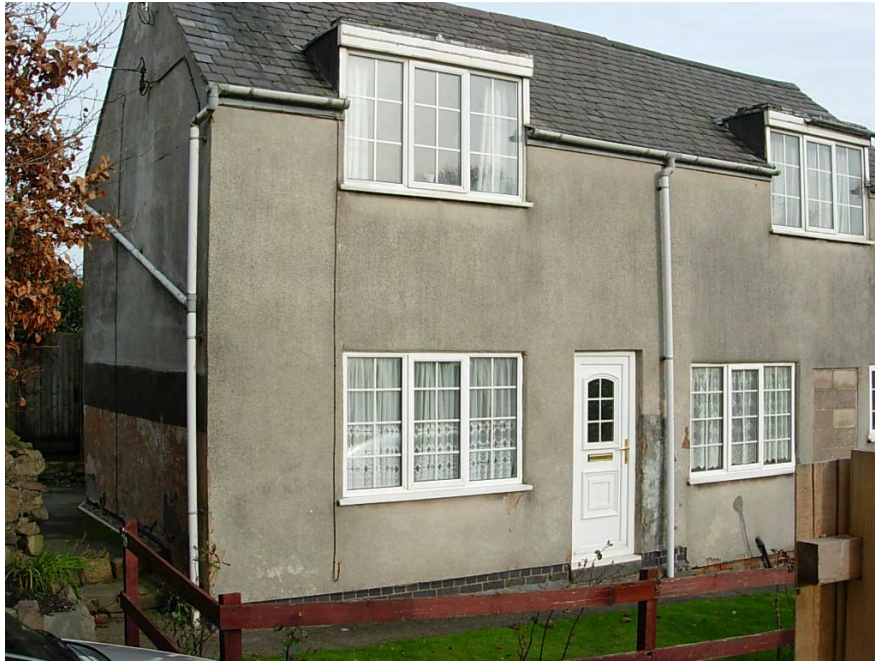
52 The Green that was originally two cottages that has lost its traditional character with its conversion into a single property and use of modern materials.

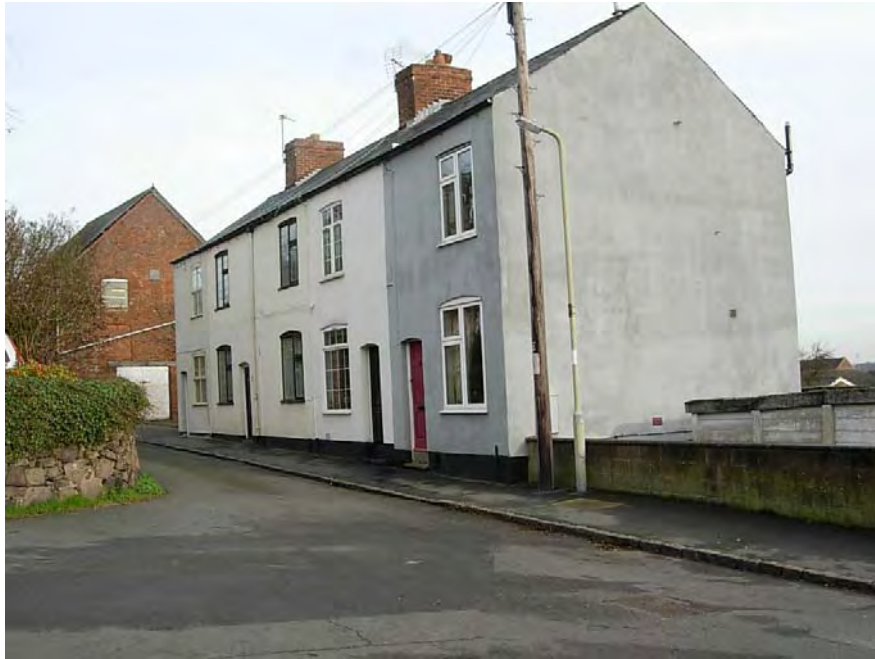
The introduction of modern replacement windows at 44 - 52 The Green has had a detrimental effect in this terrace.

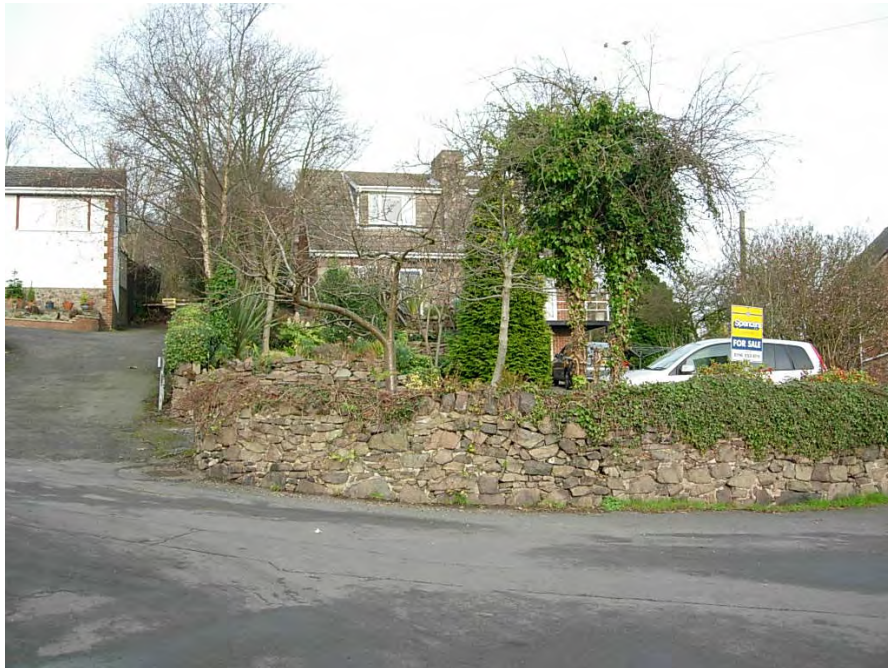
This dormer bungalow at 61 The Green does not reflect the traditional character of the village, although it does have a good stone wall running around its cartilage.

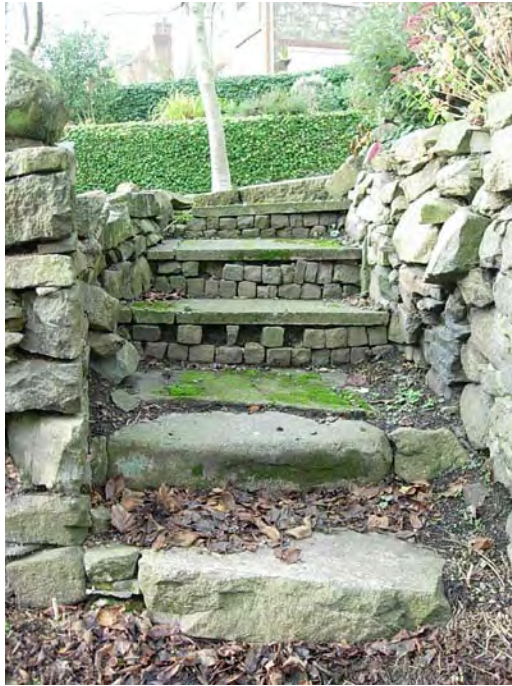
The steps leading up to 51 The Green are in need of maintenance.

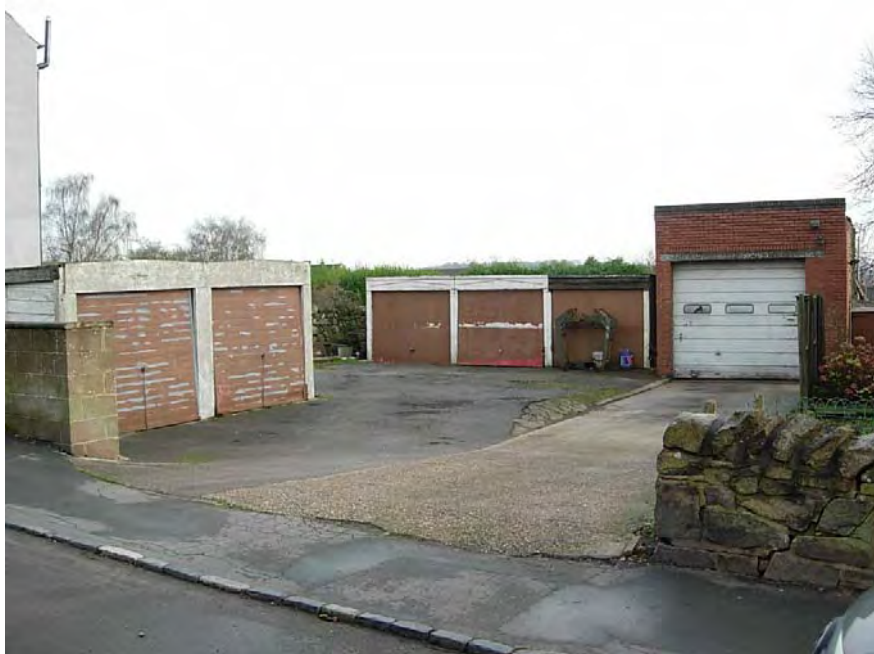
The open garage court at 38 The Green reduces the visual quality of area.

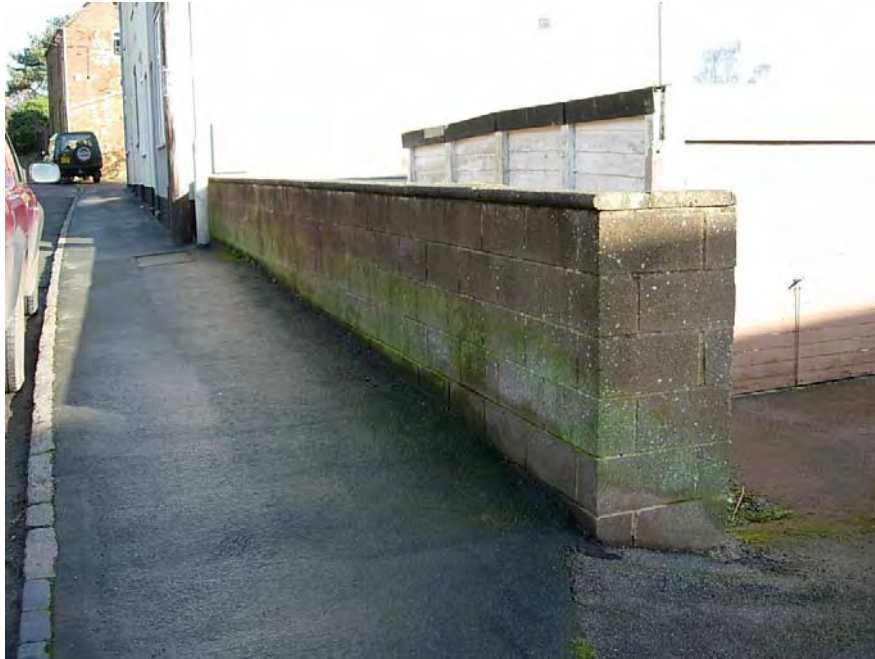
The concrete block wall fronting the garage court at 38 The Green needs replacing with a traditional granite wall.

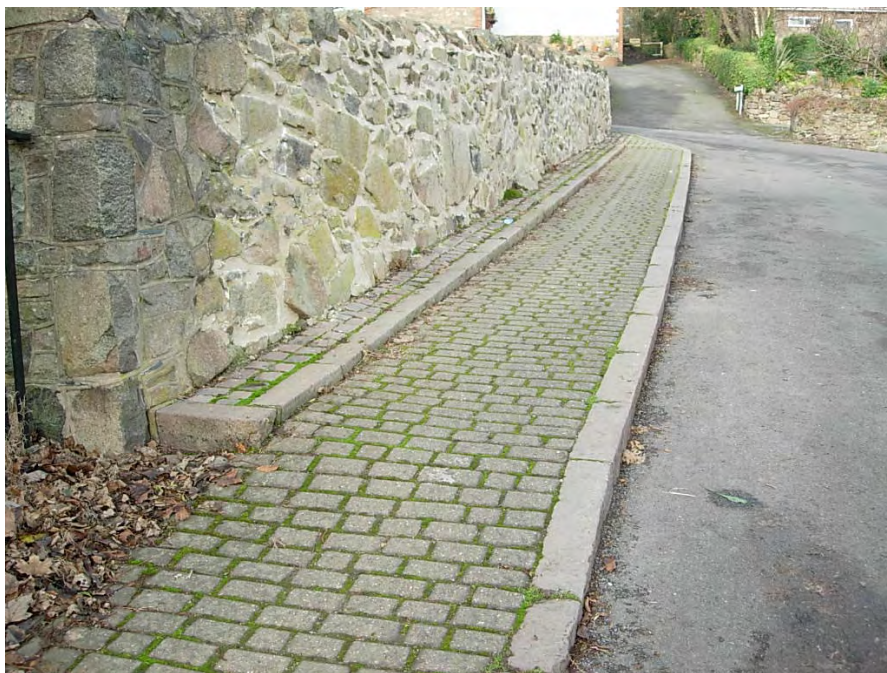
The use of granite setts to match the granite kerbs would have been preferable to the use of concrete paviours in this sensitive area fronting the parish church.

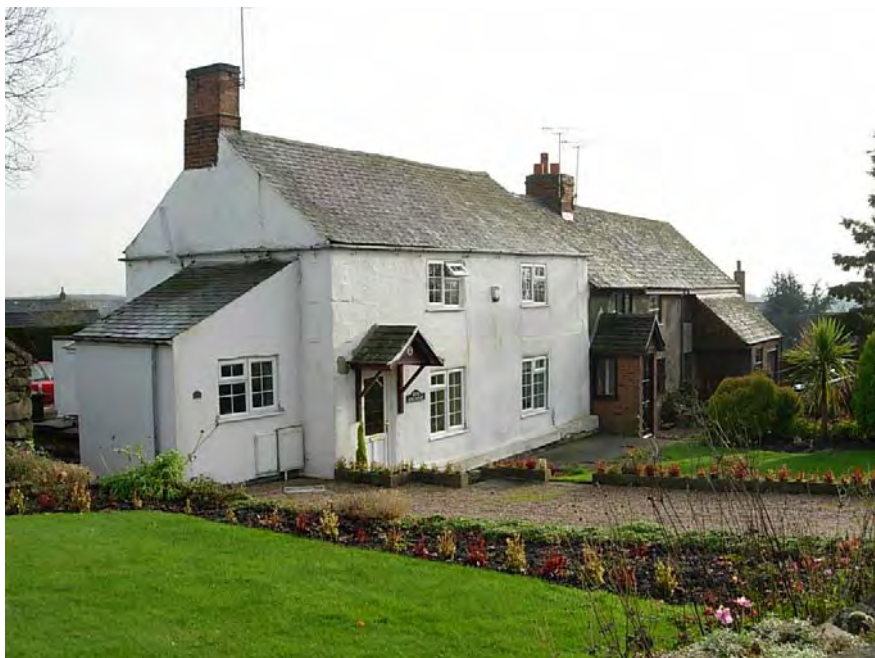
This group of building is spoilt by the front porches and canopy that tend to dominate the properties.

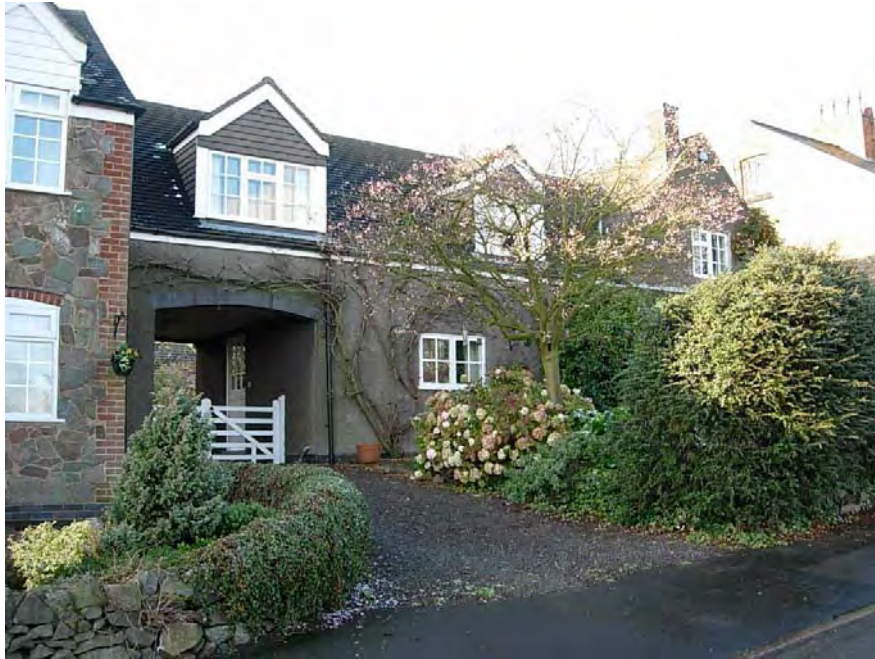
The dormers at 33 The Green are out of scale with the building fabric and the detailing does not follow the traditional form.

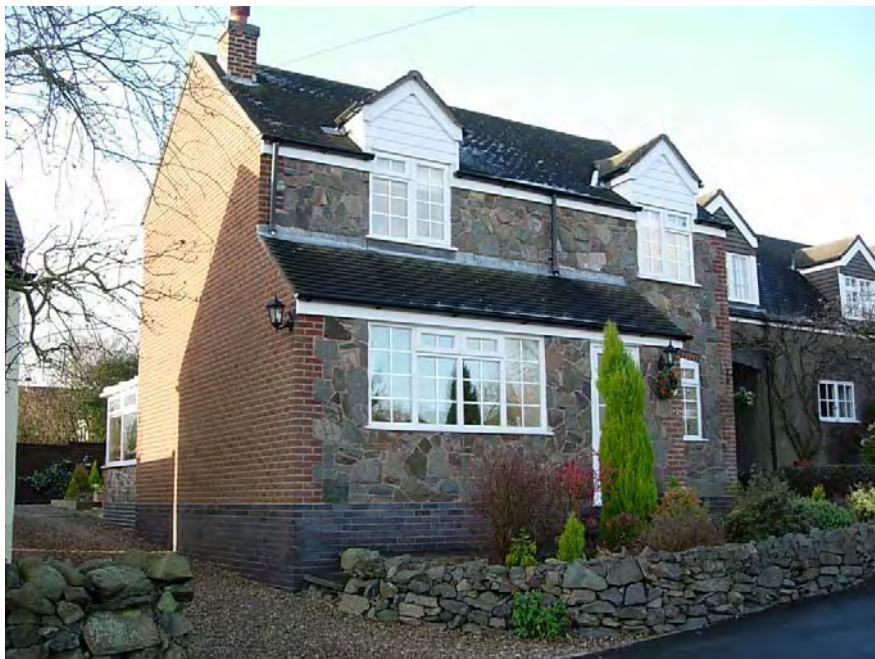
31 The Green has many non-traditional features that detract from the conservation area. They include half dormers, overly large window openings and inappropriate modern materials.

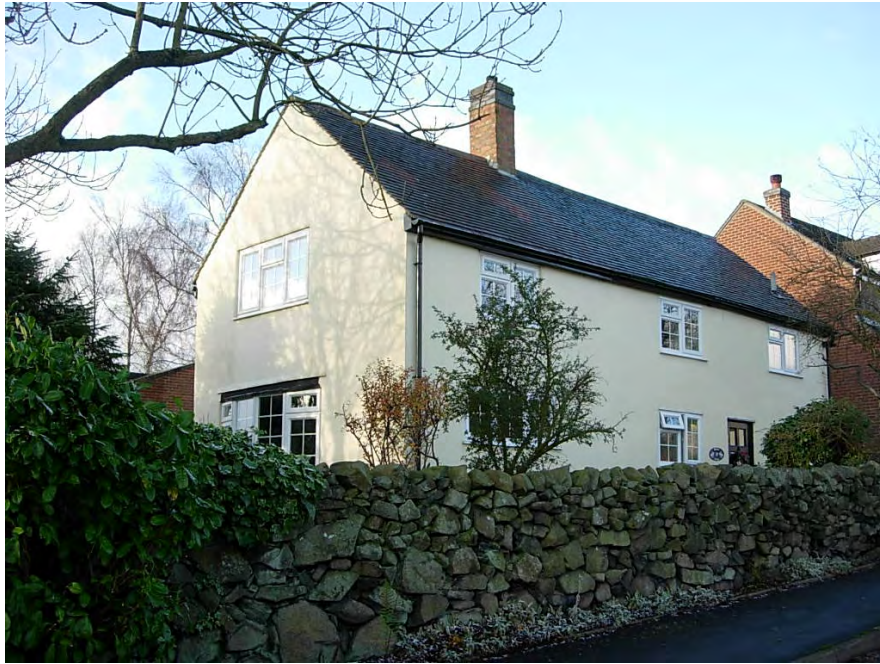
29 The Green suffers from overly large window openings in the gable and plastic windows.

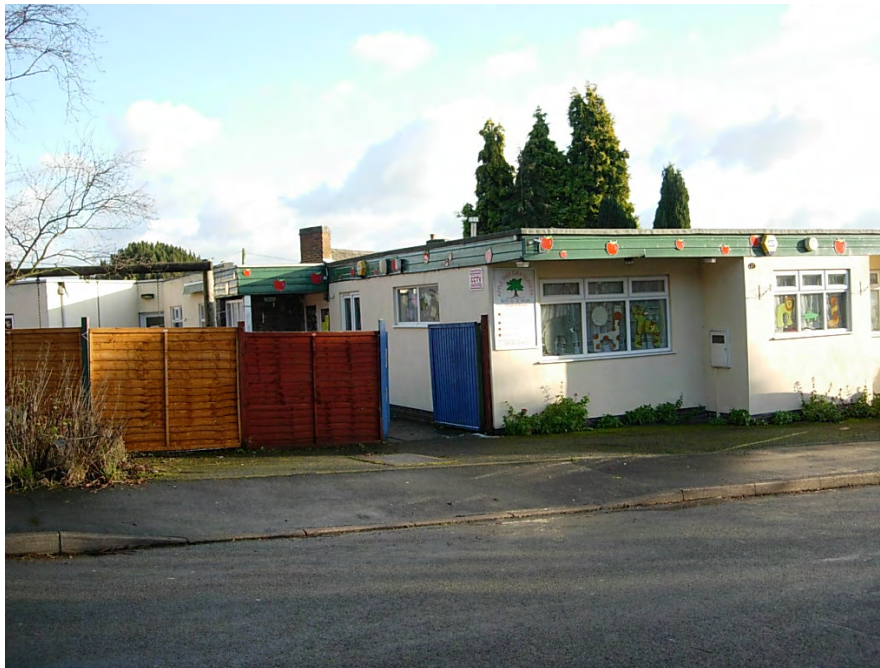
The Apple Tree Day Nursery is a particularly unattractive property sited at an important location opposite the village green and church. Re-development of this site should be considered in the future.

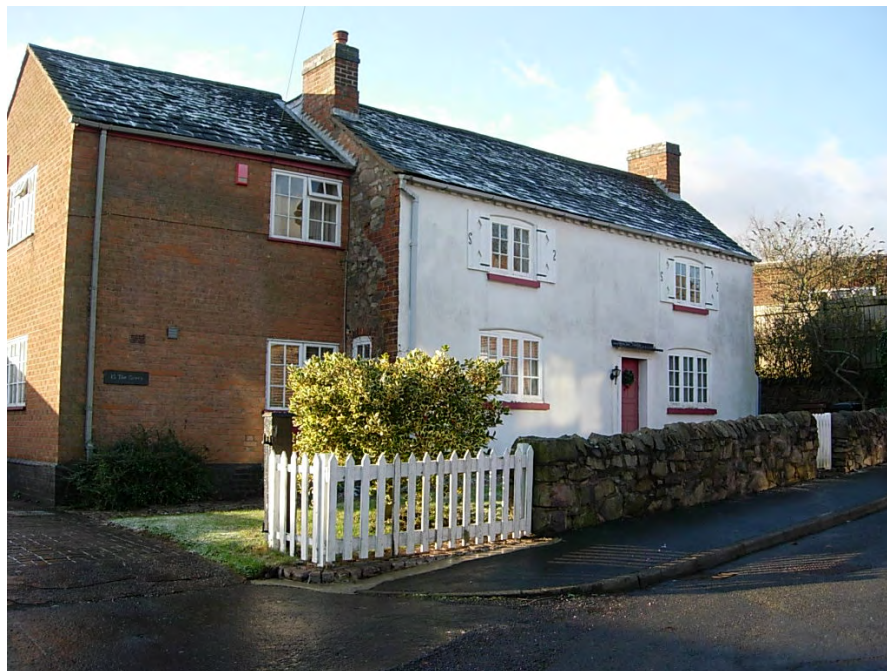
The picket fence at 15 The Green needs to be replaced with a granite wall to match the existing wall.

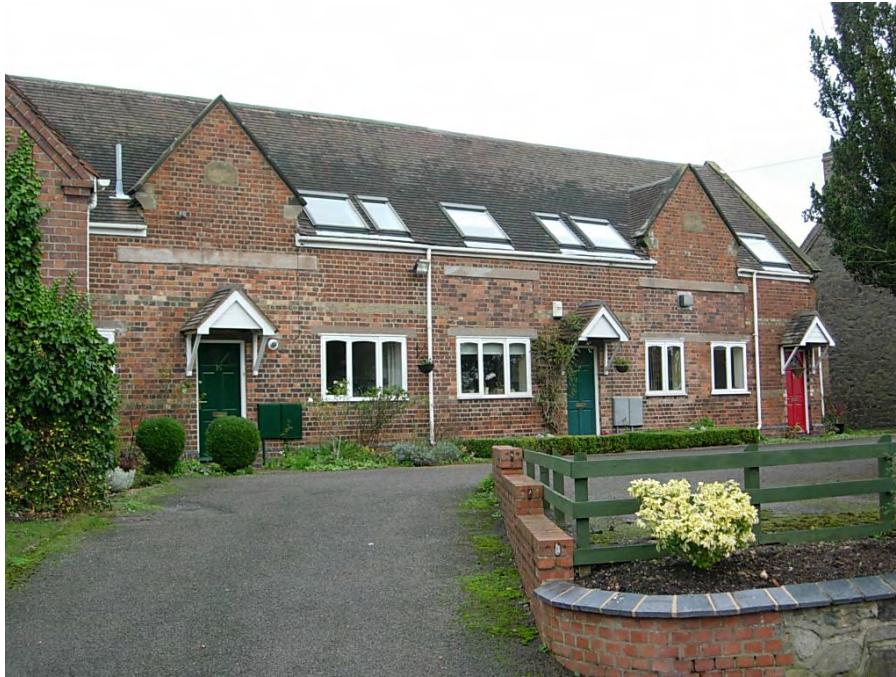
The former village primary school has lost some of its charm with the insensitive use of artificial materials and insertion of large roof lights on the street elevation.

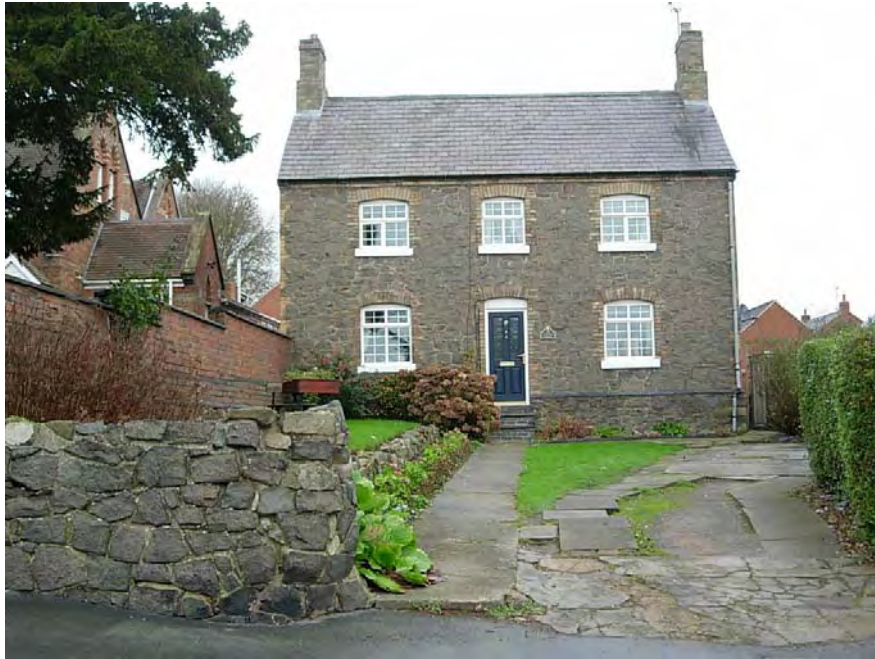
The Old School House, 10 The Green, is a fine granite dwelling with a slate roof and two chimney stacks but the car parking space fronting the property needs attention.

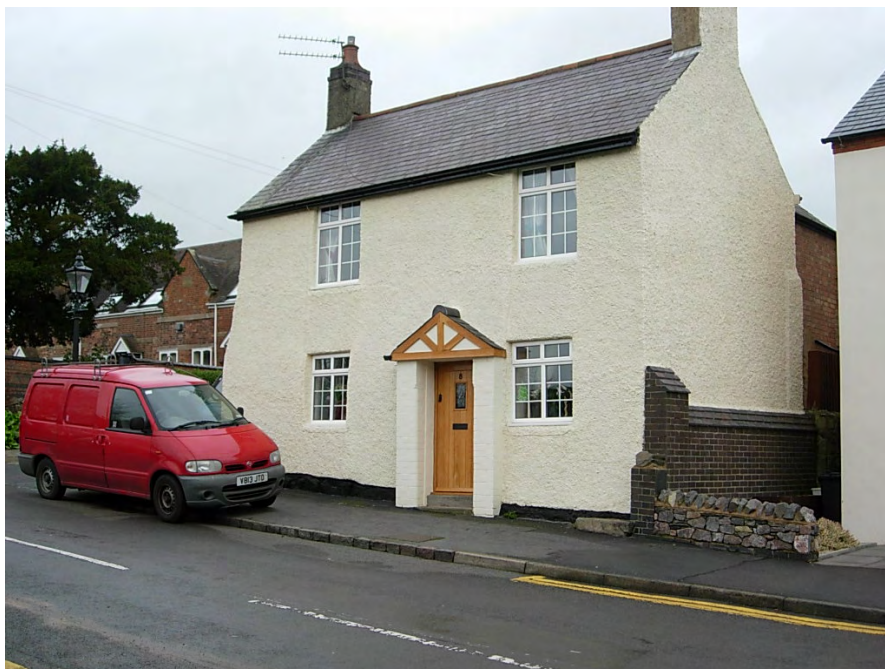
6 The Green is a rendered dwelling with plastic windows.

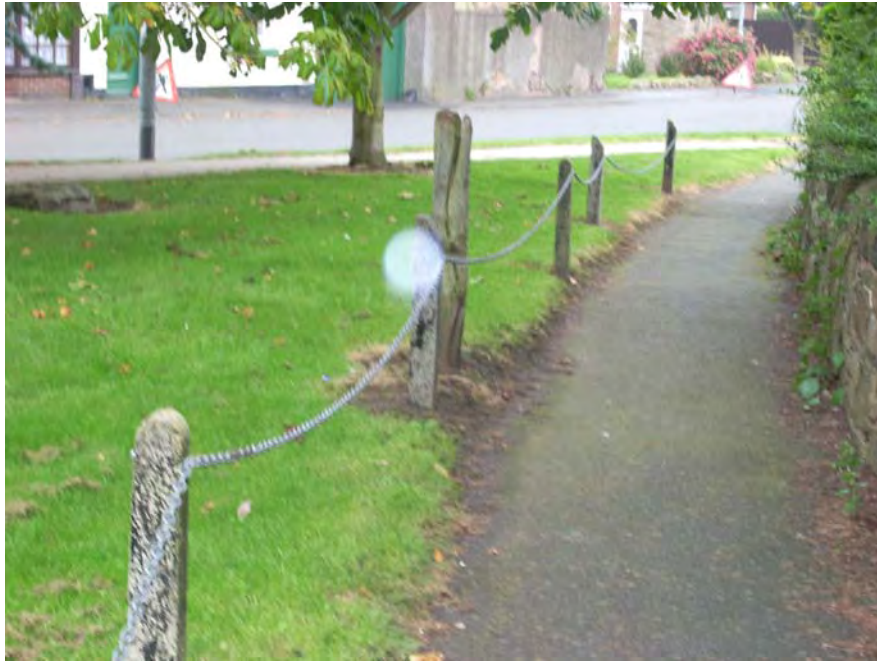
The unattractive concrete post and chain fence has recently been replaced with cast iron posts.

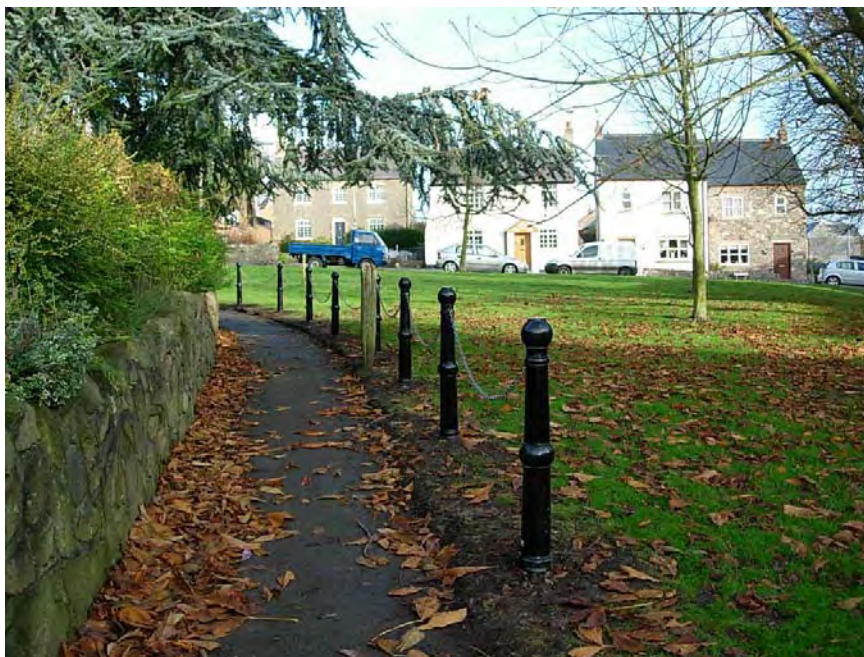
The unsightly timber post sited on Saw Pit Green marks the location of a well. It is suggested the timber post is replaced with an information board.

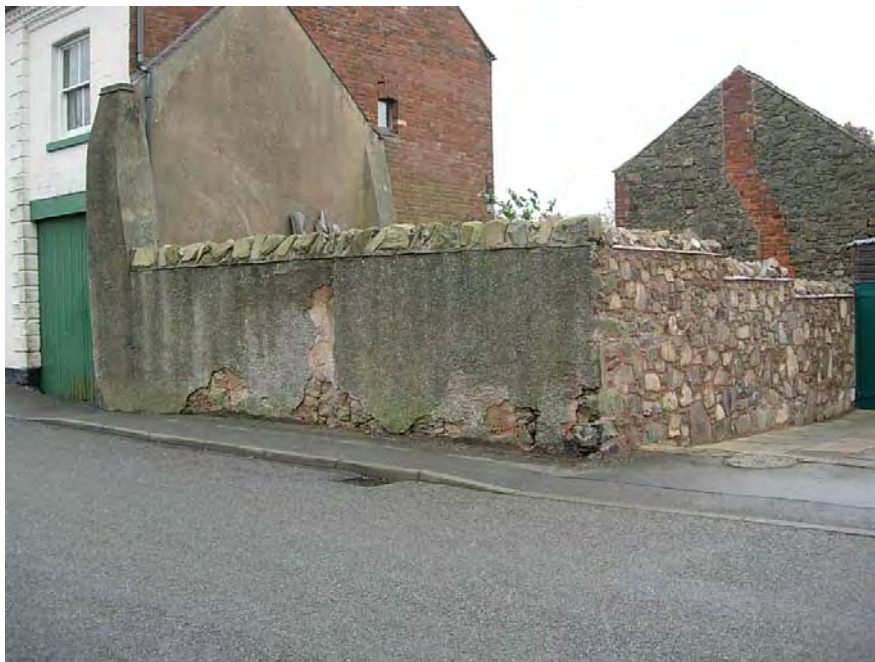
The rendering on the wall fronting 36 Main Street is unsightly and needs removing. This might require the wall to be re-built.

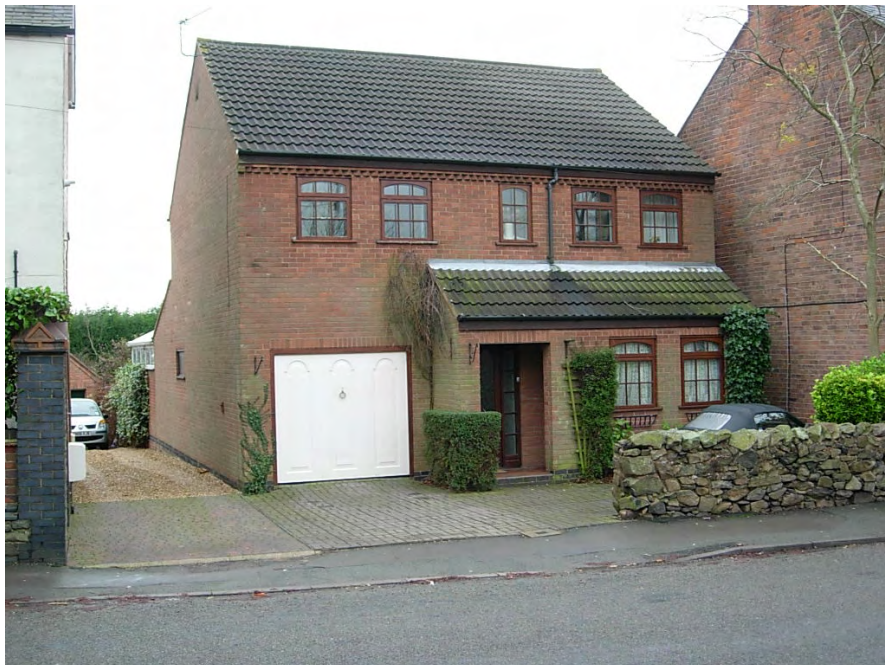
88 Main Street does not respect the village character with its integral garage and the use of modern materials.

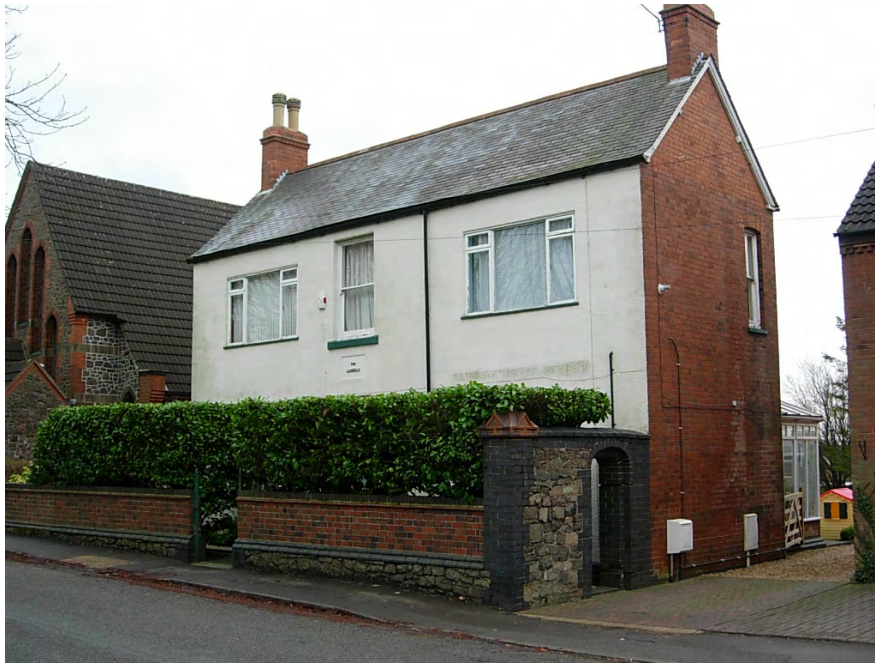
The Laurels, 40 Main Street is a fine building although it has lost some of its traditional character with the insertion of two large windows on the front elevation.

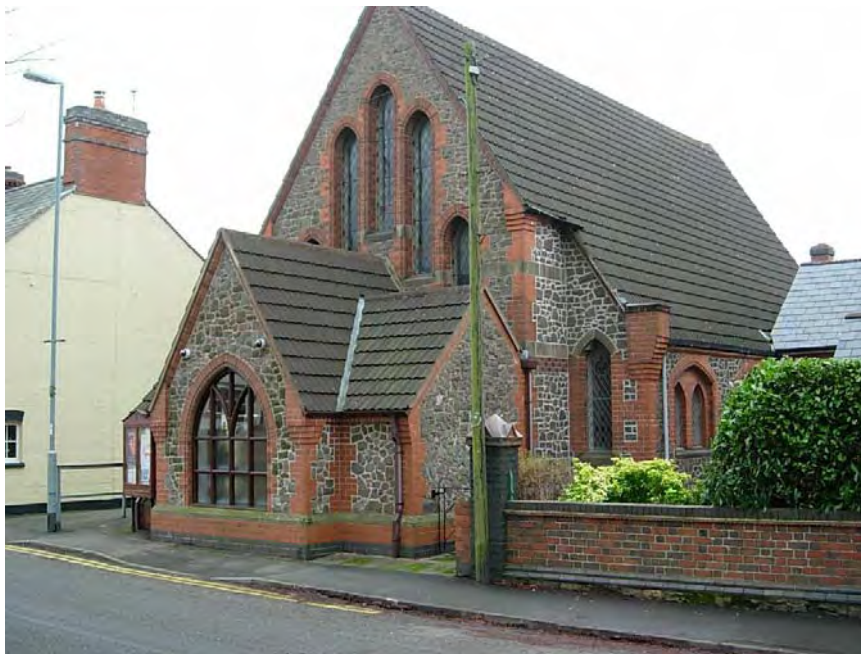
The Trinity Methodist Church is spoilt with the use of concrete tiles.

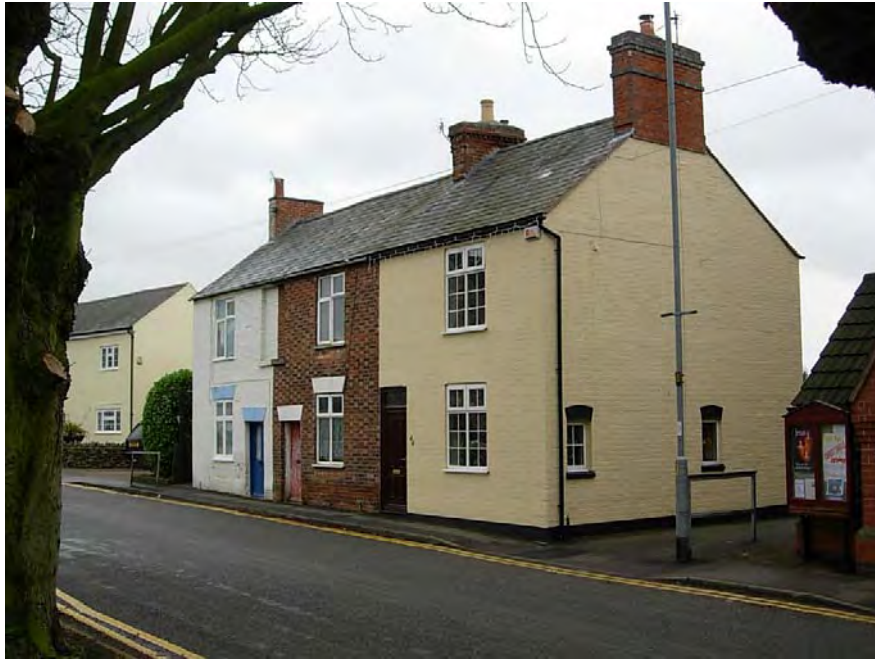
44 – 48 Main Street is a pleasant terrace that has lost its unity with new plastic windows inserted and two of the three properties painted/rendered.

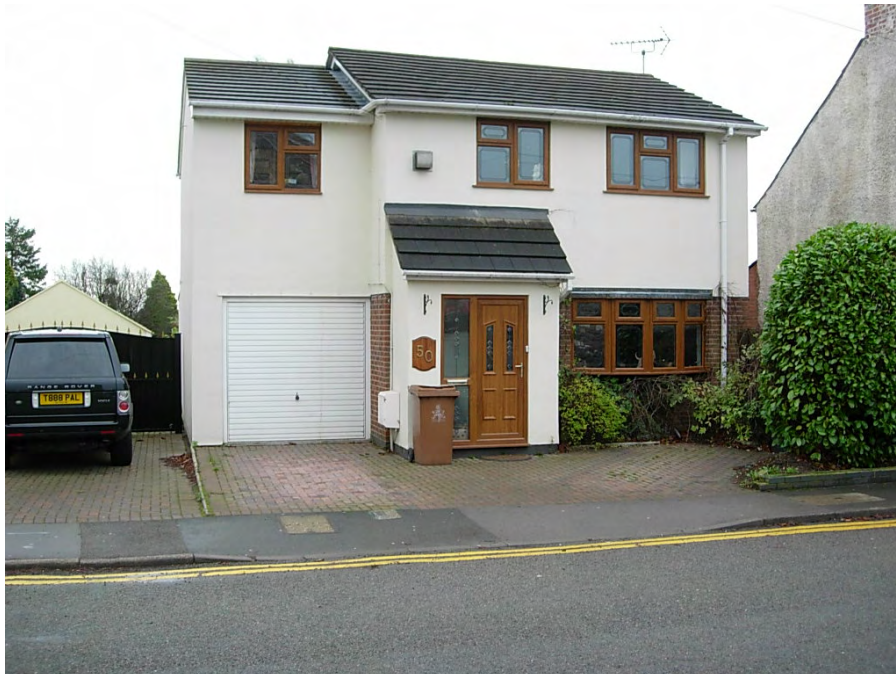
There are a number of properties built on Main Street that do not respect the traditional character by way of their design, materials, and open frontage.
