Markfield conservation area photographic survey part 4

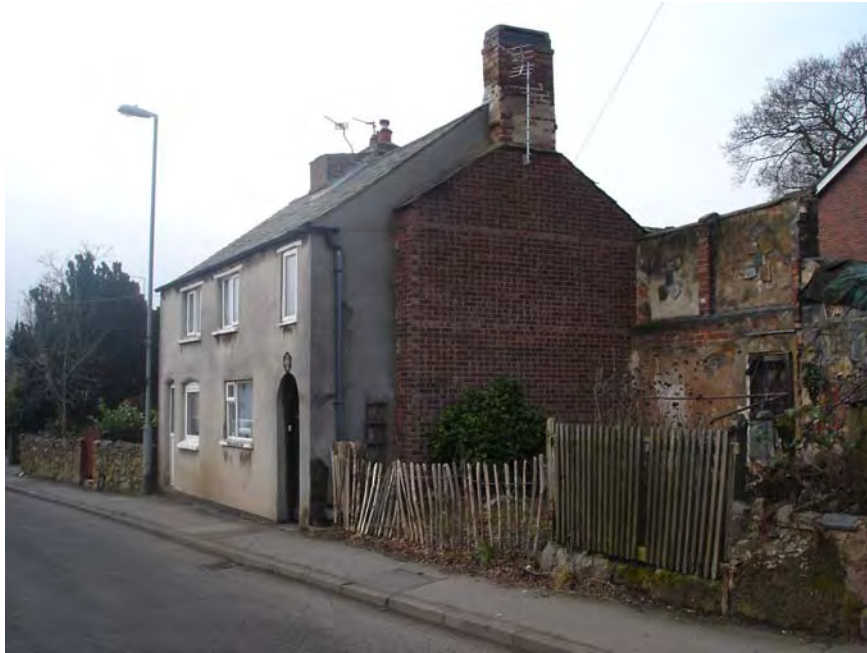
The brick skin built on the end gable at 173 Main Street to stabilise the premises is unsightly. There might be potential to build another dwelling on the adjacent land.

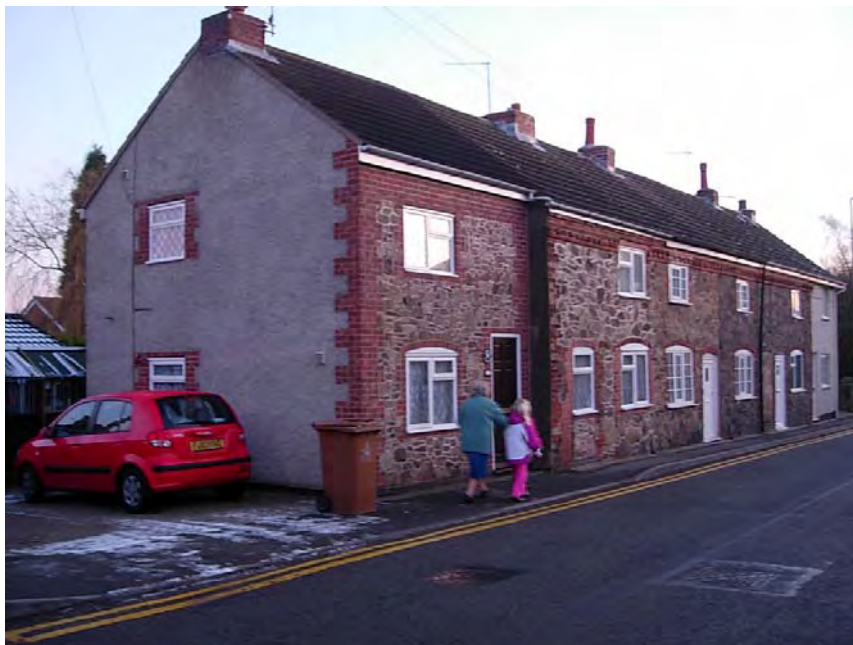
144 – 152 Main Street is still a pleasant terrace despite being considerably modernized and extended. The height of the eaves has been raised, window openings changed and concrete roof tiles used.

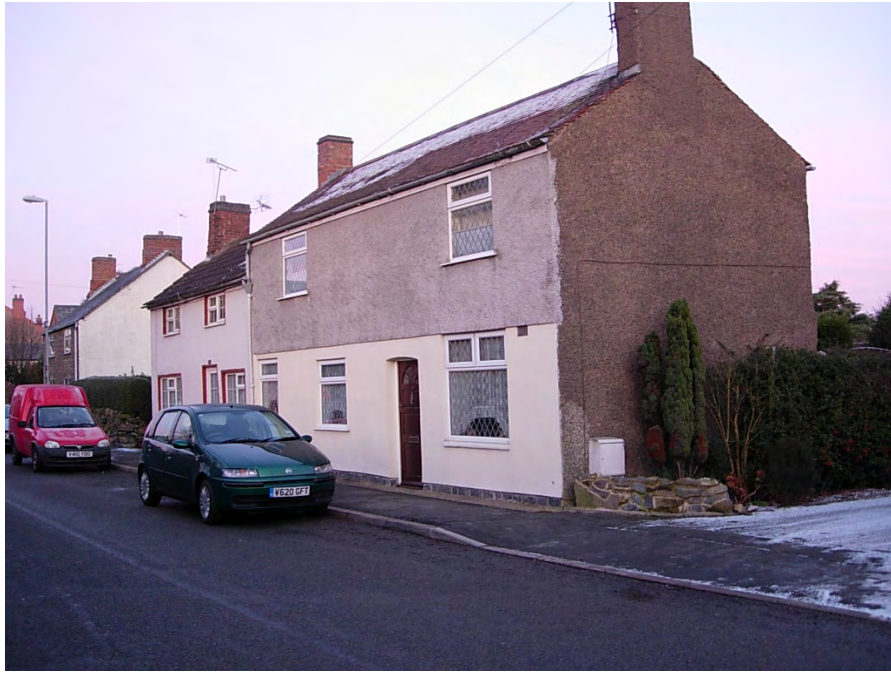
158 and 160 Main Street have different roof heights. Both have had plastic windows inserted. 158 has a Rosemary tiled roof and 160 a concrete tiled roof.

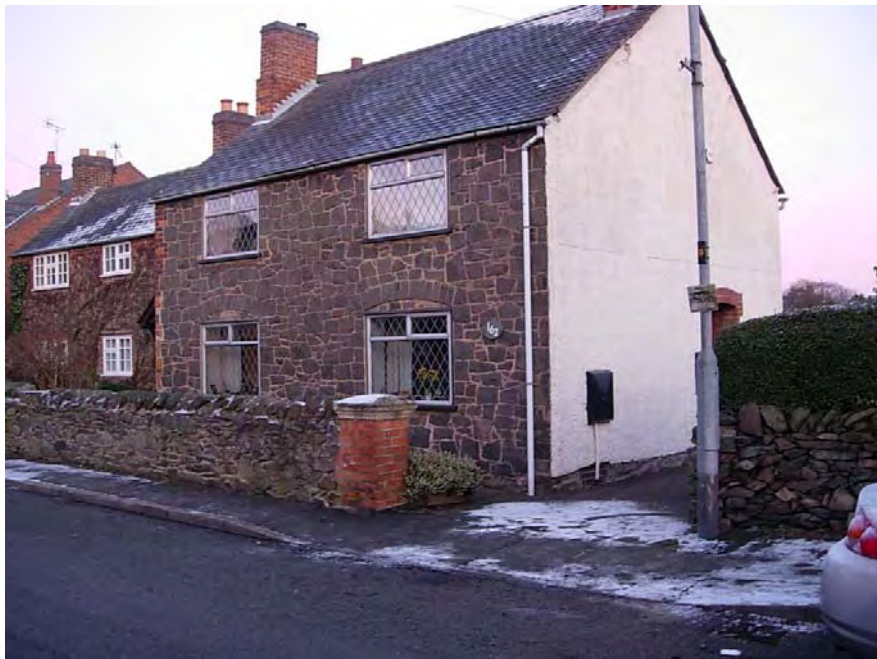
162 Main Street is a stone property rendered on its gable with a slate roof. Its chimney stacks have been rebuilt and new windows inserted.

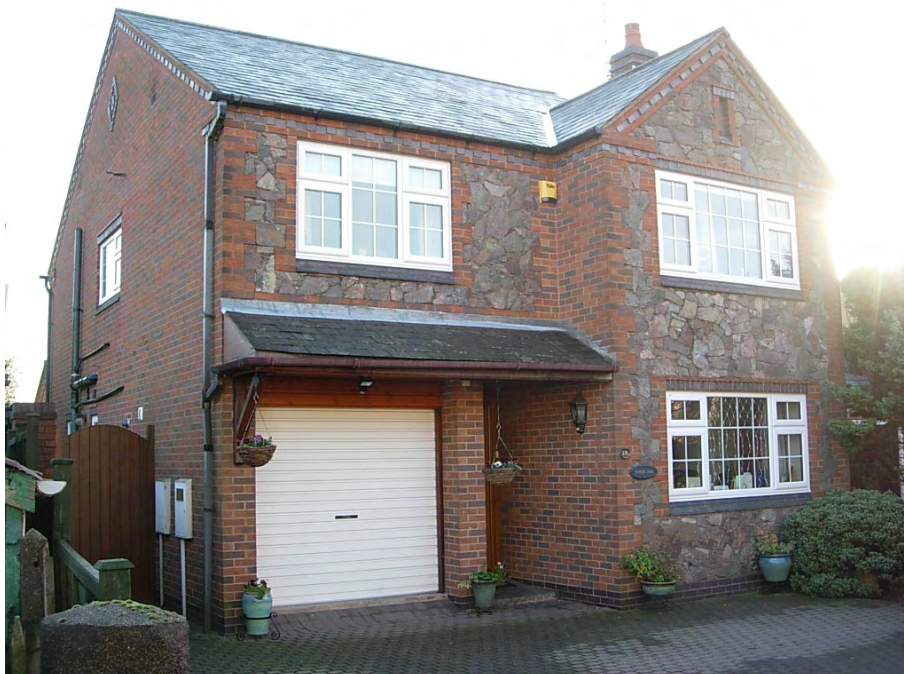
The detached dwelling, 170 Main Street, with its integral garage, is of modern design and is constructed from modern materials. It does not reflect the character of the conservation area.

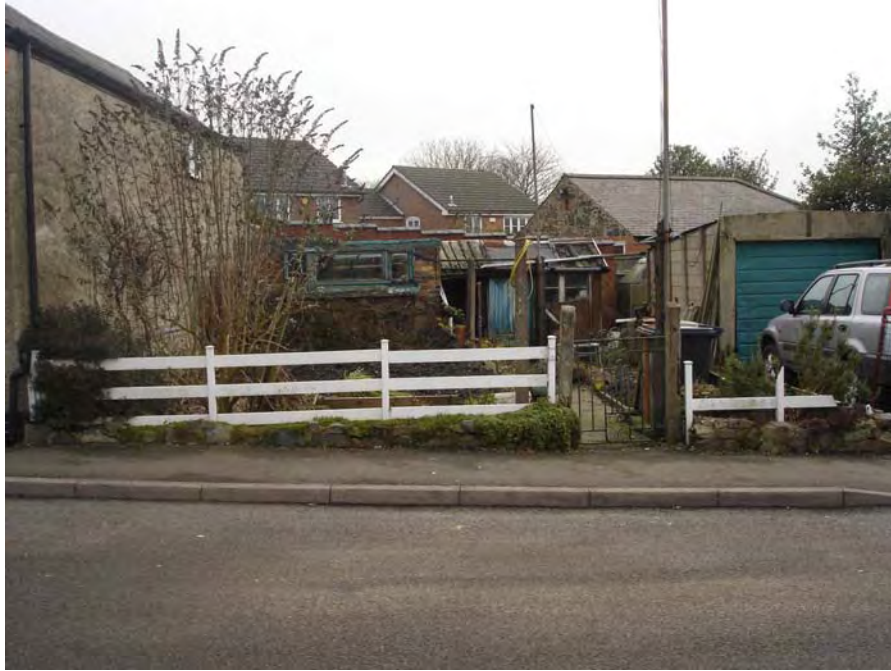
The untidy area of land could be improved if the fence was to be replaced with a granite wall or re-developed.

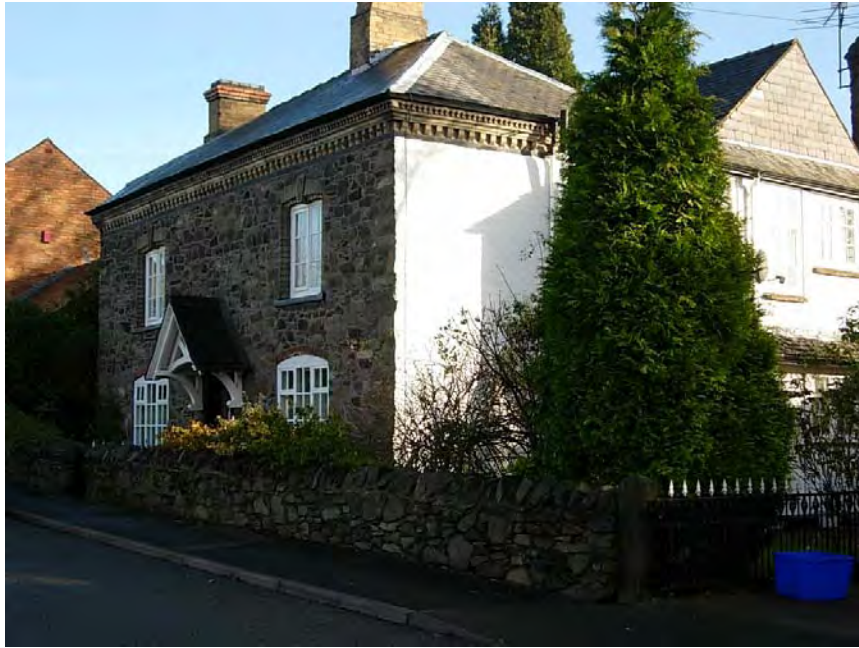
188 Main Street is an attractive property with a slate roof and decorative dentil course along its eaves. Unfortunately, it has lost its chimney pots.

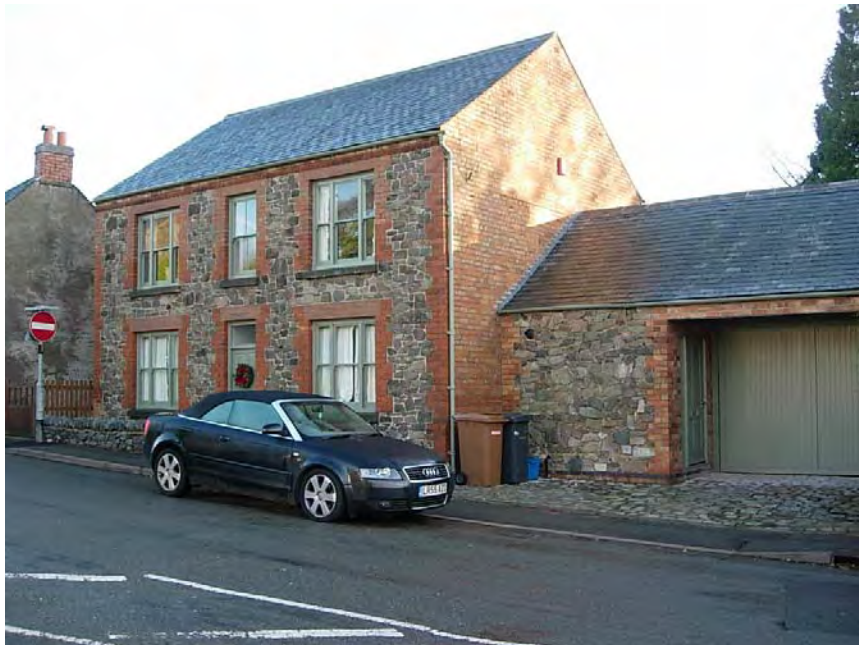
192 Main Street is a fine property that has retained its sash windows but has lost its chimney stacks.

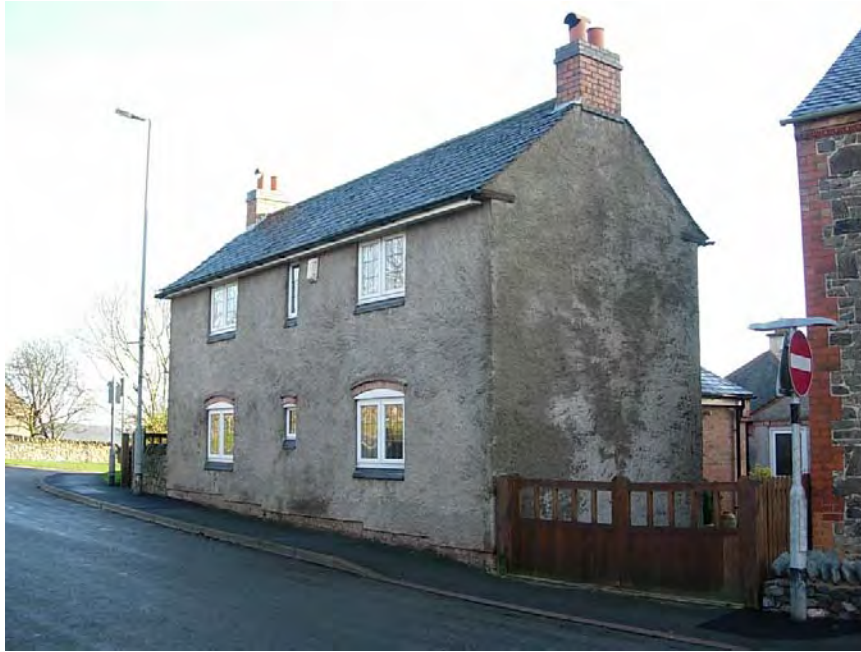
194 Main Street is an interesting property at the junction of Main Street and Leicester Road that suffers from inappropriate render and plastic windows.

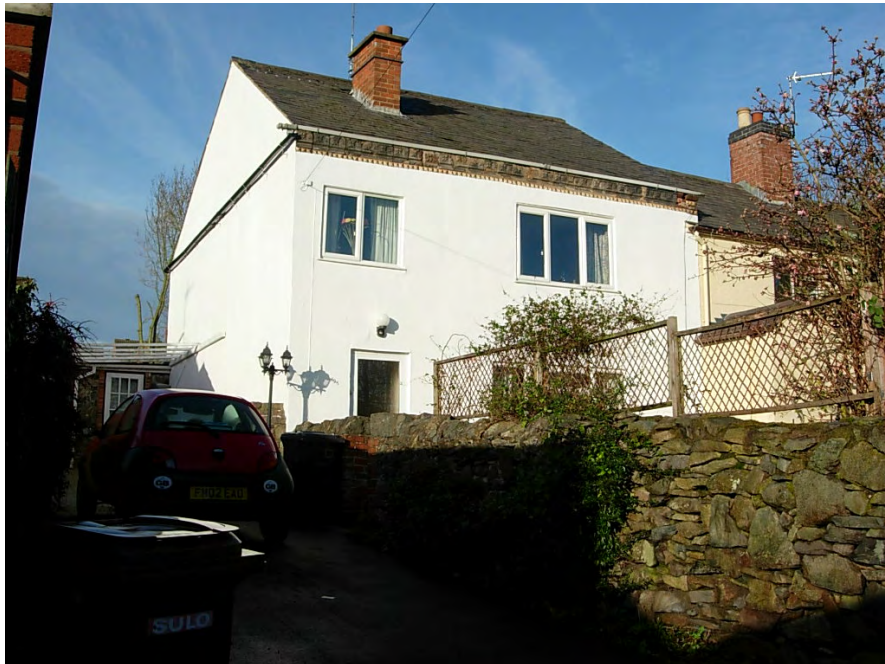
The increase in window openings at 195 Main Street has had a detrimental impact on its appearance.

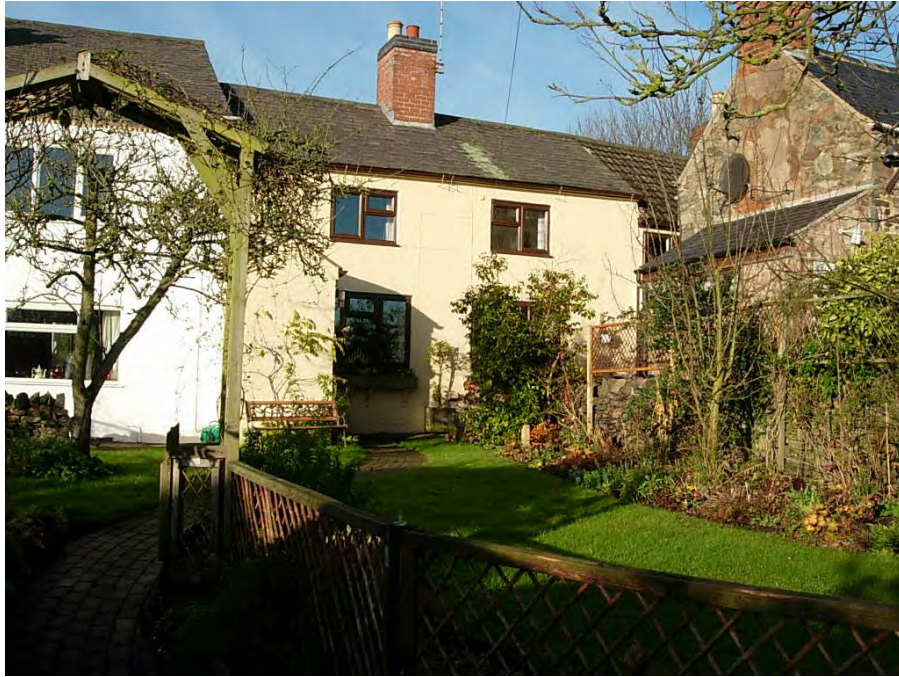
197 Main Street is part of a very interesting group of buildings that have unfortunately been changed by the use of modern materials.

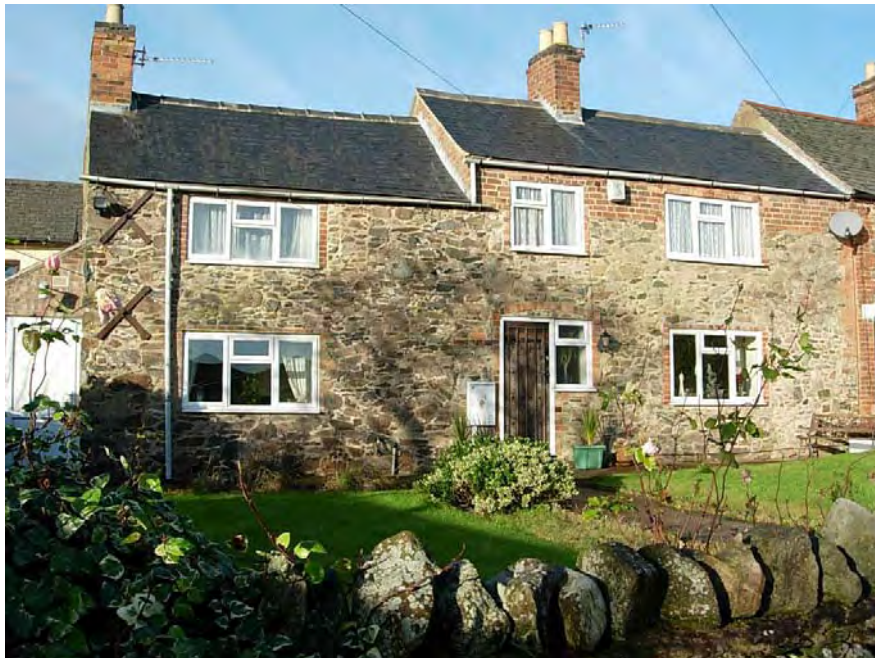
201 & 203 Main Street are part of an attractive terrace with a stepped roof. Unfortunately, their modernization has resulted in the window openings being enlarged and replaced with plastic windows. The chimneys are important features.

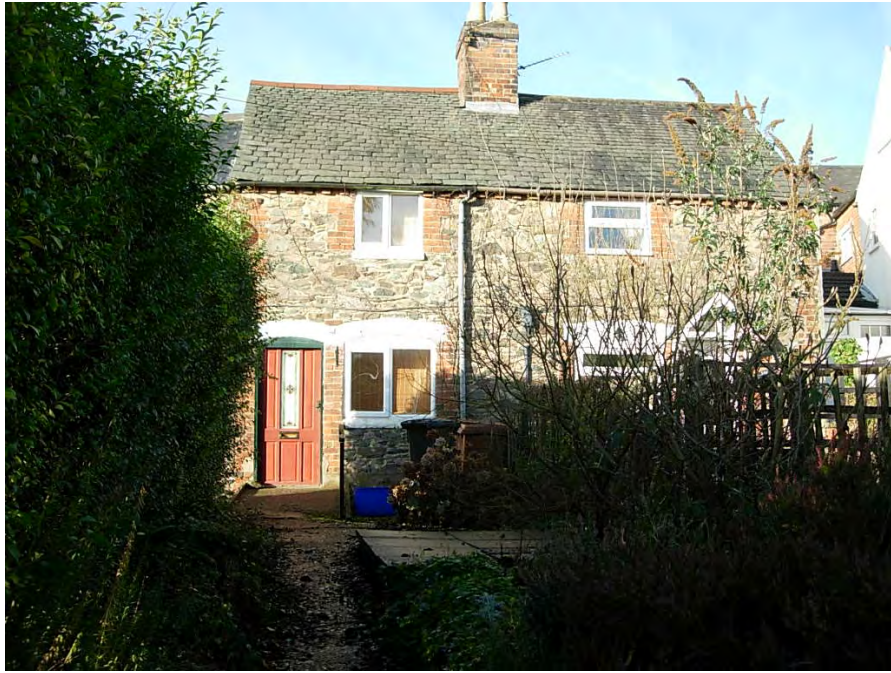
207 - 209 Main Street has retained many original features including a slate roof and chimney, unfortunately its appearance is damaged by plastic windows.

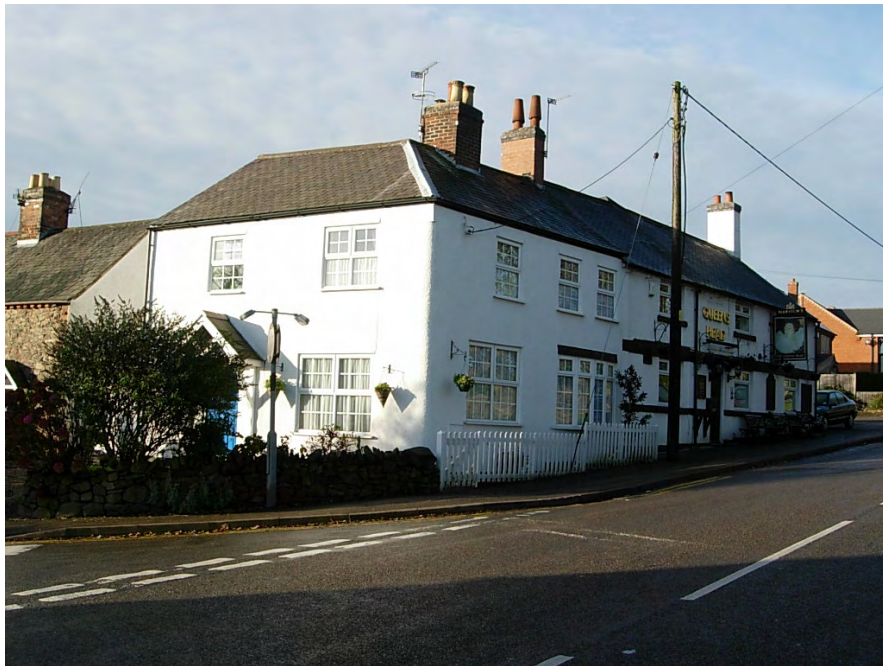
211 Main Street and the Queens Head pub on Ashby Road have retained their slate roof and chimneys but the plastic windows have a detrimental impact.

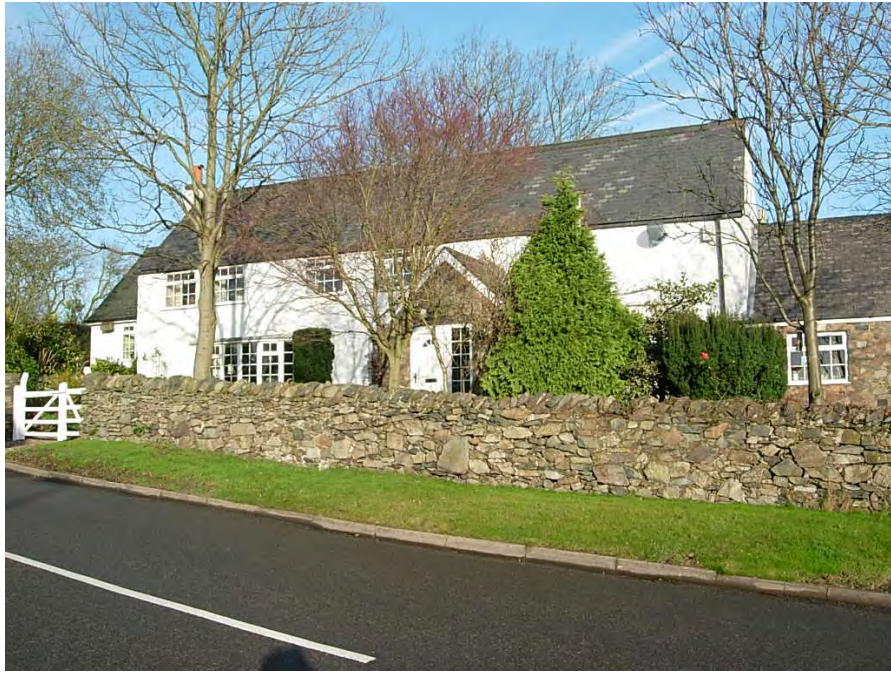
Townhead Farm sited on Ashby Road is sited well back from the road. The Property has an excellent granite wall running along its frontage enclosing a well landscaped garden. Unfortunately, a bow window and plastic windows have been inserted.

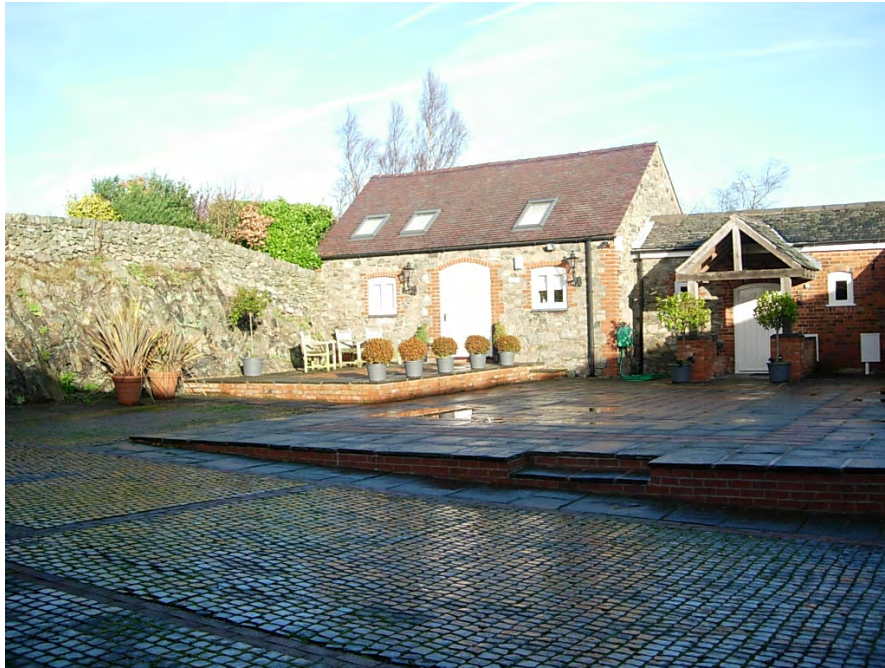
View of the outbuildings at Townhead Farm that have been converted to residential use. The roof lights on the front elevation are very prominent and do not enhance its appearance.

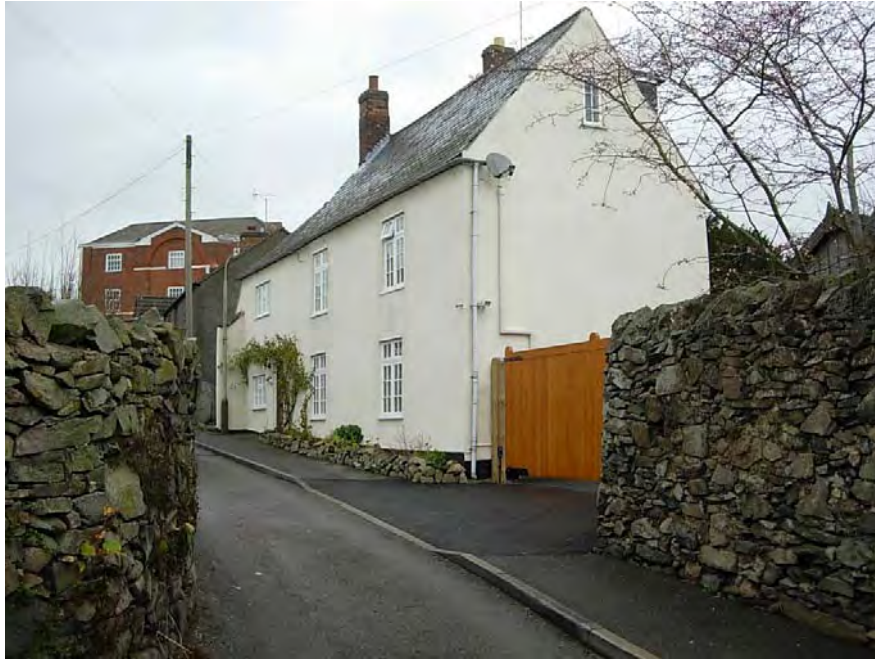
The charm of The Nook could be improved if the existing street lights were replaced with traditional heritage lights.

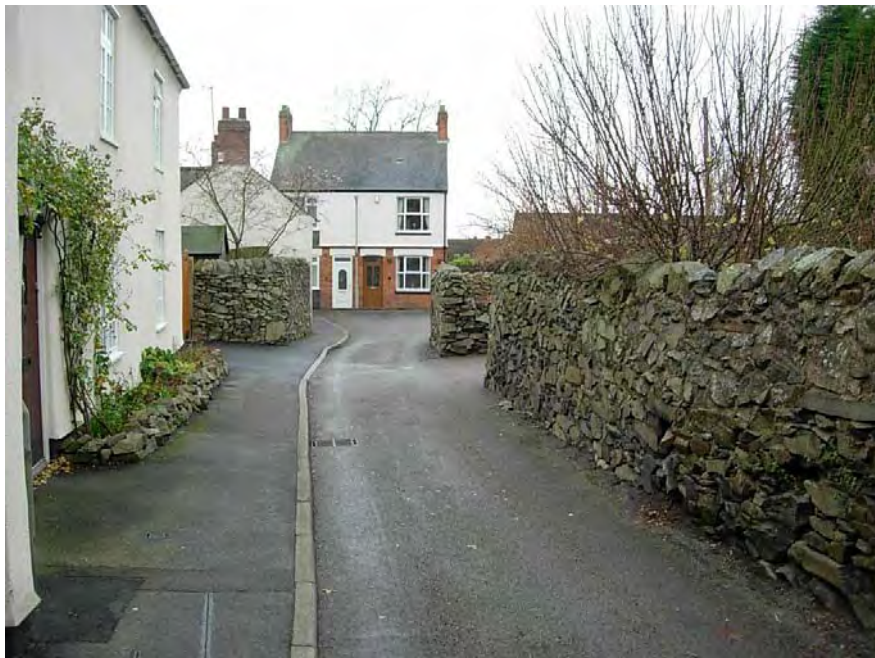
The high granite walls running down The Nook are important features that are part of its charm. It is important that the walls are retained and it is suggested that the concrete kerbs running along the edge of the carriageway are replaced with granite kerbs.

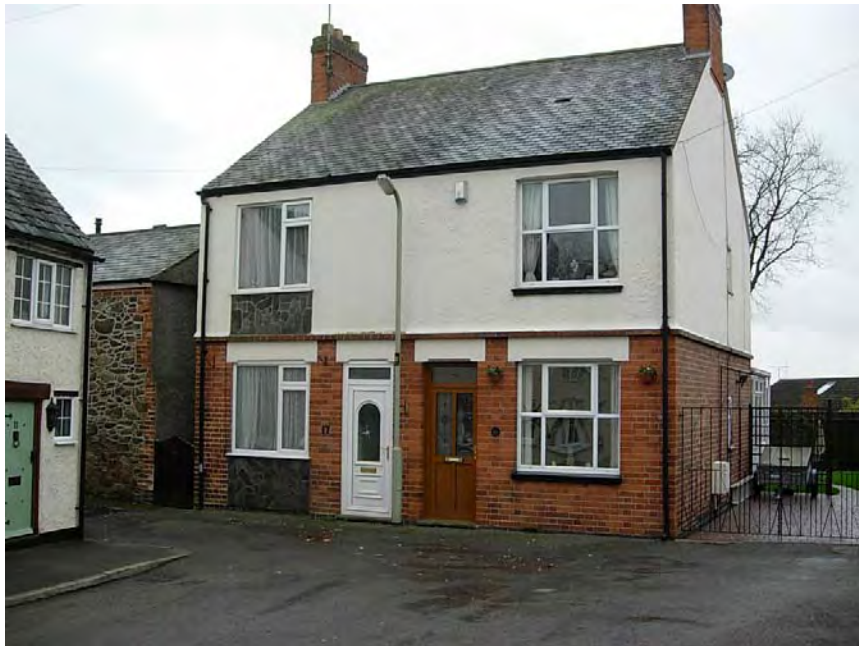
The unity of the semi-detached dwellings, 17–19 The Nook, has been lost with the use of stone cladding under the windows of one of the properties.

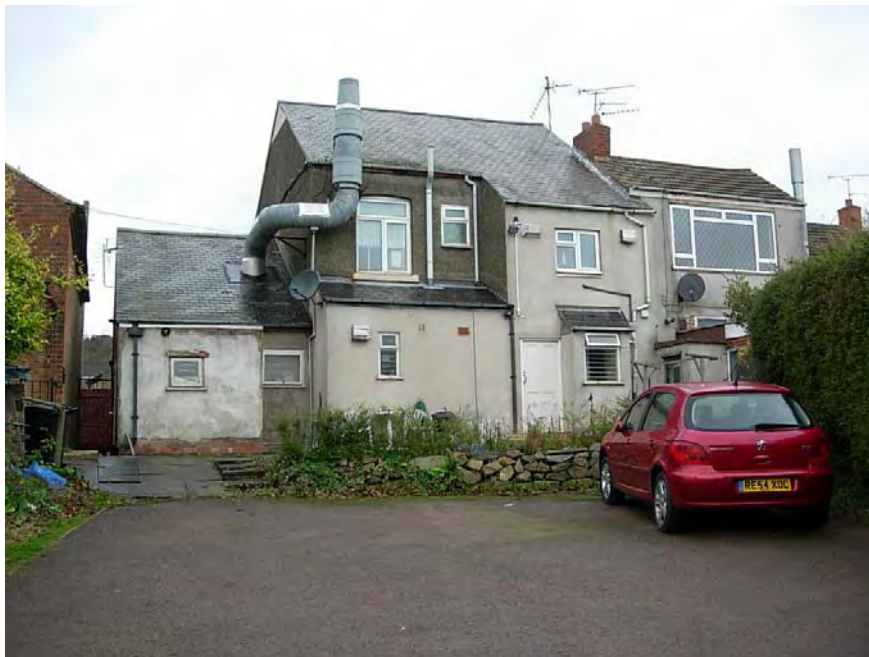
Views to the rear of properties fronting Main Street are particularly unattractive due to the unsightly metal extract flue and extensions and alterations to the original structure.
