**ASHBY CANAL
CONSERVATION AREA
MANAGEMENT PLAN**

**PHOTOGRAPHIC RECORD
OF THE BRIDGES LOCATED IN THE
ASHBY CANAL CONSERVATION AREA**

November 2009

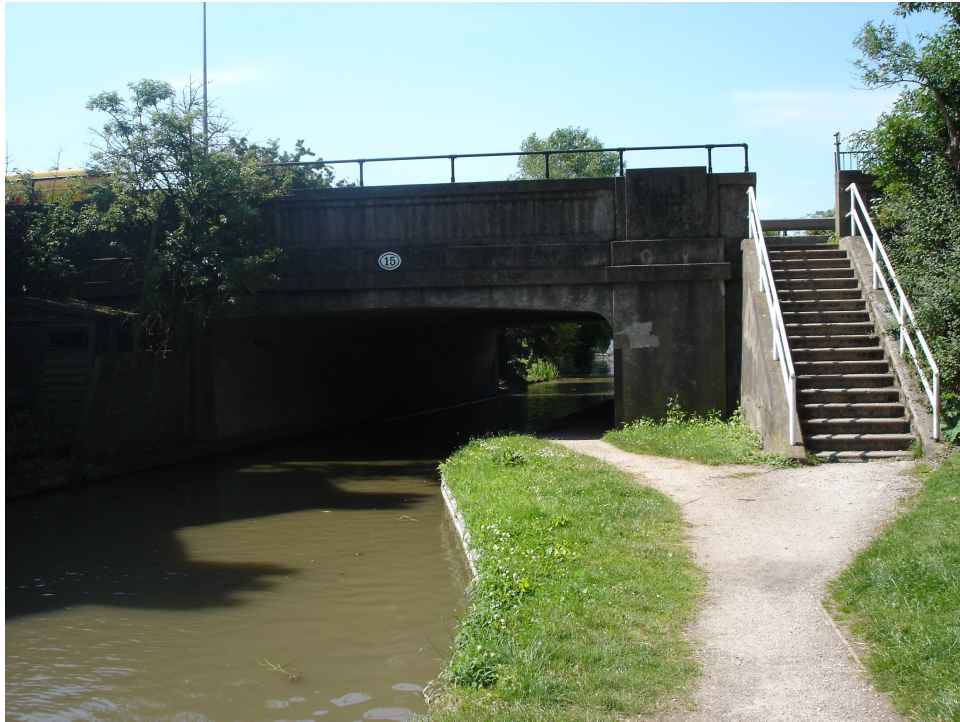
Bridge 15 (Watling Street Bridge) Northern Elevation
The bridge is a major concrete structure that carries the A5 Watling Street over the canal

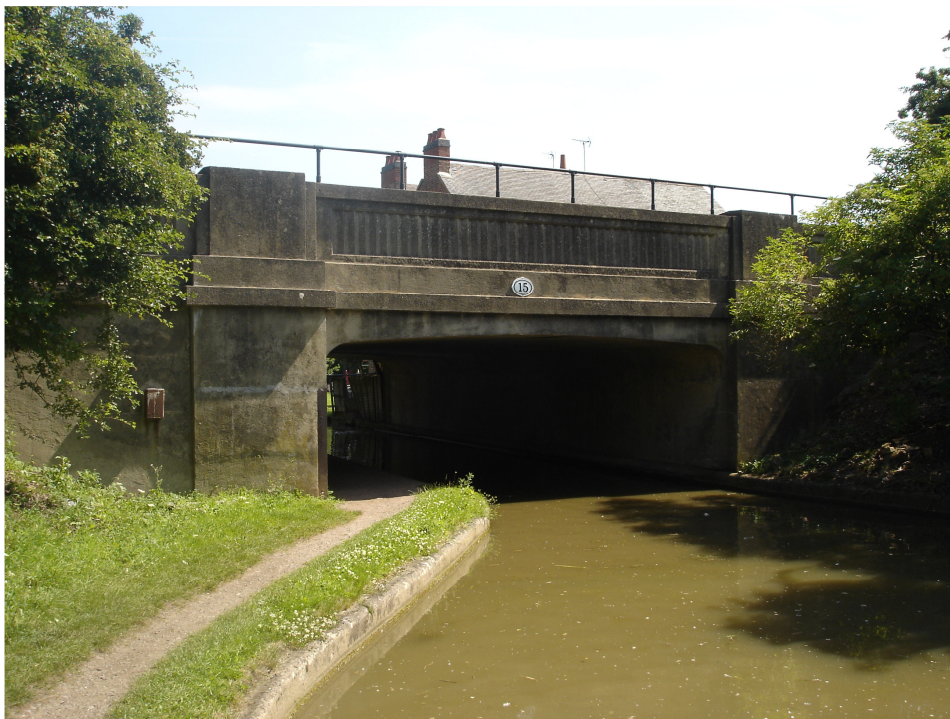
Bridge 15 Southern Elevation
Although the bridge is not a brick structure, it has a neutral impact on the canal

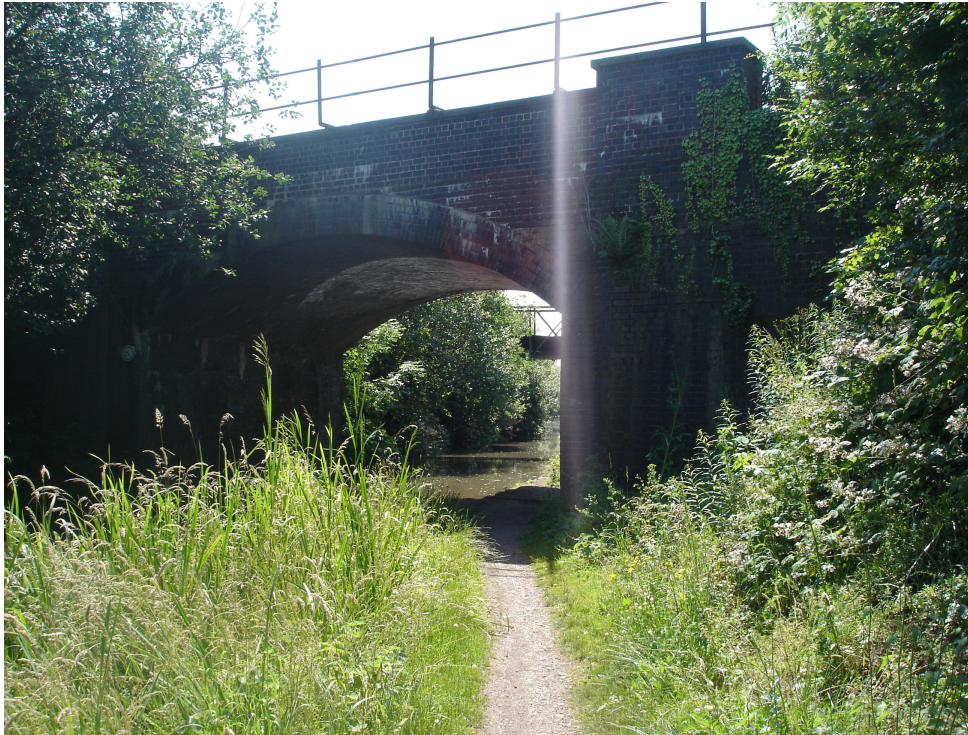
Leicester to Nuneaton Railway Bridge, Northern Elevation
This railway bridge is a fine brick structure in good condition.
Unfortunately, the modern safety railings that have been
added to the parapet detracts from its appearance

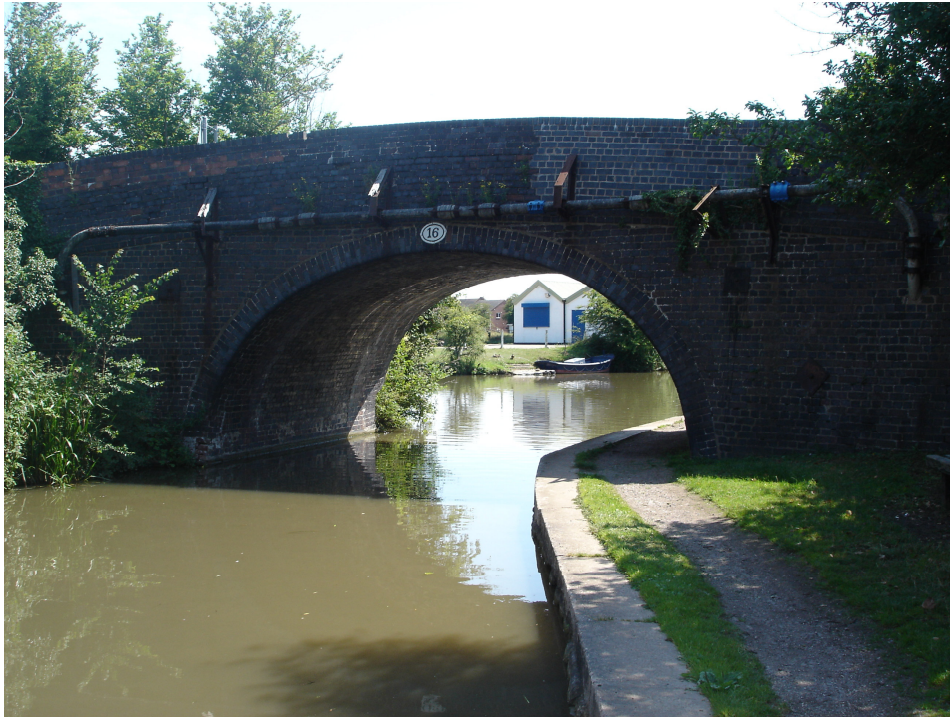
Bridge 16 (Nutt's Bridge) North Elevation

This single lane road bridge on Nutts Lane needs repairs to its brickwork. The pipes and cables running along its parapets need to be removed to enable its simple traditional design to be appreciated.

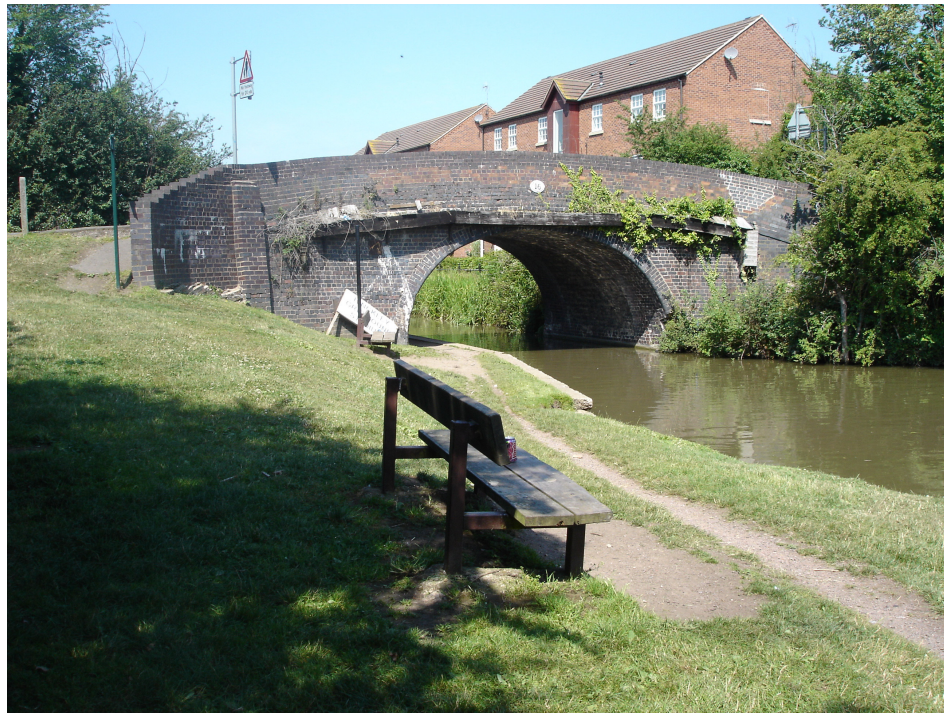
Bridge 16 Southern Elevation

The vegetation needs removing and brick work repaired

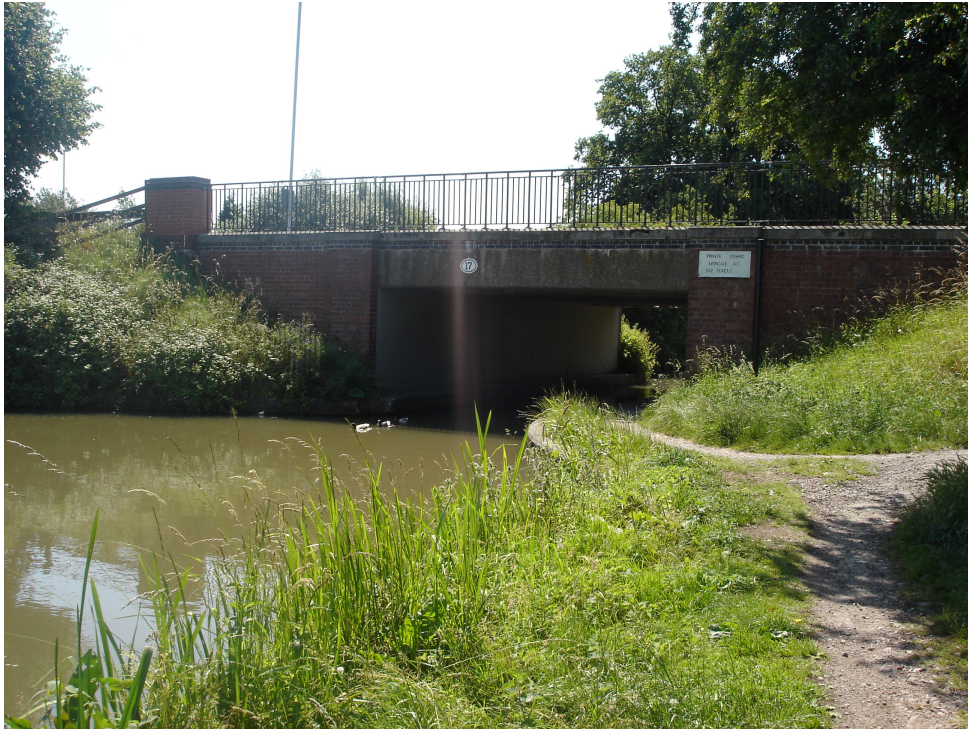
Bridge 17 (Coventry Road Bridge) Northern Elevation
This modern concrete road bridge that takes traffic on Coventry Road is out of character with the canal.

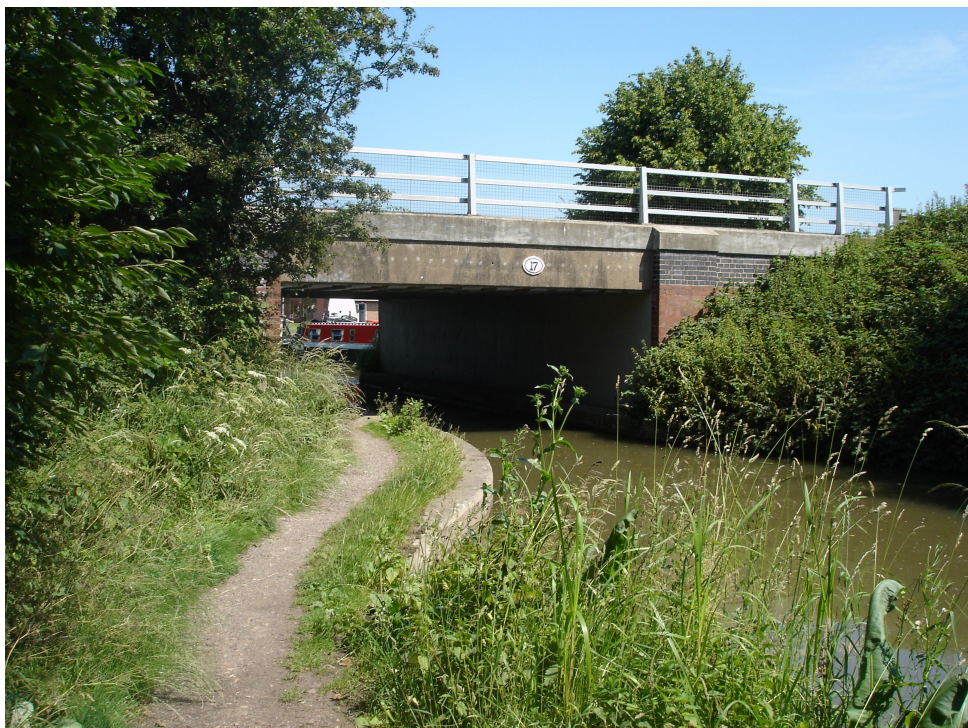
Bridge 17 Southern Elevation
The bridge has two different styles of railings on its opposite elevations. This could be improved by the adoption of a consistent approach to this feature

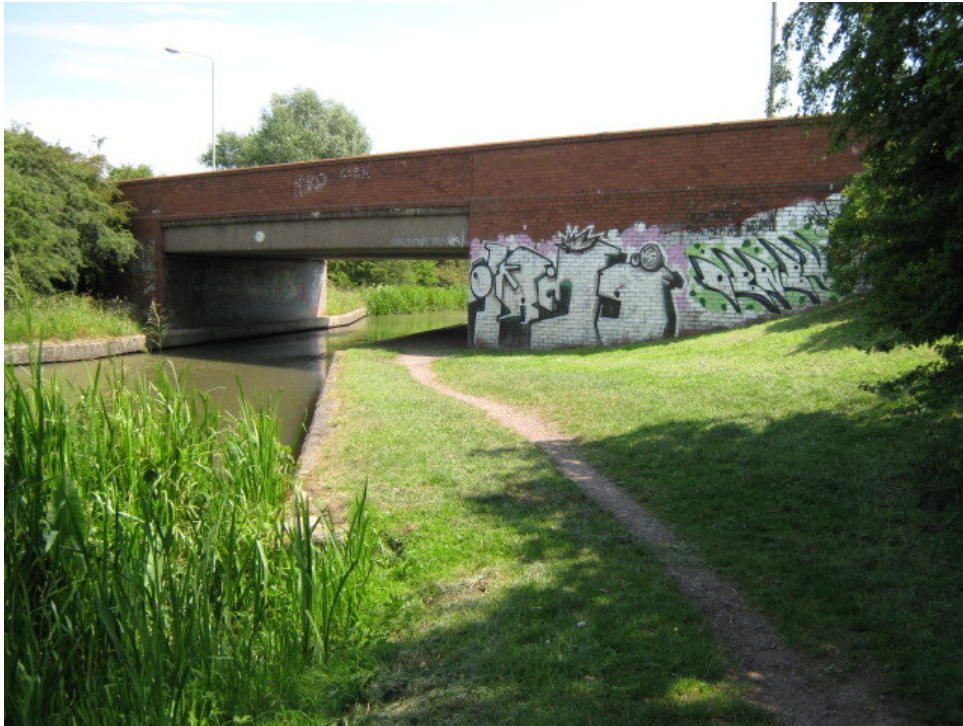
Bridge 17a (Dodwell's Road Bridge) North Elevation
This modern concrete road bridge is out of character with the canal.
The bridge was built in the 1970's and forms part of the Hinckley
Northern Perimeter Road. It has been heavily painted

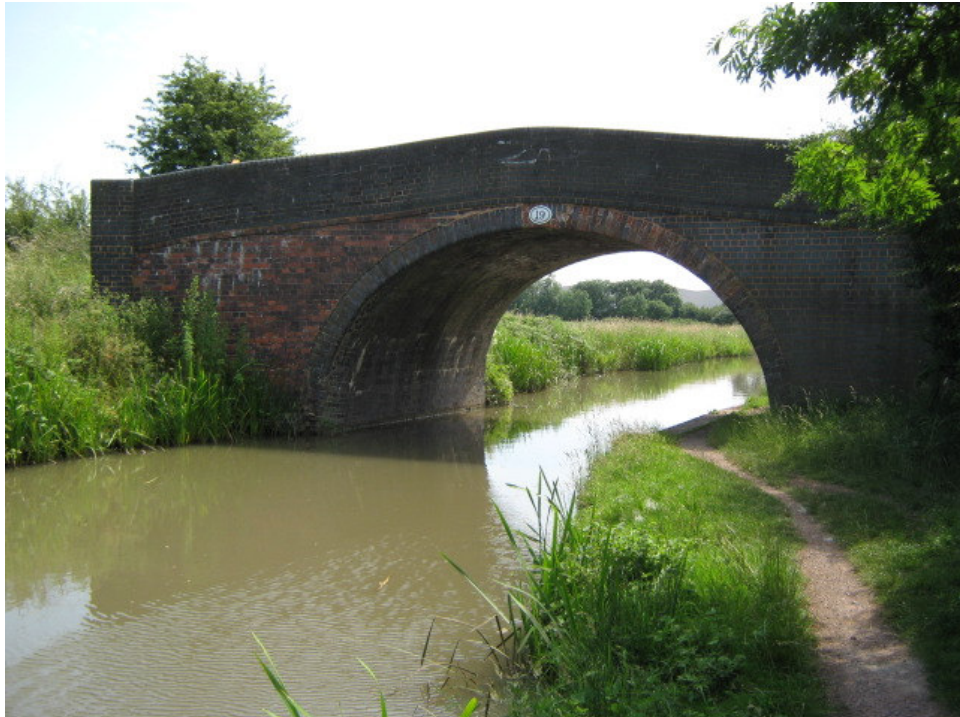
Bridge 19 (Barn Lane Bridge) North Elevation

This accommodation bridge has been partially re-built in matching brickwork. When Bridge 18 was demolished in the 1980's the public footpath U6 was diverted along the canal towpath and over Bridge 19

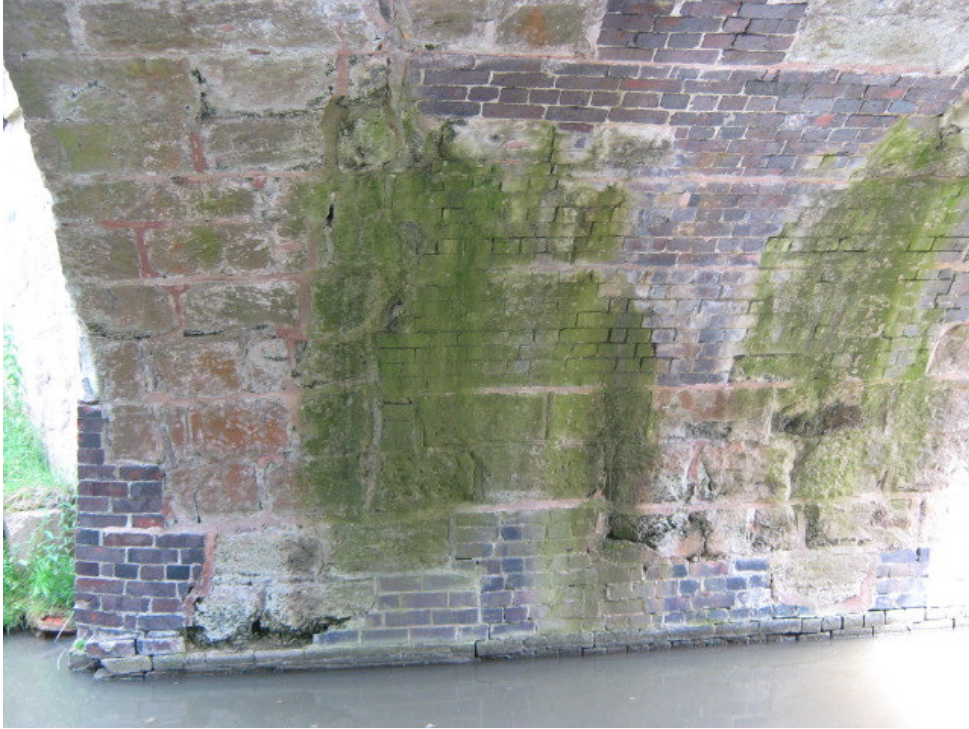
Bridge 20

Unfortunately, repairs to arch have been carried out in brickwork although this has weathered and now adds interest. Some brickwork at water level needs repairing

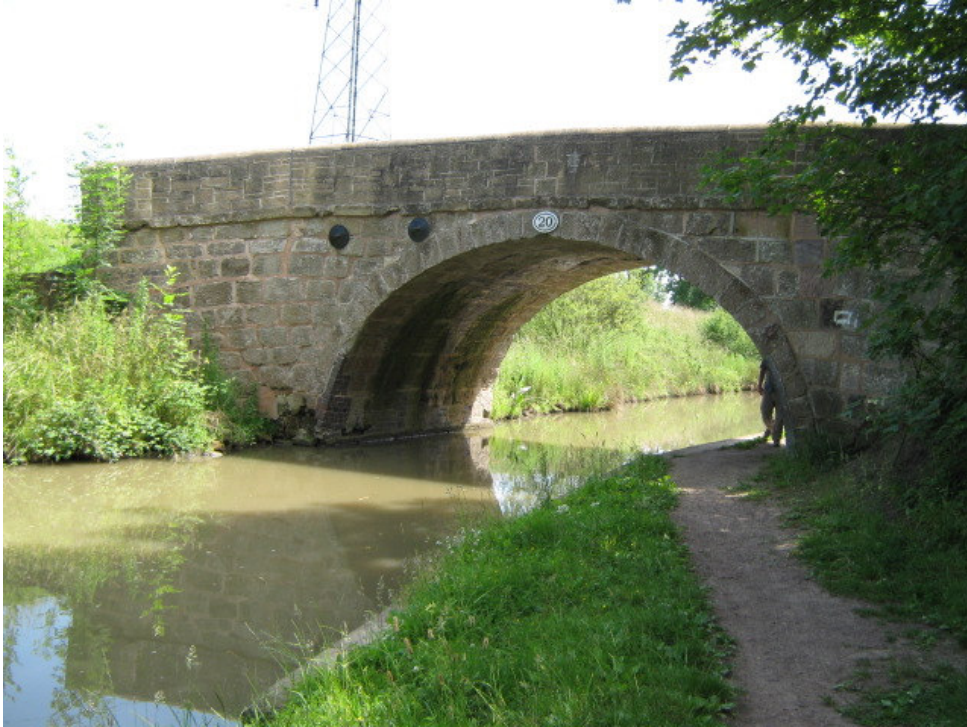
Bridge 20 (Frieston's Bridge) North Elevation

This bridge is unusual because it is the only stone bridge on the canal in the Borough. Unfortunately, the stone copings have been replaced with concrete copings which has a detrimental impact

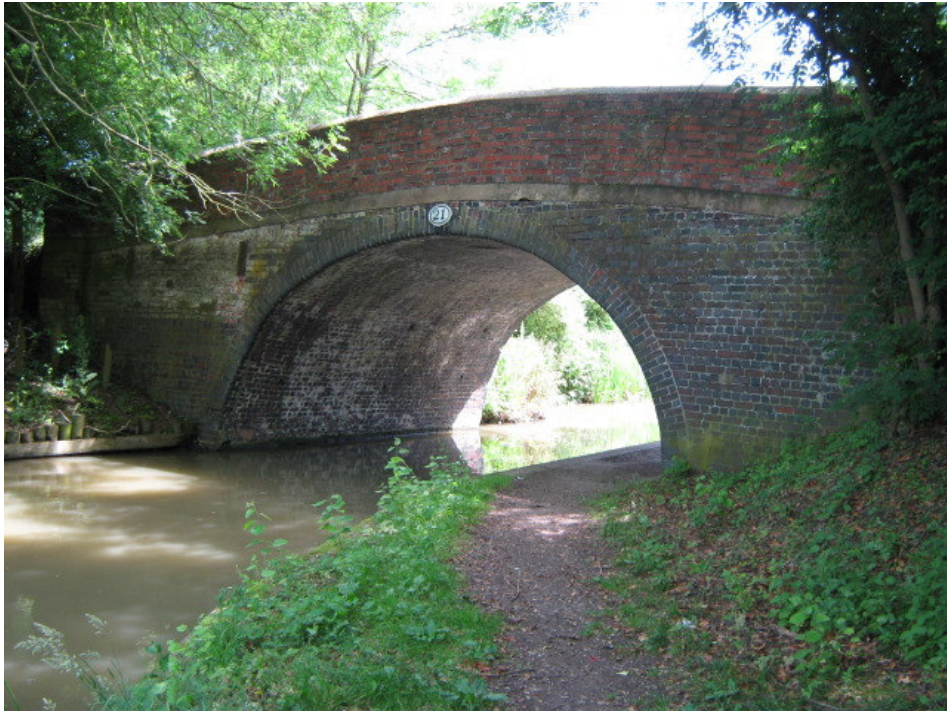
Bridge 21 (Wykin Bridge) North Elevation
This bridge is in fair condition with no obvious repairs needed

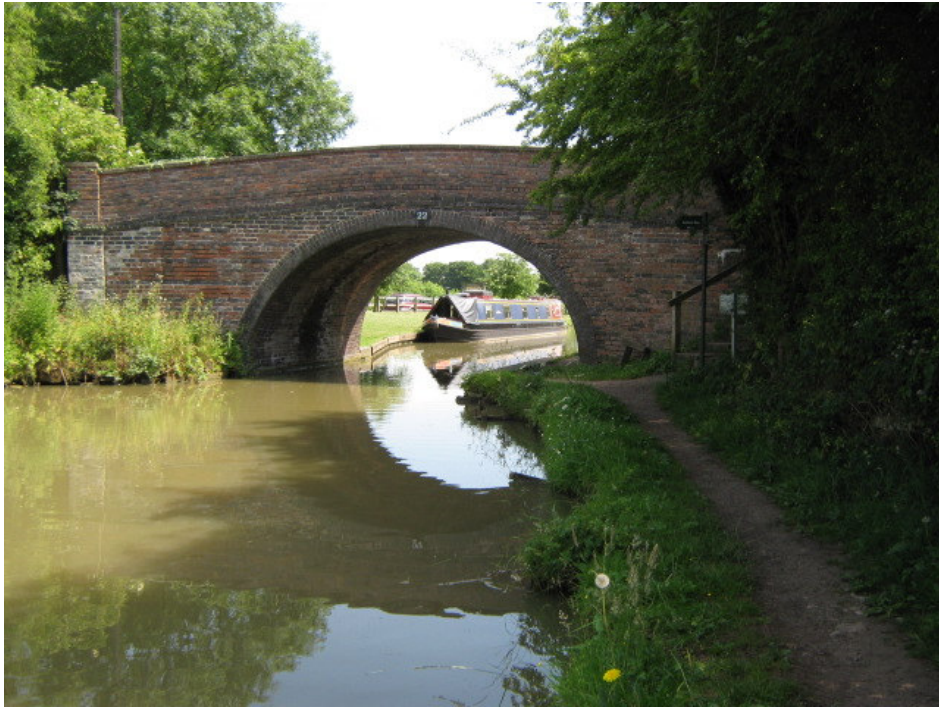
Bridge 22 (Basin Bridge) North Elevation
This bridge is in need of repairs

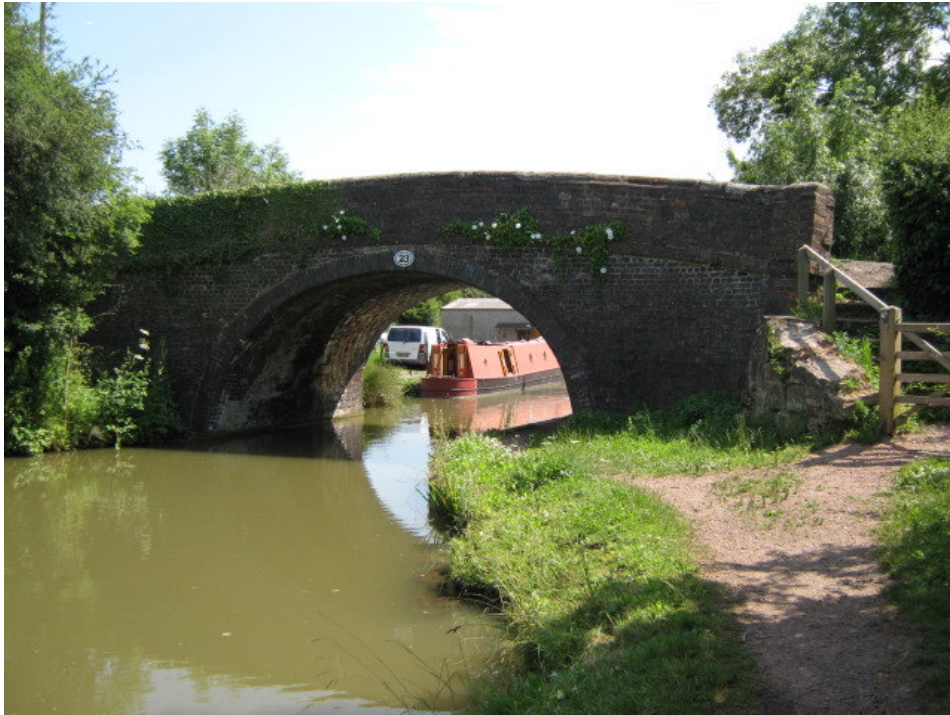
Bridge 23 (Higham Bridge) North Elevation
This brick road bridge is generally in fair condition although the wall needs repairing

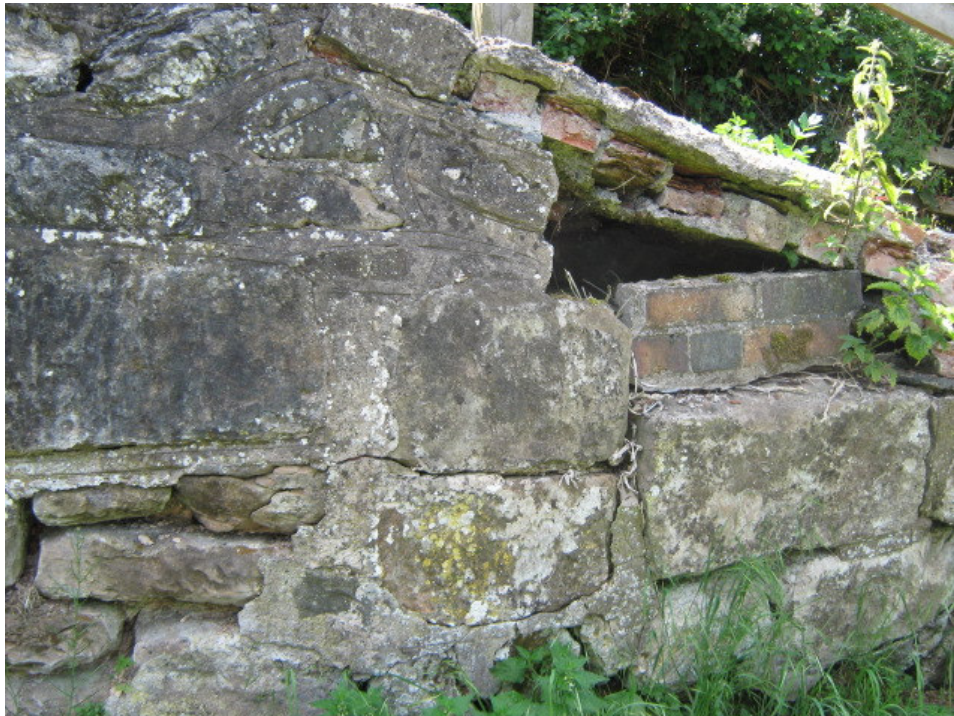
Bridge 23 showing the towpath access needs repairing

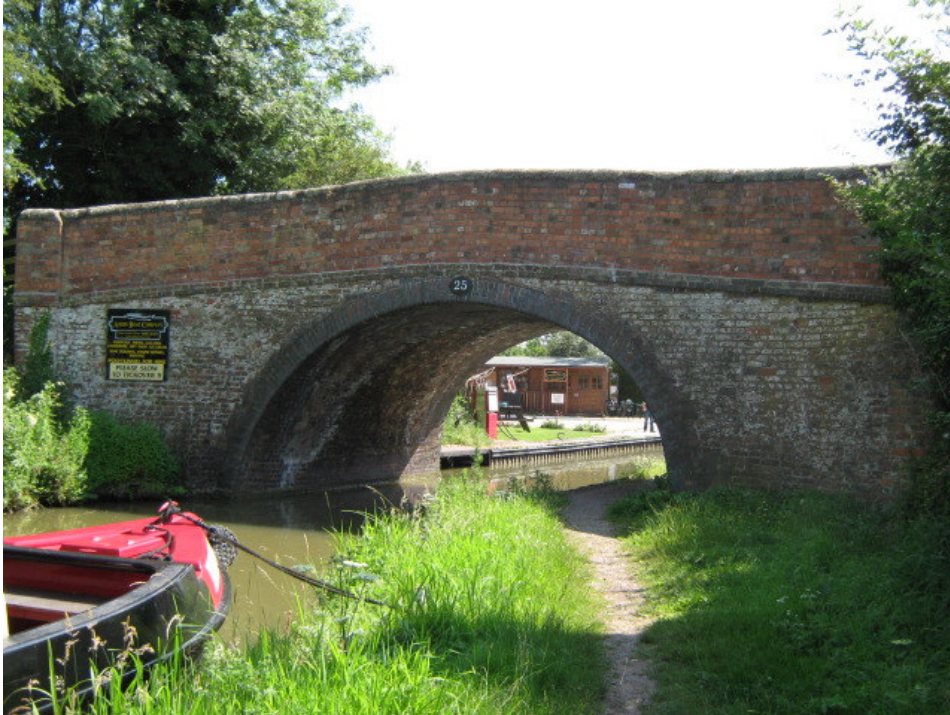
Bridge 25 (Stoke Golding Wharf Bridge) North Elevation
Although this road bridge is in a good state of repair, its parapets have been replaced with non matching brick work

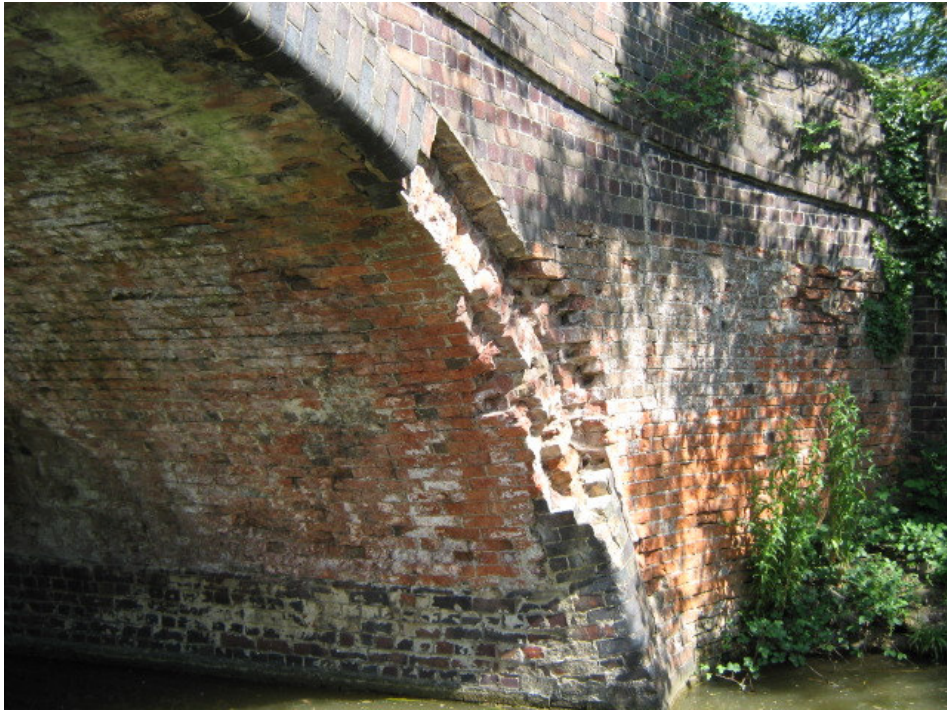
Bridge 26 South Elevation
The arch's brickwork is collapsing and in need of repair

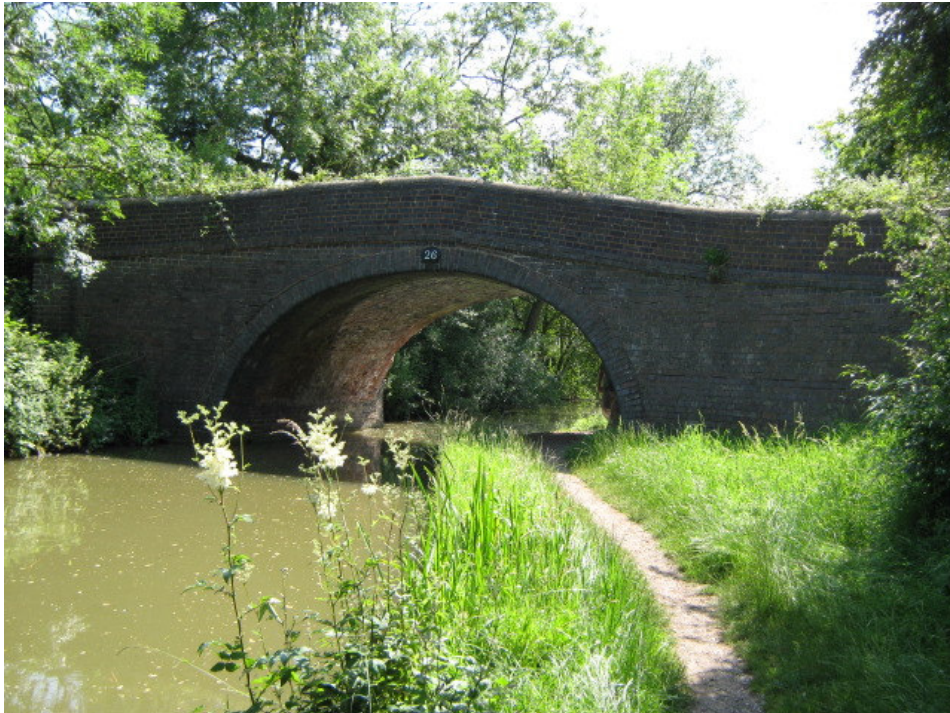
Bridge 26 (Foxwell's Bridge) North Elevation
The bridge needs repairs at water level
