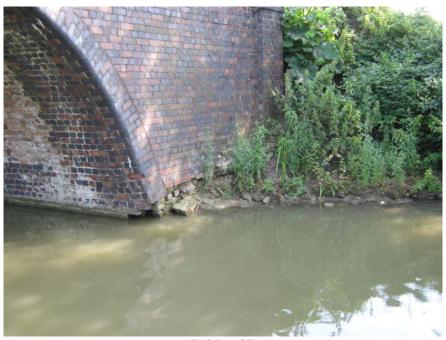
Bridge 27
Some repair work is needed at water level

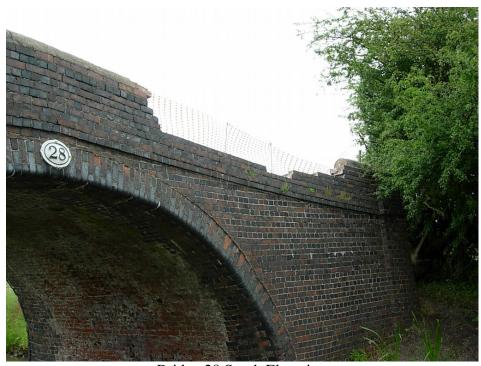
Bridge 28 South Elevation
The parapets are in need of urgent re-construction and are considered to be dangerous to both boat and towpath users

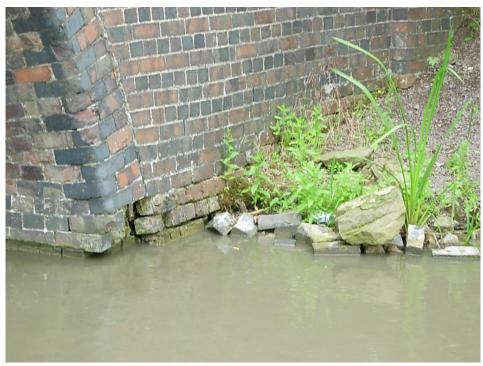
Bridge 28
Urgent repair works are required to the arches and abutments at water level

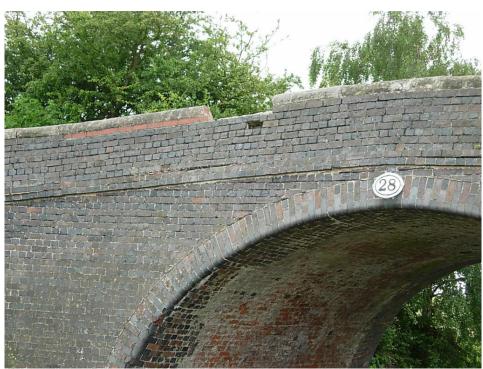
Bridge 28 (Dadlinton Bridge) North Elevation This bridge needs major repairs. The copings are a mixture of concrete and original stone

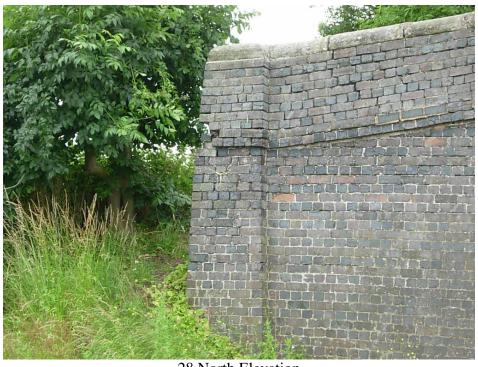
28 North Elevation
The abutments and copings need major repairs

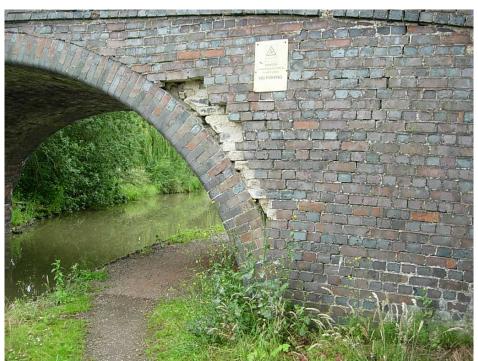
Bridge 29 North Elevation
The abutments and parapets are in urgent need of repair

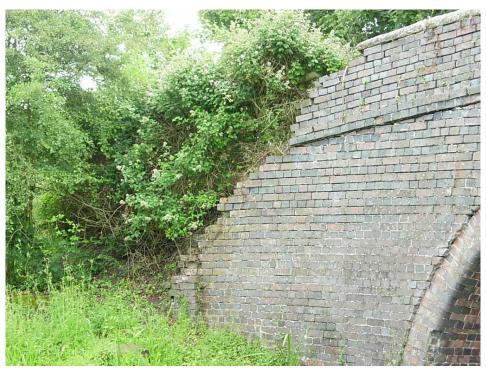
Bridge 29 North Elevation
The abutment and parapets are collapsing and in urgent need of repair

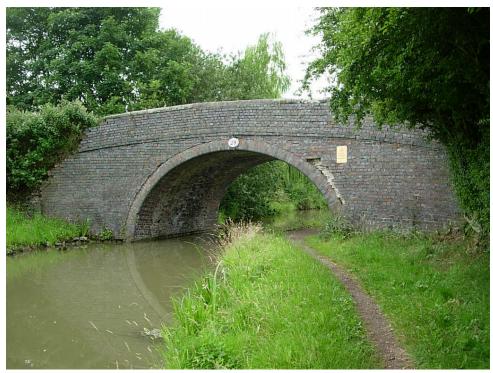
Bridge 29 (Allotments Bridge) North Elevation This private accommodation bridge is in poor condition and repairs are required to the brickwork

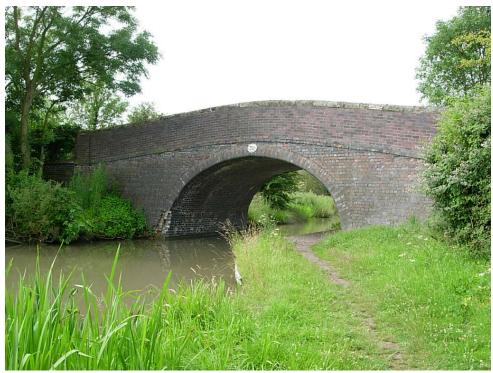
Bridge 30 (Dadlington Wharf Bridge) North Elevation This road bridge has had significant repairs. Unfortunately, the parapets have been rebuilt in stretcher bond although the stone copings have been re-seated and are complete

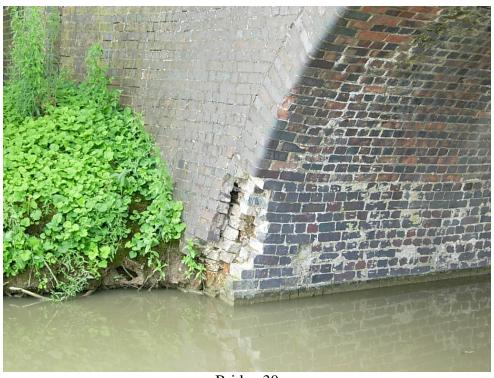
Bridge 30
The springing point of the arch is in need of repair

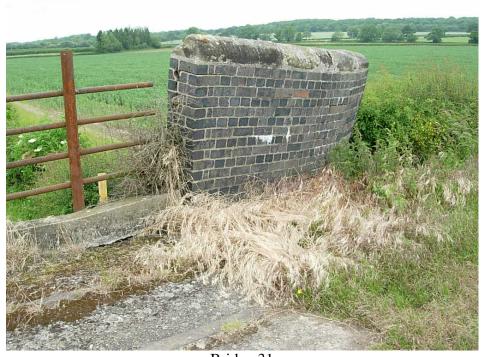
Bridge 31
The parapet has now been taken down and the bricks and stone copings stored at the British Waterways depot

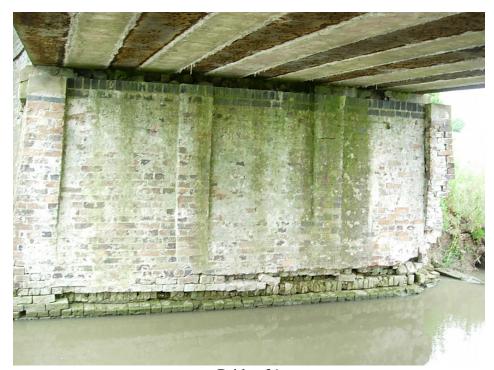
Bridge 31
The abutments at water level are in need of major repair to the brickwork

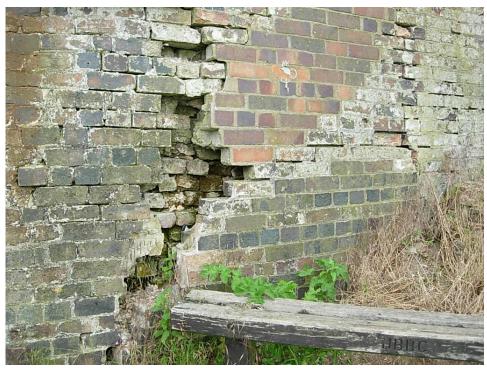
Bridge 31
The eastern abutment is also in need of major repair work

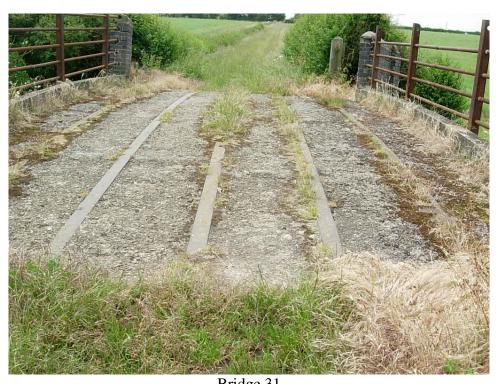
Bridge 31
The structure of the bridge consists of steel beams with concrete infill.
The steel beams could be damaging the abutments due to metal expansion

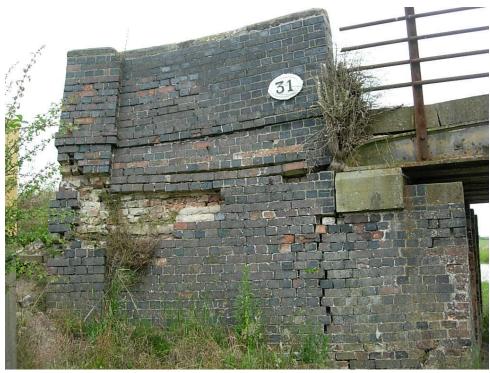
Bridge 31
Showing the parapet which has recently been taken down

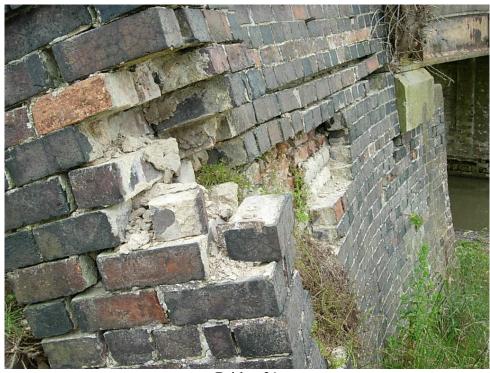
Bridge 31
The abutment requires major repair work

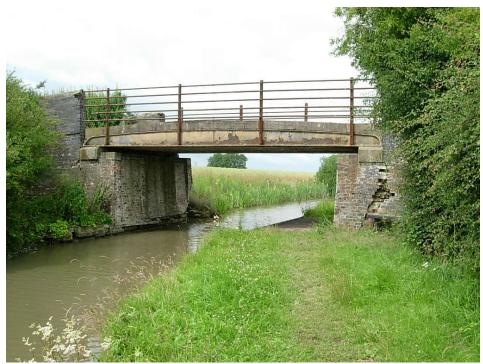
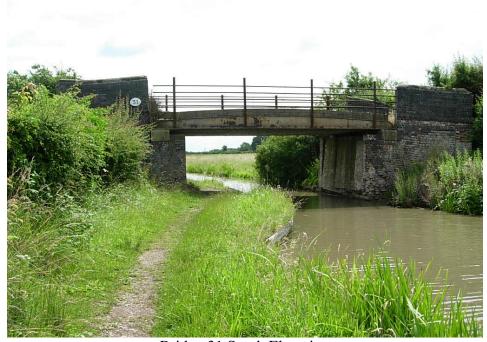
Bridge 31 (Wooden Top Bridge) North Elevation The arch on this accommodation bridge has been replaced with a modern concrete and steel structure

The bridge is in very poor condition. Its northern abutment has partially collapsed and one of the abutment's parapets has recently been taken down because it was dangerous. British Waterways propose to re-build the parapet in April 2010. The parapets across the canal itself are steel railings parts of which are missing. The abutment structure at the waterline needs major repairs

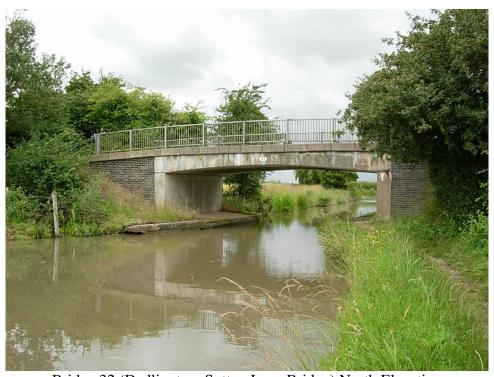
Bridge 32 (Dadlington, Sutton Lane Bridge) North Elevation
This modern concrete road bridge with
metal railings is out of character with the canal

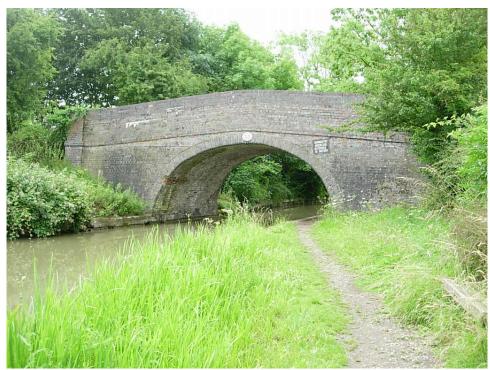
Bridge 33 (Geary's Bridge)North Elevation
This brick structure has a modern
brick soldier course to cap the parapets

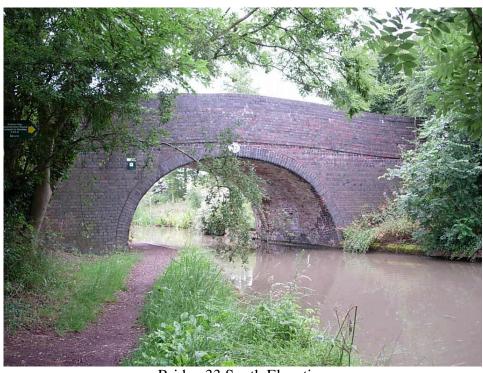
Bridge 33 South Elevation
The brick arch is in need of repairs

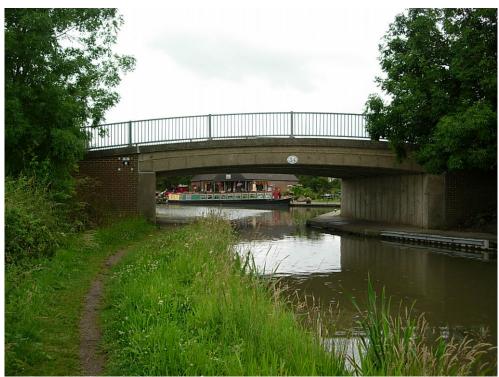
Bridge 34 (Sutton Wharf Bridge) South Elevation
This concrete road bridge has steel railings. Although it is
in good condition, its modern appearance detracts from the
character of the canal at this very important location.

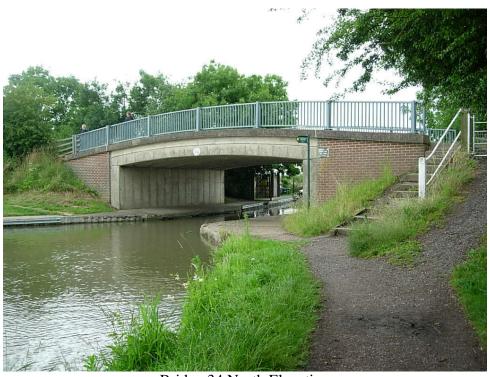
Bridge 34 North Elevation
Insensitive modern railings protect the edge of the steps down to the canal towpath

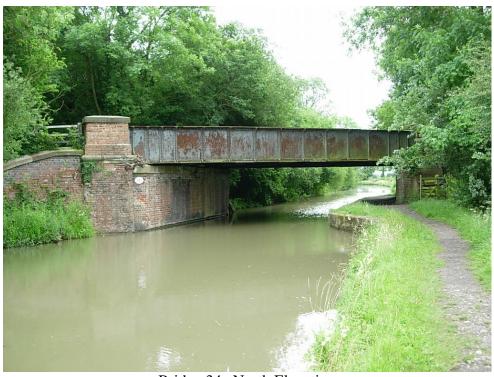
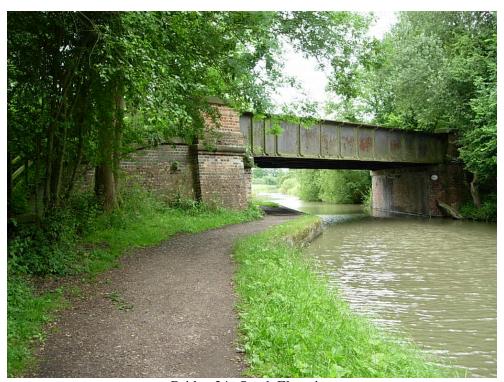
The Bridge's abutments are constructed in red brick with large stone cappings. The steel structure appears sound but is in need of re-painting. It is an important bridge on the canal that adds greatly to its character. A tree growing out of its structure is causing damage and needs removing. This bridge was previously part of the Ashby and Nuneaton joint railway and is one of the gateway's to the Bosworth Battlefield.

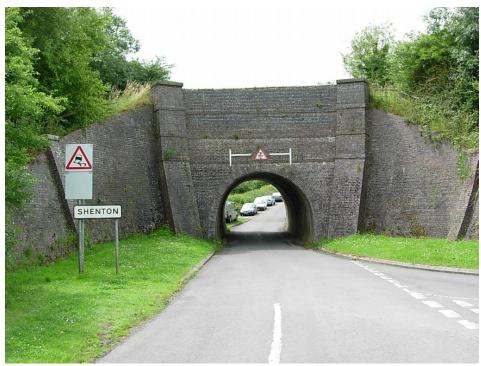
Shenton Aqueduct East Elevation
The aqueduct which crosses the road to Shenton is
constructed of blue brickwork with stone copings. It has been
repaired with red brickwork. The parapets need re-pointing
