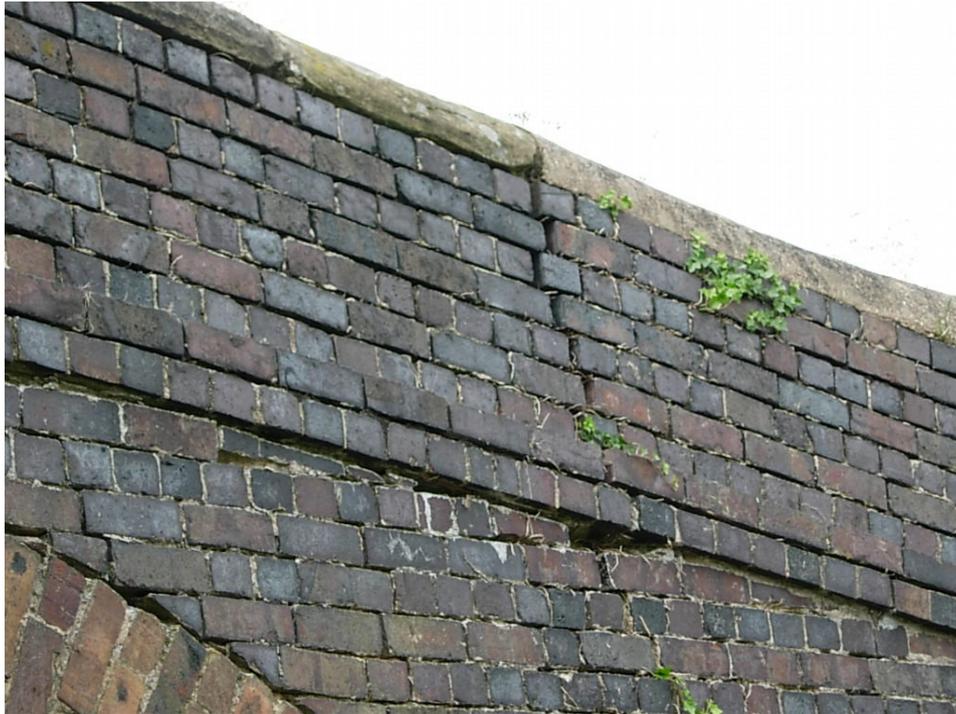
Bridge 36 South Elevation

The crack in the brick parapet requires pointing and a section of concrete coping should be replaced with stone copings

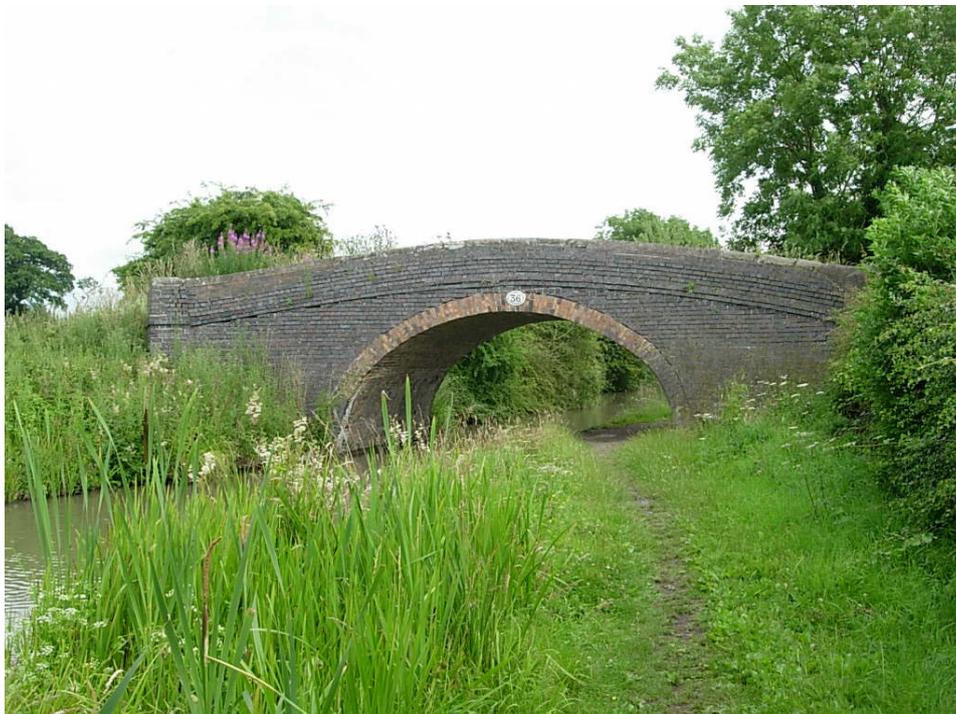
Bridge 36 North Elevation

The north side of the bridge and arch needs re-pointing and half of the stone copings have been replaced with concrete copings.

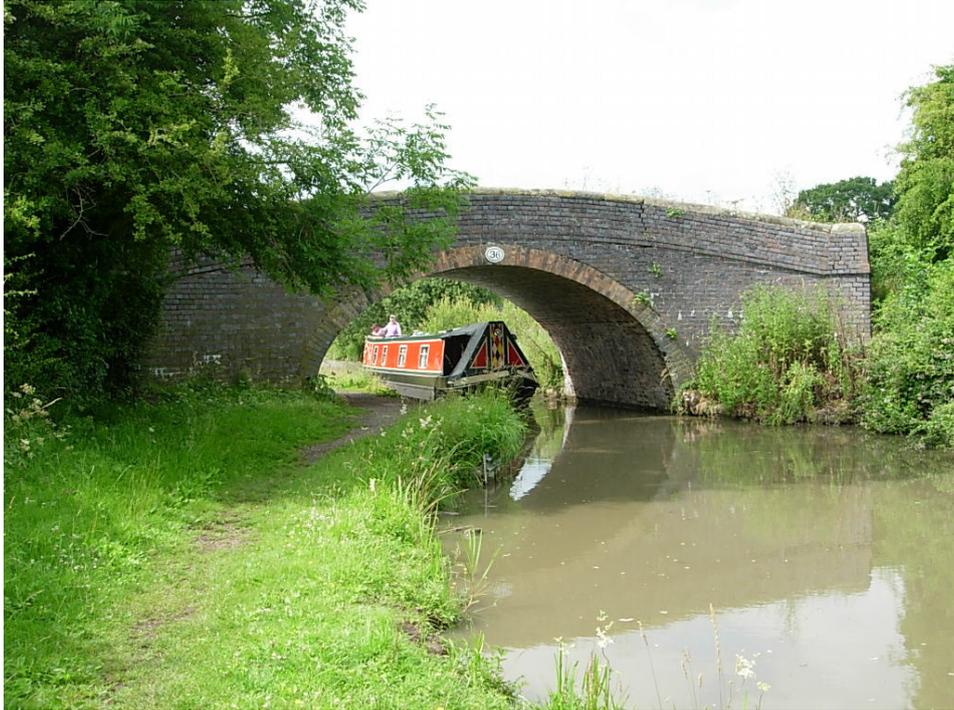
Bridge 36 (Hook's Bridge) South Elevation  
This Bridge is unusual in having a red brick arch with blue brick parapets and buttresses. The parapet needs repointing.

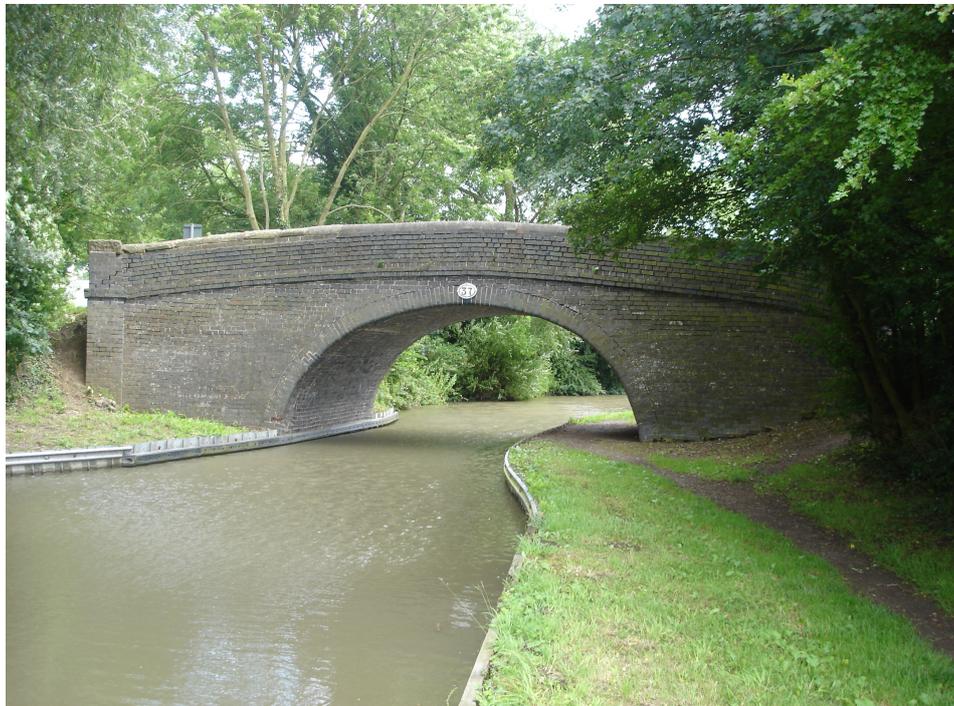
Bridge 37 North Elevation

This road bridge has been repaired with red brickwork that is out of character. The parapets are in need of re-pointing and concrete copings have mainly replaced the original copings. Part of the parapet has recently been badly damaged by a vehicle and needs re-building.

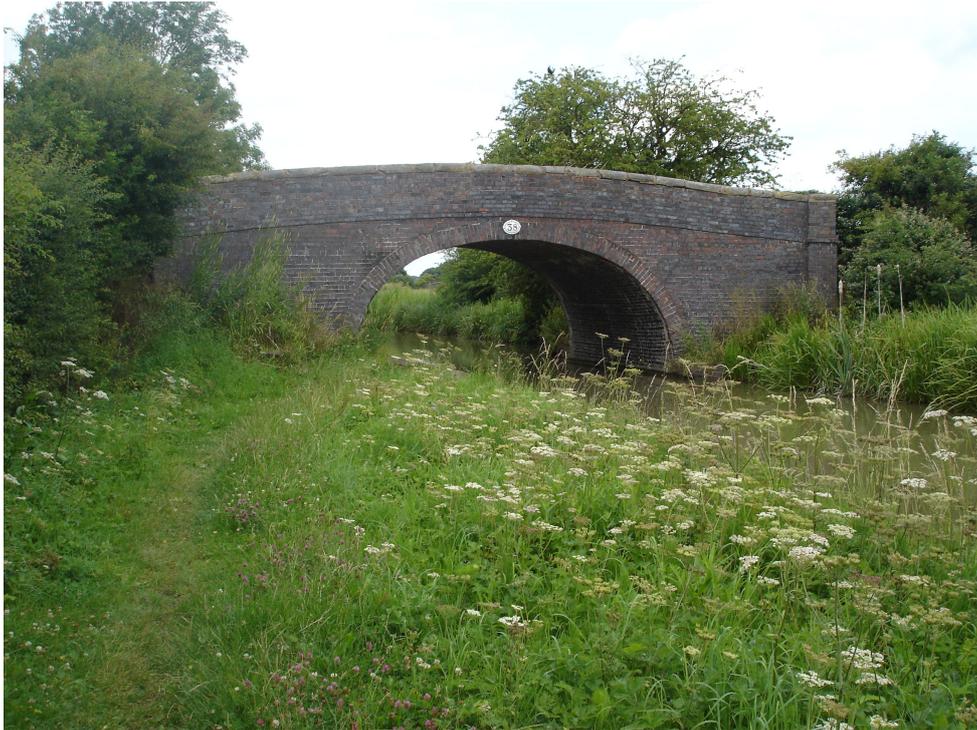
Bridge 38 (Fox Bridge) South Elevation  
A brick bridge in fair condition that has all its stone copings in place on brick parapets.

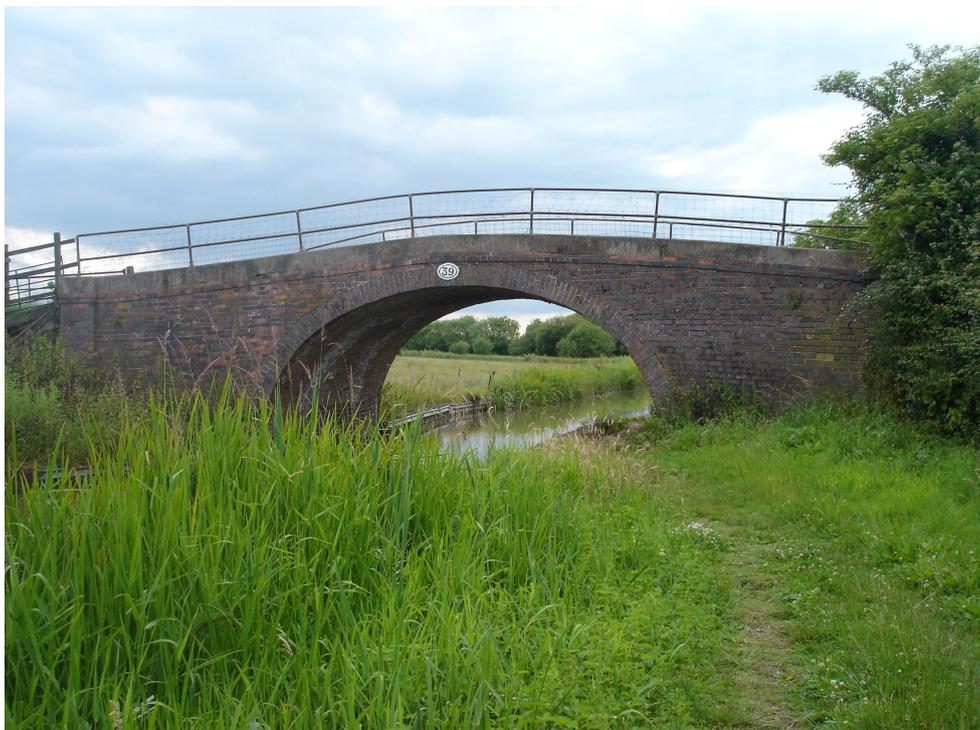
Bridge 39 North Elevation showing the detrimental impact of the railings

This accommodation bridge has had its brick parapets removed and replaced with modern railings. These are unsightly and detract from its appearance. They should be replaced with brickwork to match existing brickwork.

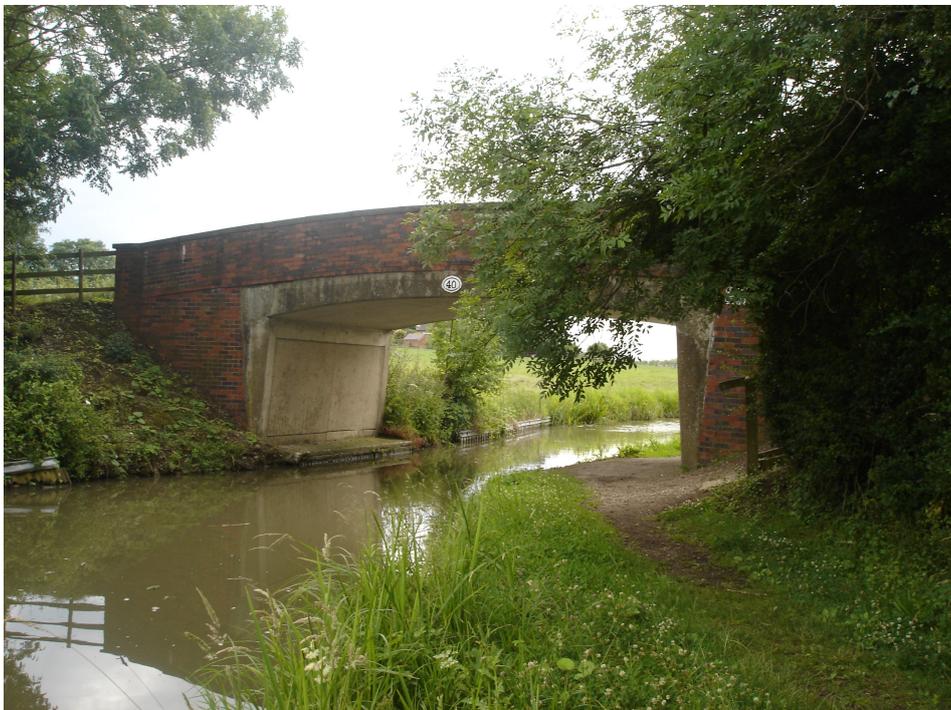
Bridge 40 North Elevation

The bridge is built of red brickwork with concrete copings

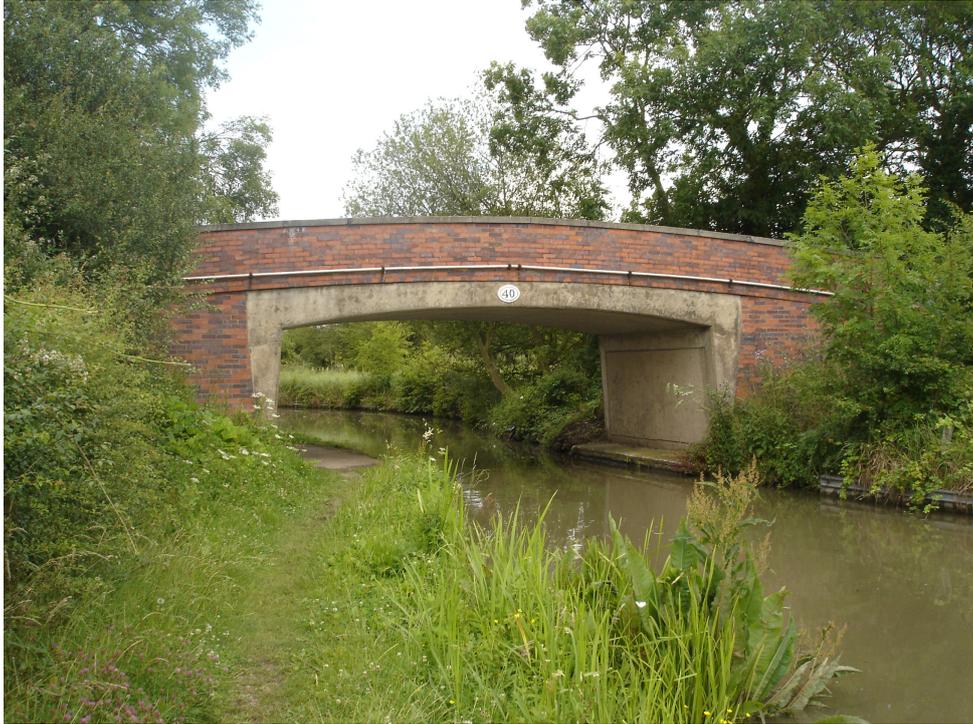
Bridge 40 (Coton Bridge) South Elevation

The original brick bridge has been replaced with a concrete road bridge which out of character with the rural qualities of the canal.

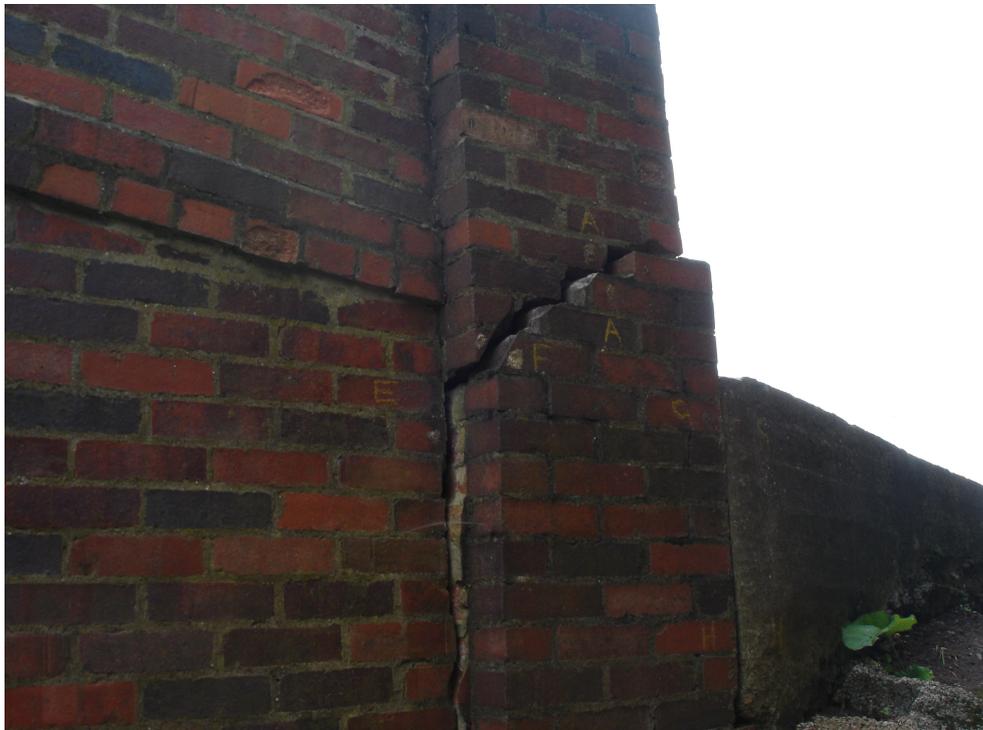
Bridge 40

There is a major crack in the abutments that has been re-pointed but movement is still recurring which has re-opened the fracture
