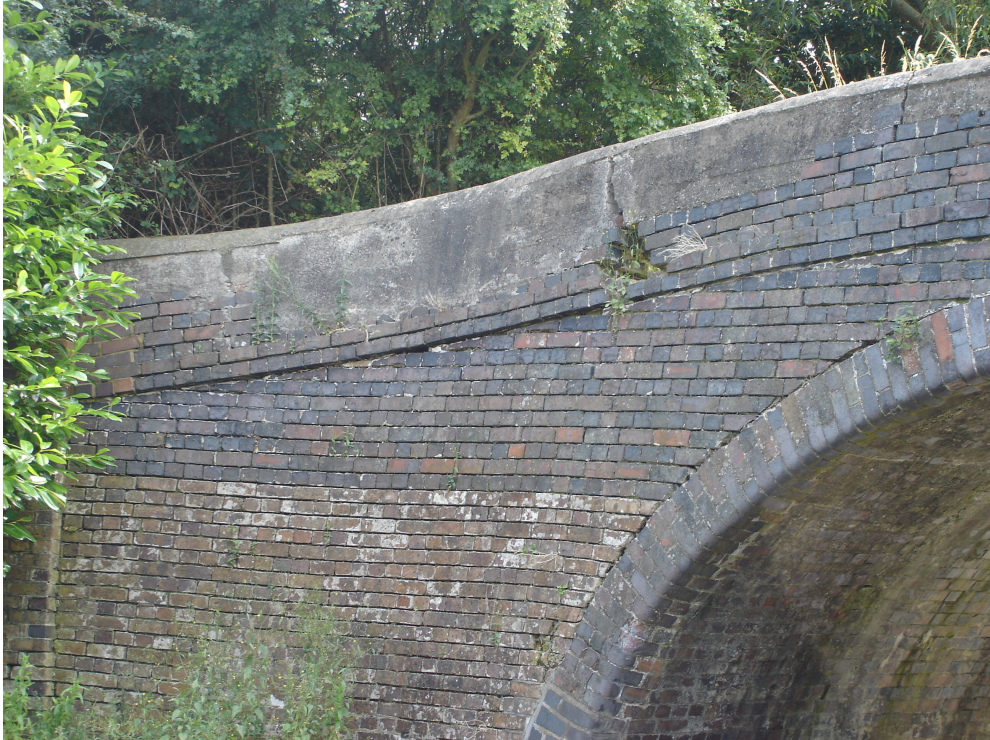
Bridge 41 North Elevation showing the settlement crack that needs attention

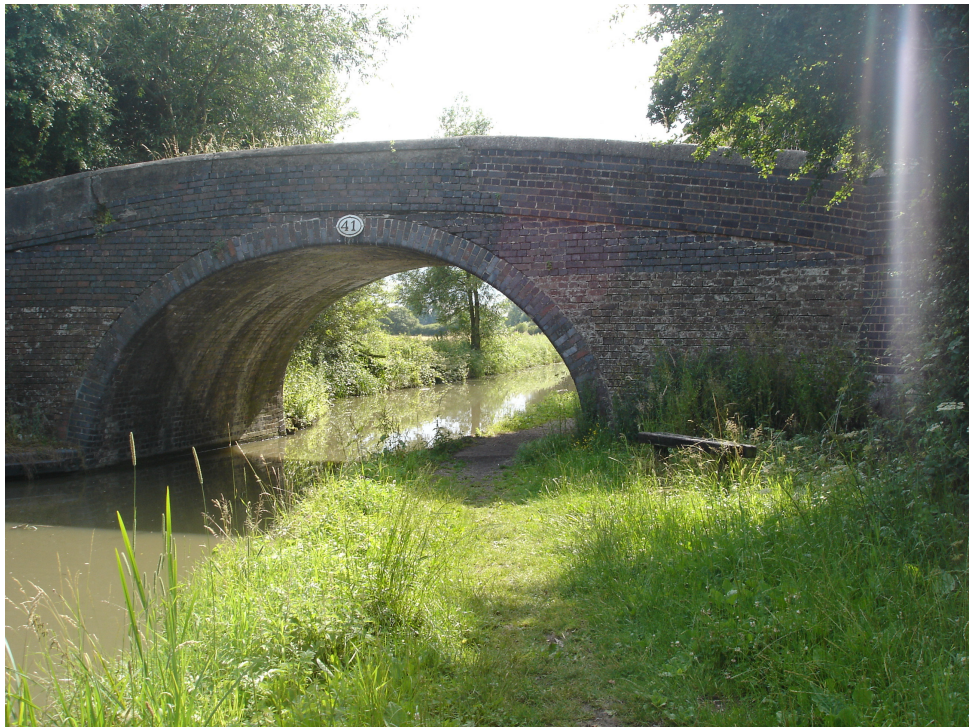
Bridge 41 North Elevation
The poor repair work has had a detrimental impact on the appearance of the bridge All of the original stone copings have been replaced with concrete.

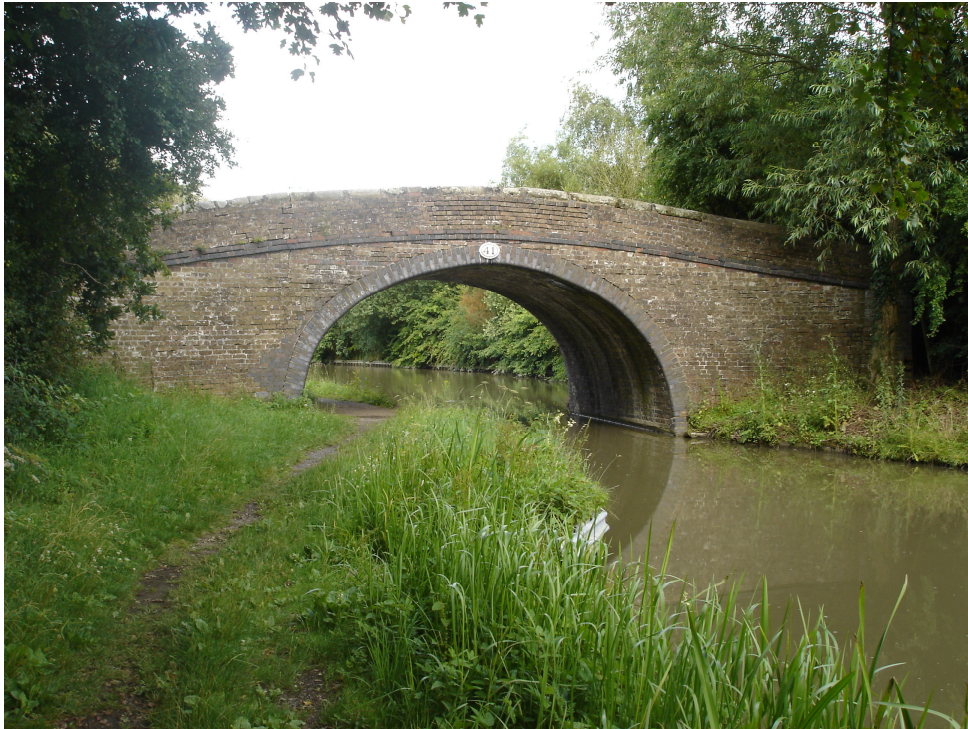
Bridge 41 (Jackson's Bridge) South Elevation

The bridge has been heavily restored with bricks that don't match the colour of the original brickwork. There is a large settlement crack that requires pointing. With the exception of a short run of concrete copings all of the original stone copings are in place.

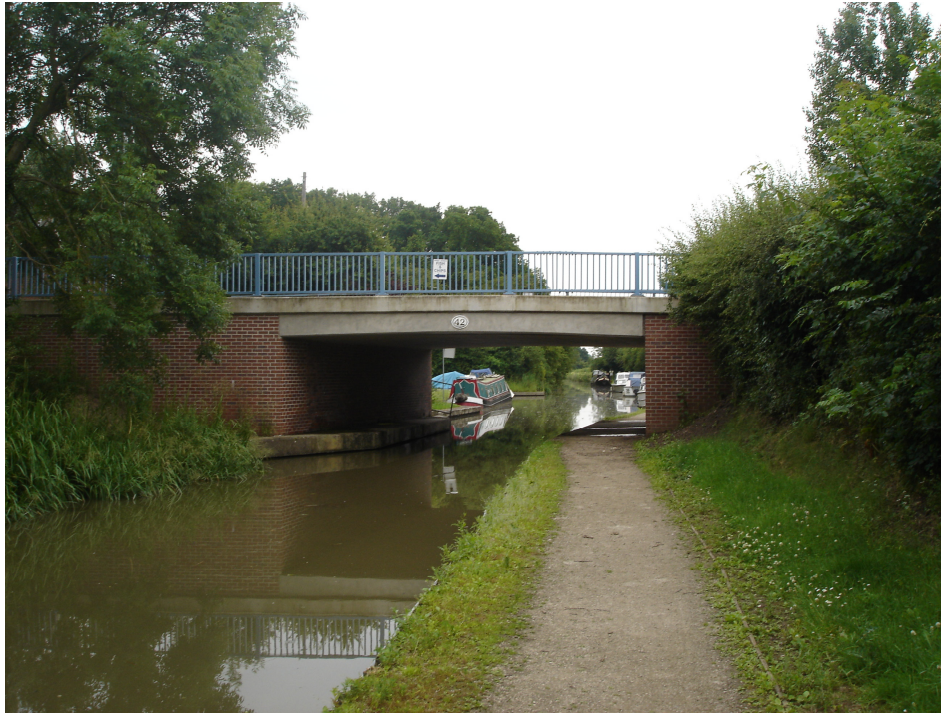
Bridge 42 (Bosworth Wharf Bridge) North Elevation

A modern concrete road bridge with metal railings and brick abutments. Its form and materials used are out of character with that of a rural canal. In future it is suggested that brick cladding and parapets rather than railings could improve the visual impact.

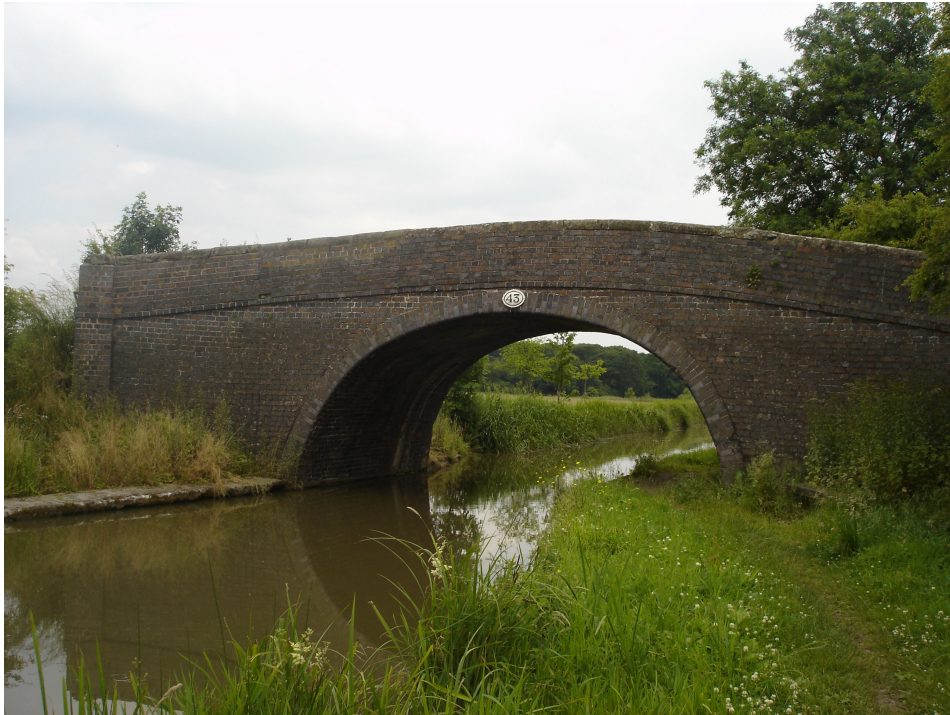
Bridge 43 (King's Bridge) North Elevation
The Bridge is in good condition with
all its original stone copings in place.

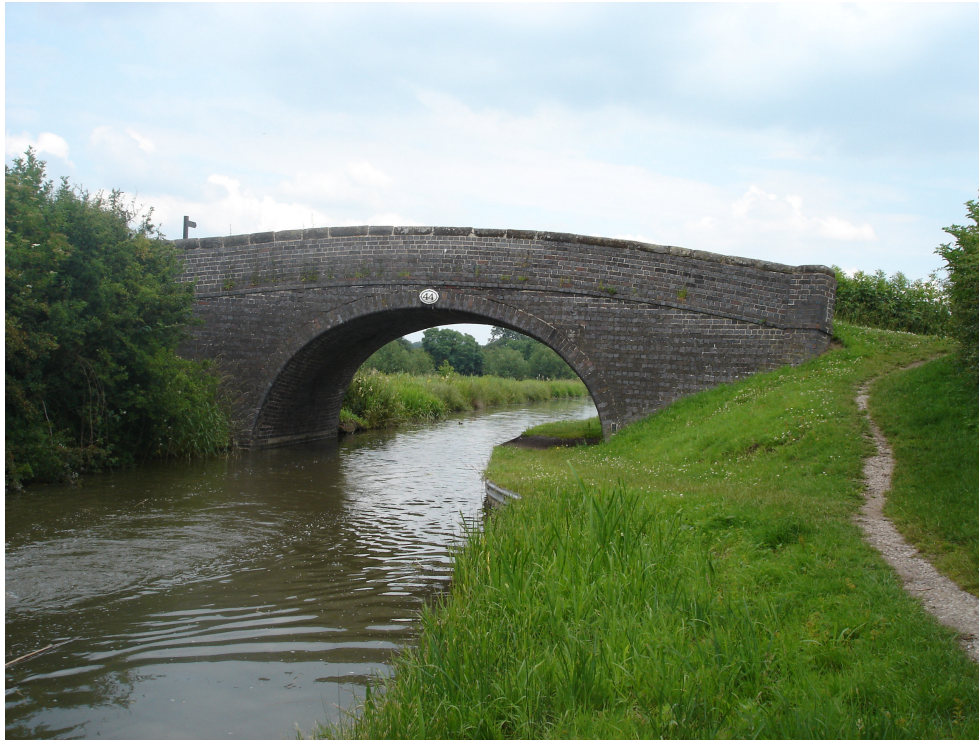
Bridge 44 (Carlton Bridge) North Elevation
This road bridge marks the start of the canal's Site of Special Scientific Importance (SSSI) running northwards. The Bridge is in good condition with all its original stone copings in place.

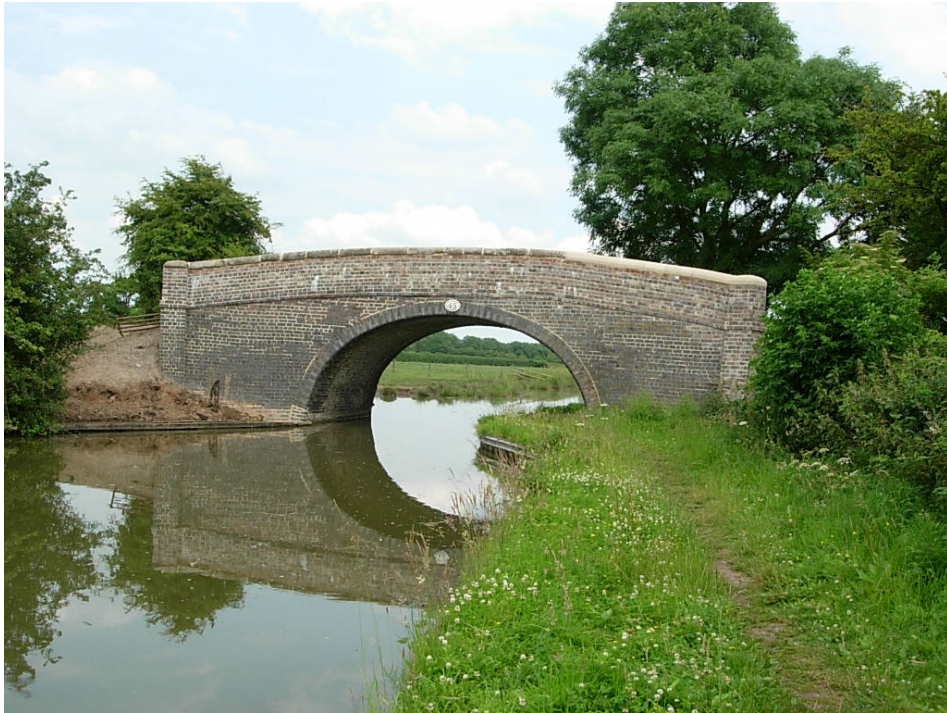
Bridge 45 (Iliffe Bridge) North Elevation

This accommodation bridge has been repaired in the recent past. The bridge and parapets have been re-pointed and new stone copings added. Its condition is good.

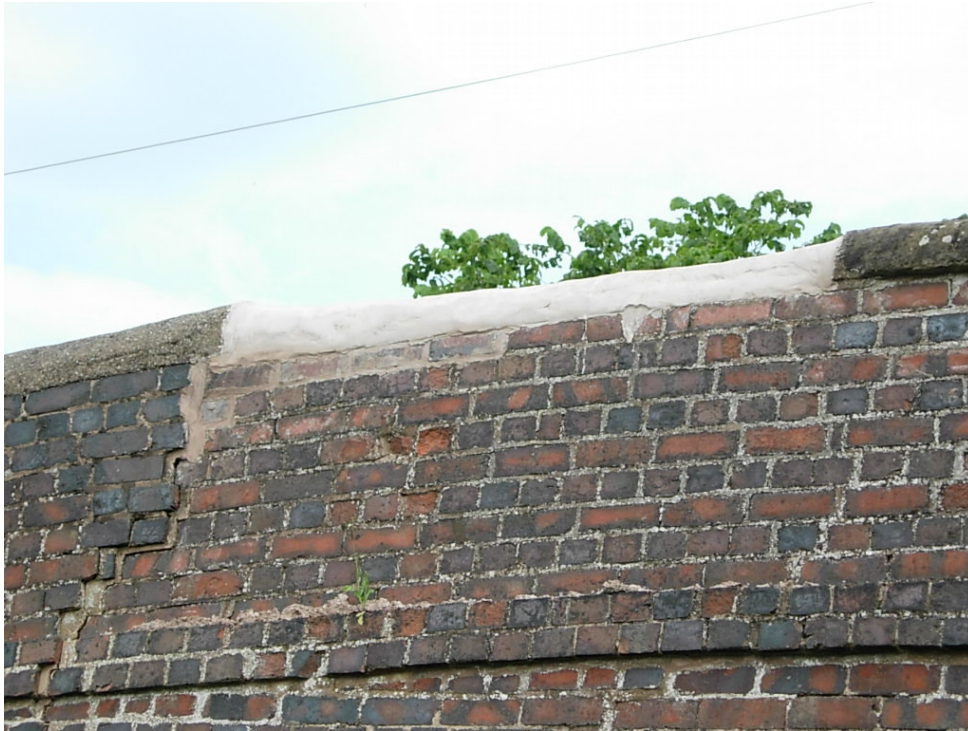
Bridge 46 showing the unsatisfactory repair to the copings. The stone copings have been replaced with sand/cement mortar which has a detrimental impact on its appearance. Work is also needed to repair the open joints on the parapet wall where the brick work has fractured
