**BARWELL (HIGH STREET)
CONSERVATION AREA APPRAISAL &
MANAGEMENT PLAN**

**PHOTOGRAPHIC SURVEY OF
CONSERVATION AREA**

September 2010

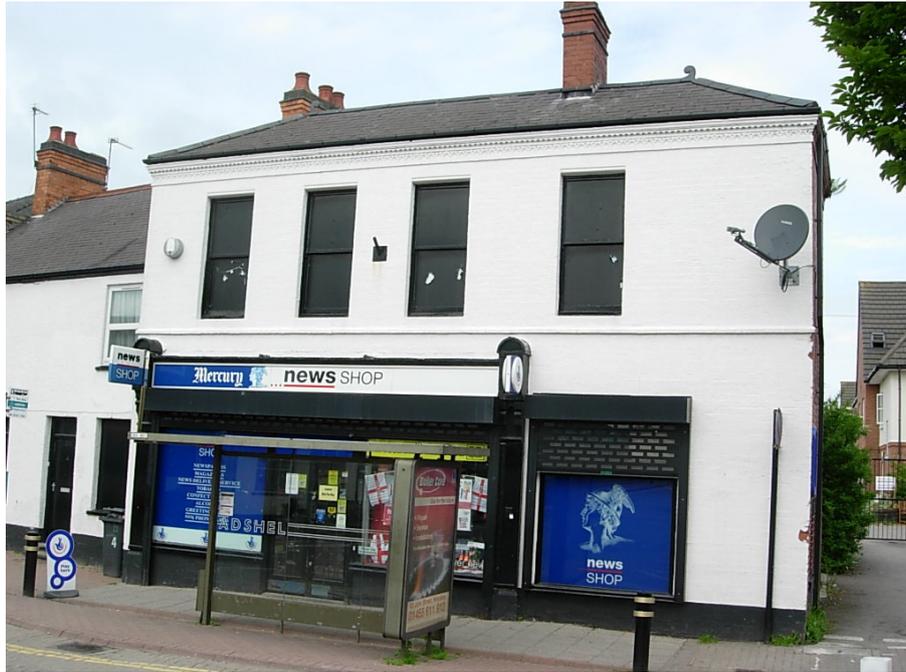
This period building, 2b High Street, has lost much of its character due to the installation of an external shutter and satellite dish.

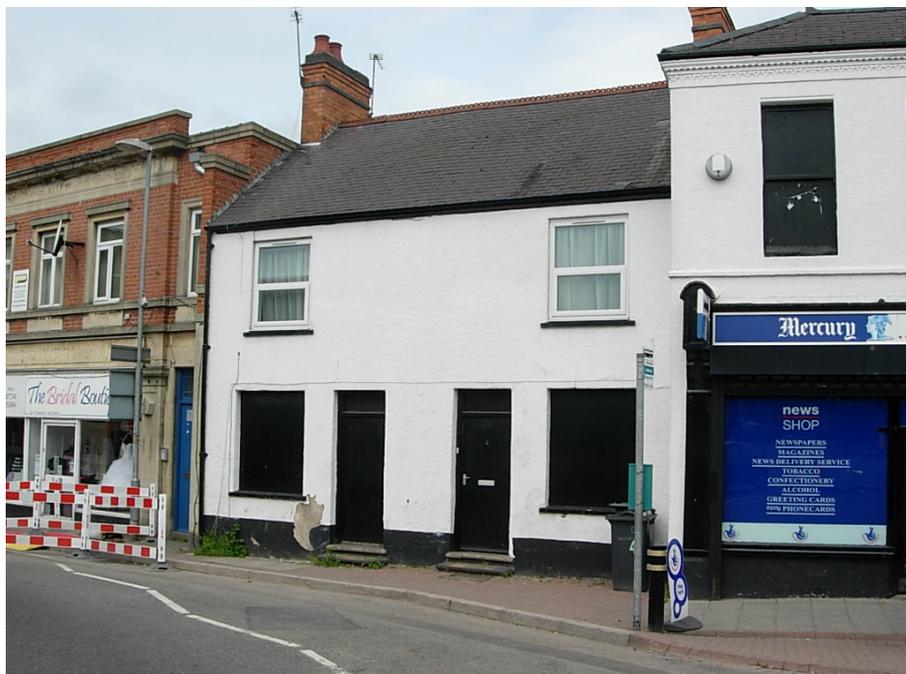
The rendered properties 2 & 4 High Street, although having its ground floor windows boarded up, has retained its slate roof and original chimney stacks.

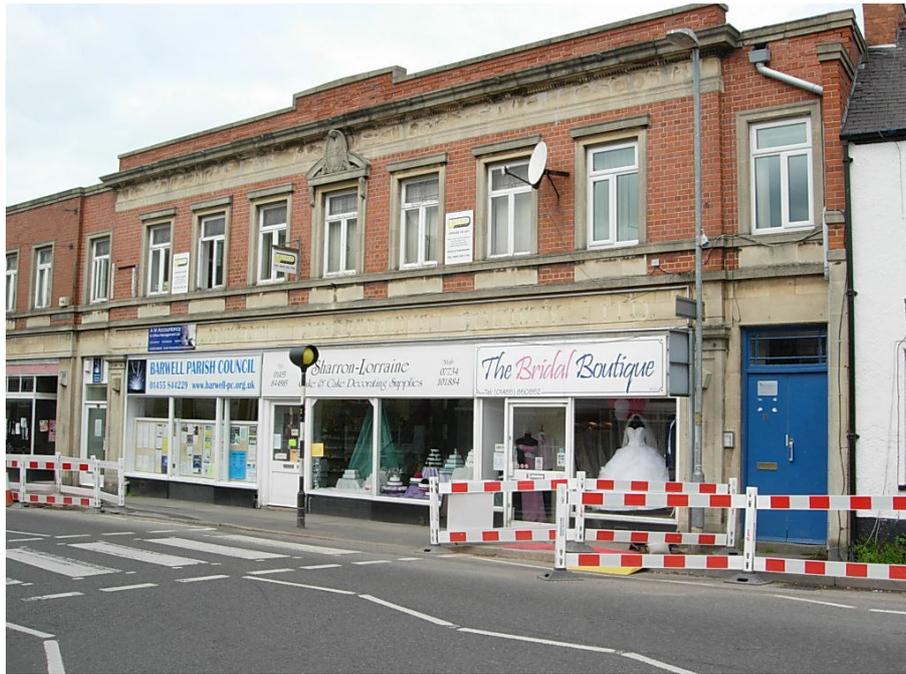
The former Co-op store is now in multi use. Unfortunately, this has resulted in the loss of its traditional shop frontage and the display of over dominant fascia signs.

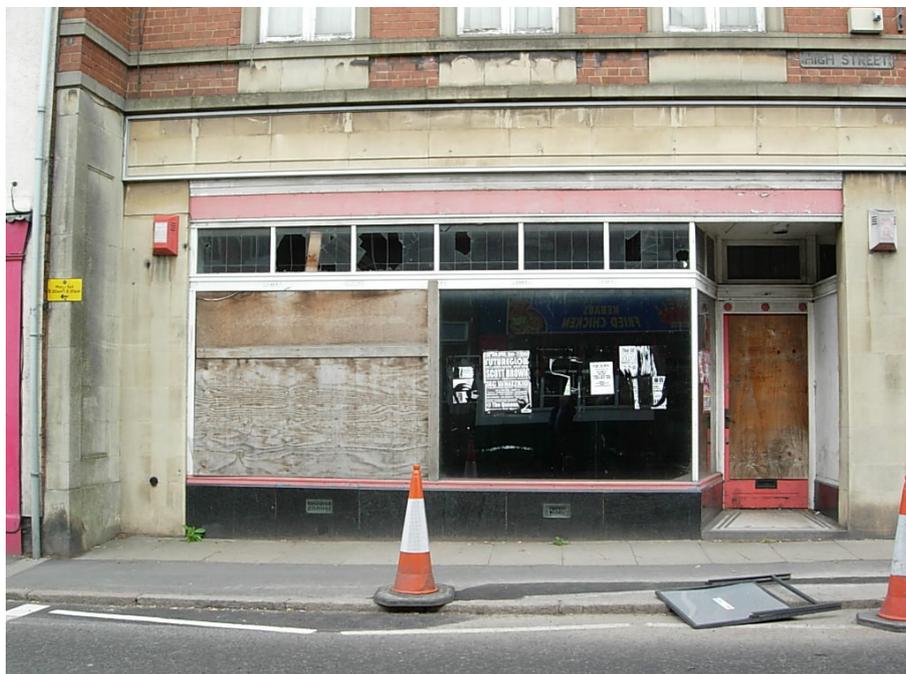
14 – 18 High Street is a later addition to the Co-Op premises. Although partially boarded at present, the vacant shop shows how the whole of the frontage would have looked without over dominant fascia signs.

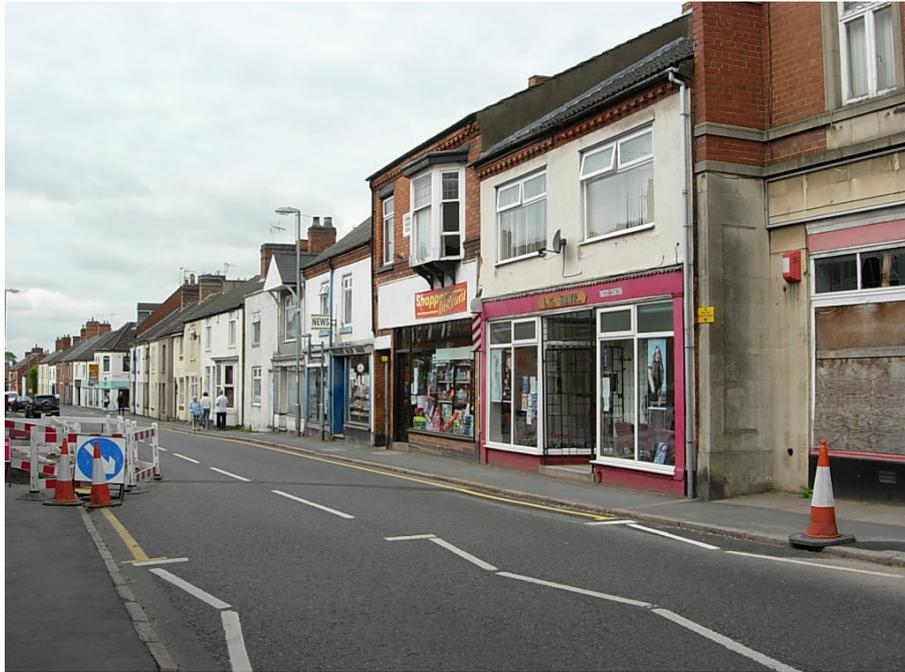
View of High Street showing terrace properties running down the west side of the road. The properties are pleasant as a group although a number have now been rendered, had their windows and roofs replaced with artificial materials, and lost their chimney stacks and pots.

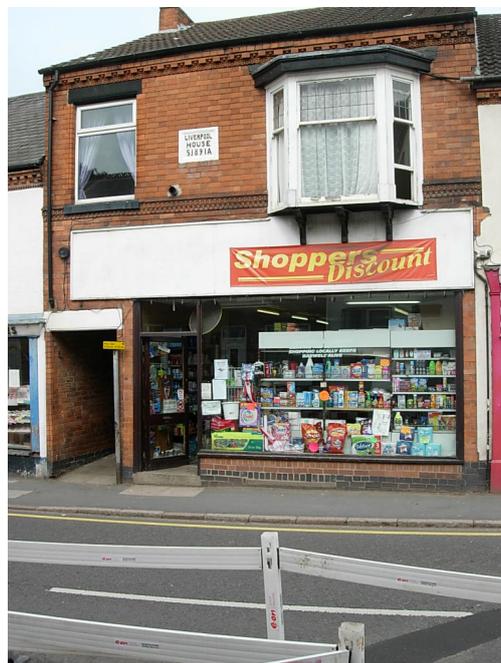
Liverpool House, 22 High Street (built 1891), showing its first floor bay window. The property has now been re-roofed with concrete tiles and the large shop fascia is out of scale, however, the property still retains some of its interesting terracotta detailing.

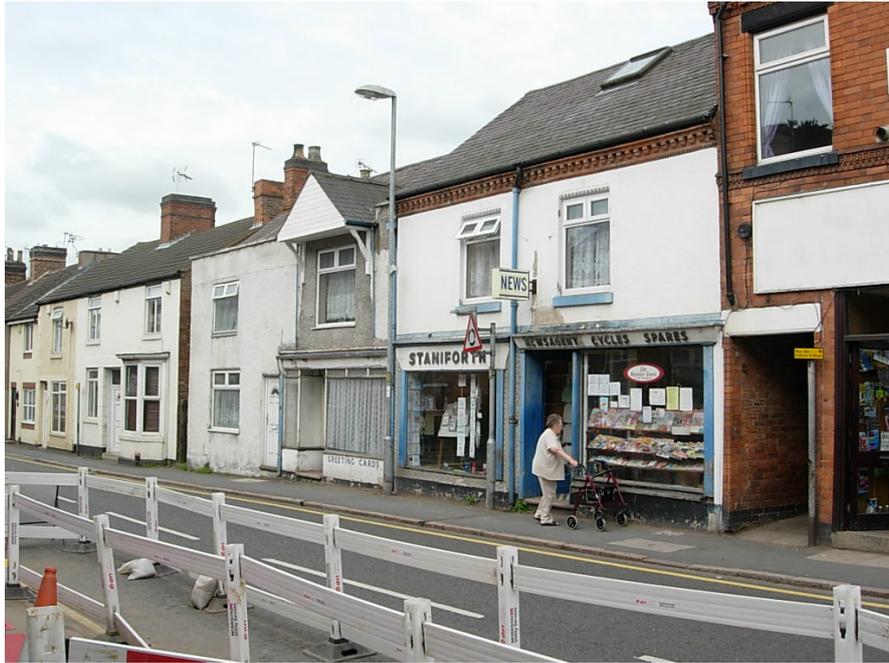
The roof light at 24 High Street is prominent facing onto the public highway. Roof lights, if needed, should be recessed into the roof and located on the rear elevation.

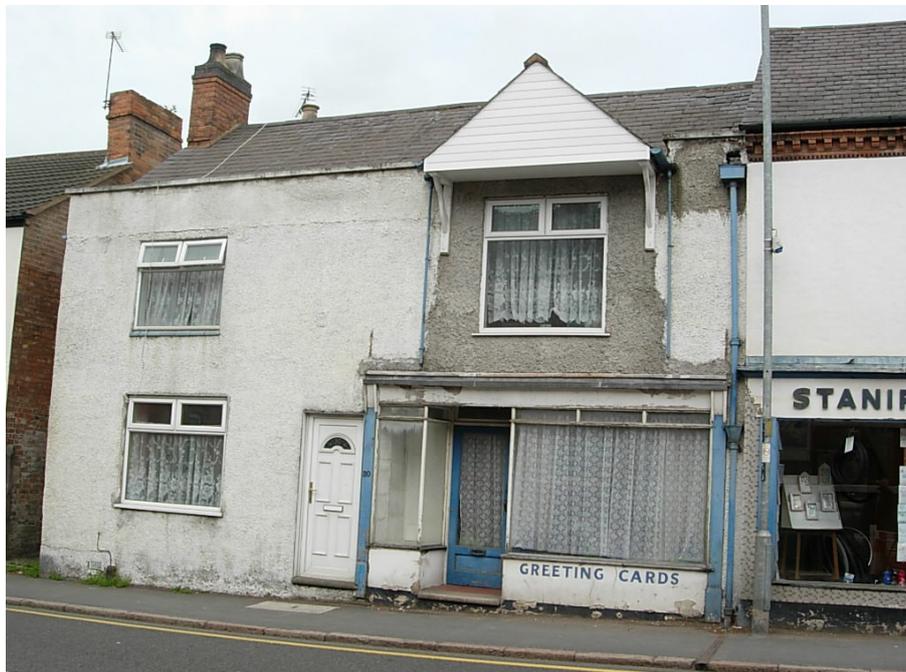
28 – 30 High Street is unusual in having a parapet wall and timber gable. The windows have been modernised but the property still retains its slate roof and chimney stack and pots.

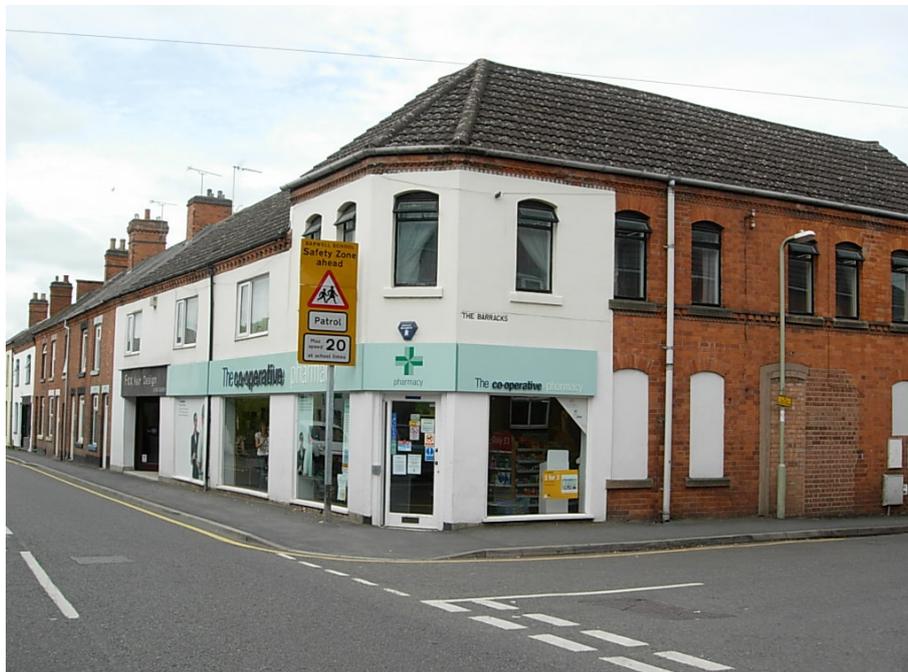
The property sited at the junction of High Street and The Barracks has lost most of its traditional appeal due to its modernisation and shop front treatment.

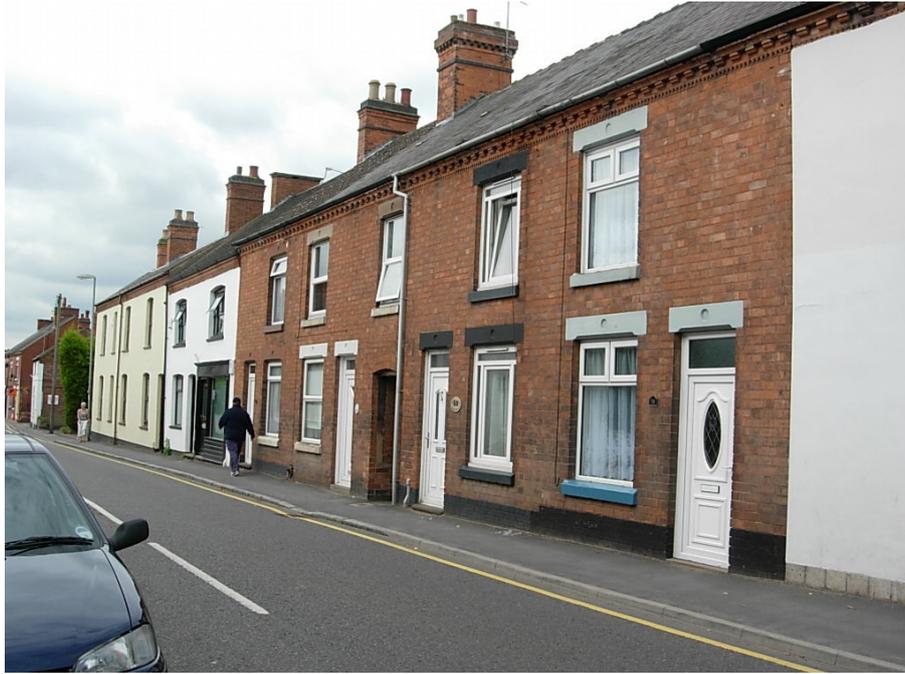
56 – 70 High Street showing how the loss of one chimney stack and its pots can have a negative impact on the visual quality of the terrace.

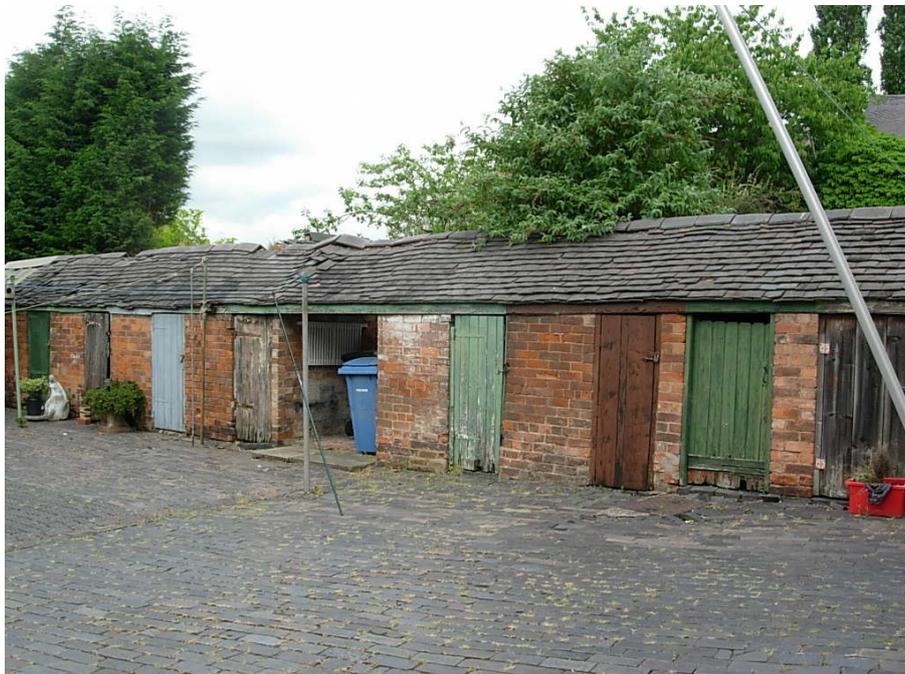
The original outbuildings to 58 -64 High Street are in need of maintenance.

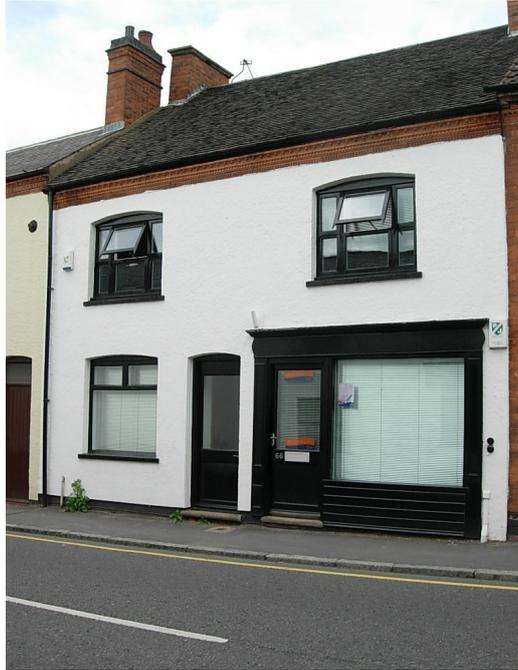
66-68 High Street have been rendered, but still retain their terra cotta detailing at their eaves. The properties have lost their original chimney stacks and pots.

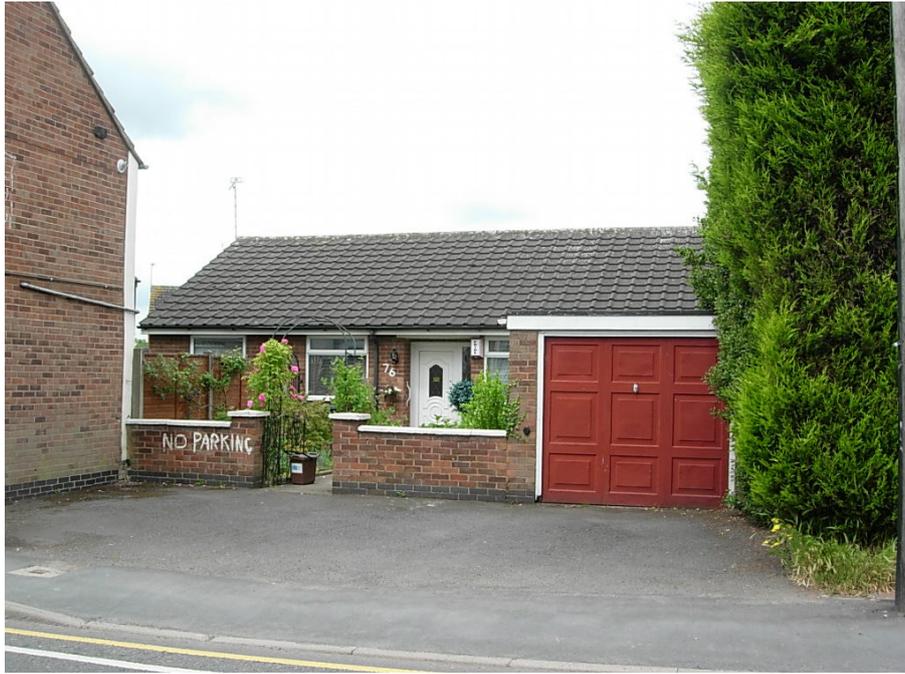
The bungalow and garage at 76 High Street are out of character with the traditional properties on High Street due to their modern design and materials, and sitting well back from the footpath.

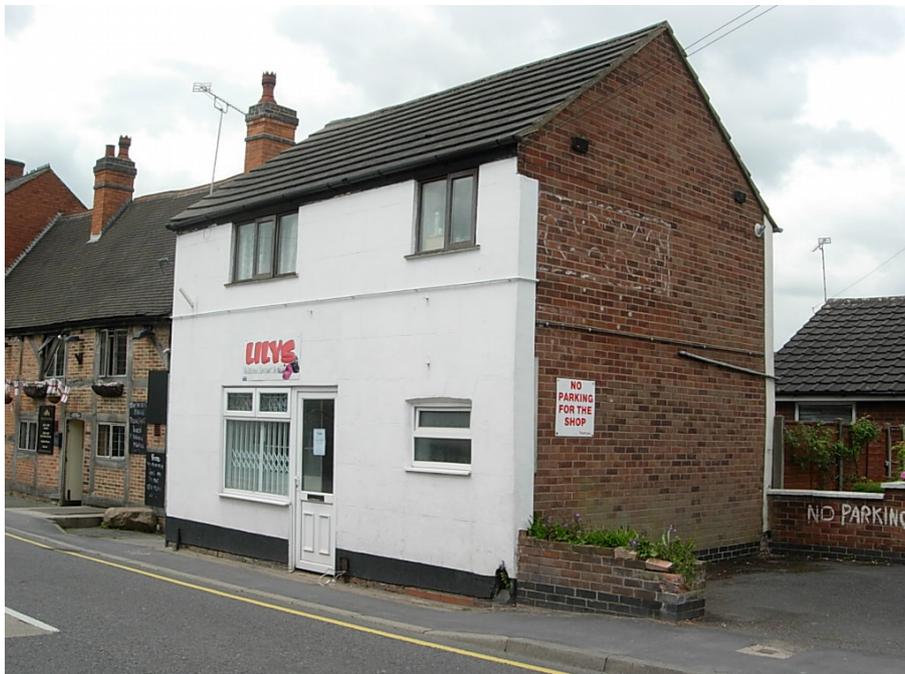
78 High Street is an important property due to its sitting on the back edge of the footpath. Unfortunately, it has suffered from modernization

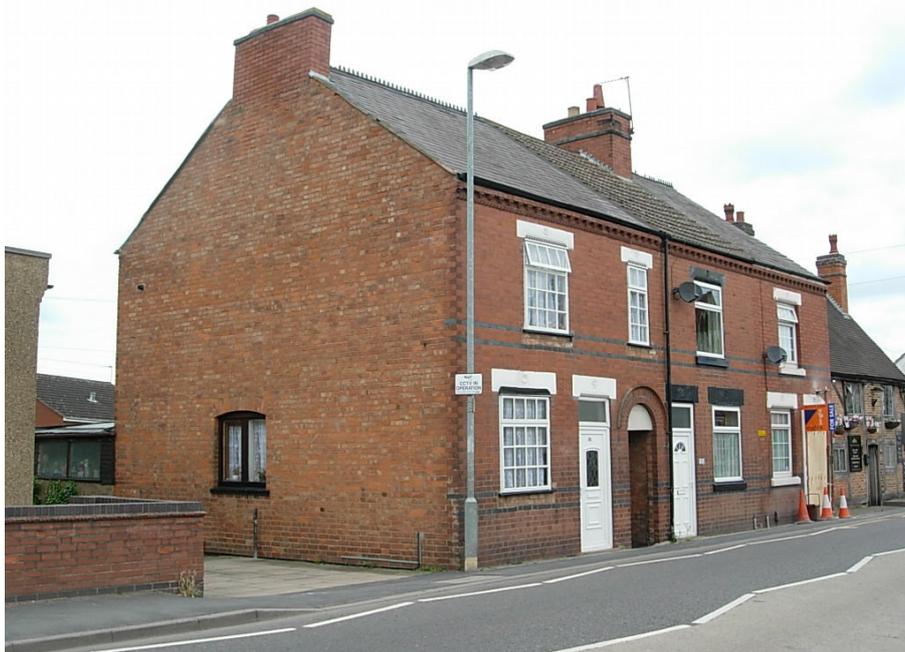
This short terrace has suffered from the introduction of modern materials which are incompatible with its traditional character. These include concrete roof tiles, plastic windows and doors.

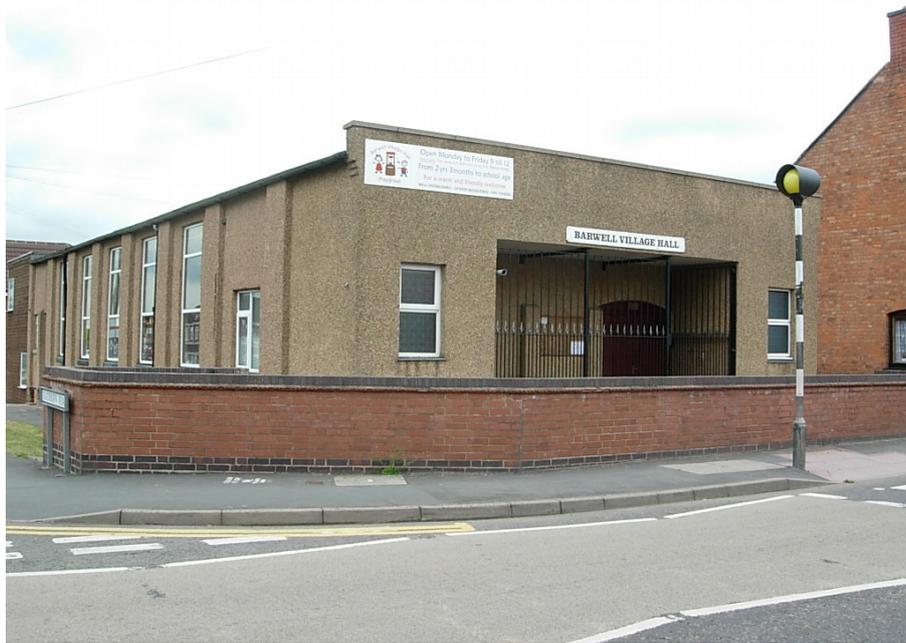
The large flat roof and stark rendering give the Village Hall an appearance which is generally out of character with traditional buildings in the conservation area.

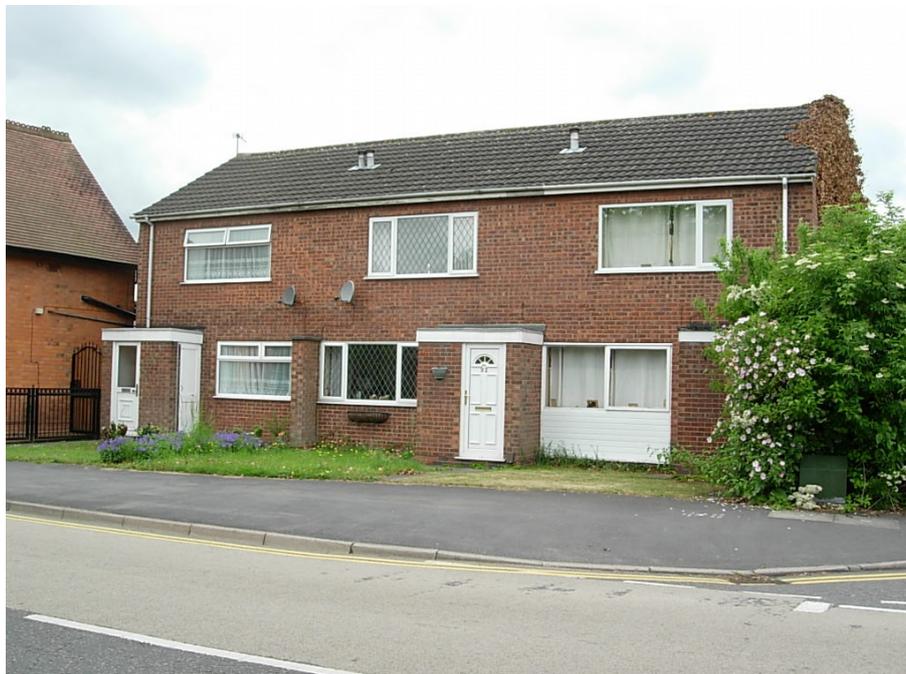
The flat roof porches, large horizontal windows and open garden frontage are out of character with most traditional features in the conservation area.

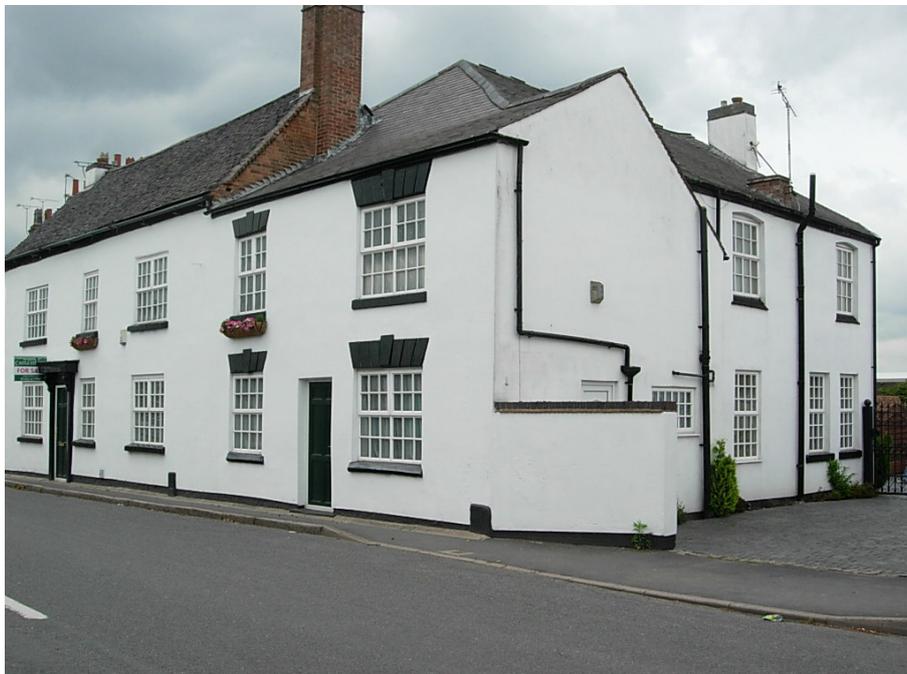
This former public house is now in residential use. The new Georgian style windows have given the building a fussy appearance.

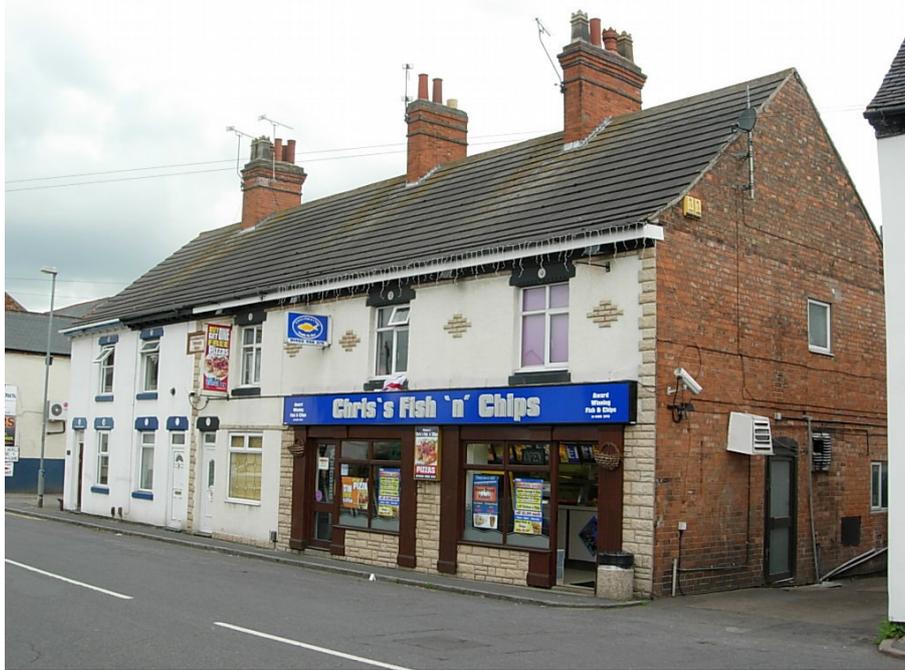
This terrace was constructed by the Barwell Co-operative Society in 1884. Its modernisation has had a detrimental affect on its appearance but the properties still retain their impressive chimney stacks and pots.

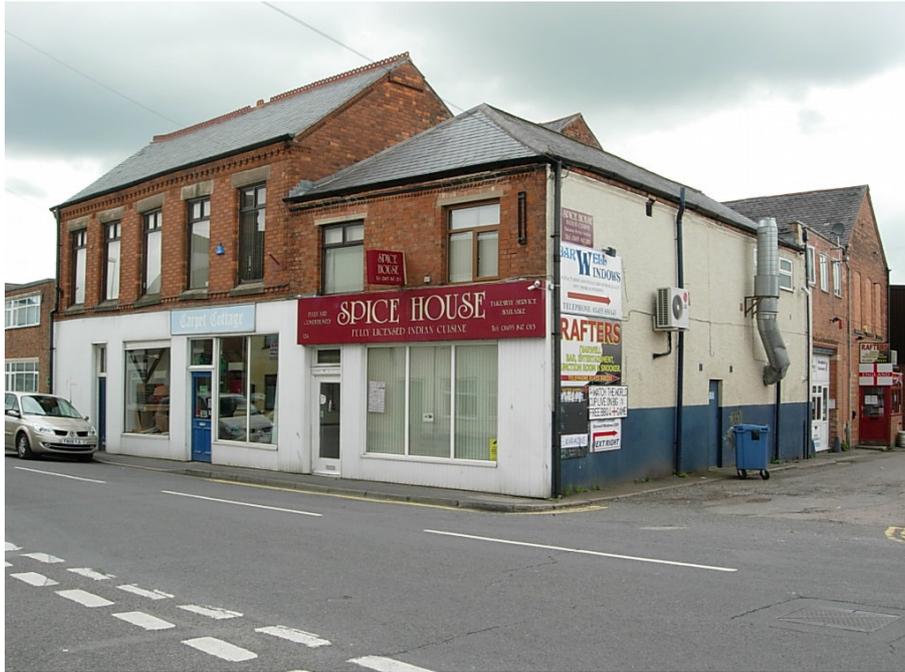
This is the original Co-op shop. Its appearance would be improved if the plastic cladding was removed to reveal the original brick face and clutter was cleared from the flank wall.

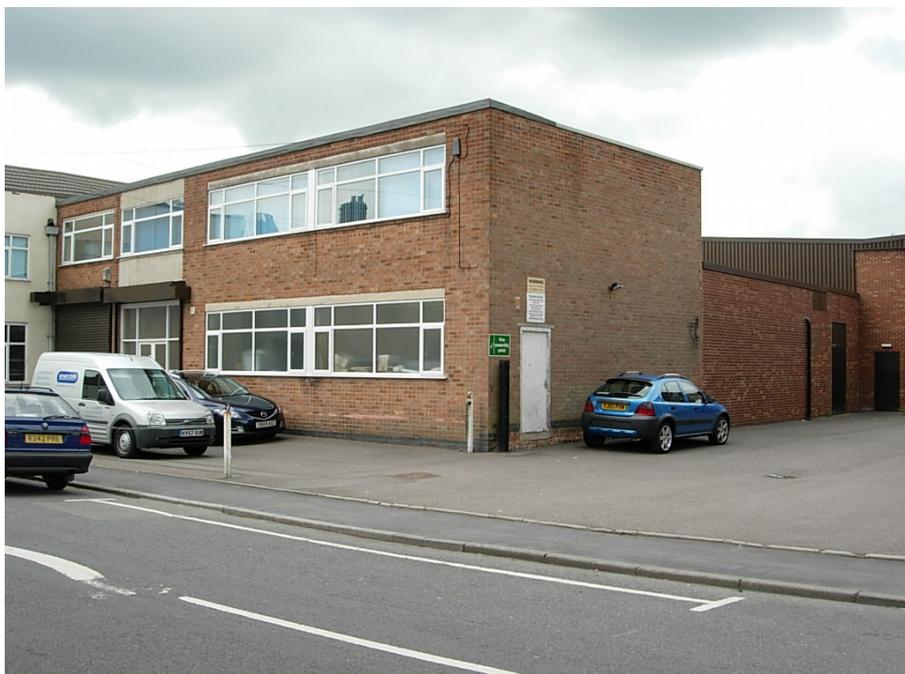
The design of this industrial premises with its flat roof and long horizontal windows is out of character with other traditional properties close by.

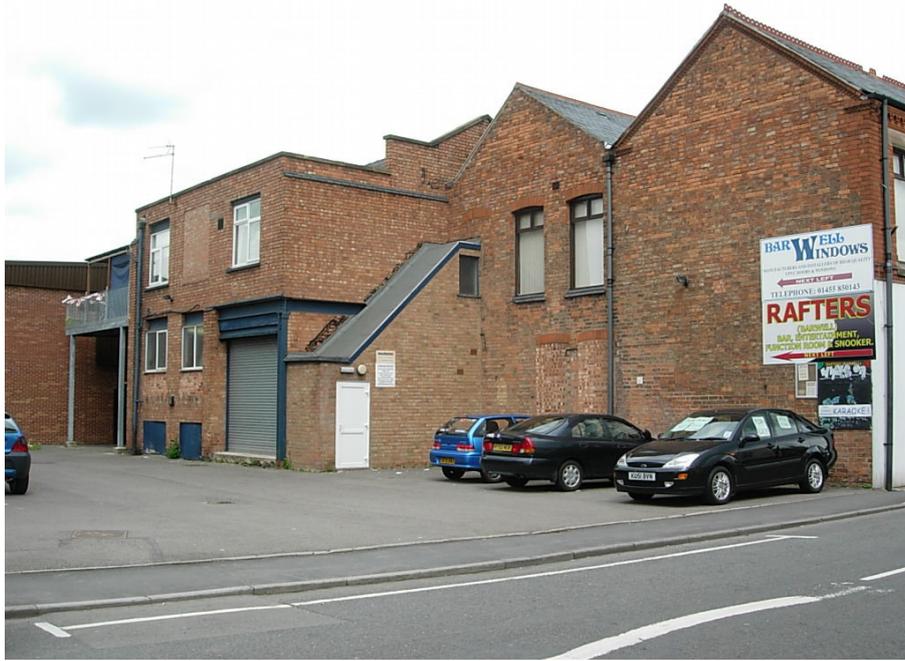
The western flank wall of the former Co-operative buildings would be improved if the signage was removed.

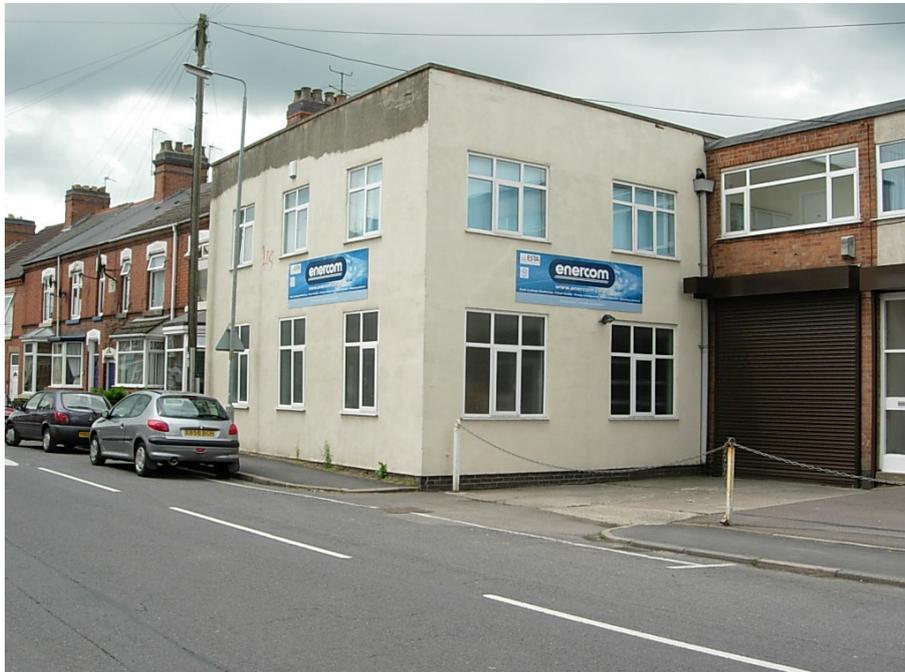
This former traditional building has had a parapet added which has had a detrimental impact on its appearance.

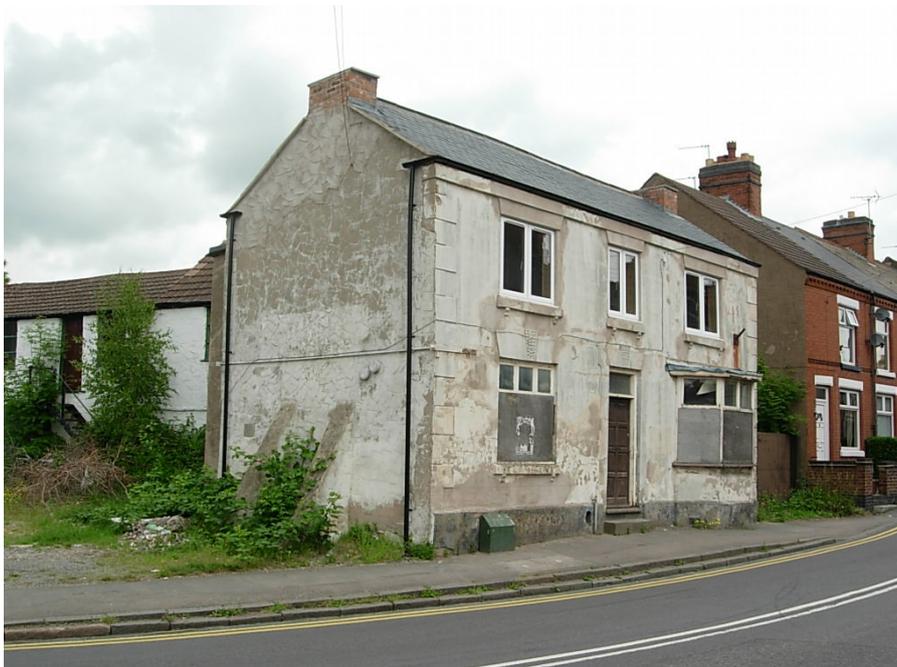
This building is located on a bend at a key road intersection. The site needs improving, the chimneys should be re-built, the render repaired and painted and the property brought back into use. It is having a detrimental impact on the area and its appearance is unacceptable.

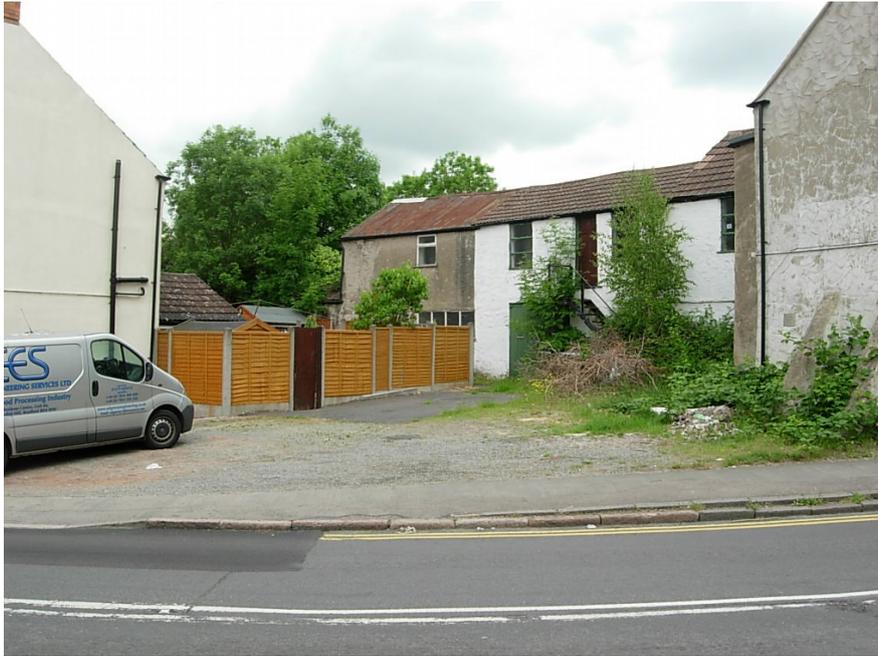
The adjoining land needs improving and a blue brick garden wall or fence erected to close off the space from the highway.

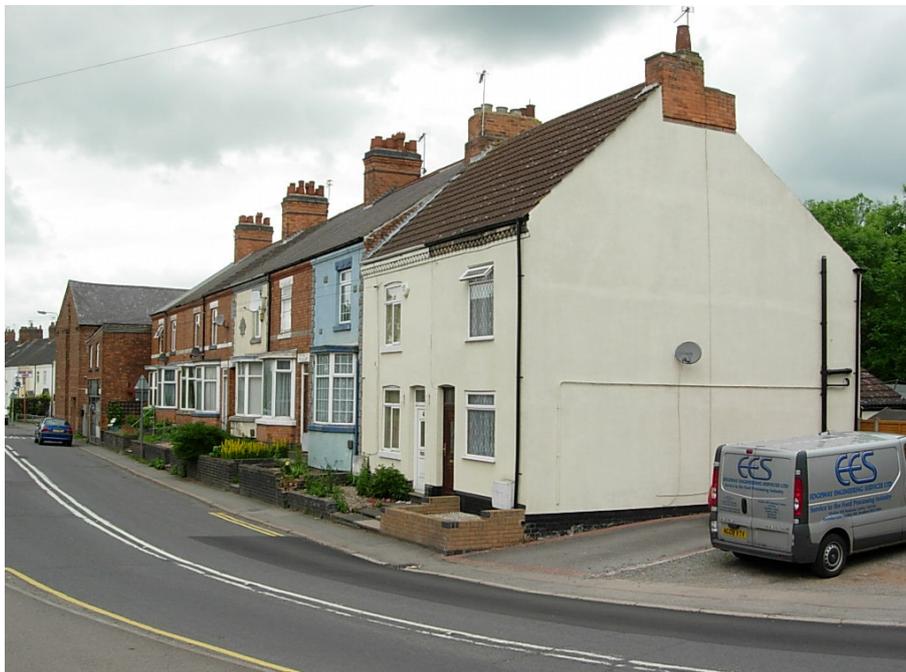
The end terrace properties have been spoiled by the use of concrete roof tiles and an inappropriate brick garden wall. These are out of character with the rest of the terrace.

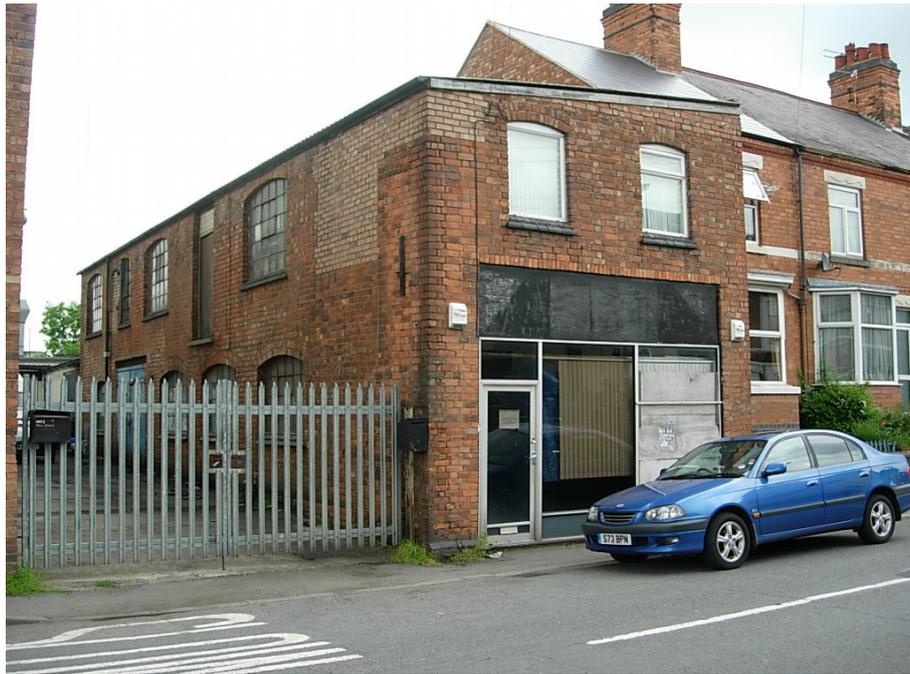
This former boot and shoe factory has had its pitched roof removed, its windows blocked up and an inappropriate shop front added. The security fencing is also having a detrimental impact on the street scene.

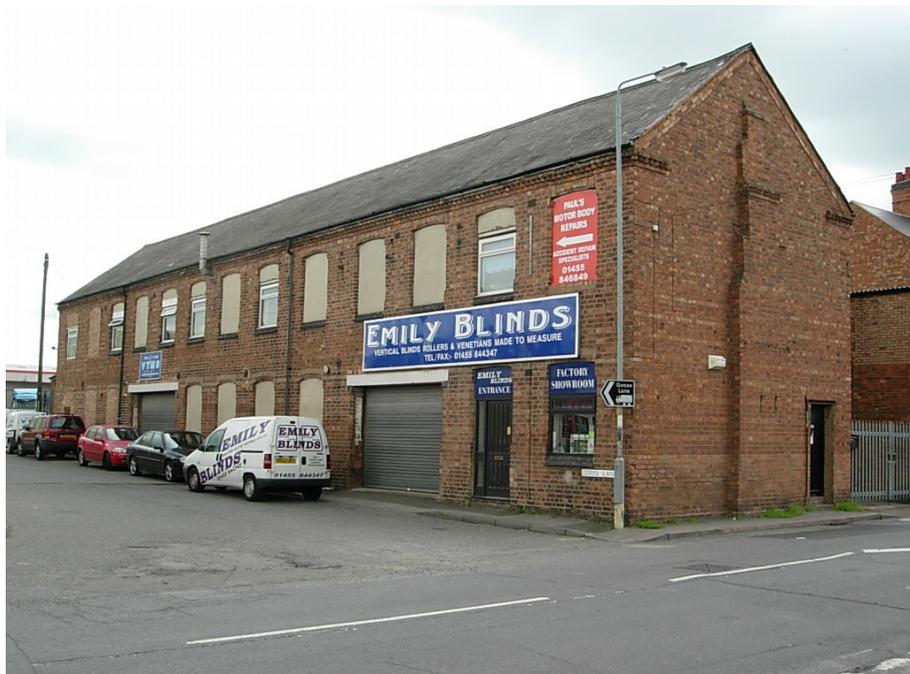
This former factory is in a very prominent location in the street. The blocked up windows, roller shutter and inappropriate signage need improving.
