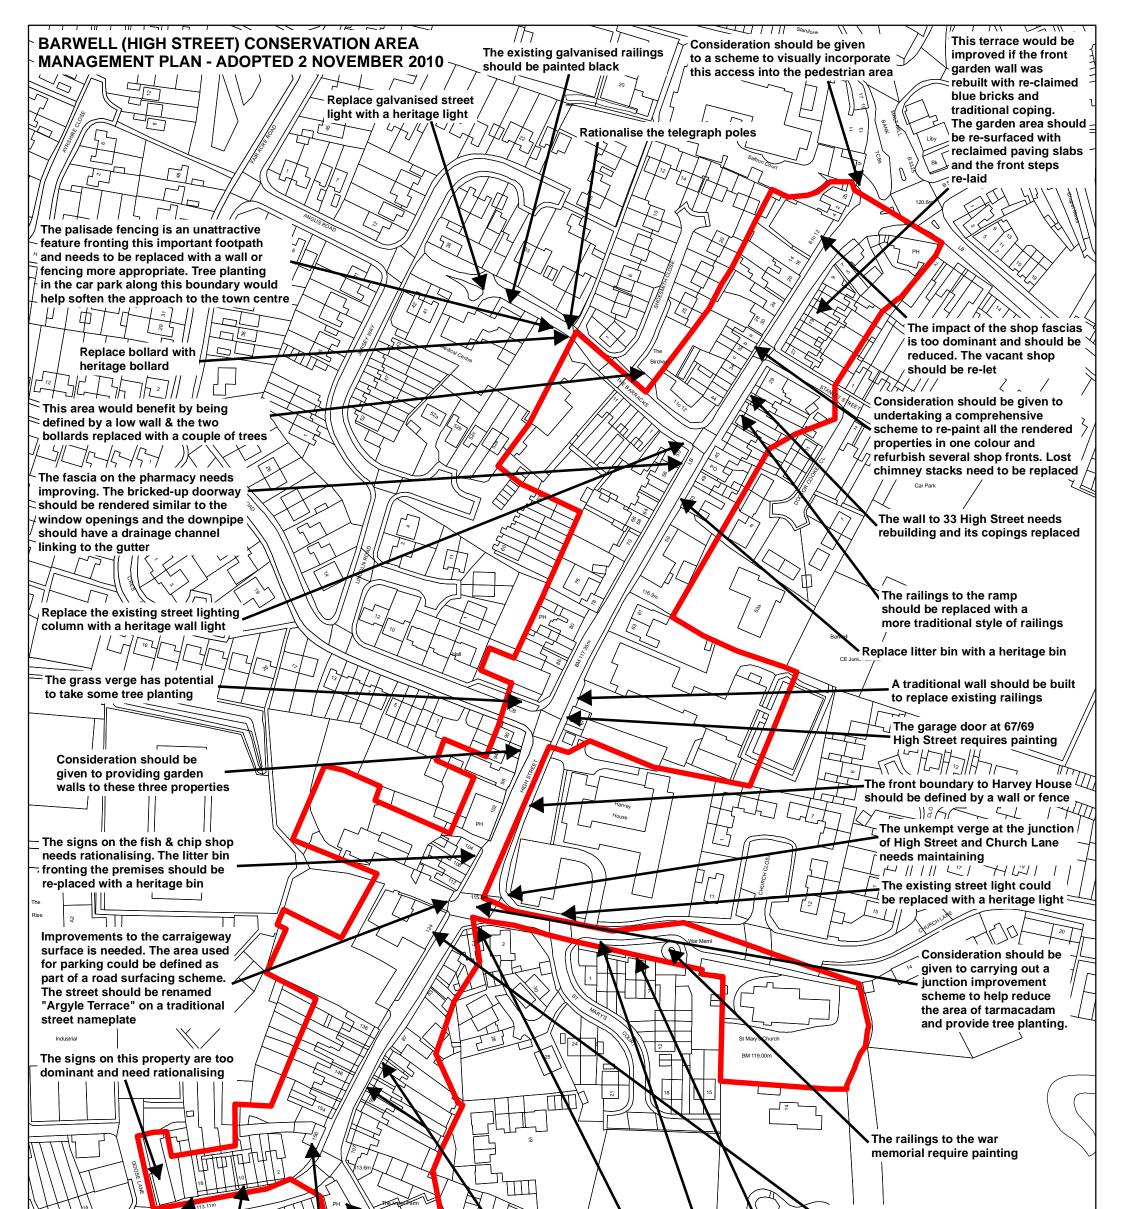
The unity of the boundary walls fronting this pleasant terrace has been lost. The wall at 4 Mill Street needs to be rebuilt in blue brick and consideration should be given to tying all the front walls together utilising a common coping. The chimney stacks on a couple of properties needs replacing. A considerable number of garden walls in the conservation area tend to be constructed with blue brick

The shop front to this property

requires improving

as tet 156 High Street is in a prominent location in the conservation area and has been derelict for a considerable period of time. Consideration now needs to be given to serving a Section 215 Notice to ensure it is renovated within a reasonable period of time. The front boundary to the adjacent land the area behind re-surfaced The plastic cladding on this property is an unattractive feature and should be removed to reveal the original brickwork. The signs need to be rationalised and if possible the flue on the side of the property removed

Ivy needs to be removed from gate pier

The grass verge fronting Church Lane should be considered for tree planting

Provide a heritage street nameplate on the corner of Church Lane

The brick pier at 91 High Street and wall at 97 High Street need rebuilding

The stone plinth to the Red Lion pub needs to be re-laid
