**BURBAGE CONSERVATION AREA
MANAGEMENT PLAN - ADOPTED
13 DECEMBER 2011**

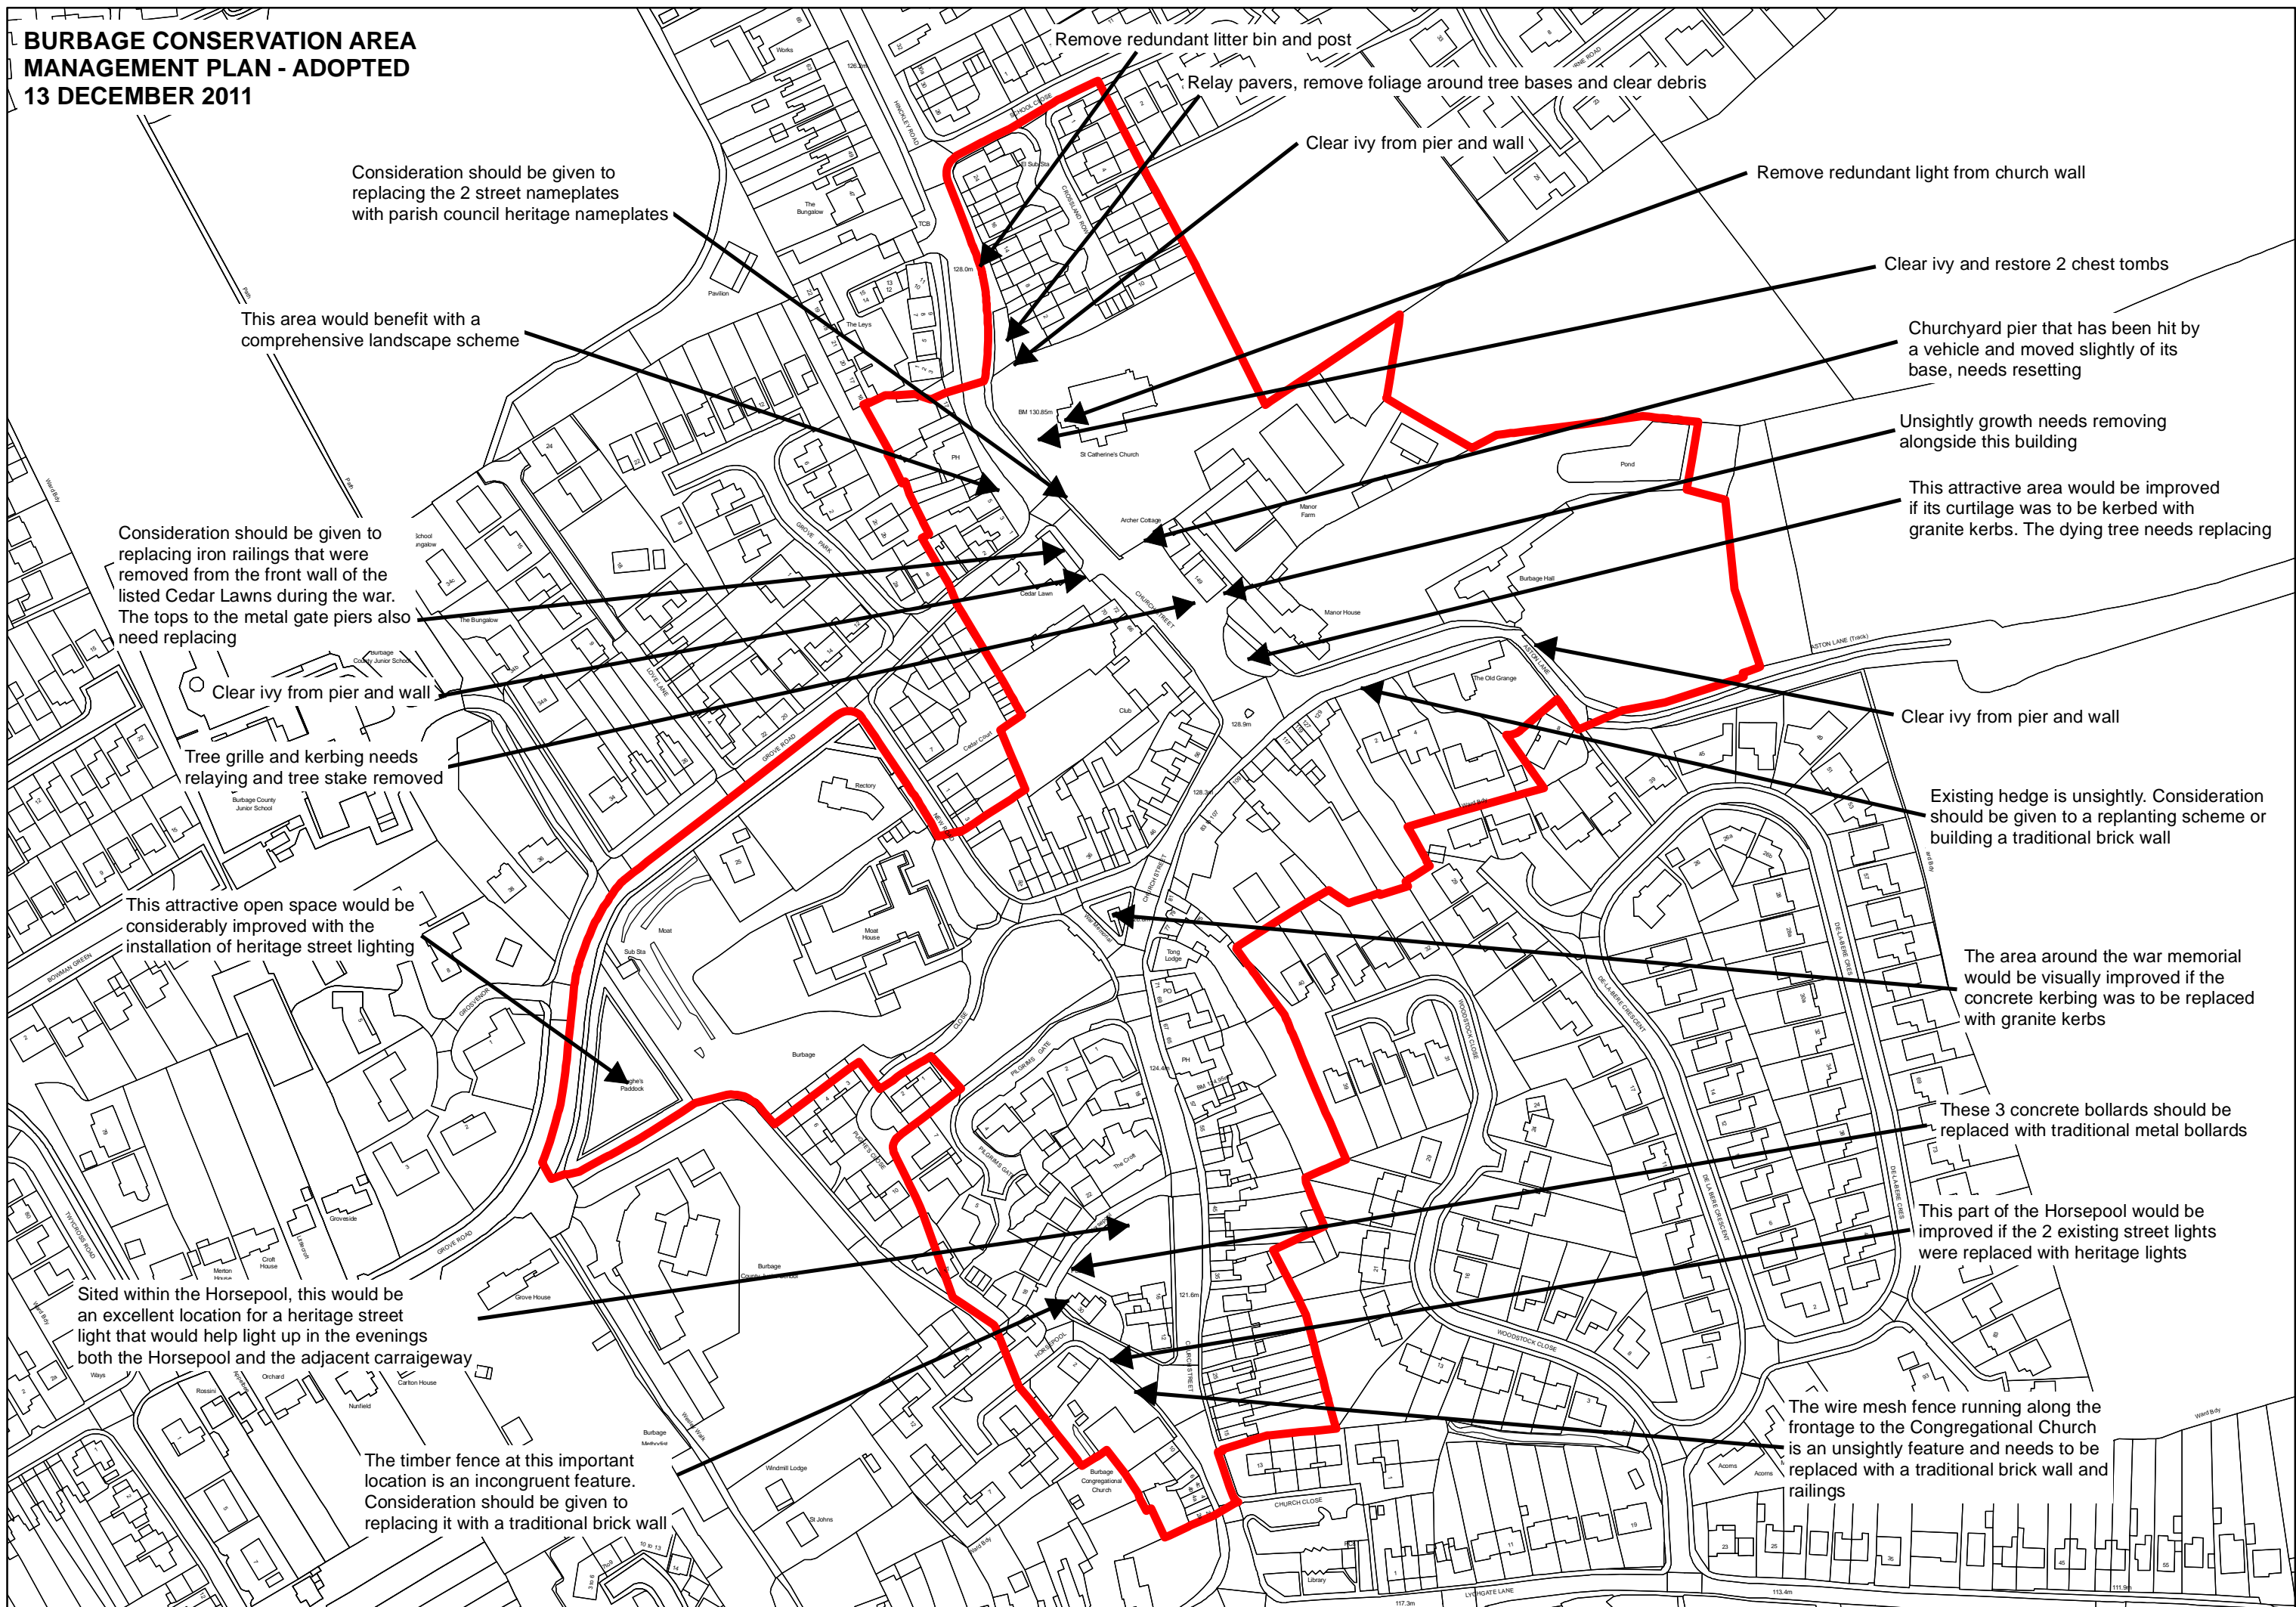
Consideration should be given to replacing iron railings that were removed from the front wall of the listed Cedar Lawns during the war. The tops to the metal gate piers also need replacing

The timber fence at this important location is an incongruent feature. Consideration should be given to replacing it with a traditional brick wall

Churchyard pier that has been hit by a vehicle and moved slightly of its base, needs resetting

Unightly growth needs removing alongside this building

Existing hedge is unsightly. Consideration should be given to a replanting scheme or building a traditional brick wall

The wire mesh fence running along the frontage to the Congregational Church is an unsightly feature and needs to be replaced with a traditional brick wall and railings

Consideration should be given to replacing the 2 street nameplates with parish council heritage nameplates

This area would benefit with a comprehensive landscape scheme

Clear ivy from pier and wall

Tree grille and kerbing needs relaying and tree stake removed

This attractive open space would be considerably improved with the installation of heritage street lighting

Sited within the Horsepool, this would be an excellent location for a heritage street light that would help light up in the evenings both the Horsepool and the adjacent carriage way

Remove redundant litter bin and post

Relay pavers, remove foliage around tree bases and clear debris

Remove redundant light from church wall

Clear ivy and restore 2 chest tombs

This attractive area would be improved if its curtilage was to be kerbed with granite kerbs. The dying tree needs replacing

The area around the war memorial would be visually improved if the concrete kerbing was to be replaced with granite kerbs

These 3 concrete bollards should be replaced with traditional metal bollards

This part of the Horsepool would be improved if the 2 existing street lights were replaced with heritage lights
