**SPECIFICATION AND SCHEDULE  
OF MINIMUM WORKS  
FOR  
STABLES  
TO BRADGATE HOUSE  
GROBY  
LEICESTERSHIRE**

**Date:** January 2024

**Reference:** EJM/CH/SPEC/22383-Minimum Works Schedule rev 2

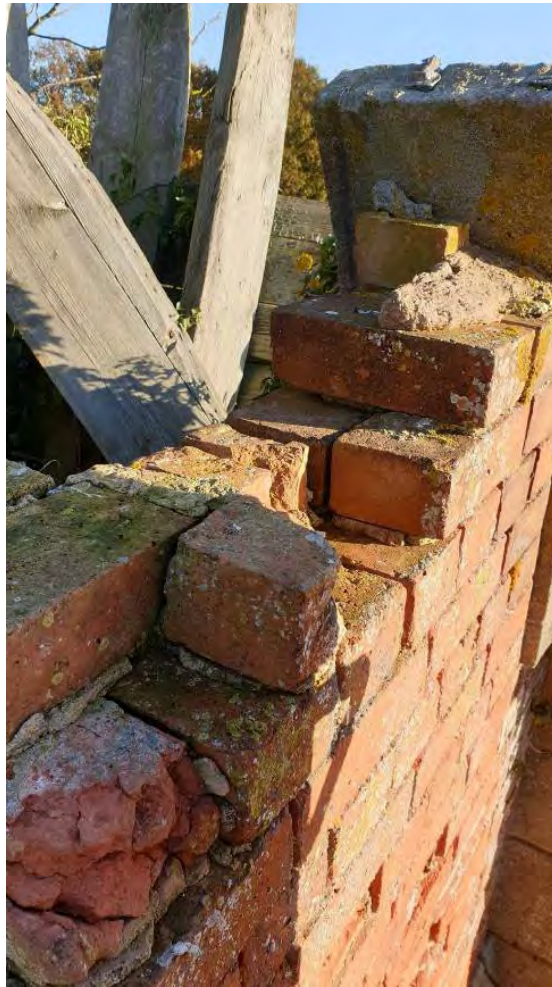
**Photograph 7:** Loose bricks at timber roof base level - south range tower

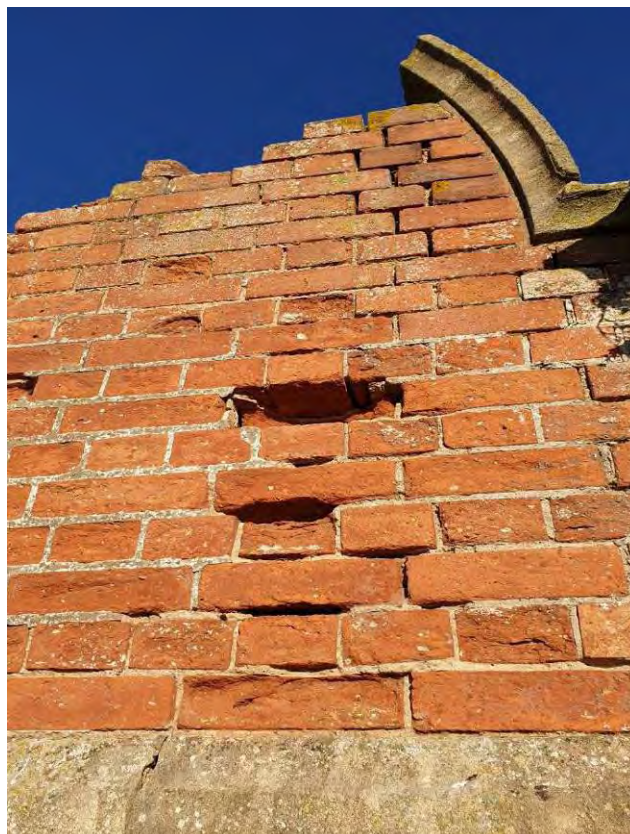
**Photograph 8:** Eroded bricks at upper stage of tower - south range south elevation (south range)

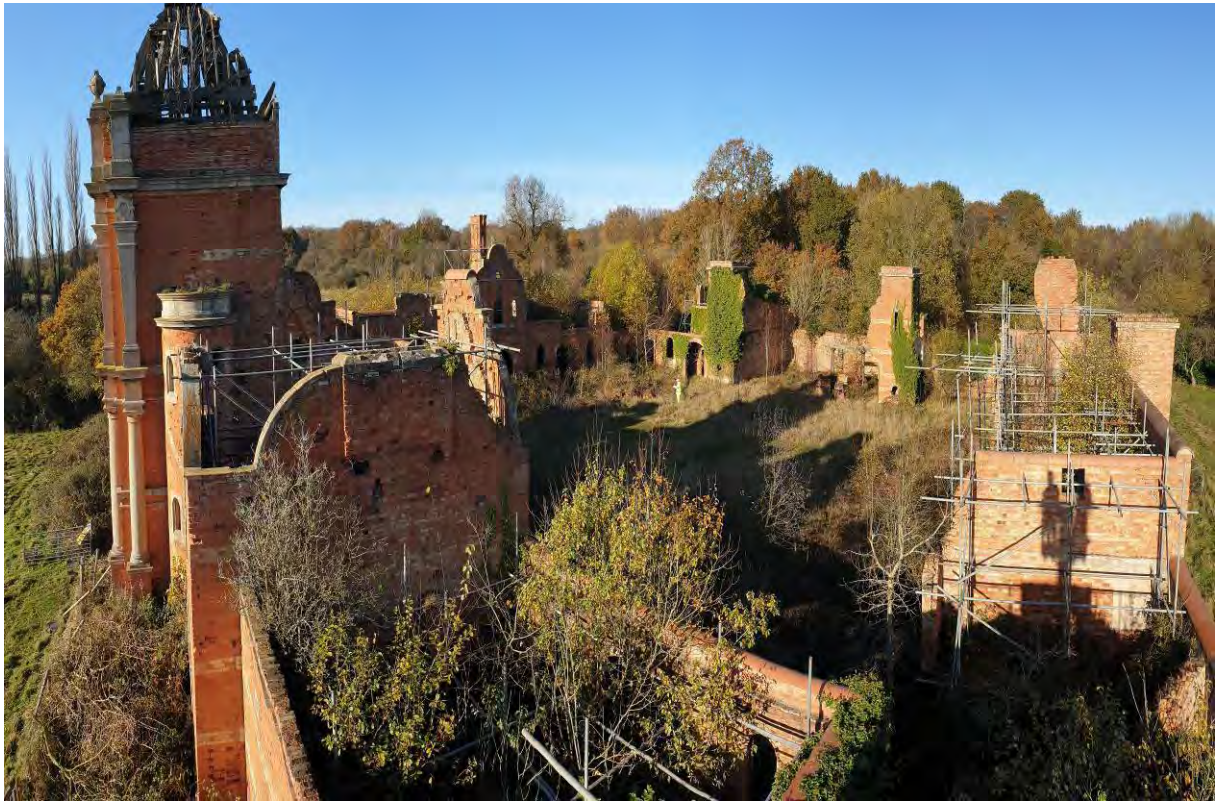
**Photograph 9:** Vegetation overgrowth throughout the stables and kennels, as seen from cherry picker

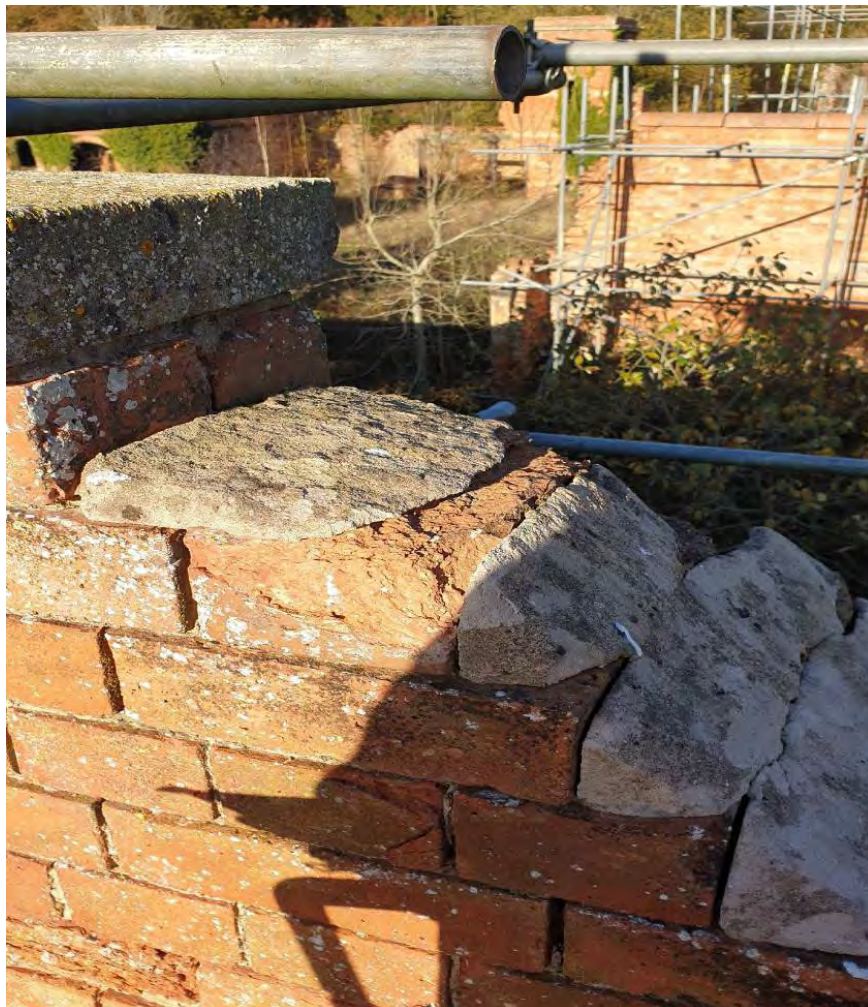
**Photograph 10:** Deteriorated coping stone noted to the east end of the south elevation

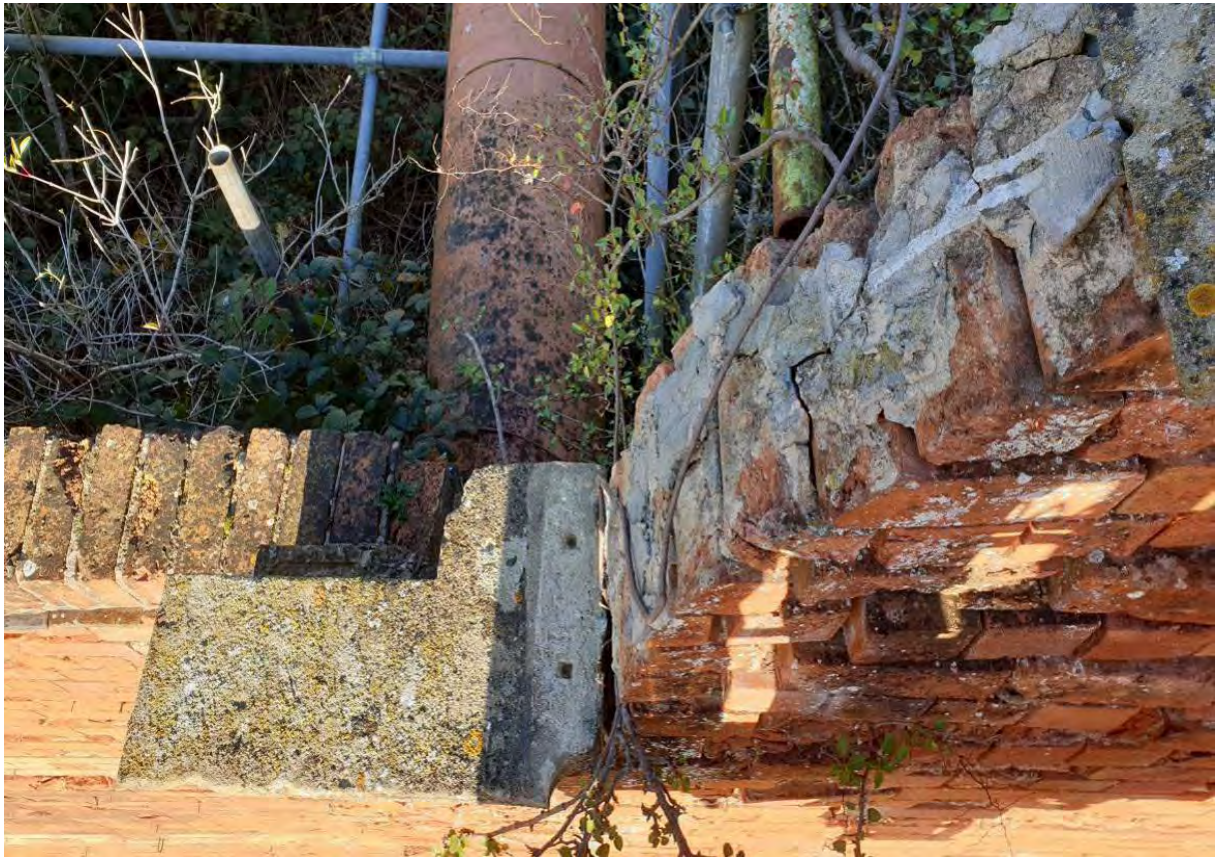
**Photograph 11:** Missing coping stone to the east end of the south elevation (south range)

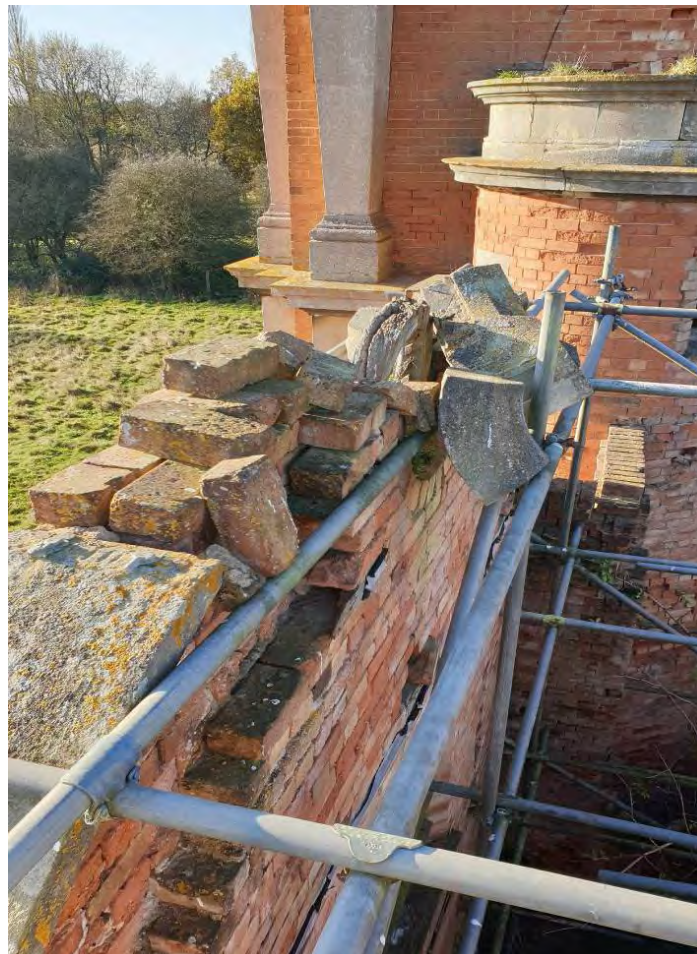
**Photograph 12:** Collapsed stone dressings to the south elevation of the south range

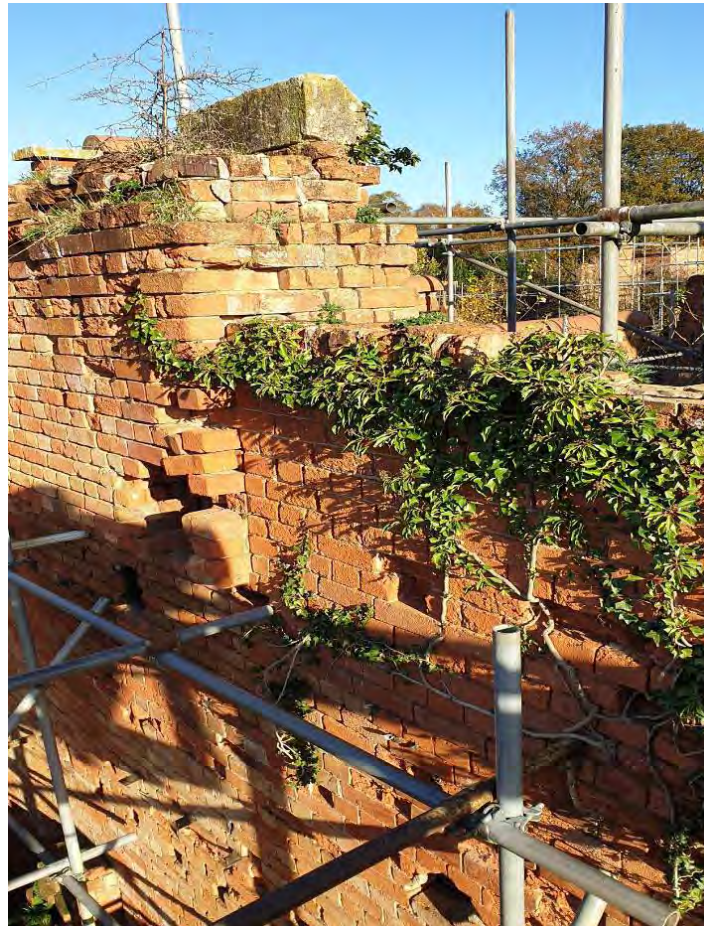
**Photograph 13:** Climbing plants overgrowth to the south range

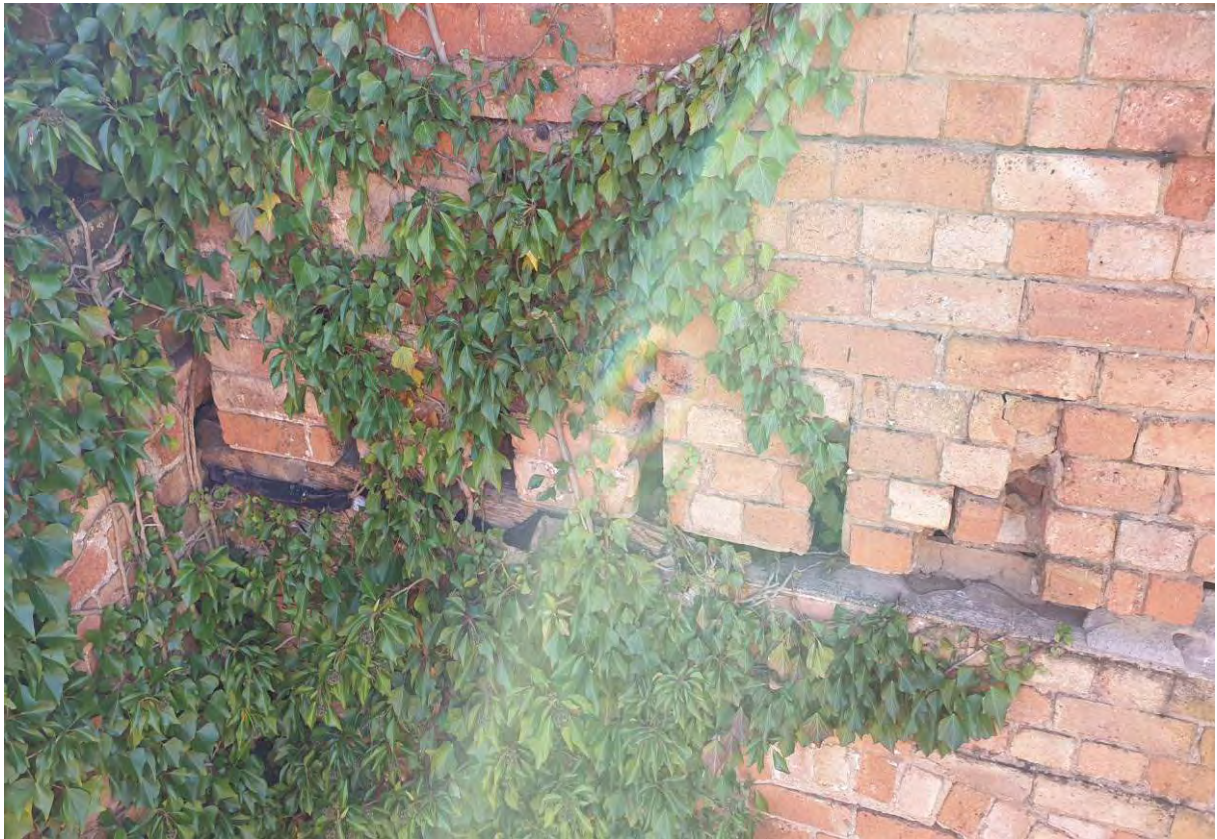
**Photograph 15:** Embedded timber plates rotten away (north range)

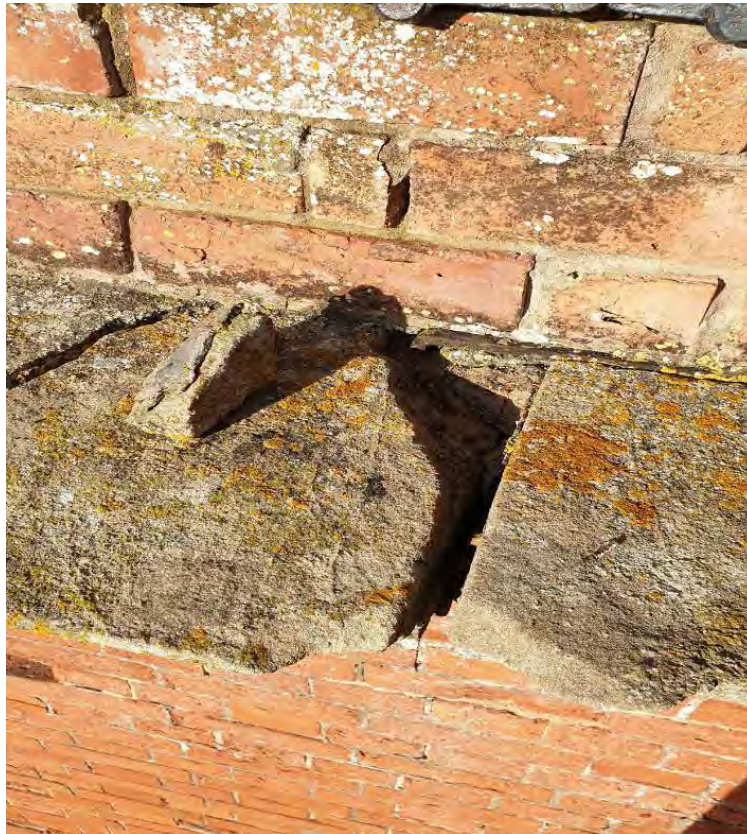
**Photograph 17:** Damaged and loose coping stone at high level (north range - area '10')

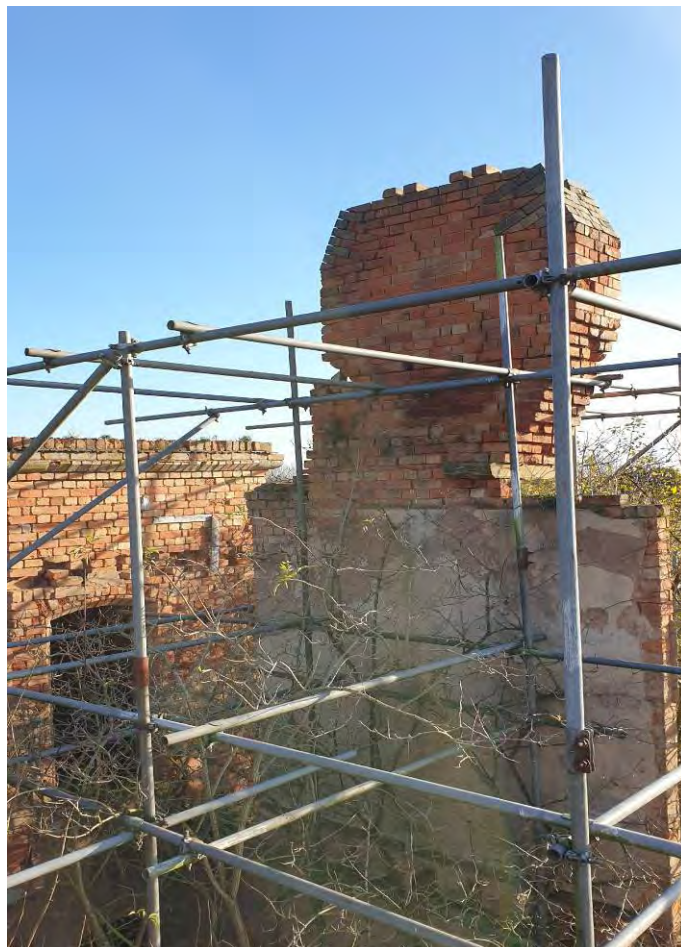
**Photograph 18:** Stepped chimney stack to be inspected from close-level, and to be provided with temporary support, as appropriate (east range)

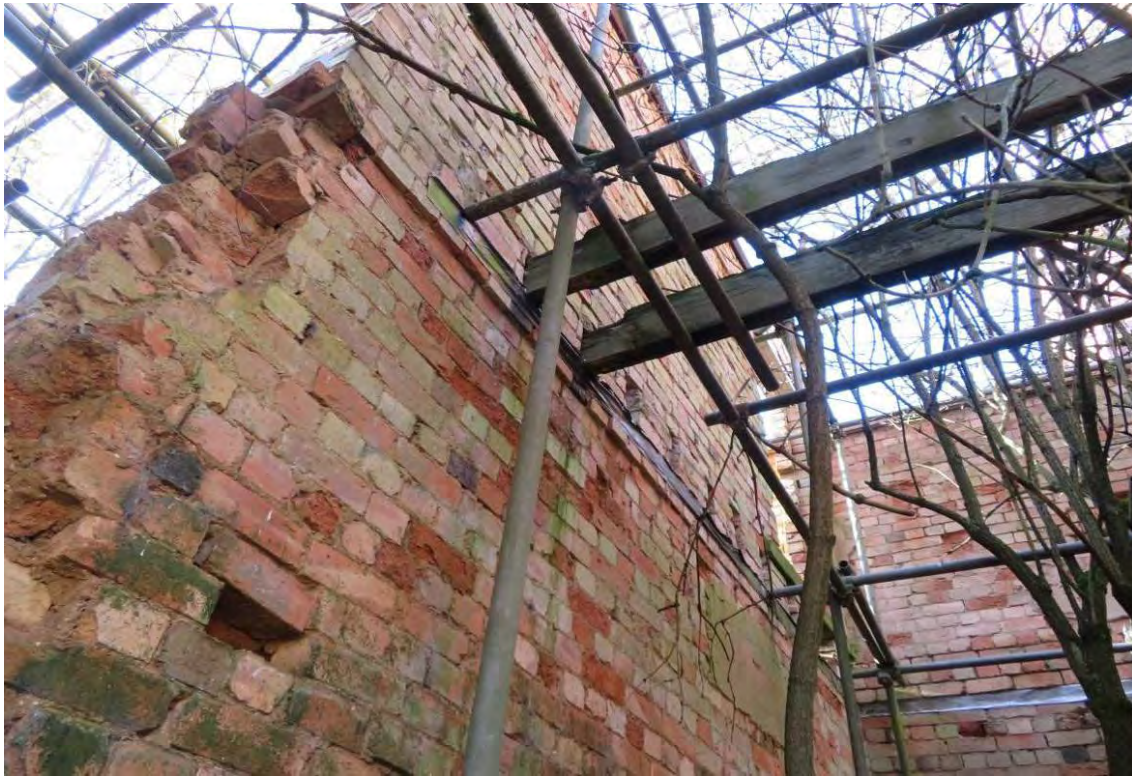
**Photograph 21:** Bonding timber acting also as a wall plate providing support to joists. Vulnerable area for the 9 inch cross wall in question.

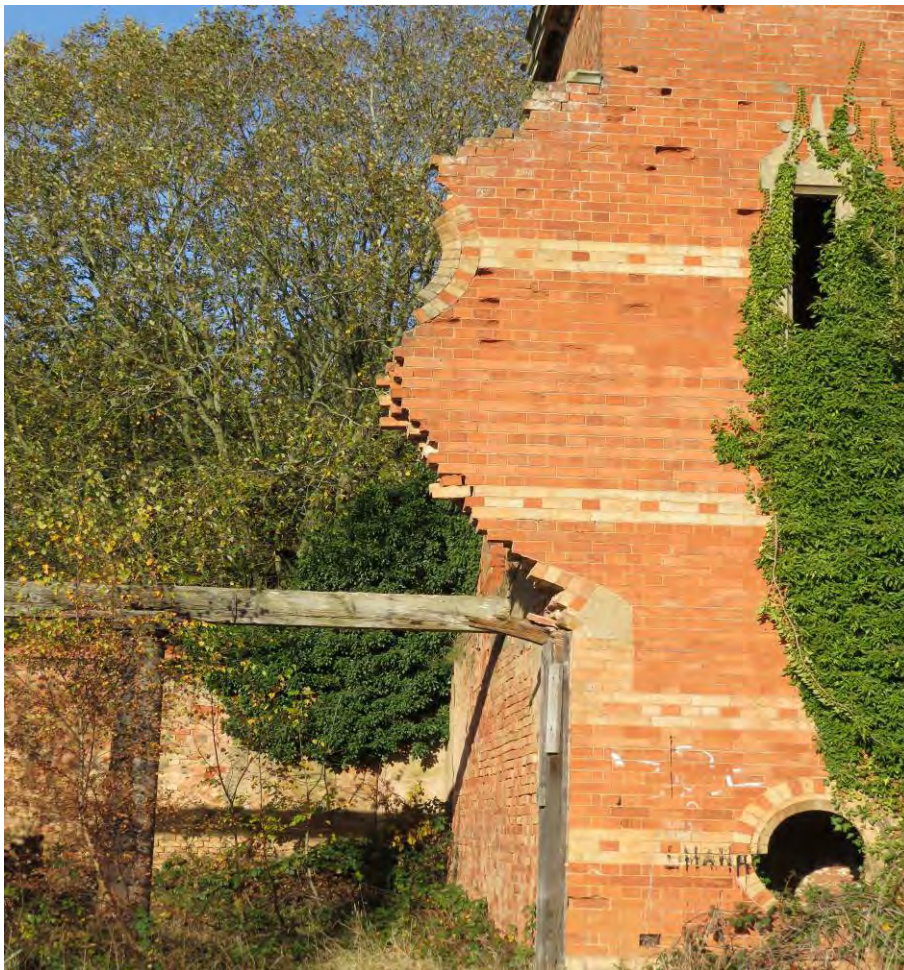
**Photograph 22:** Loose bricks and lack of adequate support to the south wall of area '9' (north range)

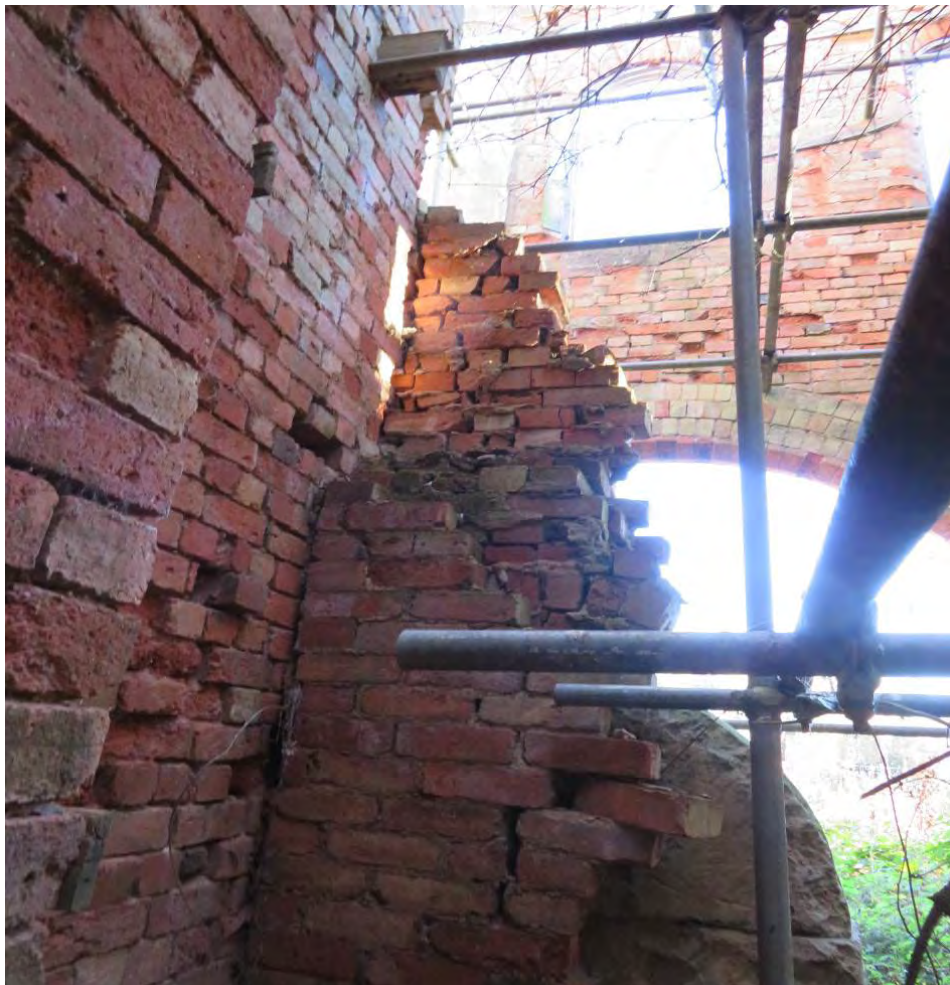
**Photograph 24:** Brickwork behind niche found to be loose in area '4'  
(refer to TMP diagrammatic plan)

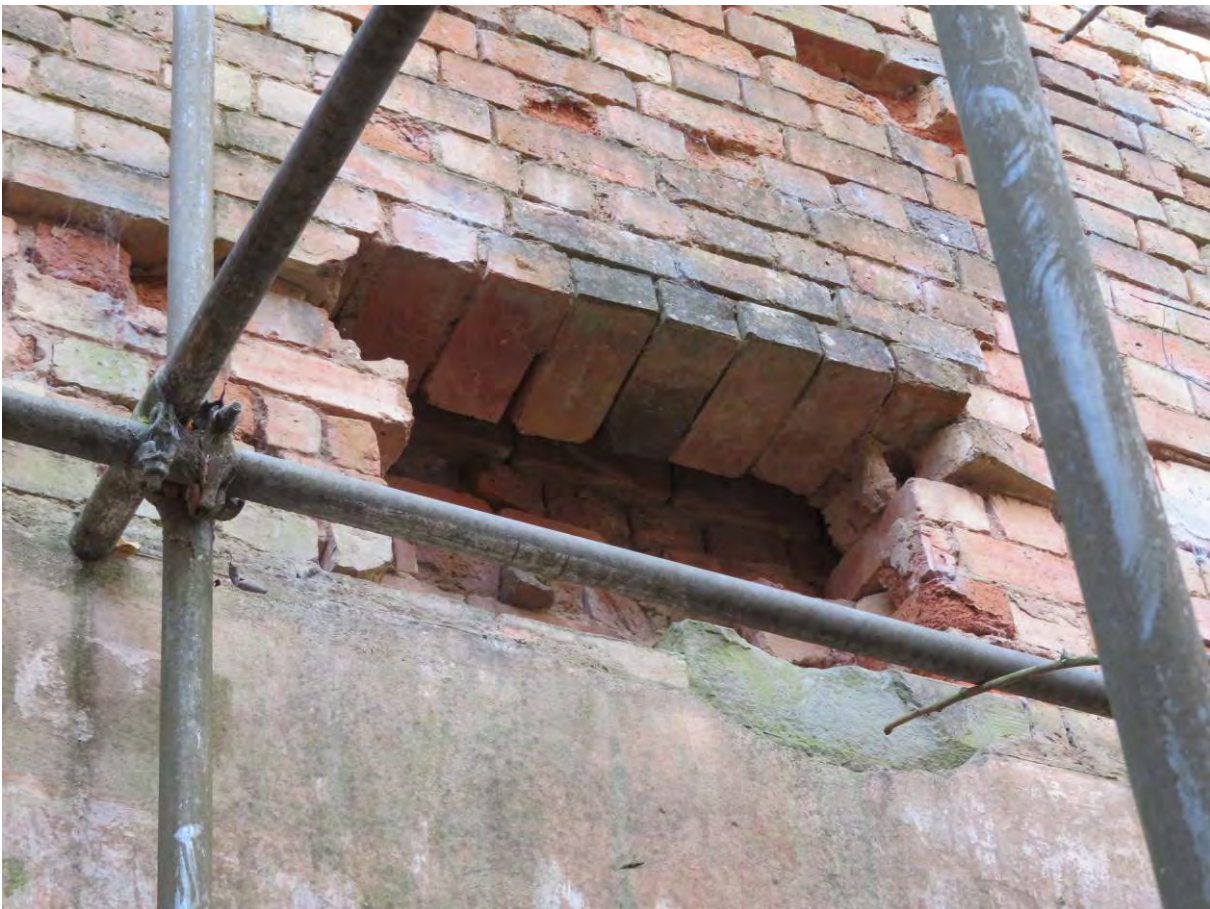
**Photograph 26:** Room 3 west wall hole

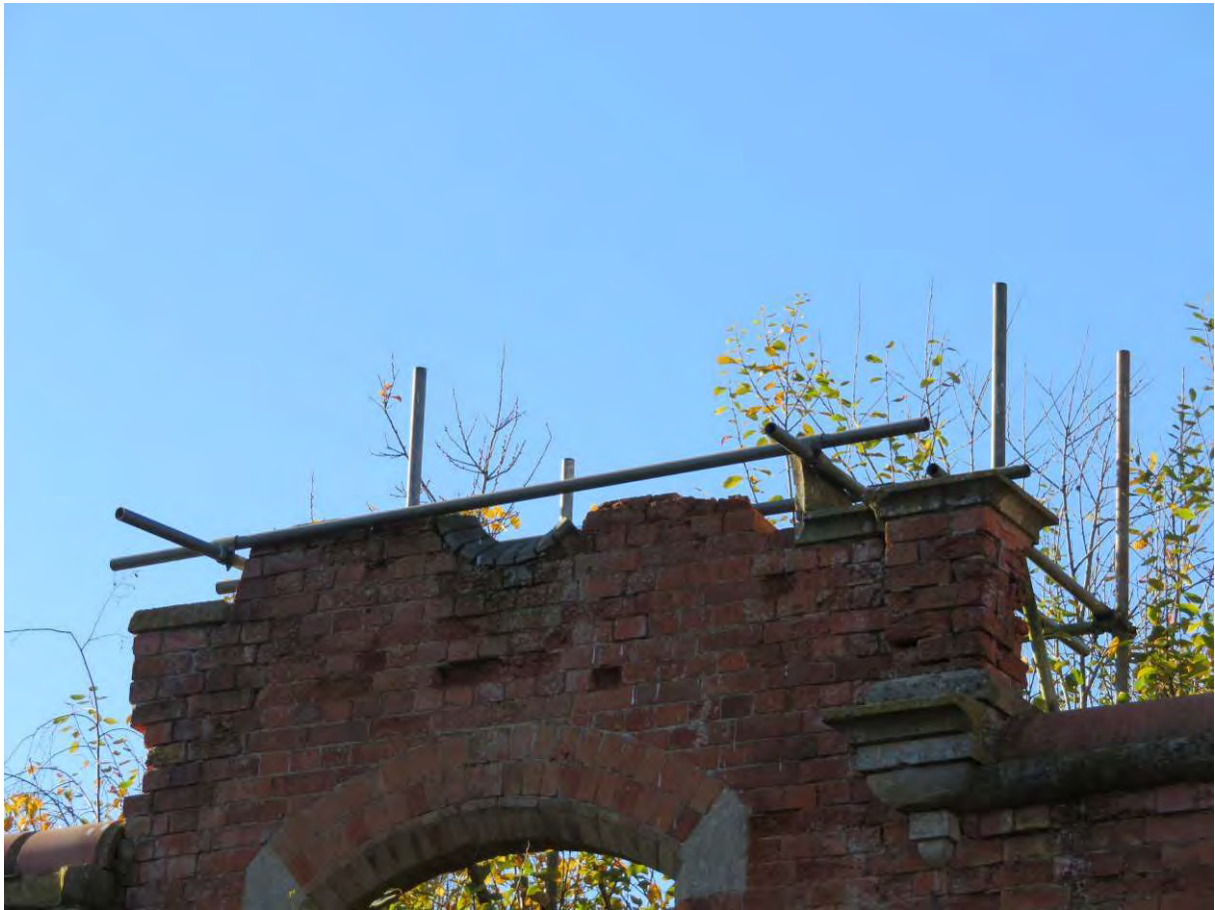
**Photograph 27:** Lost head to pediment to east side of Room 3

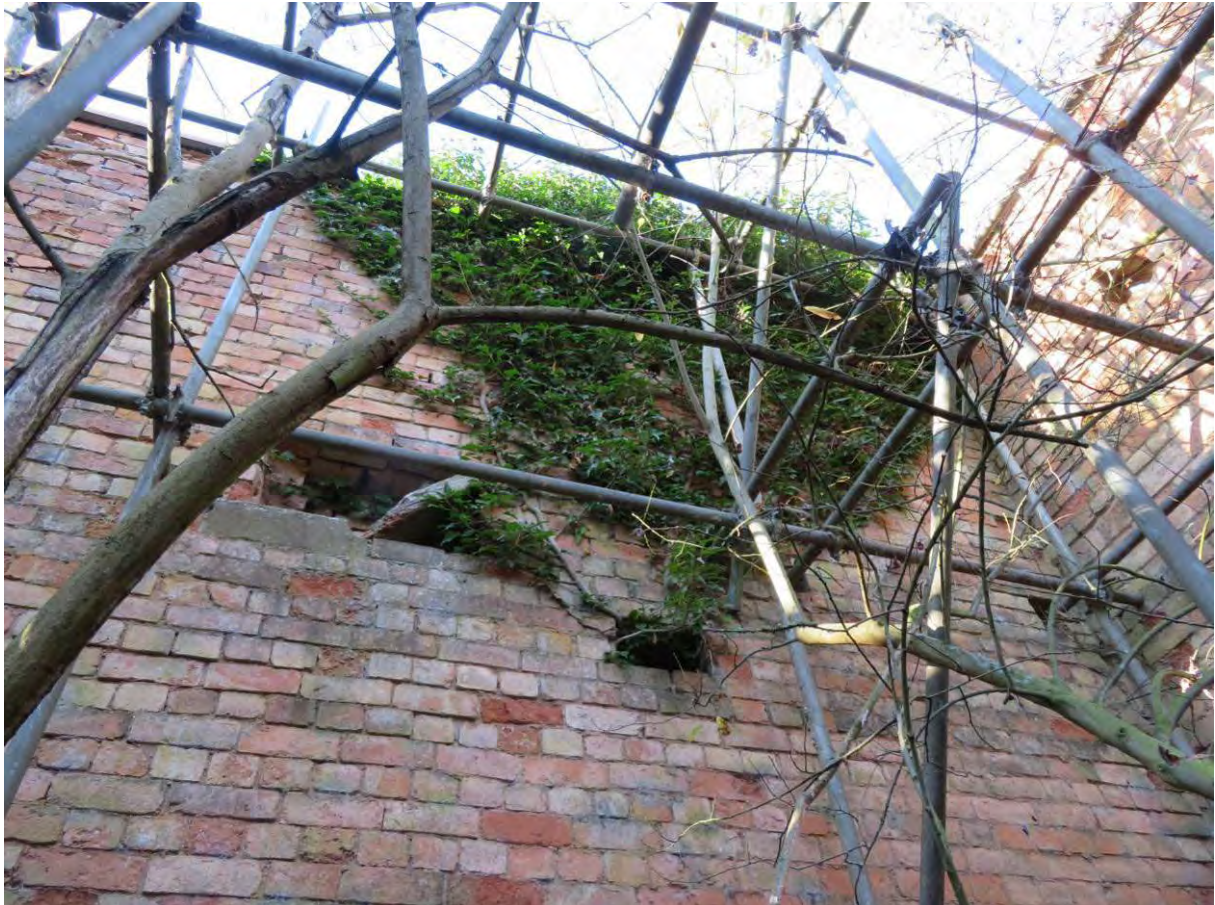
**Photograph 30:** Hole in rear wall of Room 5

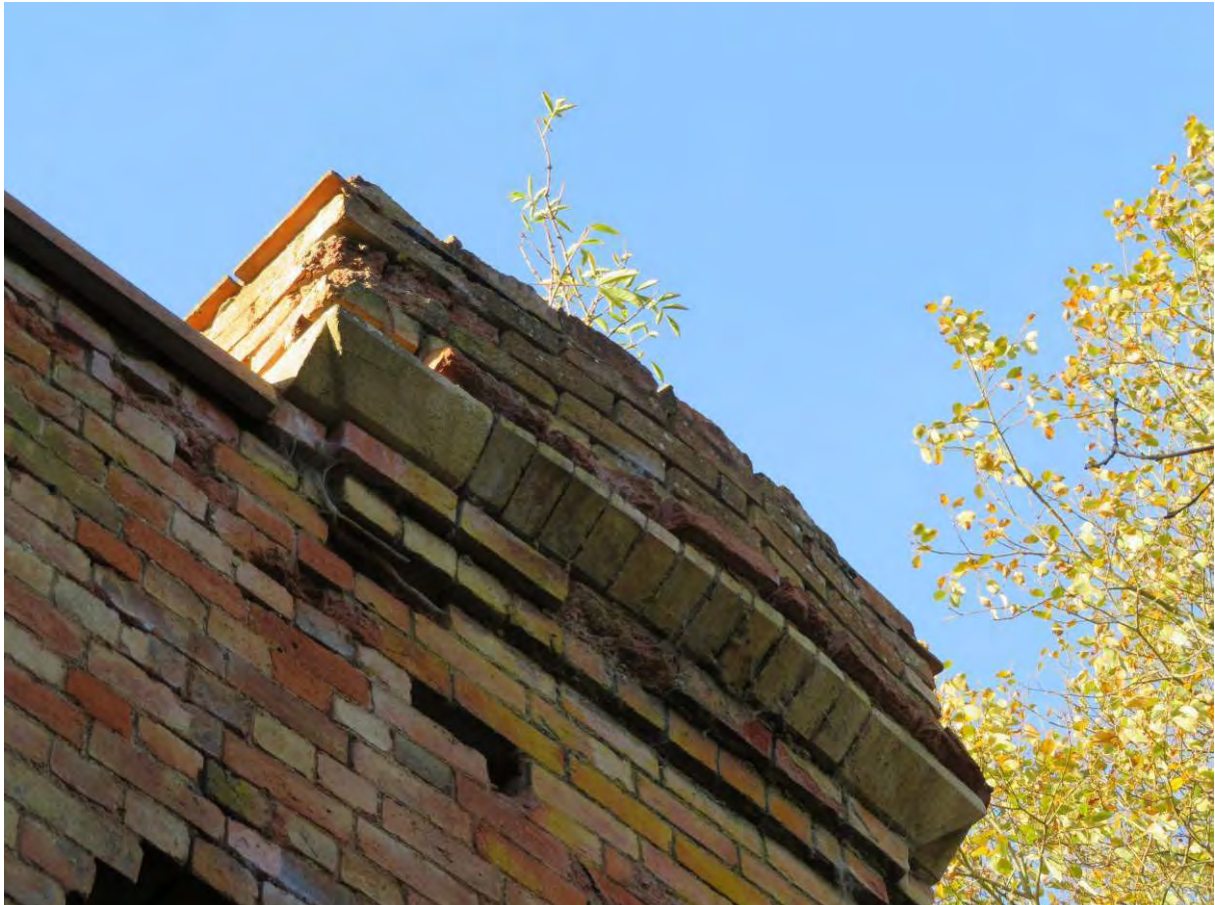
**Photograph 34:** Bulged chimney to west elevation to Room 10a

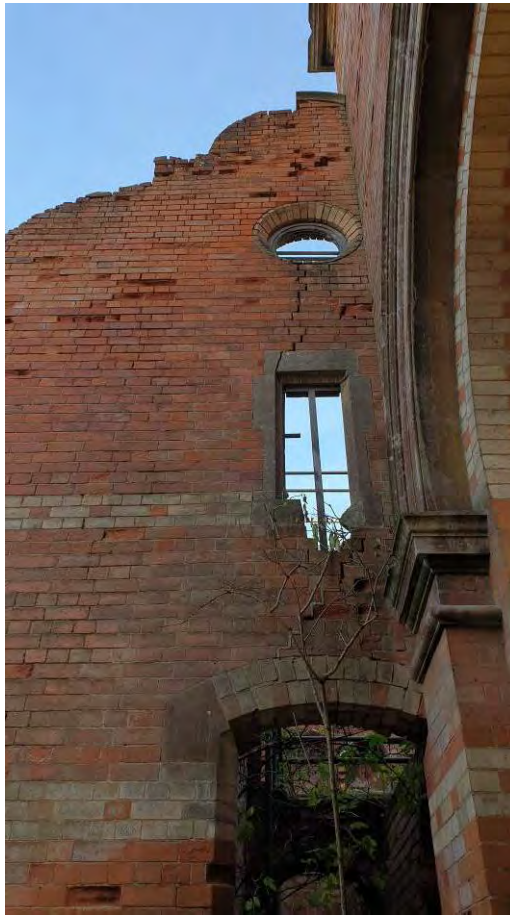
**Photograph 41:** Cracks over openings towards Room 20c

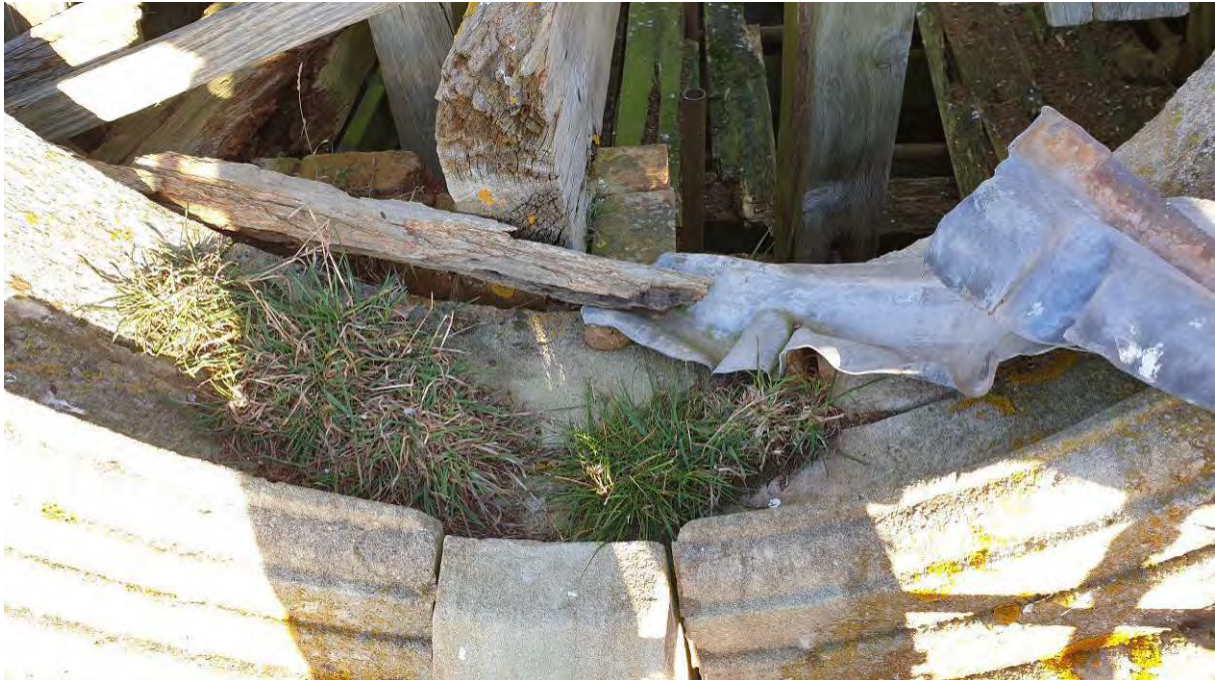
**Photograph 48: Loose timbers, leadwork etc.**

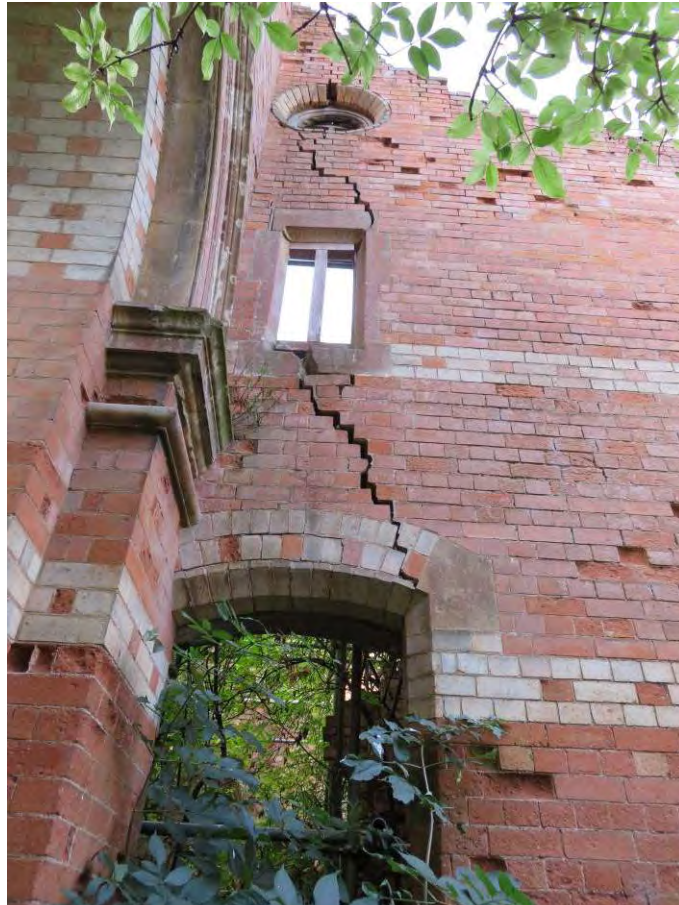
**Photograph 52:** Cracks over openings towards Room 22e

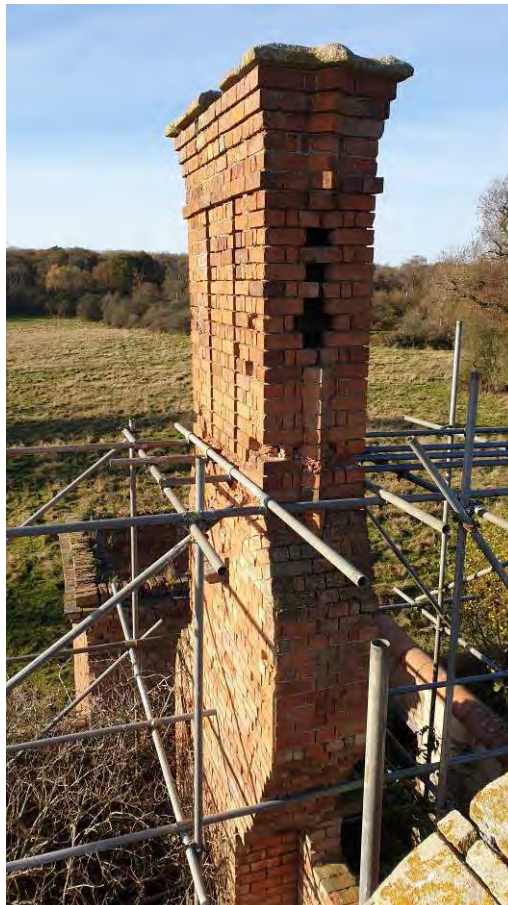
**Photograph 54:** Chimney to Room 4 with missing bricks

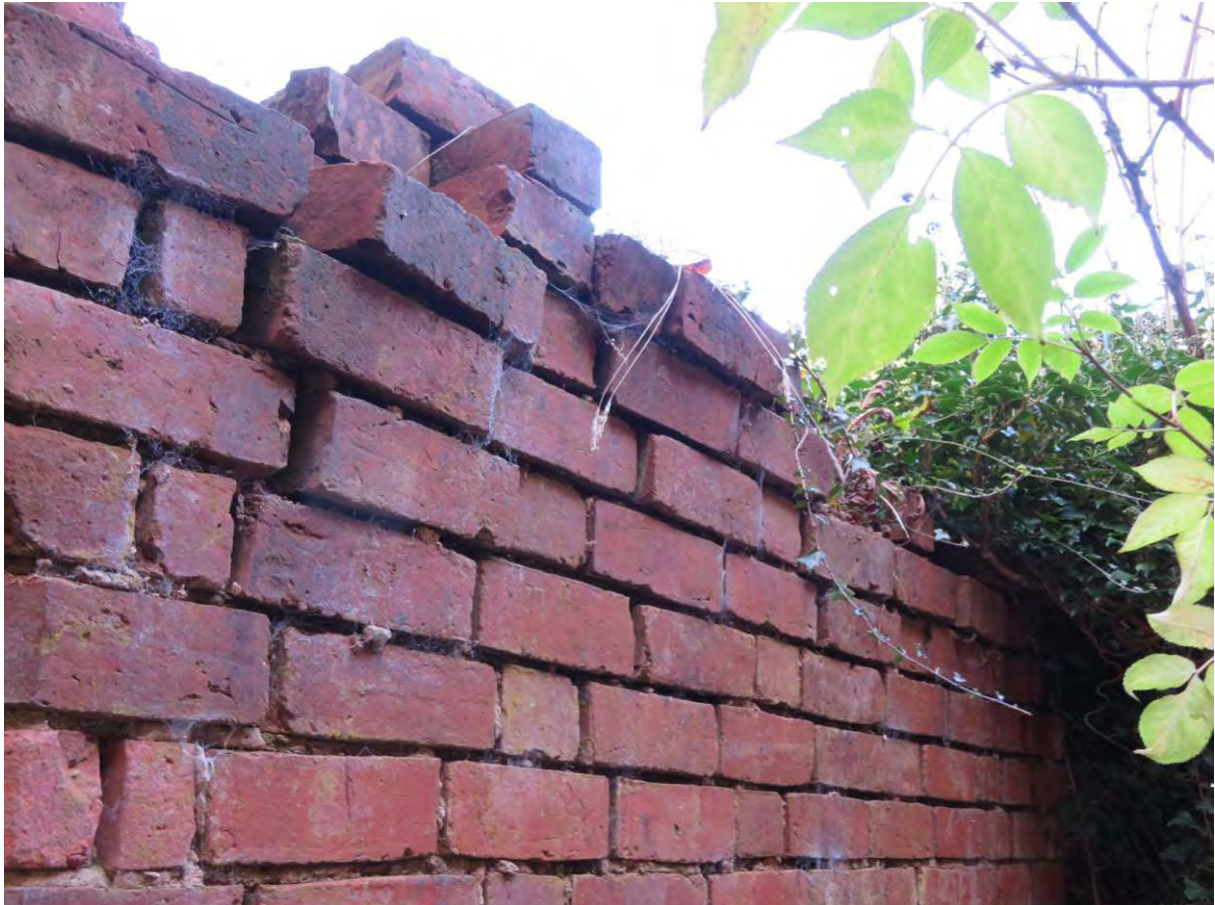
**Photograph 58:** Kennels brickwork on poor condition

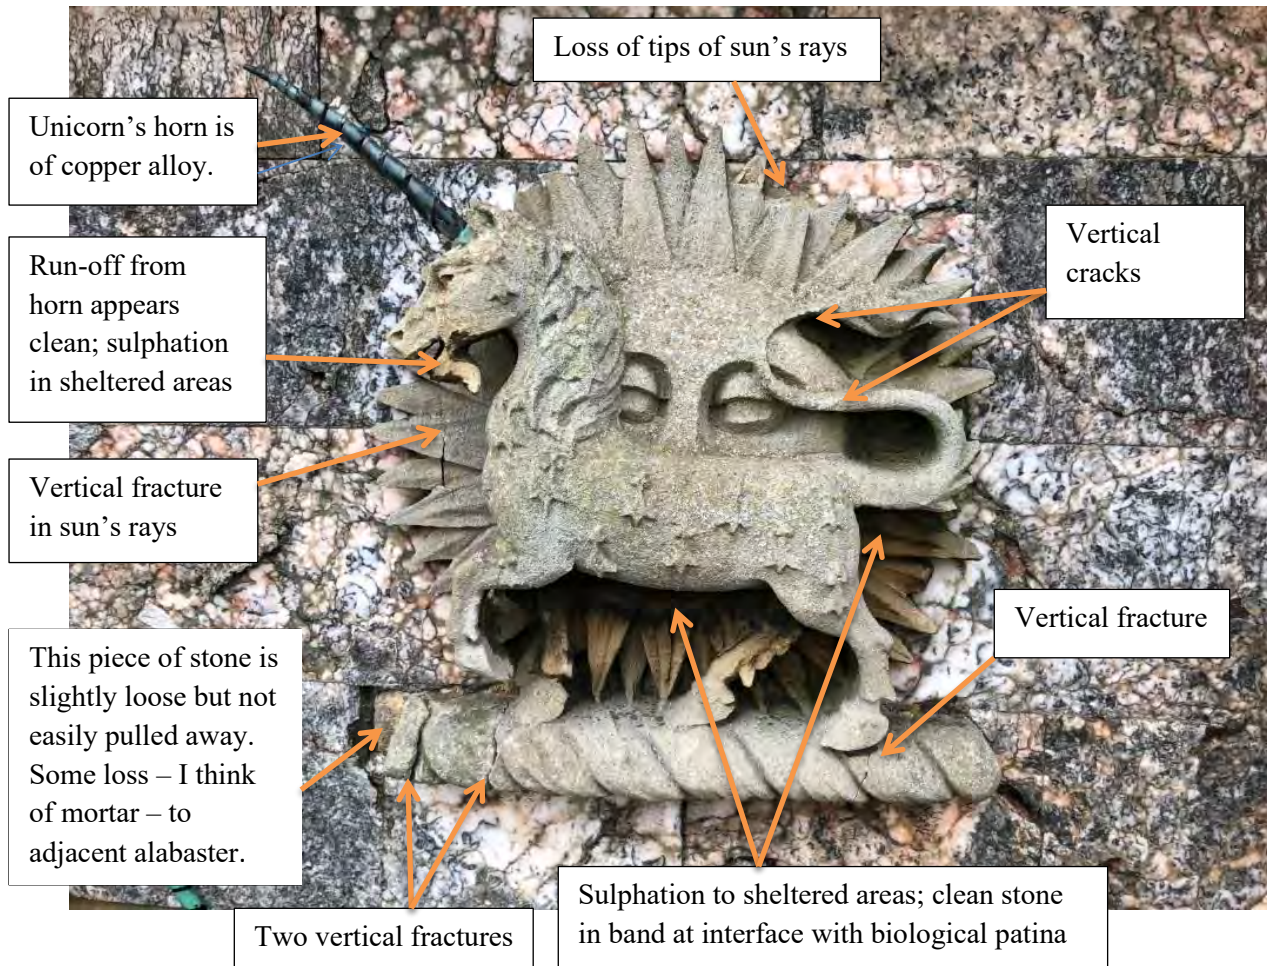
*Plate 6: Annotated photo of the unicorn and sun crest.*

This feature, looking as if it's made from a single piece of limestone, must have the back of the stone corbelled in the wall behind the alabaster. It is circa 670mm high and 700mm wide.

typically form along weak beds (is this stone laid off bed?) and in exposed and vulnerable areas – here being the tips of the sun’s rays.

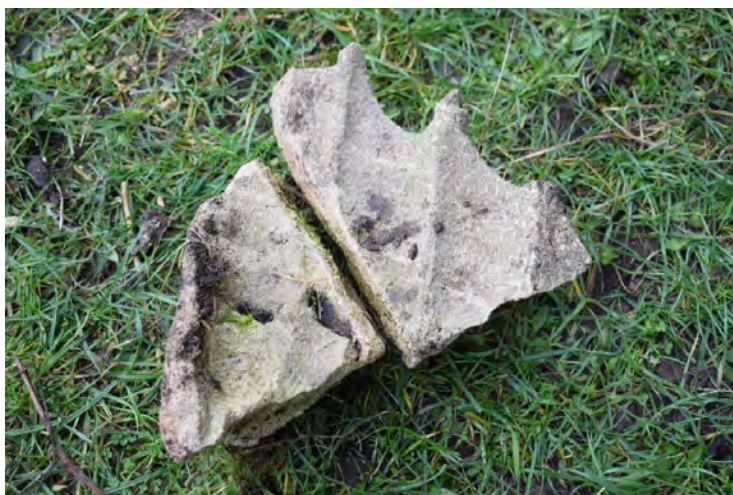
*Plate 8: The broken wyvern's wing, found in two pieces in the grass. It was placed on the side of the stonework (the adjacent column base upper ledge) for safe keeping. It is in total circa 250 x 200 x 110mm in size and has residual mortar on the back – presumably original bedding – that looks like Roman cement.*

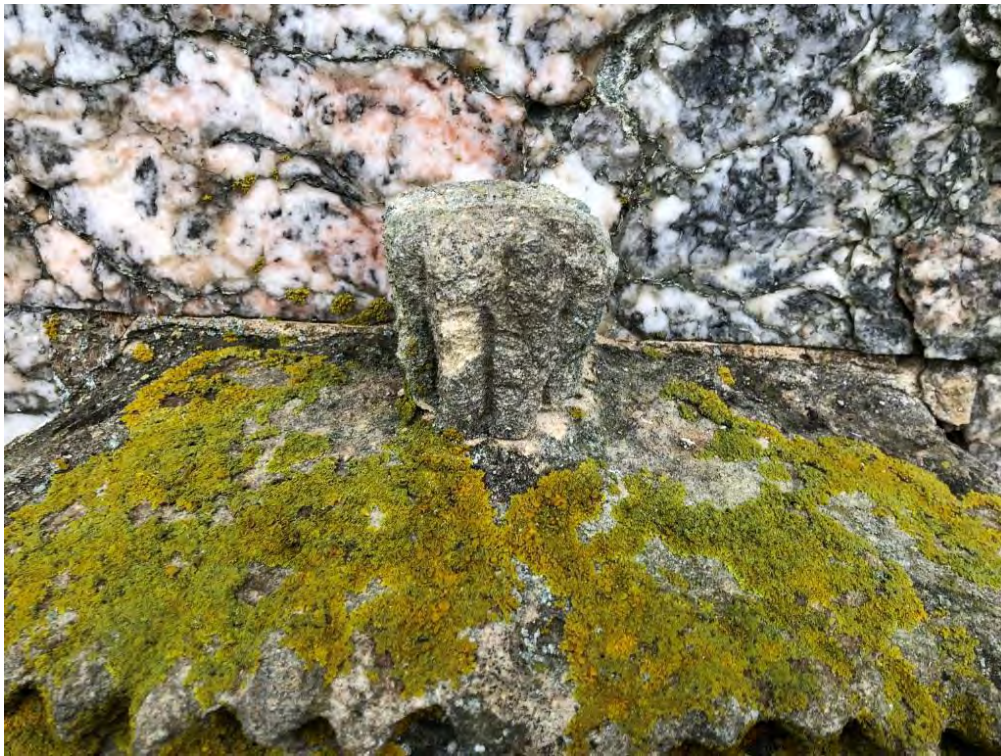
*Plate 9: The upper surface of the coronet. There is a particularly heavy build-up of lichen here.*

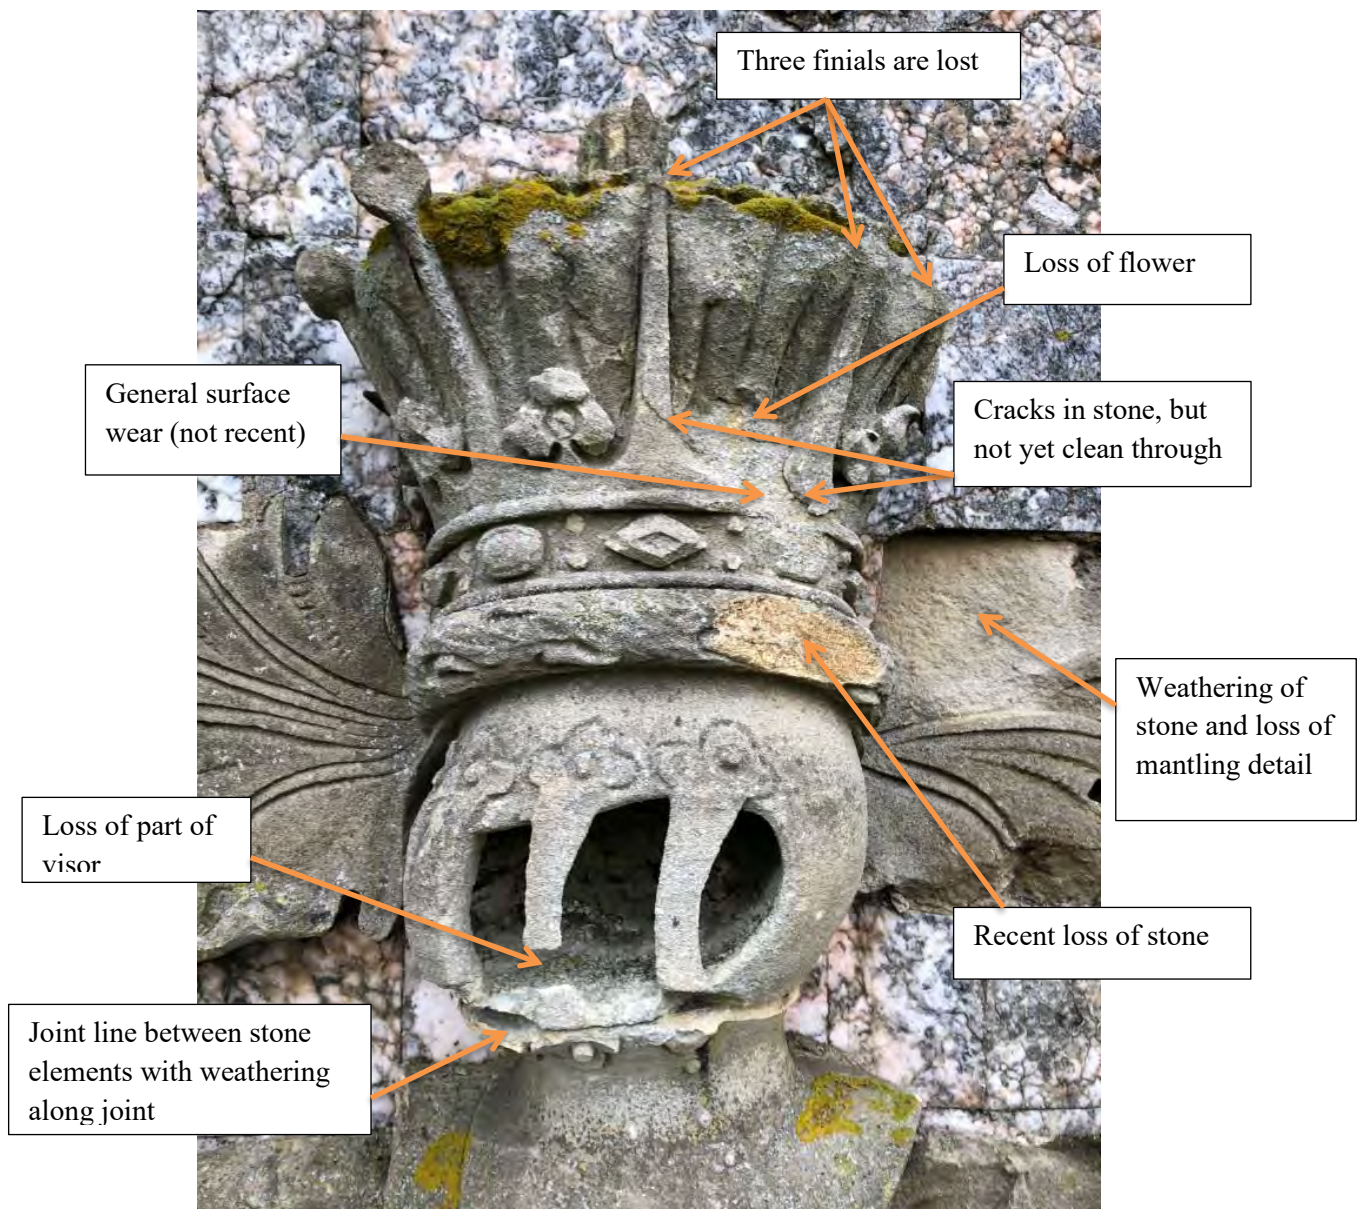
*Plate 11: Annotated photograph of the helm.*
