**SPECIFICATION AND SCHEDULE  
OF MINIMUM WORKS  
FOR  
STABLES  
TO BRADGATE HOUSE  
GROBY  
LEICESTERSHIRE**

**Date:** January 2024

**Reference:** EJM/CH/SPEC/22383-Minimum Works Schedule rev 2

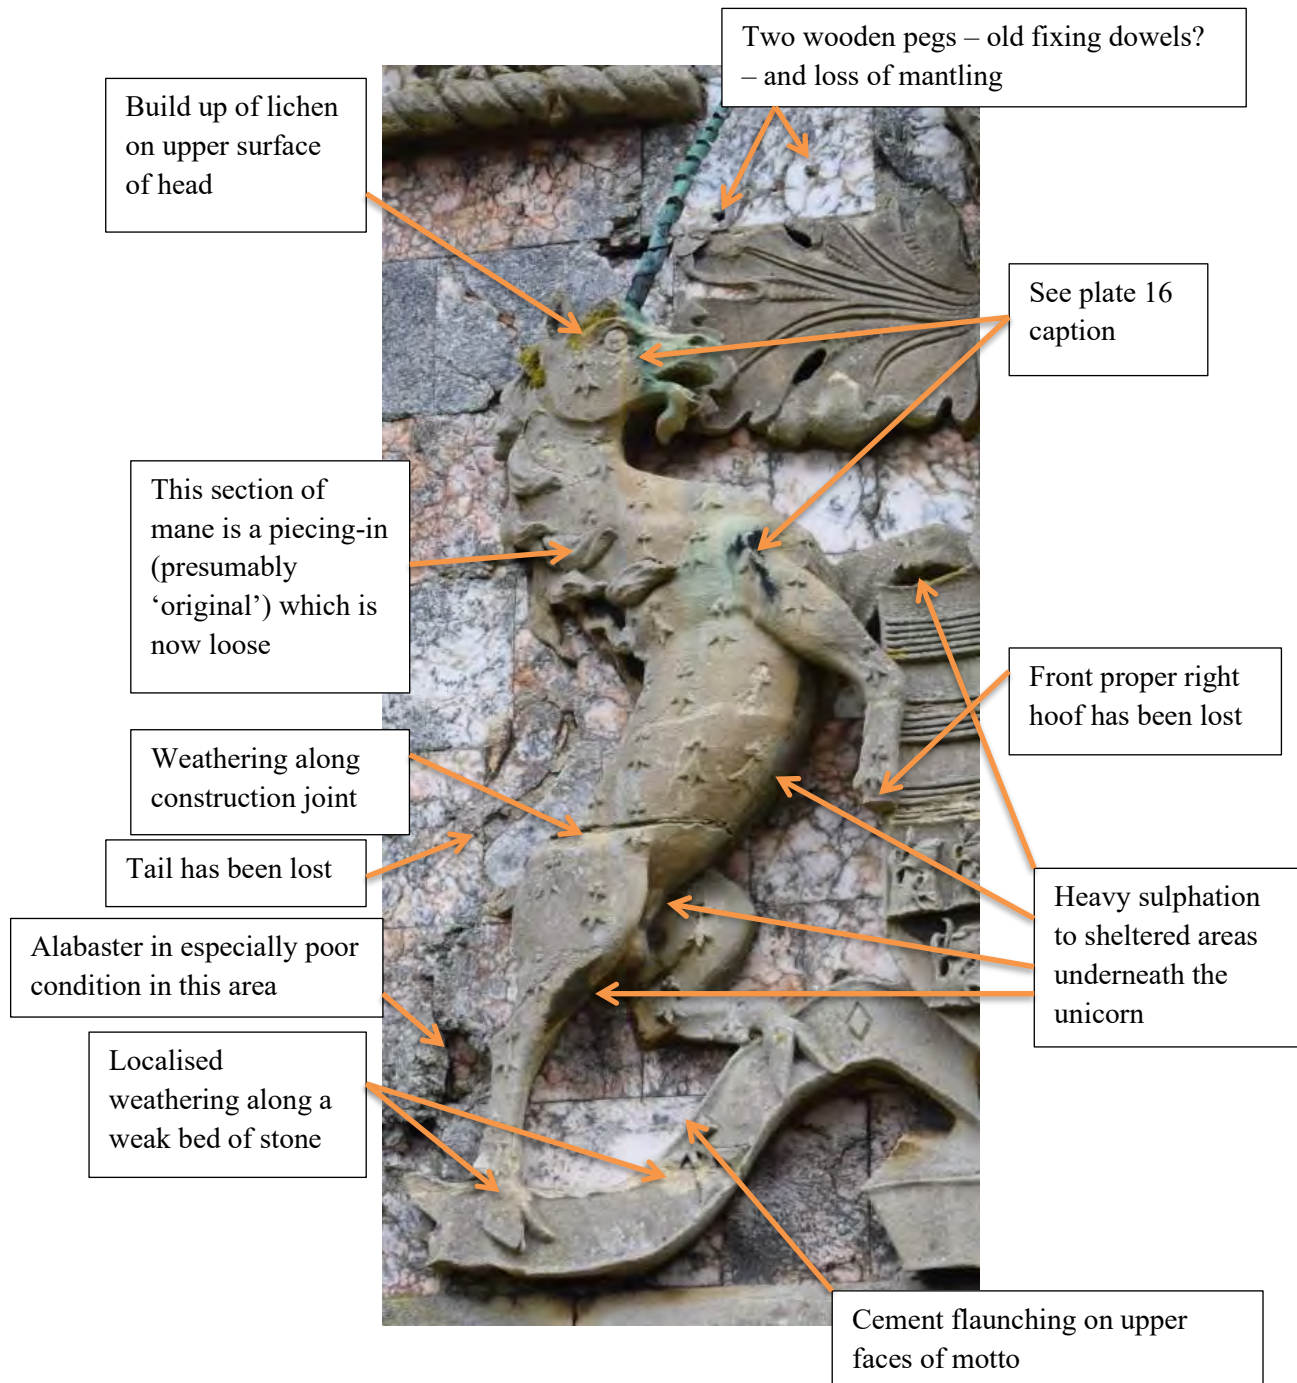
*Plate 14: Annotated photograph of the dexter unicorn.*

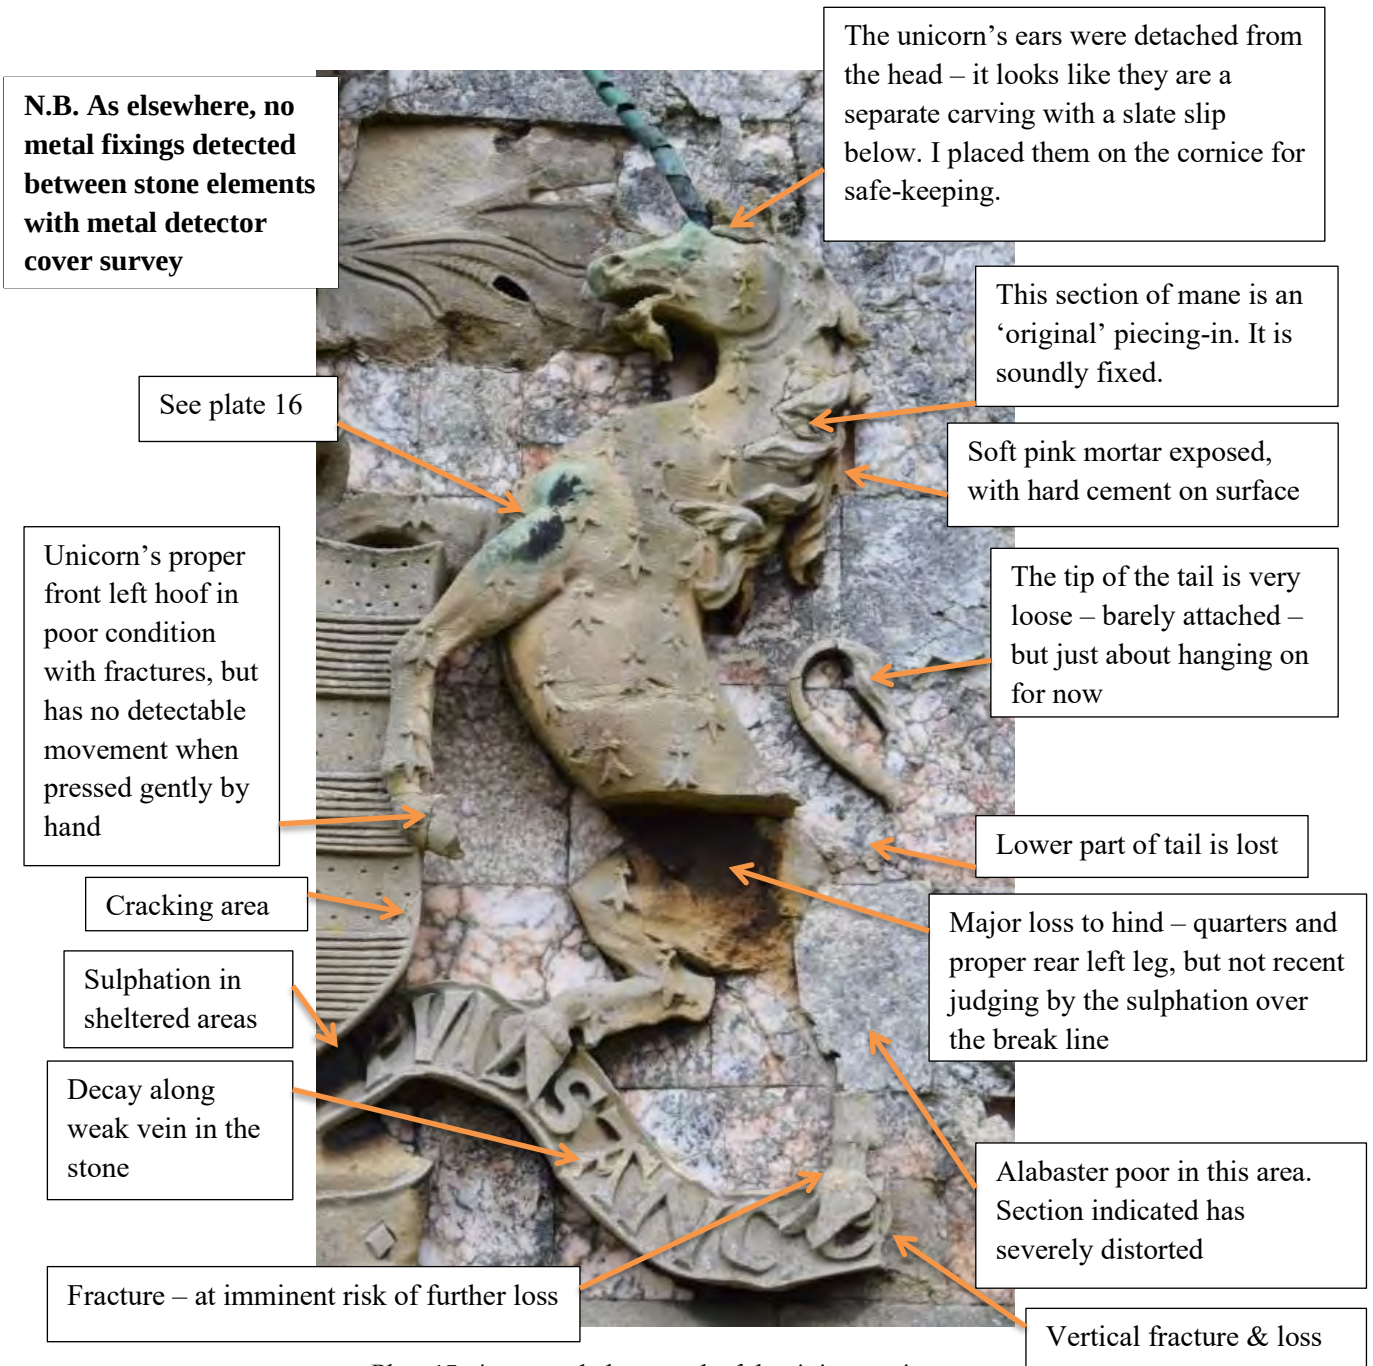
*Plate 15: Annotated photograph of the sinister unicorn.*

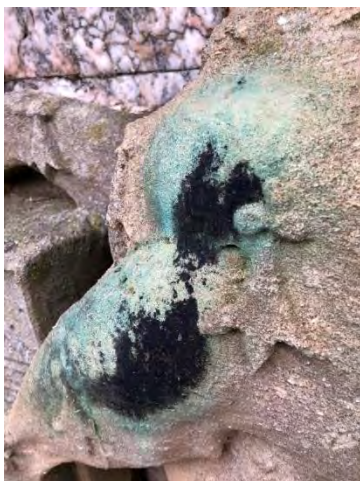
*Plate 16: – detail of the sinister unicorn's proper left front leg shoulder showing a curious pattern of staining associated with the copper run-off from the horn. This is also reflected on the dexter unicorn.*

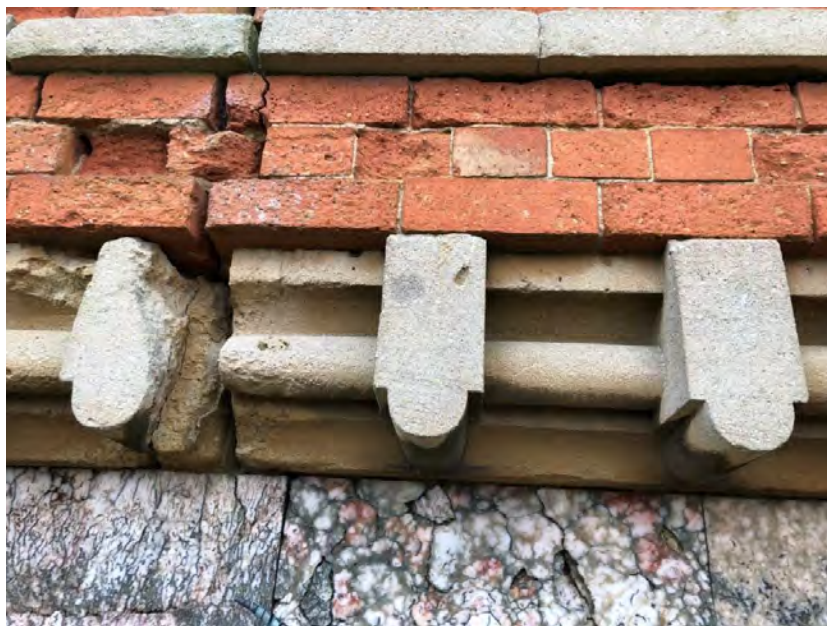
The good condition of the surrounding masonry is dependent on the functioning of features above to dispose of rainwater from the core – in this case that would be the projecting cornice, the parapets and gables above and their copings, and gutters and downpipes from the roof. All of these have failed to varying degrees – as will be covered by The Morton Partnership’s report – but the issues are perfectly exemplified in plate 17 below. A structural crack has led to open joints in key features with the deterioration of bricks and stone below being abundantly clear. In fact, although the alabaster immediately below at first looks okay, there is a concentration of failure of decorative limestone features below these areas of building defect.

*Plate 17: Cracking in the masonry above the panel leading to openings for water penetration.*
