**HIGHAM ON THE HILL
CONSERVATION AREA
MANAGEMENT PLAN**

**PHOTOGRAPHIC RECORD OF HIGHAM
ON THE HILL CONSERVATION AREA**

October 2009

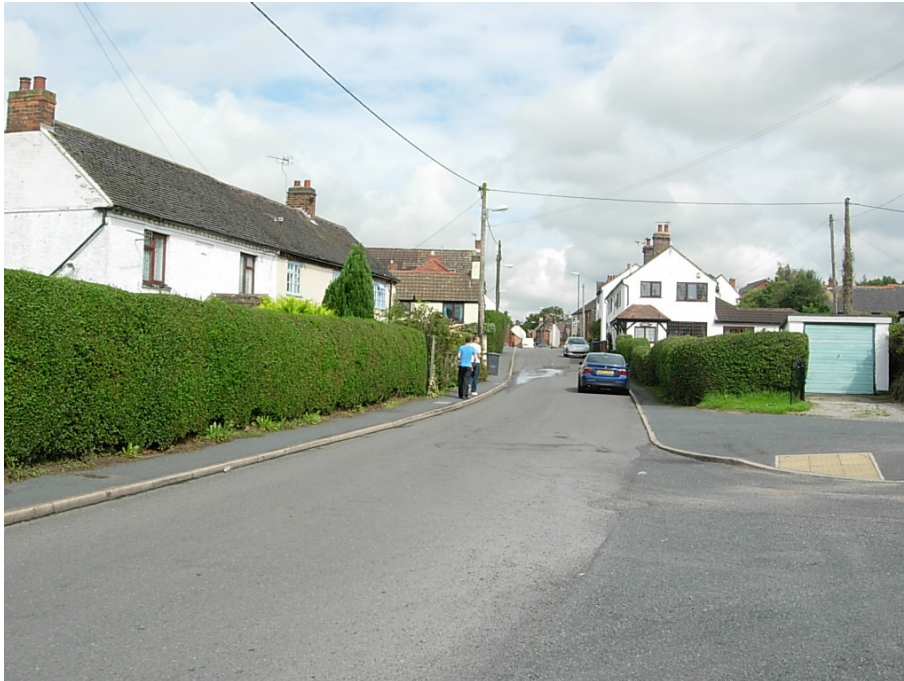
The privet hedges either side of Main Street help soften the approach into the conservation area. The garage in the garden of 26 Main Street has an adverse impact in the street scene. Its visual impact, however, could be reduced if the garage door was to be painted in a dark colour.

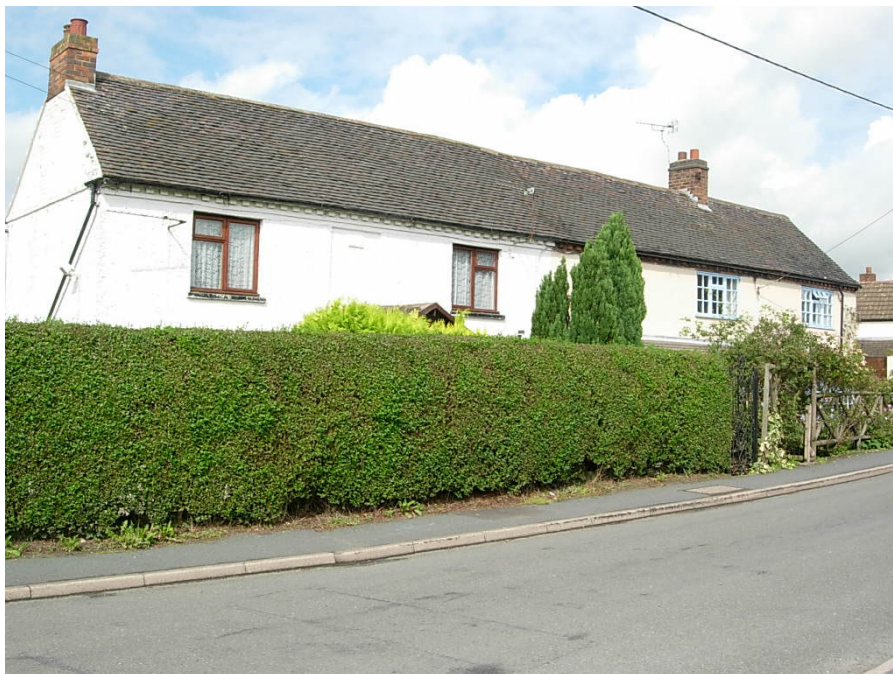
The rendered cottage 15 Main Street built in 1837 has lost some of its original character with the insertion of modern windows. The small pane windows in the end property are more in keeping with the traditional character.

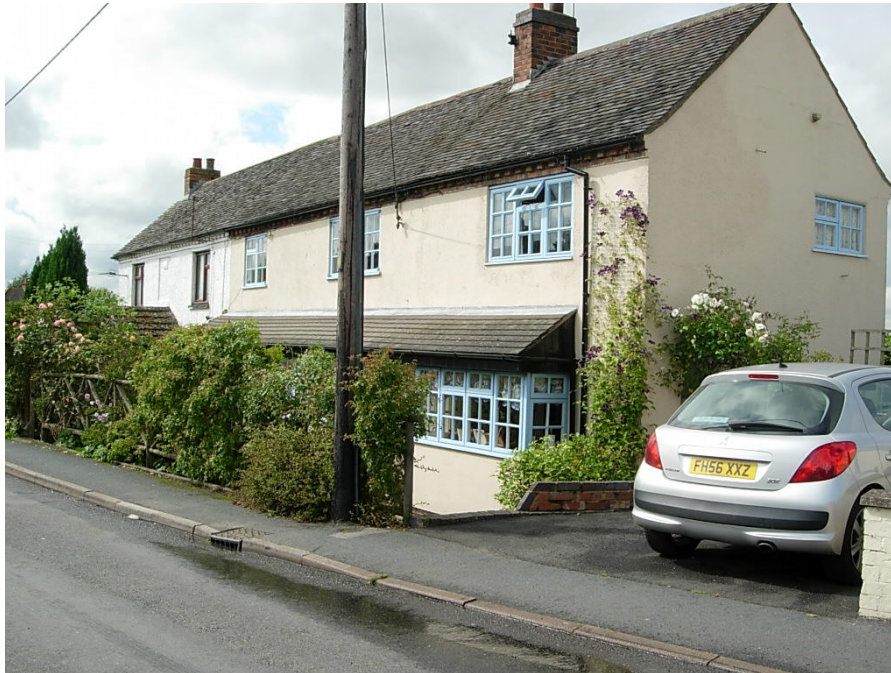
The large canopy that runs at 1st floor level over the whole length of the property at 19 Main Street is out of character with the original form of the property

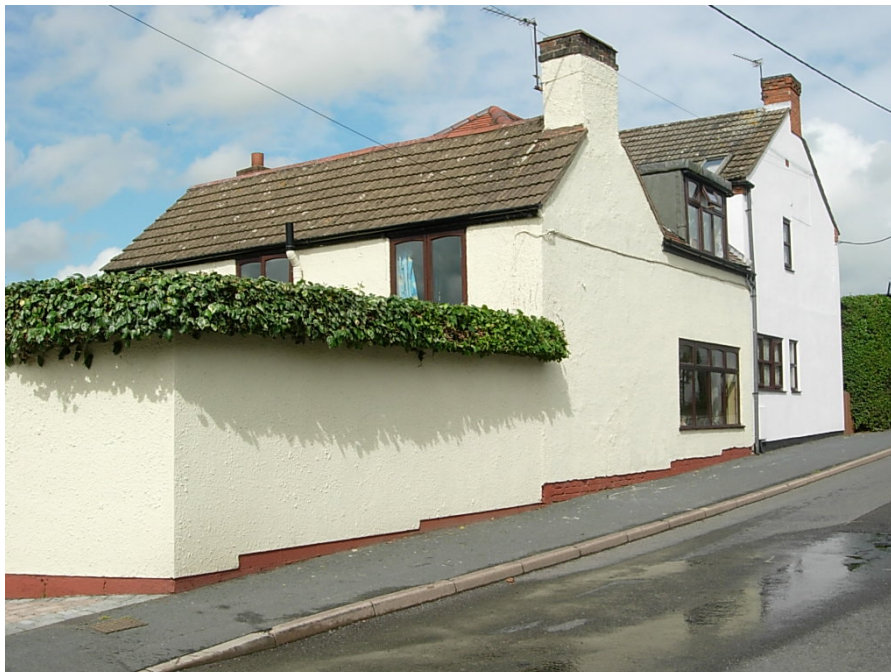
The roof of 23 Main Street could have been improved if the dormer had been set back and its felt sides finished either in tiles or lead. The dwelling has also lost its chimney pots

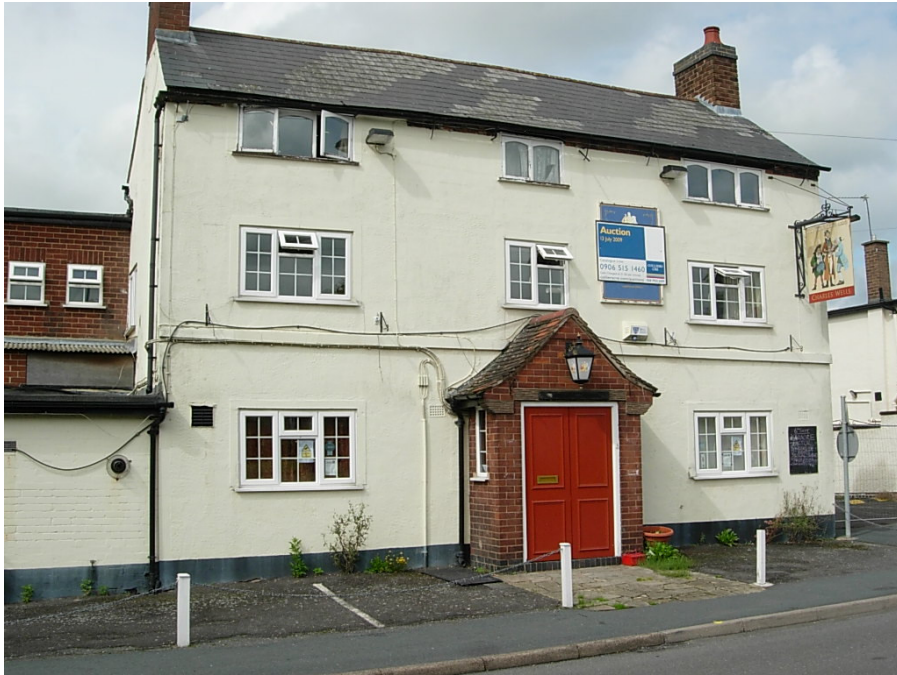
The Oddfellows Arms is an important property being sited close to the road junction at Nuneaton Lane. The three storey public house which is currently closed has unfortunately had some of its windows replaced with UPVC windows and been re-tiled with artificial roof tiles. It also suffers visually due to the flat roofed extensions.

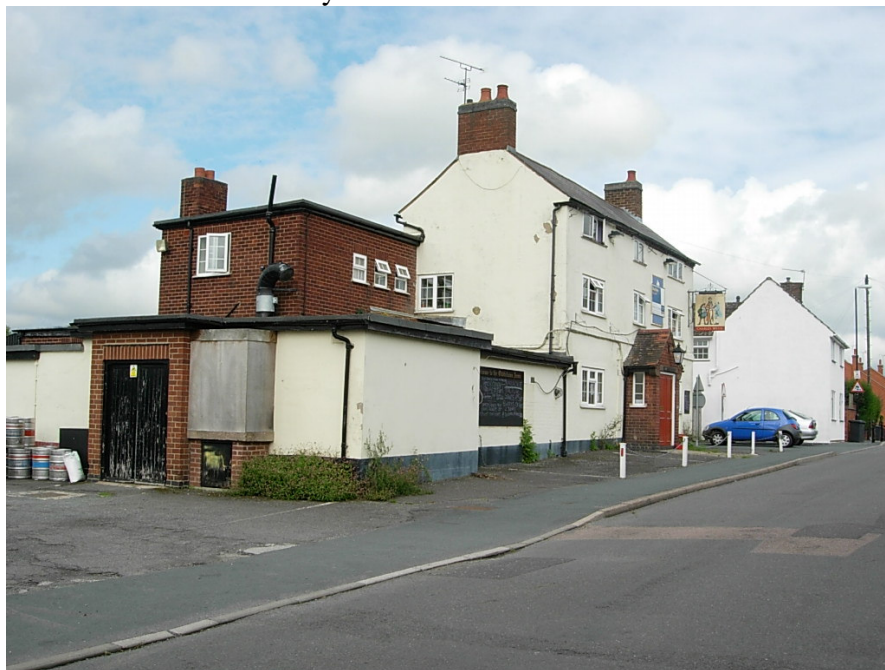
The modern outbuildings at the pub are of poor visual quality and if the pub was to be converted back to a residence their demolition would be an improvement. There might also be potential for the pub car park to be re-developed as part of a comprehensive scheme.

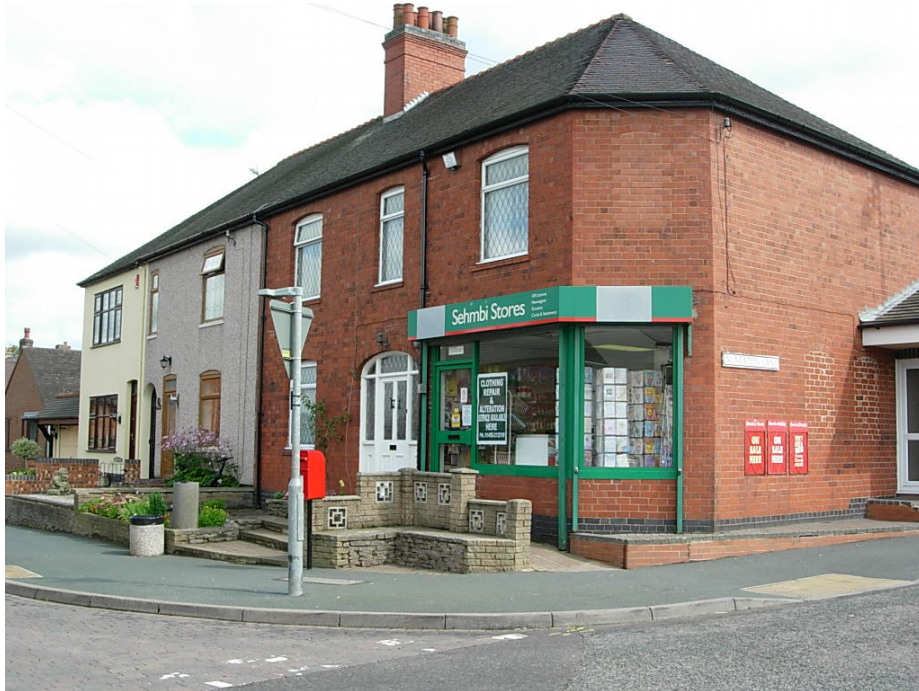
The shop front treatment and use of artificial materials at the corner of Main Street and Nuneaton Lane downgrades the visual amenity at this prominent location

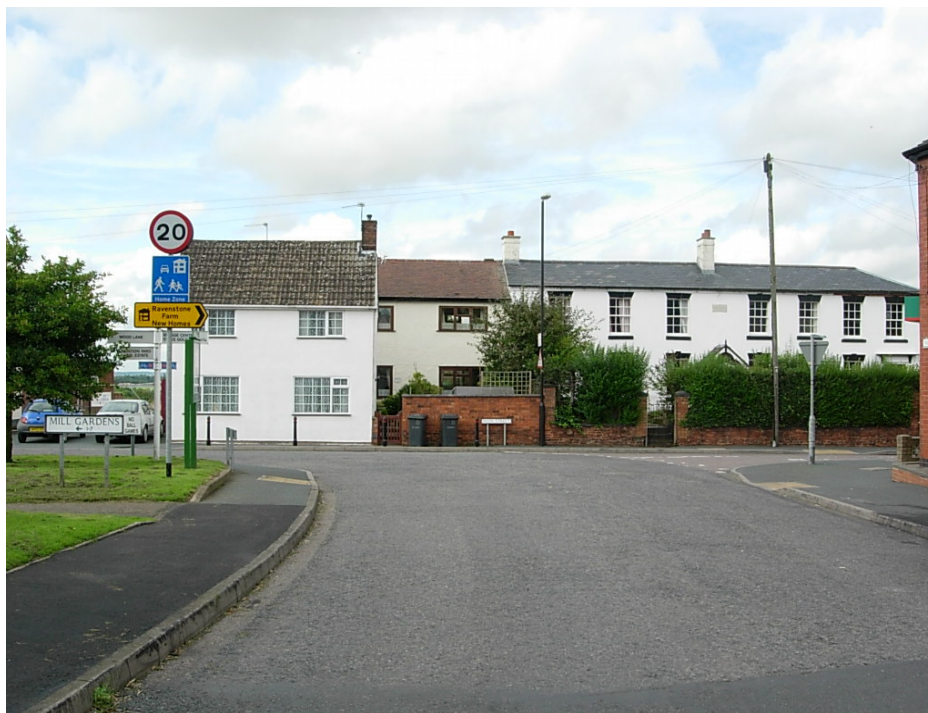
The properties 27 – 33 Main Street provide an excellent visual stop when approaching Main Street from Nuneaton Lane. However, the concrete roof tiles on 27 Main Street not in character.

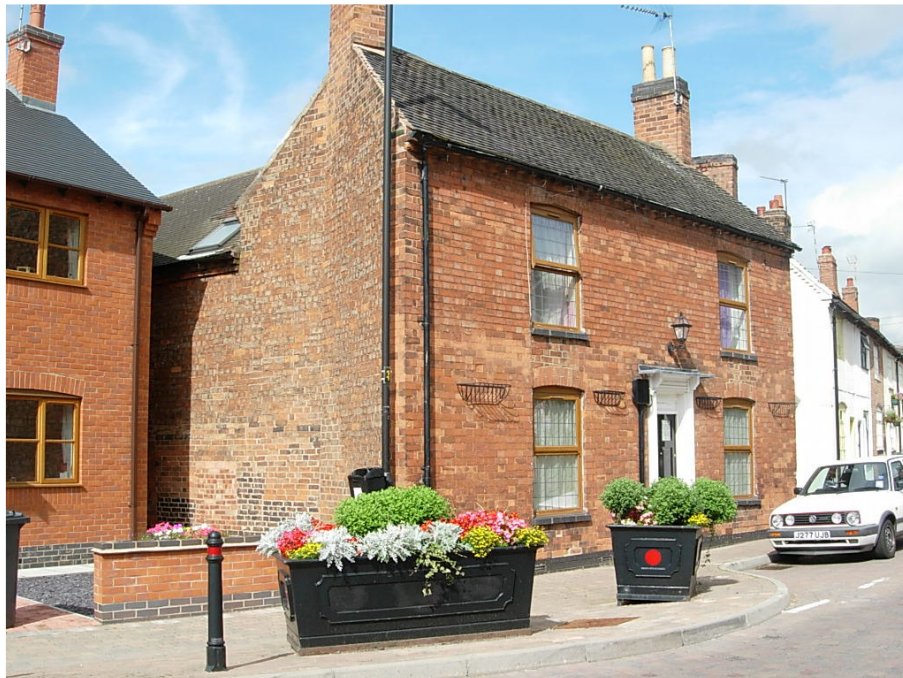
45 Main Street is a pleasant 2 storey dwelling with rosemary roof tiles and panel door. Its front elevation would be improved if the plastic windows were to be replaced with traditional timber sashes.

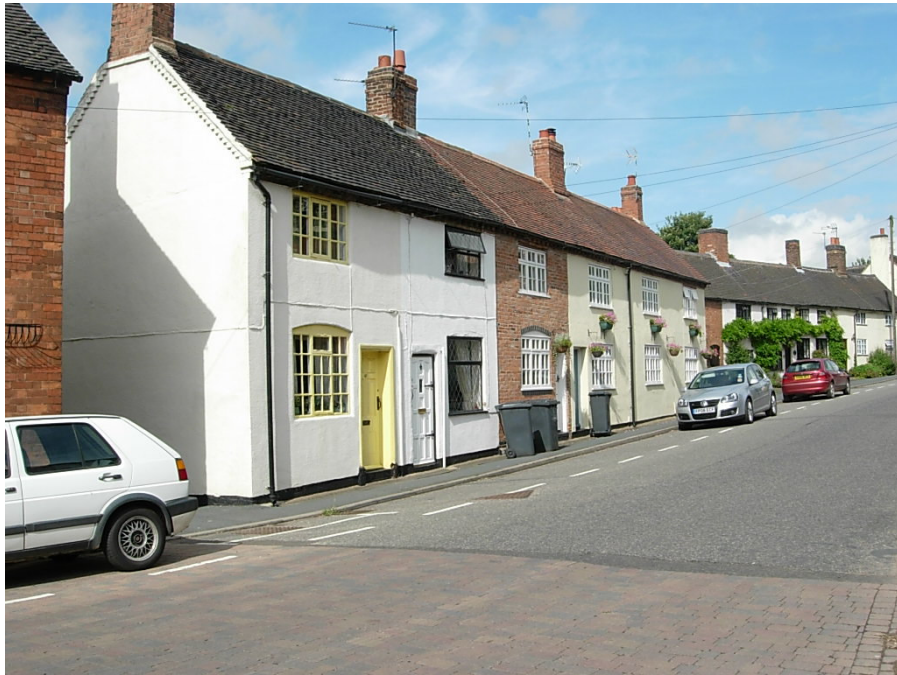
The symmetry of the terrace 47 – 55 Main Street is spoilt with new windows installed at 49 and the roof and ridge tiles changed at 51.

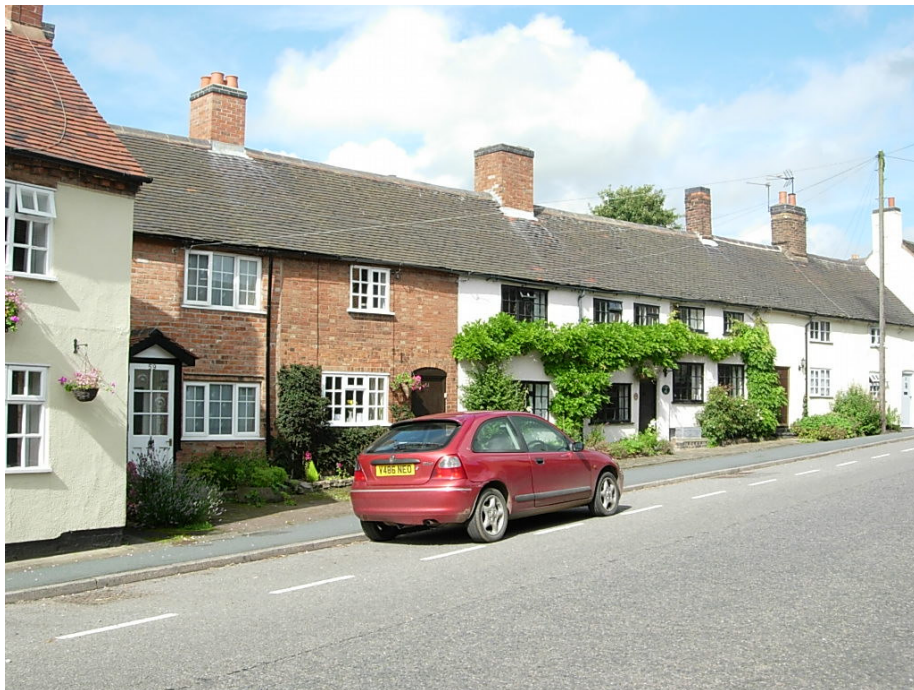
Pump Row is a pleasant group of properties that is spoilt with the loss of some chimney pots.

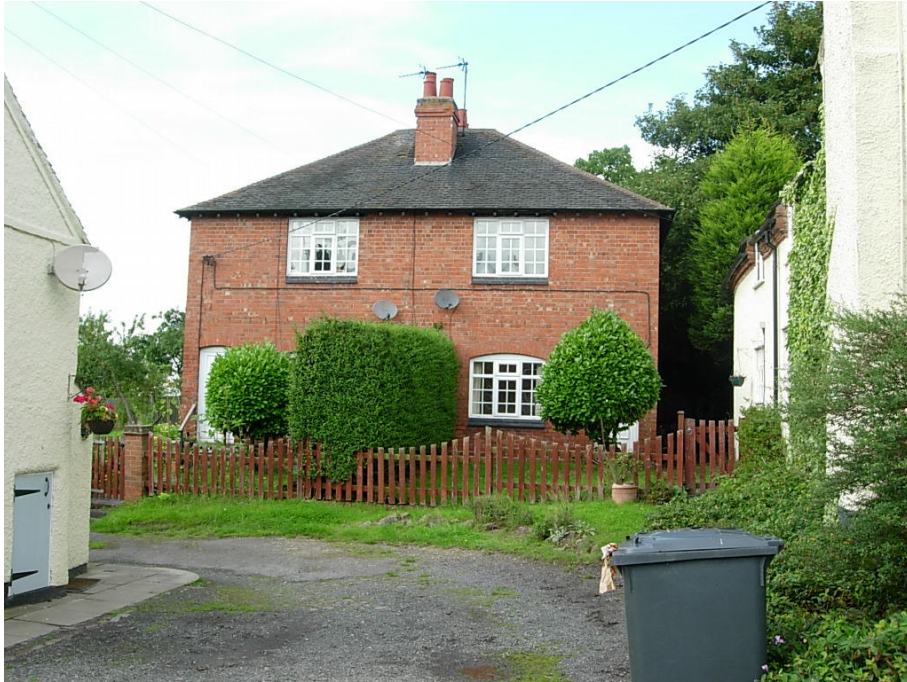
The semi detached dwellings 73 & 75 Main Street which are set well back from the carriageway have been spoilt with the installation of UPVC windows.

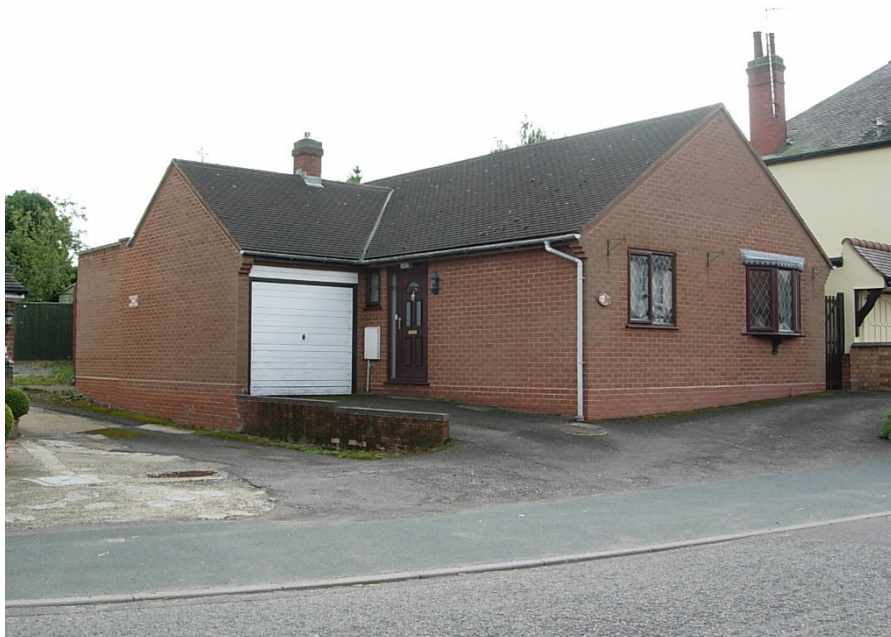
The bungalow 50 Main Street being single storey and built in modern materials has a detrimental visual impact on the conservation area. The area fronting the bungalow is open with the surfacing treatment poor.

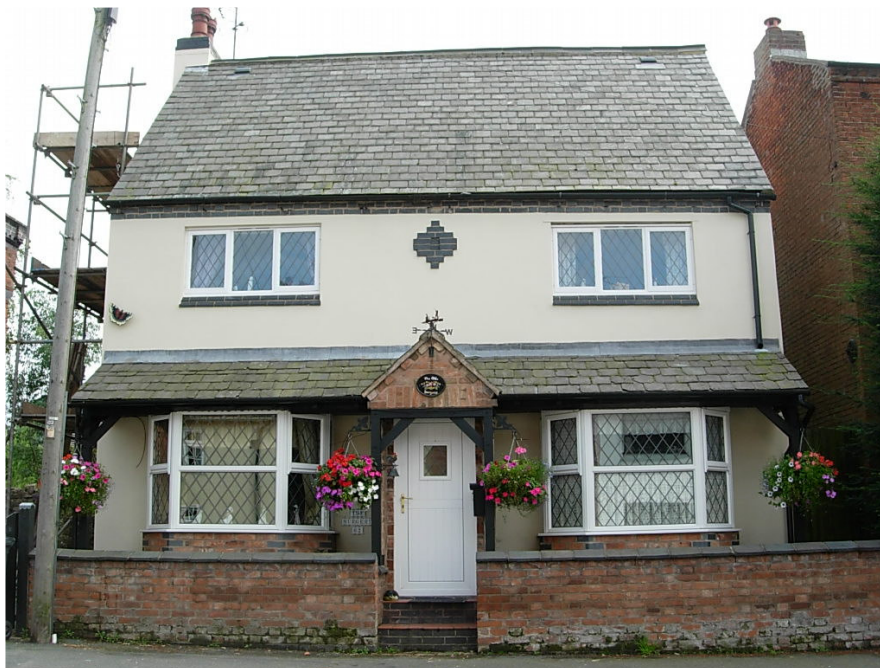
This building that was once a public reading room for men has until recently been used as a doctors surgery. The integrity of the premises has been compromised by recent improvements with a large canopy built over two bay windows and UPVC windows installed.

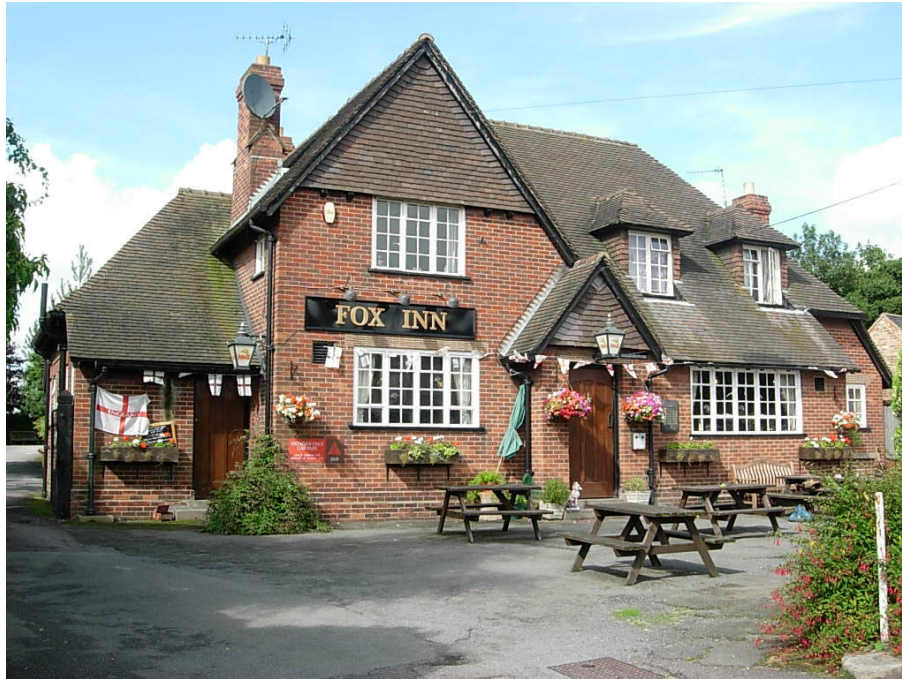
The roof of the Fox Inn built in the 1930's is a visually interesting feature, however the frontage area could be improved.

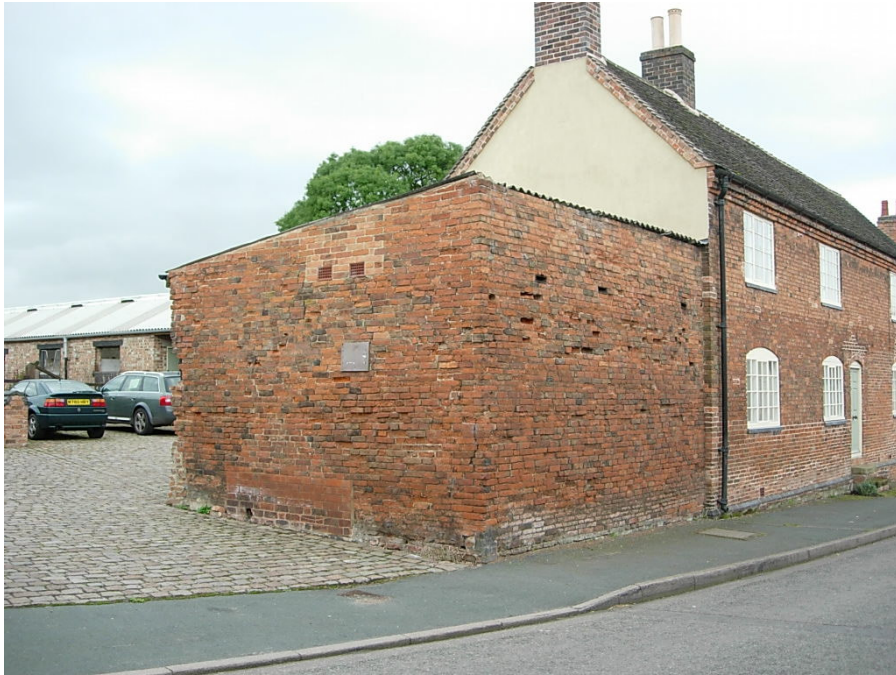
The outbuilding abutting Elms Farmhouse would be improved if the corrugated roof was replaced with a more traditional roof. The brick walls need attention but should be retained where possible.

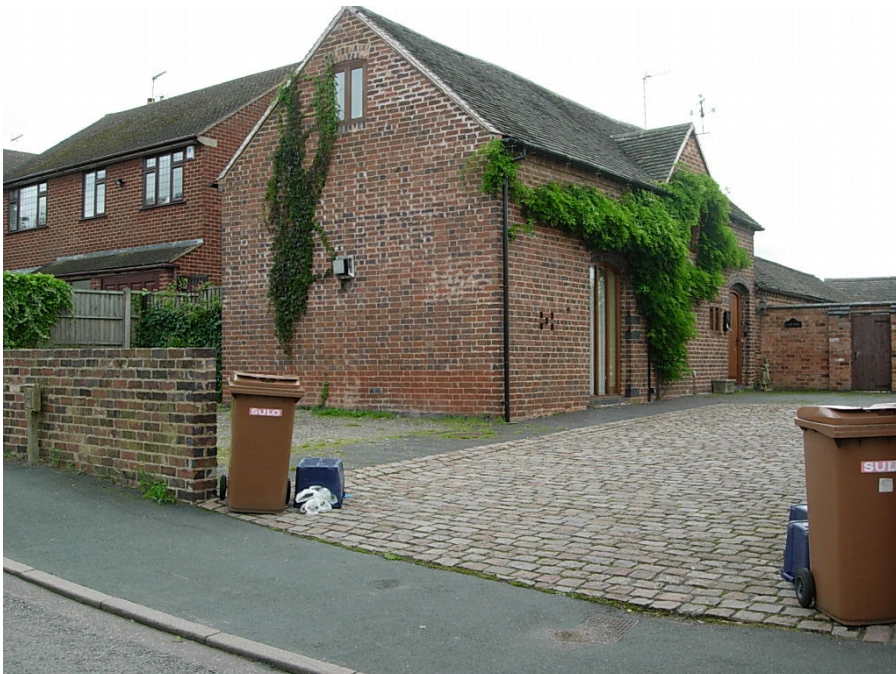
The outbuilding at Elms Farm has been successfully converted to a dwelling with an excellent forecourt surfaced with granite setts. The brick wall fronting the premises needs to be raised up and finished with a traditional coping and the area behind surfaced with granite setts.

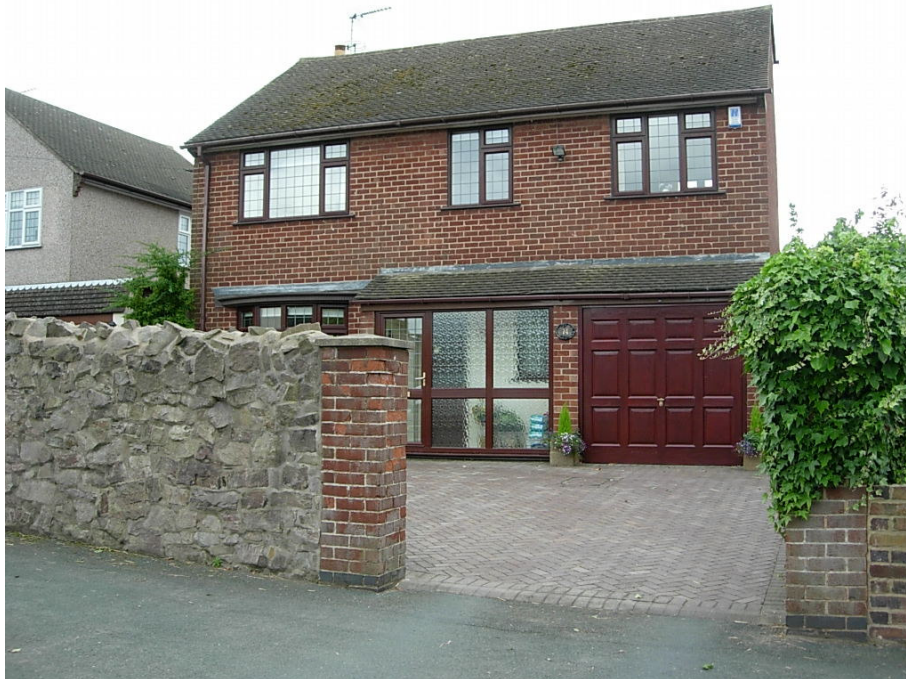
74 Main Street is a modern 2 storey dwelling that has little in character with the villages traditional buildings.

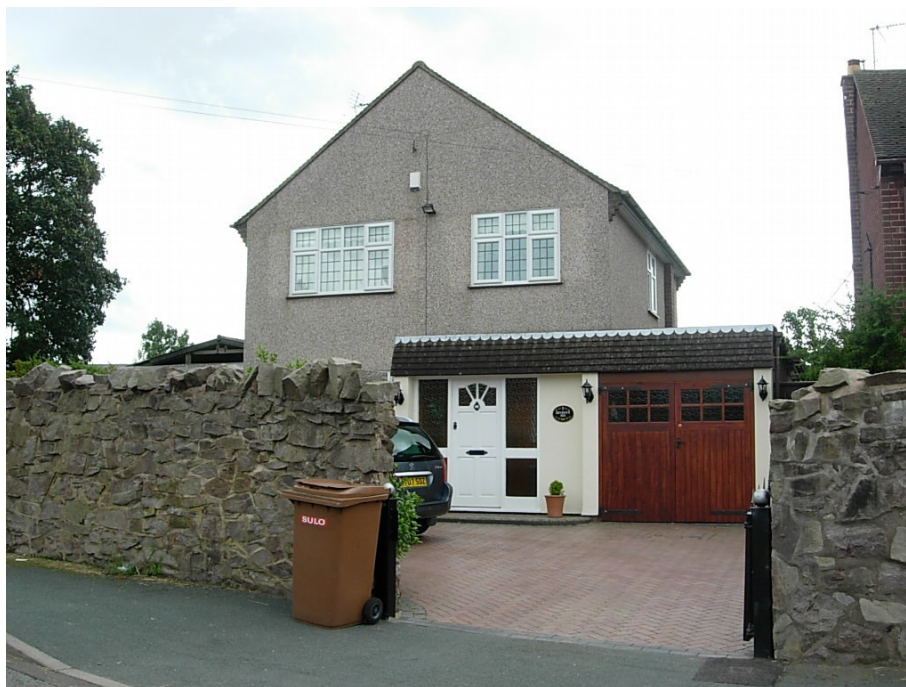
76 Main Street has lost its traditional integrity with recent improvements. The stone wall fronting the dwelling is an excellent feature which has been retained.

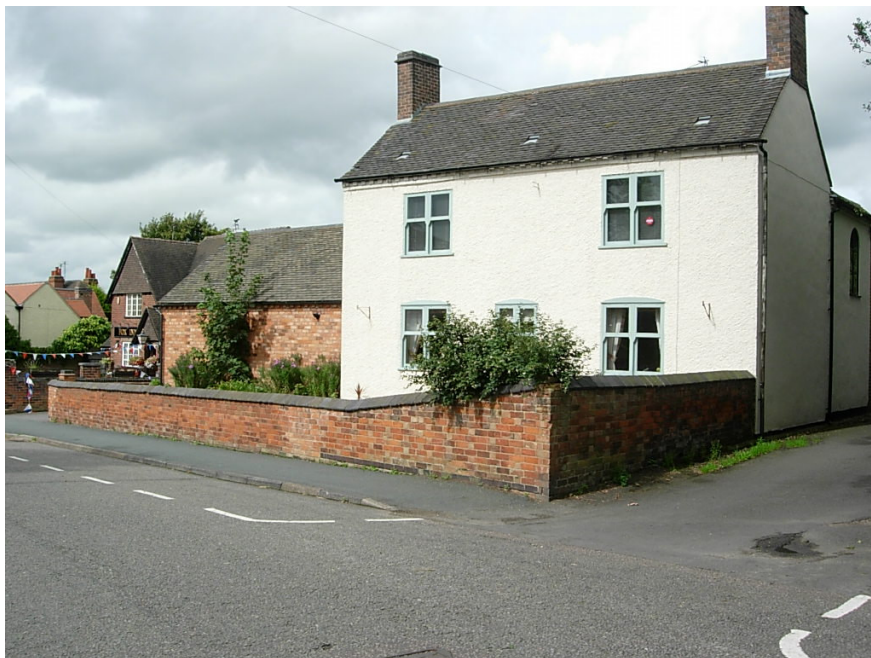
Generally, Church Farm has retained its traditional character although it has lost its chimney pots.
