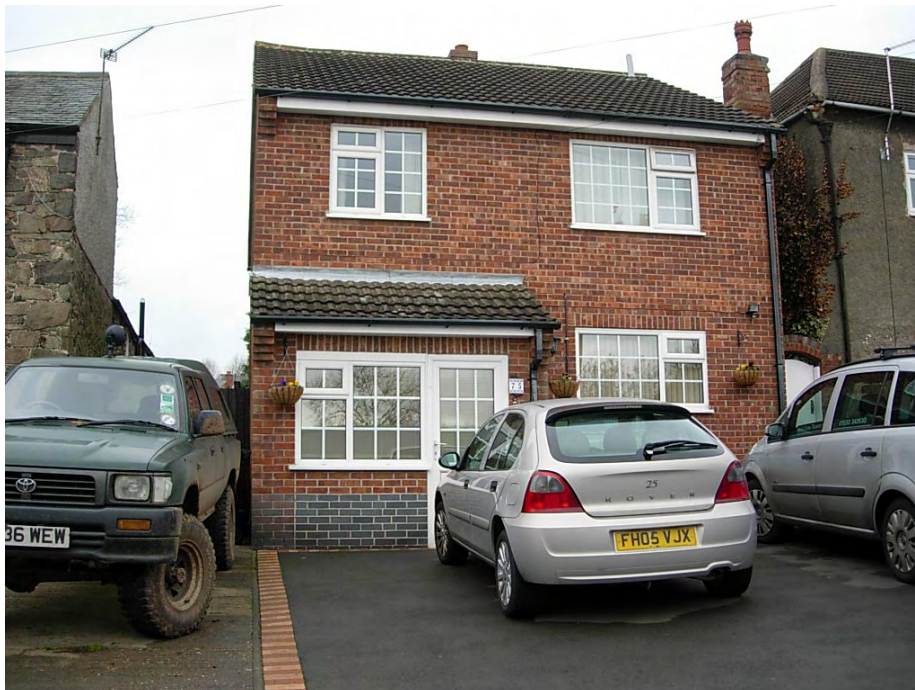
77 Main Street is a dwelling of modern design and materials with an open frontage which detracts from the conservation area.

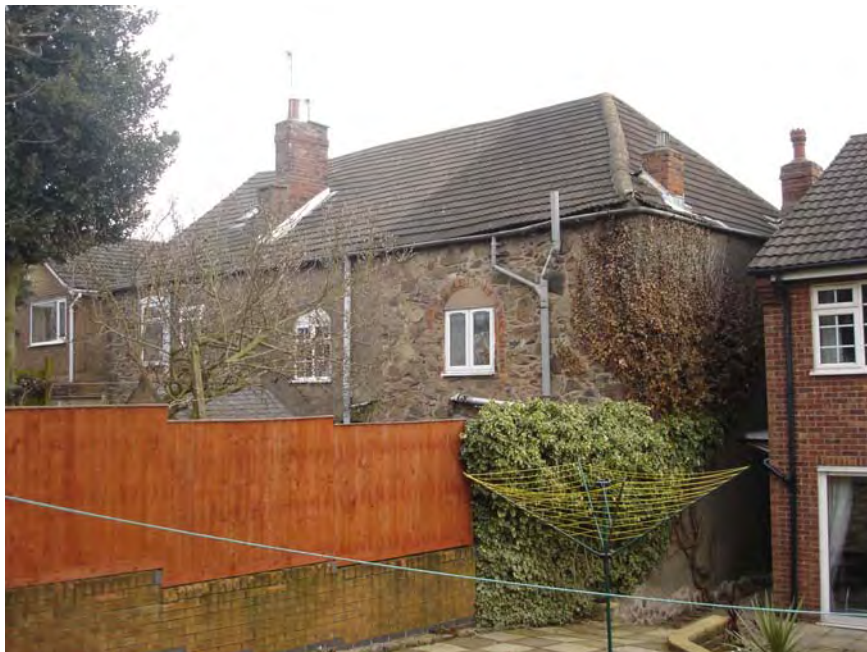
Some of the original Methodist Chapel window openings can still be seen on the rear elevation. The property's traditional character has been compromised with the use of concrete roof tiles and plastic downpipes.

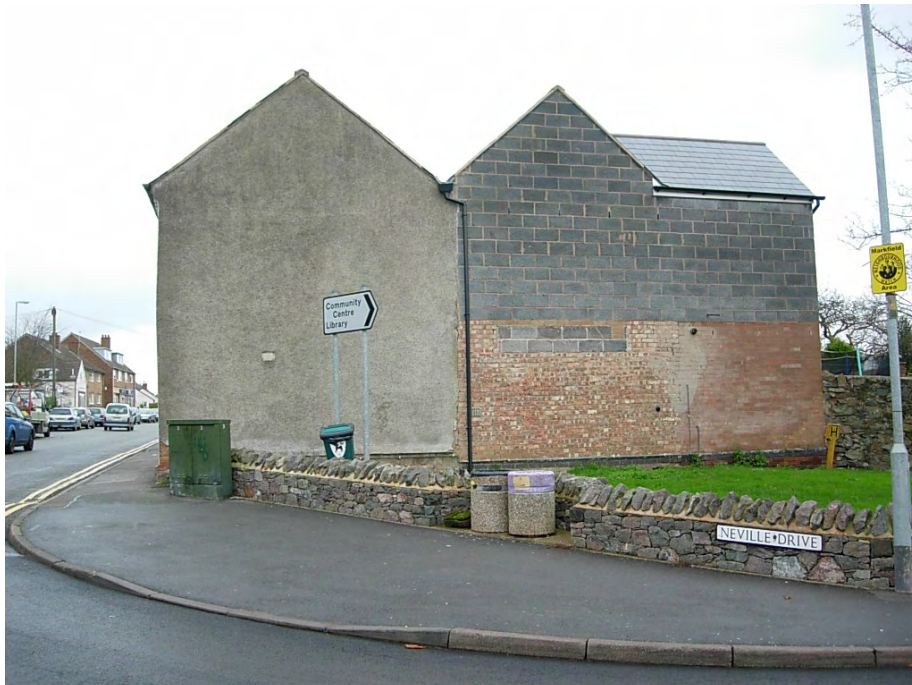
The side wall to the recent extension abutting the open space on Neville Drive needs rendering.

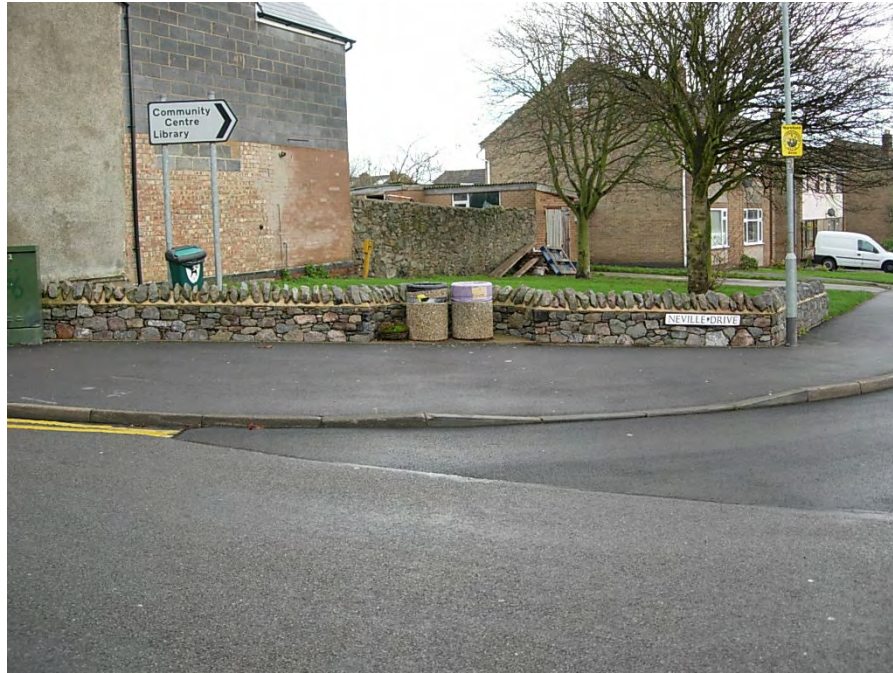
This area at the junction of Main Street/Neville Drive is rather bland. The street furniture needs replacing and shrubs planted to give the area an uplift.

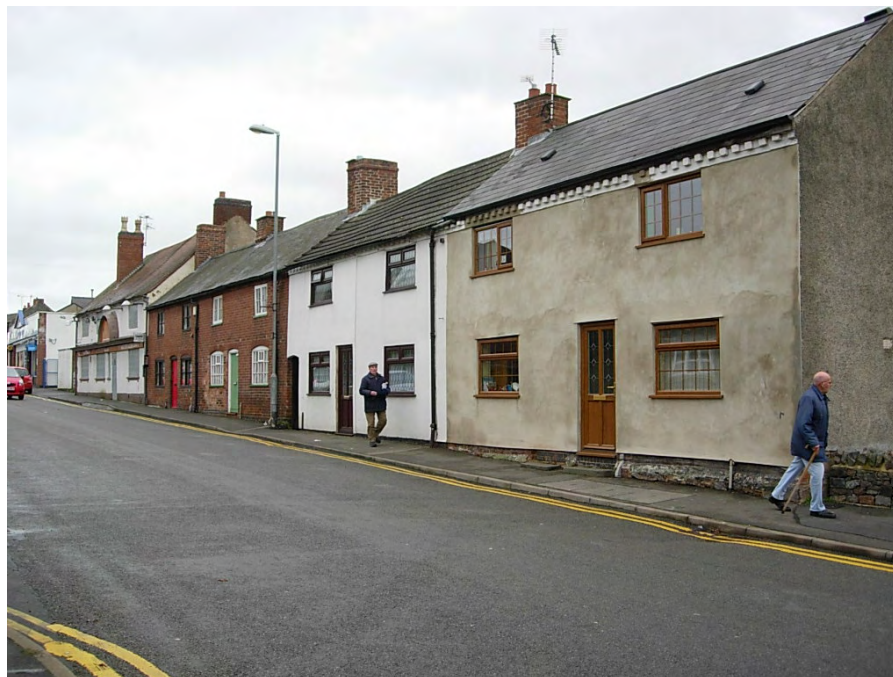
View looking at the east side of Main Street towards The George Pub. This fine terrace of properties has lost some of its traditional character due to insensitive alterations to individual buildings.

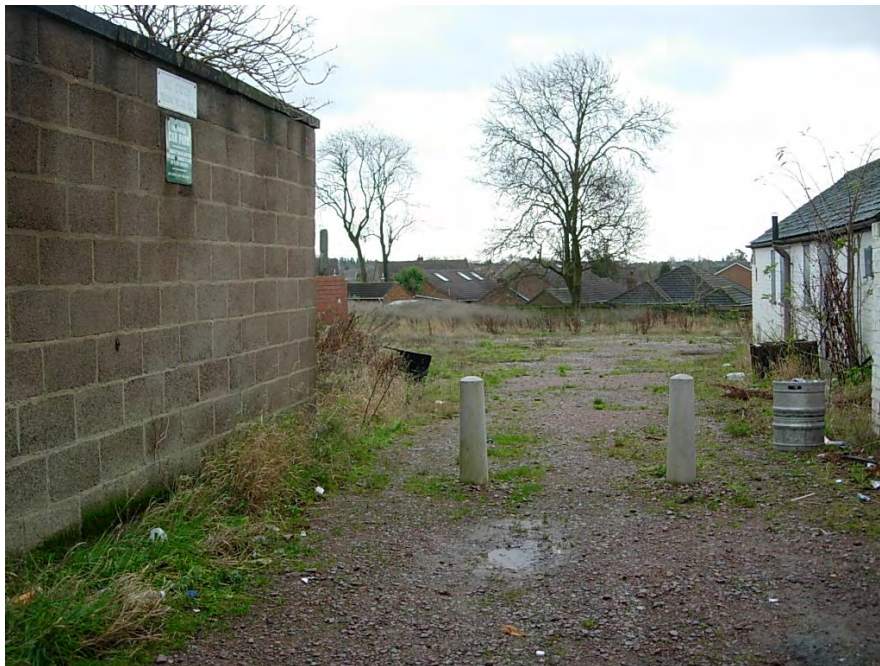
Access to the George Pub's car park is currently restricted. A comprehensive scheme to develop the land to the rear is required. Consideration should also be given to include the Co-op store in any re-development scheme and the granite boundary walls should be retained.

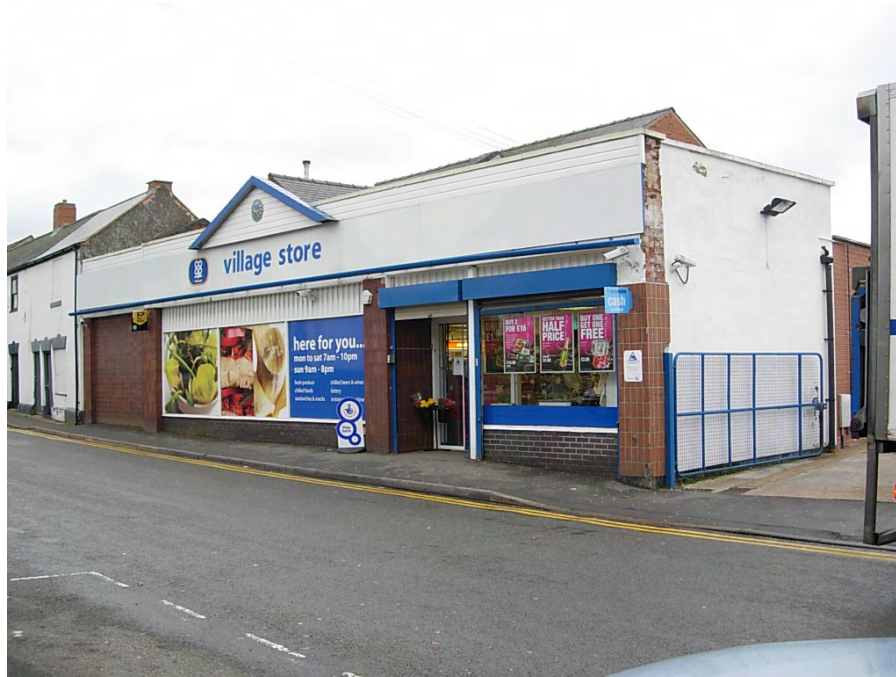
The external treatment to the Co-op store on Main Street is far too brash and prominent. Consideration needs to be given to reduce its visual impact in the street scene or its re-development as part of a comprehensive scheme involving the land to the rear.

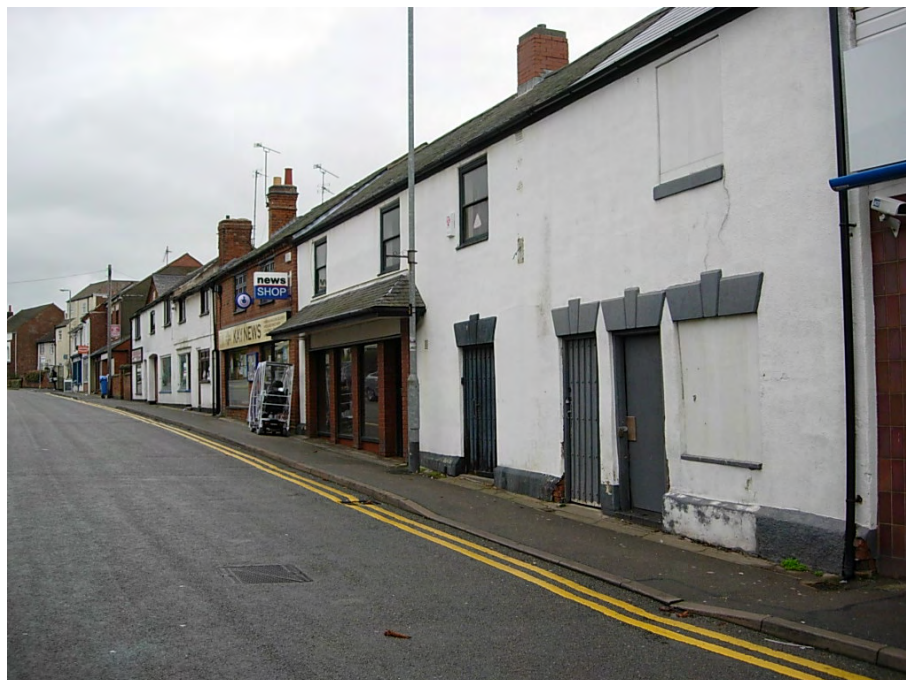
View looking northwards up the eastern side of Main Street showing how the canopy and shop front treatment tends to downgrade the visual quality of the street scene by breaking the line of the historic façade.

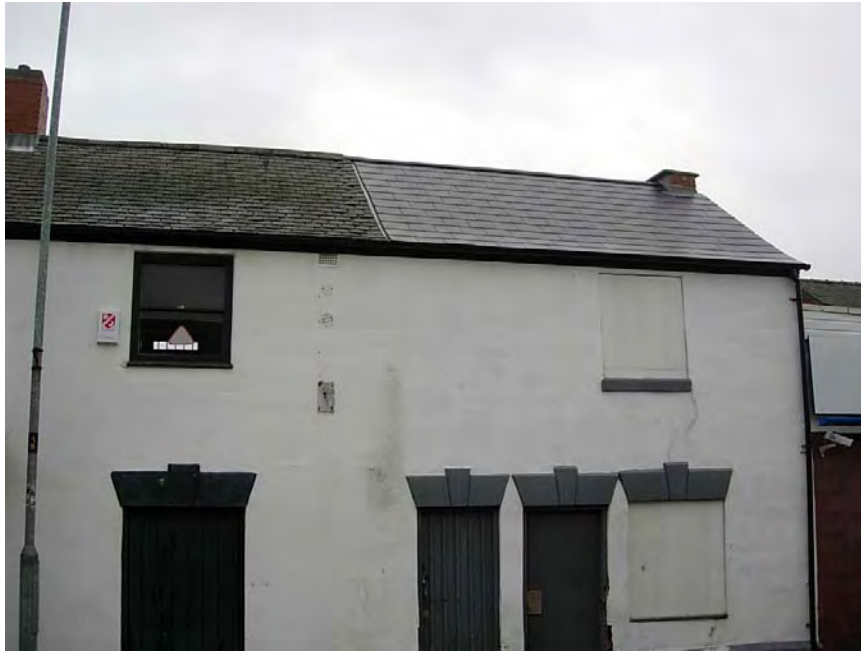
The vacant property on Main Street needs to be brought back into use. The materials used to repair the roof do not match the adjacent property and its chimney has been lost.

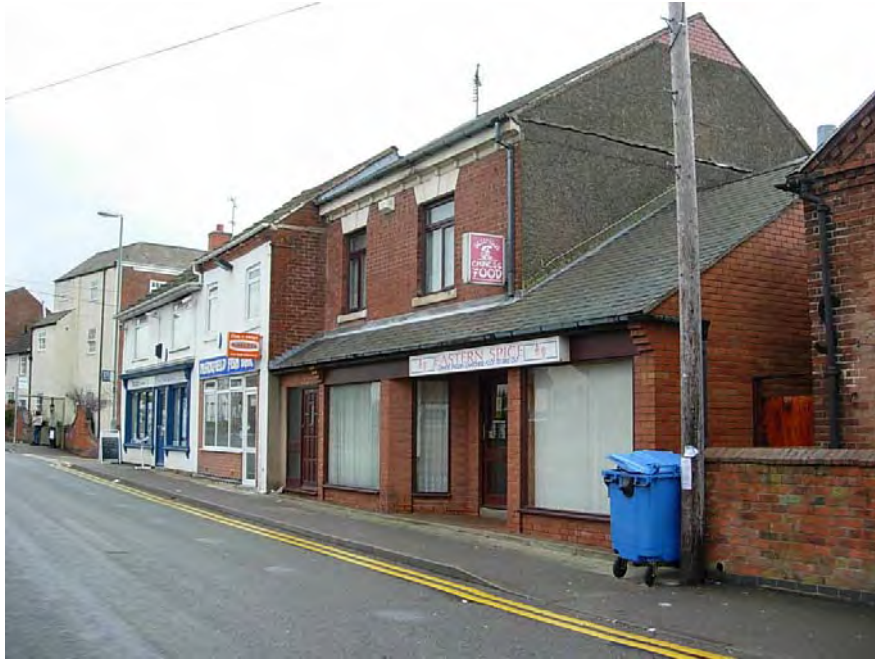
The treatment to 106 Main Street is not in sympathy with the properties either side.

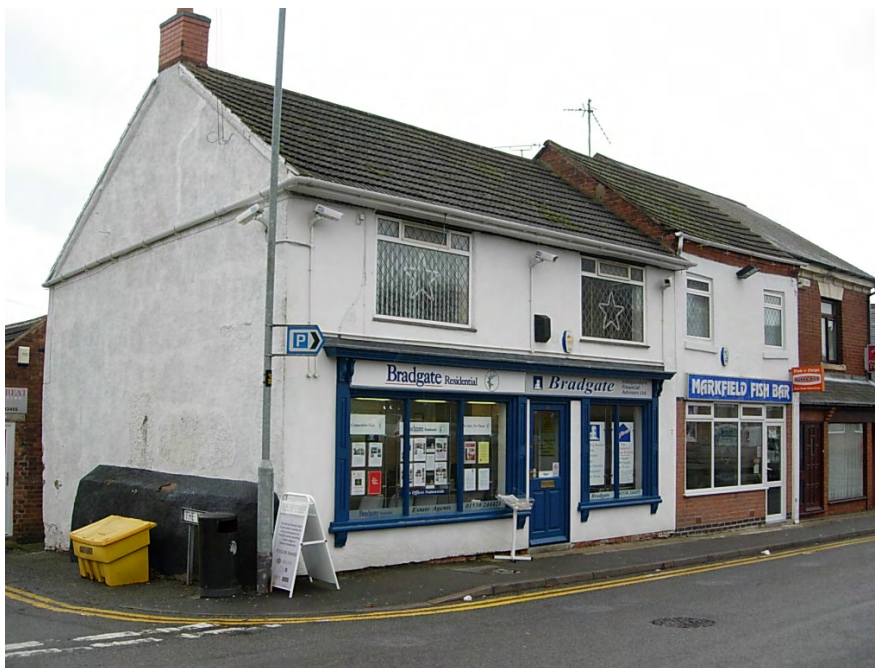
The appearance of 108 & 110 Main Street is satisfactory, although the use of concrete roof tiles and change of window openings at first floor level is unfortunate.

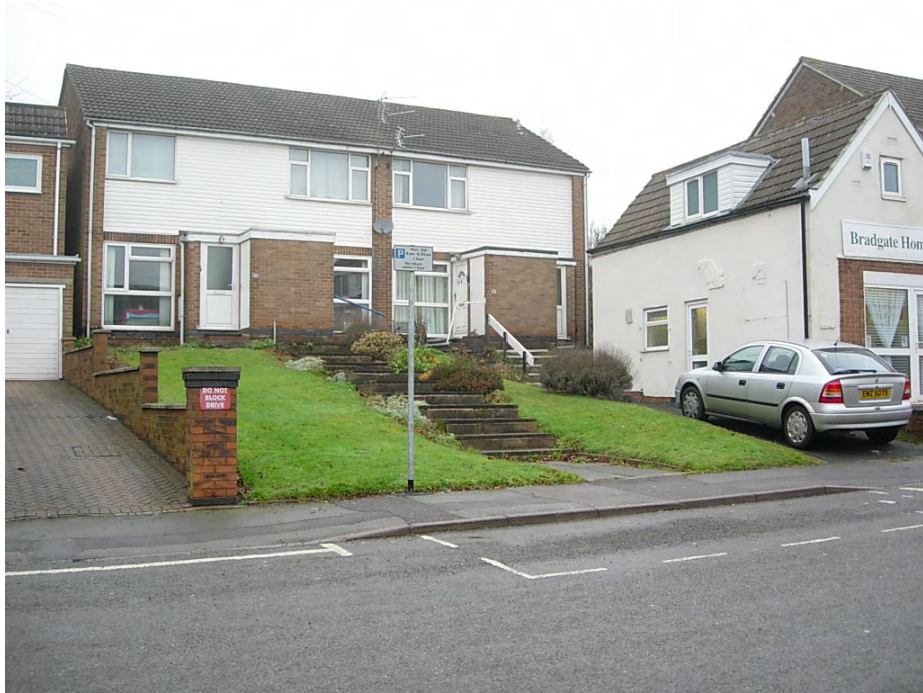
The enclosure fronting the flats at 87 Main Street has been lost. A granite wall needs to be built along the road frontage.

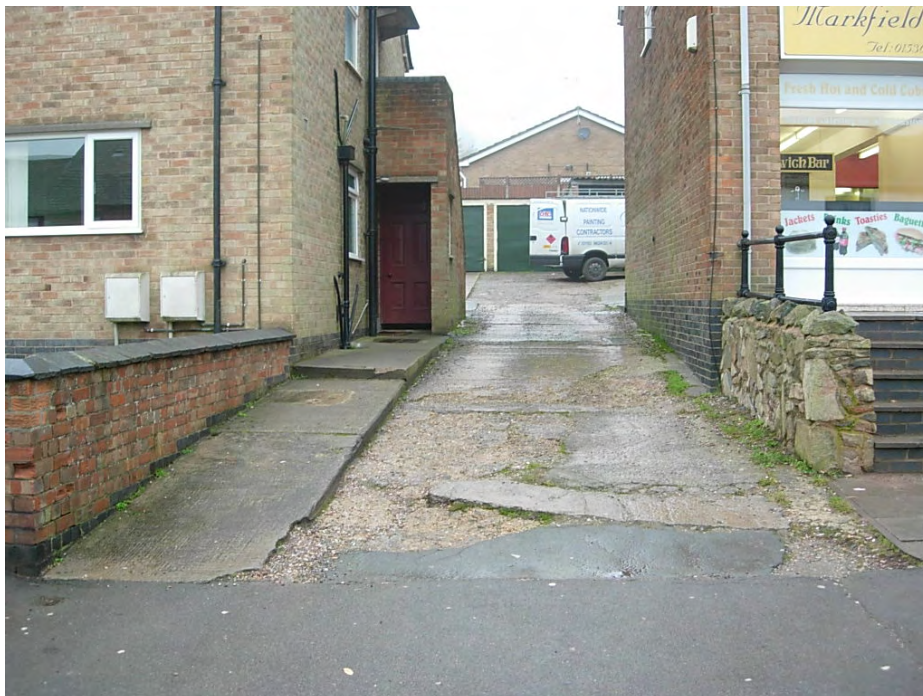
The accesses to both the garage court and 97 Main Street needs re-surfacing.

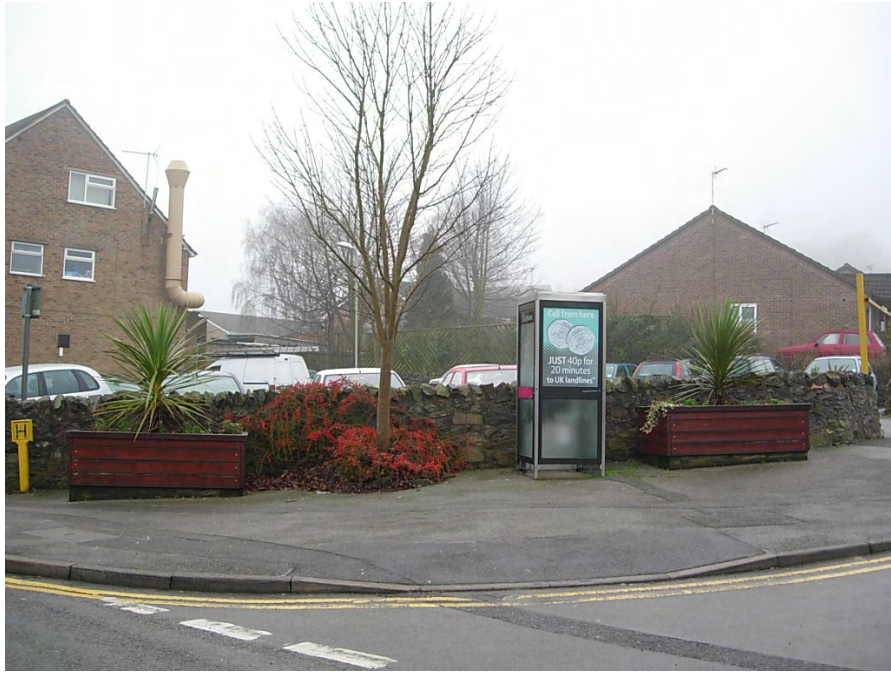
The timber planters sited at the junction of Main Street and Upland Drive are starting to look their age. Consideration should be given to replacing them with stone planters.

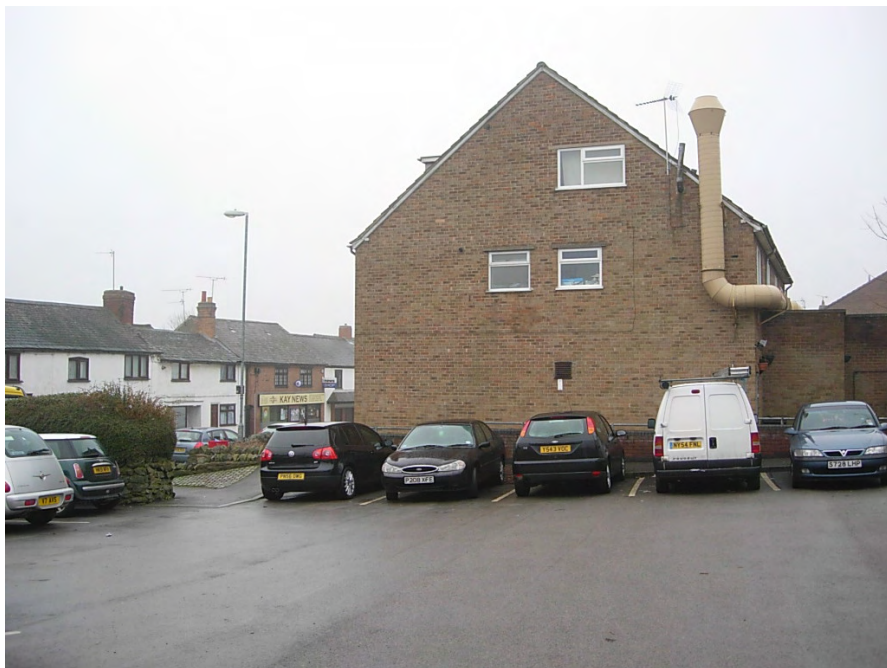
The metal extract flue attached to the gable of 99 Main Street is particularly unsightly. Consideration should be given to reducing its visual impact in this prominent position.

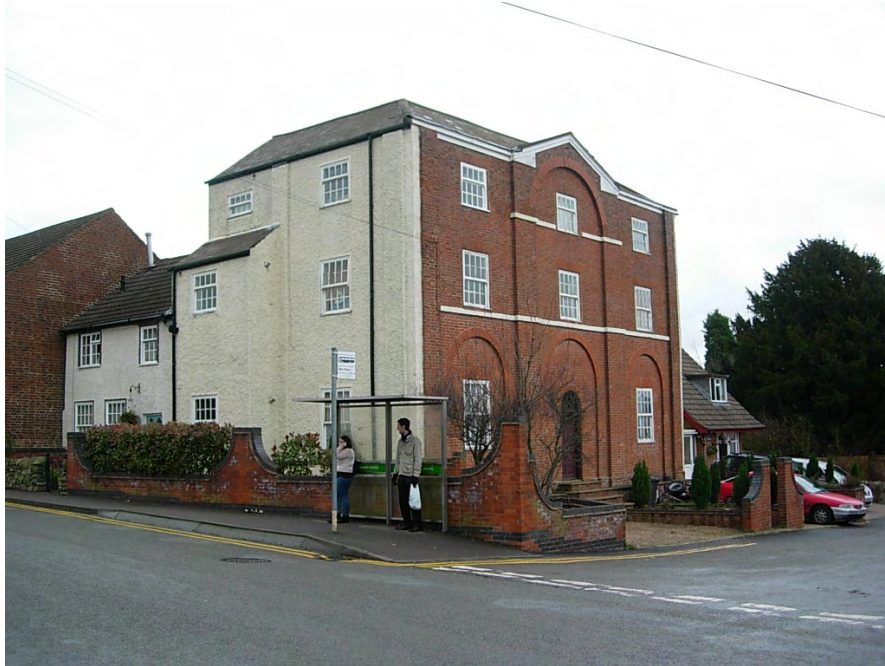
The late 18C Grade II listed Old Rectory House built in red brick with ashlar dressings and slate roof. The three storey building is a prominent feature sited at the junction of Main Street & The Nook. The modern wall fronting the property and the window treatment, however, are out of character.

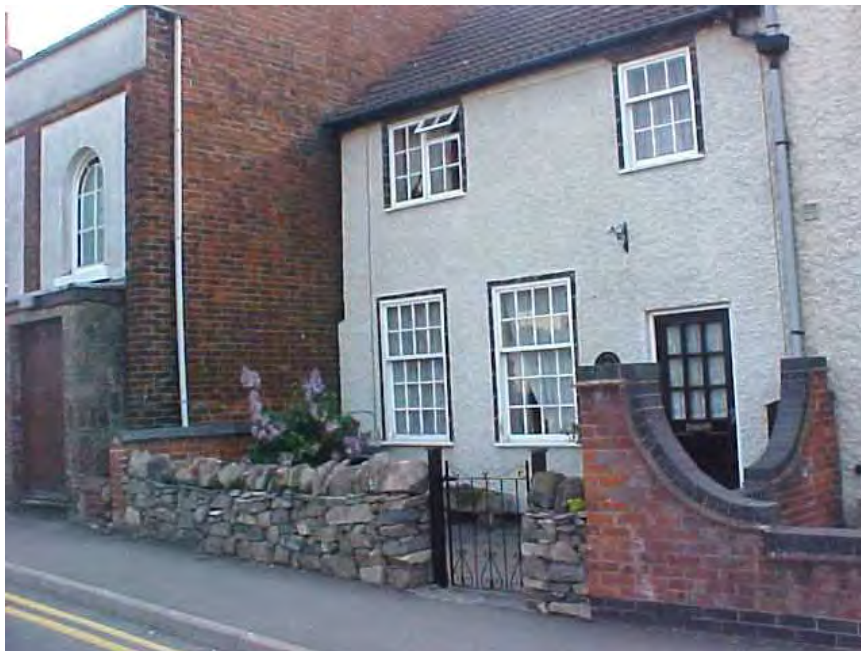
Old Rectory Cottage has had a new granite wall built fronting the property. The wall contrasts with the brick wall adjacent which is unsympathetic by way of its design and choice of materials.

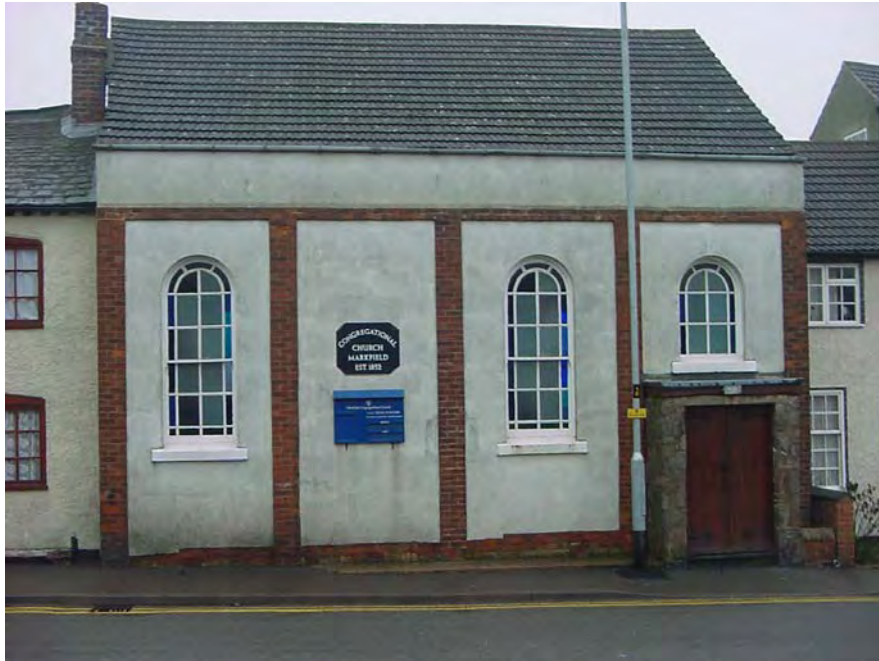
The Congregational Church is an imposing period building which, unfortunately, has been spoilt by the use of concrete roof tiles.

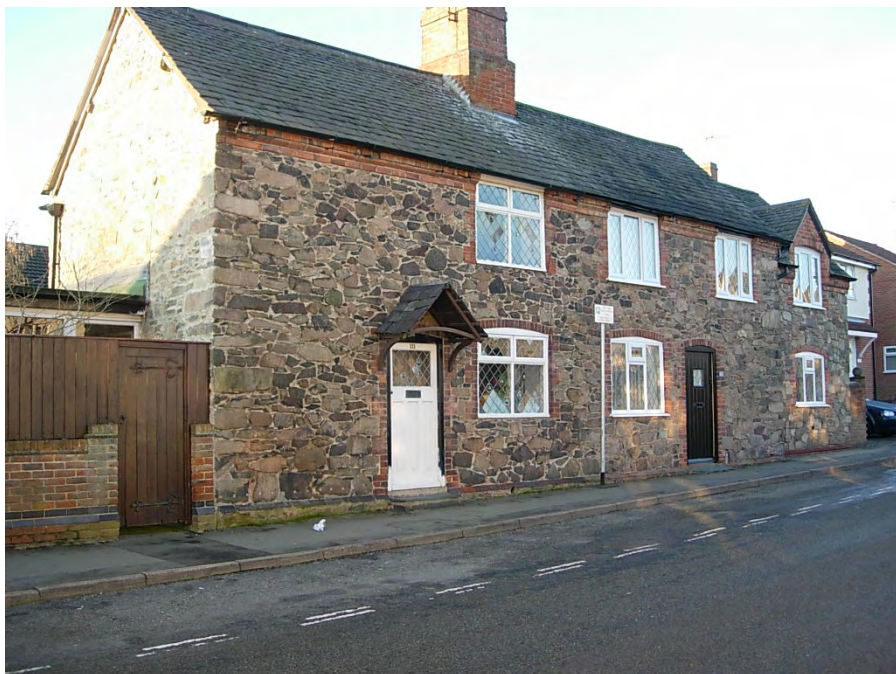
The properties, 111 & 113 Main Street, are a fine pair of granite cottages spoilt by the use of UPVC windows.

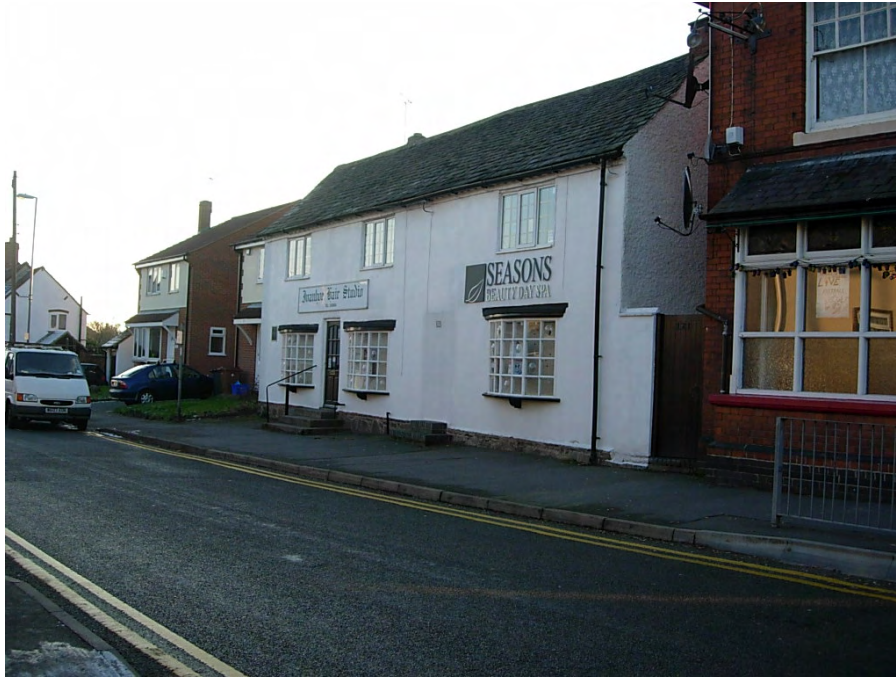
119 Main Street is a vernacular dwelling built in stone. However, the stone has been hidden due to the property being rendered and its chimneys have been lost.

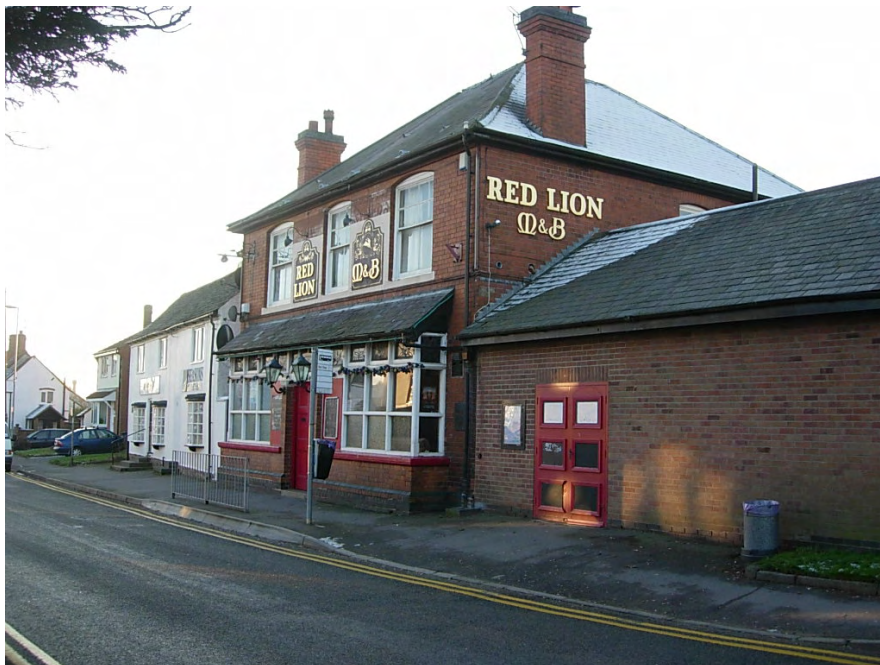
The Red Lion Pub is an imposing red brick building with a slate roof that still retains its impressive chimney stacks. The metal crown originally sited on its roof has been removed.

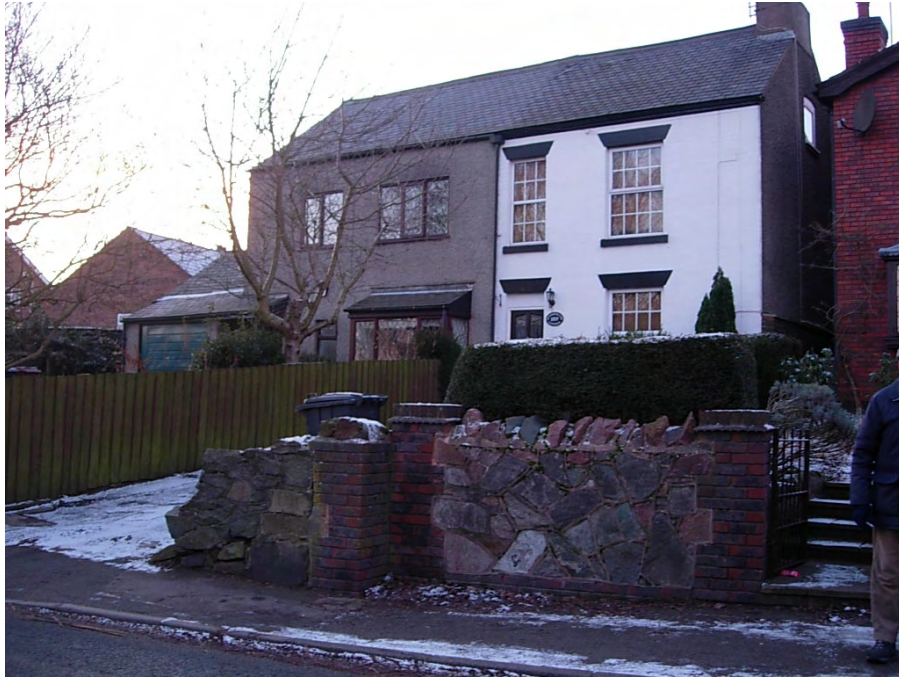
153 – 157 Main Street are properties that still retain their slate roofs but unfortunately have lost their uniformity. 157 has retained its original window openings and stone lintels unlike the adjacent property which has had inappropriate windows inserted and a garage built that needed to be set well back from the front elevation.

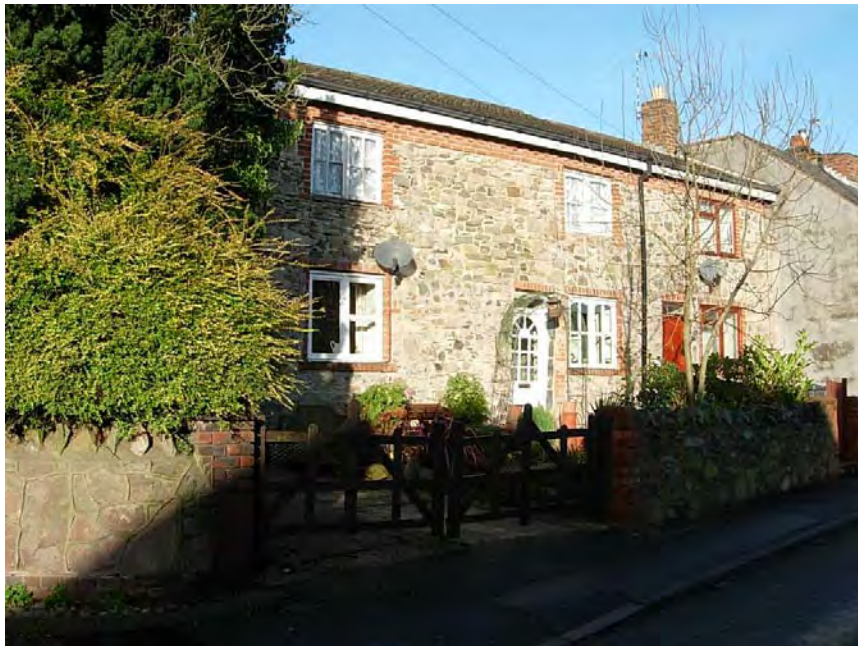
165/167 Main Street is a stone/brick property that has had its roof raised with a shallow pitch and its slate covering replaced with concrete roof tiles.

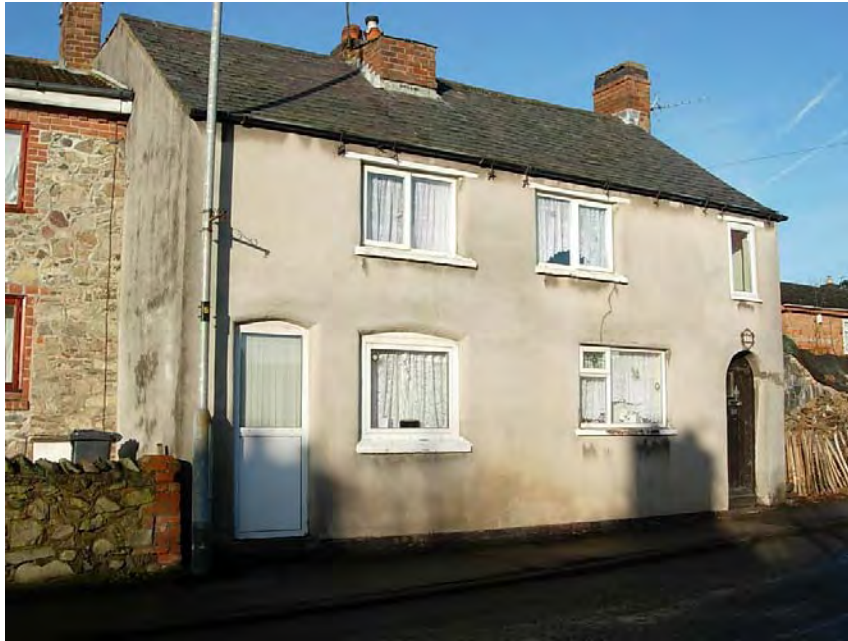
173 Main Street is a rendered property with a slate roof that has lost most of its chimney pots.

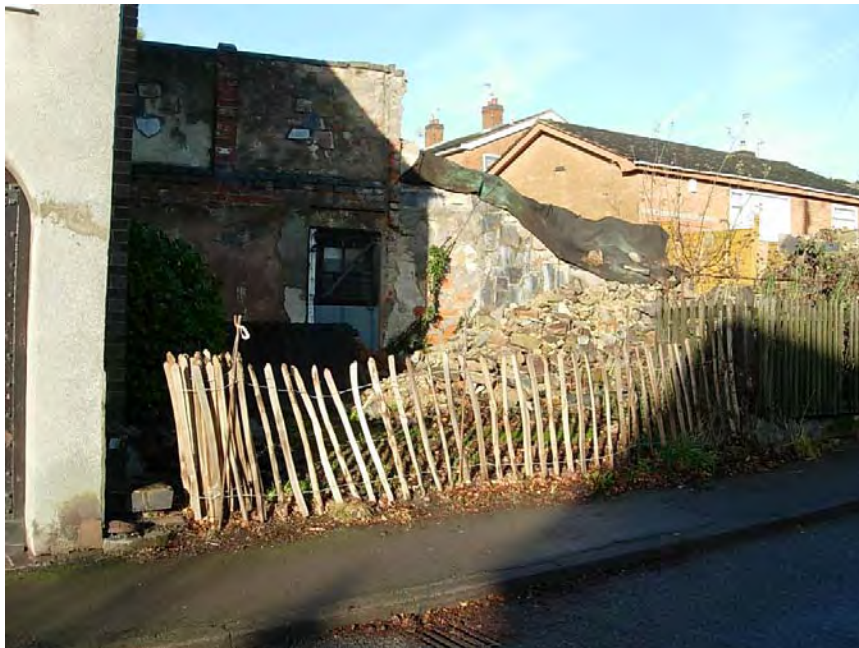
The unsightly plot of land adjacent 173 Main Street needs improving. The chestnut pale fencing should be replaced with a granite wall.
