**ORTON ON THE HILL CONSERVATION
AREA MANAGEMENT PLAN - ADOPTED
10 MARCH 2009**

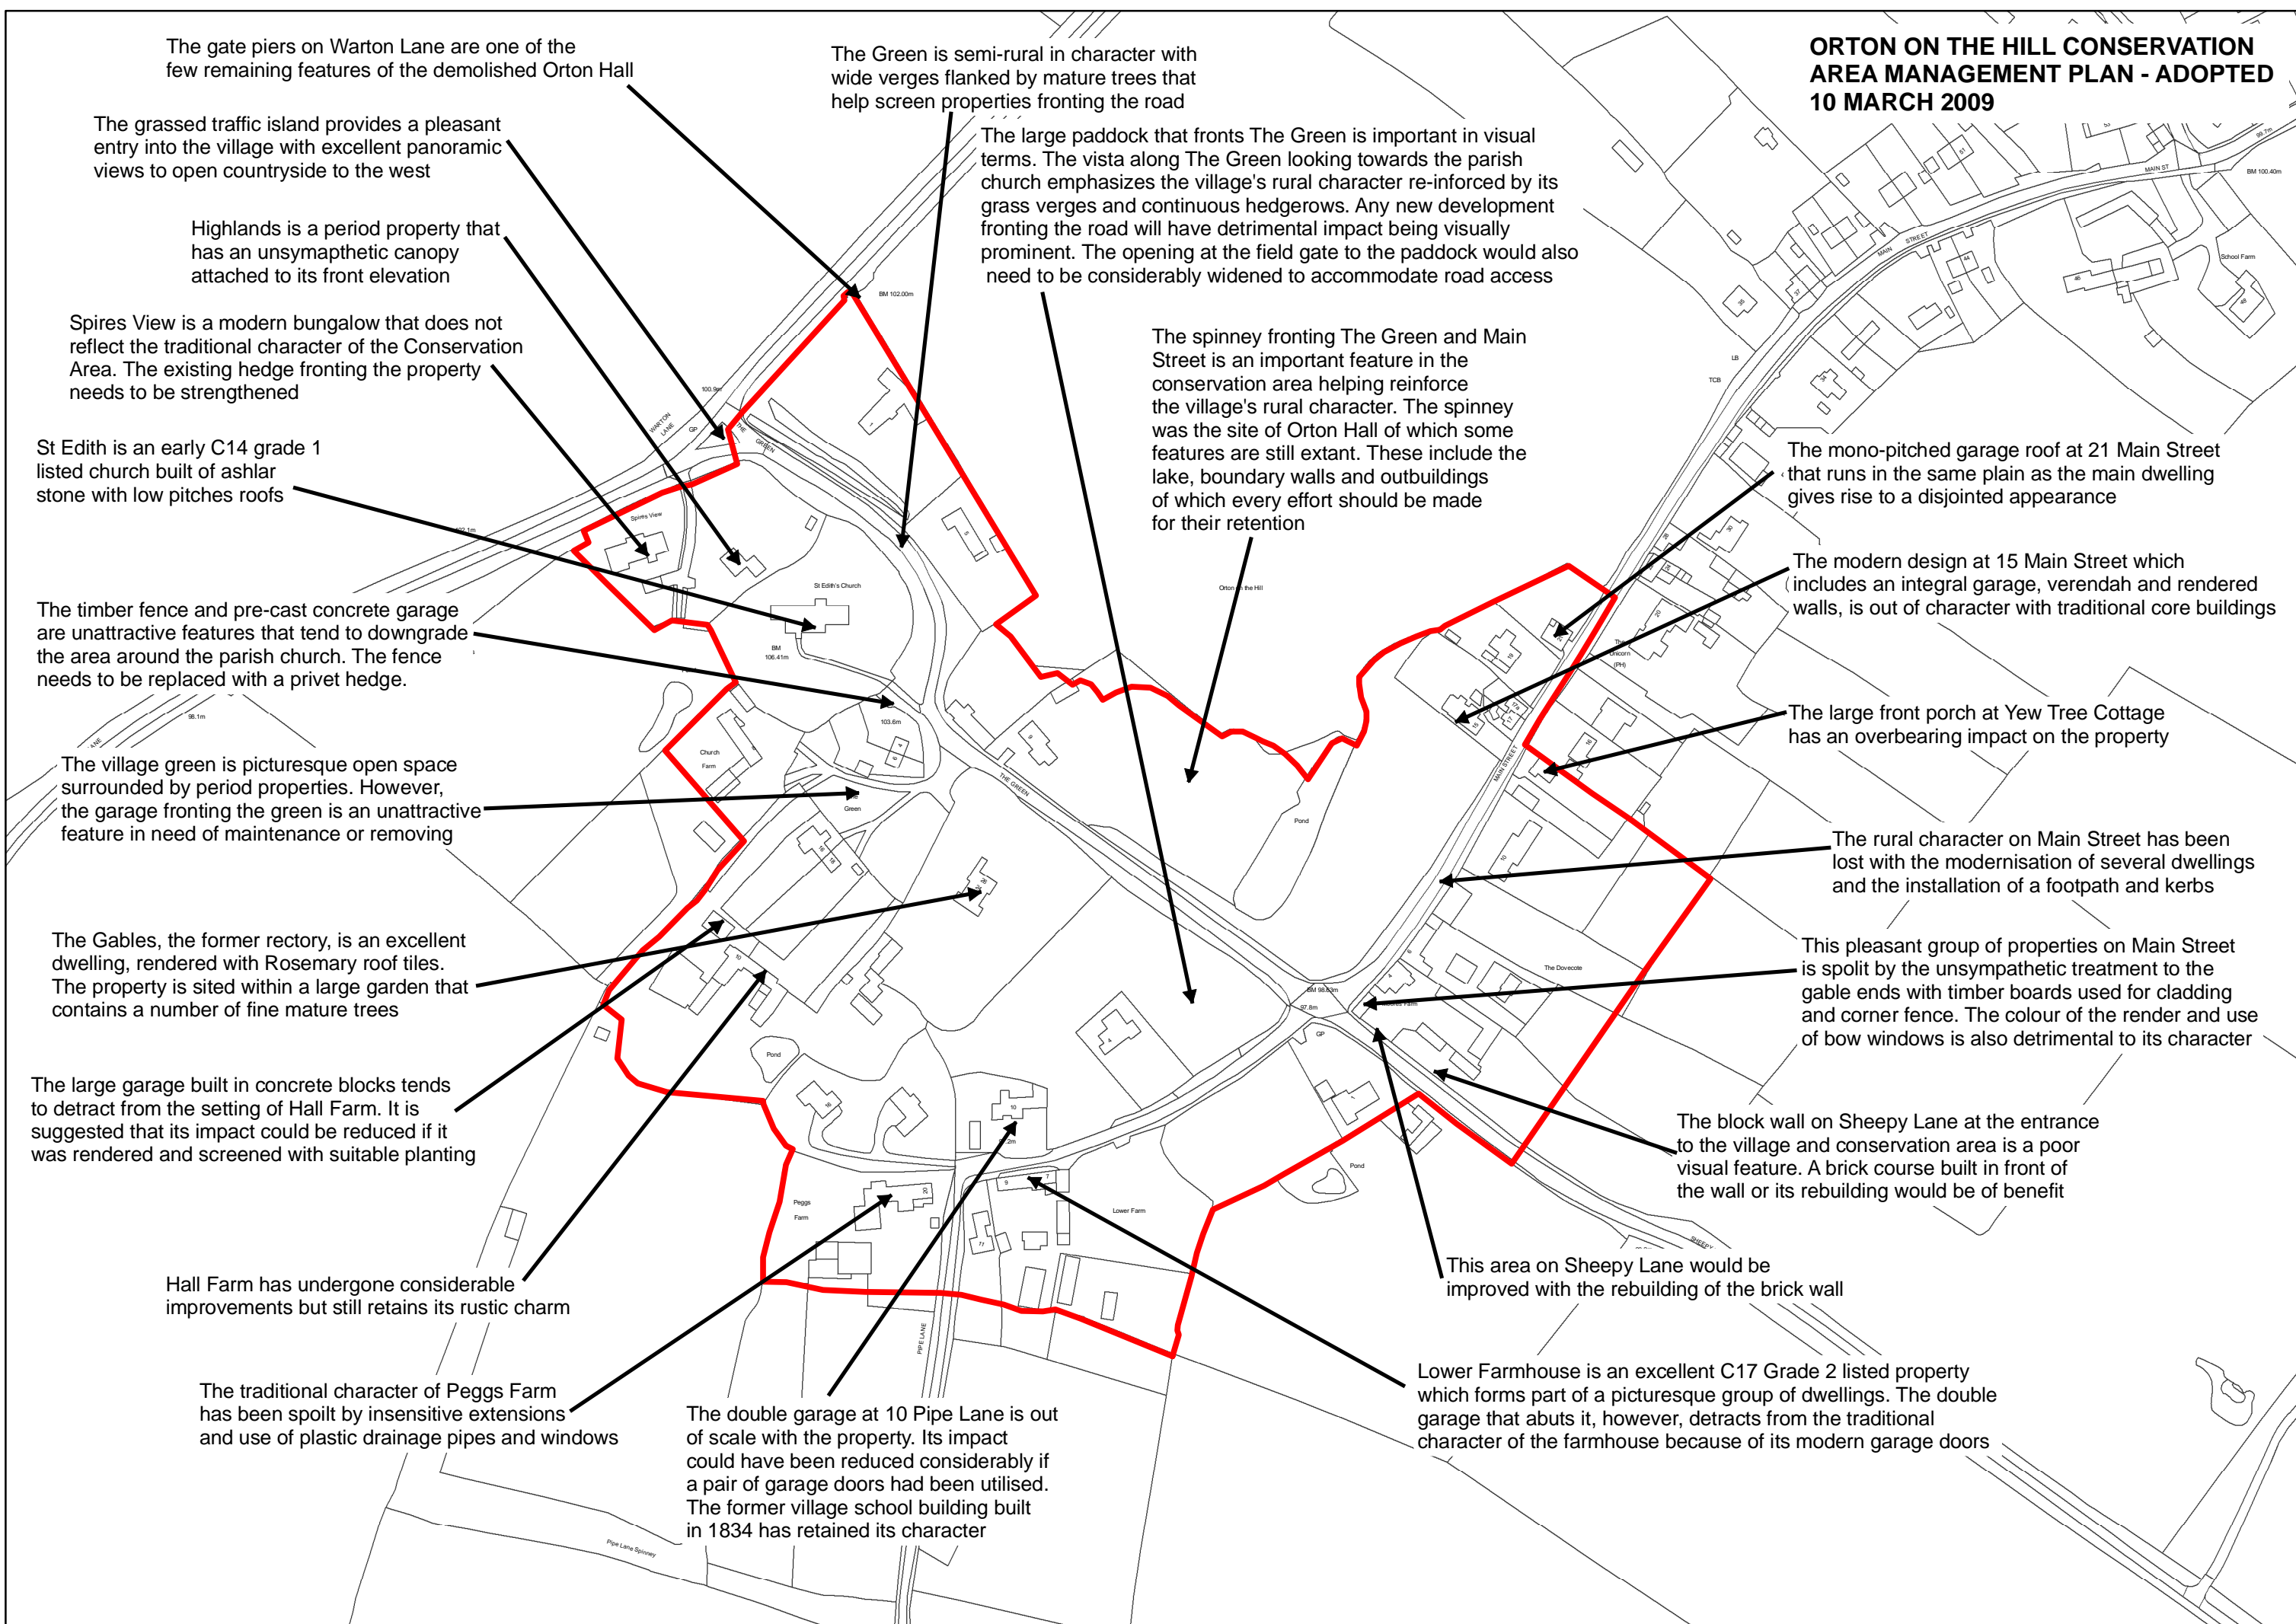
Highlands is a period property that has an unsympathetic canopy attached to its front elevation

Spire View is a modern bungalow that does not reflect the traditional character of the Conservation Area. The existing hedge fronting the property needs to be strengthened

The timber fence and pre-cast concrete garage are unattractive features that tend to downgrade the area around the parish church. The fence needs to be replaced with a privet hedge.

The village green is picturesque open space surrounded by period properties. However, the garage fronting the green is an unattractive feature in need of maintenance or removing

The large garage built in concrete blocks tends to detract from the setting of Hall Farm. It is suggested that its impact could be reduced if it was rendered and screened with suitable planting

The traditional character of Peggs Farm has been spoilt by insensitive extensions and use of plastic drainage pipes and windows

The double garage at 10 Pipe Lane is out of scale with the property. Its impact could have been reduced considerably if a pair of garage doors had been utilised. The former village school building built in 1834 has retained its character

The mono-pitched garage roof at 21 Main Street that runs in the same plain as the main dwelling gives rise to a disjointed appearance

The modern design at 15 Main Street which includes an integral garage, verendah and rendered walls, is out of character with traditional core buildings

The large front porch at Yew Tree Cottage has an overbearing impact on the property

The rural character on Main Street has been lost with the modernisation of several dwellings and the installation of a footpath and kerbs

This pleasant group of properties on Main Street is spoilt by the unsympathetic treatment to the gable ends with timber boards used for cladding and corner fence. The colour of the render and use of bow windows is also detrimental to its character

The block wall on Sheepy Lane at the entrance to the village and conservation area is a poor visual feature. A brick course built in front of the wall or its rebuilding would be of benefit

This area on Sheepy Lane would be improved with the rebuilding of the brick wall

Lower Farmhouse is an excellent C17 Grade 2 listed property which forms part of a picturesque group of dwellings. The double garage that abuts it, however, detracts from the traditional character of the farmhouse because of its modern garage doors
