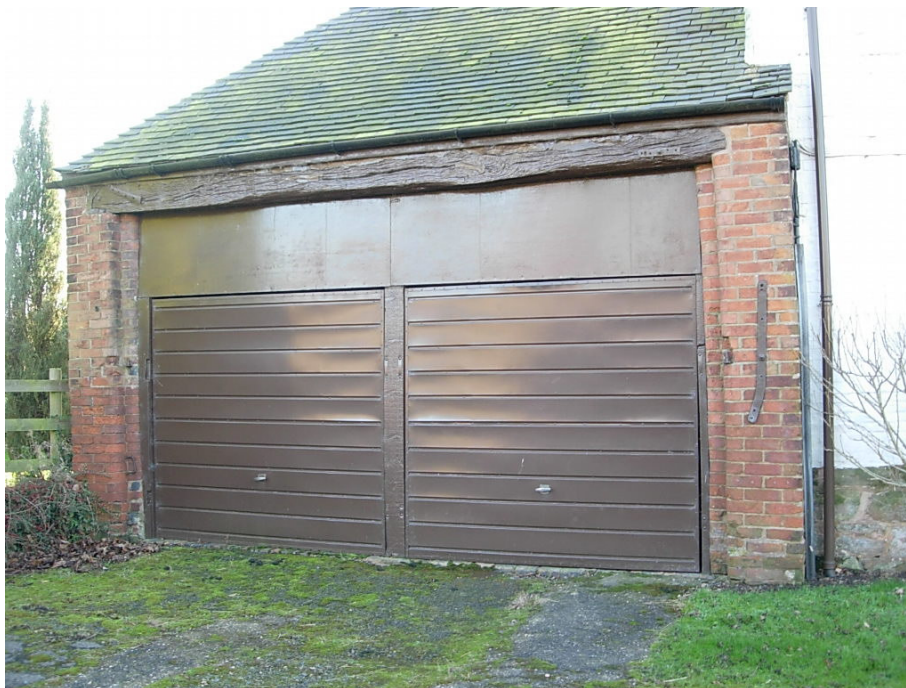
The double garage that adjoins Lower Farmhouse detracts from the traditional character of the listed vernacular building because of the use of modern garage doors.

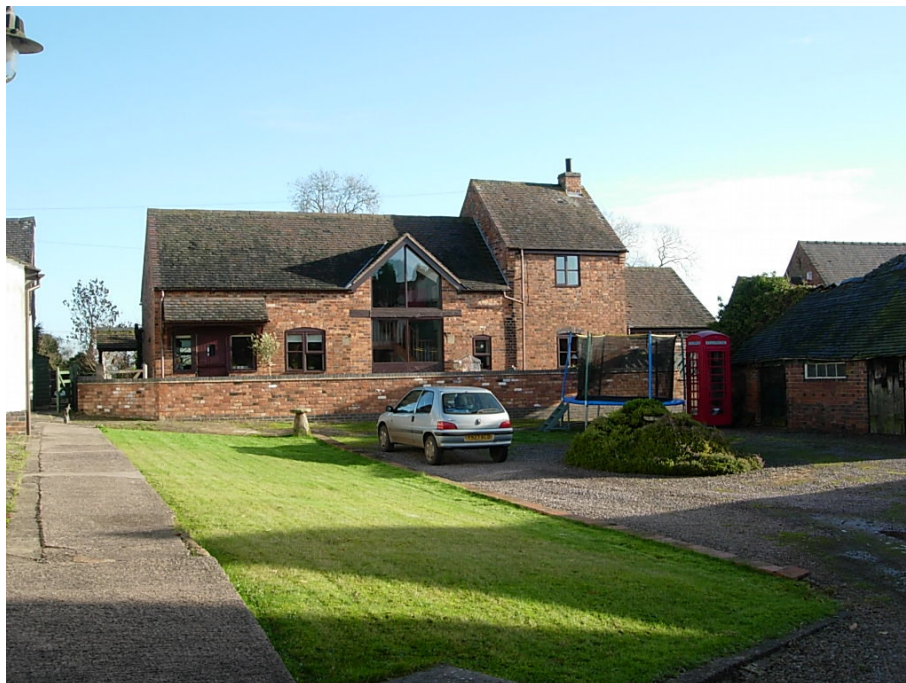
The inner court yard at Lower Farm showing the conversion and modernization of one of the farms outbuildings that incorporates features which are out of character with traditional buildings in Orton.

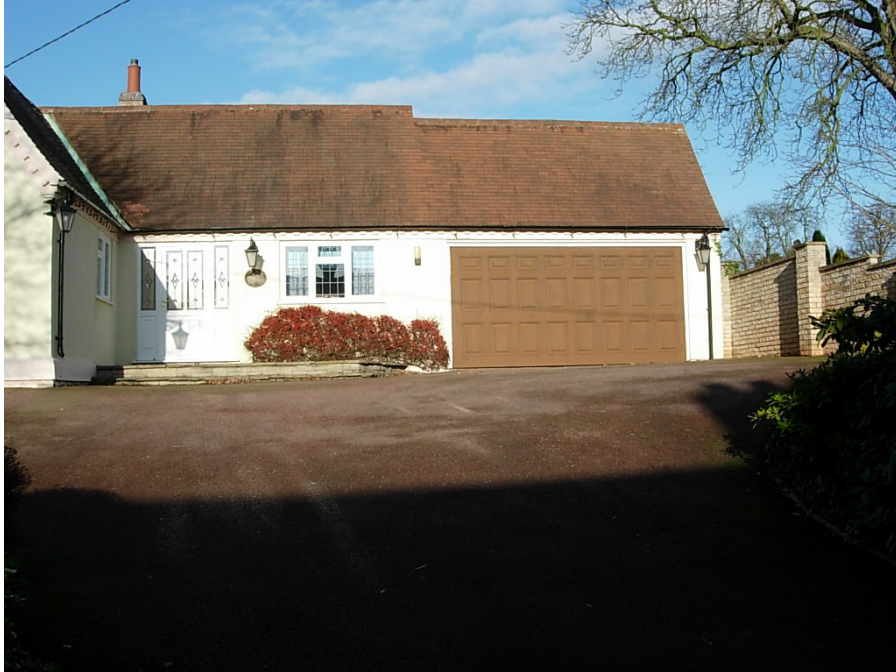
The double garage at 10 Pipe Lane is out of scale with the property. Its impact could have been reduced considerably if a pair of garage doors had been utilized.

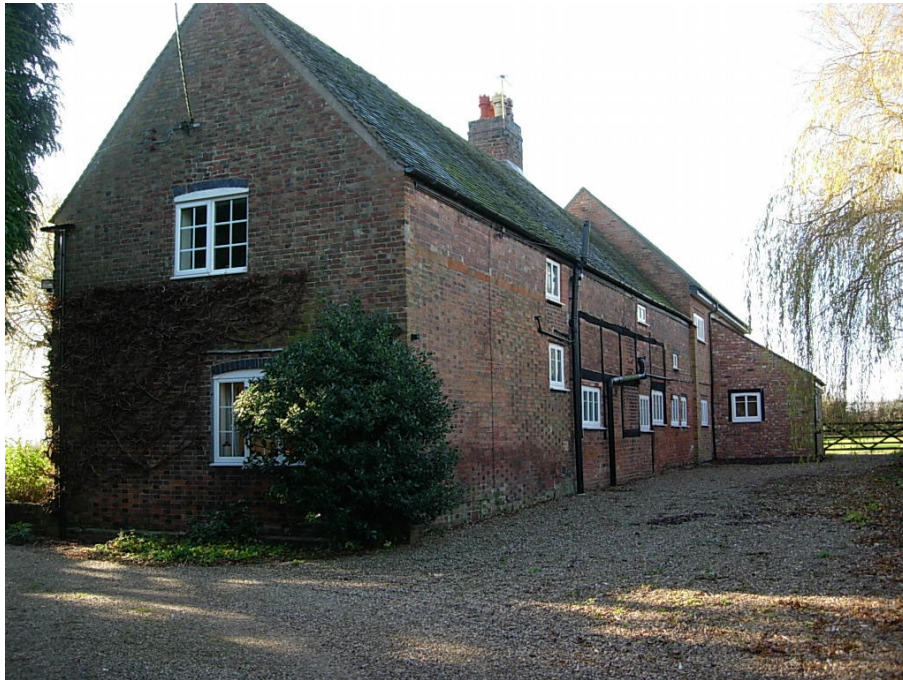
The plastic drainage pipes on the side of Peggs Farm spoil the visual quality of this property.

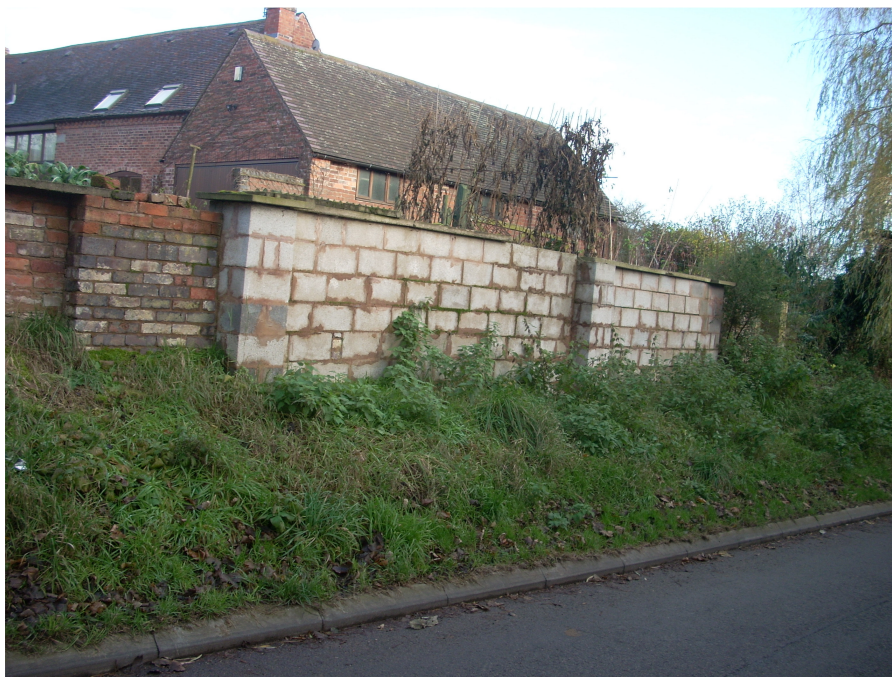
The block wall on Sheepy Lane at the entrance to the village and conservation area is a poor visual feature. A brick course built in front of the wall or its re-building would be of benefit.

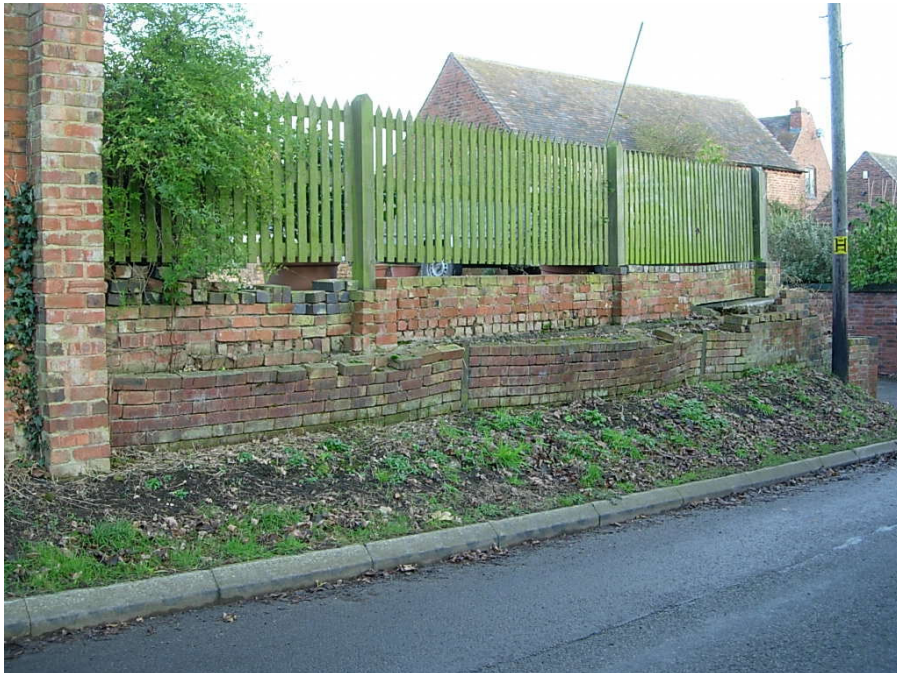
This area on Sheepy Lane could also be improved with the rebuilding of the brick wall.

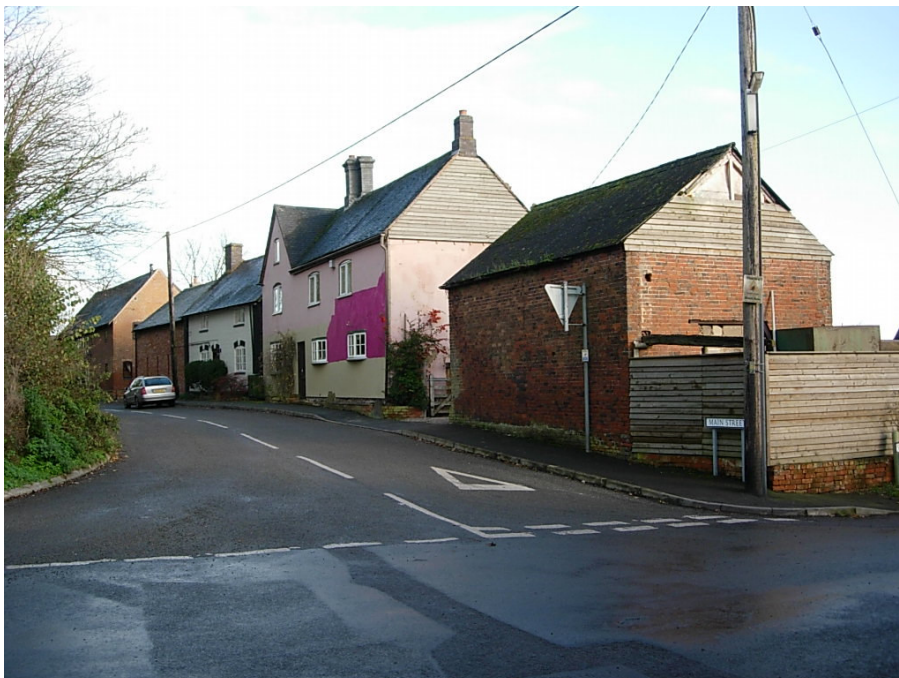
This pleasant group of properties on Main Street is spoilt by the unsympathetic treatment to the gable ends with timber planks used as cladding and corner fence. The colour of the rendering and use of bow windows is also unfortunate.

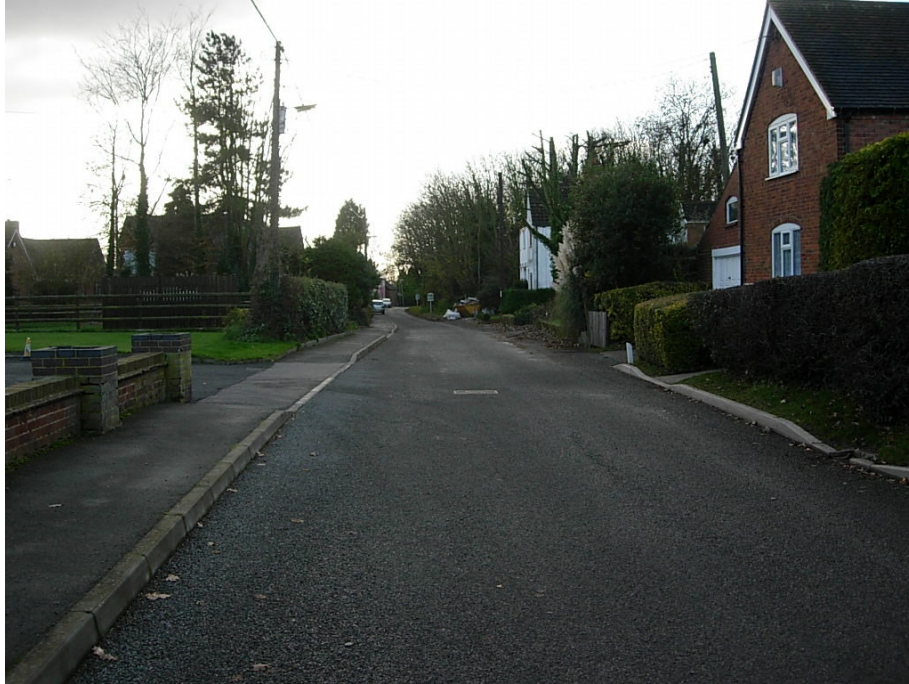
View looking down Main Street showing how the construction of a footpath and use of concrete kerbs can have a marked detrimental effect on the visual quality of a conservation area.

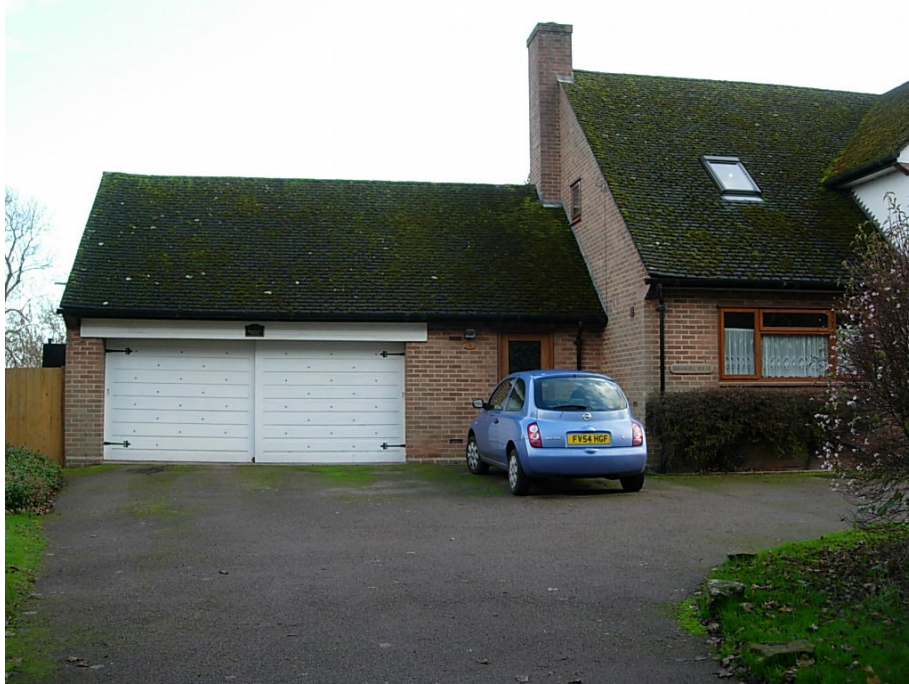
The bungalow and double garage at 10 Main Street does not reflect the traditional character of the conservation area due to its modern design and brickwork.

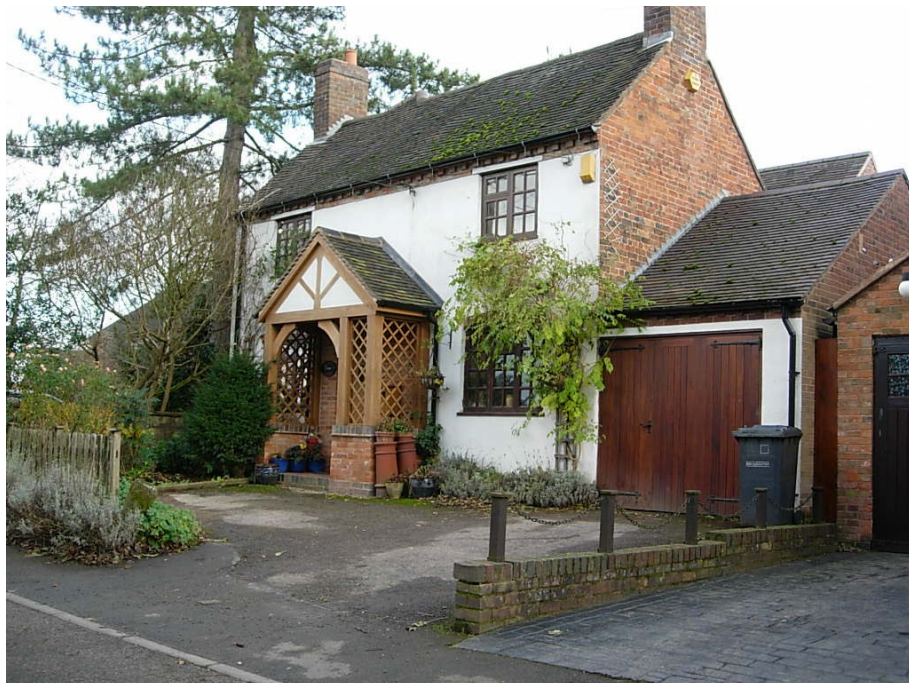
The front porch at Yew Tree Cottage has an overbearing impact on the property.

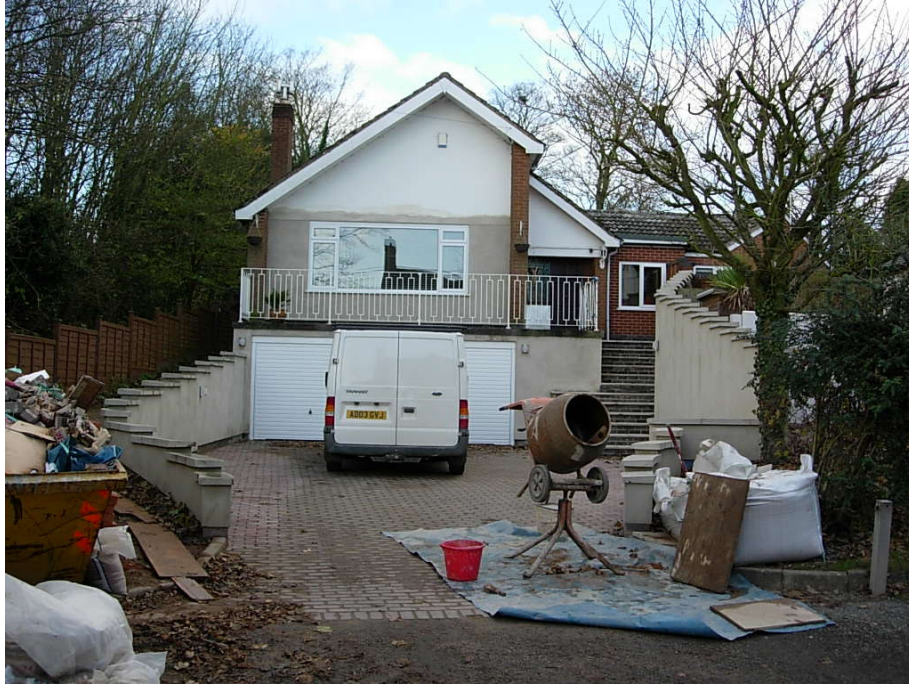
The modern design of 15 Main Street, which includes an integral Garage, verandah and rendered walls, is totally out of character with the traditional core buildings and walls in the conservation area.

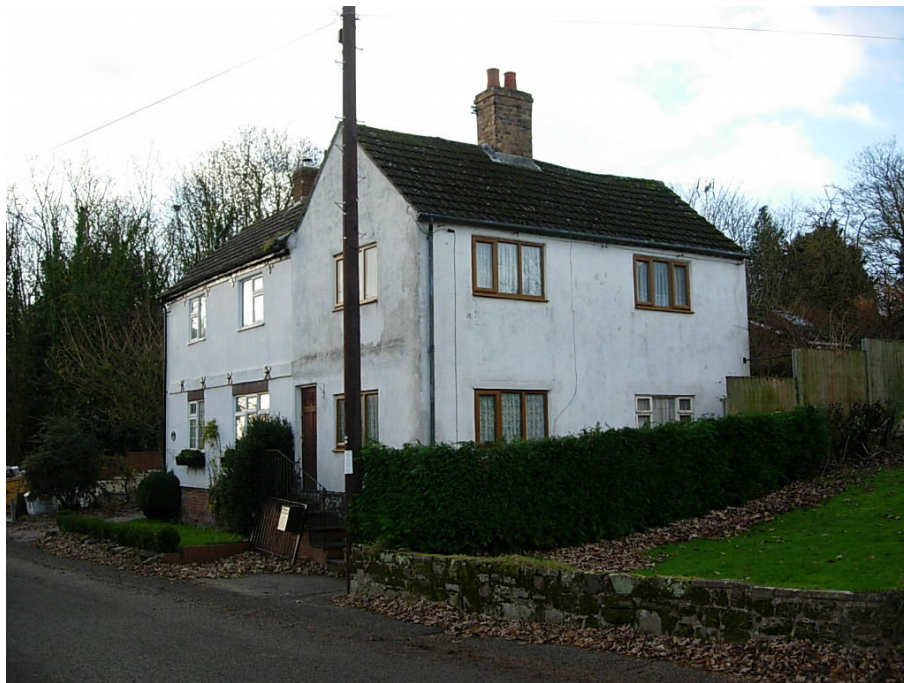
The concrete roof tiles at Ivy Cottages are a modern material that detract from the character of the conservation area.

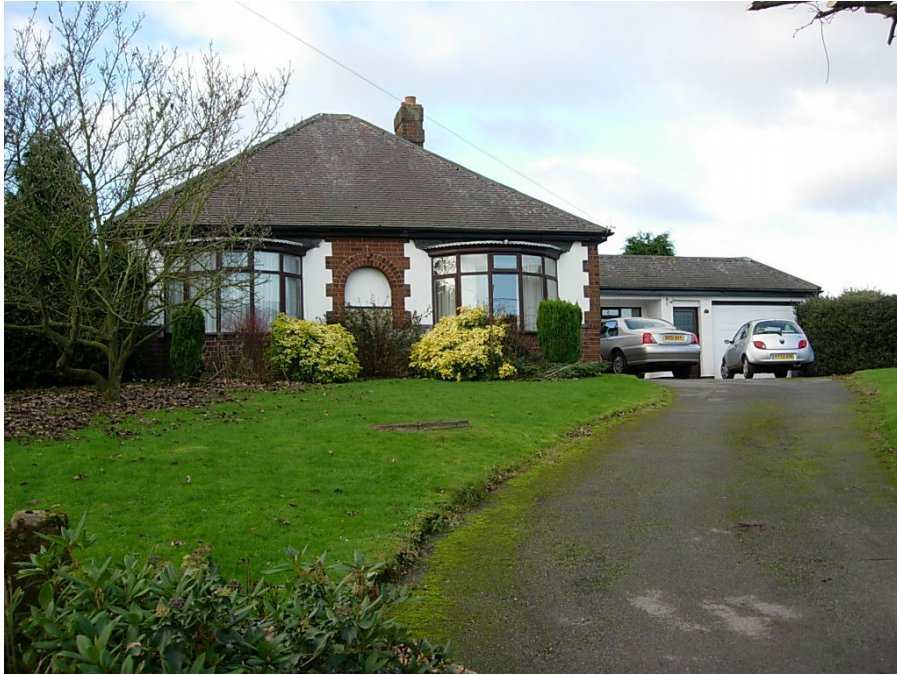
No 19 Main is a typical 1930's bungalow sited in a raised location and set well back from the highway. However, it is out of character with the traditional form of building.

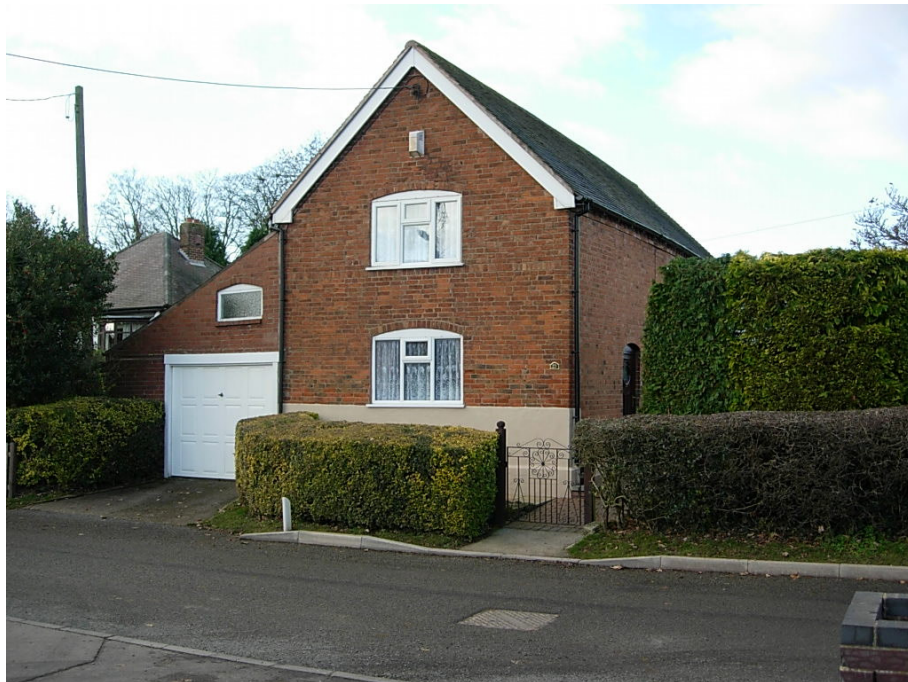
The pitched garage roof at 21 Main Street runs in the same plain as the main dwelling which gives rise to an unusual appearance.
