**SHENTON CONSERVATION
AREA MANAGEMENT PLAN**

**PHOTOGRAPHIC RECORD OF
SHENTON CONSERVATION AREA**

December 2007

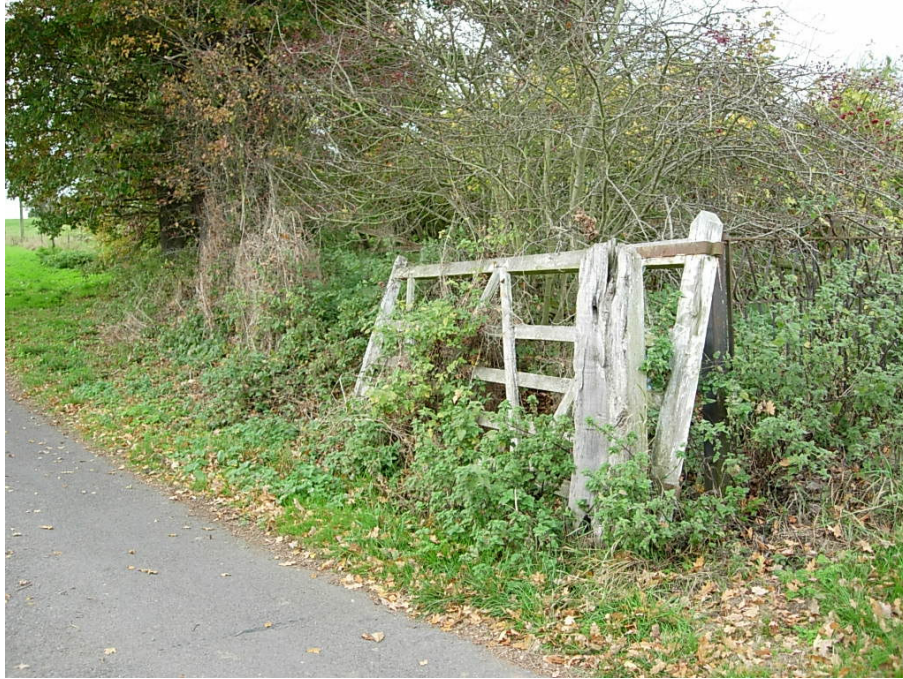
Upton Lane with its wide verges was once a gated road. The gate is still visible situated at its junction with Sibson Lane.

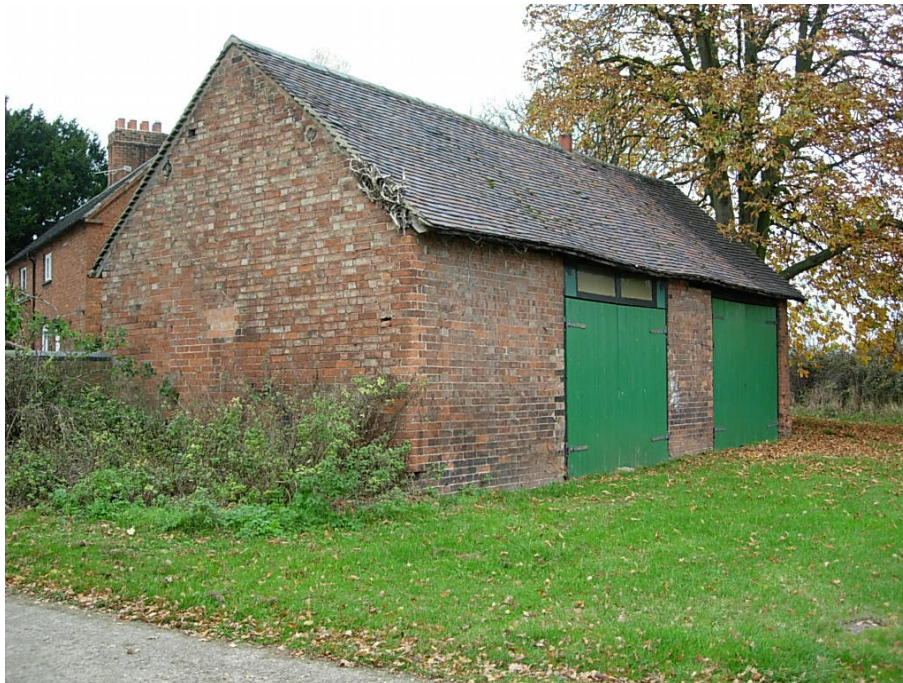
The building situated at the junction of Upton Lane and Sibson Lane was once Shenton's Smithy.

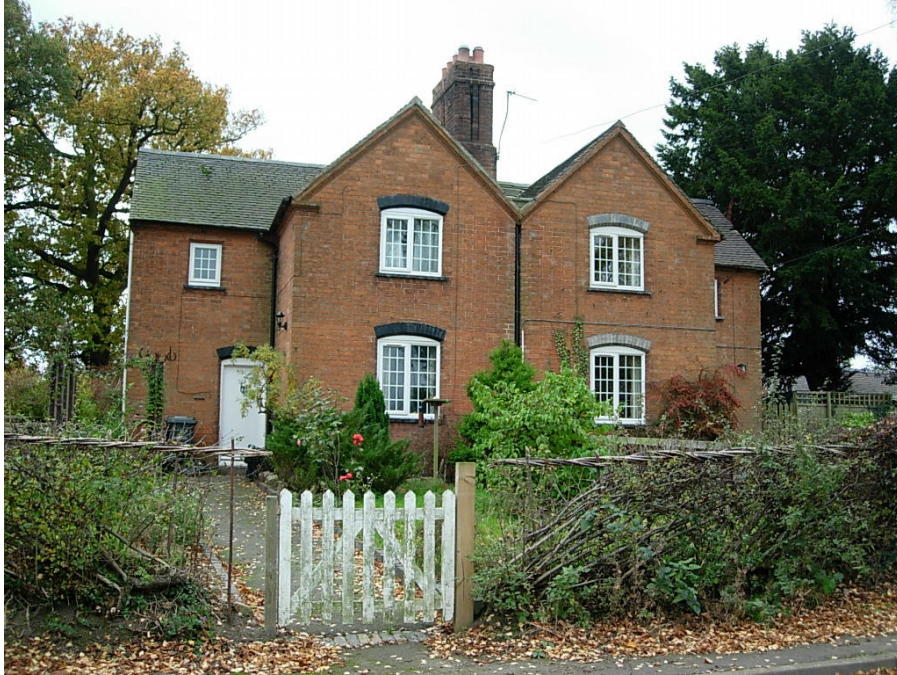
17 & 18 Sibson Lane is a typical 'Shenton Estate' semi-detached dwelling of which there are several scattered throughout the settlement. Unfortunately, as is occurring with many of the dwellings in Shenton, the original timber windows are slowly being replaced with UVPC windows.

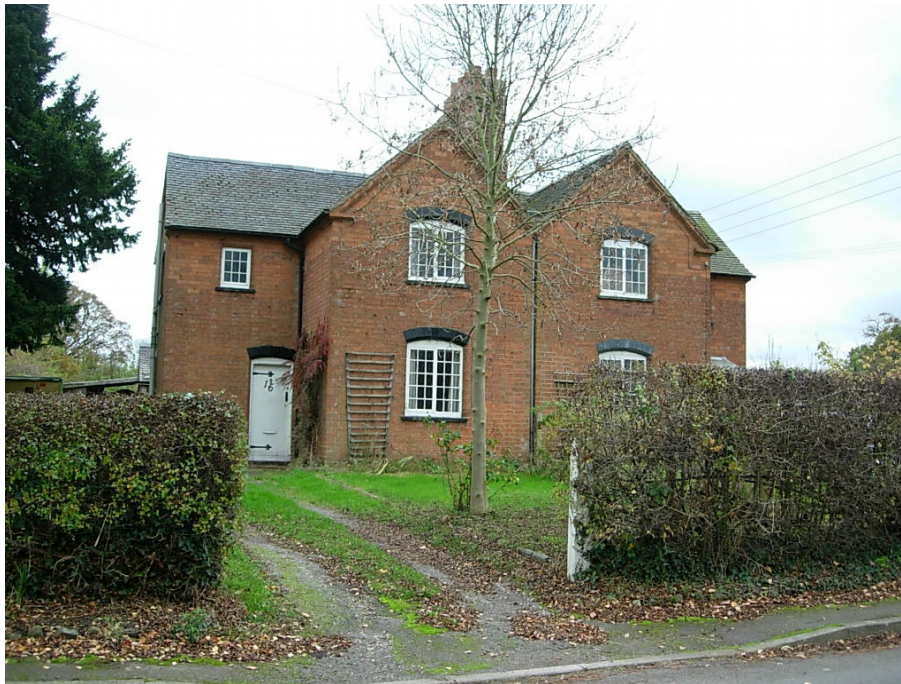
The properties 15 and 16 Sibson Road still have their original timber windows and rosemary roof tiles.

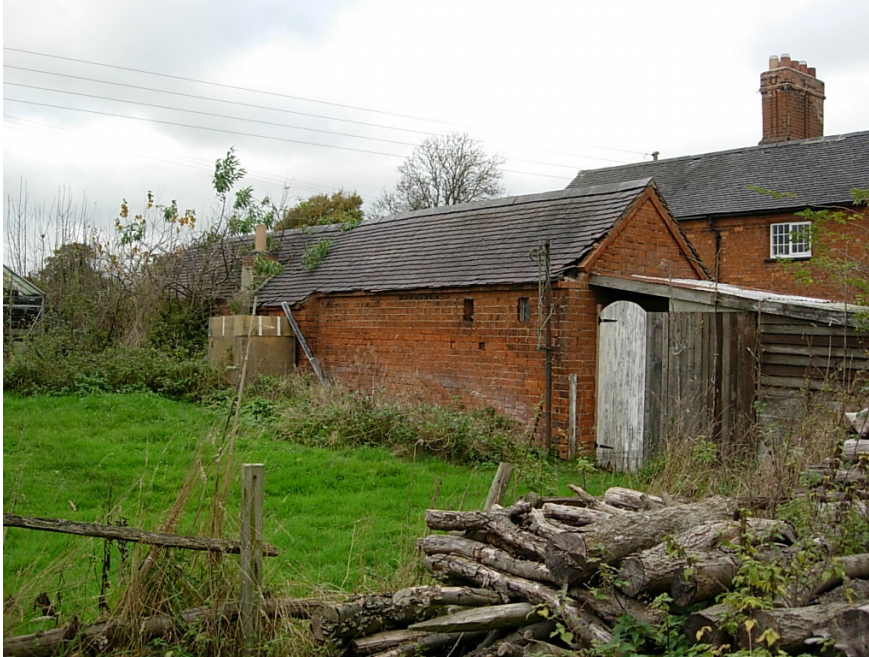
Many of the estate dwellings have retained their original outhouses in the rear gardens. They include a toilet, coal store and communal washroom. The outhouses, many of which are in need of urgent maintenance, are important features to the conservation area that should be retained.

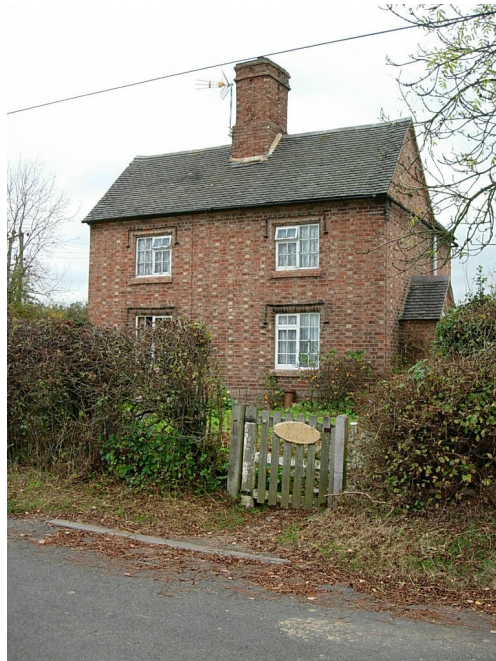
Rose Cottage on Sibson Lane showing 'hood' moldings as features over its windows. Again the traditional 2 light windows have been changed.

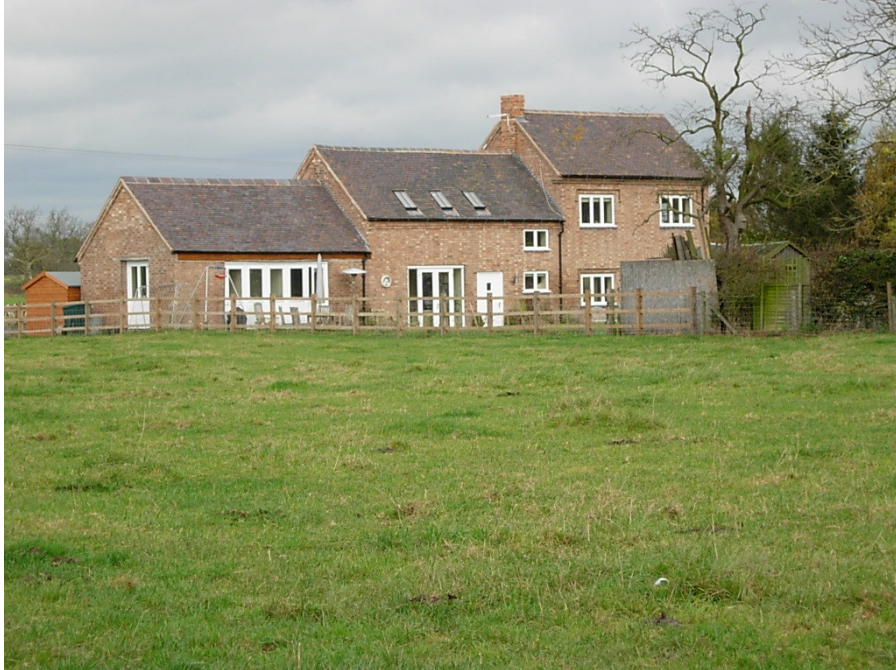
View of Brookfield Barn from Sibson Road. The use of white paint makes the windows particularly prominent when viewed from a distance. Dark brown or green is more appropriate on barn conversions.

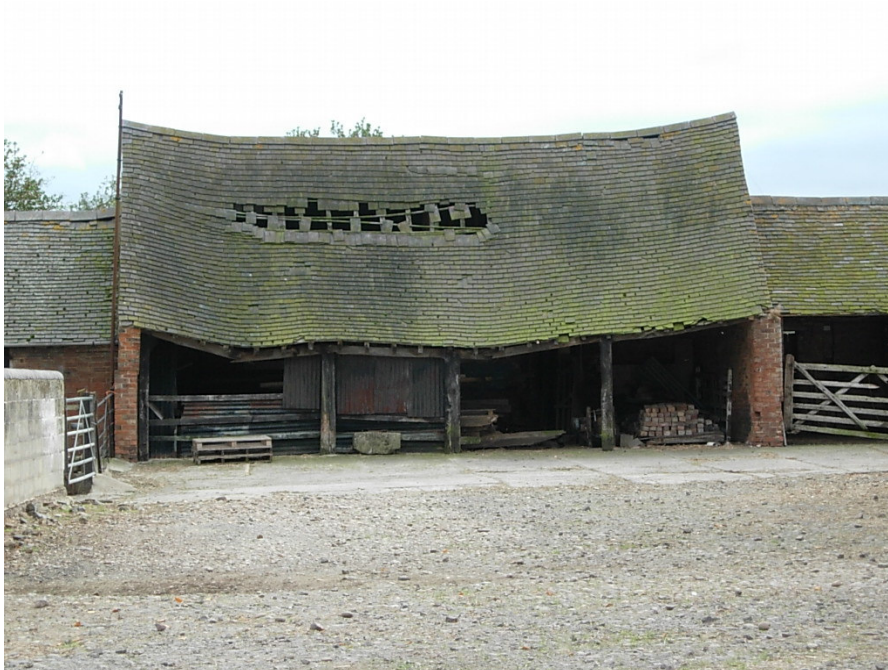
Several of the outbuildings at Stud Farm are important to the character of the conservation area but are in urgent need of maintenance.

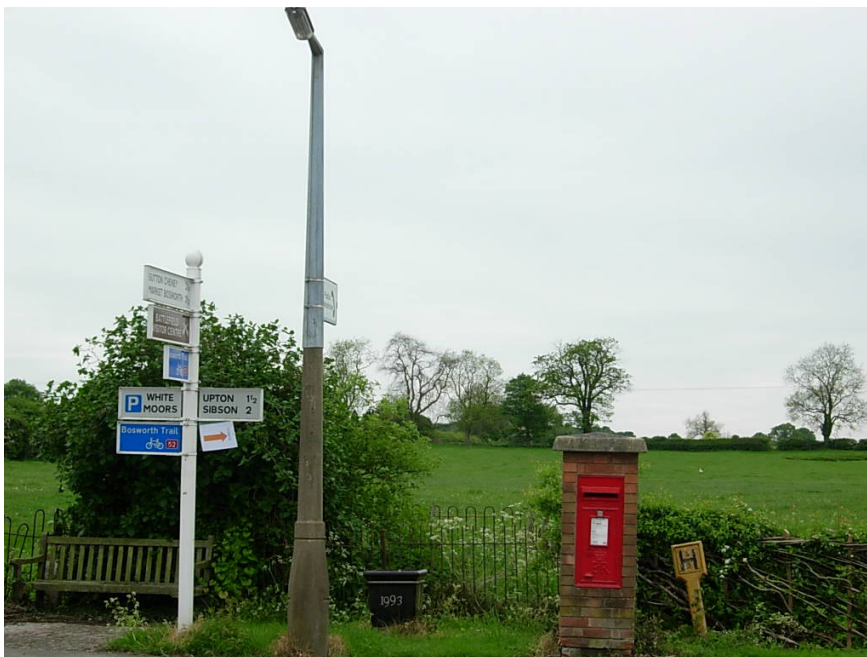
The small fenced area, litter bin, timber seat, post box and directional sign are an important group of features at this key road intersection. The area would benefit with the shrub being removed, maintenance carried out to the features and the concrete street lighting column replaced with a heritage column.

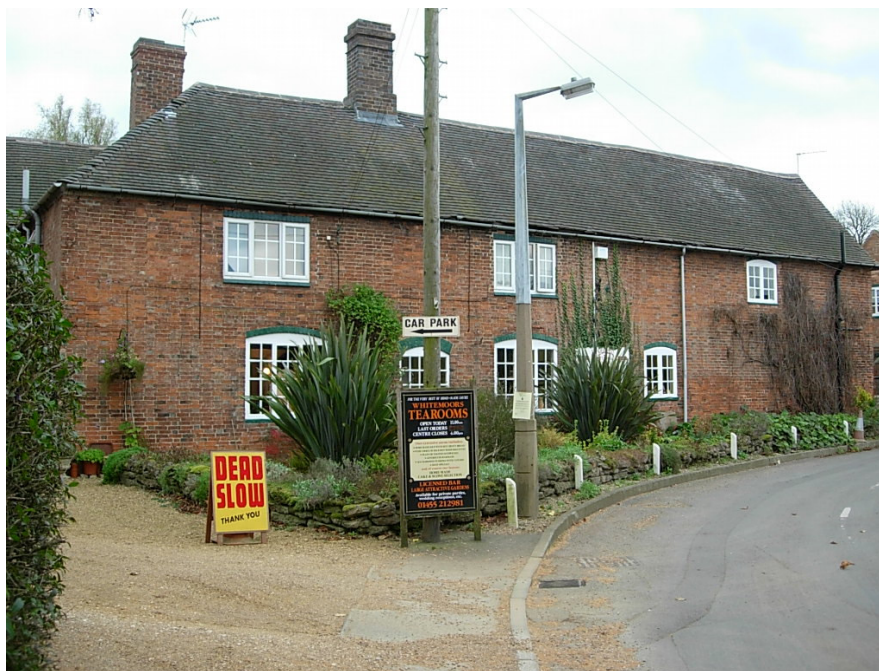
The listed White Moors located at the bend on Mill Lane has been converted into an arts and craft centre. The notices, telegraph pole and light column add to the clutter fronting the property. The UPVC windows at 1st floor level should be replaced with timber windows to help retain the traditional character.

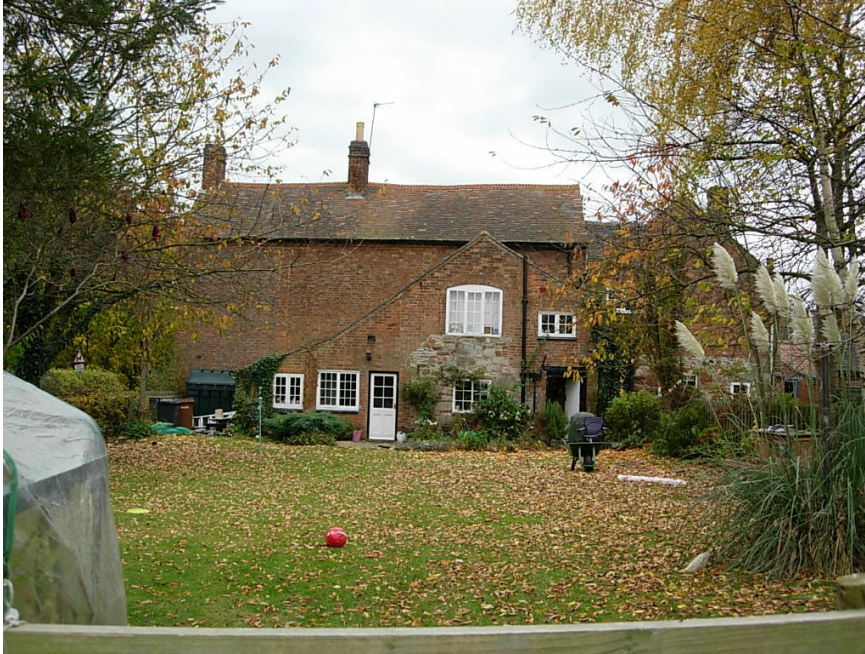
The side elevation of Ivy House Farmhouse on Main Street. The listed Farmhouse which is sited at right angles to the carriageway has had several of its windows replaced with modern plastic ones to the detriment of its traditional character.

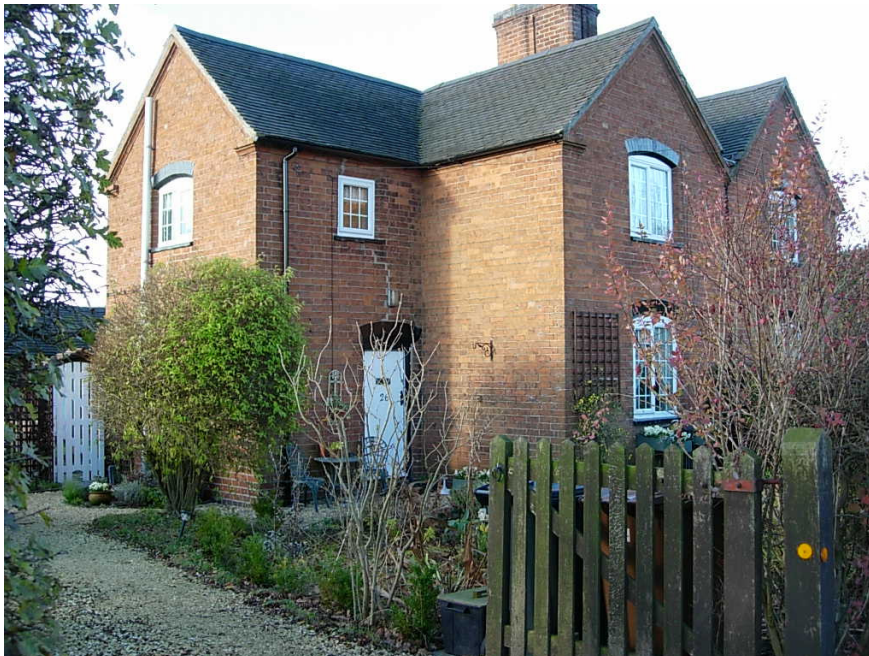
The replacement plastic windows fitted in 26 Mill Lane detract from the traditional appearance of the dwelling.

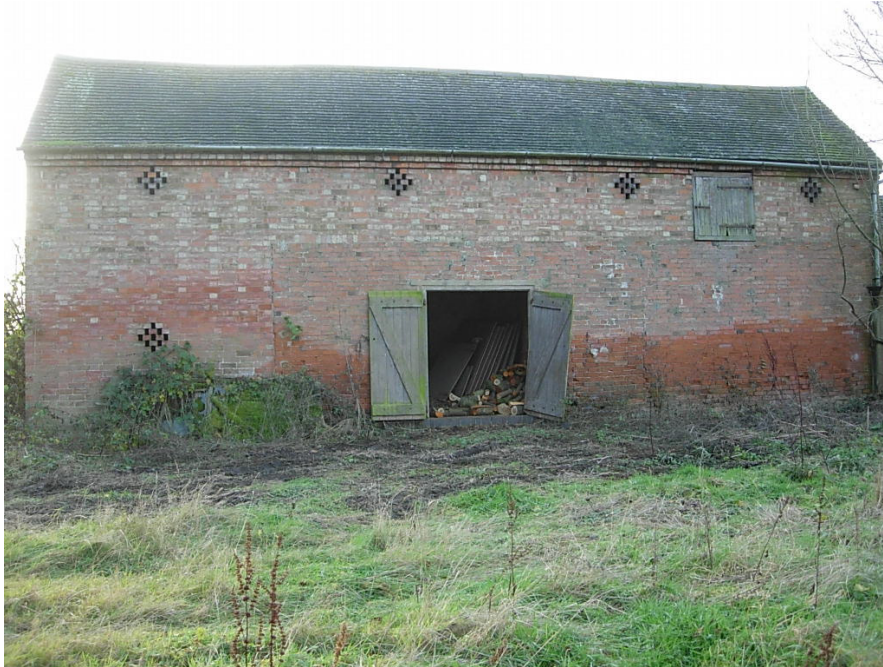
This fine barn on Mill Lane is suffering from poor maintenance.

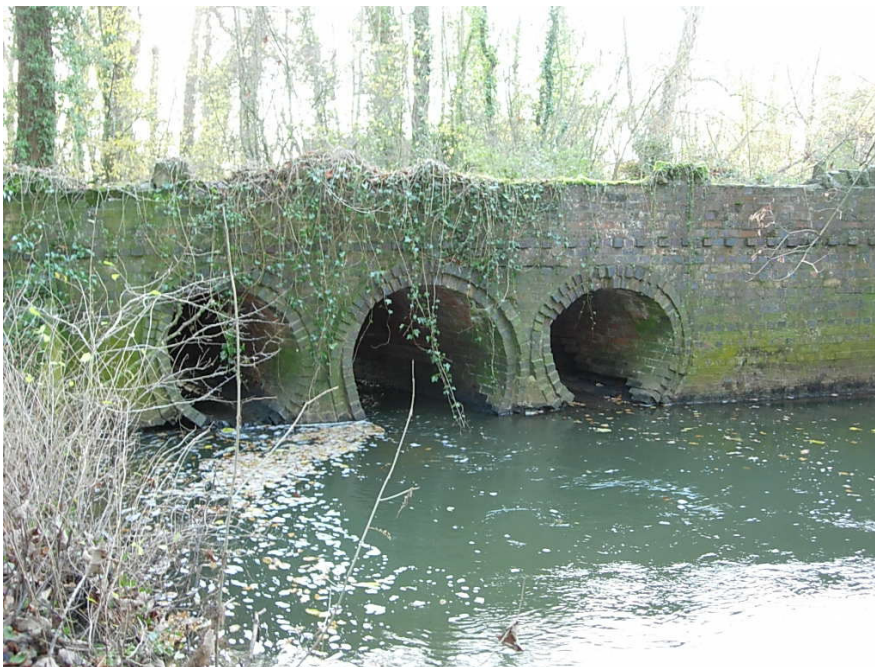
The bridge that leads to New Barn Farmhouse requires urgent maintenance. Part of the stone copings are missing and the brickwork is in need of repair.

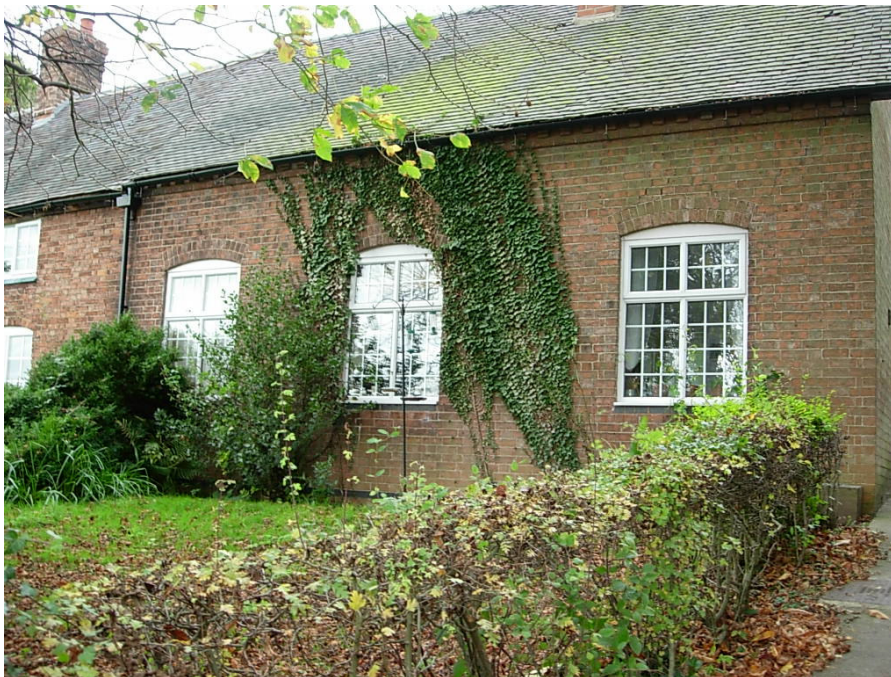
Number 7 Pump Lane is a single storey property attached to a two storey dwelling. The plastic windows detract from its appearance.

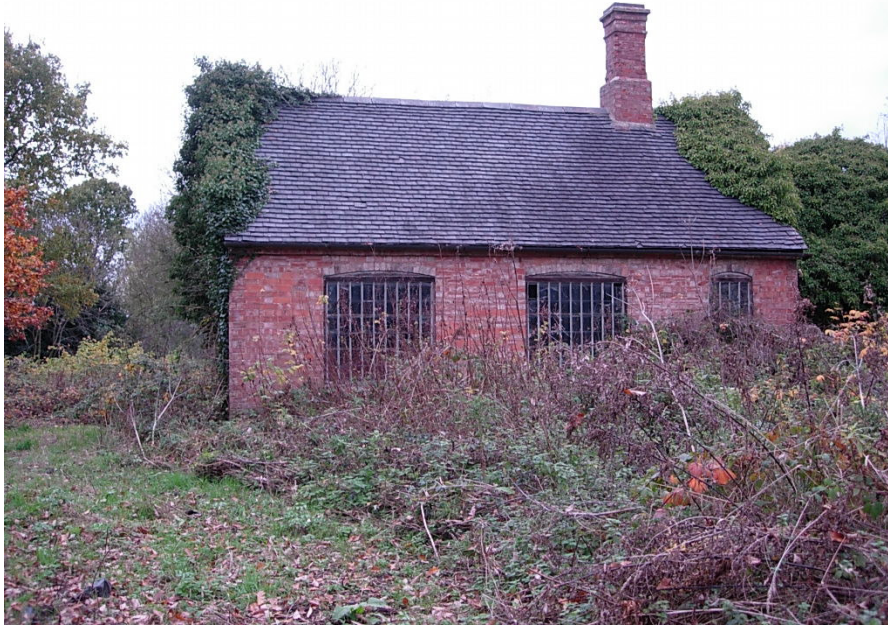
This building is situated within a small copse fronting Pump Lane. The property, now derelict, was once used as a joiner's workshop but is now in need of repair or it will be lost.

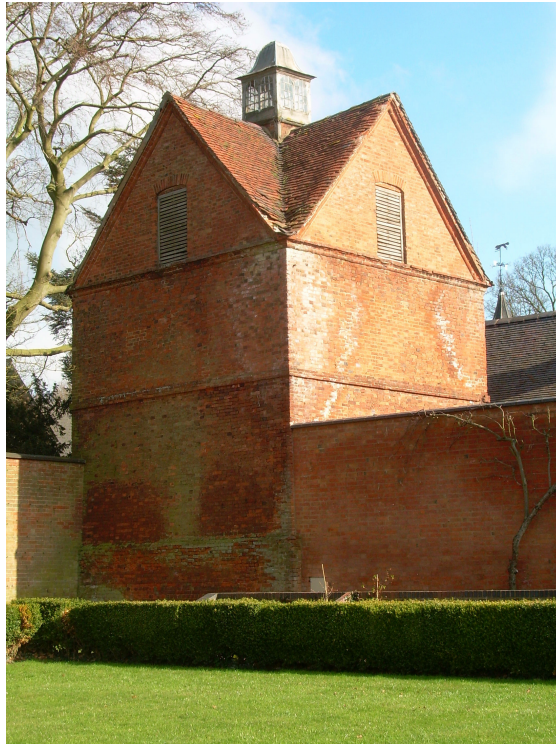
The listed Dovecote at Shenton Hall dated 1719 has benefited from recent conservation repairs.

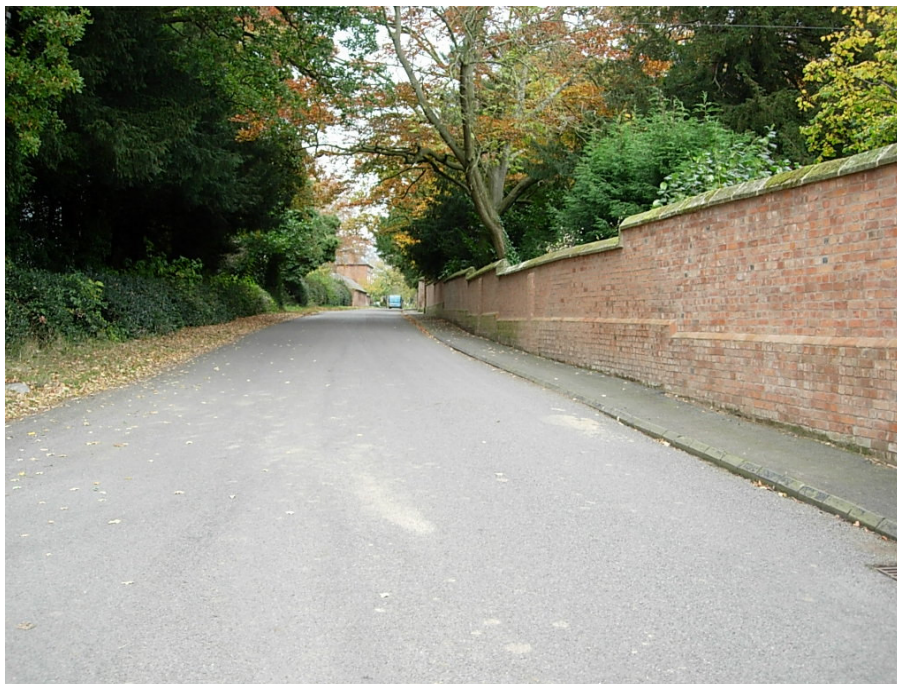
View looking north eastwards up Bosworth Road showing the boundary wall to Shenton Hall which has recently been repaired.

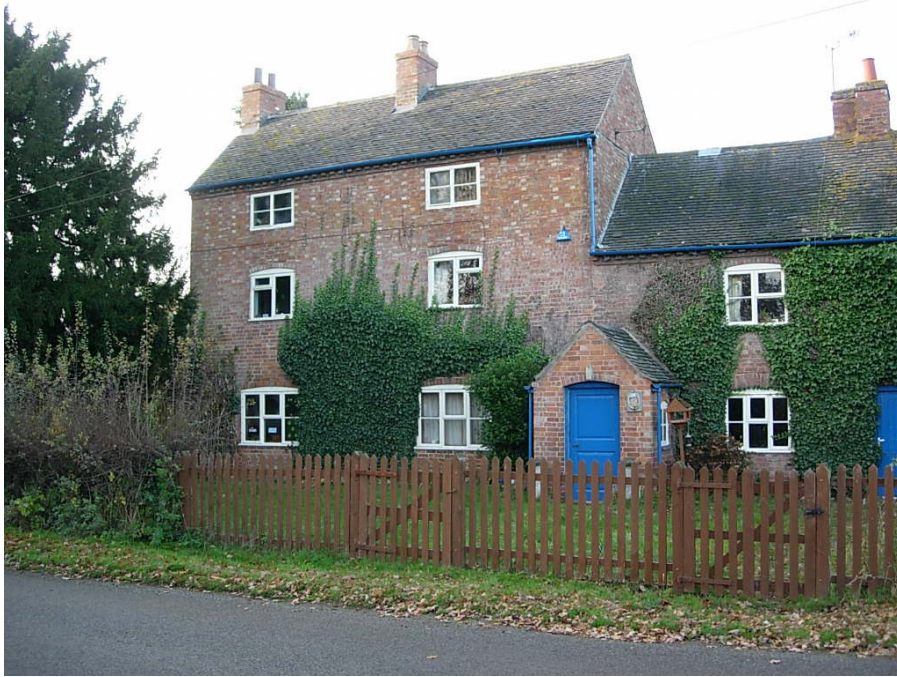
Aqueduct Farm would benefit from the re-placement of its first floor windows with traditional designed windows.

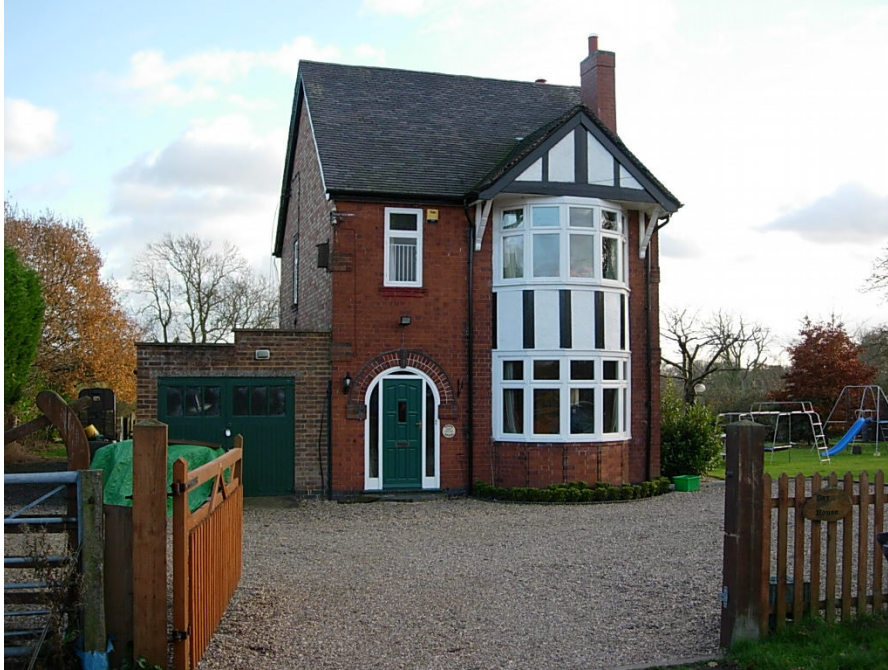
Twemloe House on Bosworth Road is a fine detached 1930's dwelling which unfortunately, is out of character with the traditional buildings in the settlement.

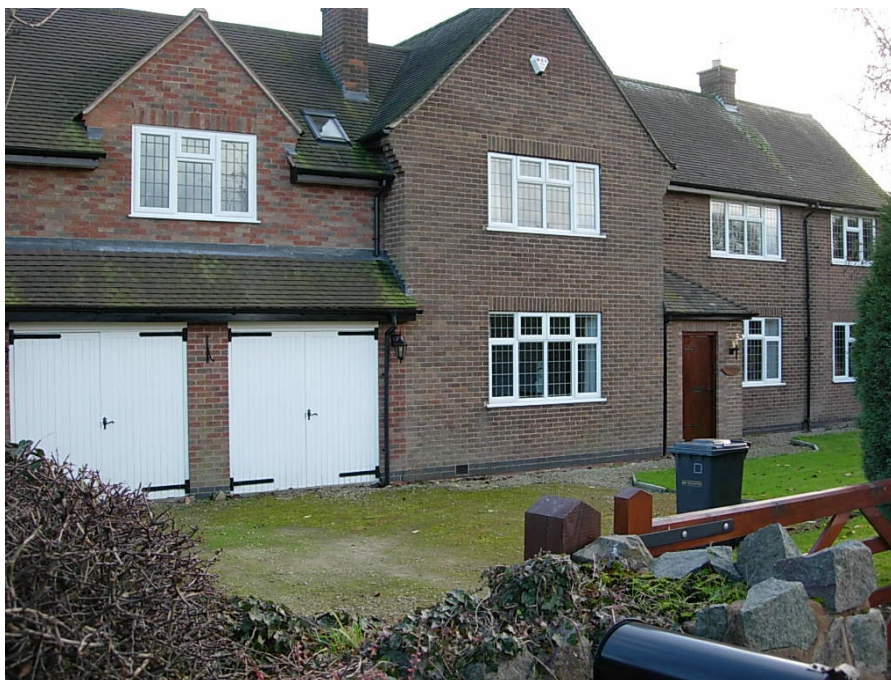
Greystones, a modern post war property built at the entrance into the village which does not reflect the traditional character of Shenton's traditional buildings.
