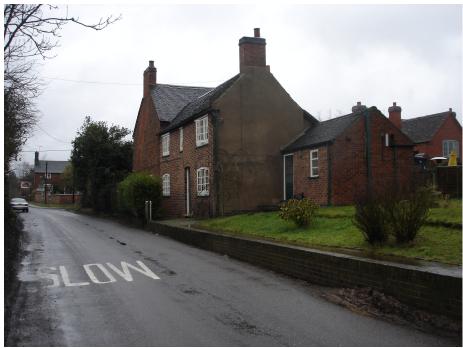
Field View is at the southern entrance of the conservation area on Wharf Lane. Enclosure has been lost due to the open nature of the garden. Some form of enclosure is needed, preferable with the building a traditional brick wall.

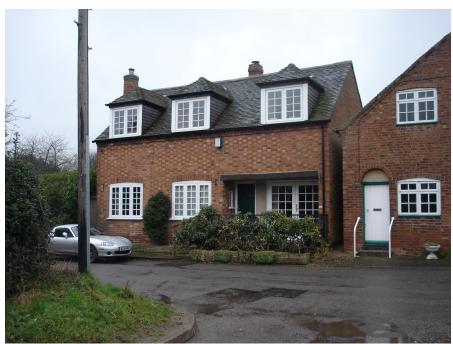
The Old Chapel on Wharf Lane has had improvements made to it. The dormers on the front elevation are out of scale with the property.

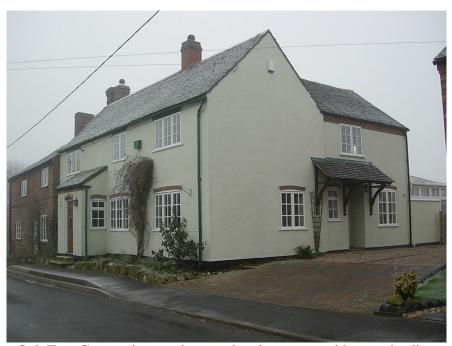
Oak Tree Cottage is a modern rendered property with steps leading up to its front door. The dwelling displays traditional characteristics being flat fronted with a gabled end although it has had a modern porch and side canopy added.

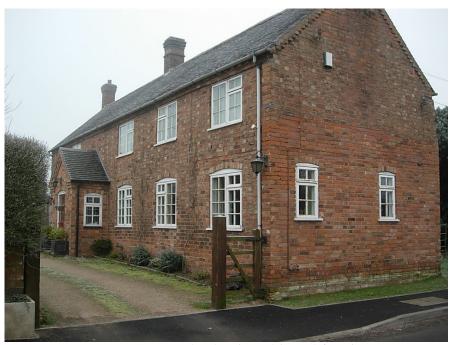
Moores Cottage that has its gable end fronting Bosworth Road has lost some of its chimney pots.

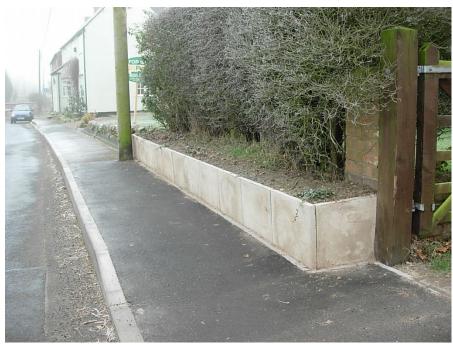
The concrete retaining slabs on Bosworth Road are a poor visual feature which should be replaced by a brick wall.

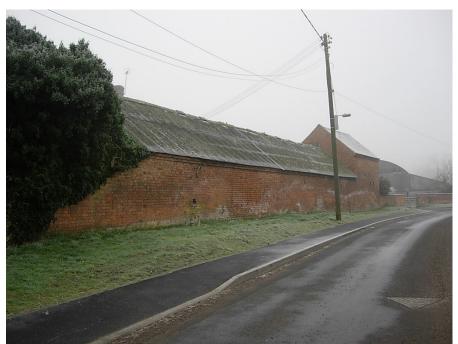
The farm buildings to Townshead Farm help channel views down Bosworth Road. Together with the grass verge there is a rural feel to the road which has been spoilt with the introduction of concrete kerbing.

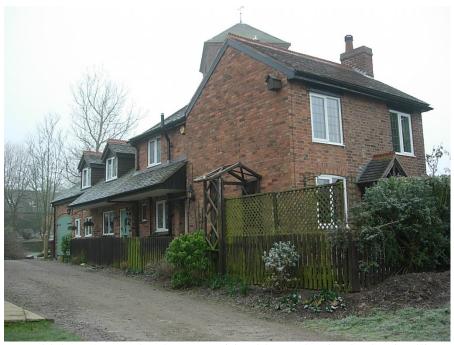
Bumblebee Cottage has been considerably modernized. The dwelling is one of few properties in the village that has barge boarding. With the introduction of plastic windows, roof lights, canopy and satellite dish, it provides a poor setting to the parish church.

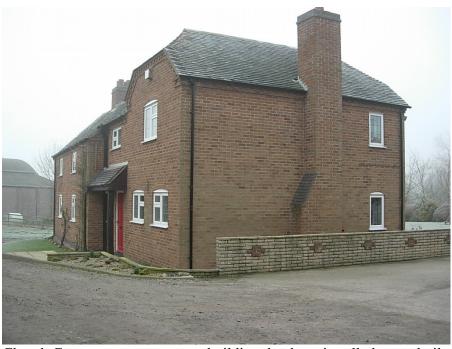
Church Cottage was once a core building that has virtually been rebuilt.

The use of re-constituted materials has a negative effect in what is a very sensitive area of the Conservation area.

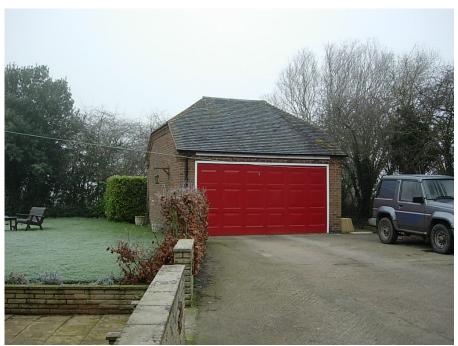
The modern double garage to Church Cottage is unsympathetic to the traditional character of the conservation area.

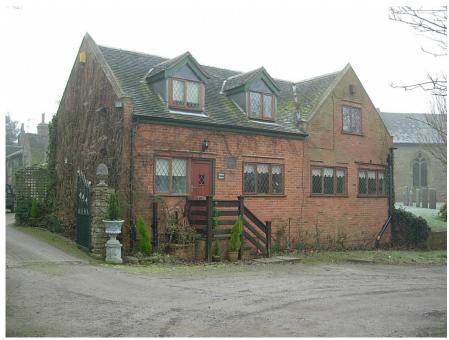
Sutton House sited to the rear of the parish church. The windows to the property are very modern in appearance and detail and the front staircase railings are non traditional in character.

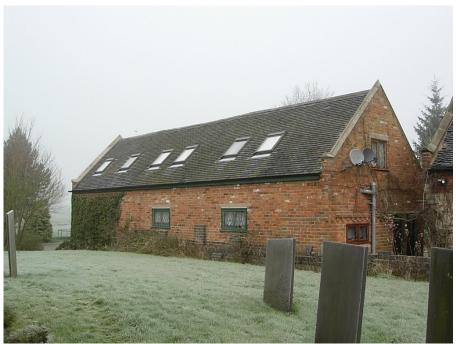
The side elevation of Sutton House viewed from the parish churchyard. The roof lights, concrete lintols to the windows and satellite dish are unsympathetic features adjacent to the historic church and alms house.
