**TWYCROSS CONSERVATION  
AREA MANAGEMENT PLAN**

**PHOTOGRAPHIC RECORD OF  
TWYCROSS CONSERVATION AREA**

**December 2007**

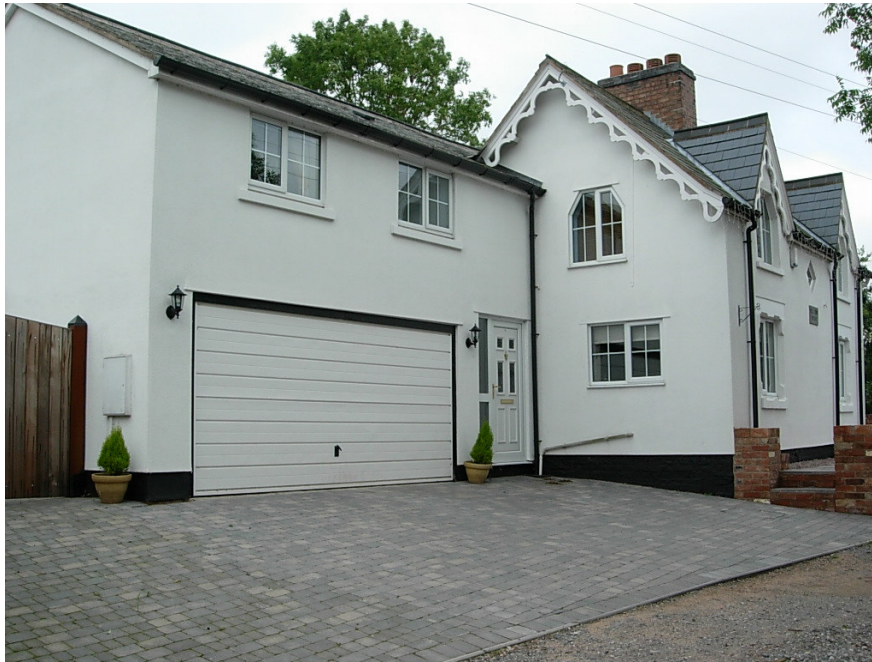
A large unsympathetic side extension / integral garage has been built at 15 Sheepy Road which is out of scale and character with its period dwelling.

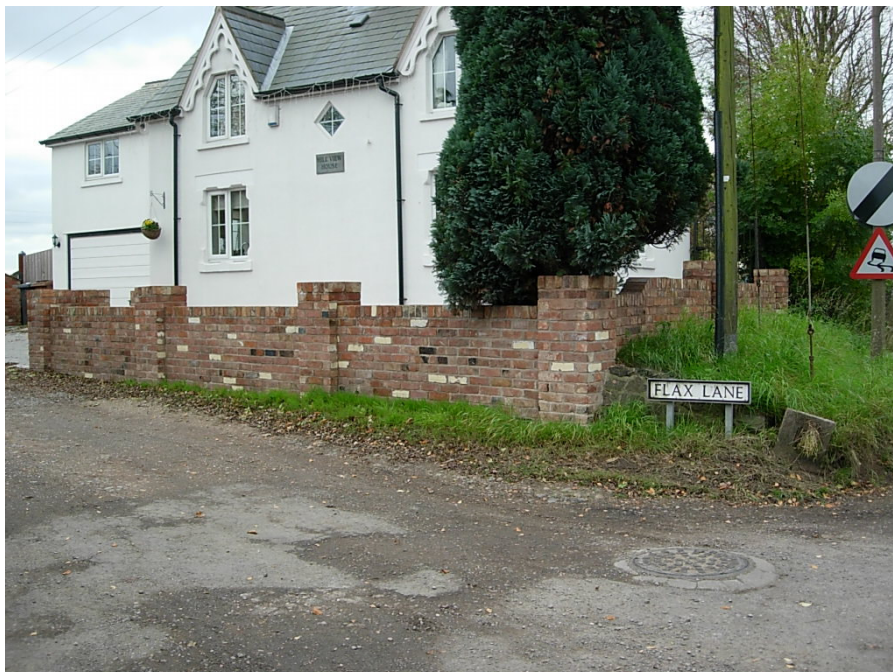
The design of this recently built wall fronting 15 Sheepy Road is out of character with other traditional boundary walls in the conservation area.

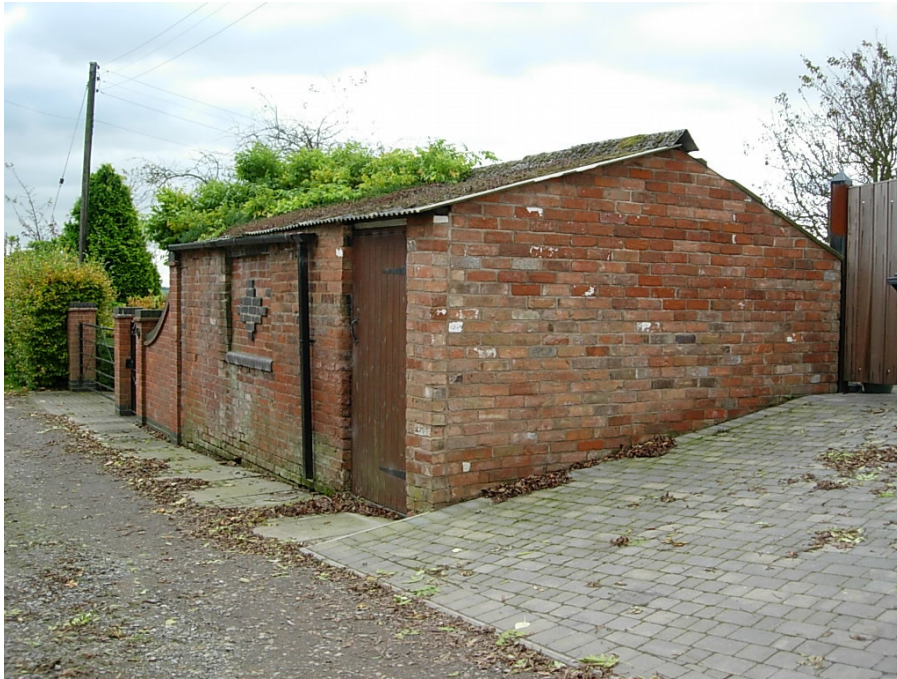
Significant changes to this small Victorian outbuilding on Flax Lane has had a detrimental impact on its character. The pitch of the roof has been reduced and the roofing material changed from its original.

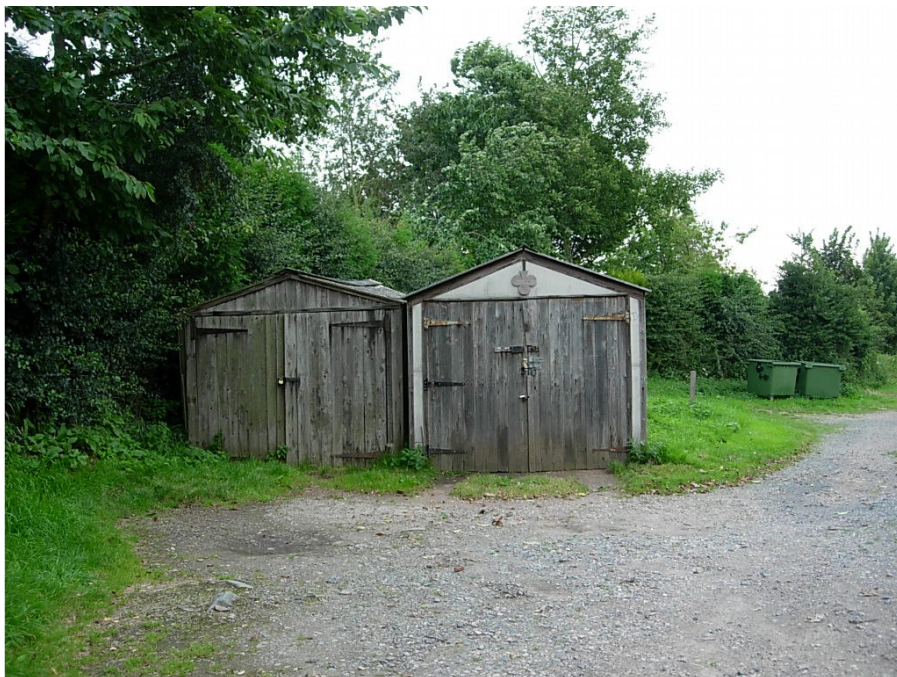
The two garages and surface dressing of the carriageway are unattractive features that tend to detract from the appearance of Flax Lane.

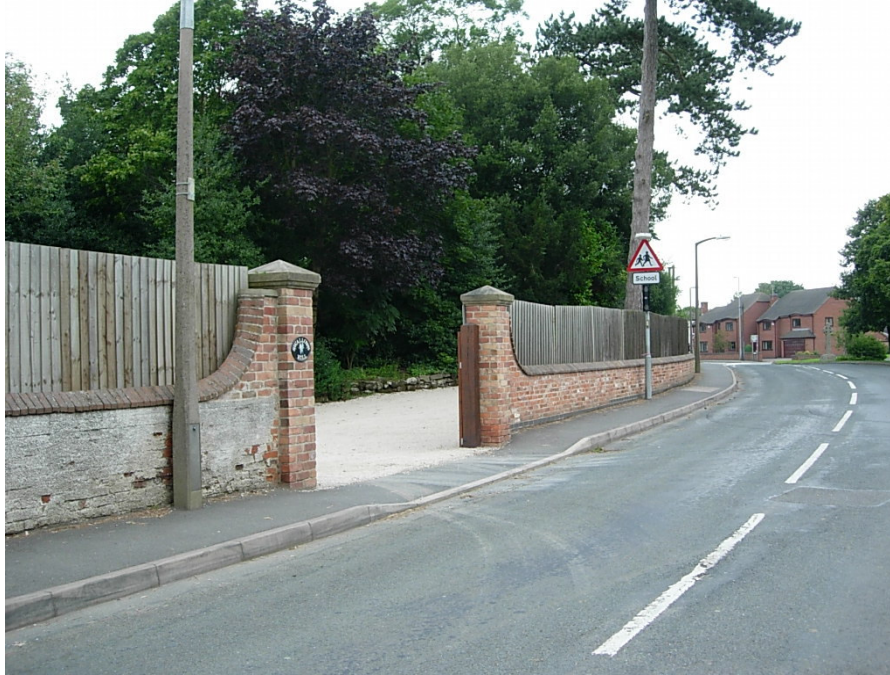
The timber fence is an incongruous feature that restricts views into the mature grounds of the preparatory school. If security is a issue, consideration should be given to replacing the close boarded fencing with iron railings.

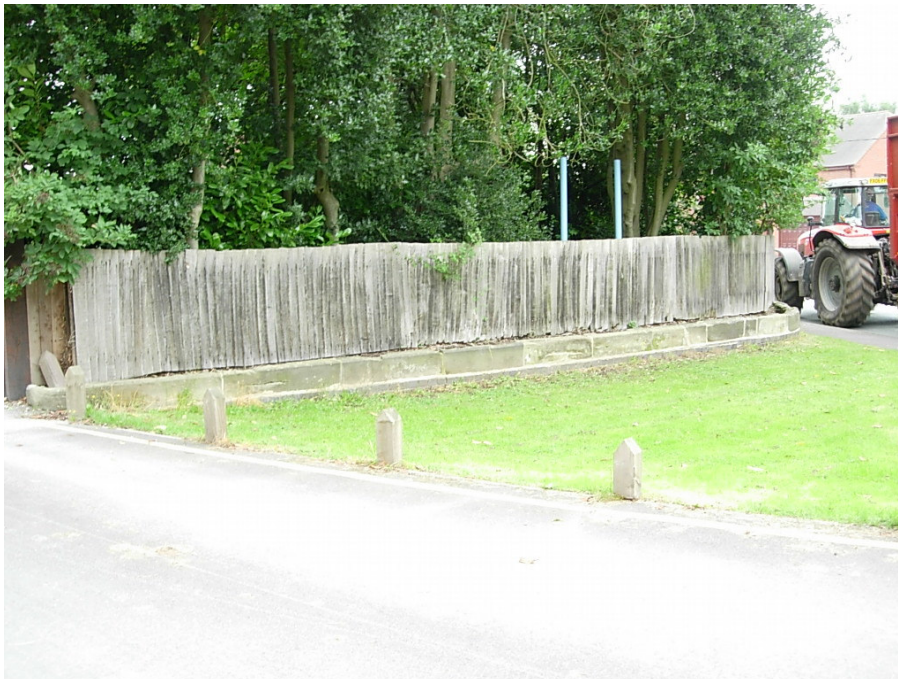
The timber fence at one of the entrances into the preparatory school would benefit by being replaced by iron railings, similar in design to the railings that were originally in this location.

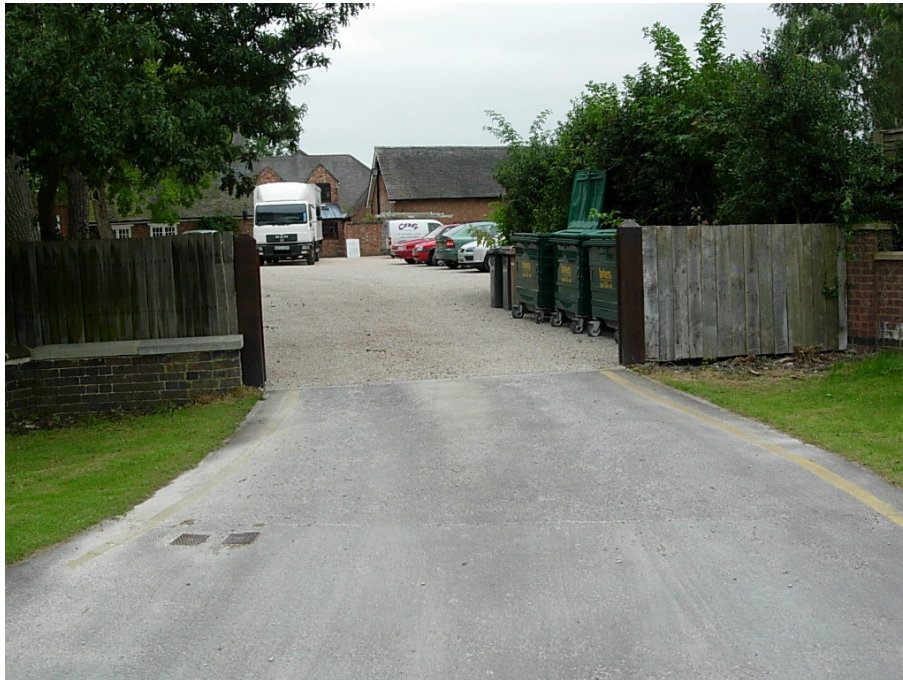
The second entrance into the preparatory school would be visually improved with the timber fences replaced with low brick walls and iron railings.

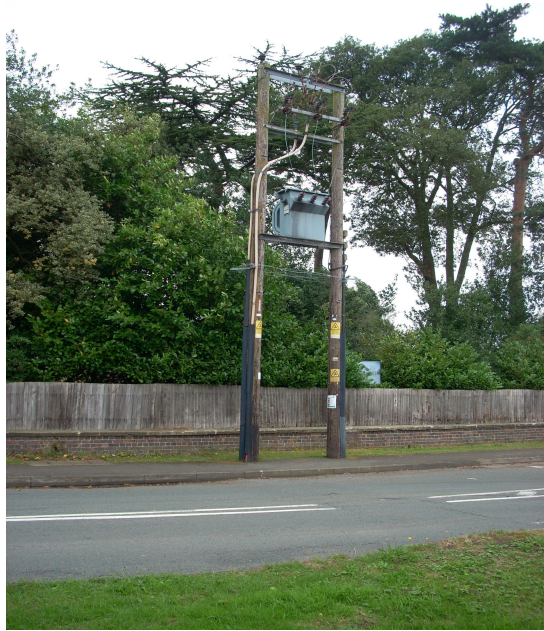
The pole transformer on Main Road is an incongruent feature that needs to be removed and the overhead electric cables in the conservation area undergrounded.

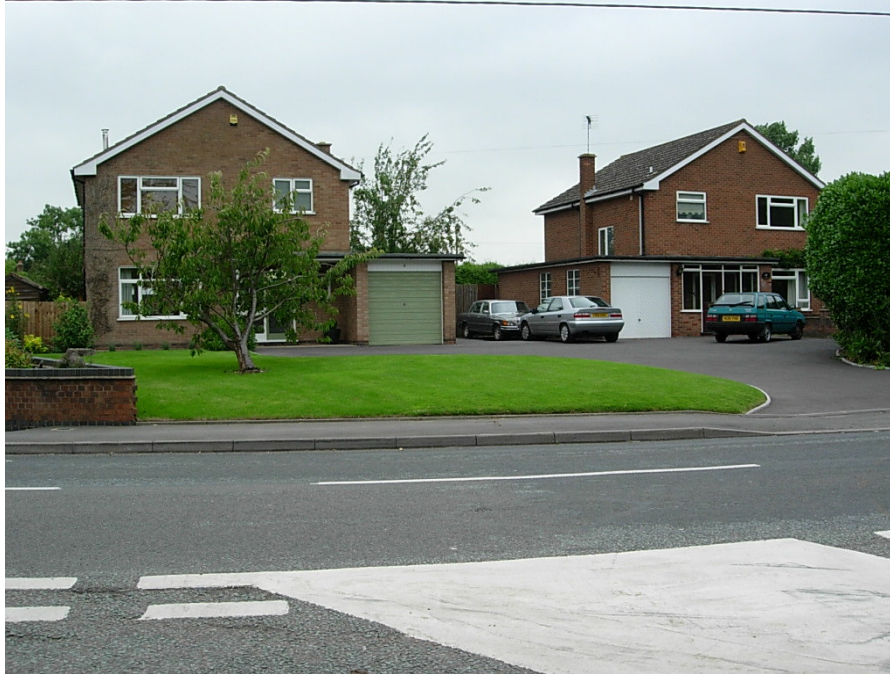
The two modern dwellings 4-6 Main Road are out of character with the traditional 'core' buildings in the conservation area. Enclosure is also lost with their open aspect fronting the carriageway. Consideration should be given to the building of a brick wall of traditional materials and brick bond.

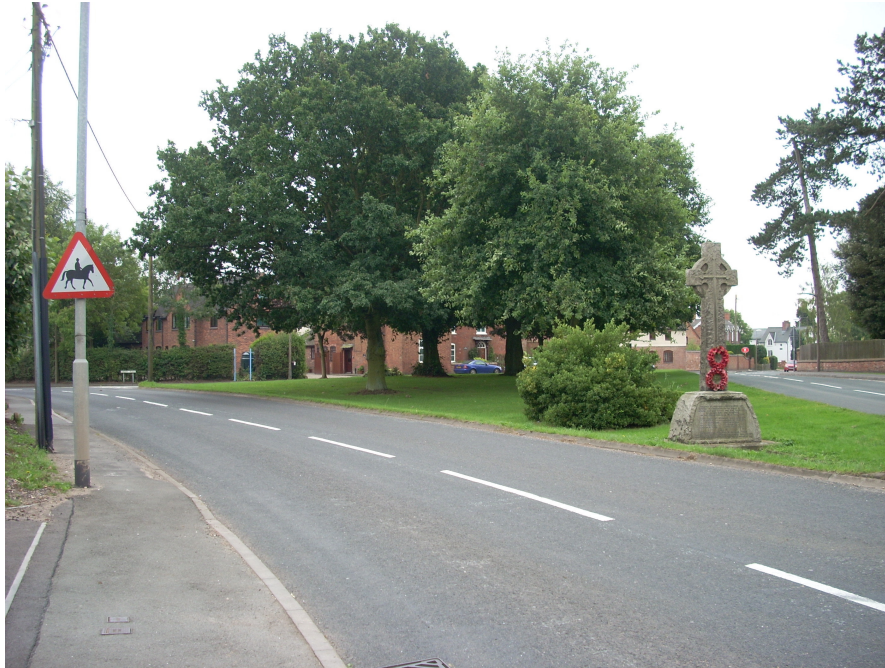
The attractive village green with its mature trees is the focal point of the conservation area. Consideration should be given to the removal of existing shrub that restrict views under the tree canopies and view of a plaque to commemorate Queen Elizabeth II's coronation.

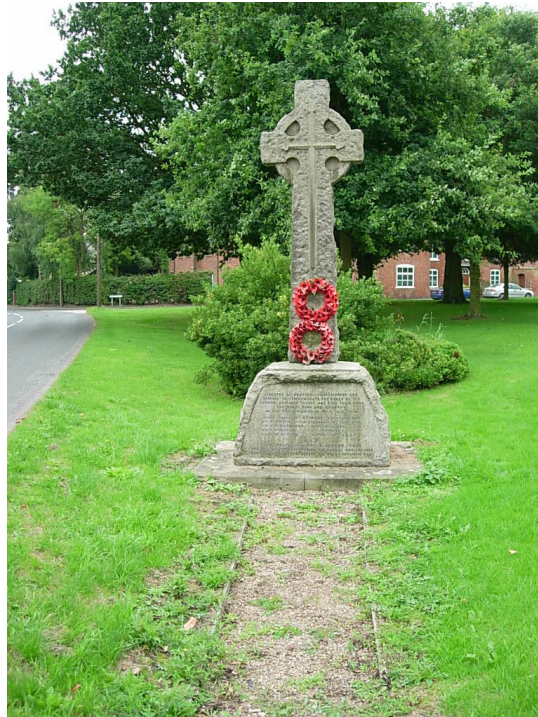
The area around the war memorial needs to be tidied-up and re-defined

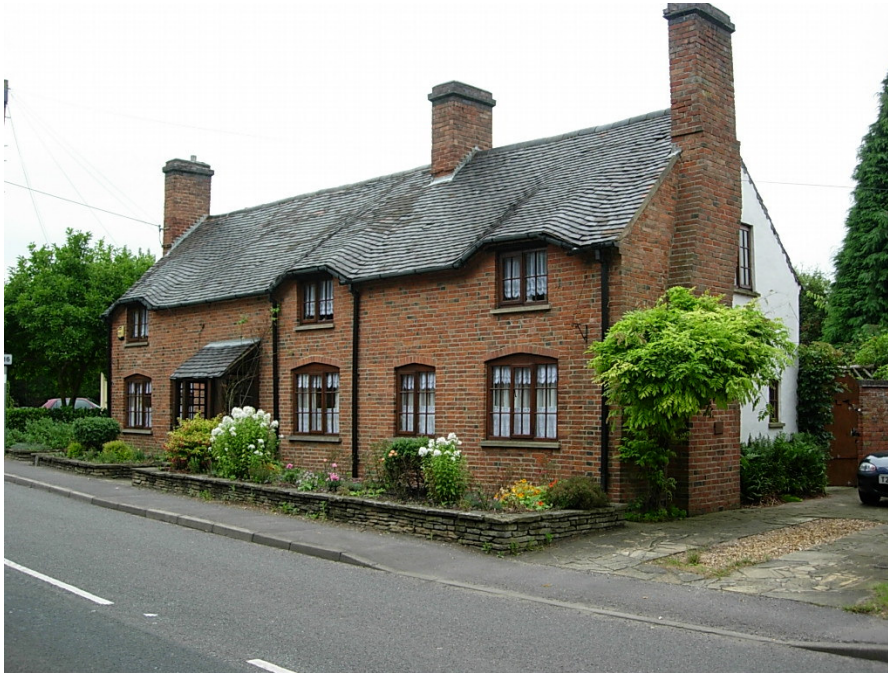
3 Church Street has been converted into one dwelling generally utilizing natural materials. Although the chimney stacks have been retained, the chimney pots are a missing element.

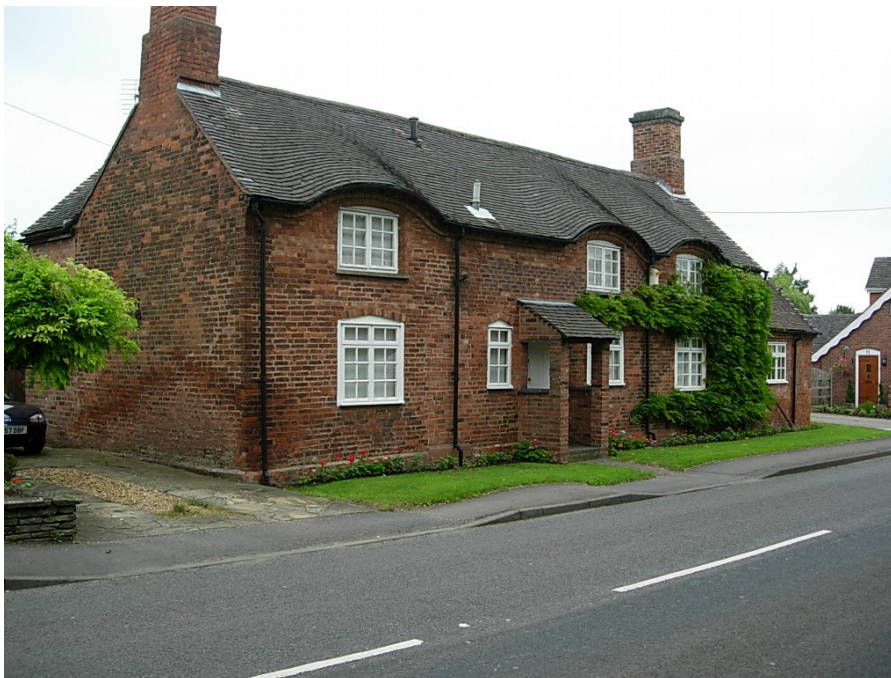
7 Church Street has also been converted into one cottage which has resulted in the loss of one of its original doors and chimney pots.

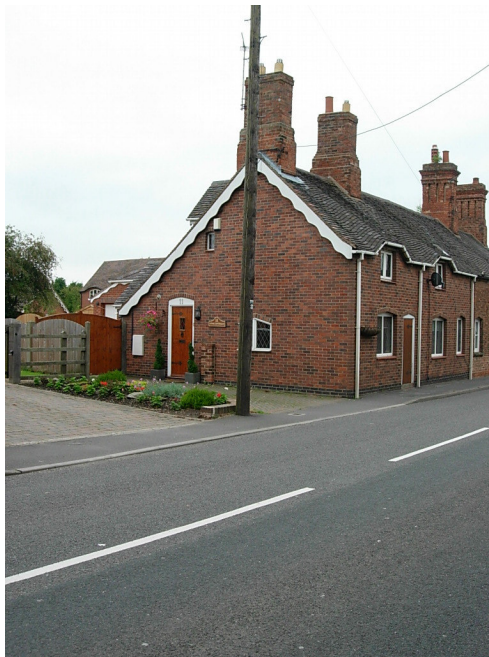
The barge boarding on the gable end of 11 Church Street is prominent incongruous feature on Church Street.

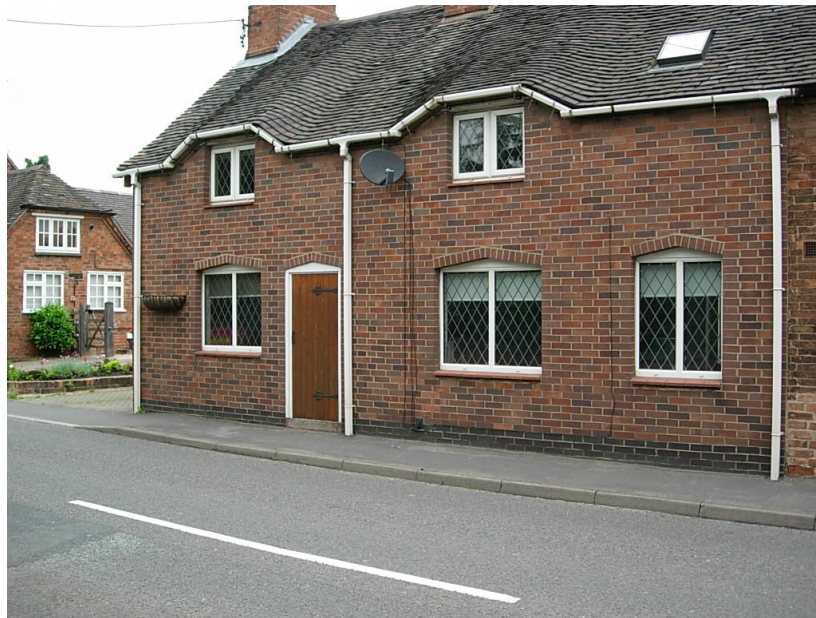
11 Church Street has been modernized utilizing; a modern brick laid stretcher bond, whiteUPVC guttering and down pipes, roof light and satellite dish mounted on the front elevation. The property is at discord with the rest of the terrace and should have been modernized utilizing natural materials and traditional building methods.

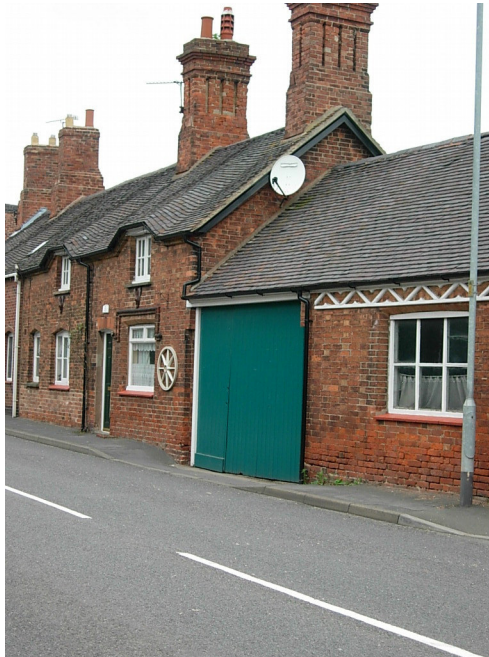
The satellite dish is an incongruent feature on 15 Church Street visible from the highway. The chimney stacks are excellent features which should be retained.

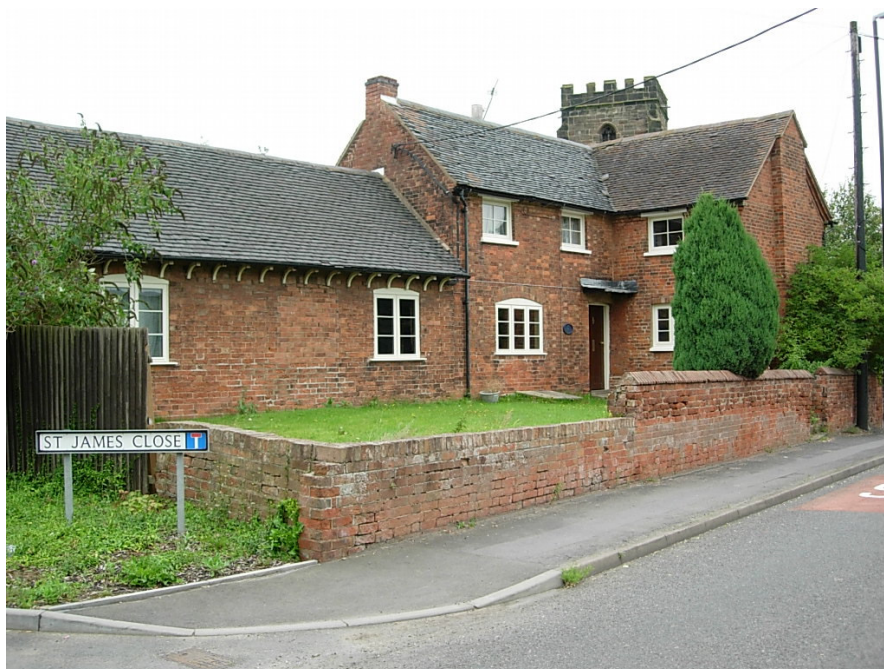
19 Church Street is an attractive dwelling which generally retains its rustic charm although it would benefit from a traditional saddleback coping running over the whole length of its boundary wall and having the chimney stack replaced on its gable end.

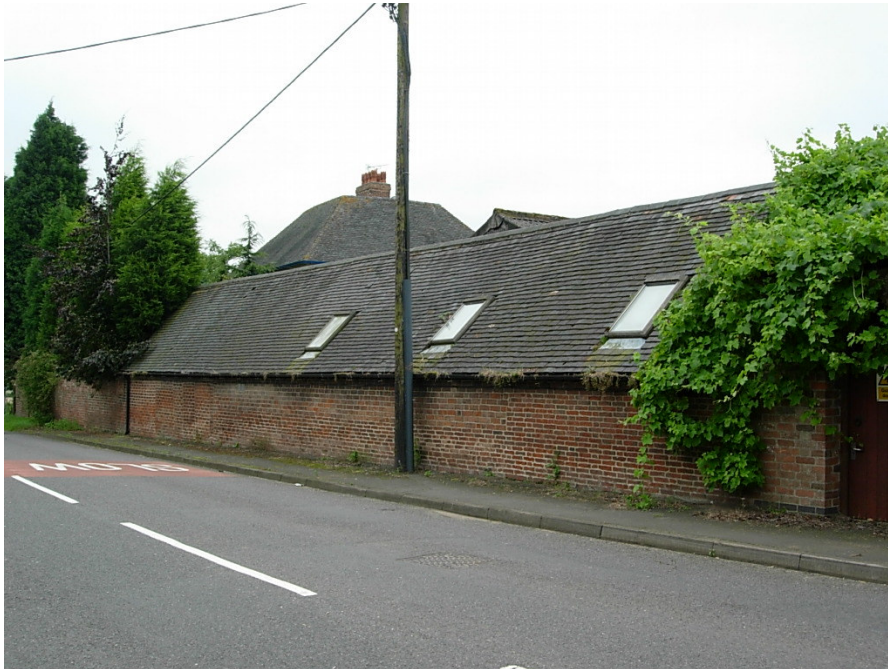
The single storey building fronting Church Street is located within the curtilidge of the listed Grade 2 Manor Farmhouse. The insertion of three large roof lights detracts from its appearance and former agricultural use.

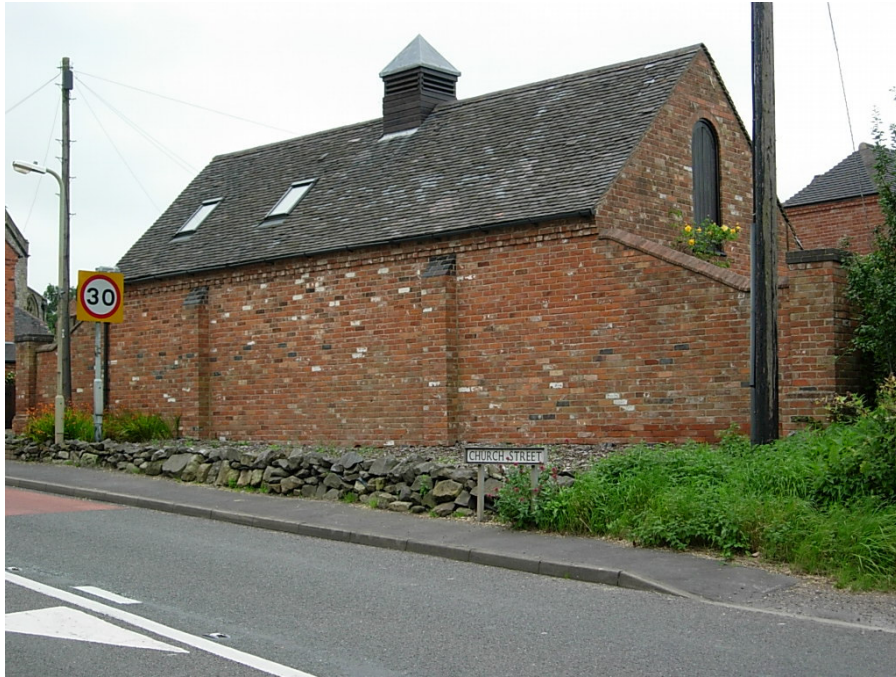
This existing building has been converted into garages/store. The roof lights on the front elevation should have been restricted to the rear elevation only

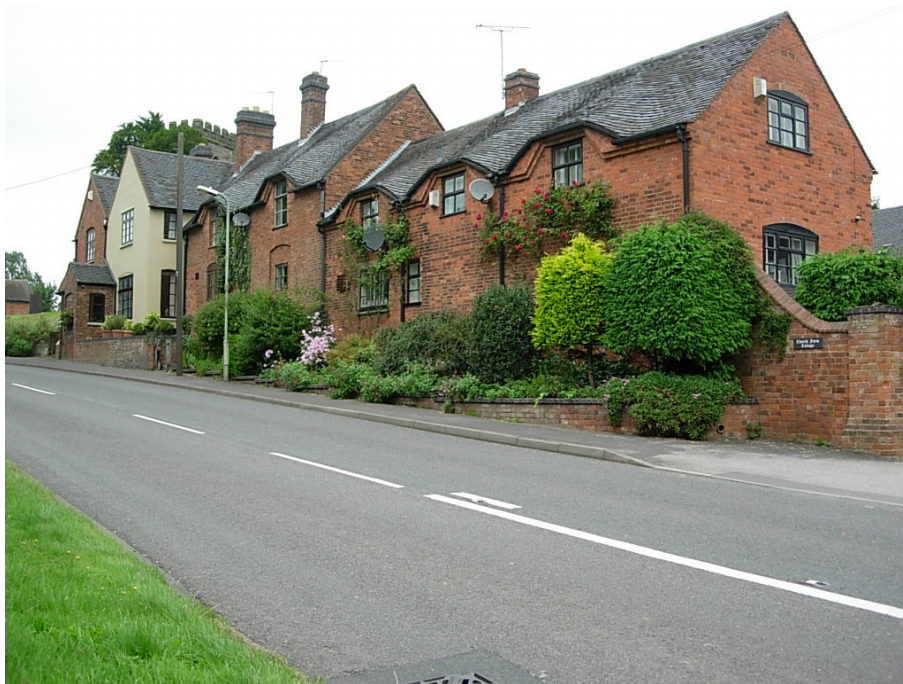
The properties situated at the entrance to the village that step up Church Street form an attractive terrace. Unfortunately, several satellite dishes mounted on their front elevation detract from its appearance.

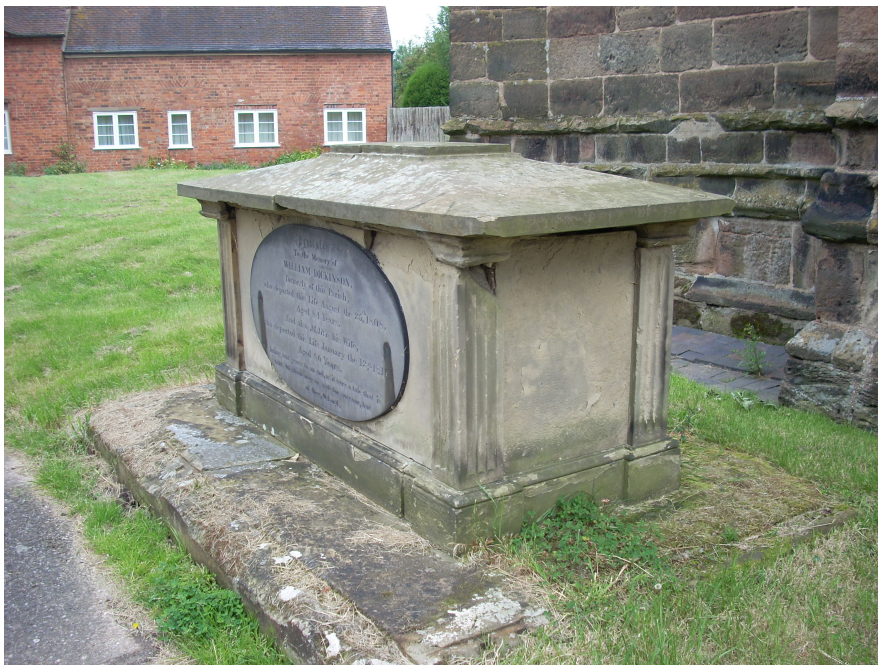
The Listed William Dickinson Tomb Chest is one of several interesting features within St James's Churchyard in need of maintenance and the replacement of iron railings.
