## **DESFORD CONSERVATION AREA APPRAISAL & MANAGEMENT PLAN**

**PHOTOGRAPHIC RECORD OF  
DESFORD CONSERVATION AREA**

**March 2010**

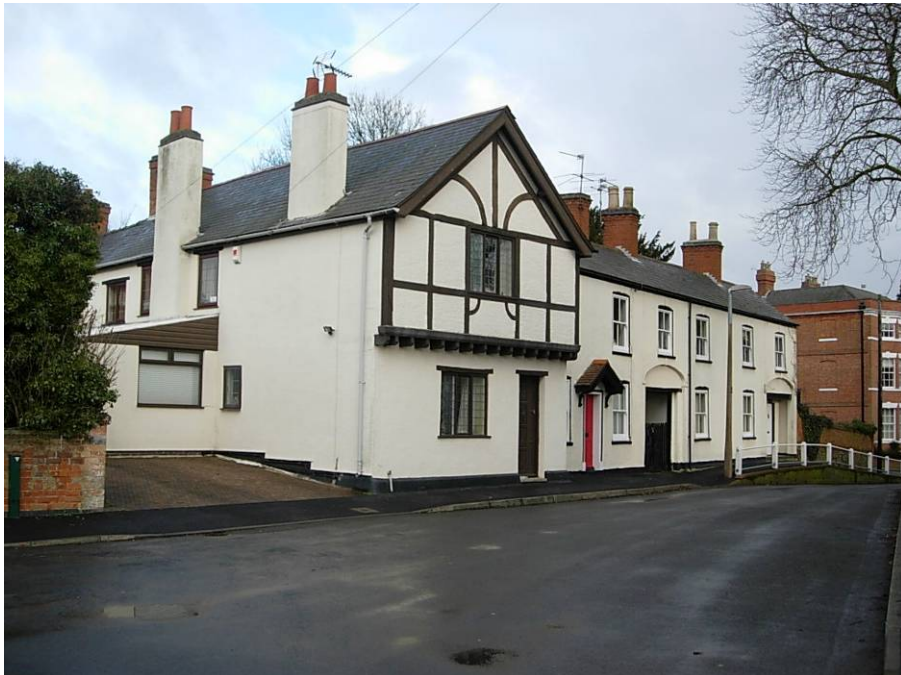
1 & 3 Church Lane are attractive rendered properties opposite the parish church that still retain their slate roofs and chimneys. The mono pitched roof side extension at No1 however, is out of character. The raised pavement and post & rail fence is an excellent visual feature that is evident at several locations throughout the village.

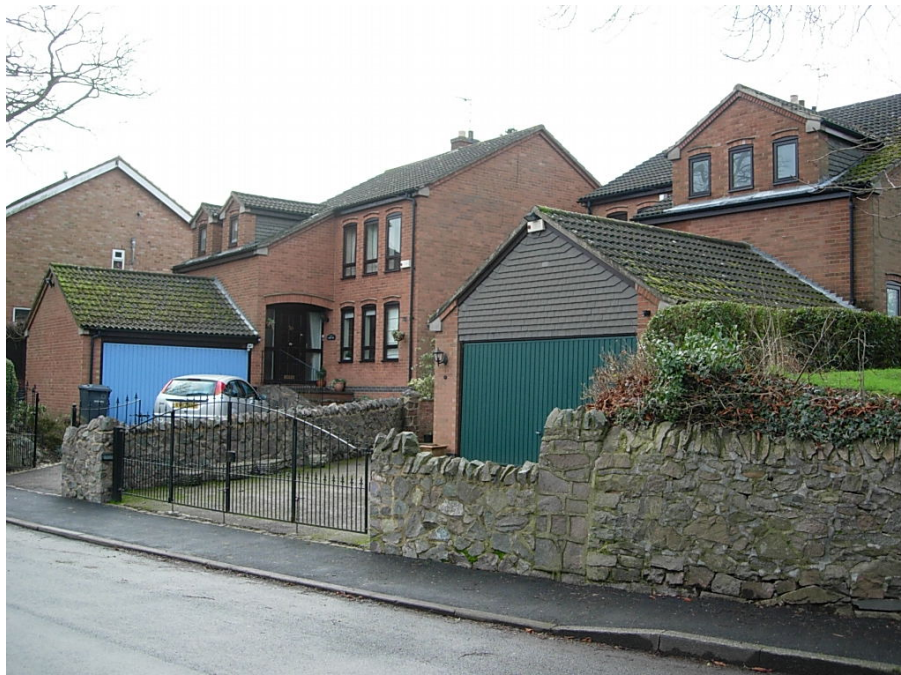
The properties 28-30 Church Lane do not reflect the traditional character of the conservation area.

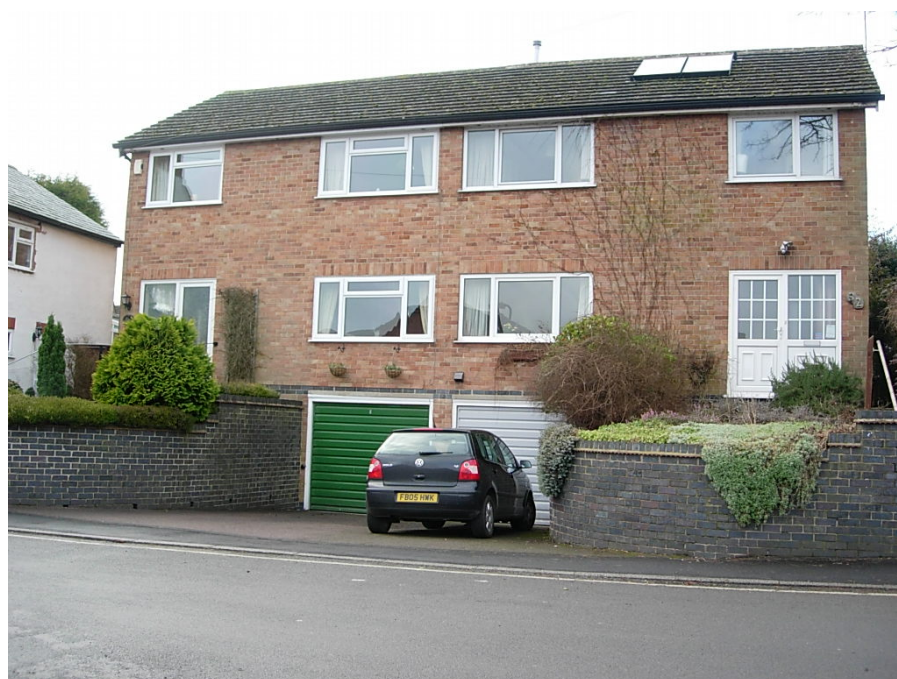
The design, integral garages and use of modern materials at 32-34 Church Lane visually detract from the conservation area. Church Lane is an attractive road which has lost some of its visual quality due to modern development. Both garages should be painted green.

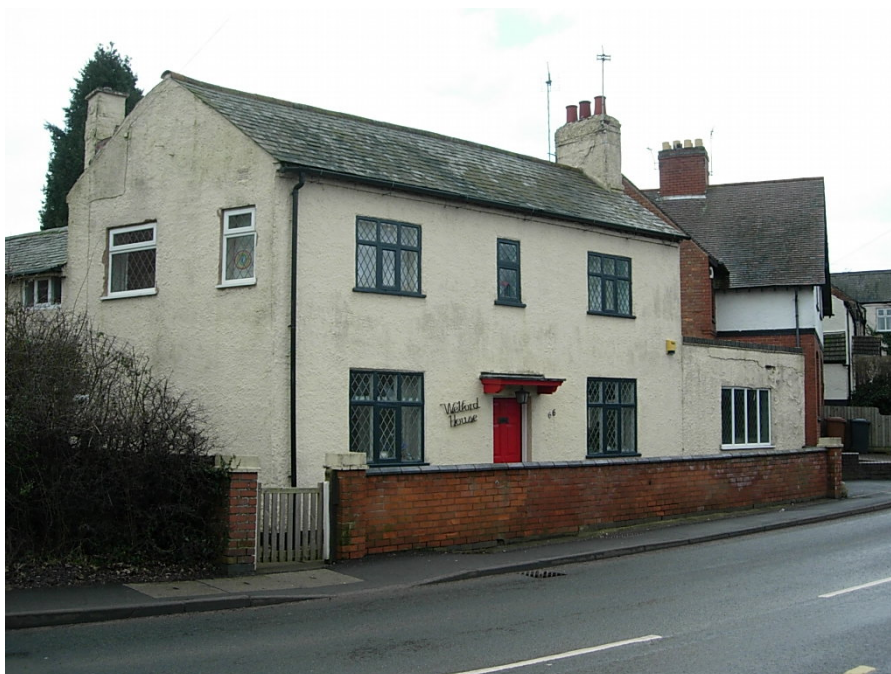
The rendered property 66 High Street has lost some of its traditional character due to the insertion of modern windows although it has retained its traditional brick wall fronting the carriageway.

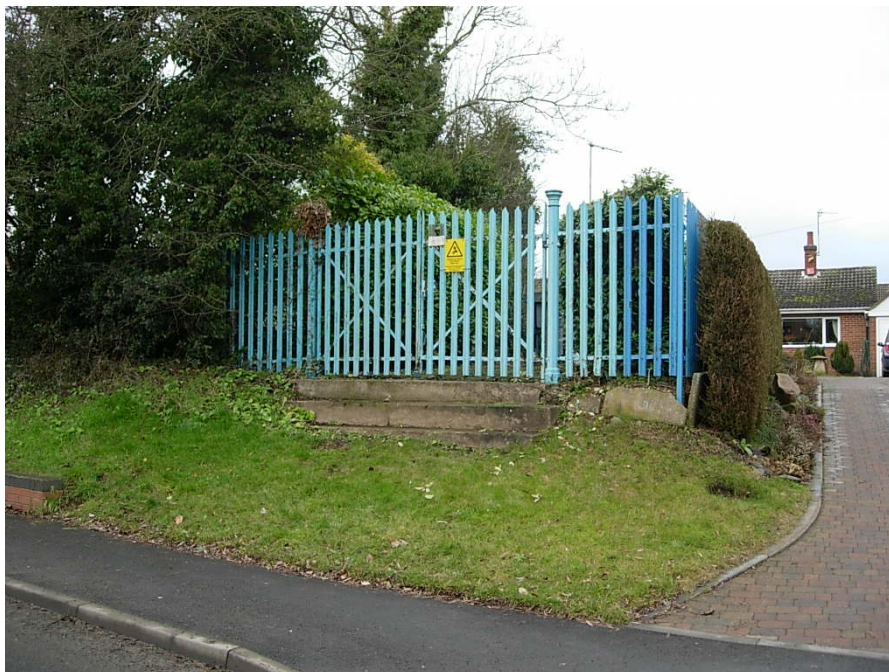
The fencing protecting the sub station on High Street is an unattractive feature that needs to be painted dark green to help reduce its visual impact.

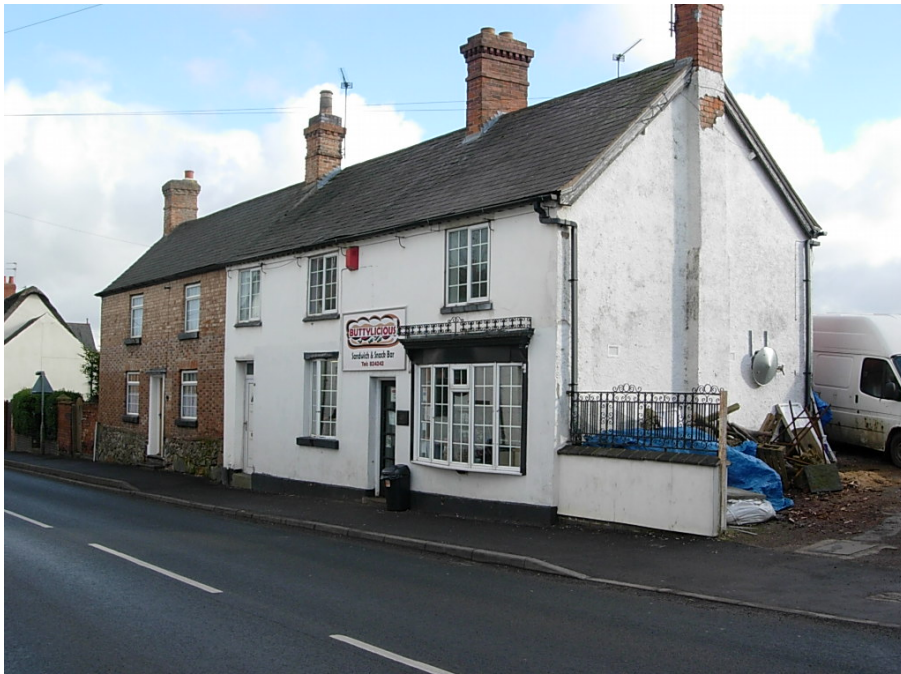
The bow window and wall fixed sign to the shop at 40 High Street are out of character with other traditional properties on the road.

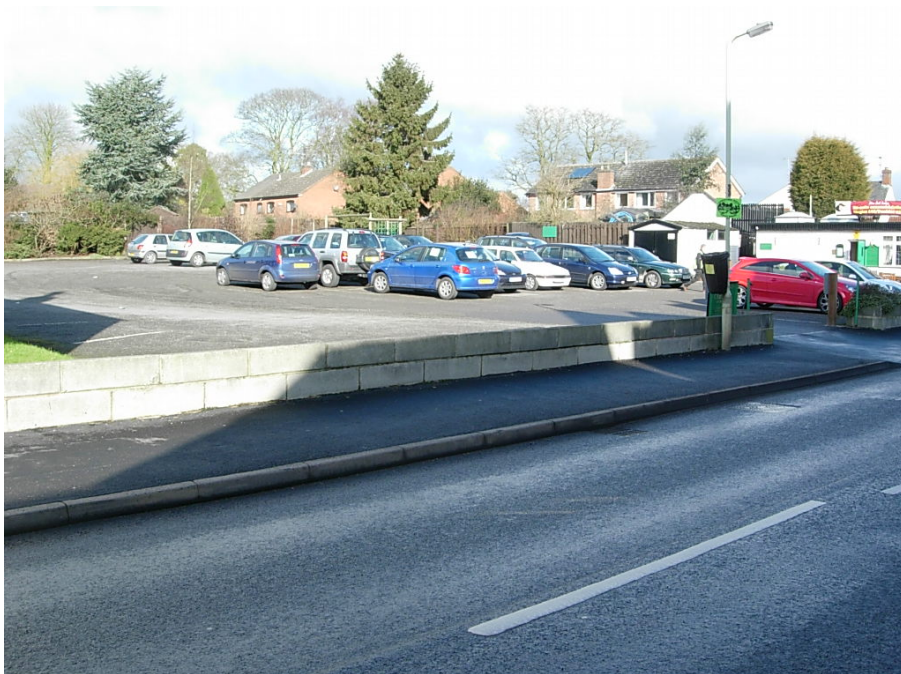
The block wall fronting the Bluebell Pub Car Park is an unattractive feature that needs replacing with a traditional brick wall.

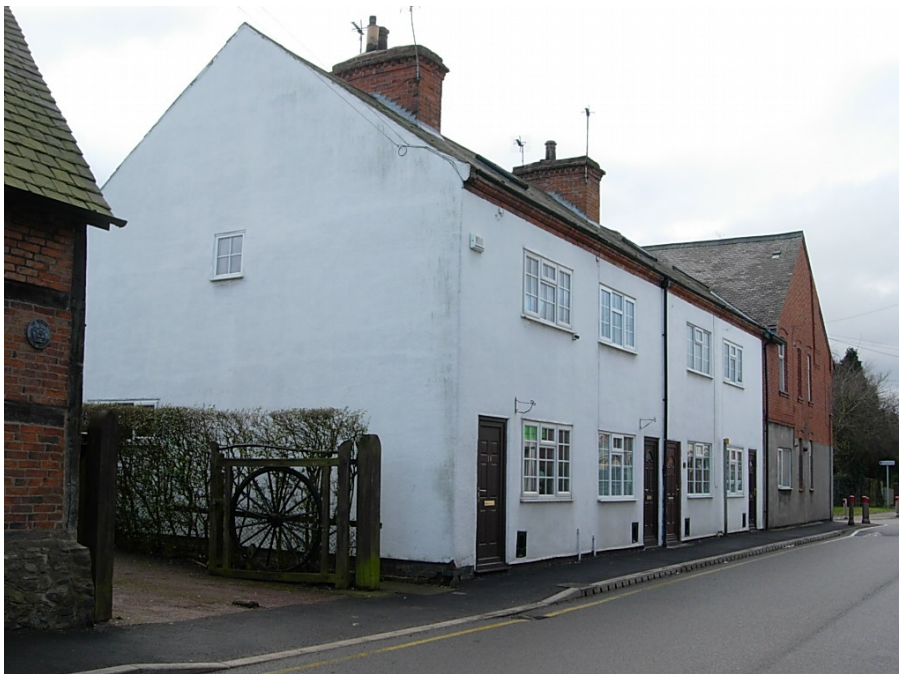
The rendered terrace 4-10 High Street has been spoilt with the insertion of roof lights and plastic windows.

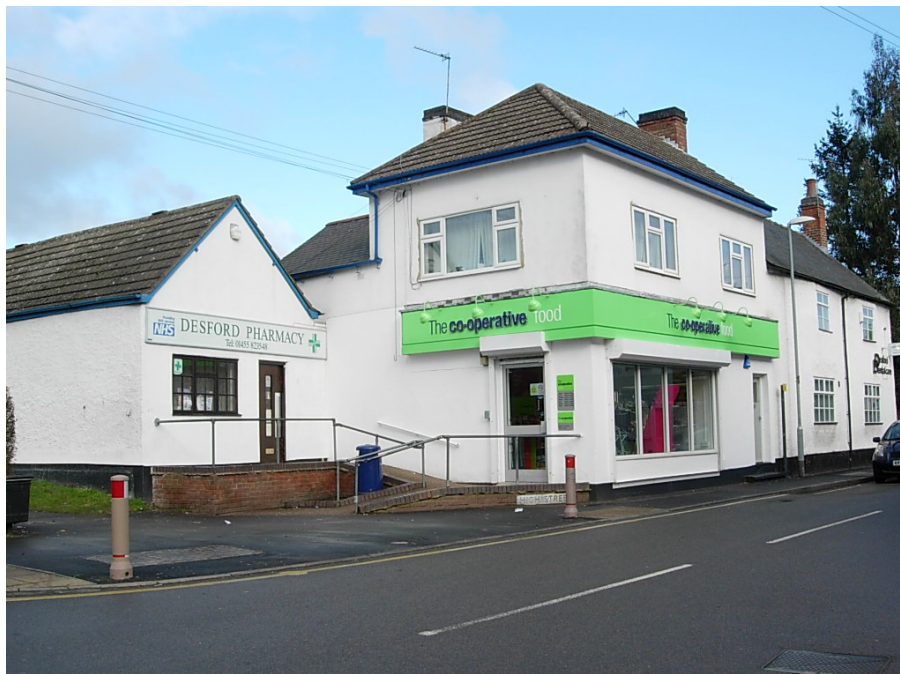
The shop fascia to the Co-Op store is too visually dominant and the building's original features have been lost.

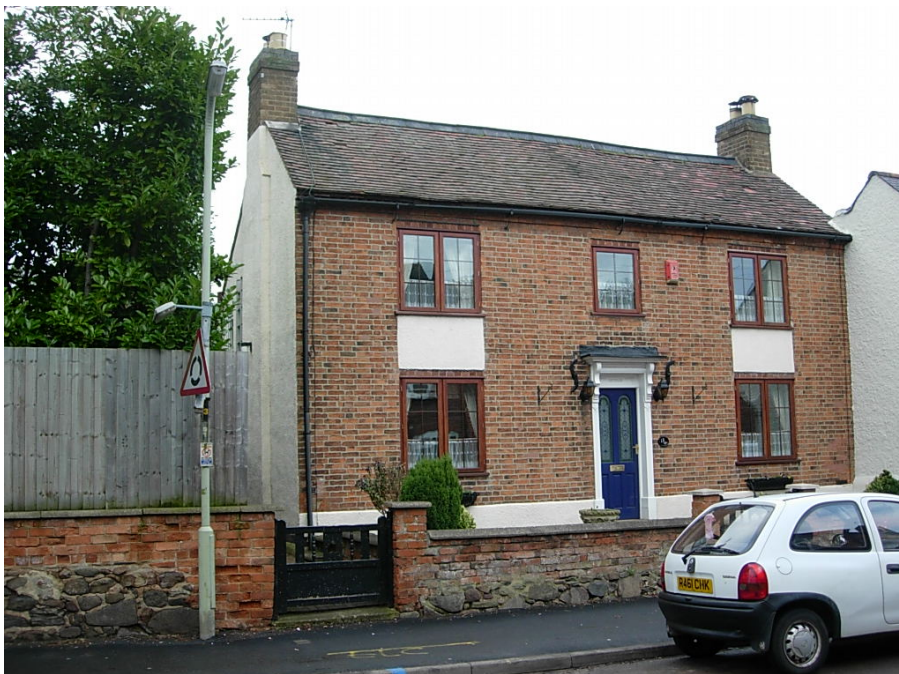
13 High Street is an attractive dwelling with a traditional wall fronting the road built of stone and brick. The street scene would be enhanced if the close boarded fence was to be replaced with a traditional brick wall.

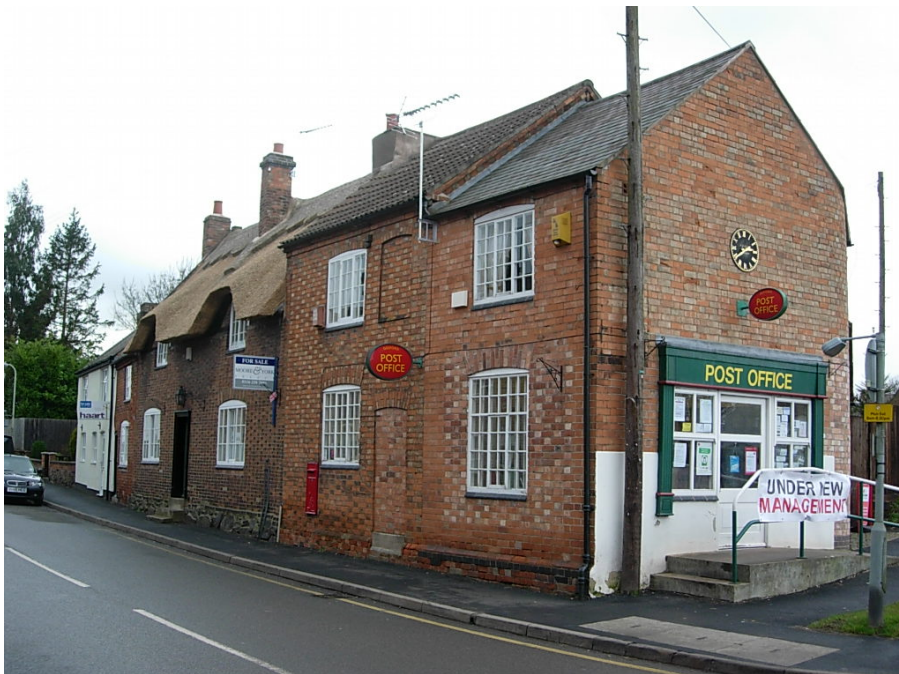
19, 21 and 23 High Street are late C18 to mid C19 Grade II listed properties with a combination of thatch, slate and concrete roof tiles. Consideration needs to be given to replacing the concrete tiles with Swithland tiles. The insensitive use of the concrete ramp into the Post Office is also unfortunate.

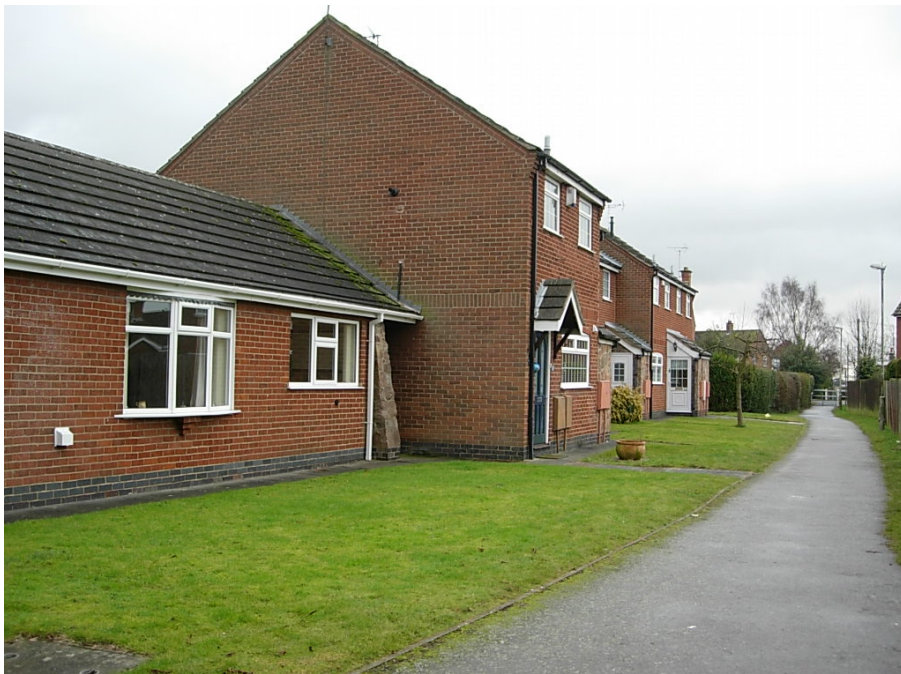
The modern terrace, 7-13 Stewards Court, fronts the footpath. The properties help to give enclosure along the footpath, however their design and choice of materials do not enhance the character of the conservation area.

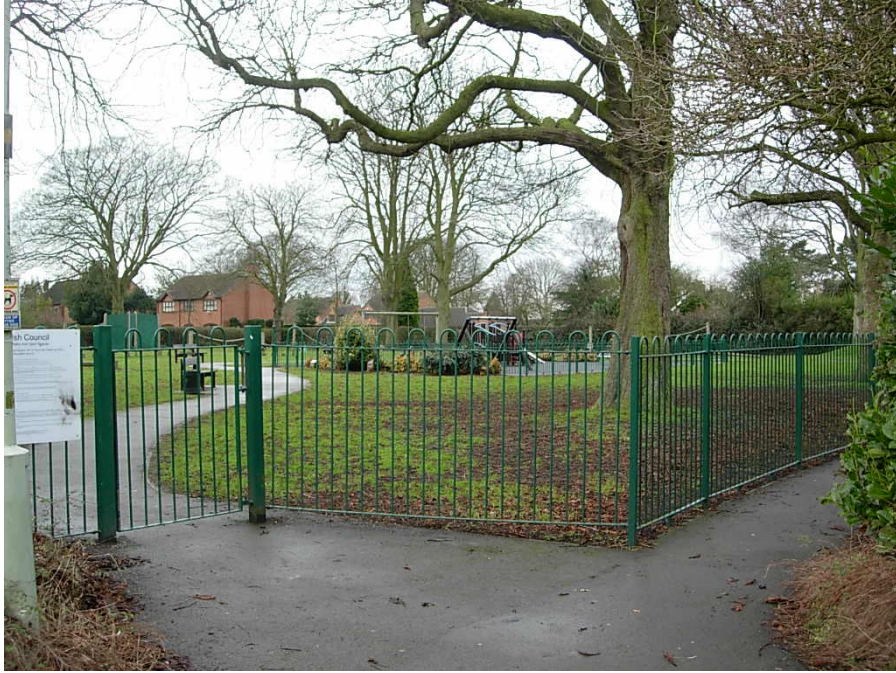
Pickard Recreation Ground is an attractive open space that has a number of mature trees sited around its curtilidge. There are however a few gaps, where tree have died, that need to be replanted.

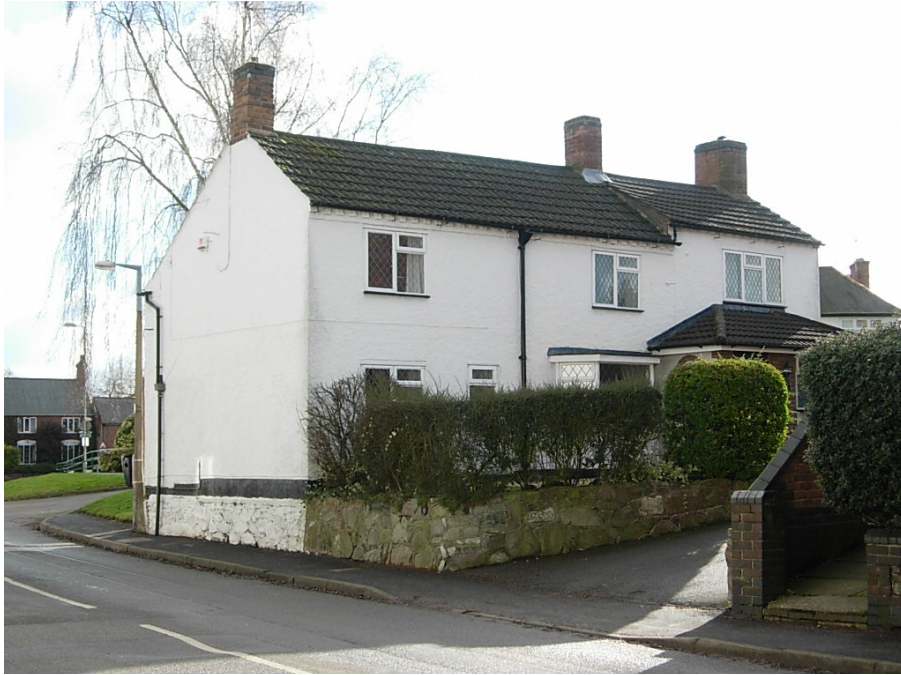
9 Main Street is a fine rendered property with its gable fronting the road that is spoilt by the choice of concrete roof tiles.

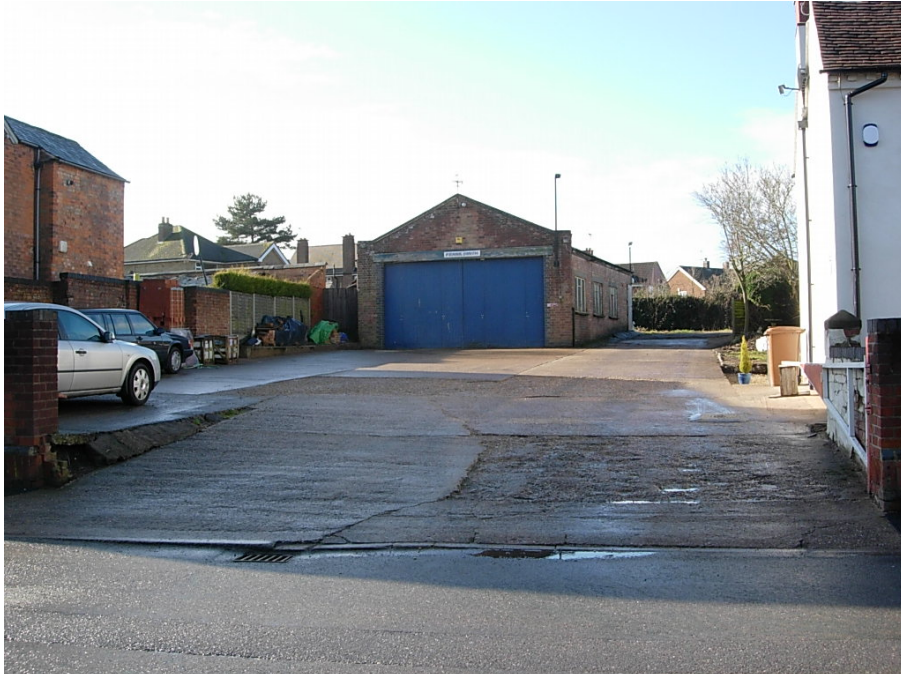
The haulage depot with its large concrete forecourt is an unattractive feature on Main Street. The site has re-development potential.

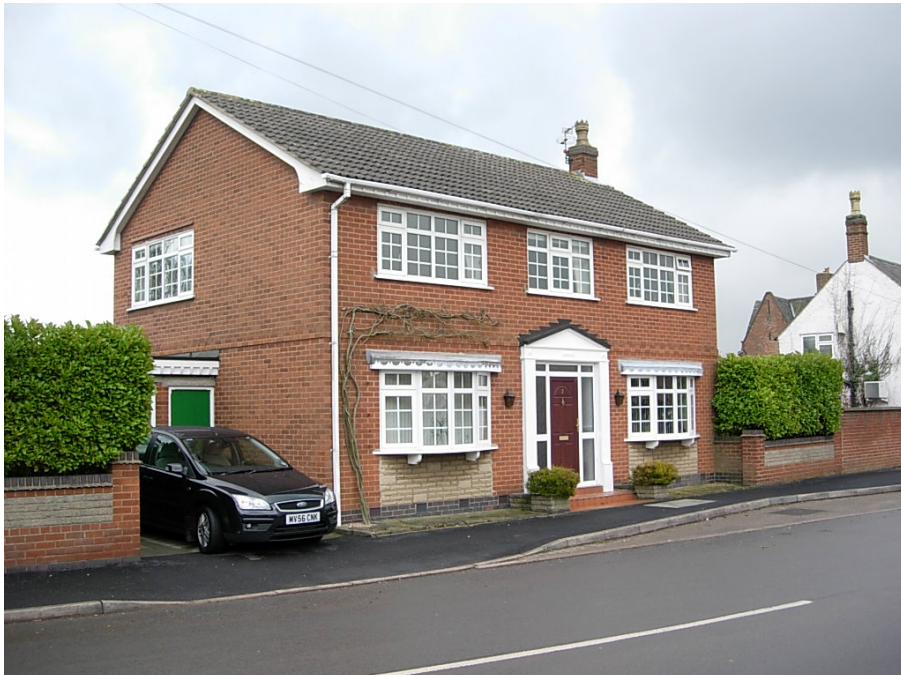
The dwelling, 2 Main Street, does not respect the traditional character of the conservation area by way of its design, materials, and open frontage.

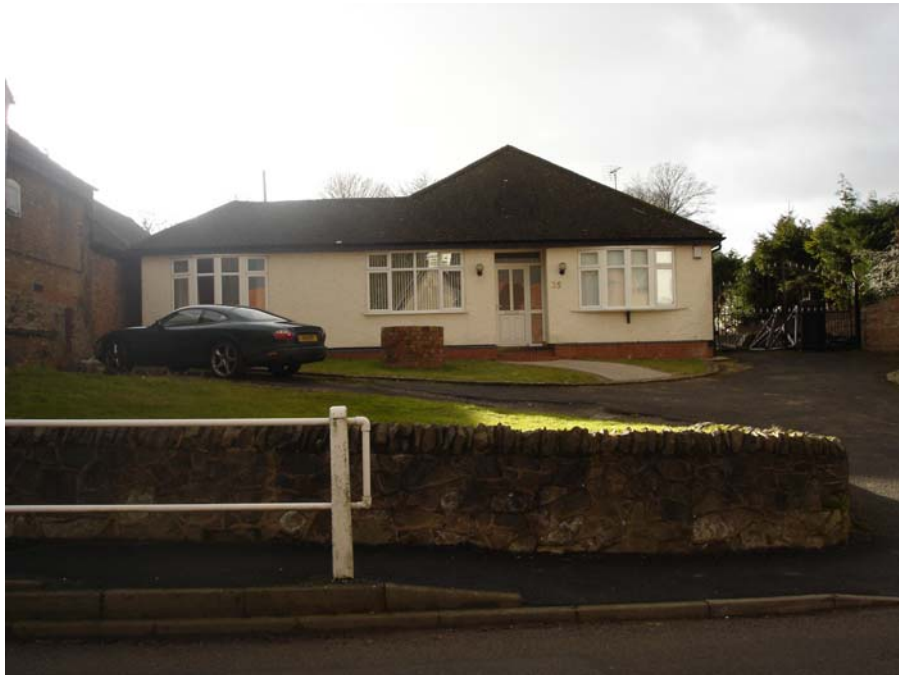
This modern bungalow, 35 Main Street, does not reflect the traditional character of the village by way of design, materials and siting.

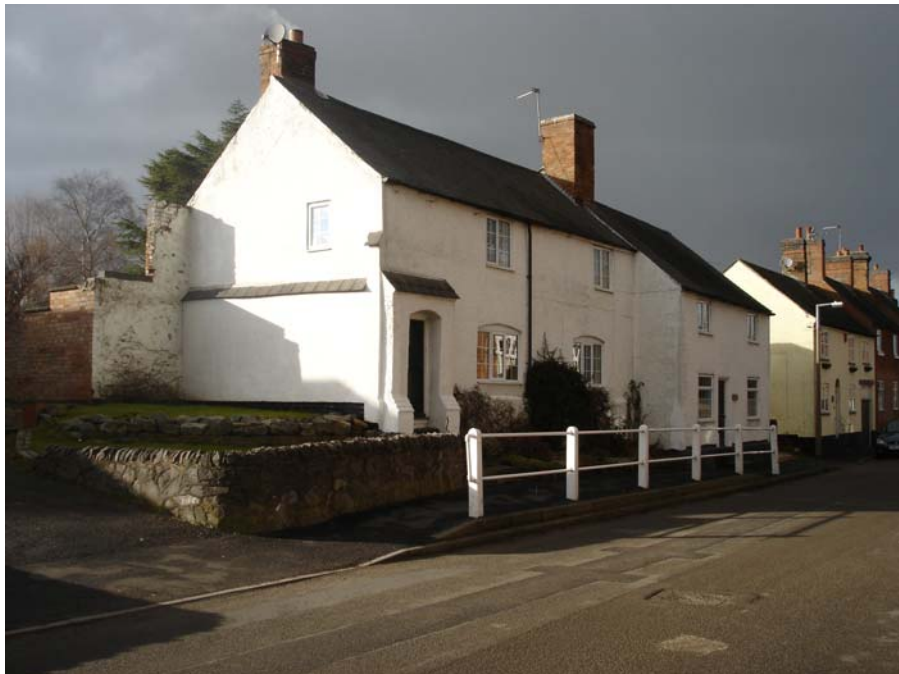
The attractive terrace, 47-51 Main Street, showing the end of the property sited forward. The post and rail fence enhances the setting. Unfortunately one of the properties has lost its chimney pot.

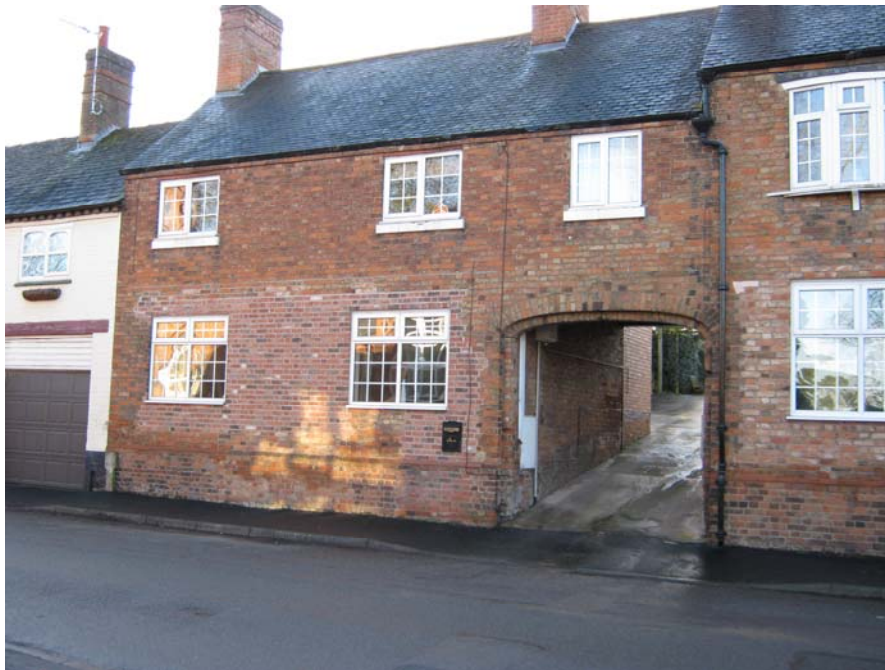
The access to the rear yard of 55-59 Main Street is gained through an impressive archway. Unfortunately, the windows in the properties on either side have been replaced with plastic windows and the bow window to the bedroom is inappropriate.

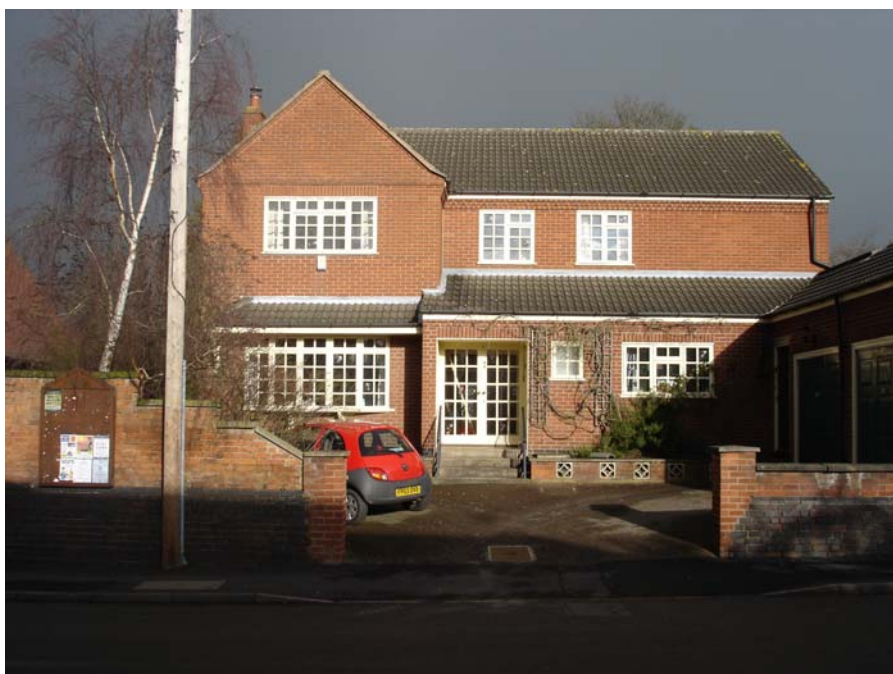
44 Main Street is a modern dwelling that would have been better sited outside the conservation area due to its design and choice of materials.

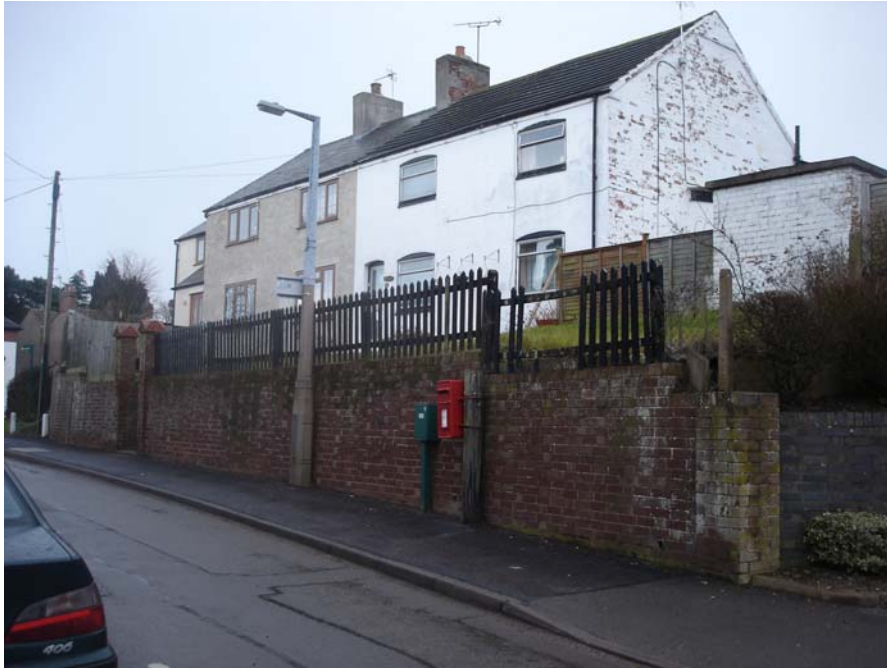
The properties 5-11 Newbold Road occupy a prominent position on the road sited behind a tall retaining wall. The terrace has been modernised to its visual detriment.

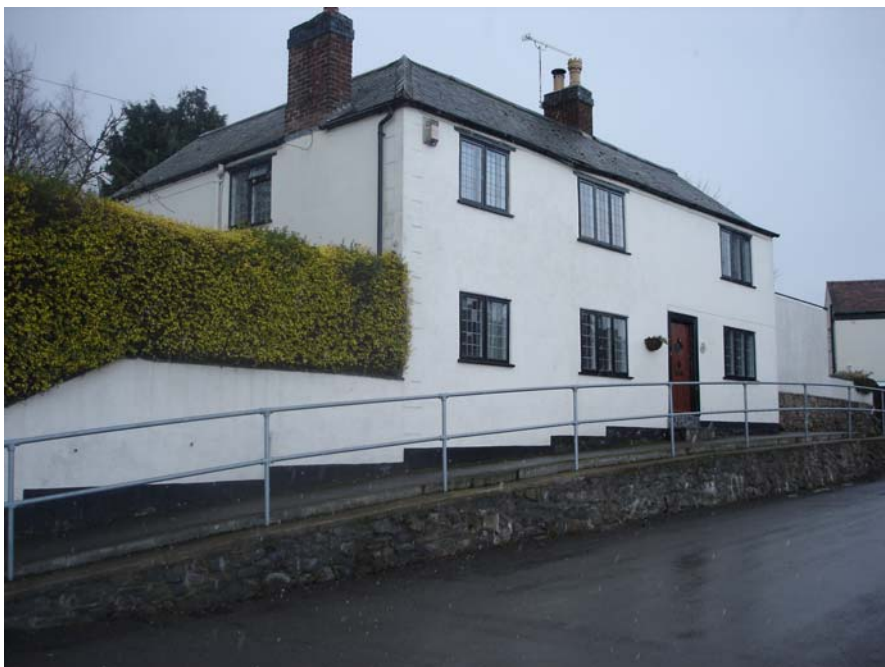
29 Newbold Road is an attractive rendered dwelling fronting a raised pavement. It is unfortunate that the original railings have been replaced with modern railings.

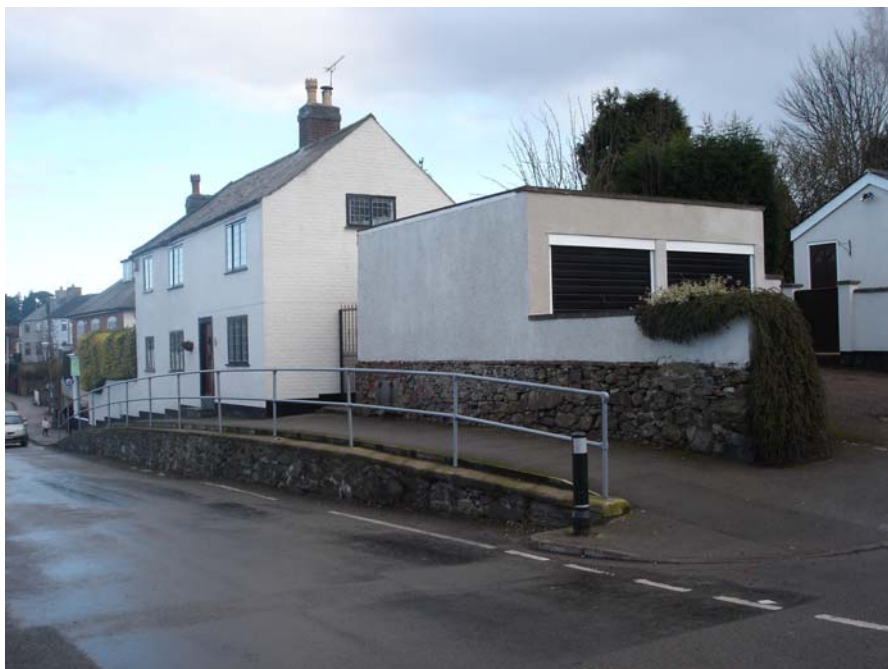
The new railings installed fronting 29 Newbold Road do not have the same visual appeal or match the rest of the post and rail fences sited in other parts of the village. The flat roof double garage does not respect the traditional character of the conservation area.

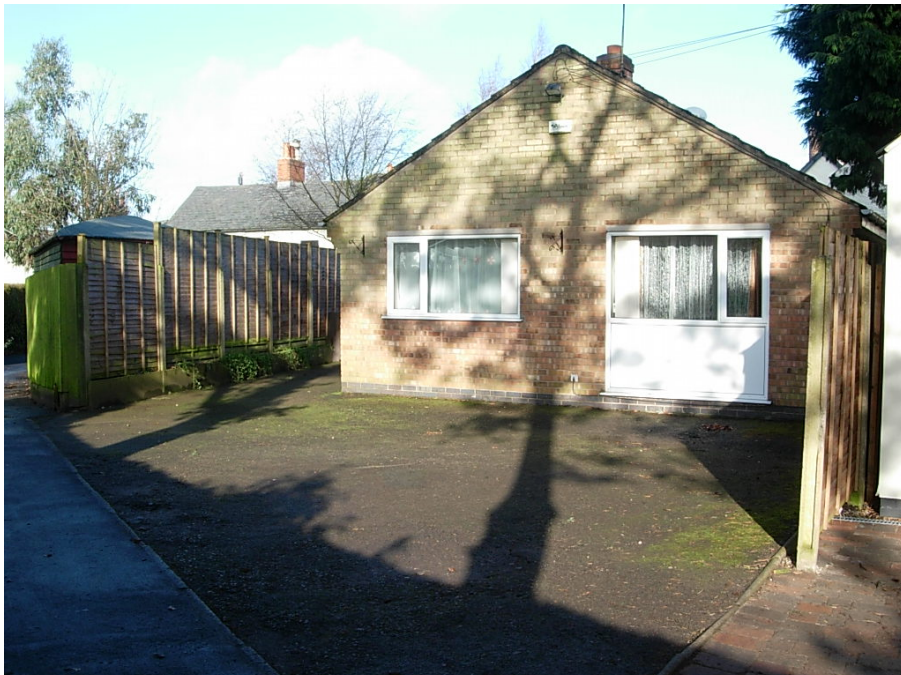
The bungalow, 13 Cottage Lane, is one of four properties that do not respect the traditional character of the conservation area by way of their design, materials, and open frontage.

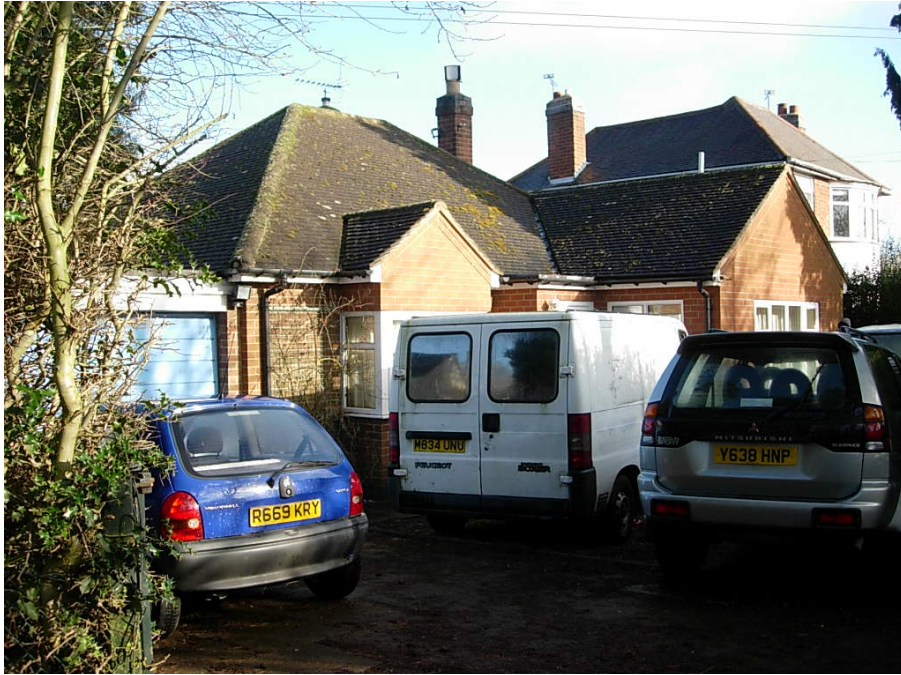
The bungalow, 15 Cottage Lane, does not respect the traditional character of the conservation area by way of its design and choice of materials.

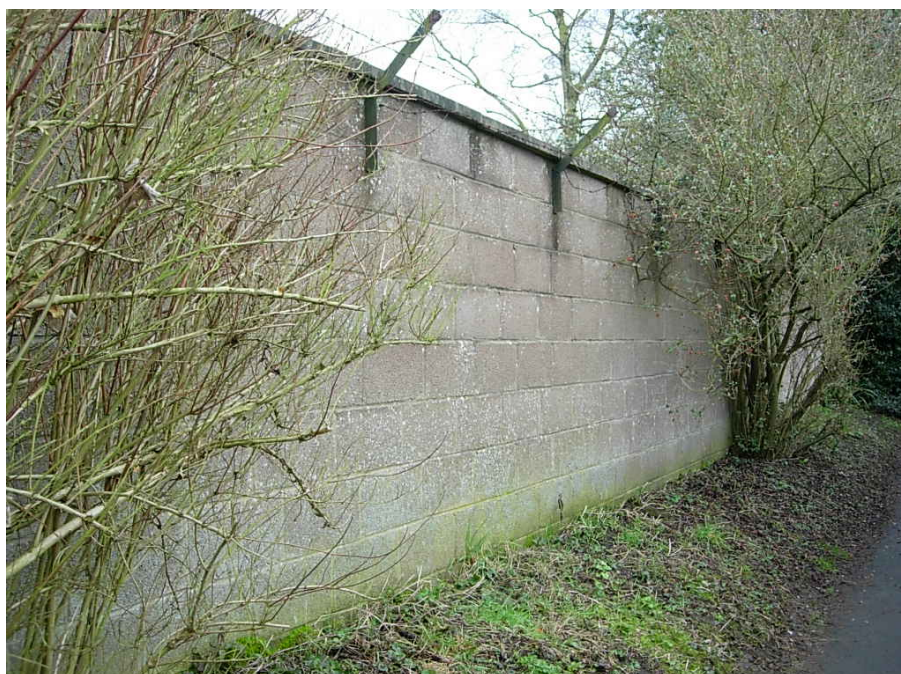
The concrete block boundary wall to the Desford Free Church is an unattractive feature running along the footpath leading to the Pickard Recreation Ground. It needs to be finished with render.
