CONGERSTONE CONSERVATION AREA MANAGEMENT PLAN

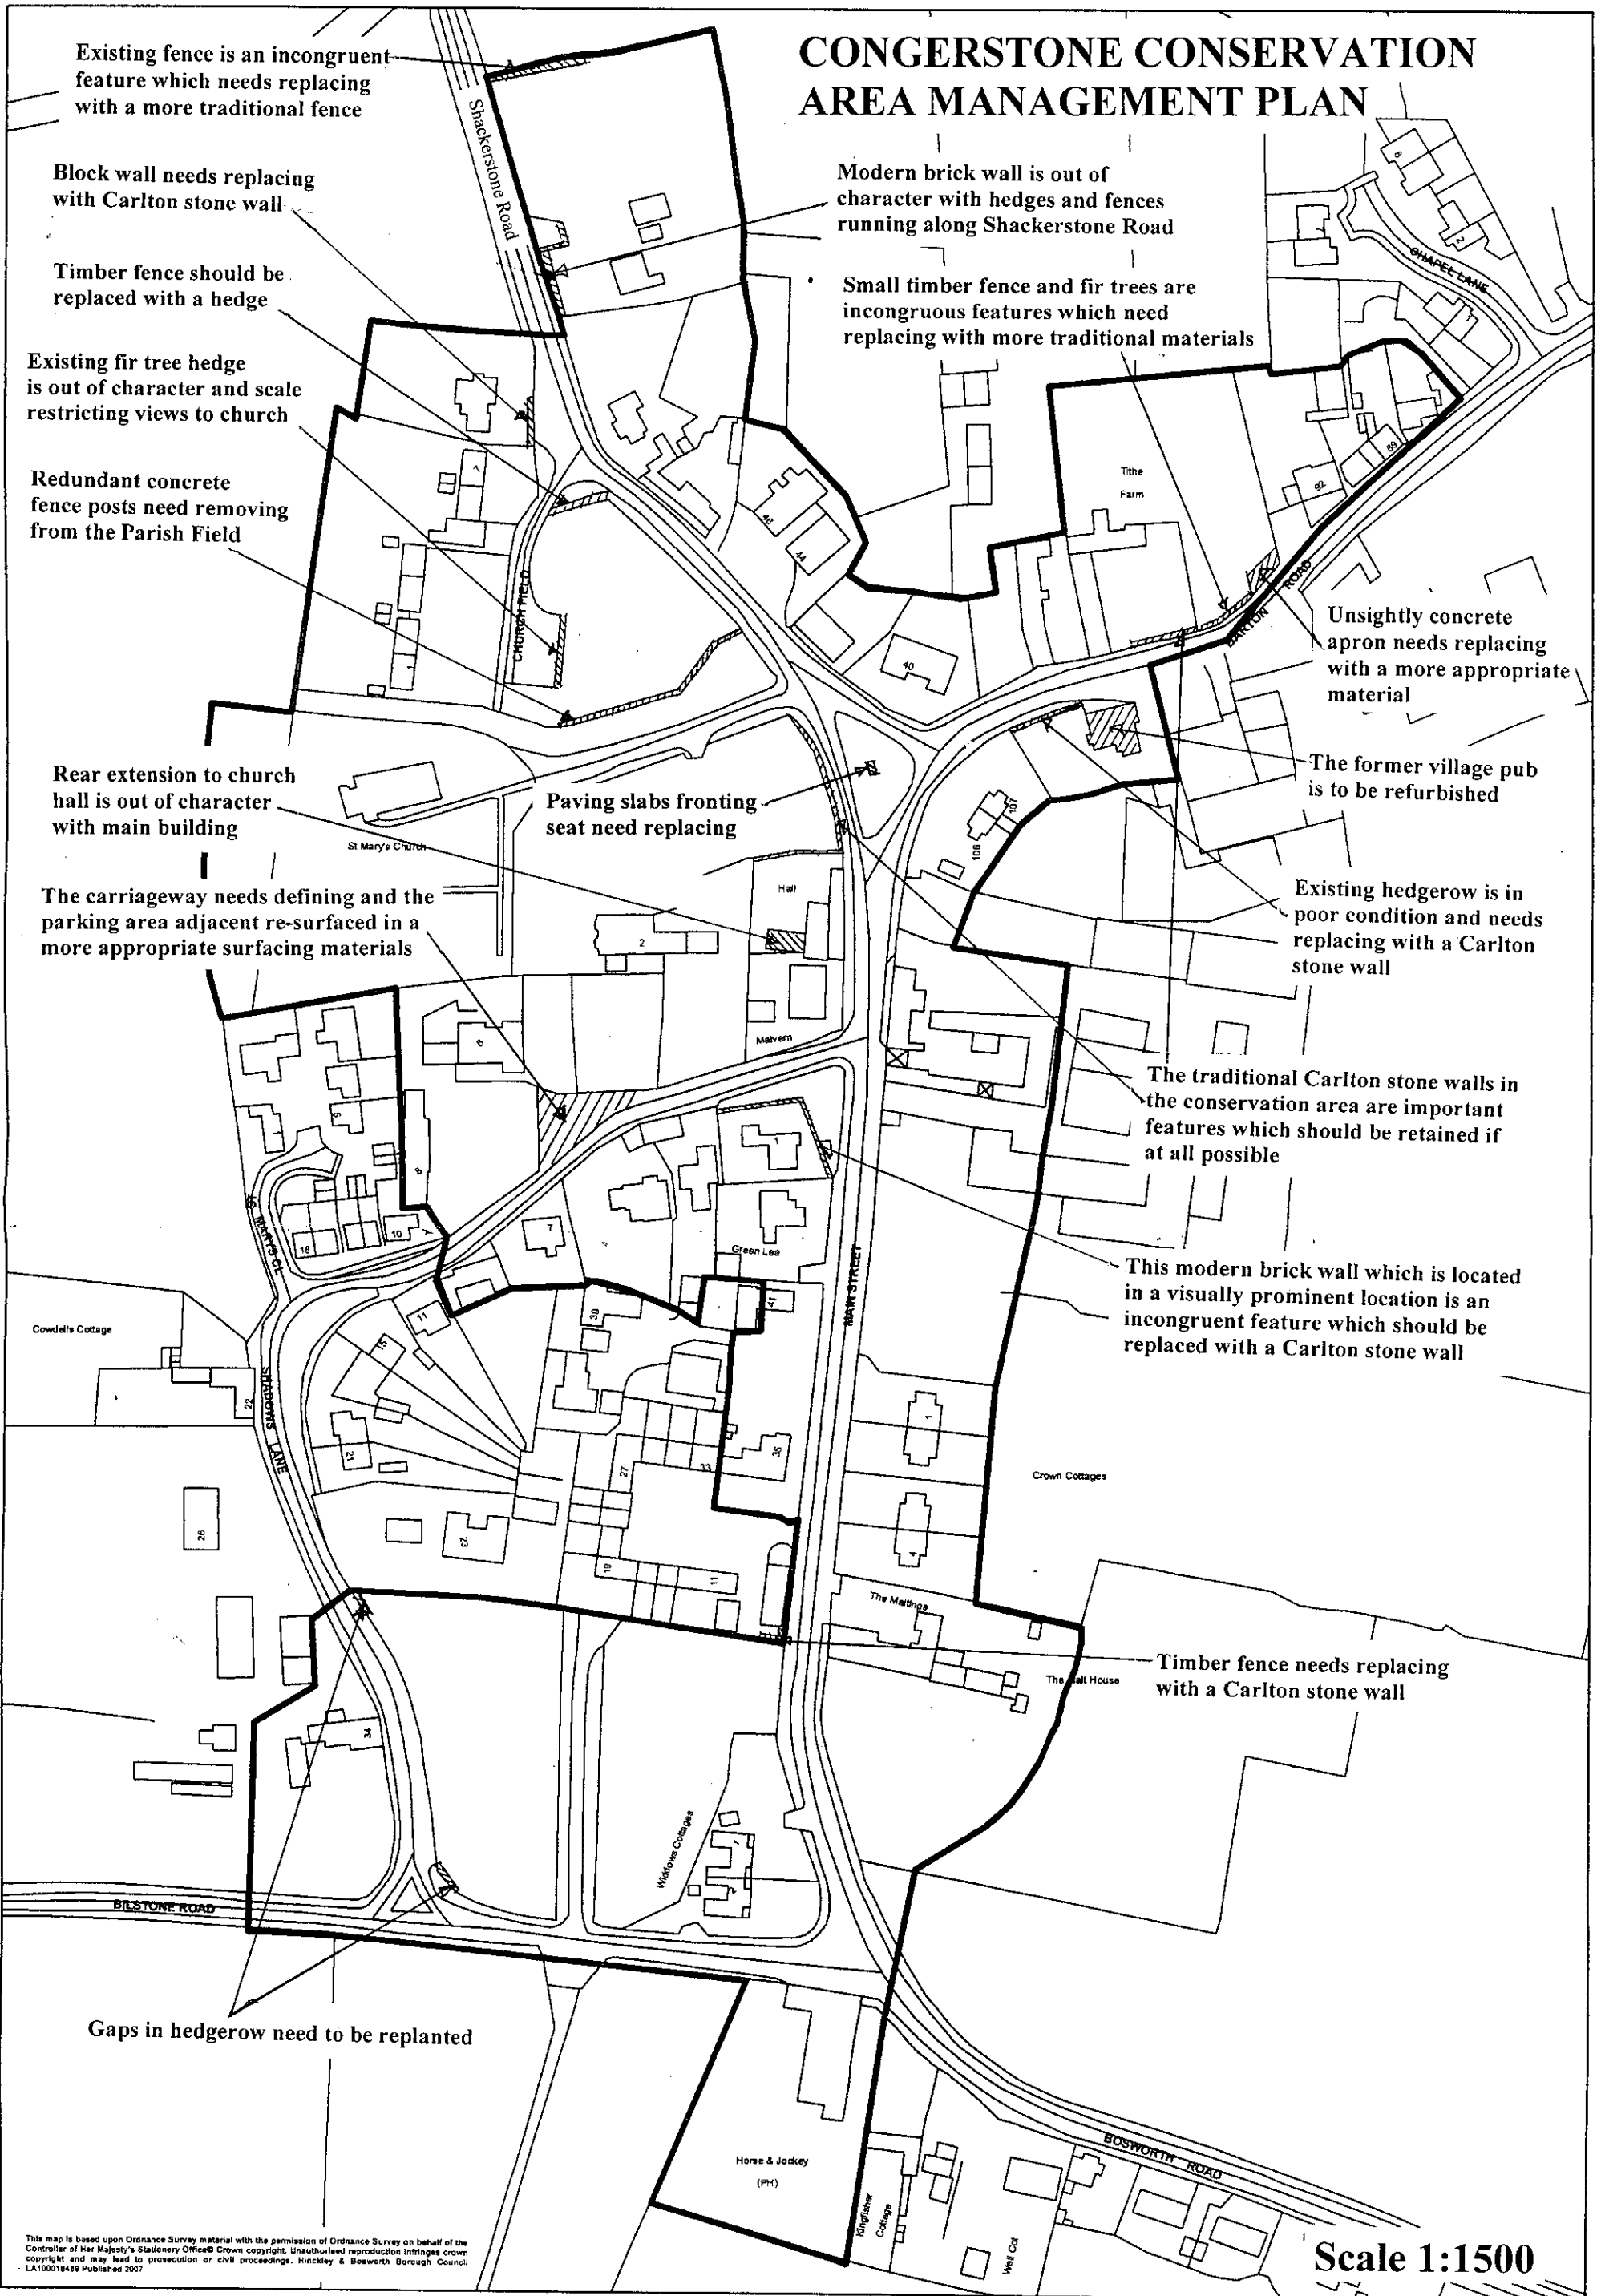
Existing fence is an incongruent feature which needs replacing with a more traditional fence

Block wall needs replacing with Carlton stone wall

Timber fence should be replaced with a hedge

Existing fir tree hedge is out of character and scale restricting views to church

Redundant concrete fence posts need removing from the Parish Field

Rear extension to church hall is out of character with main building

The carriageway needs defining and the parking area adjacent re-surfaced in a more appropriate surfacing materials

Paving slabs fronting seat need replacing

Modern brick wall is out of character with hedges and fences running along Shackerstone Road

Small timber fence and fir trees are incongruous features which need replacing with more traditional materials

Unightly concrete apron needs replacing with a more appropriate material

The former village pub is to be refurbished

Existing hedgerow is in poor condition and needs replacing with a Carlton stone wall

The traditional Carlton stone walls in the conservation area are important features which should be retained if at all possible

This modern brick wall which is located in a visually prominent location is an incongruent feature which should be replaced with a Carlton stone wall

Timber fence needs replacing with a Carlton stone wall

Gaps in hedgerow need to be replanted
