## CONGERSTONE CONSERVATION AREA MANAGEMENT PLAN

## PHOTOGRAPHS OF DETAILED PROPOSALS

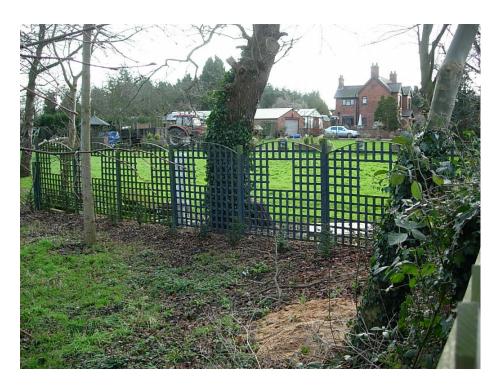
(1) Existing fence at the entrance to the conservation area on Shackerstone Road is an incongruous feature which needs replacing with a more traditional fence

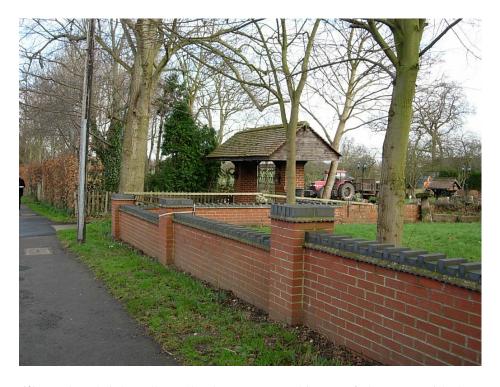
(2) Modern brick wall on Shackerstone Road is out of character with the boundary hedges generally running along the residential frontages

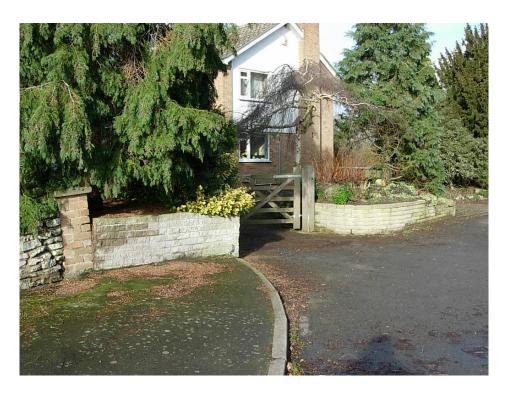
(3) The block wall on Shackerstone Road needs replacing with traditional Carlton stone wall

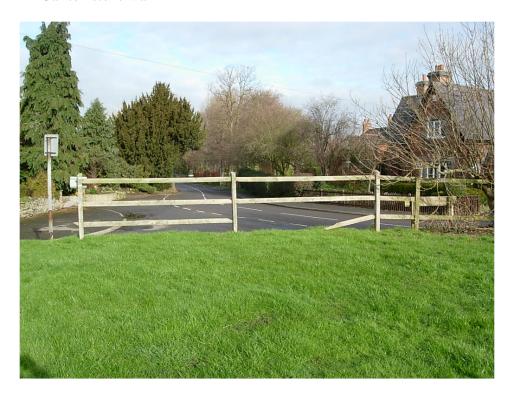
(4) Existing hedge needs extending to replace unattractive timber fence at the Church Field

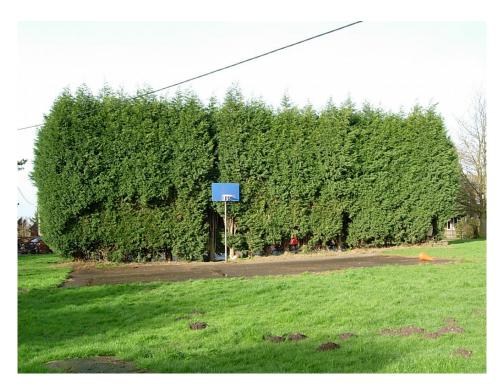
(5) Existing fir tree hedge is out of character and scale at the Parish Field restricting views to the Parish Church

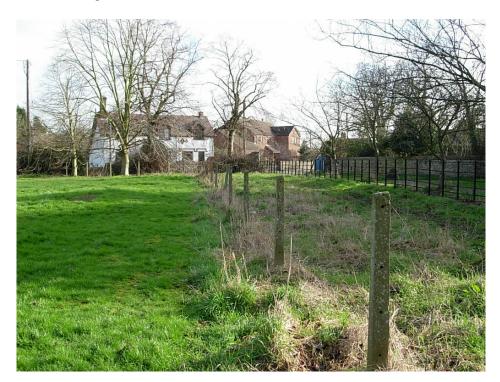
(6) Redundant concrete fence posts need removing from the Parish Field

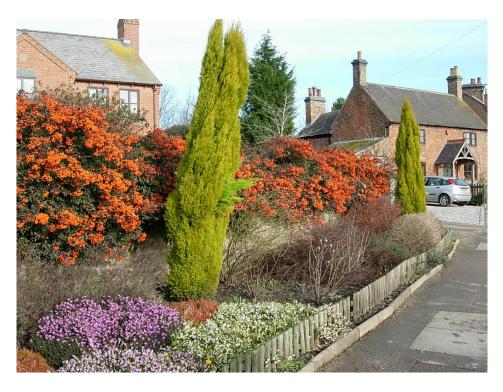
(7) Low level timber fence and fir trees are incongruous features on Barton Road which need replacing with more traditional materials

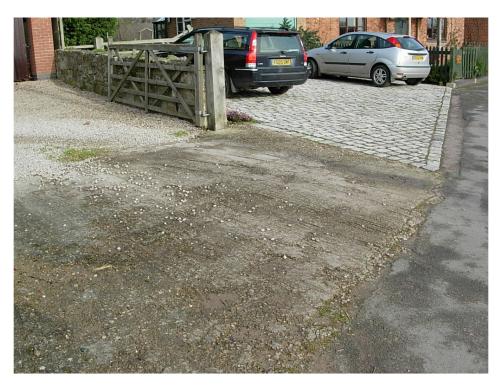
(8) Area would be improved on Barton Road if the unsightly concrete apron was replace with granite setts to match the adjacent property
