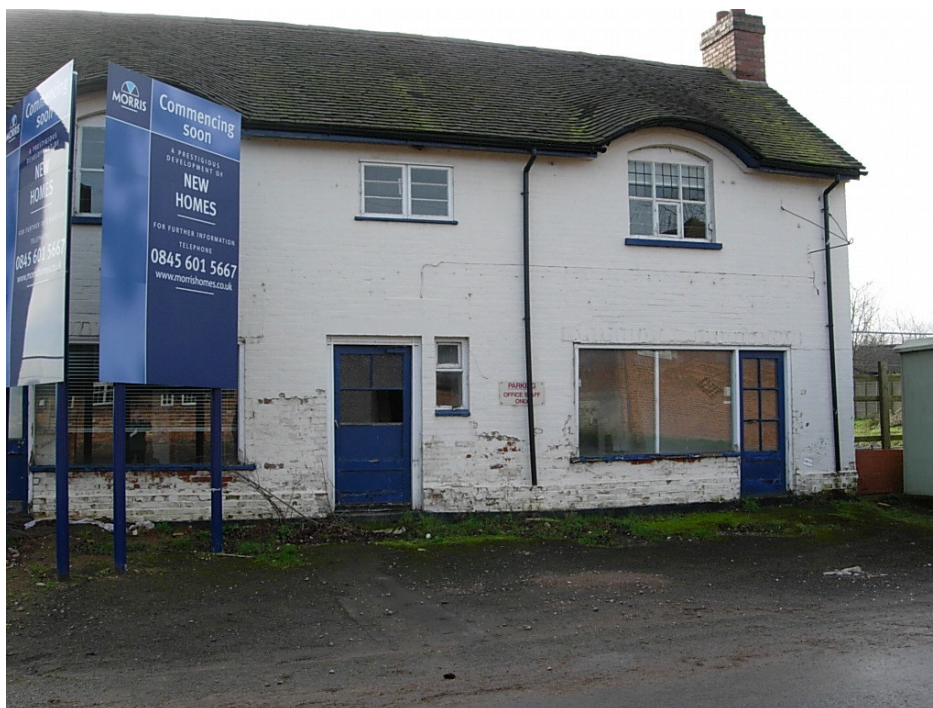
(9) The former village pub with eyebrow windows on Barton Road is to be restored

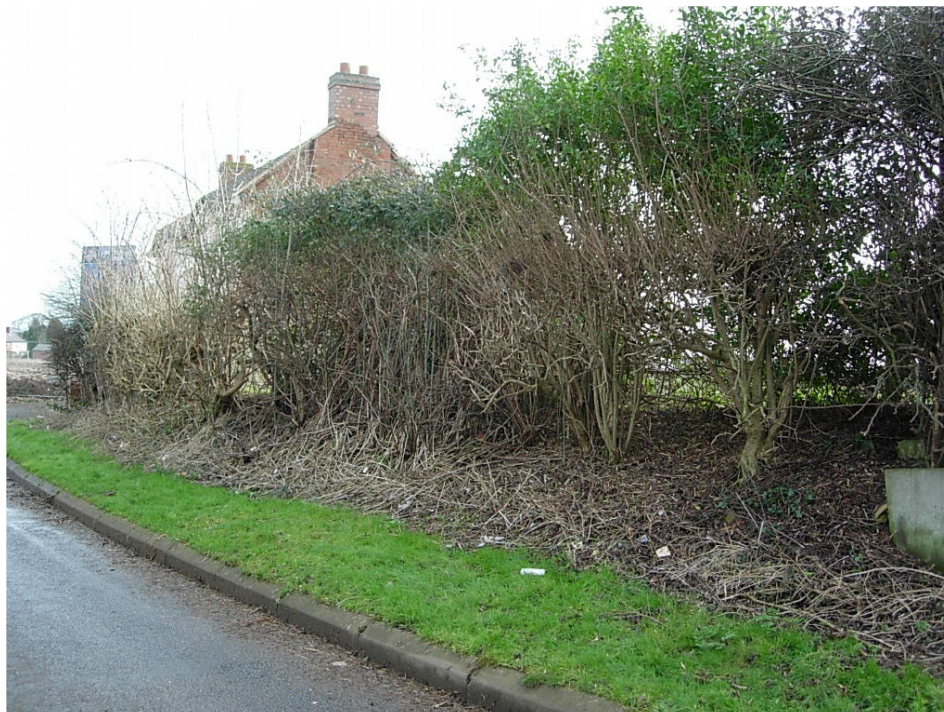
(10) Existing hedgerow on Barton Road needs replacing with Carlton Stone wall

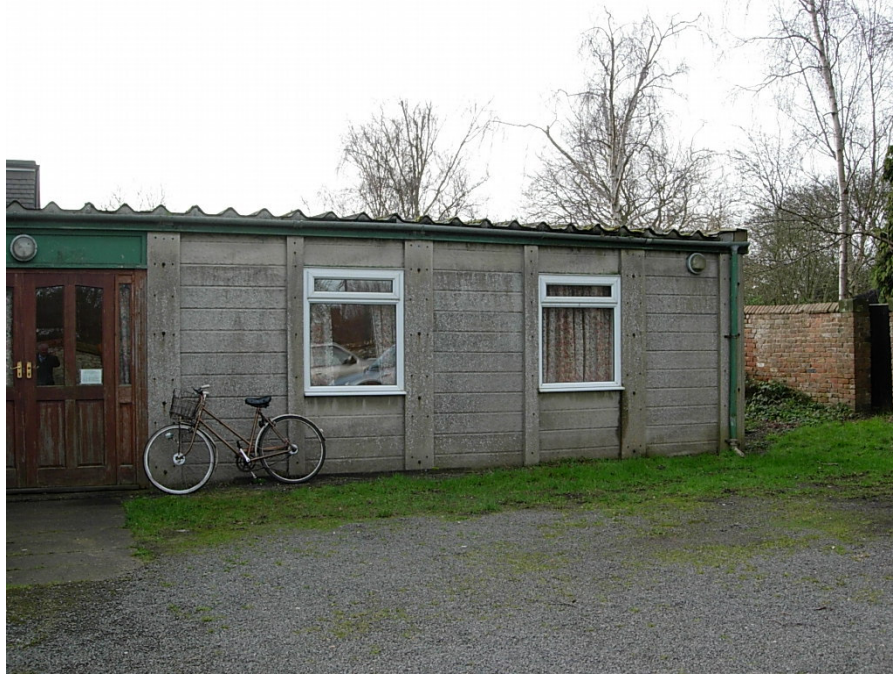
(11) Rear extension to the church hall is out of character with the main building

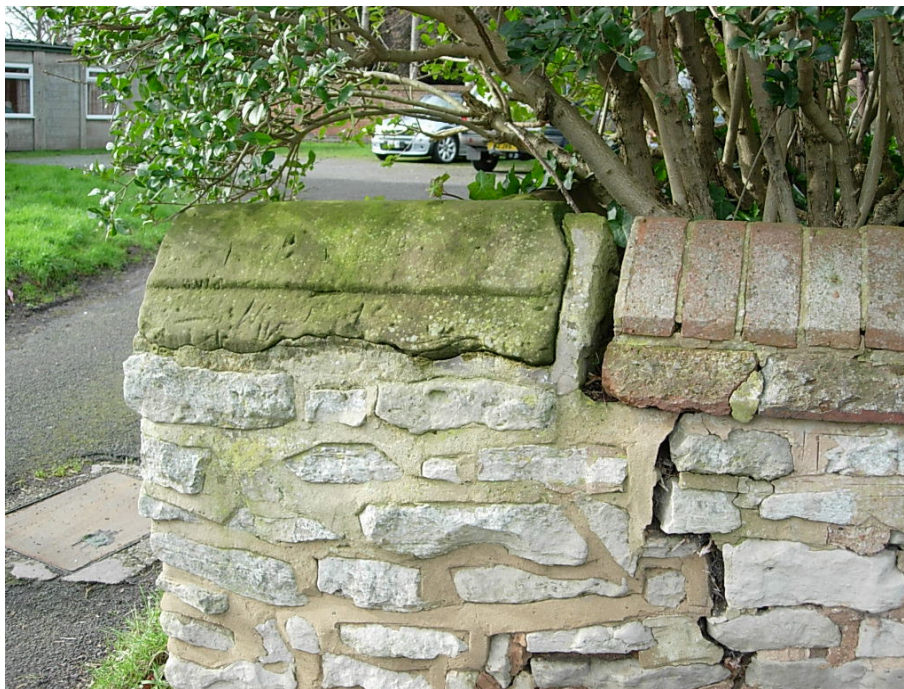
(12) The existing traditional Carlton stone walls, many of which are in poor repair, are important features in the conservation area which should be retained at all cost

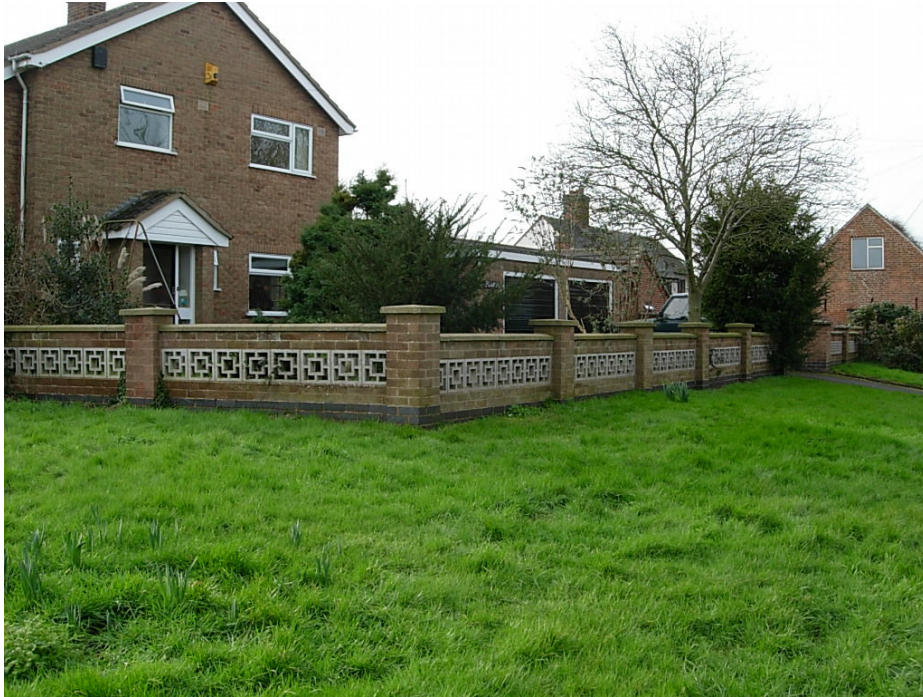
(13) Modern brick wall is an incongruent feature at the junction of Main Street and Shadows Lane. Its replacement with a Carlton Stone Wall would visually improve the junction setting

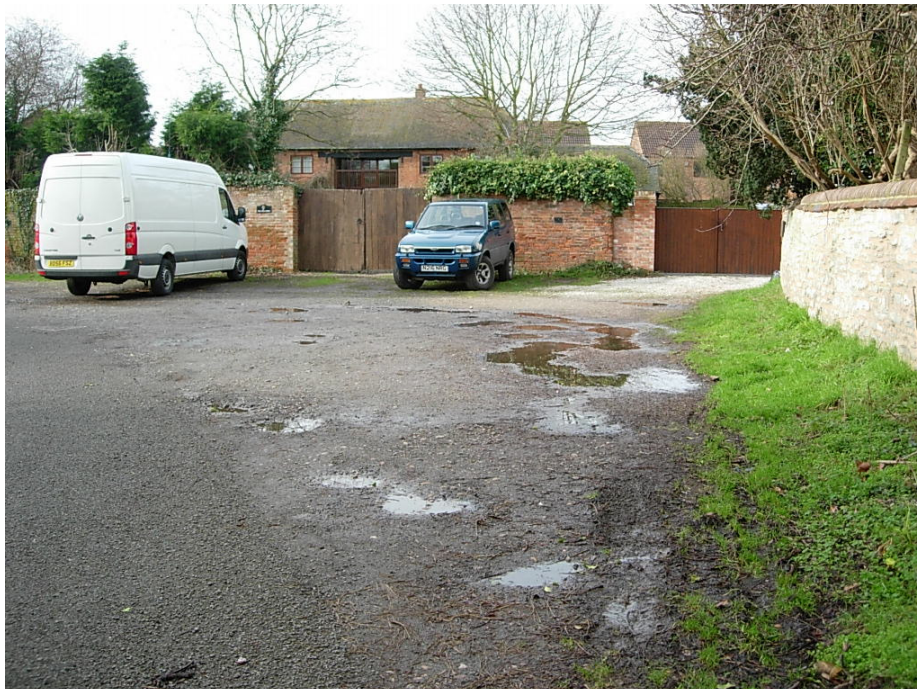
(14) The carriageway on Shadows Lane needs defining and the parking area re-surfaced in a traditional material

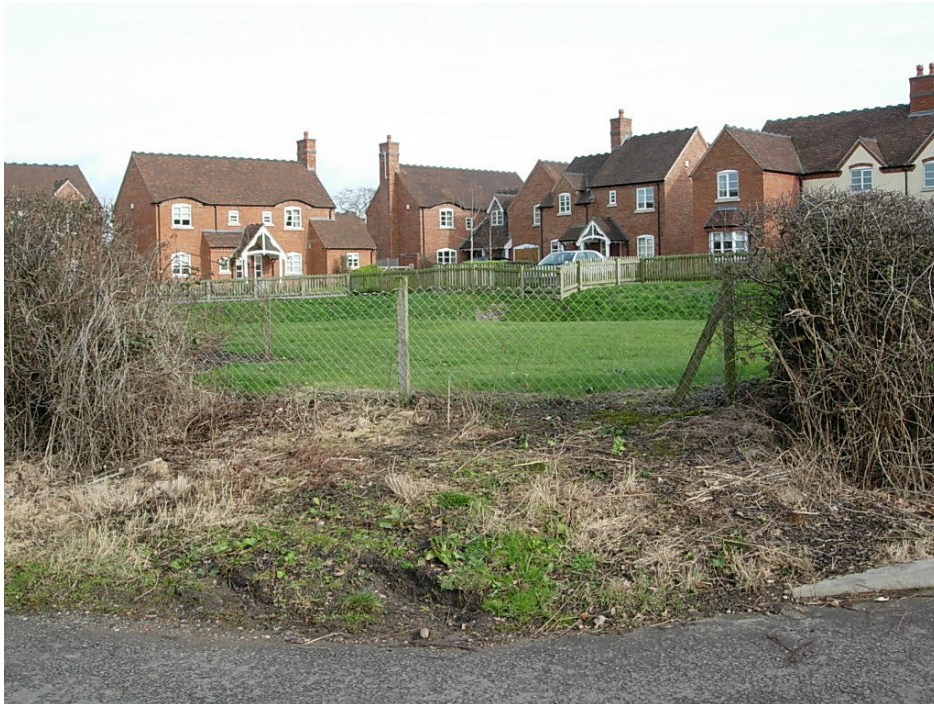
(15) Gaps in hedgerow need to be re-planted along boundary of new housing development on Shadows Lane

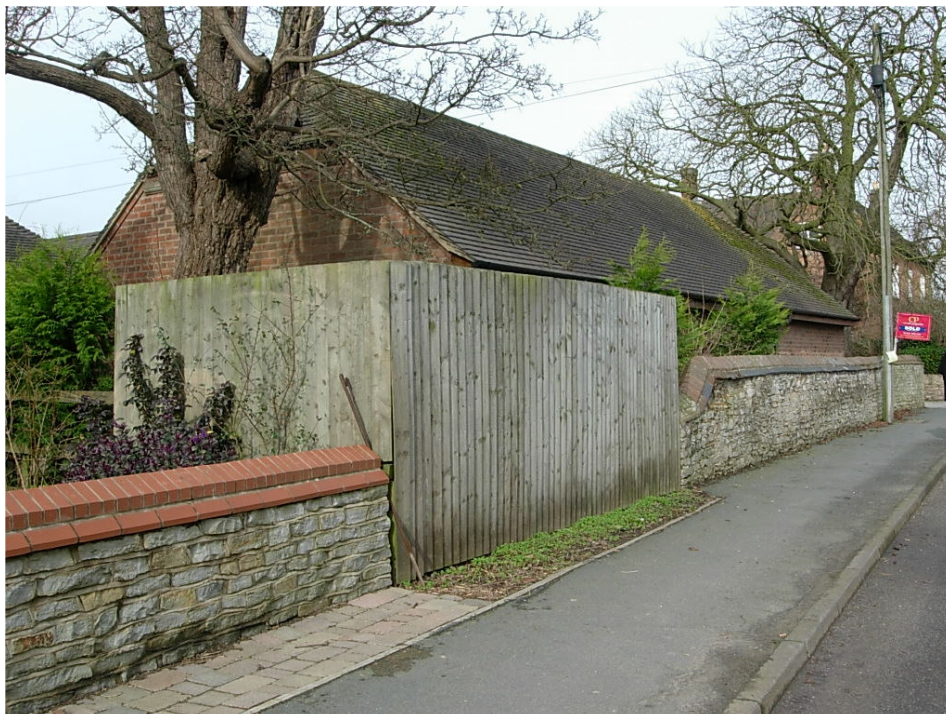
(16) Timber fence on Main Street needs replacing with Carlton stone wall to link up to adjoining walls
