HOLLYCROFT CONSERVATION AREA APPRAISAL & MANAGEMENT PLAN

**PHOTOGRAPHIC RECORD OF
HOLLYCROFT CONSERVATION AREA**

**Adopted by Hinckley and Bosworth Borough Council
1 March 2011**

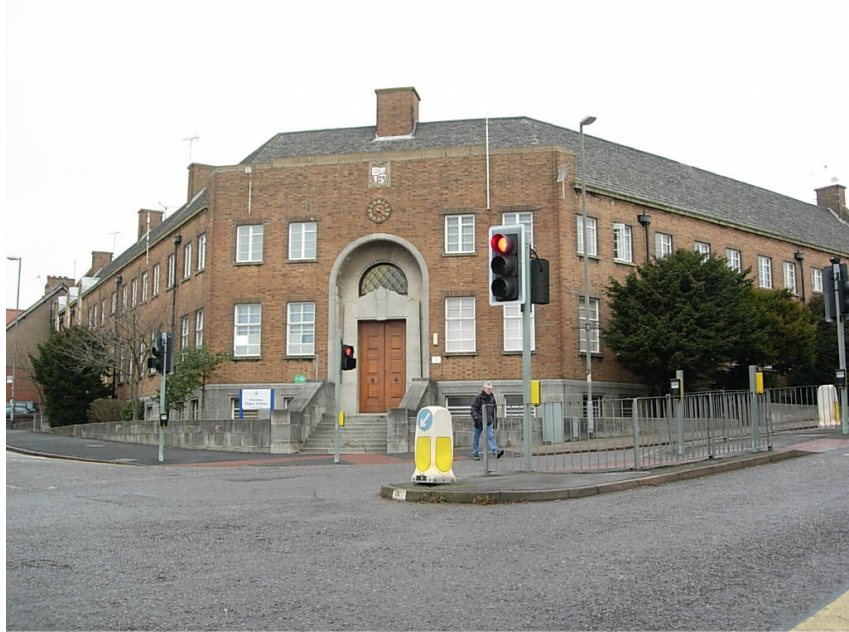
Hinckley Police Station in the Art Deco style.
This important building dominates the road junction of
Hollycroft with Bond Street.

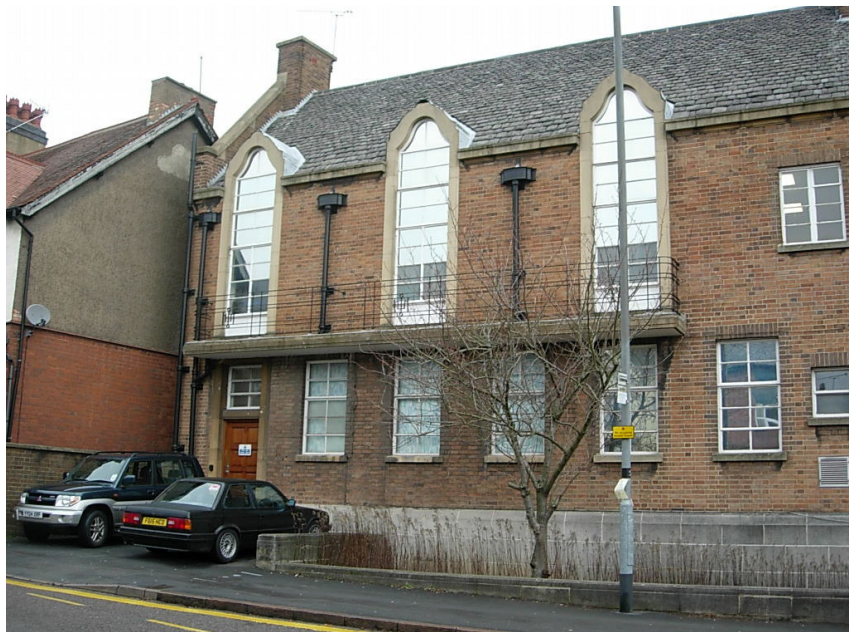
The feature dormer windows and balcony add interest to the
Hollycroft street elevation. The low walls forming the planters
are also an attractive Art Deco feature.

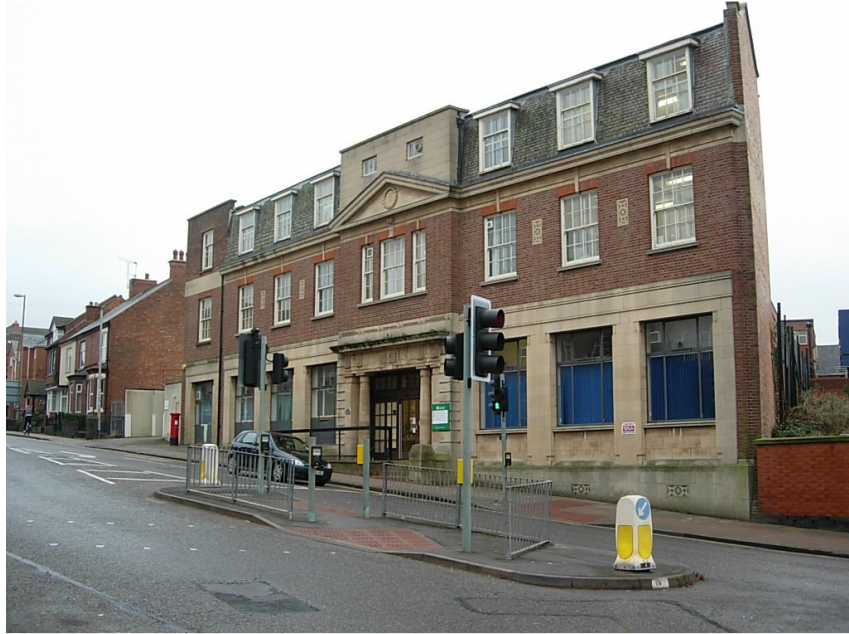
The impact of the former offices of the Hinckley & Warwickshire Power Company has been reduced by the unfortunate addition of the roof extension. This detracts from its appearance.

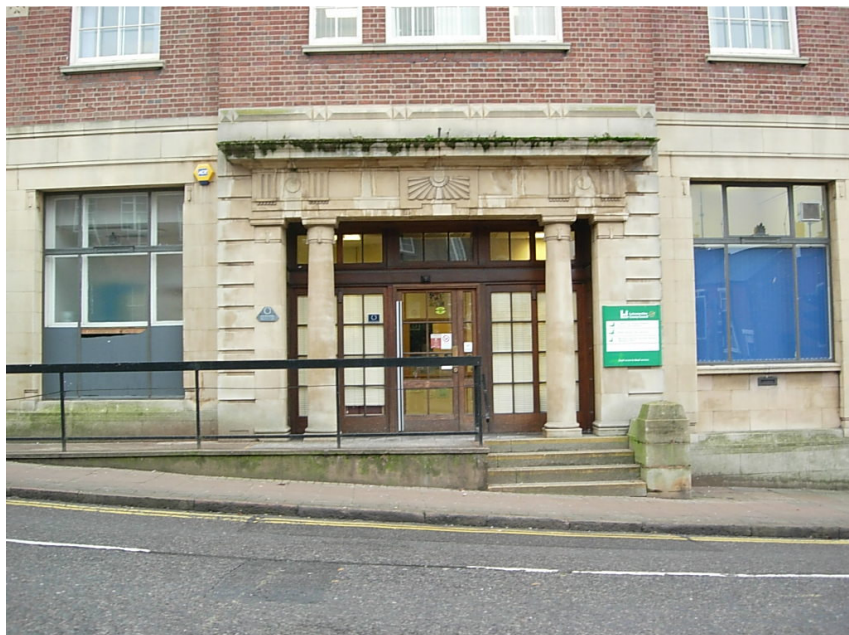
The fine portico with its neo-classical motifs, adds character to the façade of the former offices of the Hinckley & Warwickshire Power Company.

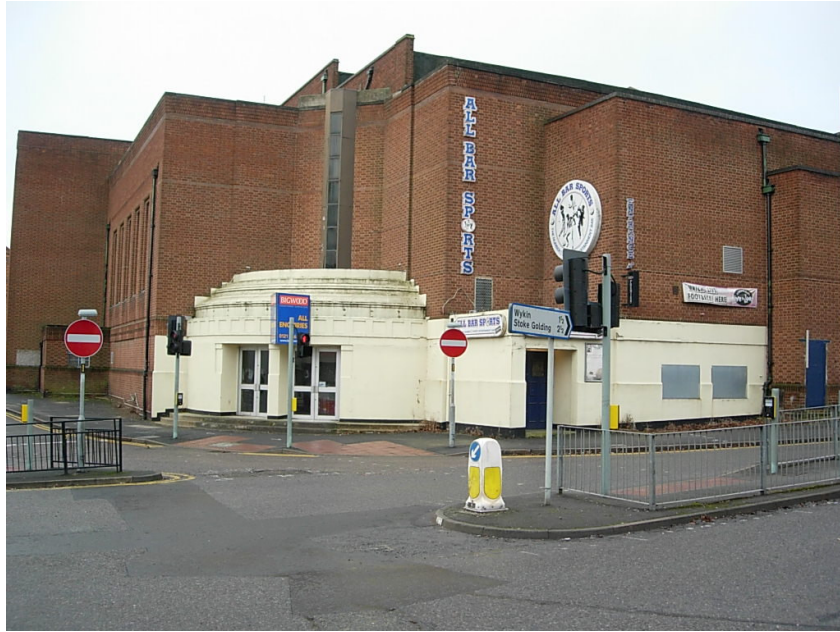
The appearance of the Dalilo super cinema, now vacant, has suffered from the later extension added to the Hollycroft elevation which has destroyed its symmetry. It is in need of a programme of maintenance.

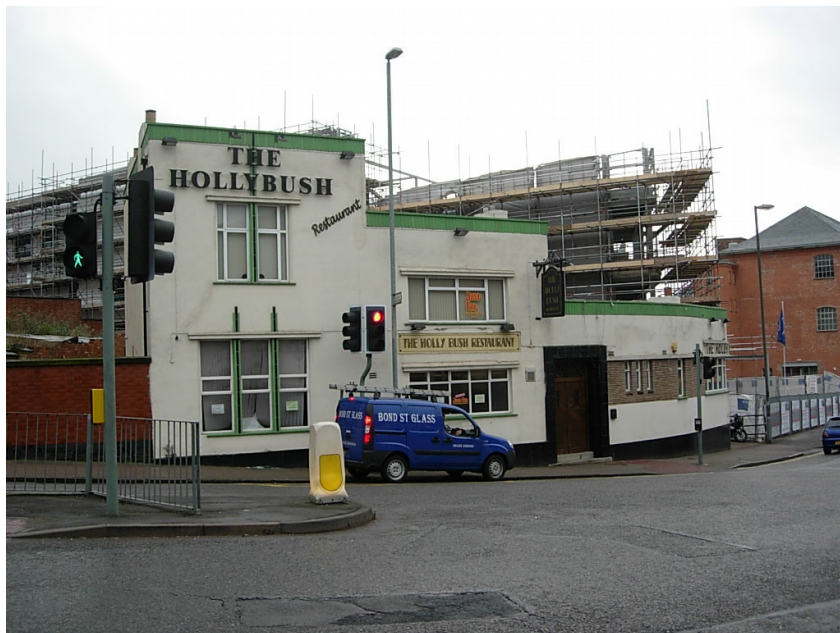
The Hollybush Inn is a fine example of an Art Deco building. Its curved façade is a prominent feature when viewed from Lower Bond Street..

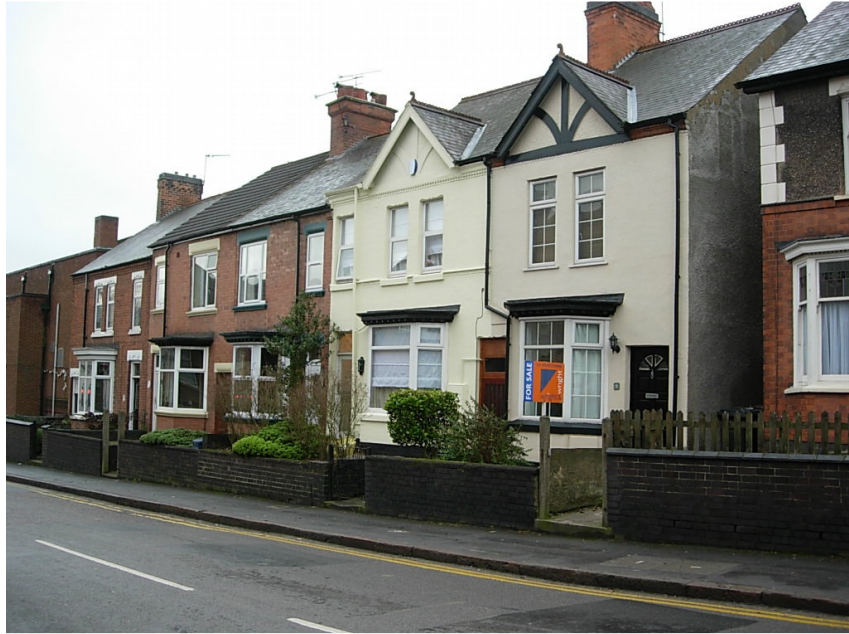
1 – 9 Hollycroft.

This interesting group of properties was designed as a series of semi-detached houses. Many original features have survived, including the chimneys and bay windows. The replacement concrete roof tiles have had a detrimental impact on the appearance of the block.

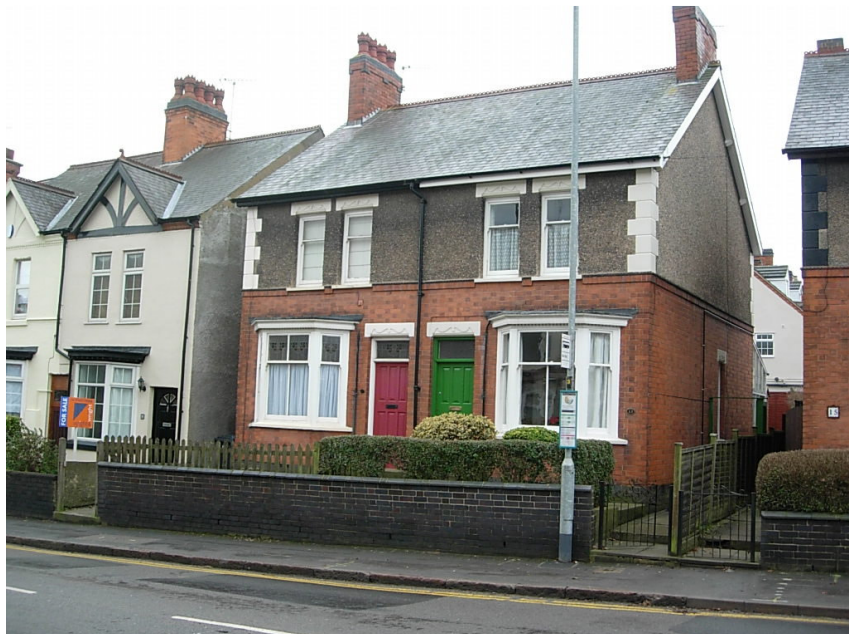
11 – 13 Hollycroft.

This is a fine pair of well maintained early 19C properties. They have many original features including timber sash windows and doors. The right-hand chimney has unfortunately lost its pots.

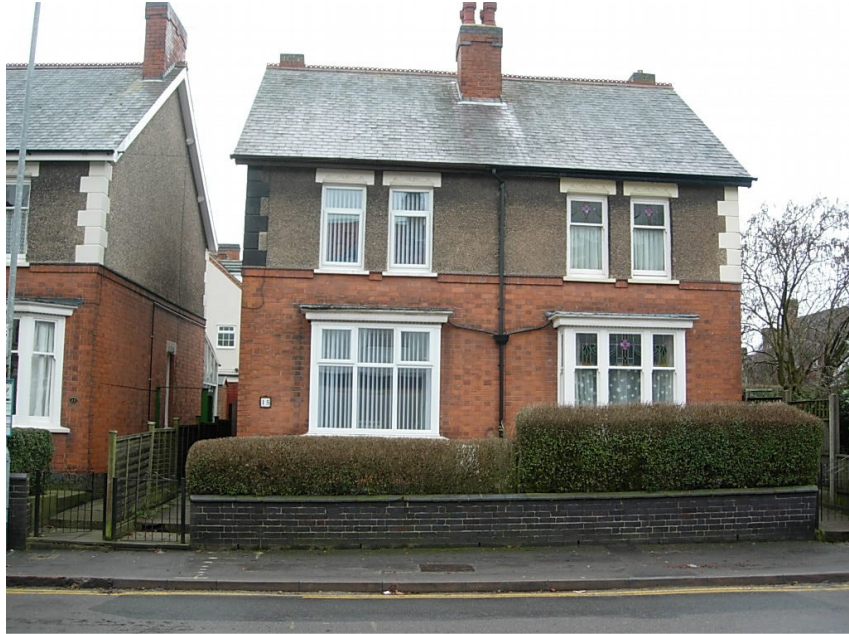
15 – 17 Hollycroft.

When new elements are added to terraces or semi-detached properties, such as windows, it is important to retain a symmetrical appearance. This retains the quality and unity of the original design.

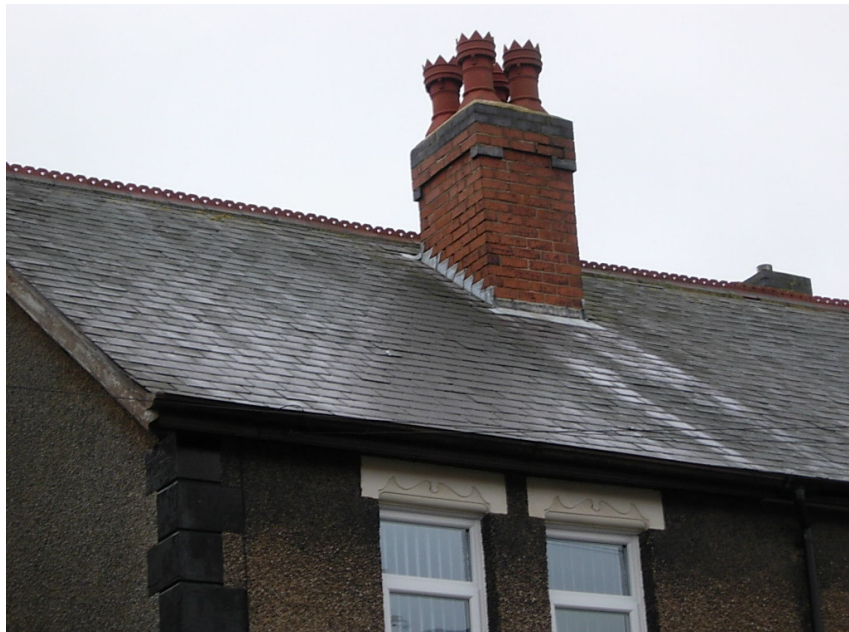
15 Hollycroft.

These decorative chimney pots and ridge tiles are important features on the sky-line and add character to the conservation area.

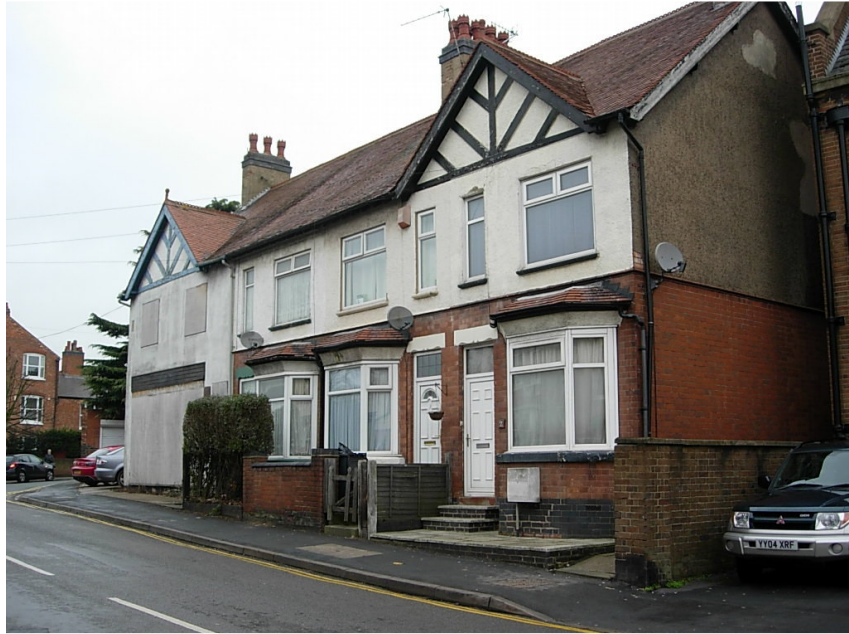
2 – 8 Hollycroft.

Changes to this terrace have not been sympathetic to the original design and the unity of the block has been lost. Features which have been lost include the end bay, the window sub-divisions and the brick boundary walls.

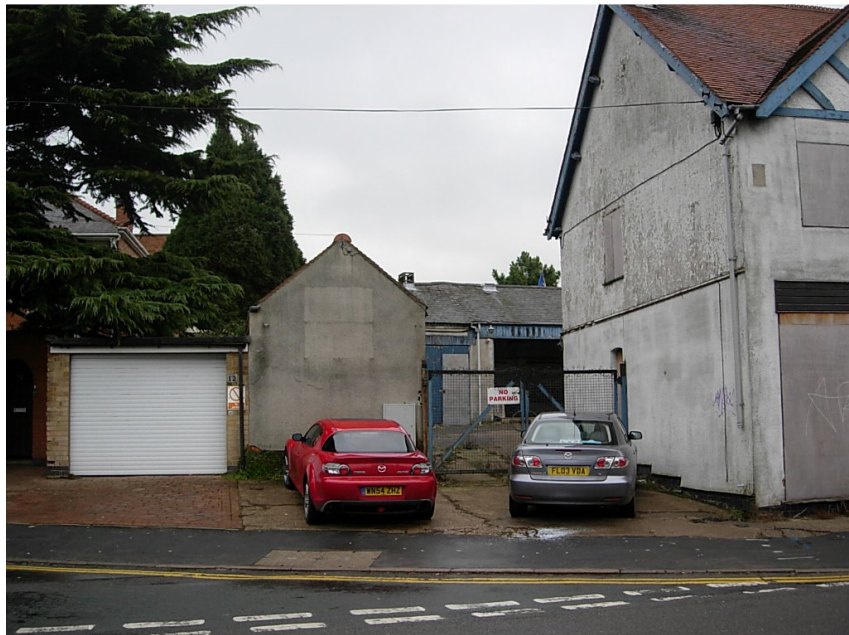
Former dairy.

These small buildings are in a prominent location at the end of Factory Road but they detract from the street scene. The flat garage roof is out of character with the other pitched roofs. The appearance of the roller shutter door would be improved if replaced by a pair of timber side hung doors. The ground surface also needs improving.

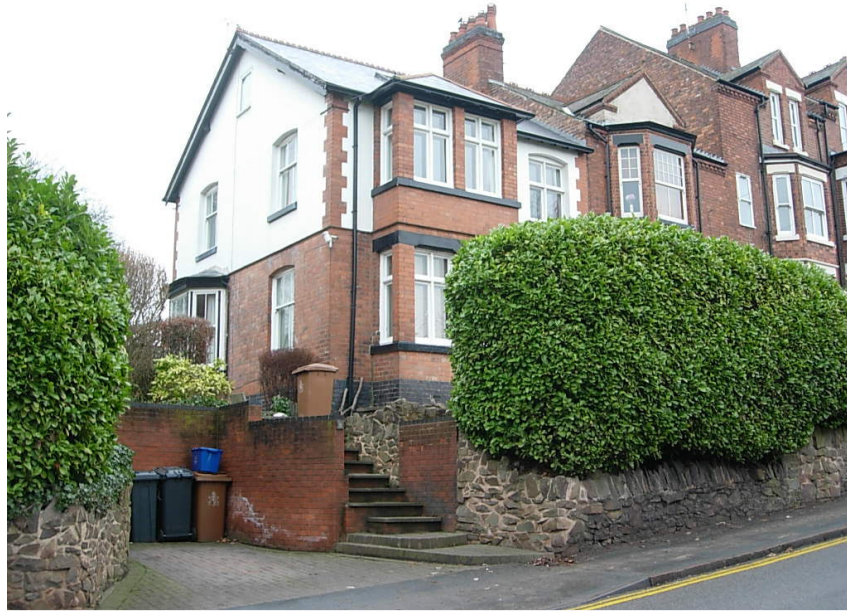
18 – 22 Hollycroft.

Although constructed after the adjacent terrace, this property includes many similar features and is generally in keeping. The boundary wall has unfortunately been constructed in stone, not brickwork.

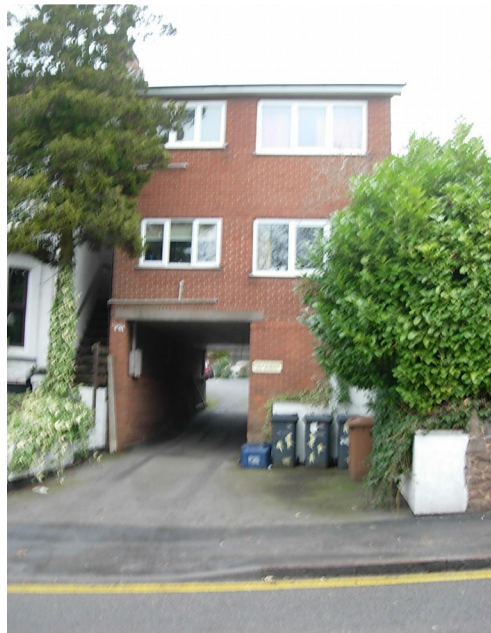
This addition is completely out of character with the adjacent buildings and the traditional qualities of the conservation area. The window proportions and roof profile are particularly incongruent.

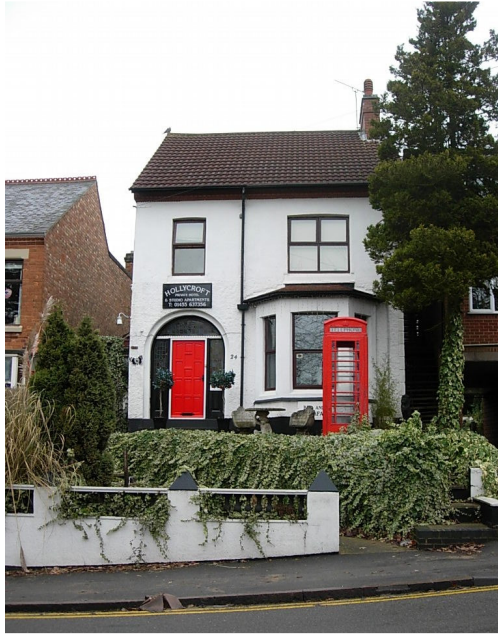
24 Hollycroft.

This is a traditionally proportioned building which has unfortunately been rendered, had a concrete tiled roof covering added and its boundary wall rebuilt. None of these changes are in keeping with its original appearance or the character of the conservation area.

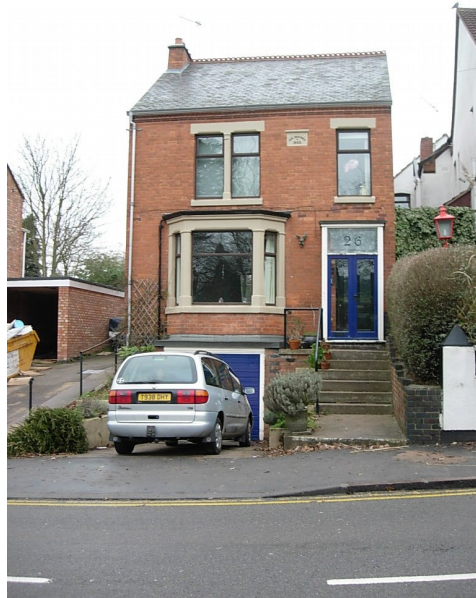
26 Hollycroft.

This property has unfortunately had its chimney reduced, its ground profile changed, a garage inserted and its boundary walls demolished.

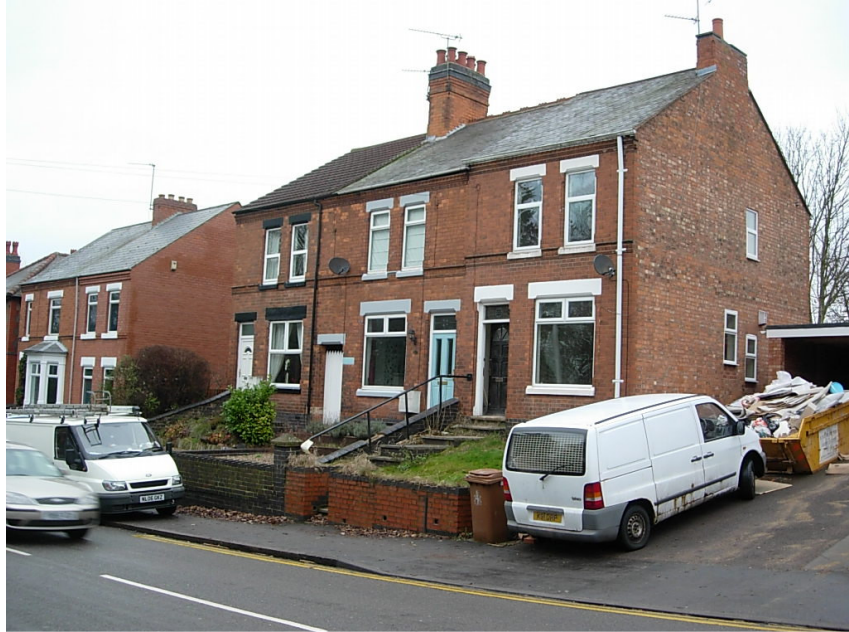
28 – 32 Hollycroft.

This property has lost part of its chimney and its original window sub-divisions. It is also unfortunate that a flat roof garage has been erected too close to the road which has closed off the view between the properties.

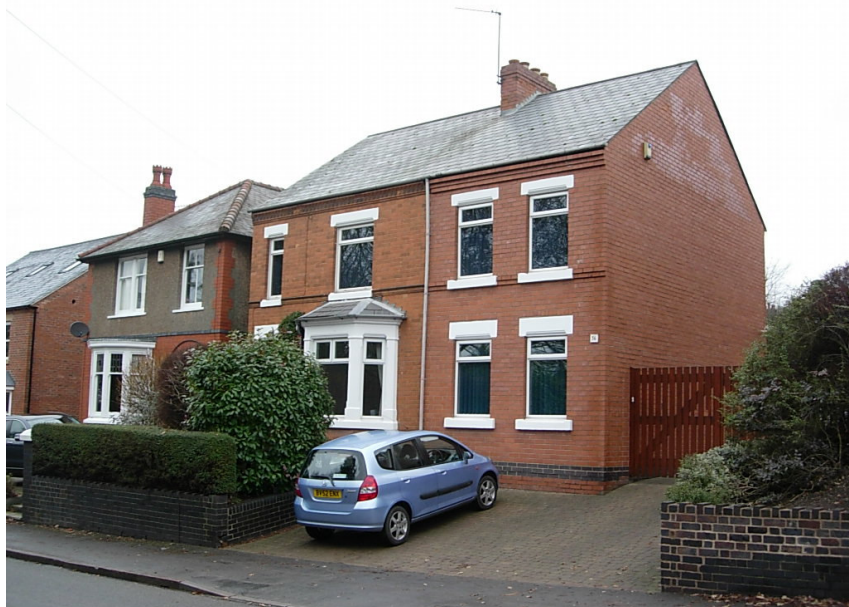
36 Hollycroft.

This property has lost its garden wall which has had a detrimental impact on the street scene.

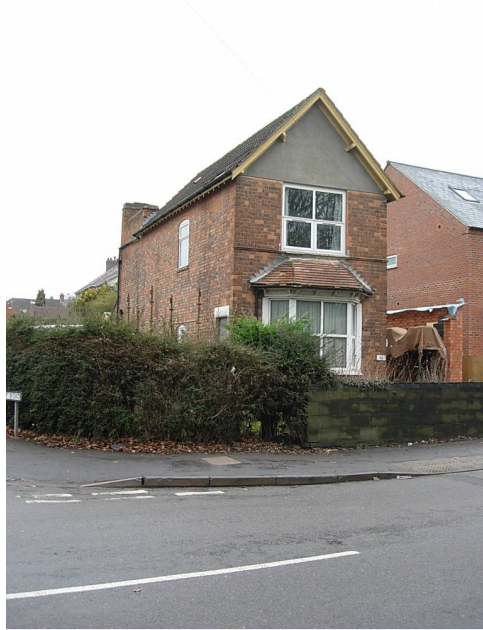
42 Hollycroft.

This corner property on the Stanley Road junction has lost its chimney but retained its garden wall.

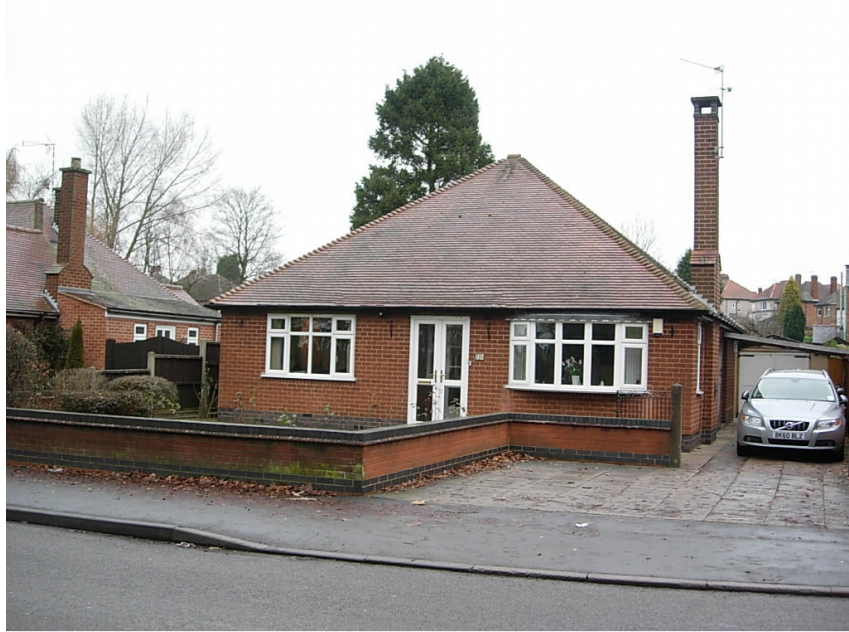
48 Hollycroft.

Although this bungalow has retained its original window subdivisions, it is unfortunate that the garden wall does not follow the edge of the plot.

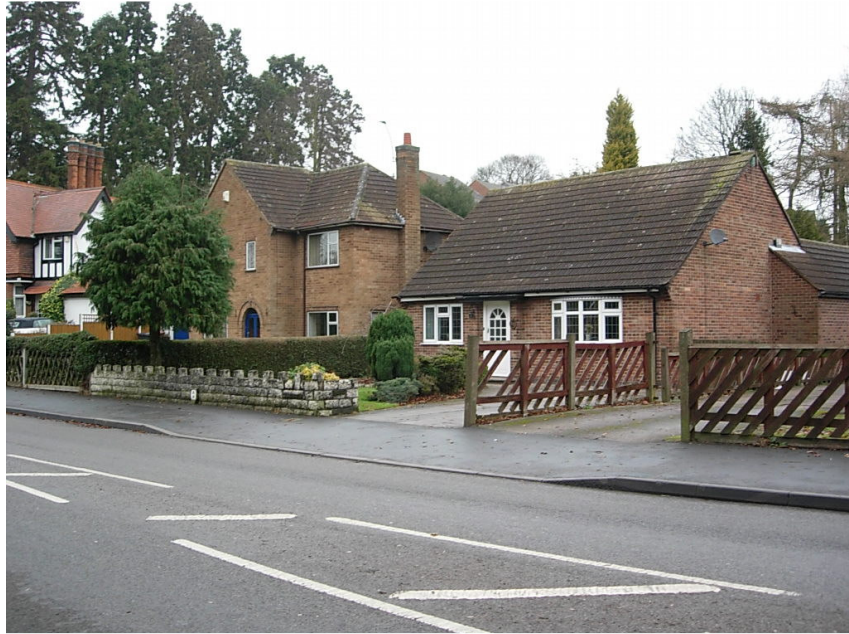
45 – 56 Hollycroft.
The reconstituted stone wall is out of character with the other walls in the conservation area.

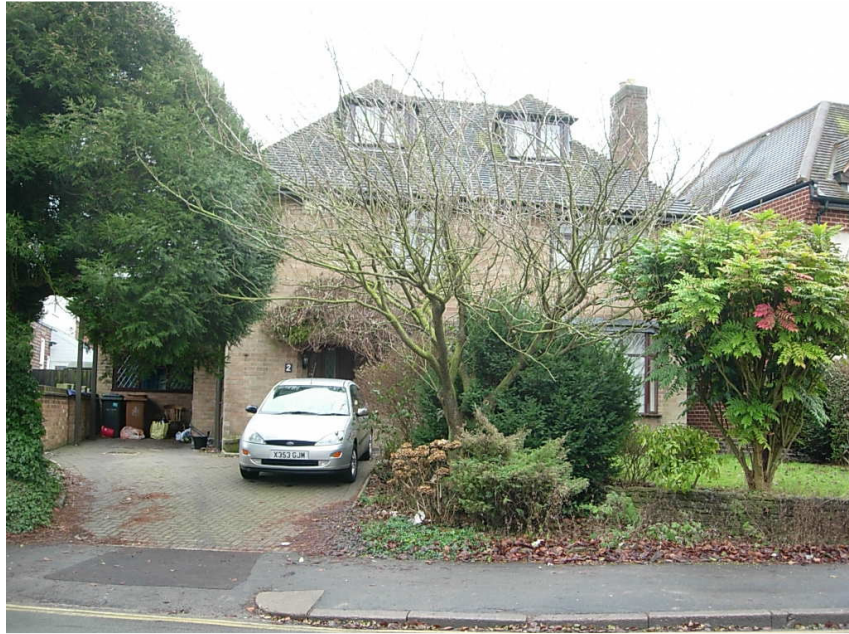
2 Shakespeare Drive.
Dormers are not a traditional feature of 1930's properties

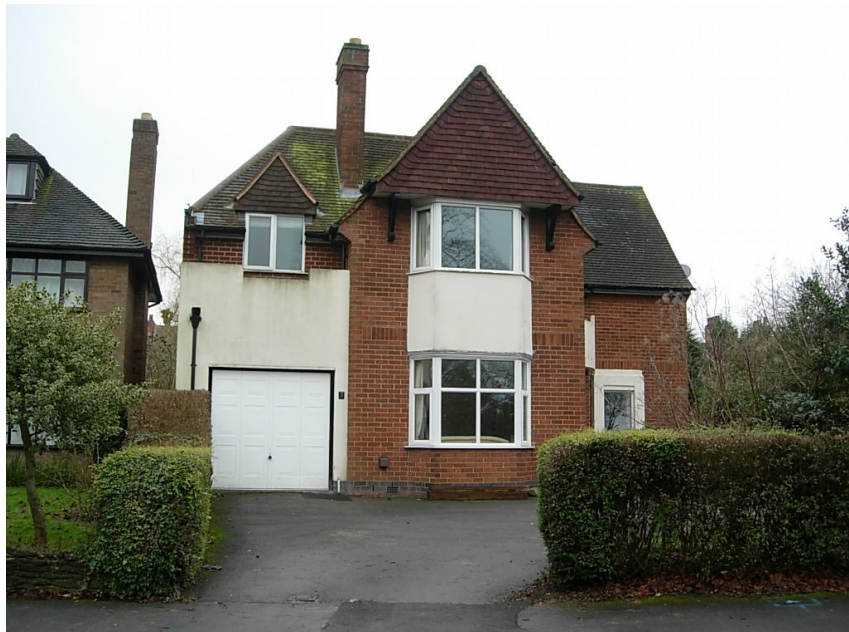
3 Shakespeare Drive.
This property has been extended in the past and it would have been improved if the render had been replaced with brickwork.

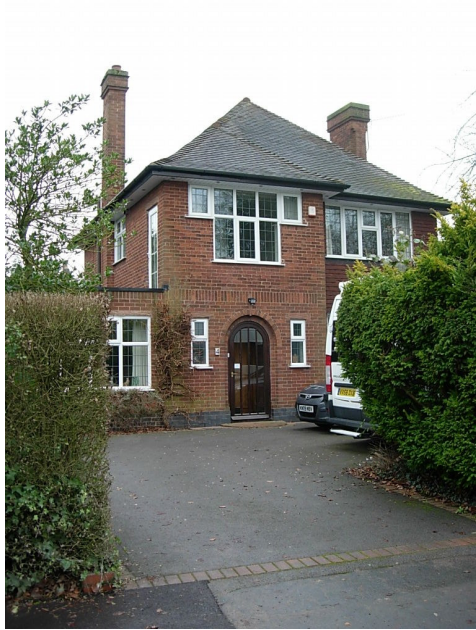
4 Shakespeare Drive.

This is a good example of a 1930's suburban property. It is unfortunate that the garage door infill has changed the subdivision of the windows.

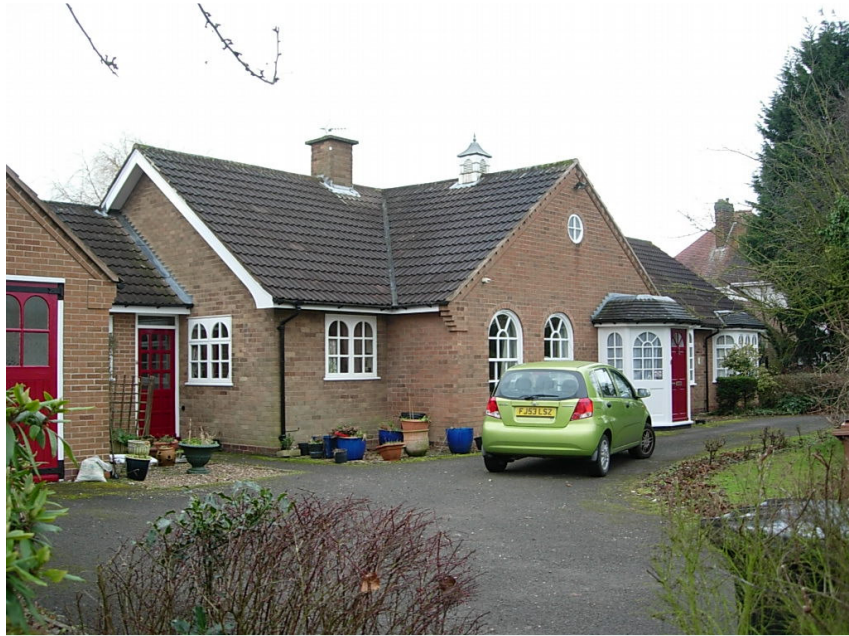
6 Shakespeare Drive.

This dwelling has had several modern extensions and other changes which are not in keeping with its original character. These include concrete roof tiles and cottage style windows. However, the property has an attractive garage door.

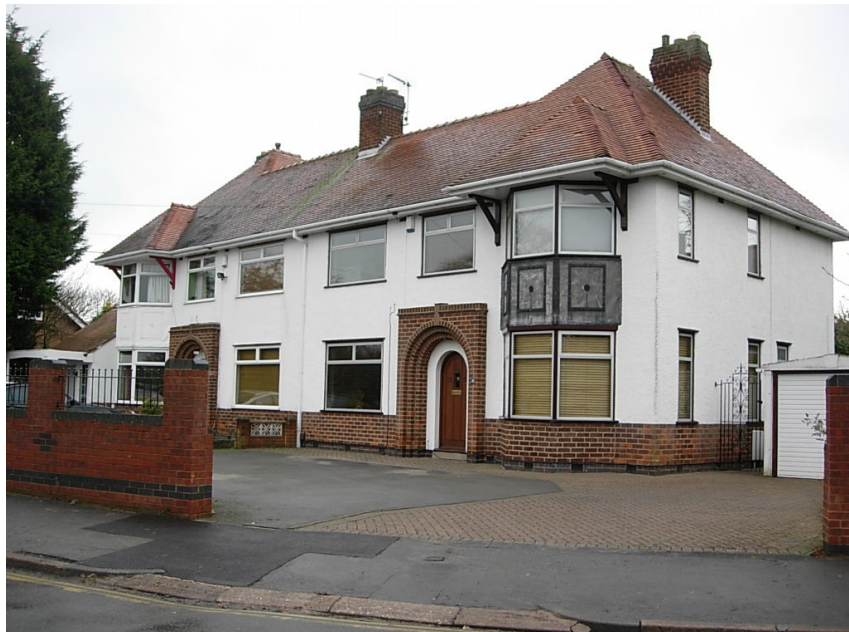
7 – 8 Shakespeare Drive.

This semi-detached property unfortunately has lost its original window sub-divisions and one set of bay spandrel panels has been painted over.

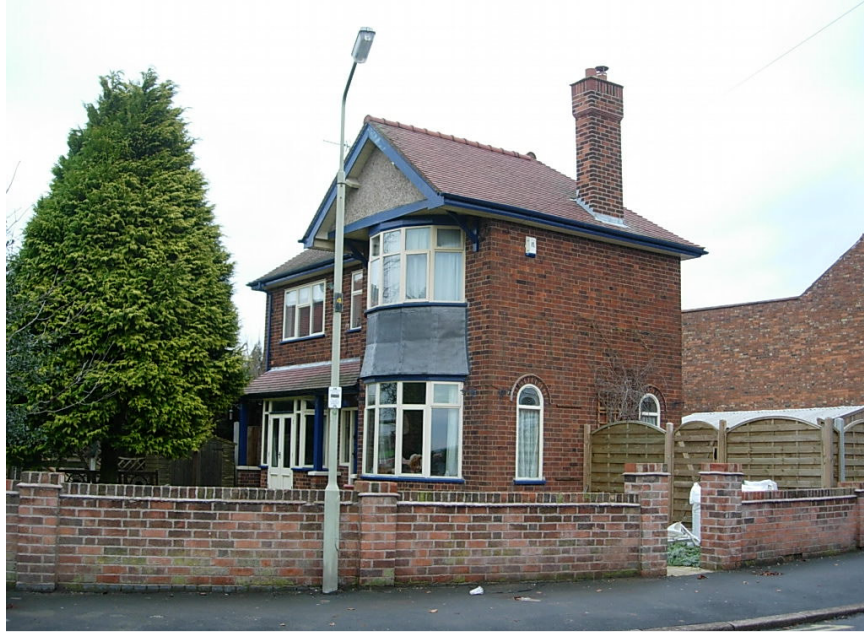
9 Shakespeare Drive.
This property on the corner of Canning Street has recently had its garden wall rebuilt. The curved top fence panels are out of character.

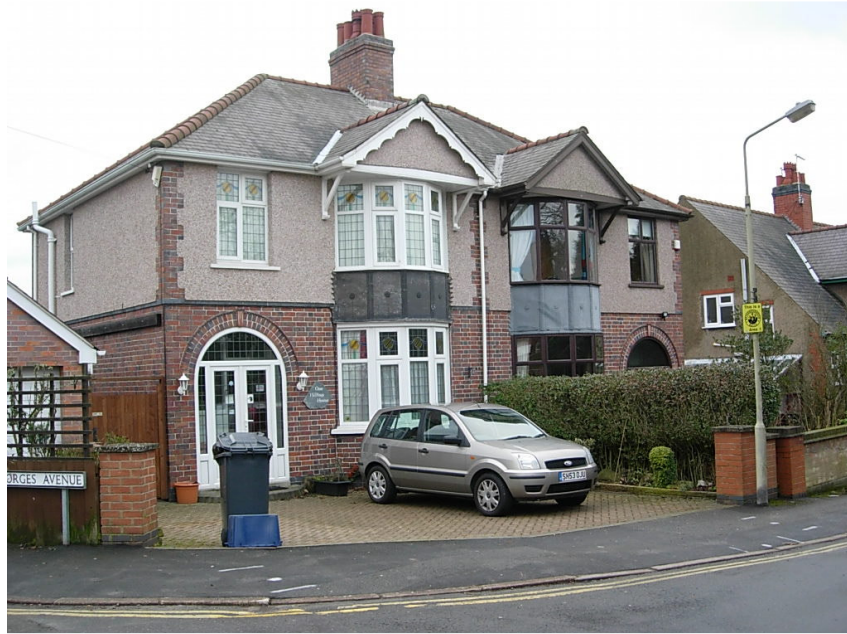
1 – 3 St .George's Avenue.
This property, although well maintained, has lost most of its garden wall which impacts on the street scene. The gable bargeboard is also out of character.

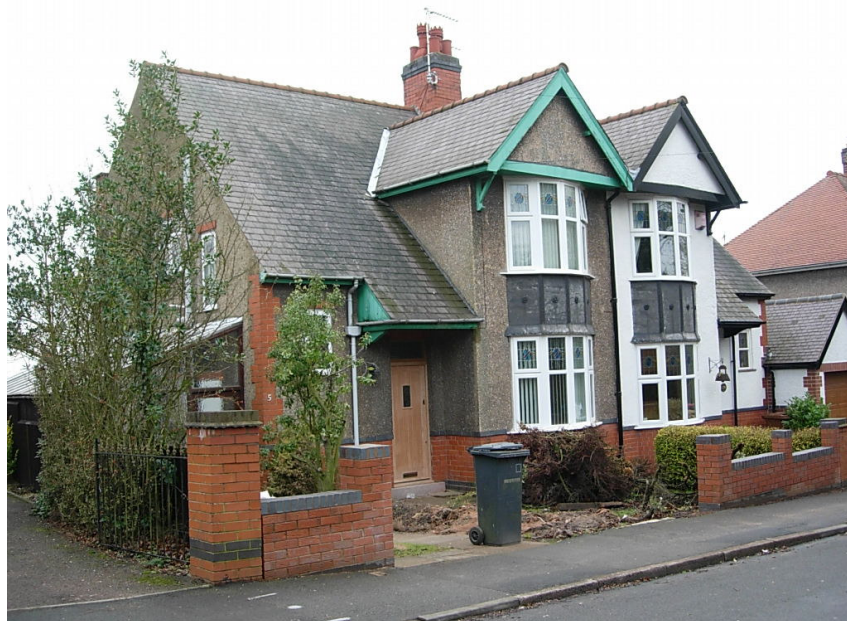
5 – 7 St. George's Avenue.
This pair of houses has retained many original features. It is unfortunate that the garden wall has been lost on one of them.

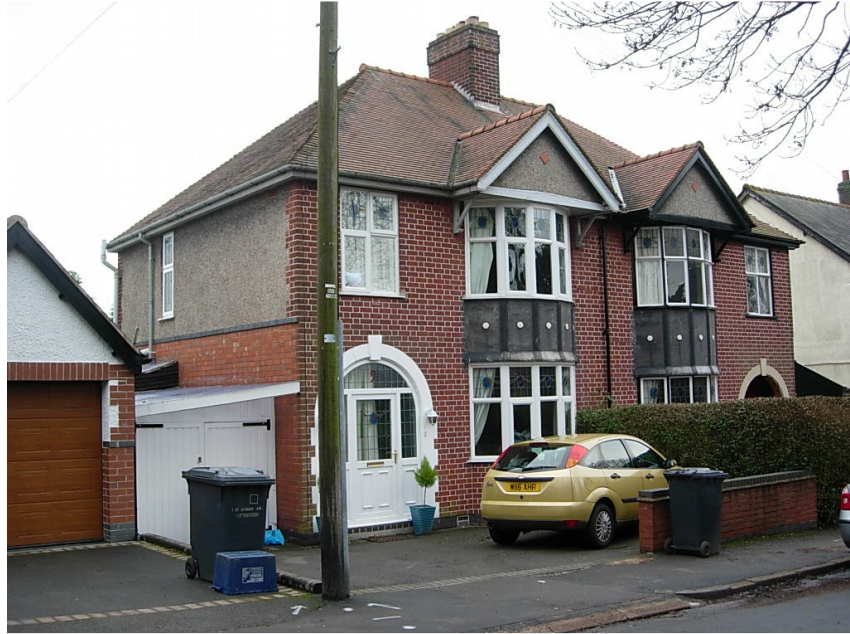
9 – 11 St. George's Avenue.

The loss of the garden wall of this property, together with the adjoining garage access, has created a wide gap in the street frontage.

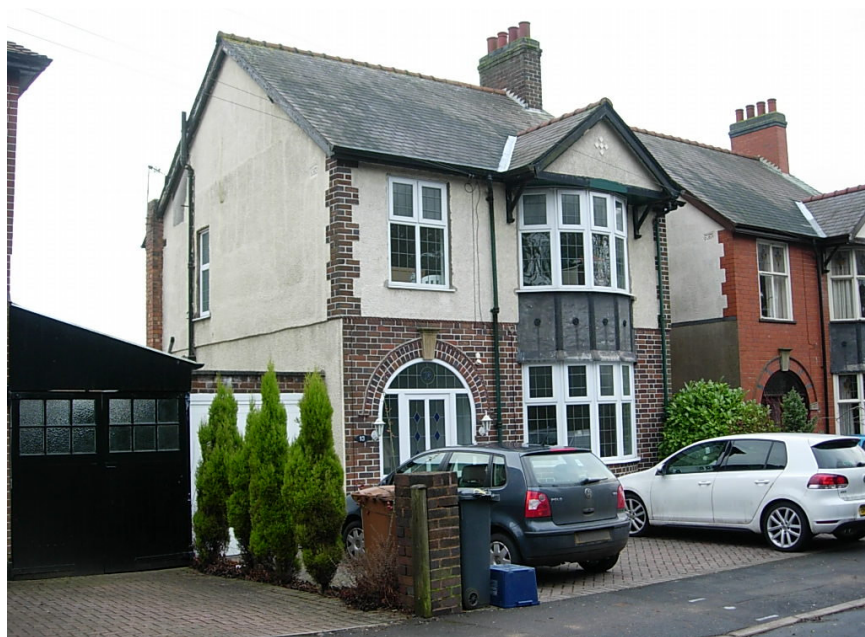
13 St. George's Avenue.

The destruction of garden walls to allow vehicles to park in the front gardens, is a common problem on this road. It has a detrimental impact on the appearance of the conservation area.

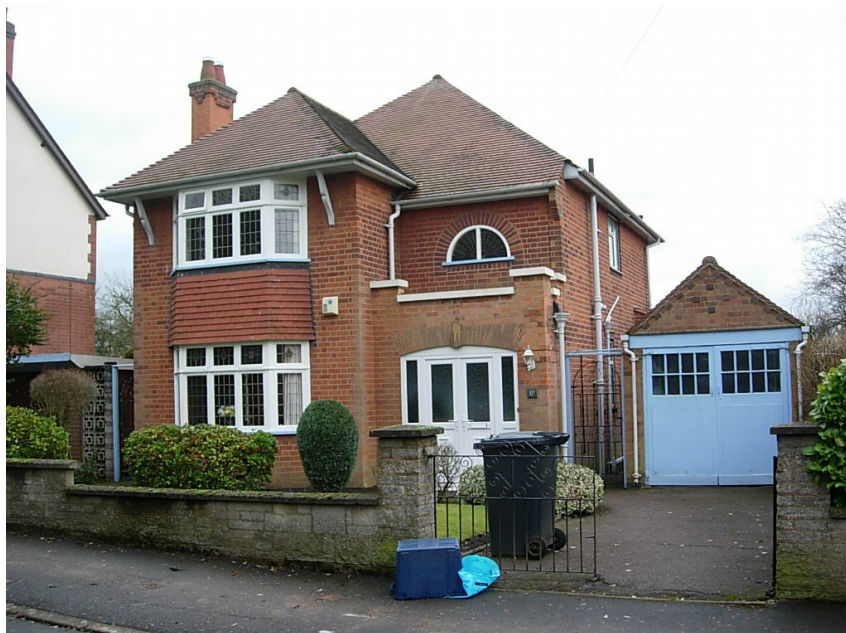
17 St. George's Avenue.
Although the material used to construct the garden wall is out of character, the design of the garage and its doors are in keeping. The vehicle access width has also been kept to a minimum.

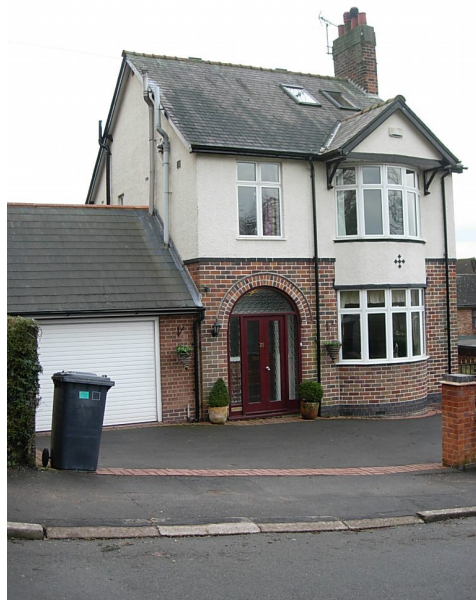
25 St. George's Avenue.
The garage roof and door are out of scale with other features on this property.

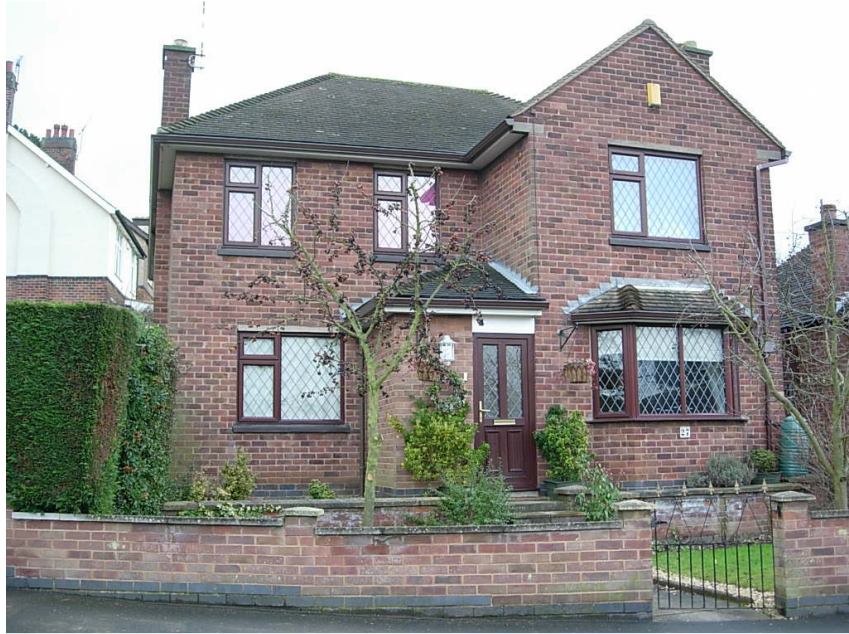
27 St. George's Avenue.
The modern window sub-divisions on this property detract from its appearance.

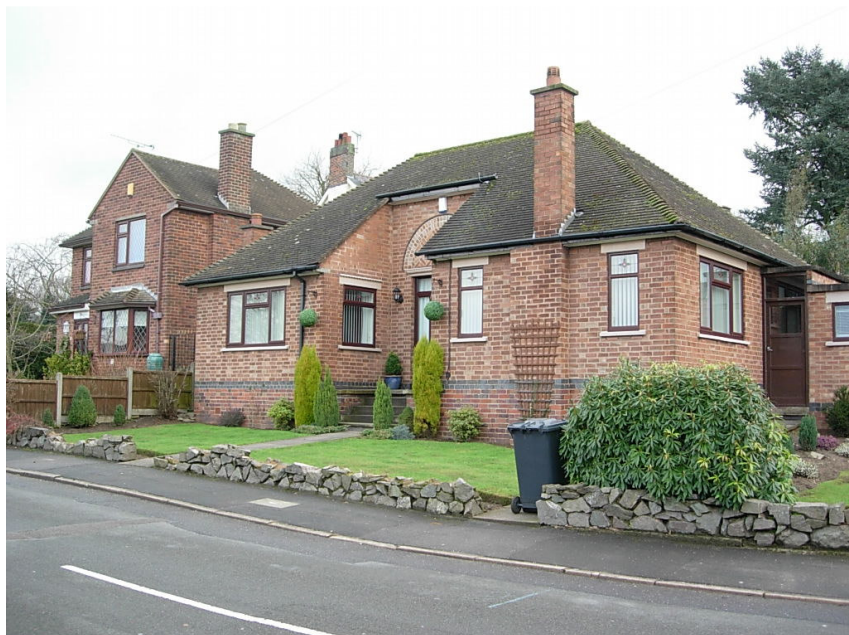
29 St. George's Avenue.
The stone wall fronting this interesting property detracts from its appearance and character of the conservation area. It should be constructed of brickwork and is too low.

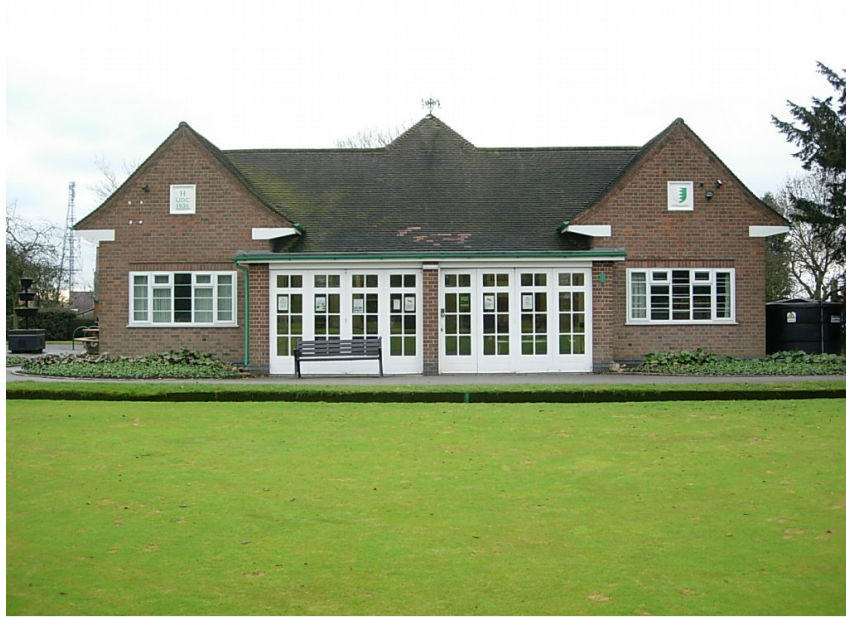
The modern French window double screens have had a detrimental impact on the appearance of the park's bowling green pavilion.

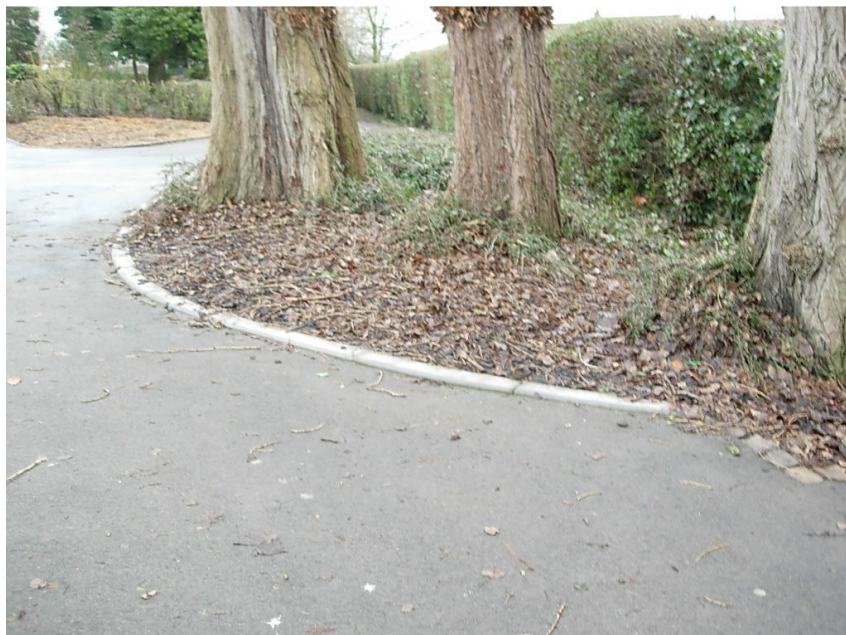
Smooth concrete edging is now superseding granite sets to mark the path edge.
