BURBAGE CONSERVATION AREA APPRAISAL & MANAGEMENT PLAN

**PHOTOGRAPHIC RECORD OF
BURBAGE CONSERVATION AREA**

November 2011

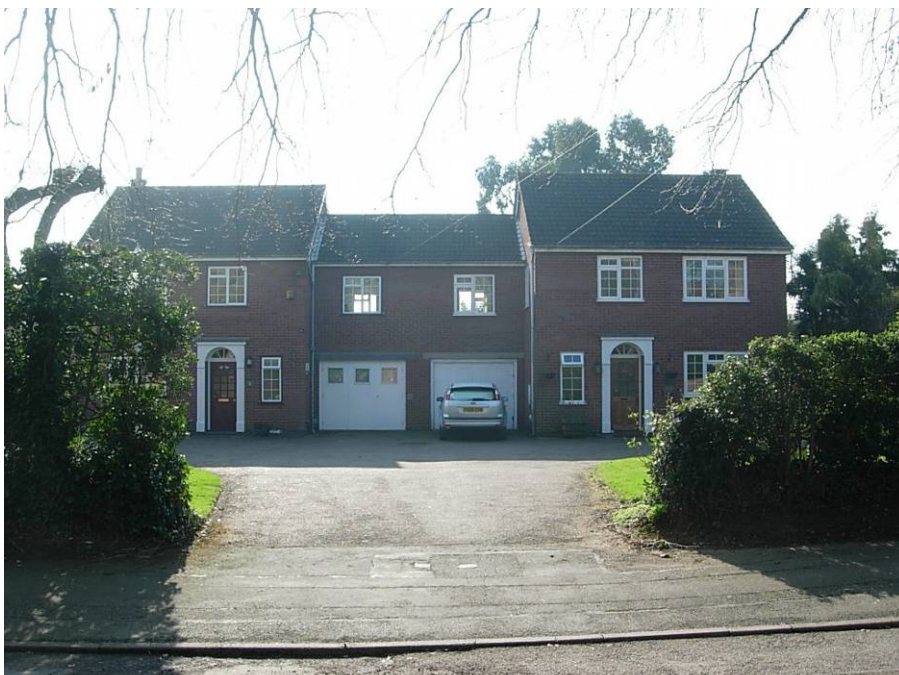
These large properties, 2 & 4 Aston Lane unfortunately do not respect the traditional character of Aston Lane by way of their design, use of modern materials and siting. By being sited well back from the carriageway, enclosure on the lane has also been lost.

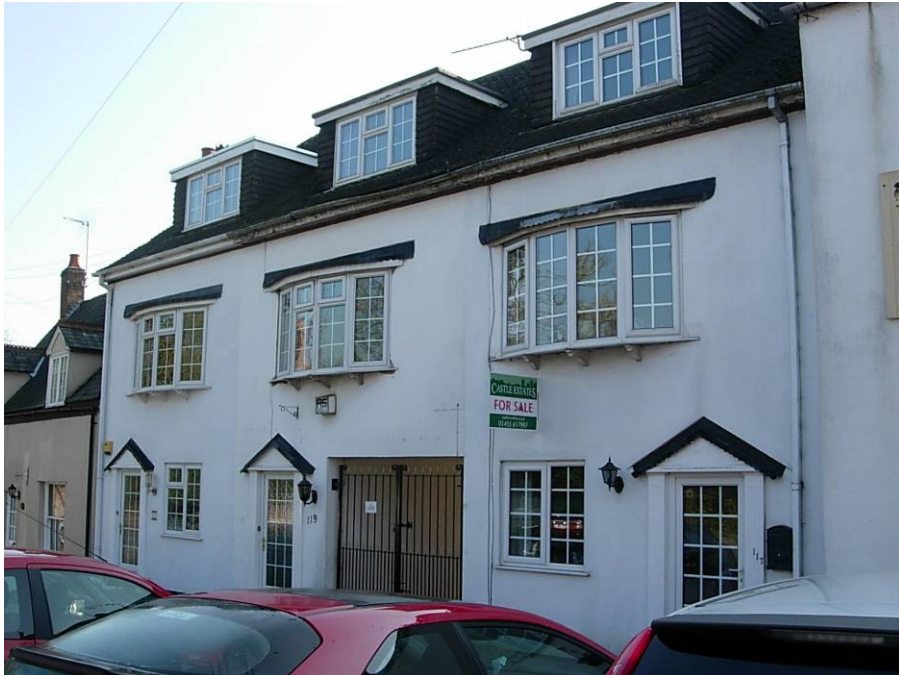
The three storey building which stood on this site was demolished around 1970 and replaced with this terrace, 117-127 Church Street, which does not follow the traditional character of the area. Its first floor bow windows and large flat roofed dormers are particularly incongruent.

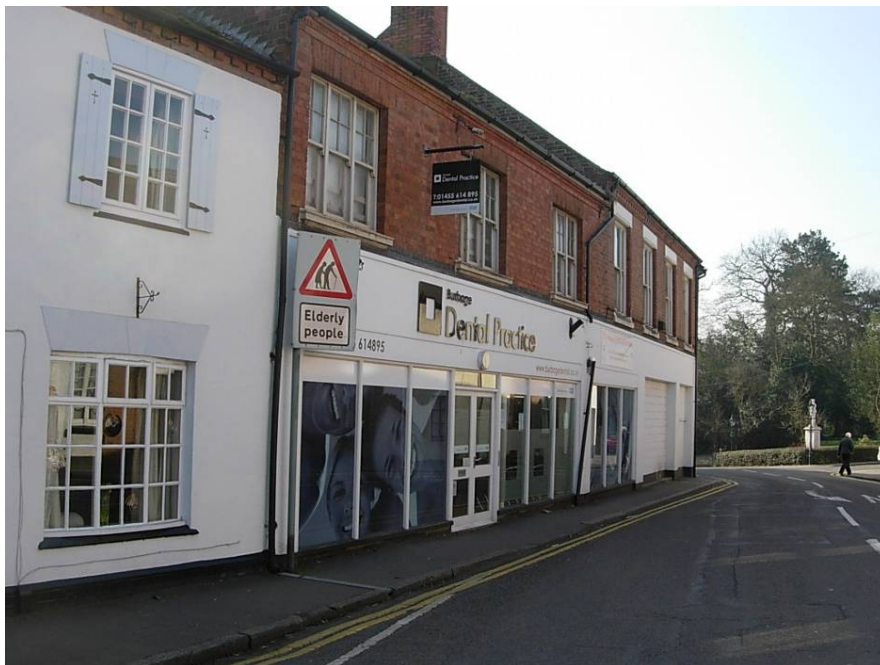
The shop front treatment to this property on Church Street is unfortunate. The fascia and display windows are overly dominant and the original three bay frontage has been ignored.

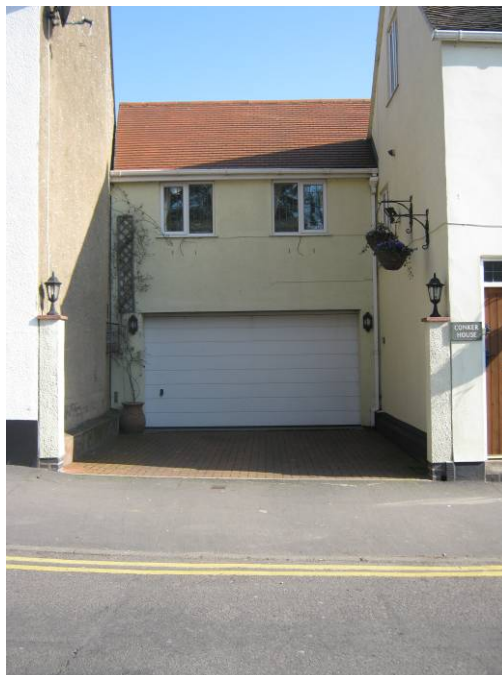
The visual quality of the conservation area would be improved if the double plastic garage door was to be replaced by two timber doors. It is unfortunate that generally modern plastic windows and doors are replacing traditional timber features in the conservation area.

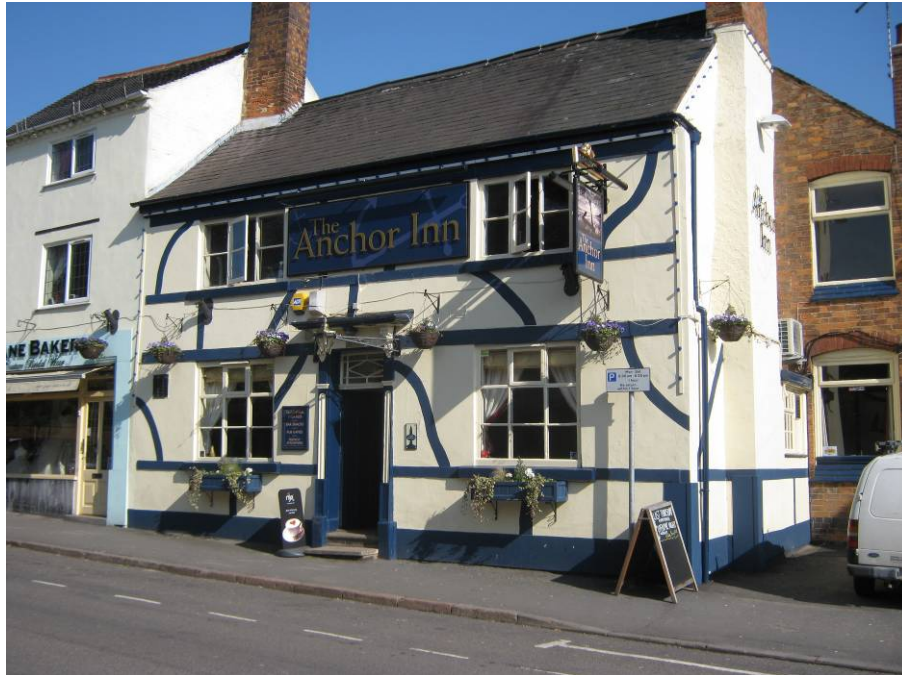
The painted stripes on the Anchor Inn Pub are overly prominent and fussy. They do not reflect traditional timber construction. The building is not a timber framed structure and should not attempt to appear as such. It was here that the Court Leat was held which dealt with all matters of public interest.

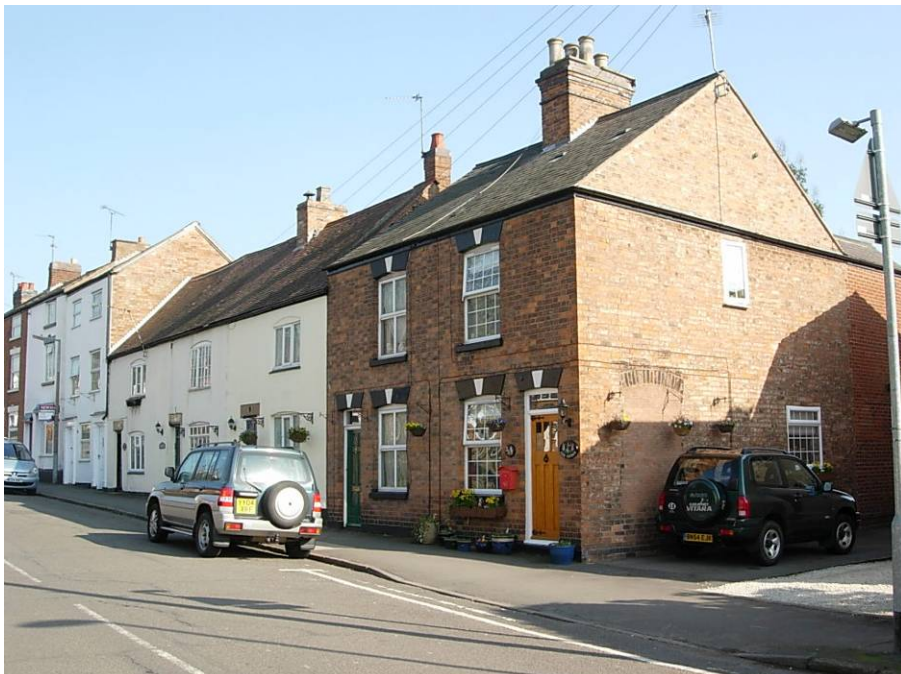
The dwellings at 35-37 Church Street have retained their traditional appearance. Their original brick construction, window openings, lintols and chimney add significantly to the character of the street scene. The side door, that appears to be an added feature, has unfortunately been bricked up. It is unfortunate that the adjoining properties have been rendered.

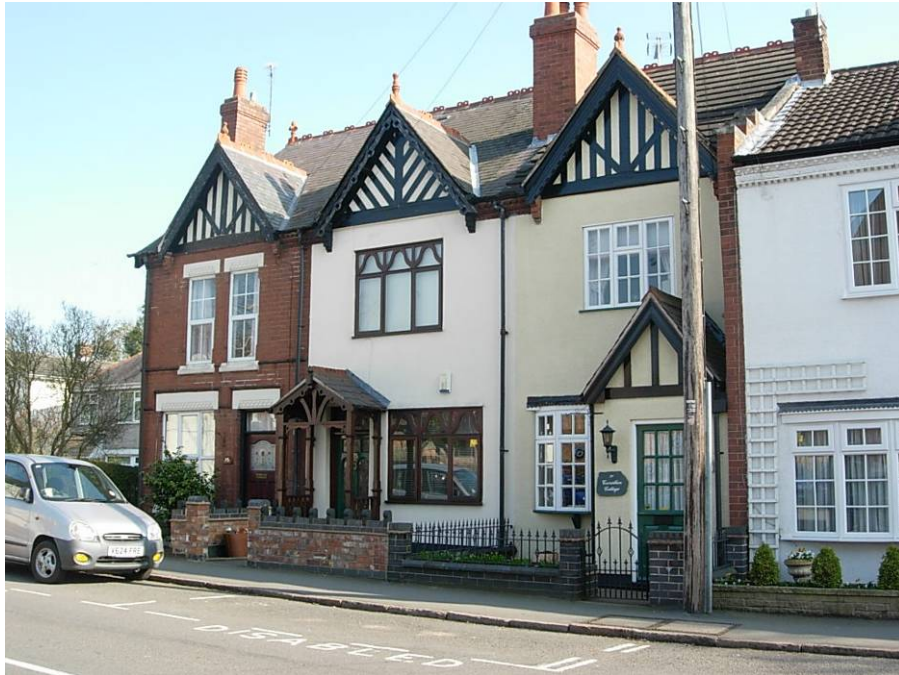
Although, as a block, 21-25 Church Street has retained its gables and chimneys, the unity has been lost due to the modernization of 21 & 23. The end property shows how the block would have looked if the facing brickwork, sash windows, stone lintols and window sills had been retained unaltered. The other two properties have unfortunately been rendered, their window openings enlarged, porches added and the roof material of one property changed. The brick wall at 23 should have been built in blue brick.

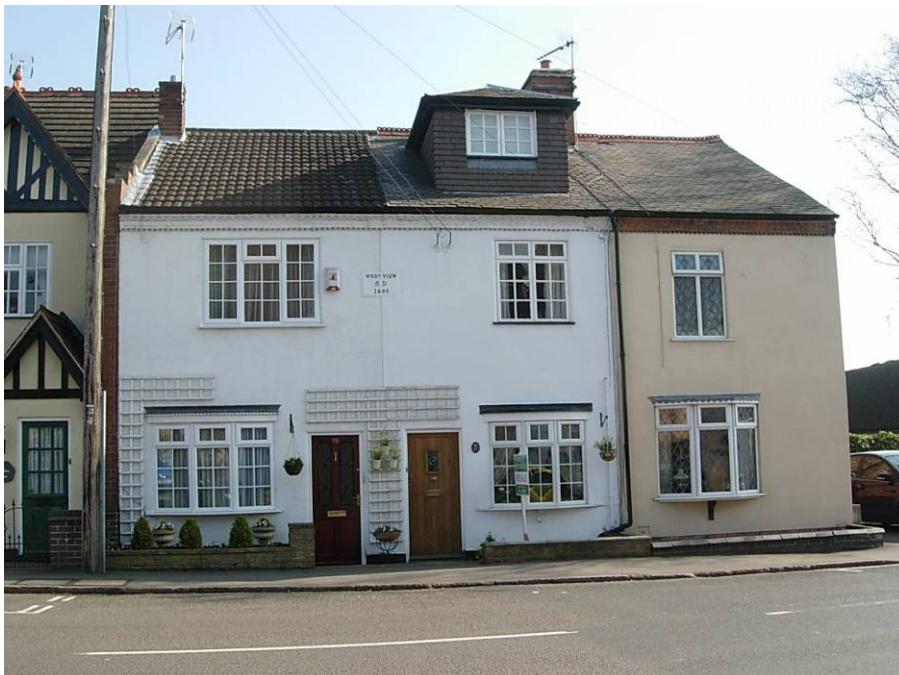
The traditional character of the properties 15-19 Church Street has been lost due to the installation of bow windows, concrete roof tiles and a massive dormer window.

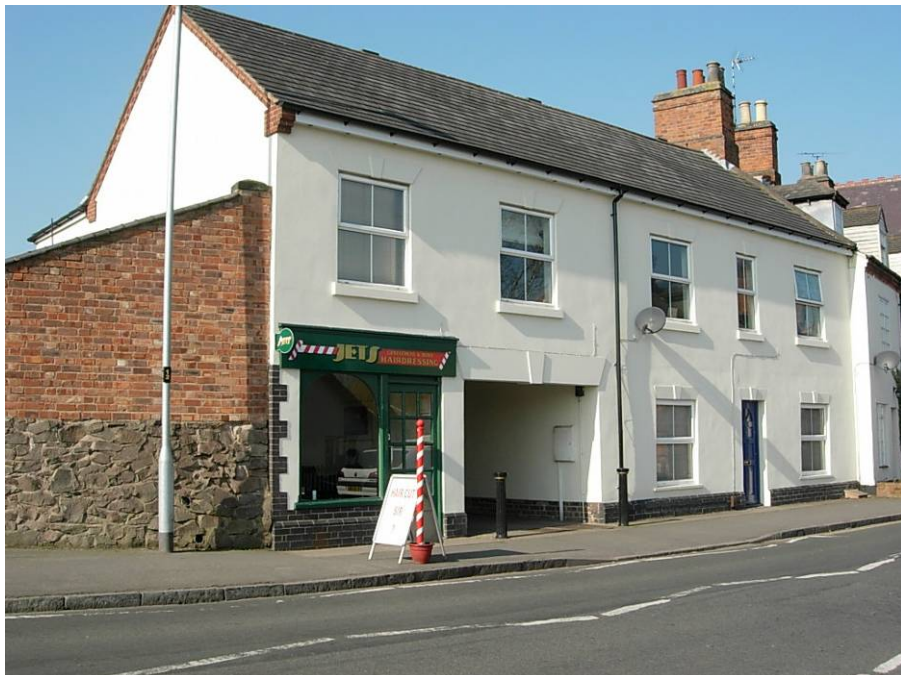
This modern property, 2 & 2a Church Street blends in with the rest of the block. The shop front is in scale. Unfortunately, the chimney stacks are missing. The impact of changes on the unity of the terrace should always be carefully considered particularly in conservation areas where the street scene is particularly important.

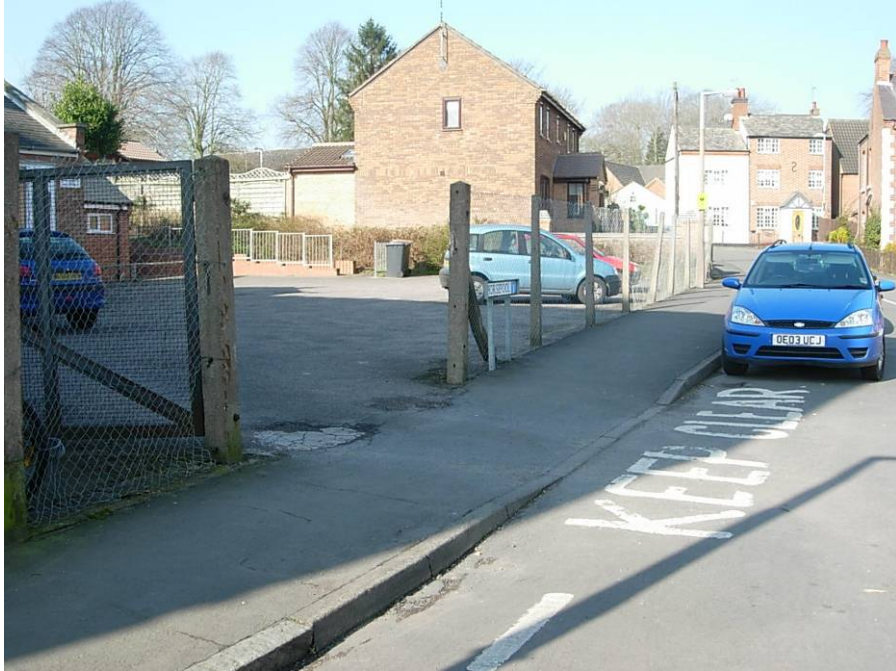
The concrete post & wire fence along the Burbage Congregational Church's frontage should be replaced with a wall or railings in keeping with the traditional character of the conservation area.

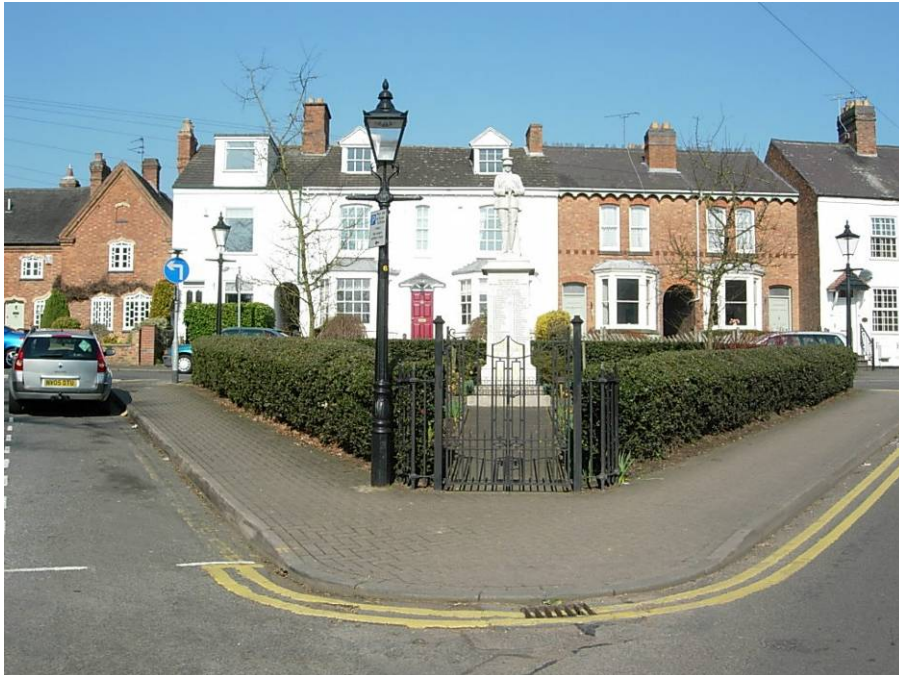
The war memorial on Church Street is an attractive feature enclosed by a privet hedge with heritage street lights sited at each corner. The concrete kerbs and modern block pavers do little to enhance the traditional character of the conservation area.

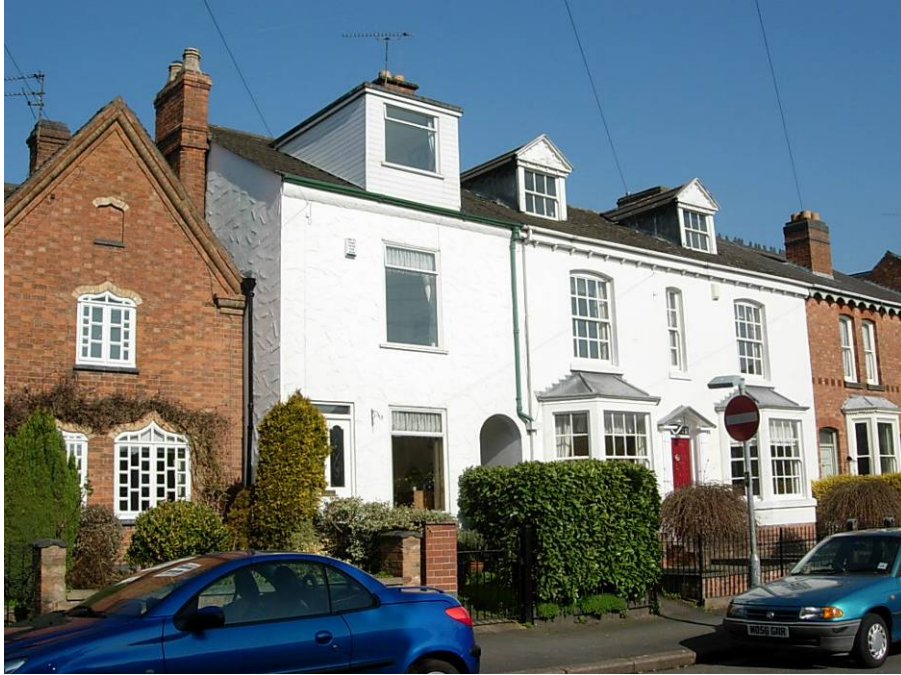
The modernization of 34 Church Street does not respect the traditional character of the property. The windows have been modernized, the type of rendering is inappropriate and the flat roof dormer is out of scale and of poor design. The dormer should have been constructed the same design as the 2 adjacent dormers. Consideration should have been given to the impact of these changes on the terrace as a whole.

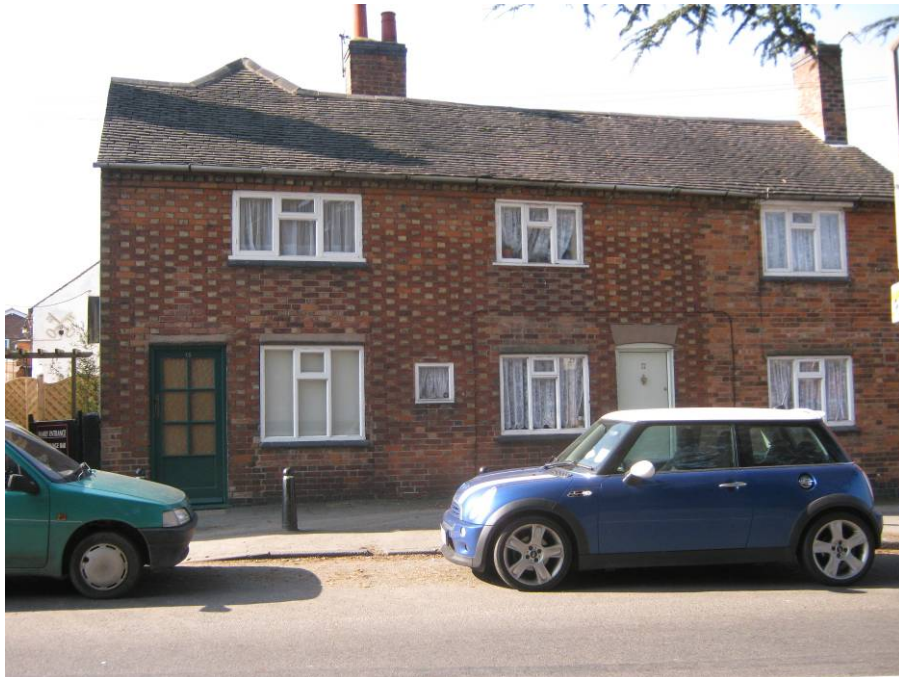
The decorative pattern on the front elevation of 15 & 17 Hinckley Road has been achieved utilizing brick headers. It is unfortunate that the traditional brick arches have been replaced by concrete lintols above the windows and doors.

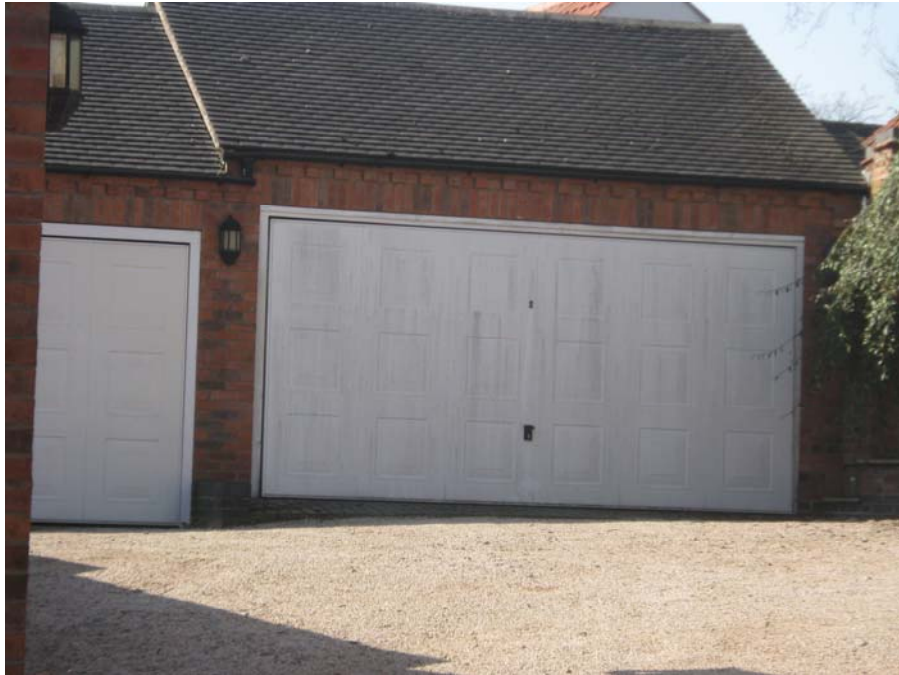
Double garage doors are not a traditional feature in conservation areas. Any future developments should consider using 2 timber doors and not as shown above.

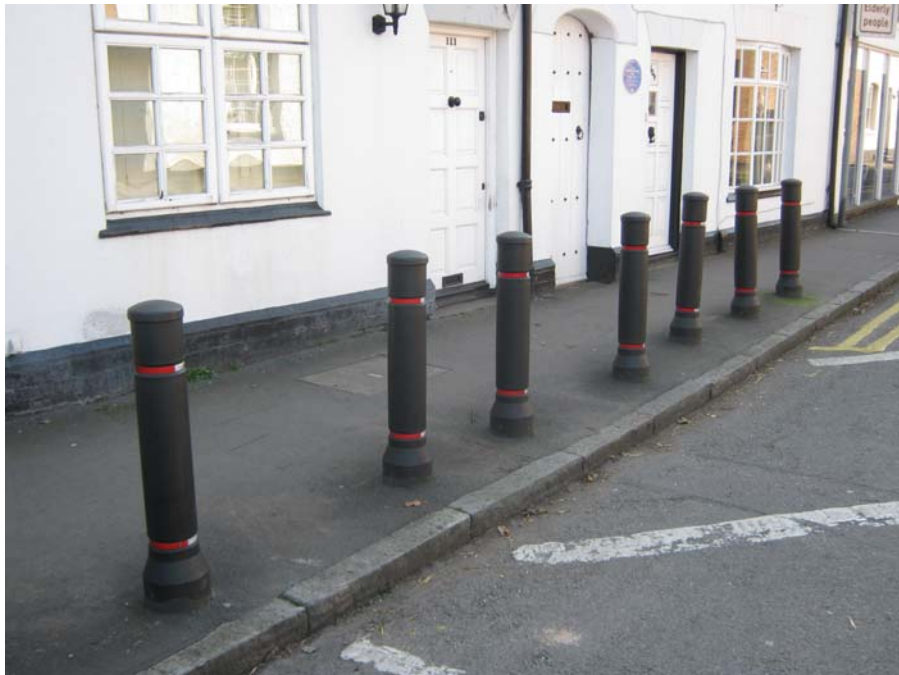
This row of unattractive plastic bollards should be replaced with the 'gunner' type bollards utilized in other areas of the centre.
