HOLLYCROFT CONSERVATION AREA MANAGEMENT PLAN - ADOPTED MARCH 2011

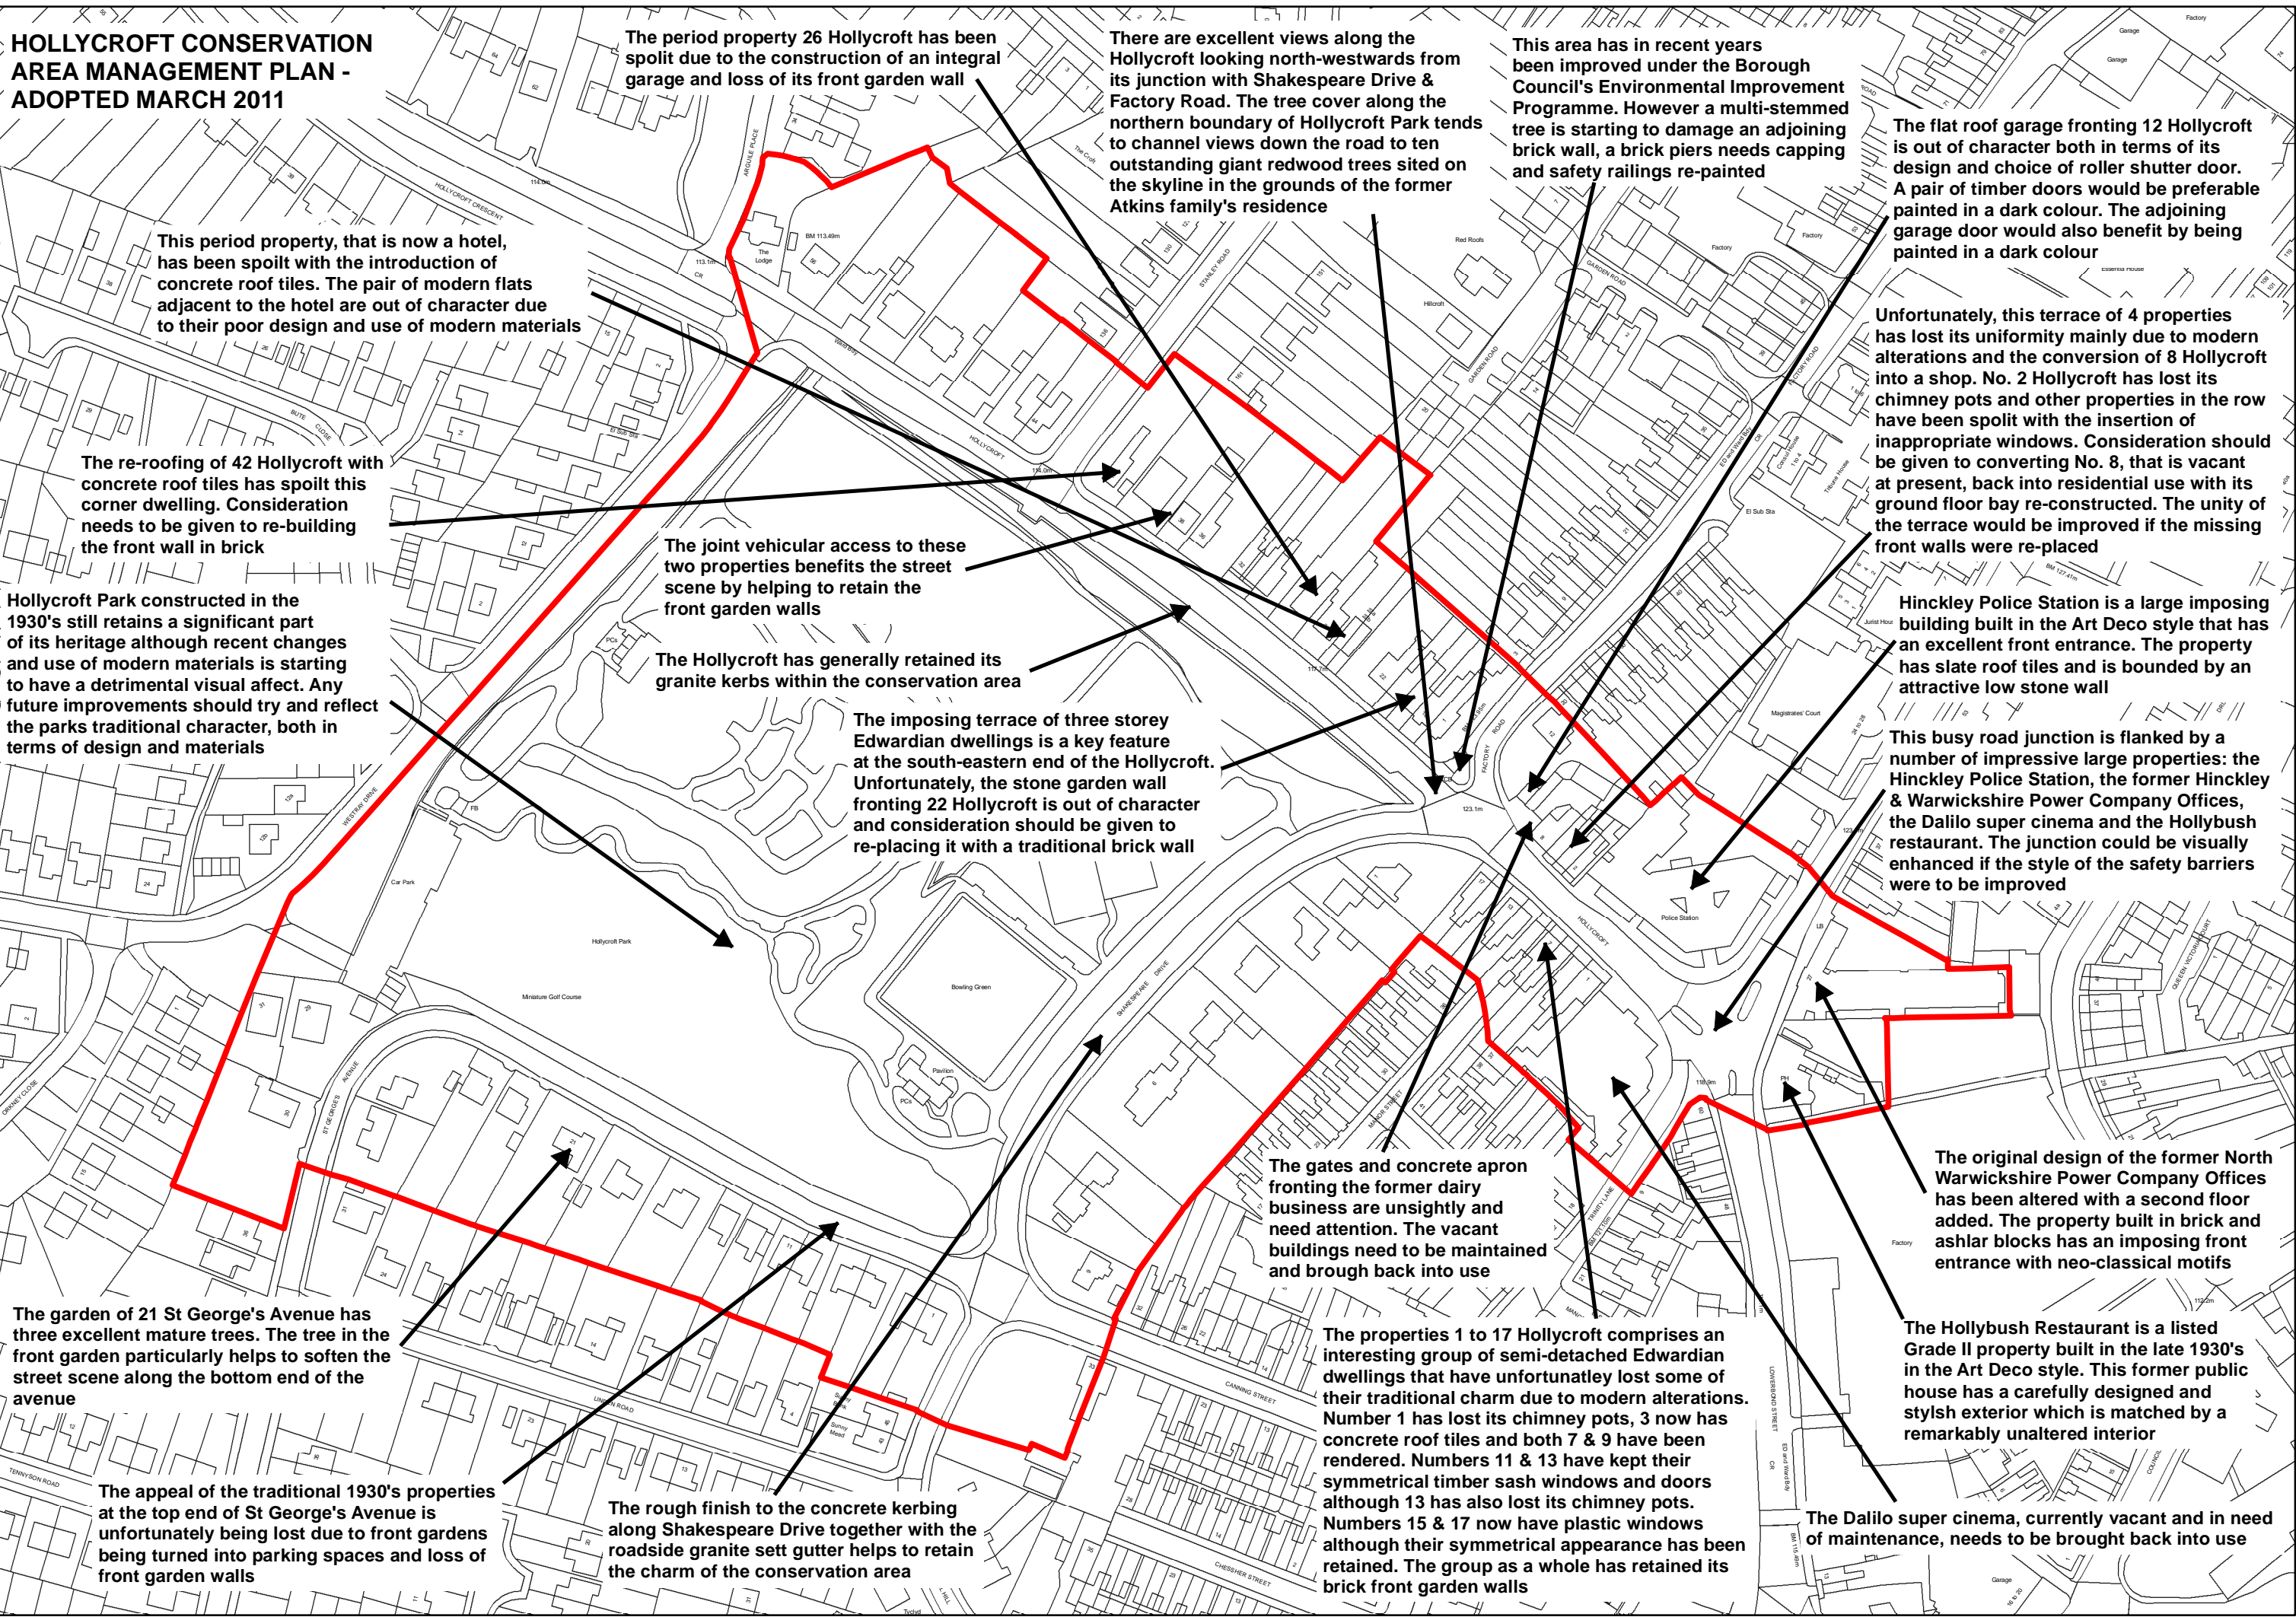
The period property 26 Hollycroft has been spoilt due to the construction of an integral garage and loss of its front garden wall

This area has in recent years been improved under the Borough Council's Environmental Improvement Programme. However a multi-stemmed tree is starting to damage an adjoining brick wall, a brick pier needs capping and safety railings re-painted

The flat roof garage fronting 12 Hollycroft is out of character both in terms of its design and choice of roller shutter door. A pair of timber doors would be preferable painted in a dark colour. The adjoining garage door would also benefit by being painted in a dark colour

This period property, that is now a hotel, has been spoilt with the introduction of concrete roof tiles. The pair of modern flats adjacent to the hotel are out of character due to their poor design and use of modern materials

Unfortunately, this terrace of 4 properties has lost its uniformity mainly due to modern alterations and the conversion of 8 Hollycroft into a shop. No. 2 Hollycroft has lost its chimney pots and other properties in the row have been spoilt with the insertion of inappropriate windows. Consideration should be given to converting No. 8, that is vacant at present, back into residential use with its ground floor bay re-constructed. The unity of the terrace would be improved if the missing front walls were re-placed

The re-roofing of 42 Hollycroft with concrete roof tiles has spoilt this corner dwelling. Consideration needs to be given to re-building the front wall in brick

The imposing terrace of three storey Edwardian dwellings is a key feature at the south-eastern end of the Hollycroft. Unfortunately, the stone garden wall fronting 22 Hollycroft is out of character and consideration should be given to re-placing it with a traditional brick wall

The gates and concrete apron fronting the former dairy business are unsightly and need attention. The vacant buildings need to be maintained and brought back into use

The properties 1 to 17 Hollycroft comprises an interesting group of semi-detached Edwardian dwellings that have unfortunately lost some of their traditional charm due to modern alterations. Number 1 has lost its chimney pots, 3 now has concrete roof tiles and both 7 & 9 have been rendered. Numbers 11 & 13 have kept their symmetrical timber sash windows and doors although 13 has also lost its chimney pots. Numbers 15 & 17 now have plastic windows although their symmetrical appearance has been retained. The group as a whole has retained its brick front garden walls

The appeal of the traditional 1930's properties at the top end of St George's Avenue is unfortunately being lost due to front gardens being turned into parking spaces and loss of front garden walls

The Dalilo super cinema, currently vacant and in need of maintenance, needs to be brought back into use
