**Hinckley Town Centre  
Conservation Area Appraisal and Management Plan**

**Photographic Record 5 - Station Road**

**February 2013**

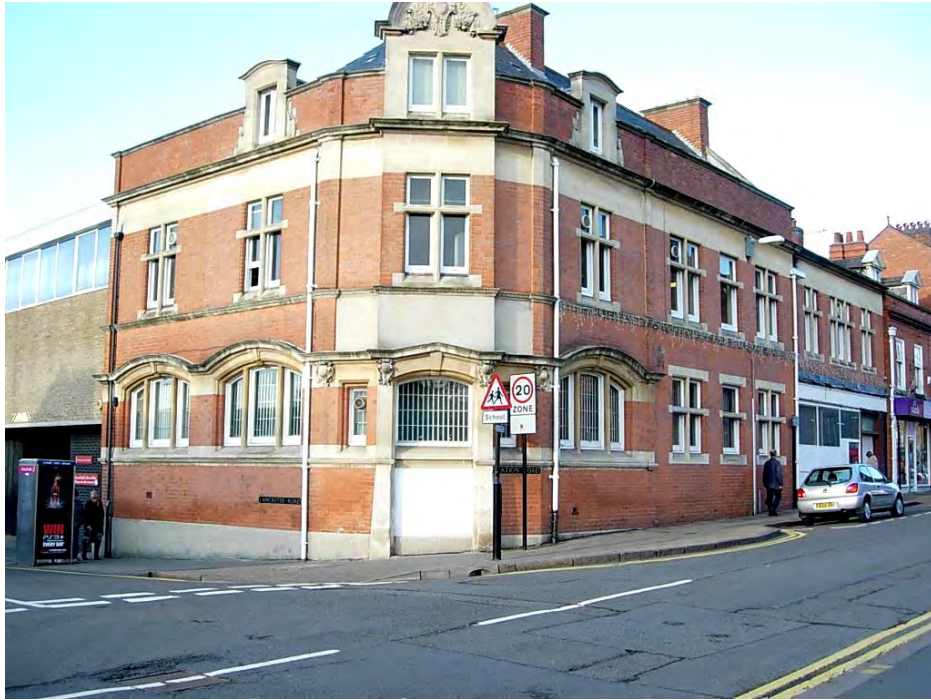
22 Station Road was originally built as the town's post office. This two and half storey office block is an imposing building and an important heritage asset sited on the corner of Station Road and Lancaster Road. The curved ground floor window lintols and the corner parapet detail are very distinctive features. Unfortunately the building has lost several of its original chimneys.

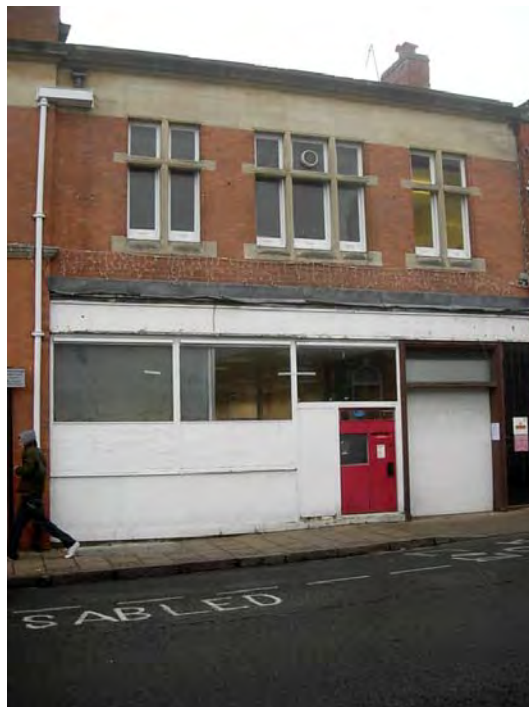
The northern section of the building was constructed with an overhanging roof and the ground floor was unfortunately rendered which detracts from the appearance of the building.

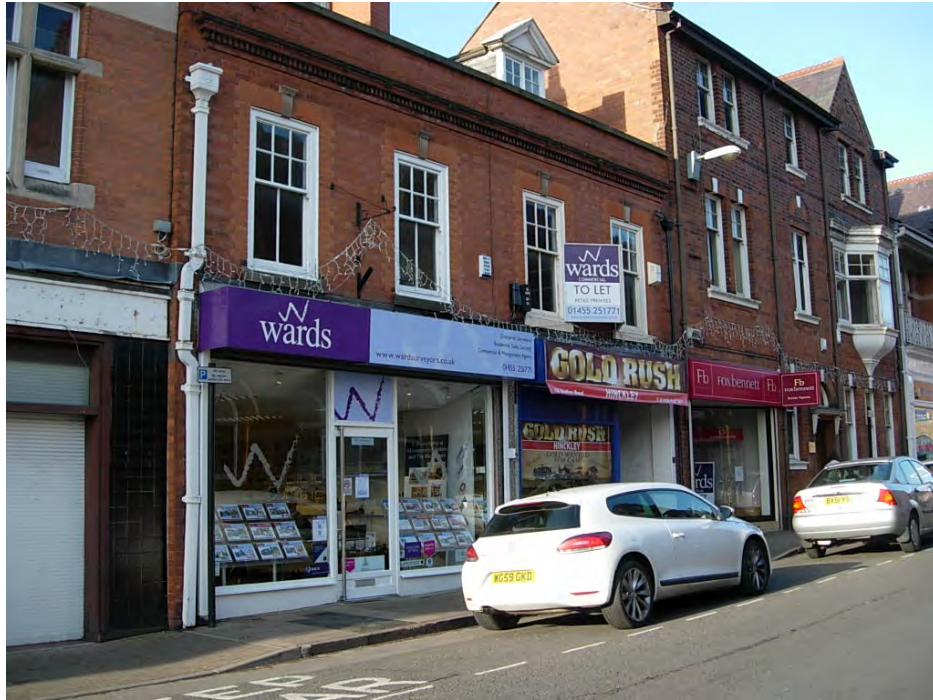
18/20 Station Road is a low key infill development that successfully links the former post office with the adjacent three story building. It is unfortunate that roller shutters have been fitted which have caused modern projecting shop fascias to be introduced above the traditional shop fronts.

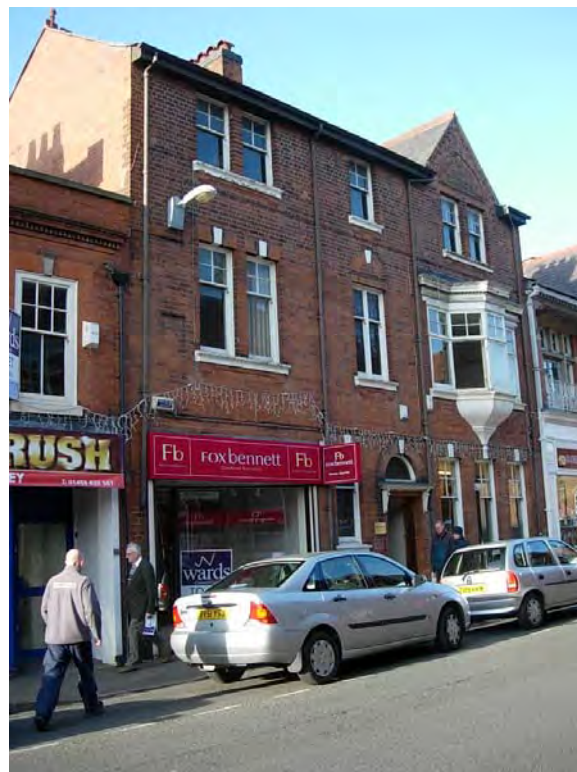
16 Station Road, although having an unbalanced elevation, is quite an attractive building and an important heritage asset mainly because of its hanging first floor bay window and roof level gablet. The central entrance door gives access to the first floor offices. It is believed that the shop window is a later addition.

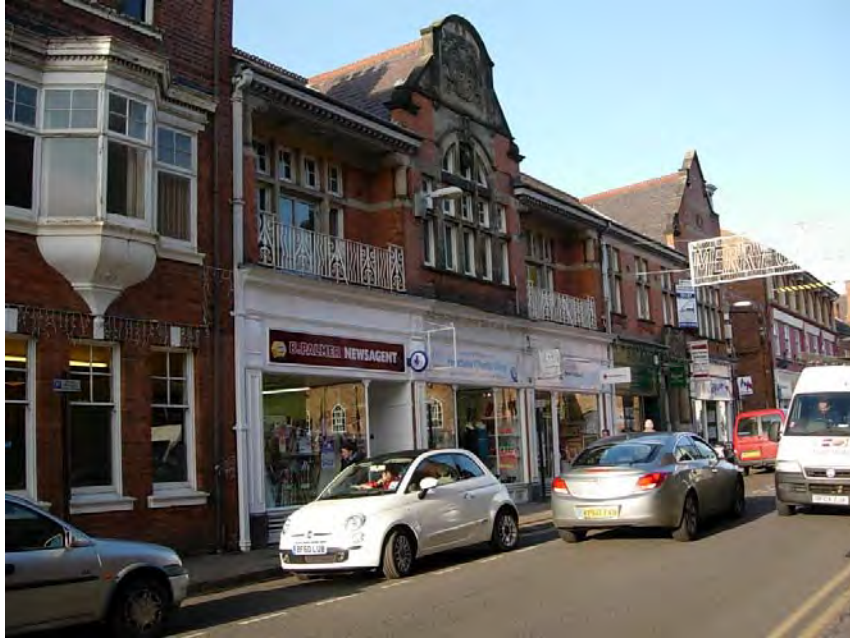
10-14 Station Road is a fine example of an Edwardian shopping complex and an important heritage asset. It includes standardized shop fronts, recessed balconies with decorative cast iron railings and twin flush gables.

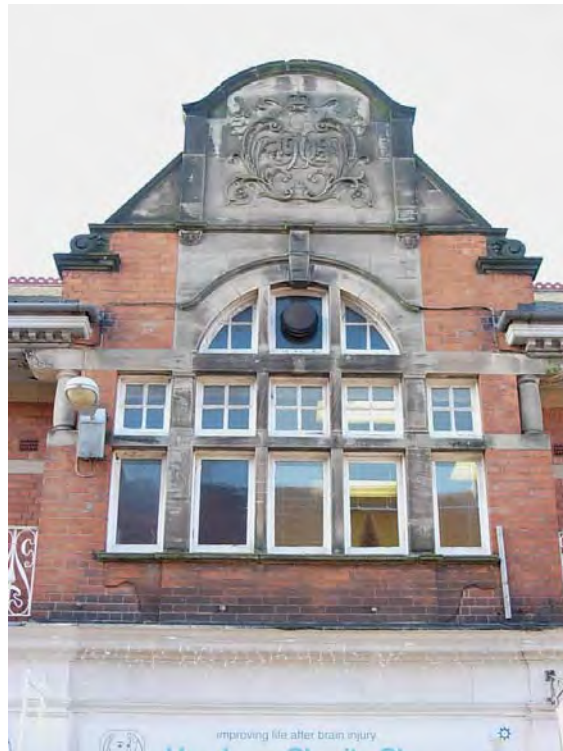
This detail picture of the gable on 12 Station Road highlights the designer's interest in stonework details which includes the decorative date stone, volutes and cornice.

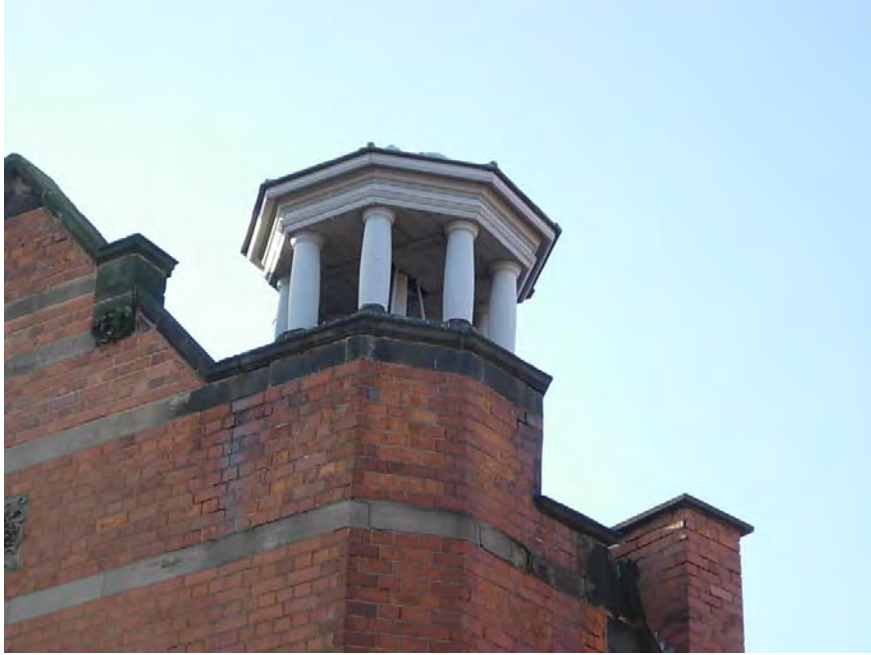
8 Station Road includes a feature turret structure on the corner of the building. Corner features occur frequently on traditional buildings in the town centre.

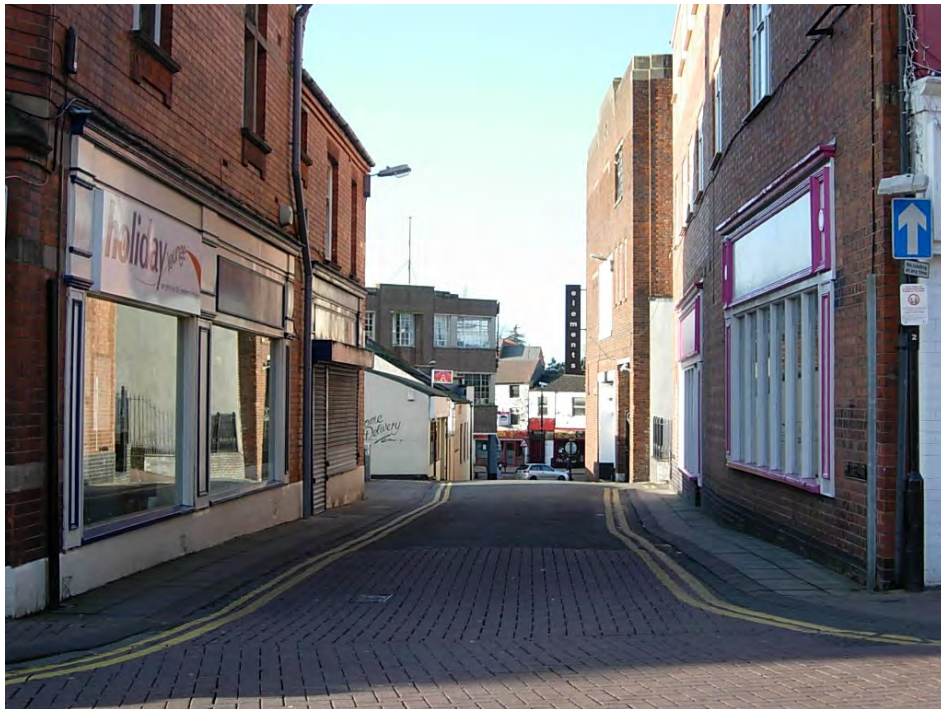
View looking westwards down The Horsefair. The buildings on the two corners of this street form a strong sense of enclosure and direct the view towards the former liberty hosiery factory at the end of the street.

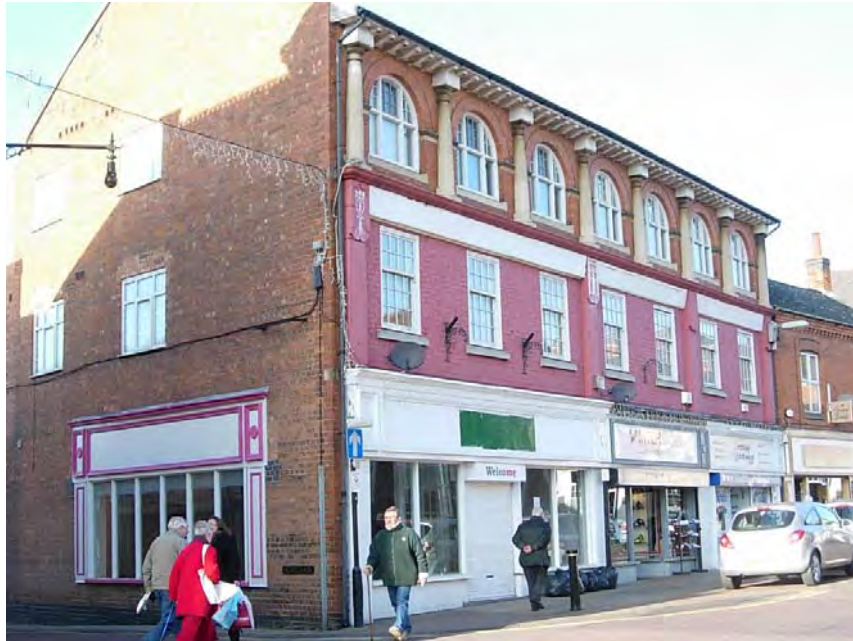
4a-6a Station Road has suffered from inappropriate changes to the street elevation because its appearance originally included three 2 storey glazed screens. Although it now includes traditional features such as sash windows and recessed shop entrances, the painted brickwork is unfortunate and it does not have the elegance of the original structure.

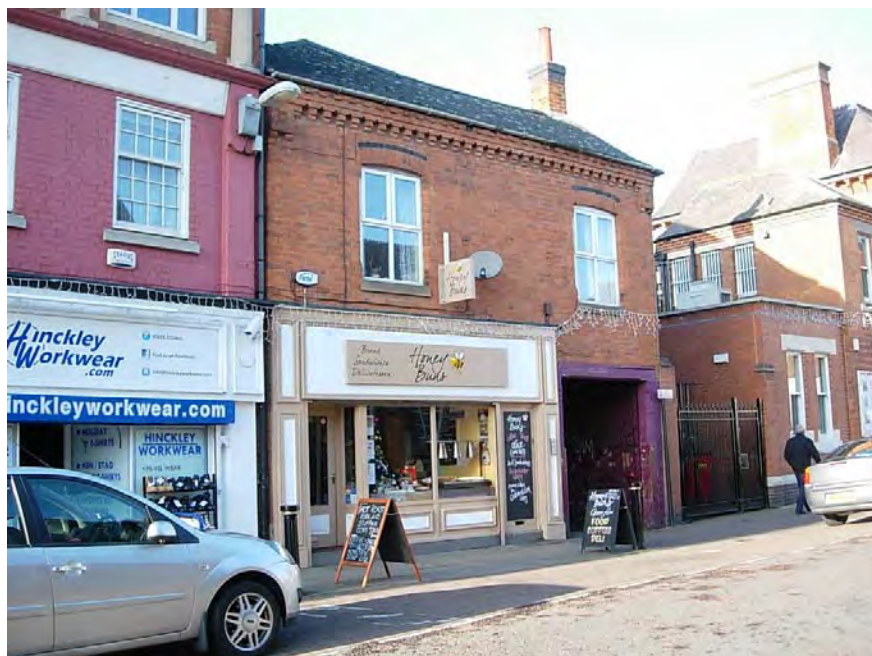
4 Station Road has a simple elevation that includes a cart entrance and shop front with recessed entrance that adds character to this part of the street and is an important heritage asset.

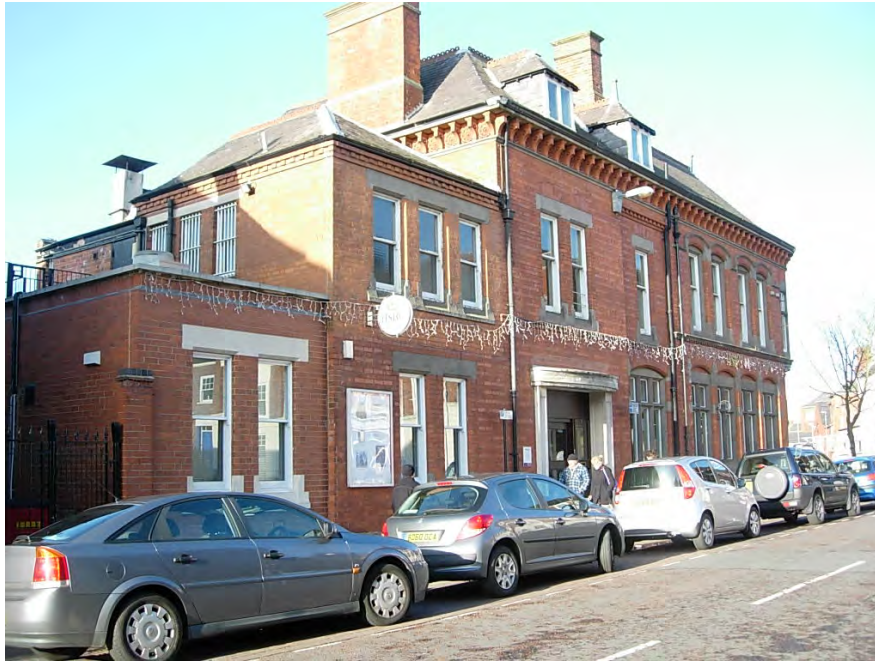
The HSBC bank on the corner of the Market Place is a grand building which has many fine details and forms a significant end to Station Road. This street is one of the most interesting in the town centre and is an important heritage asset in the Conservation Area. It is essential that none of the buildings are lost to redevelopment in the future.

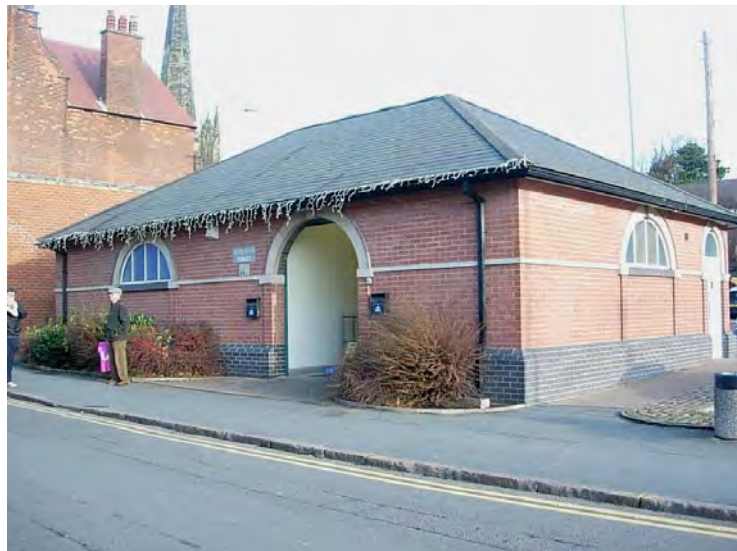
The public toilets, although performing a useful function, has replaced an architecturally very significant community billiard hall. The current building is out of scale with other buildings in the street.

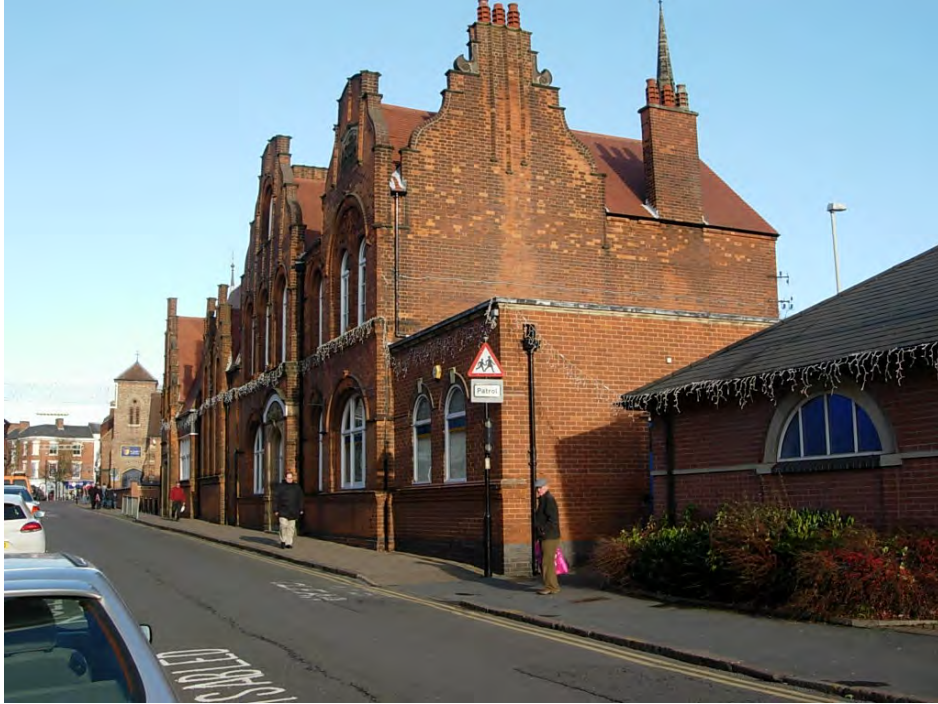
This former Council office building has many striking architectural features, particularly its gables which are landmark features in the street.

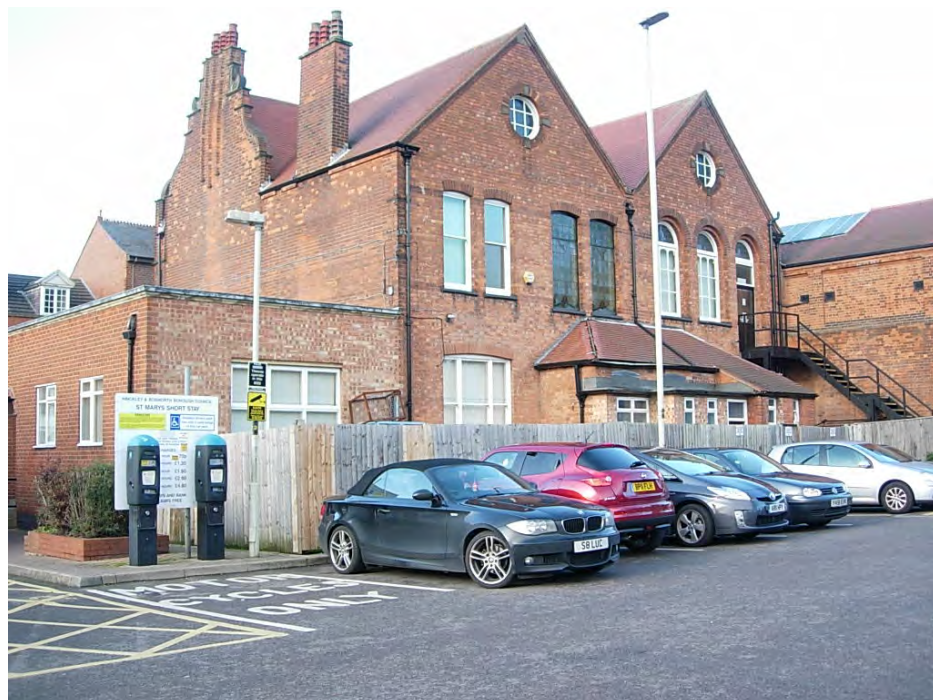
The elevation of the former Council offices which faces the car park has been modified with the addition of inappropriate extensions and a steel escape staircase. The appearance of the building, which is listed, would be improved if the boundary fence was replaced with a brick wall.

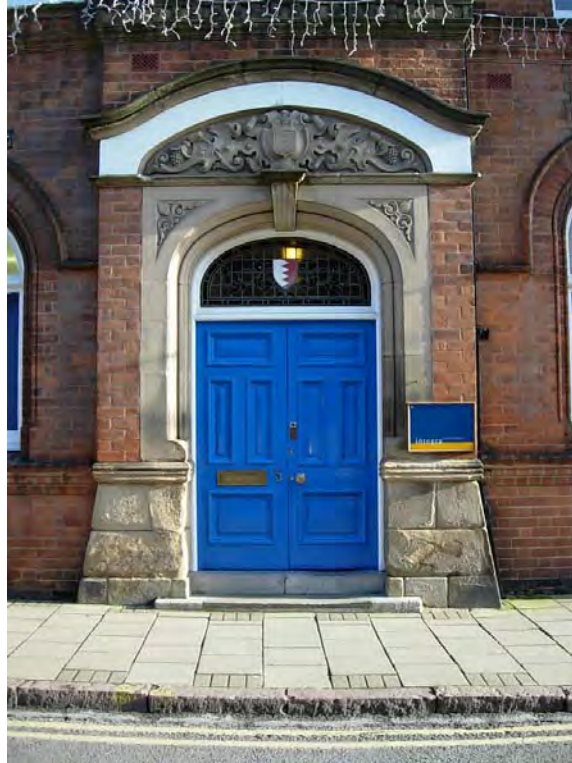
The entrance to the former council offices is a significant architectural feature in the street.

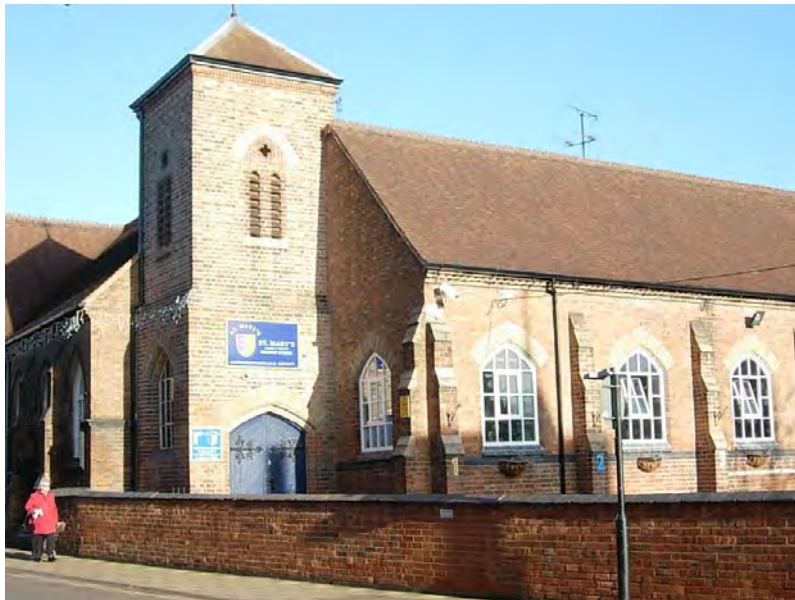
St Mary's school is a Gothic revival building that adds significant character to the street and its tower ensures the building successfully turns the corner with a structure of note.

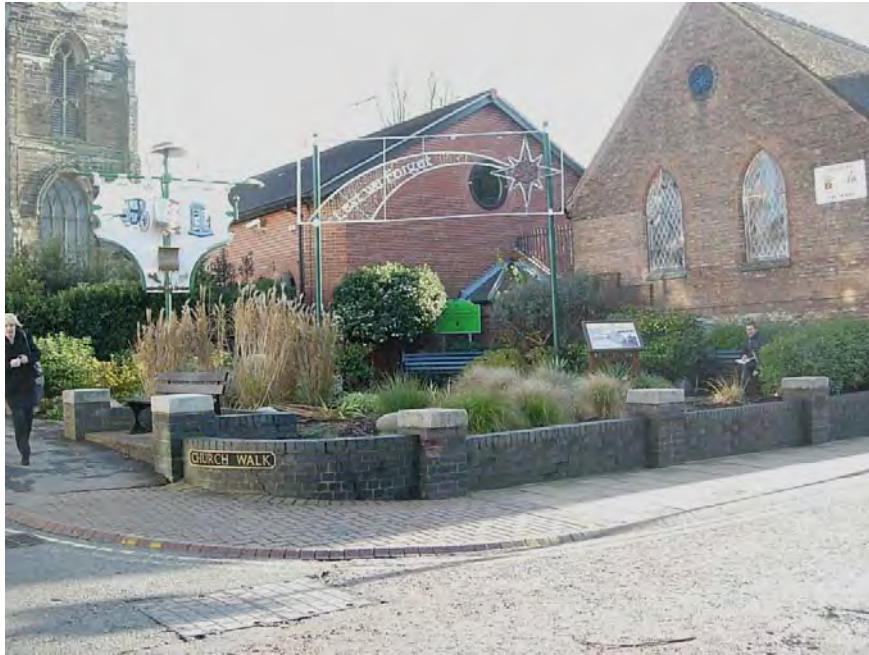
The north-west corner of the school, although providing a small garden for public use, has a very uncomfortable appearance because it fails to link the new structure to the old.
