**Ratby Conservation Area Appraisal and Management
Plan**

**Photographic Record 2 – Church Lane, Chapel Lane &
Berrys Lane**

**December 2013
(Adopted February 2014)**

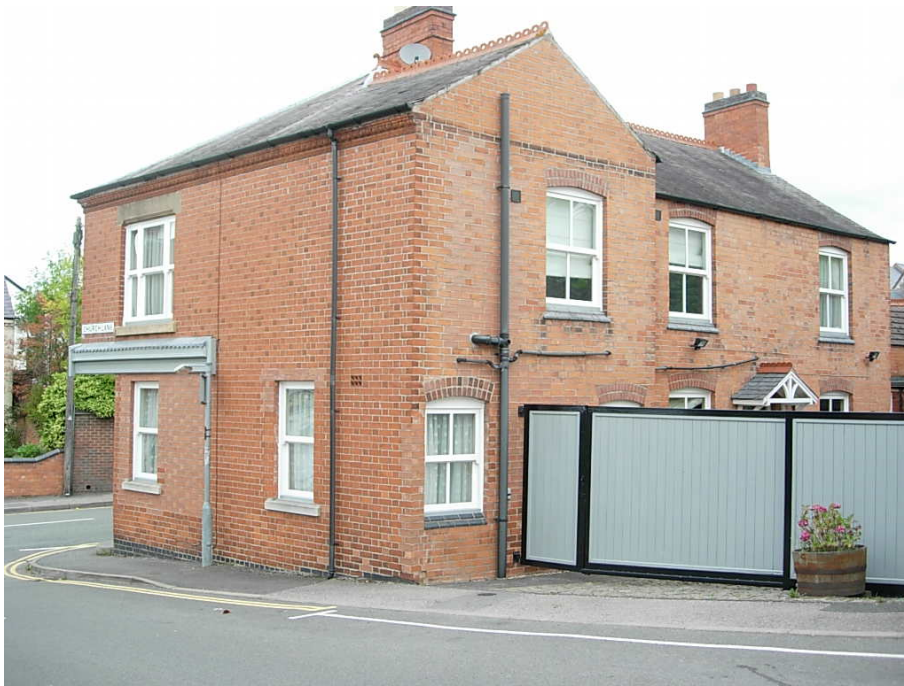
The high timber fence to the rear of 88 Main Street is not in keeping with the traditional character of the property.

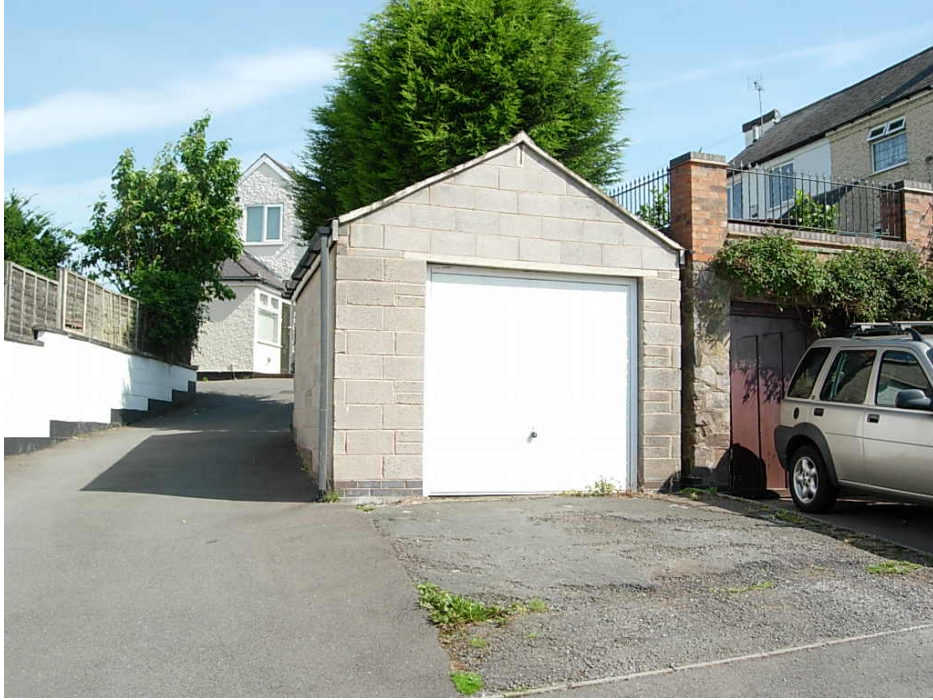
The materials of this garage are unsympathetic to the Conservation Area.

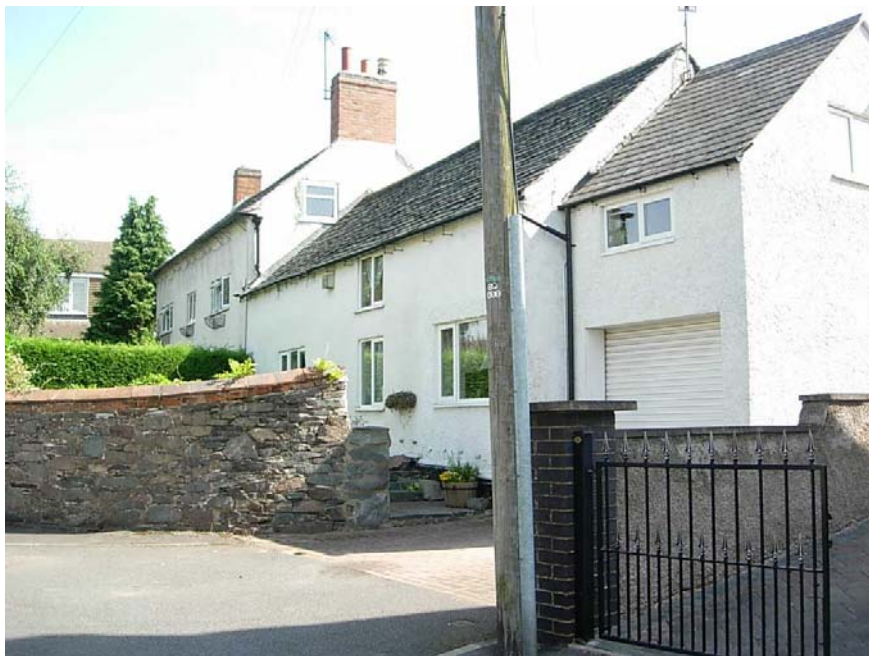
The integral garage built on the end of Nook Farm is a non-traditional feature.

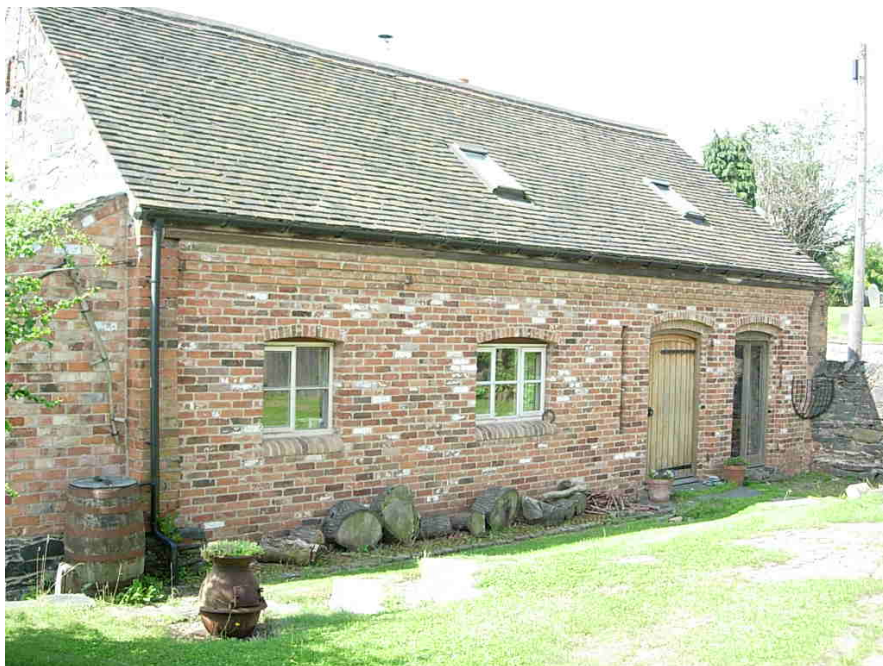
This property, once linked to Woodley Farm, has been converted to residential use. The roof lights would be less prominent had they been recessed.

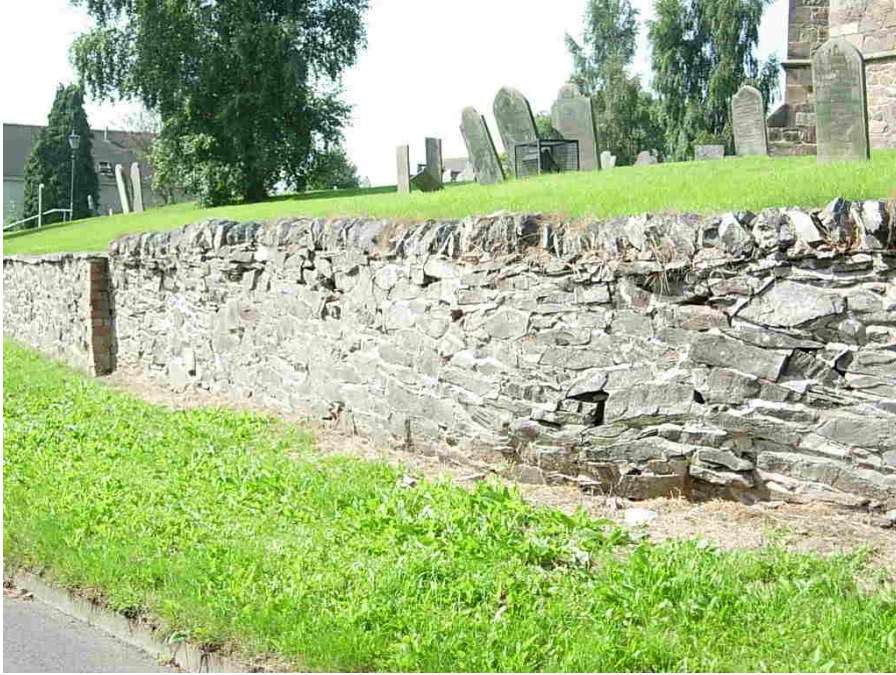
This section of churchyard retaining wall is starting to bulge due to the wet weather but is due to be re-built shortly.

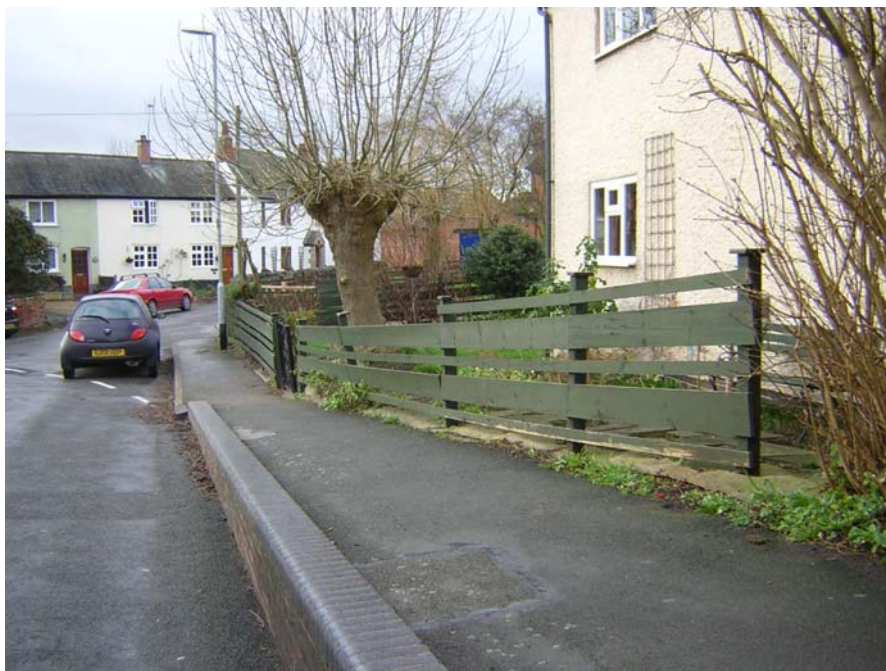
The timber fence fronting 68 Church Lane is visually poor. Consideration should be given to replacing it with a traditional stone or brick wall.

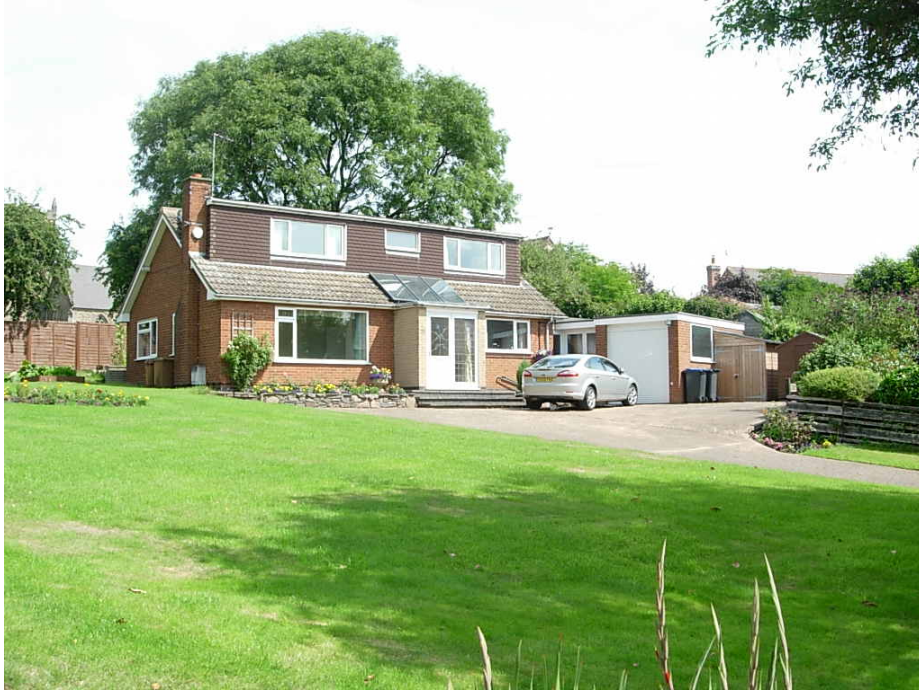
The property, 70 Church Lane, is a modern dormer bungalow set well back from the highway. The front dormer is a prominent feature that tends to visually dominate the dwelling. Dormers should not extend the whole length of a property and should be set below the ridge.

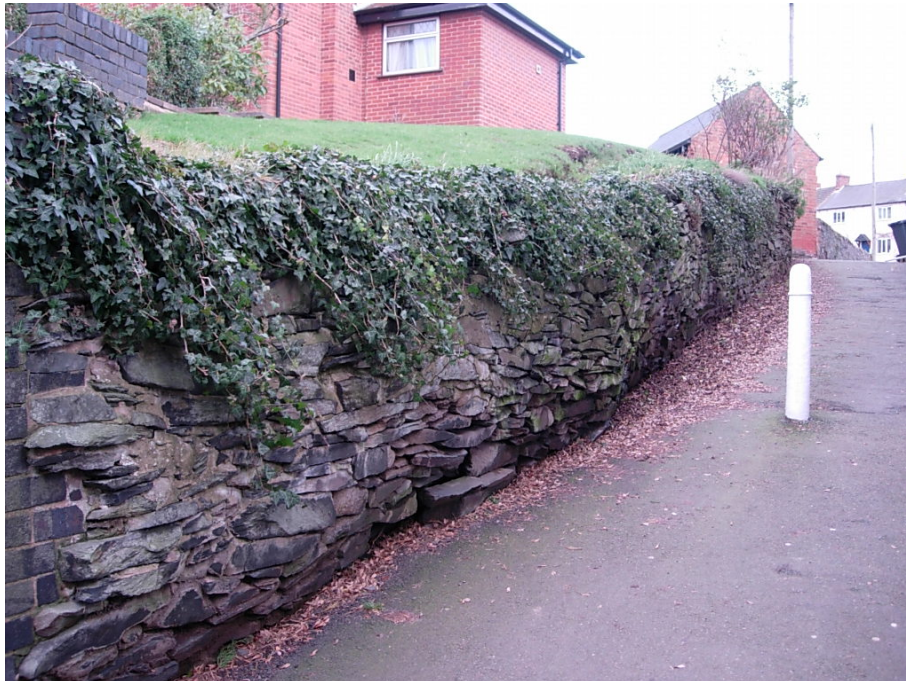
Although the stone wall fronting 19 Berry's Lane is starting to bulge, every effort should be made to keep this feature which enhances the character of the lane.

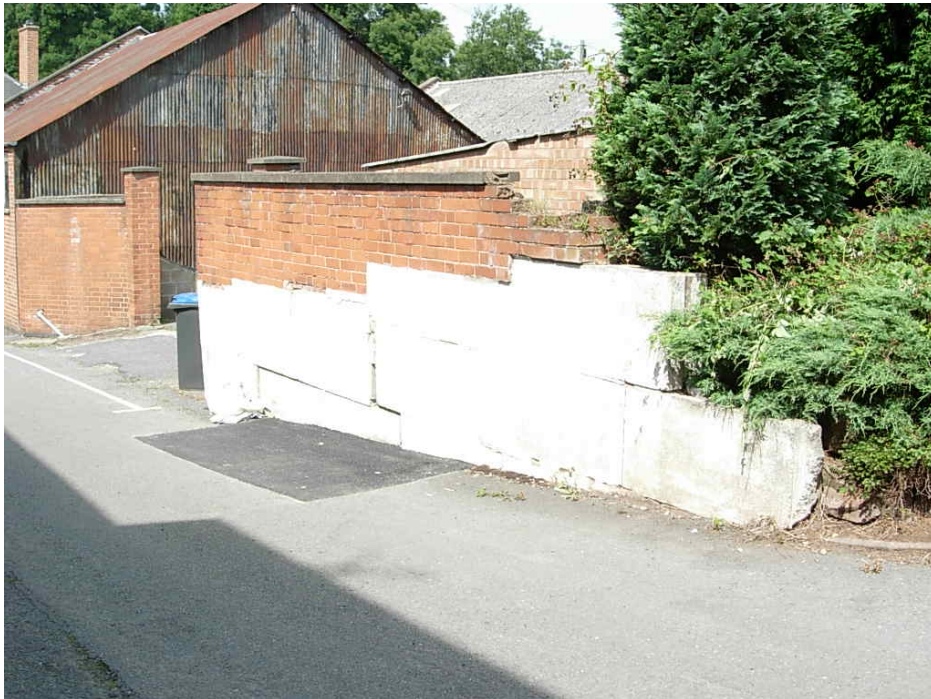
The repairs to this wall on Berry's Lane using concrete blocks is another feature that has a detrimental impact on the visual quality of the lane.

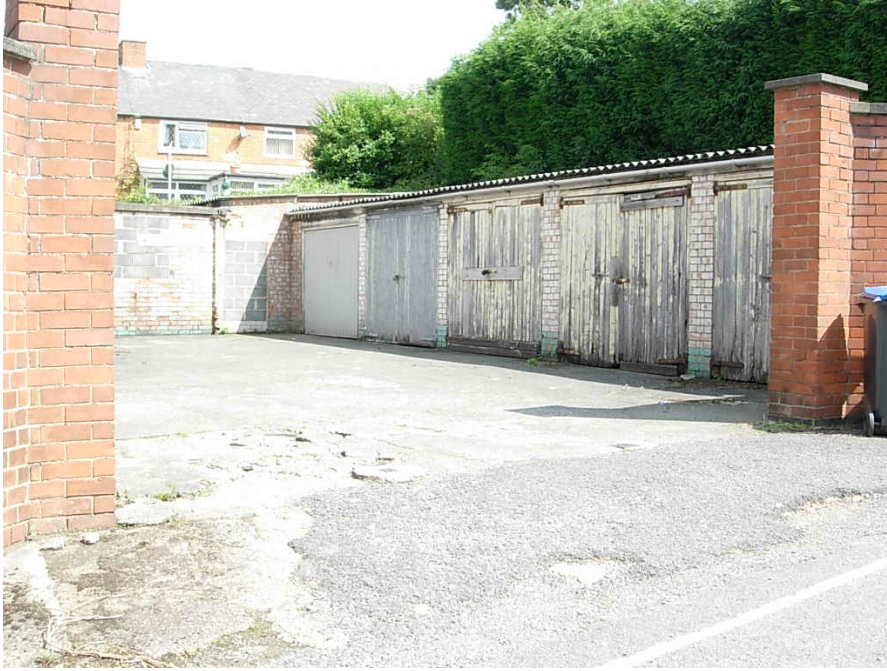
Views into this garage court are poor. In the short term, consideration should be given to re-painting the doors.

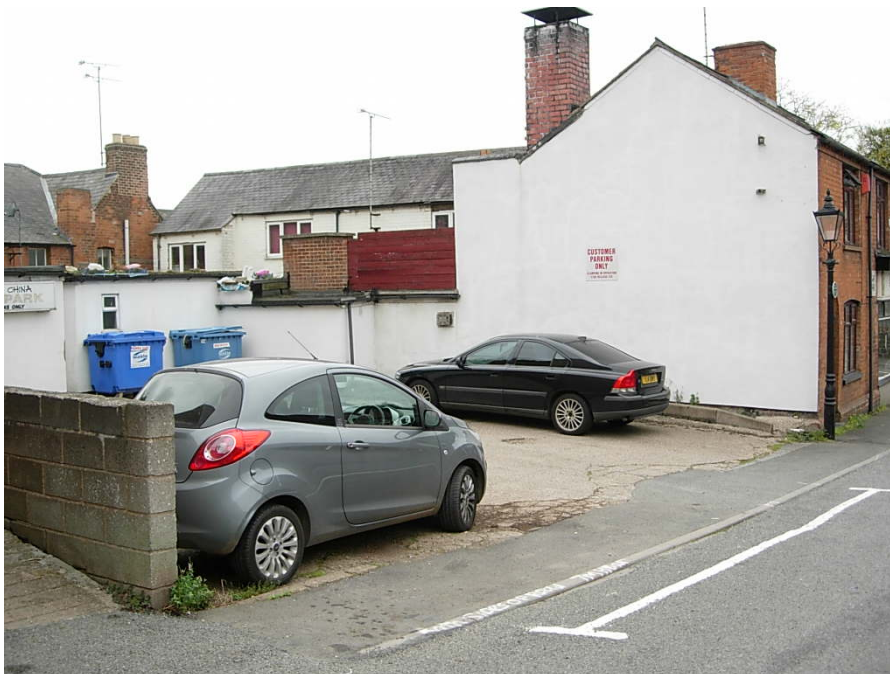
The enclosure at the bottom end of Berry's Lane is lost along this car park frontage. A short length of wall built along the back edge of the footpath would help to reduce the width of this gap in the streetscene.

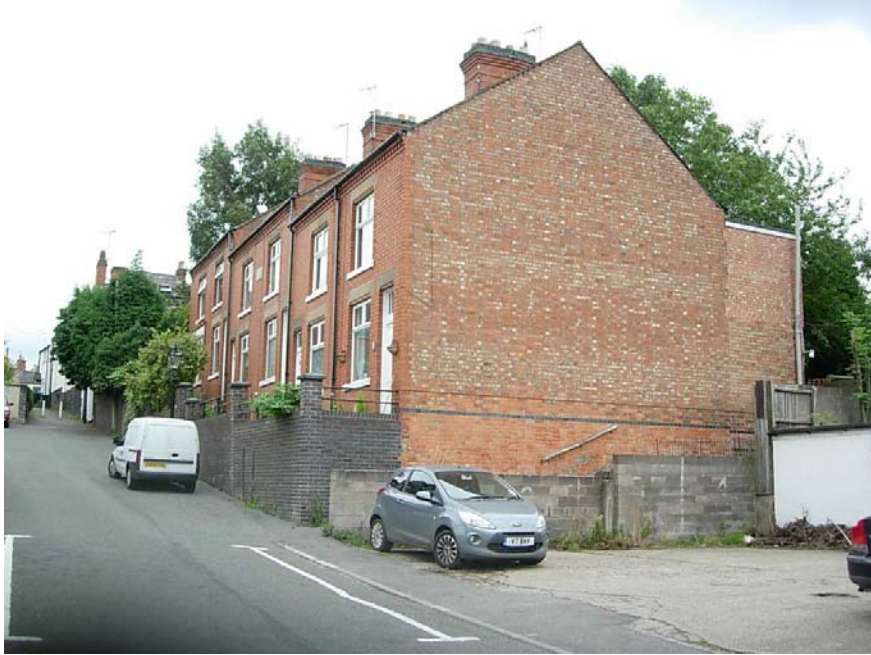
The gable to the block of the Victorian dwellings 8–18 Berry's Lane, built in 1898, is a prominent feature. The concrete block wall running down the side boundary of the Chinese take-away car park is an incongruent feature in the Conservation Area.

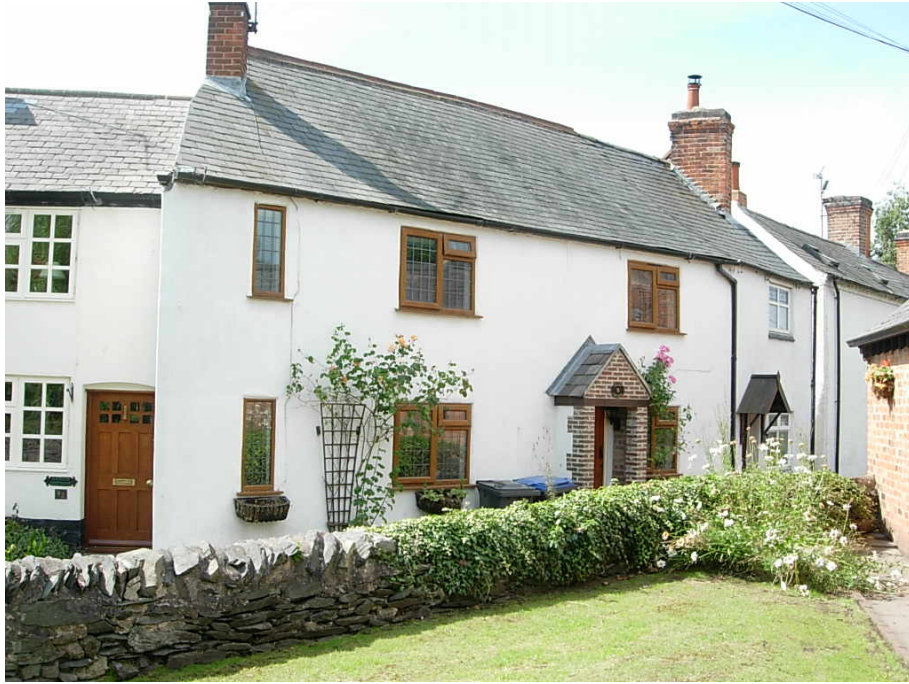
This cottage at the top of Berry's Lane has unfortunately had its timber windows replaced with plastic.

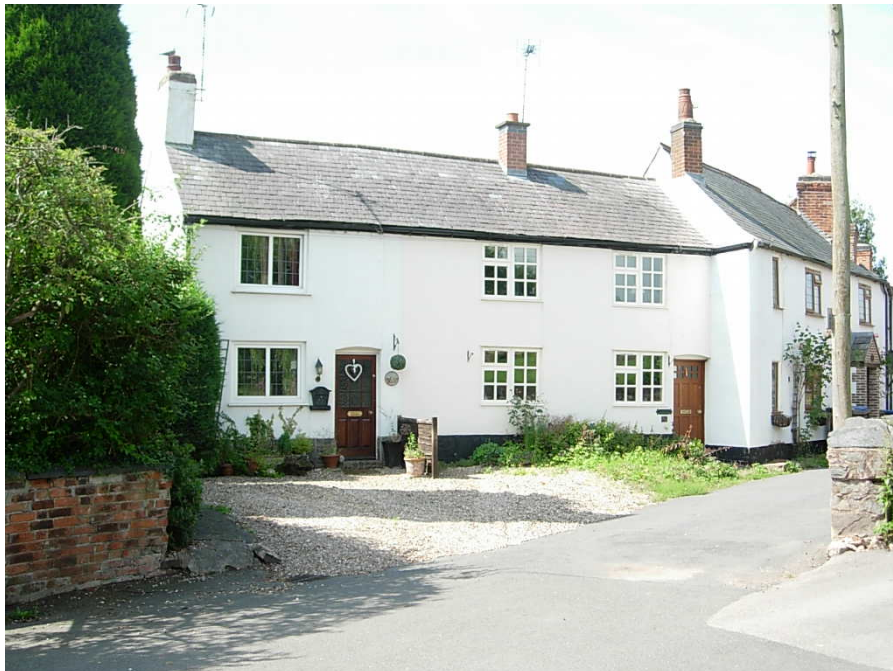
This view highlights the detrimental impact that different styles of window can have on terraced properties.

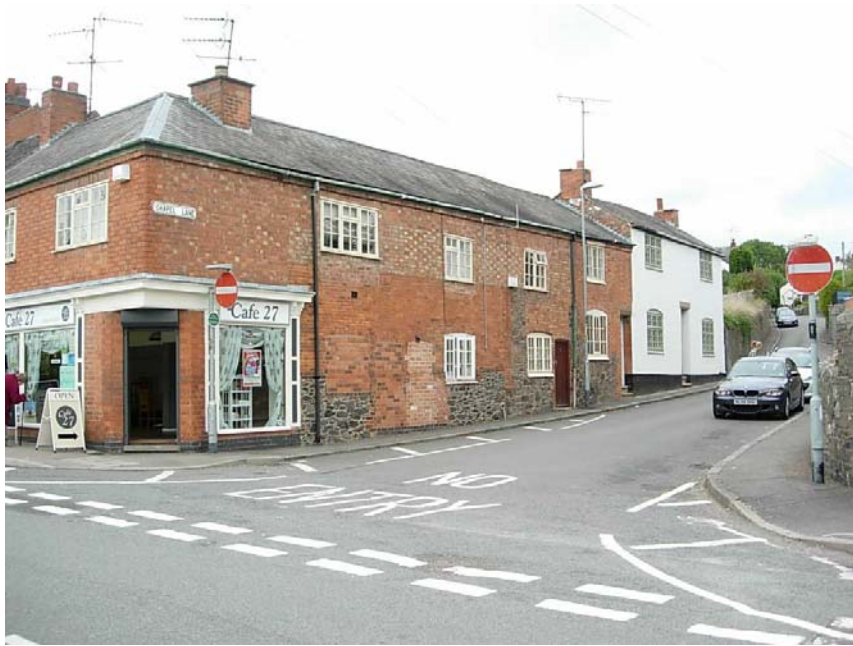
Unfortunately this terrace has lost some chimneys, had others truncated and the segmental heads to its first floor window openings have been straightened. As a result there has been a loss of character in the streetscene.

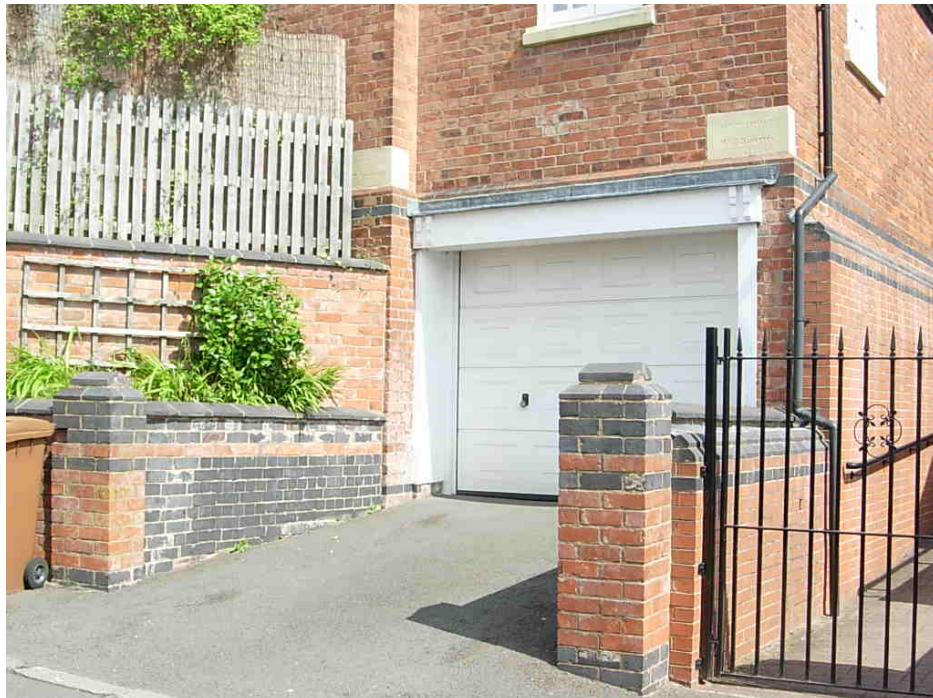
The appearance of the garage door in the former Church Rooms would be improved if painted a darker colour.

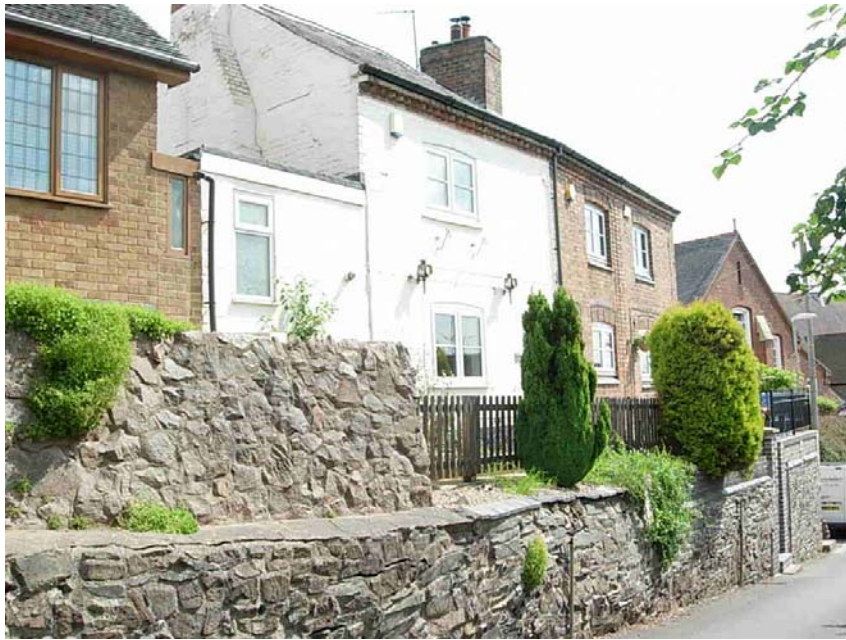
The flat roofed side extension to these traditional properties would be considerably improved if it was replaced with a pitched roof.

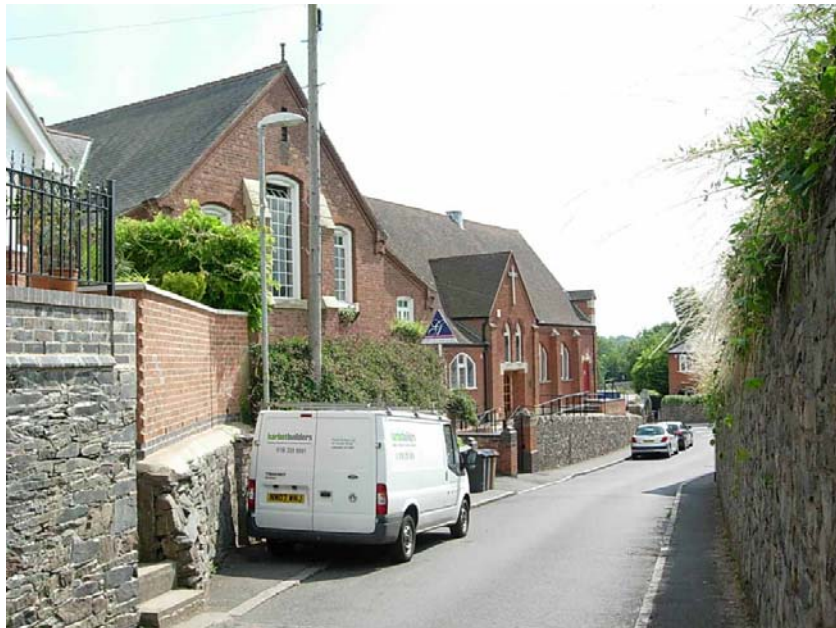
The brick retaining wall in this view along Chapel Lane would have enhanced this part of the Conservation Area if stone had been used instead.

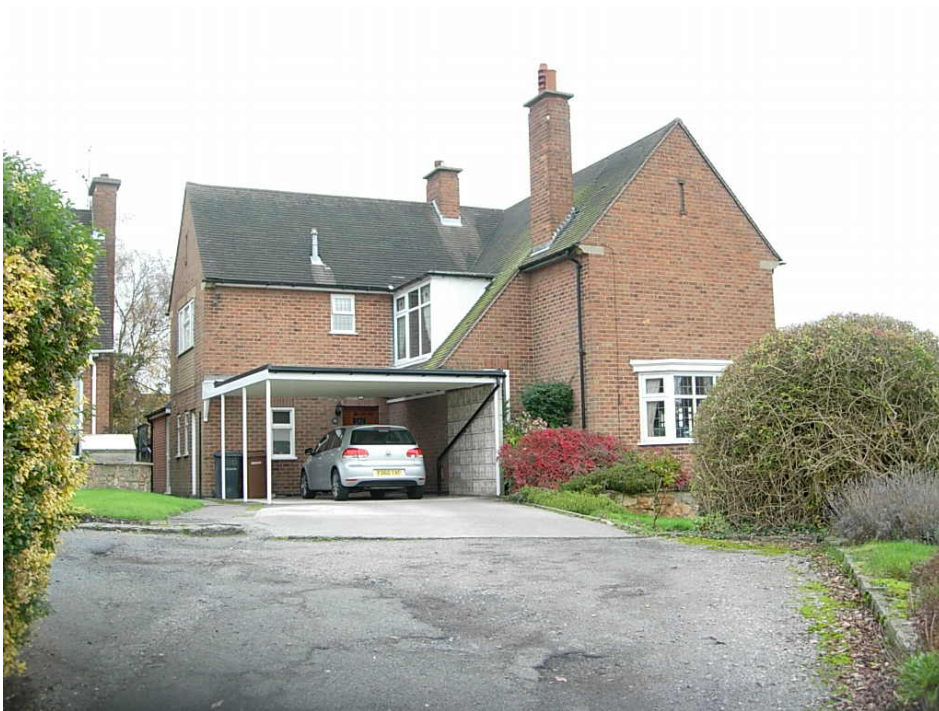
The scale of the dormer structure and flat roof car port at 32 Chapel Lane tend to dominate the appearance of the traditional period property.

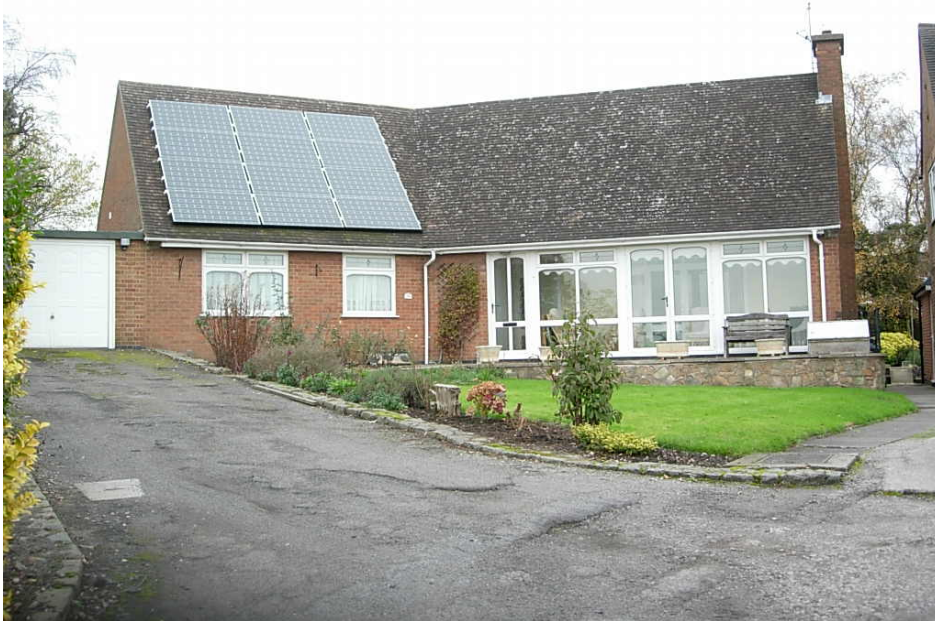
The solar panels on the roof of 34 Chapel Lane dominate the front elevation of the bungalow. Where possible solar panels should be located on rear elevations away from public view.
