**Market Bosworth Conservation Area Appraisal and
Management Plan**

**Photographic Record 1
The Park, Bosworth Hall, Church Street and Barton Road**

March 2014

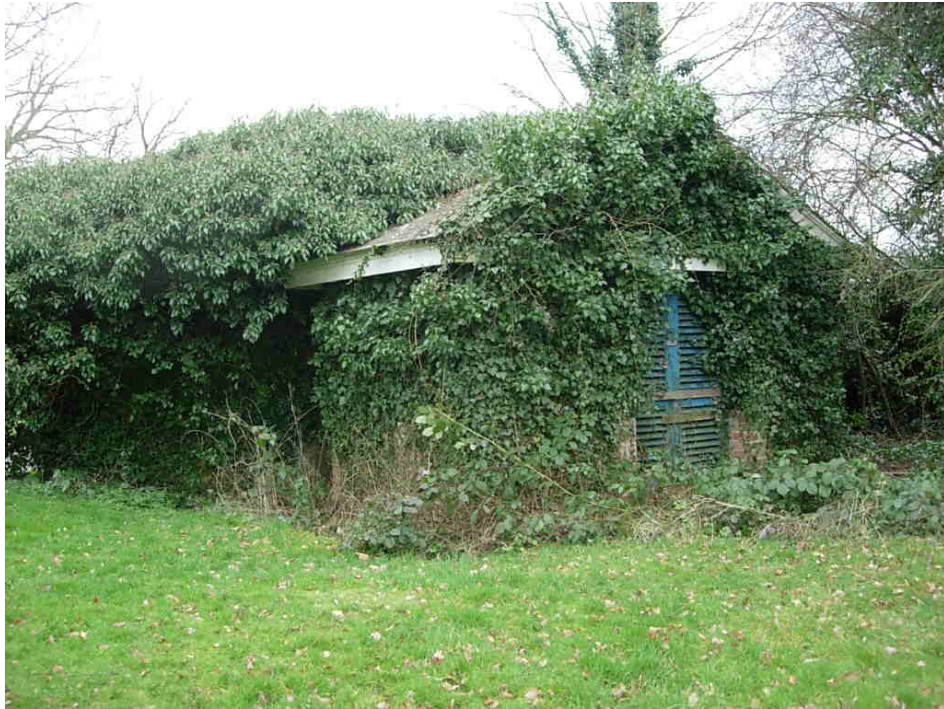
This feature building in front of Bosworth Hall is in need of urgent maintenance.

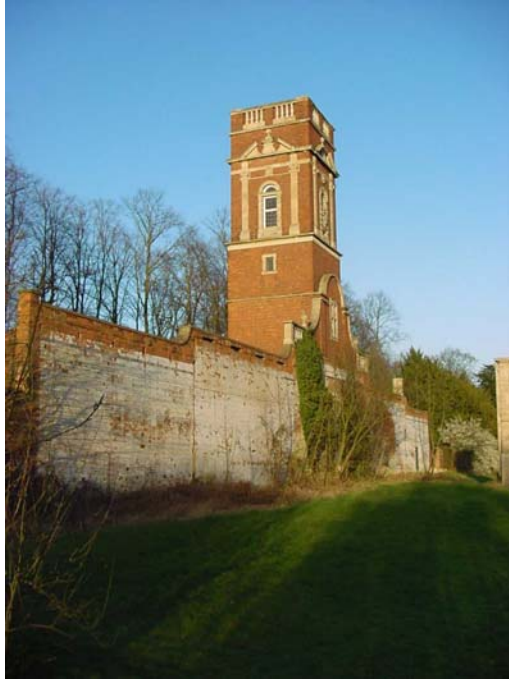
This Watertower is a major landmark visible on entering the Conservation Area. It unfortunately is in desperate need of repair.

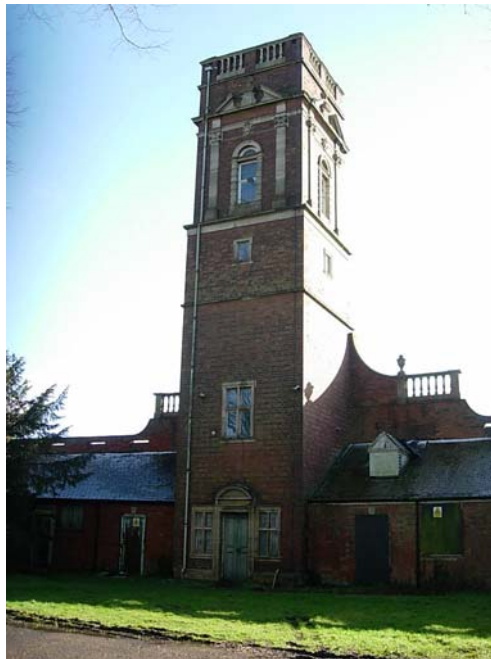
The Watertower, seen from the north, highlights the urgent need for repairs.

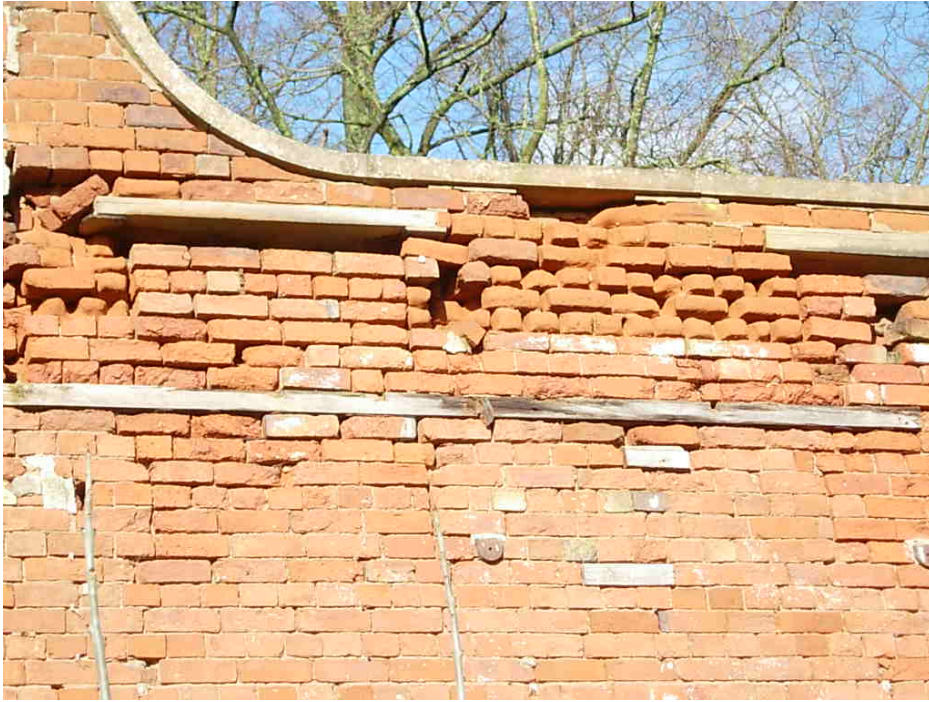
This is an example of the brickwork to the walled garden which is also in need of urgent conservation.

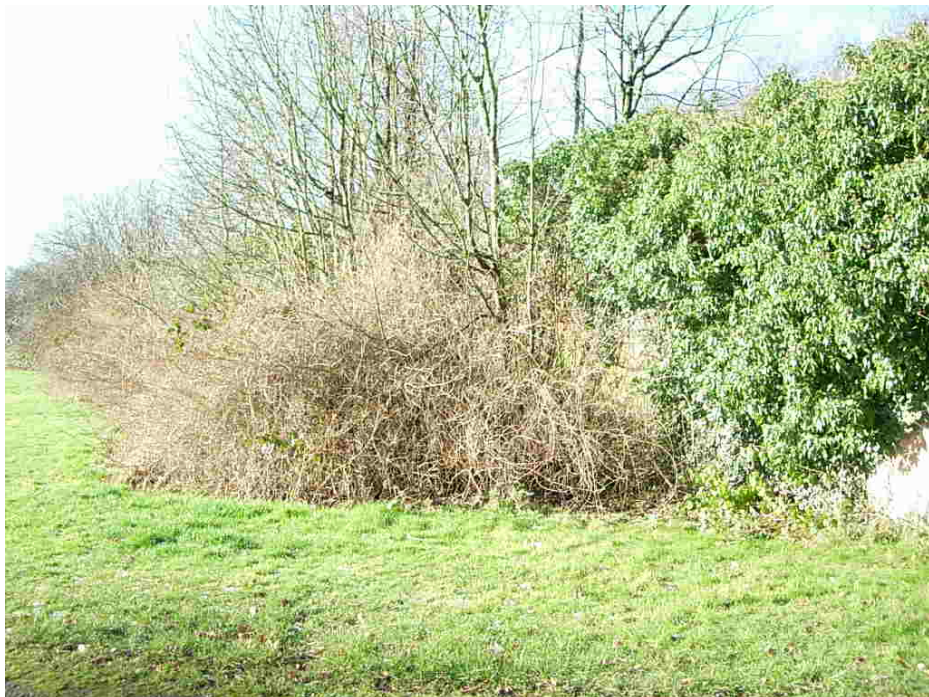
Ivy and self set trees are undermining the stability of the walls around the walled garden. They need to be removed urgently.

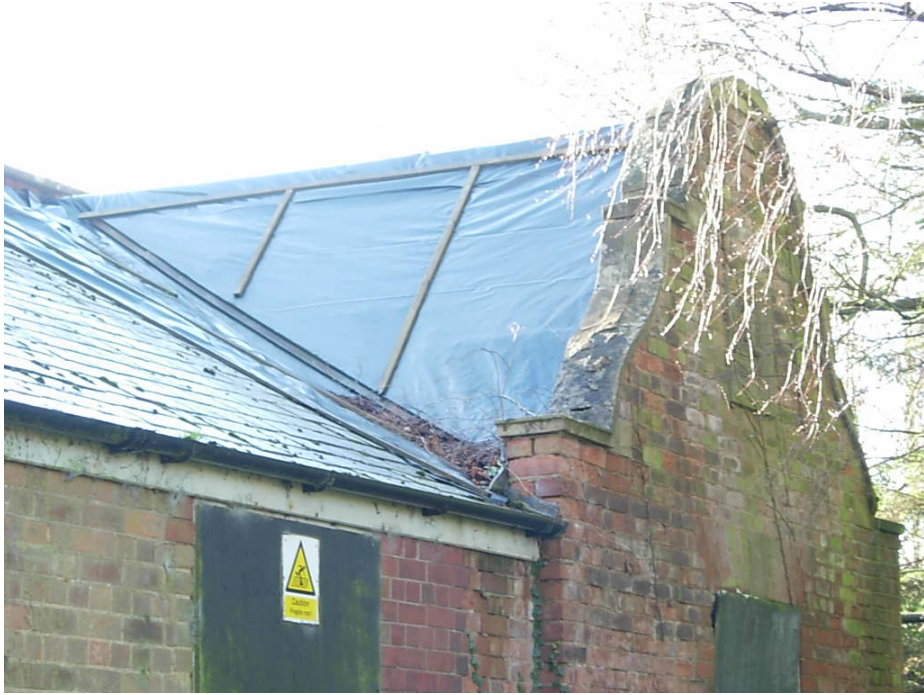
Short term repairs have been made to these garden buildings but they are inadequate and more permanent repairs are needed.

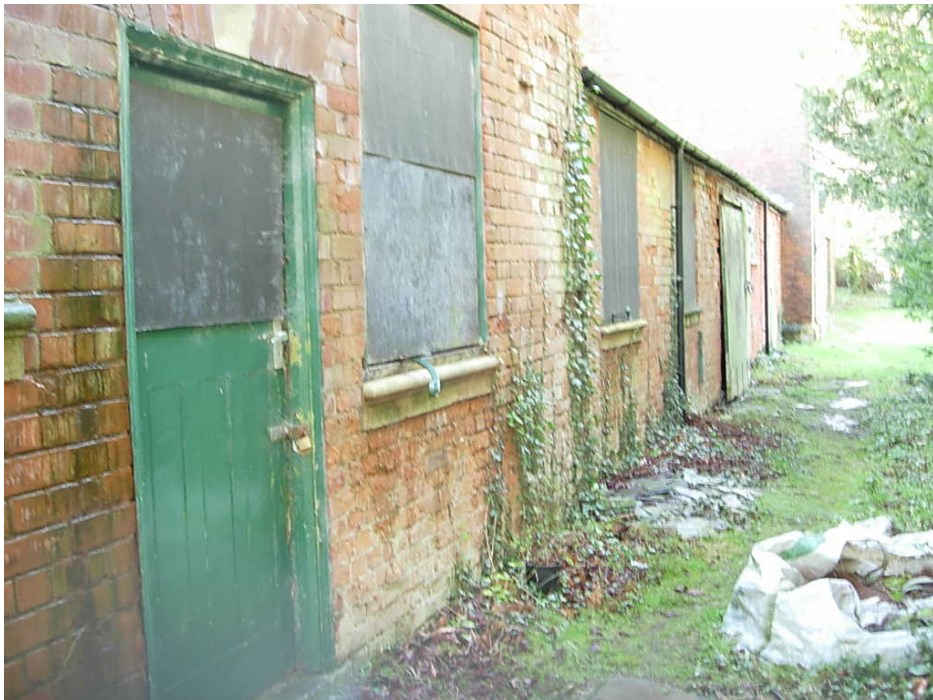
Boarding up windows and doors is not acceptable and a more permanent solution is required.

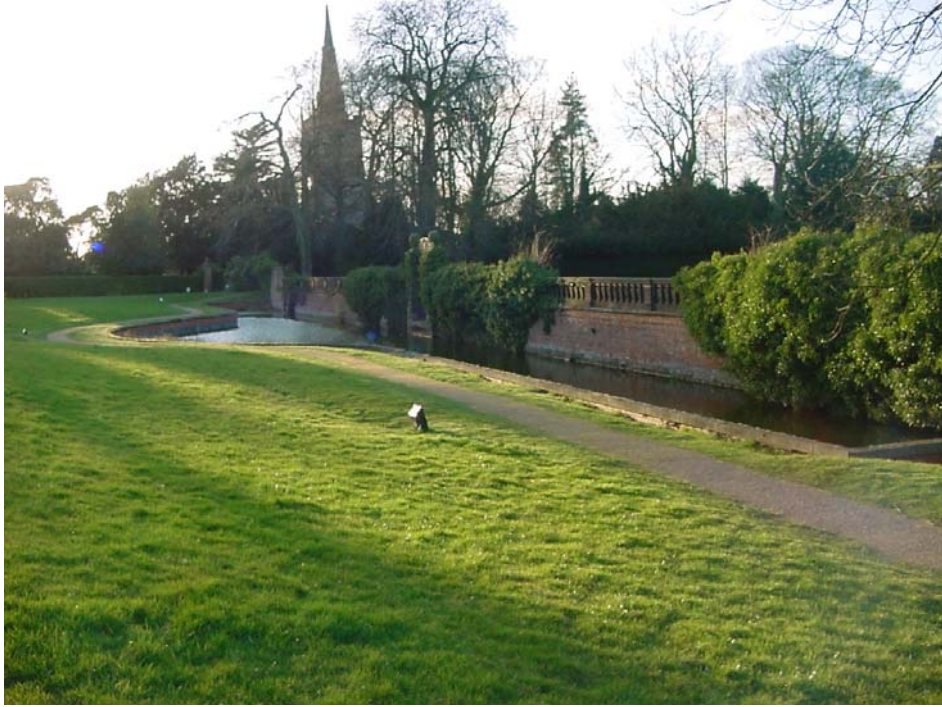
The walls around the garden are becoming over-run with ivy which is damaging the pointing.

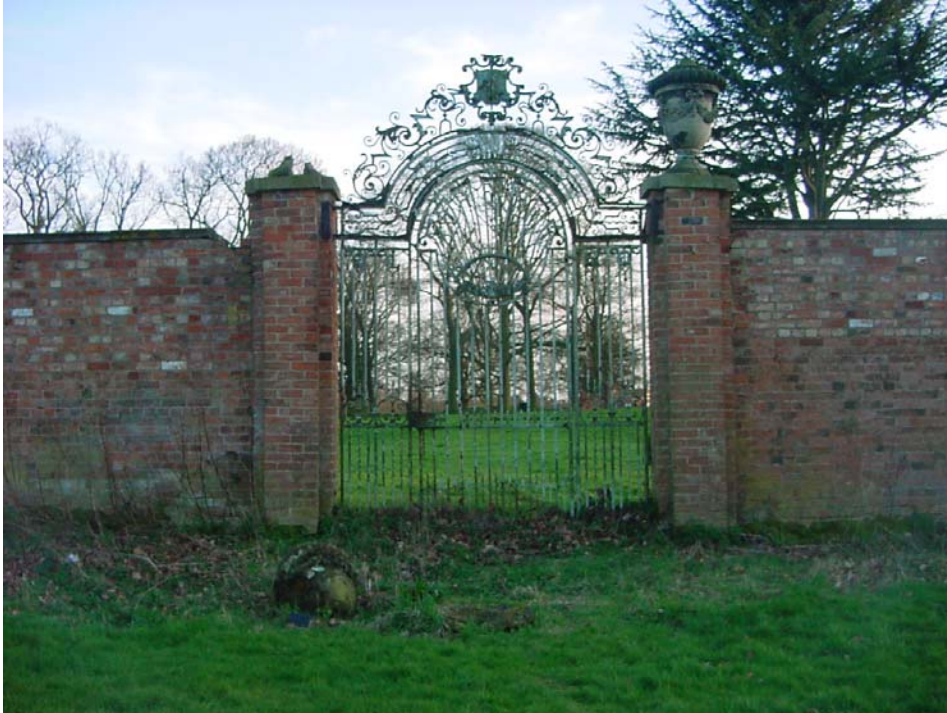
Both urns on the gate piers have now been removed. They both need to be replaced as they are part of Bosworth Hall's listing.

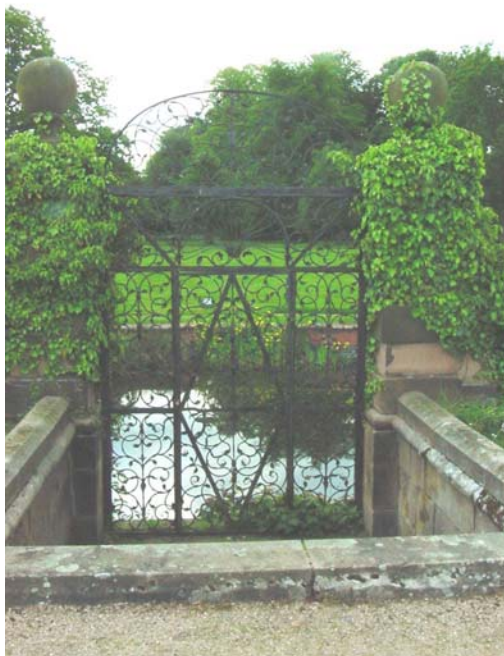
Ivy generally needs to be removed from the stone features around the park.

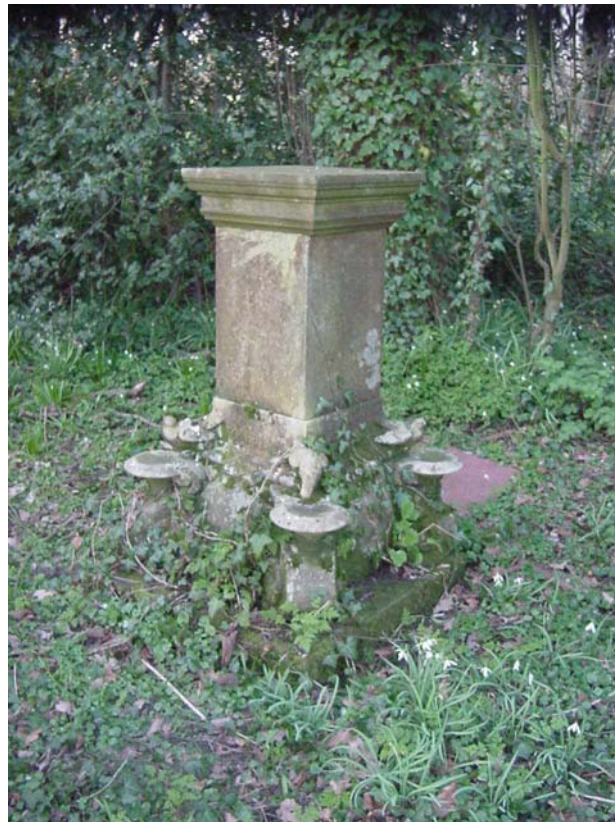
This quaint grave stone in the Bosworth Hall grounds to commemorate Teddy, the Lakeland Terrier, has been damaged and needs to be repaired.

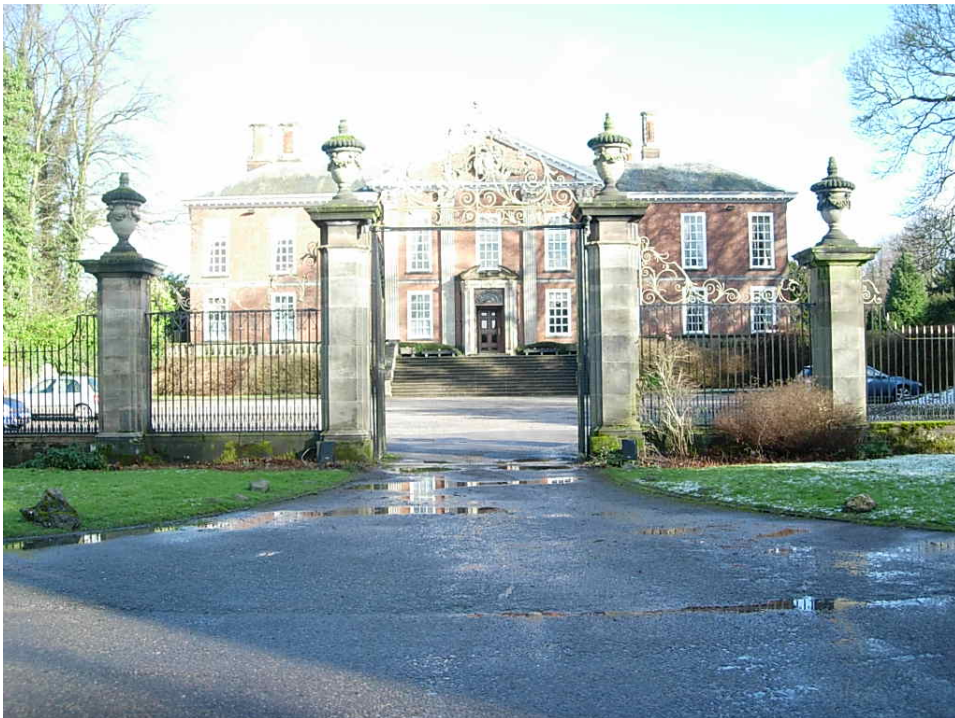
One of the impressive entrance gates to Bosworth Hall Hotel with all the urns intact. The gates would benefit from repainting.

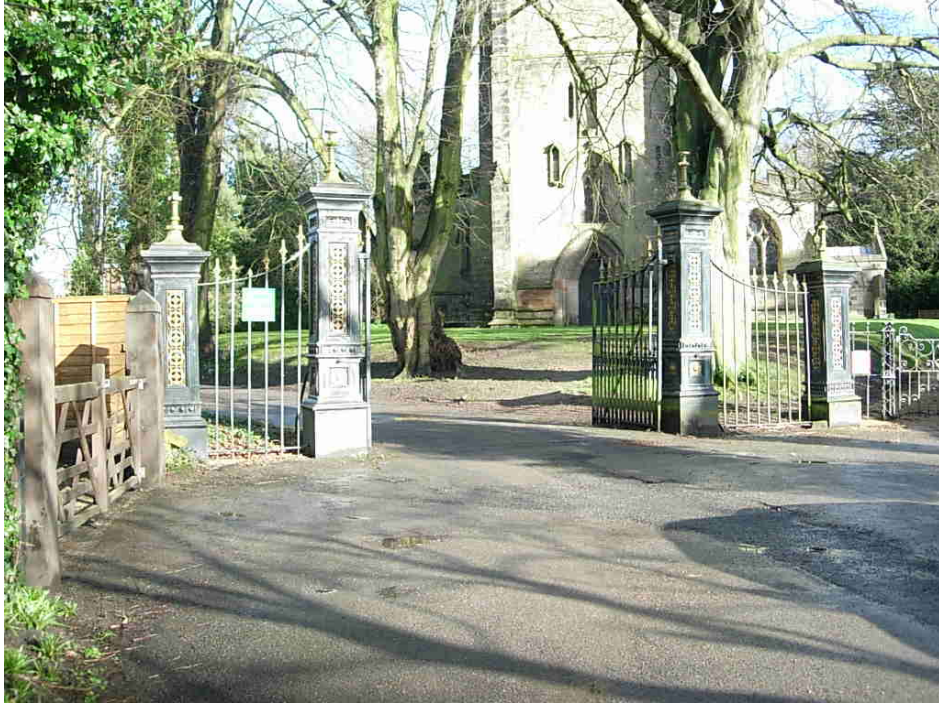
The outer entrance gates to Bosworth Hall Hotel and St Peter's Church would also benefit from being repainted.
