# MARKET BOSWORTH CONSERVATION AREA MANAGEMENT PLAN - ADOPTED 27 MAY 2014

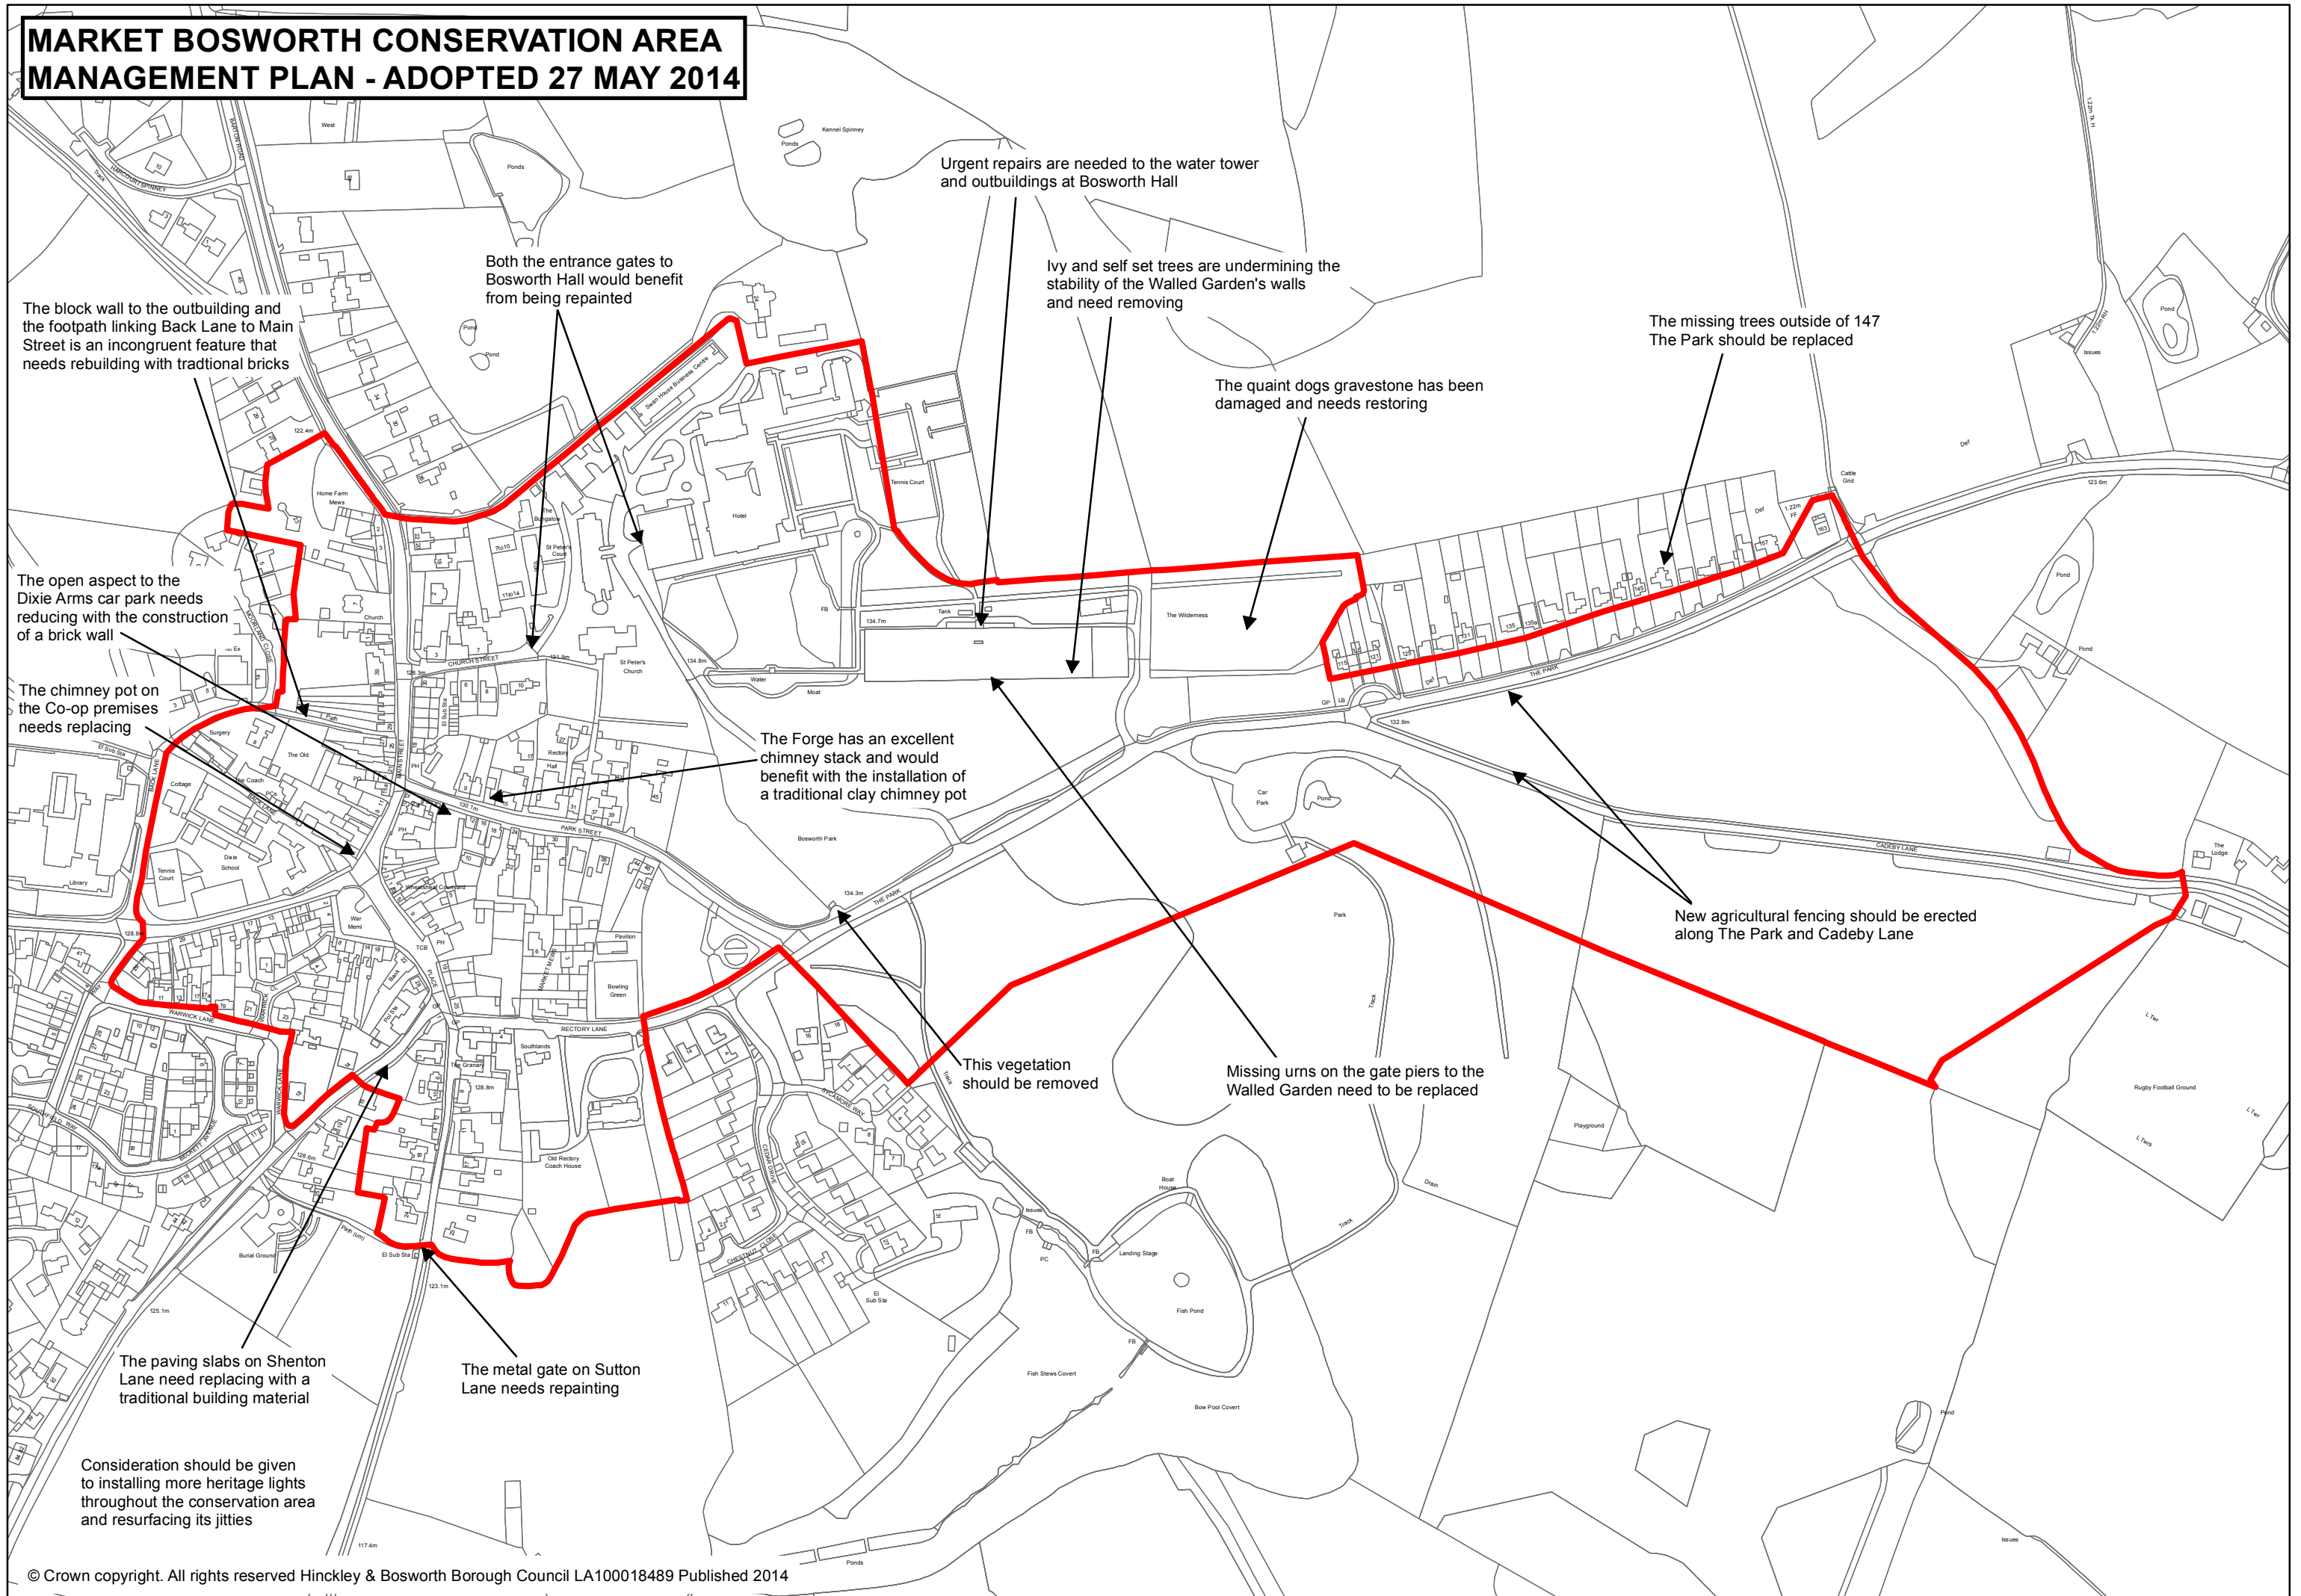
The block wall to the outbuilding and the footpath linking Back Lane to Main Street is an incongruent feature that needs rebuilding with traditional bricks

The open aspect to the Dixie Arms car park needs reducing with the construction of a brick wall

The chimney pot on the Co-op premises needs replacing

The paving slabs on Shenton Lane need replacing with a traditional building material

Urgent repairs are needed to the water tower and outbuildings at Bosworth Hall

Ivy and self set trees are undermining the stability of the Walled Garden's walls and need removing

The quaint dogs gravestone has been damaged and needs restoring

The missing trees outside of 147 The Park should be replaced

This vegetation should be removed

Missing urns on the gate piers to the Walled Garden need to be replaced

Consideration should be given to installing more heritage lights throughout the conservation area and resurfacing its jitties

Both the entrance gates to Bosworth Hall would benefit from being repainted

The metal gate on Sutton Lane needs repainting

The Forge has an excellent chimney stack and would benefit with the installation of a traditional clay chimney pot

New agricultural fencing should be erected along The Park and Cadeby Lane
