**OSBASTON CONSERVATION
AREA MANAGEMENT PLAN**

PHOTOGRAPHIC RECORD OF OSBASTON

January 2009

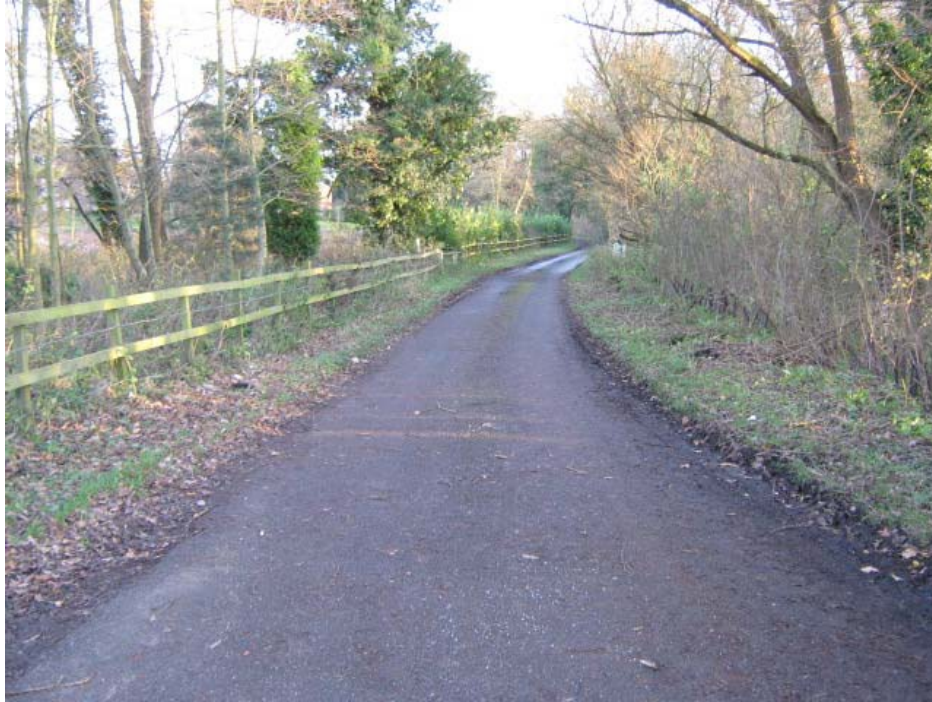
Pleasant entry into Osbaston Conservation Area from the A447 along Hall Lane (originally known as Watery Lane) with excellent views of Osbaston Hall on its northern side. An important feature of the lane is its rural character with grass verges and no defined edge to the road.

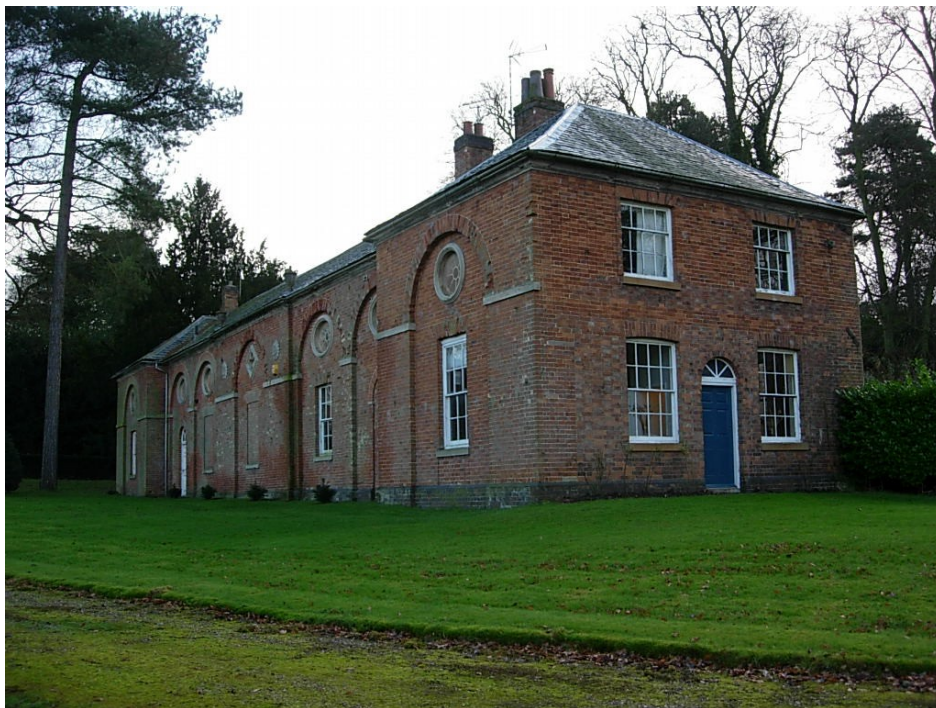
The grade 2 listed stable block and cottage, a late 18th century brick building with stone dressings and plain tiled roof situated in the grounds of Osbaston Hall.

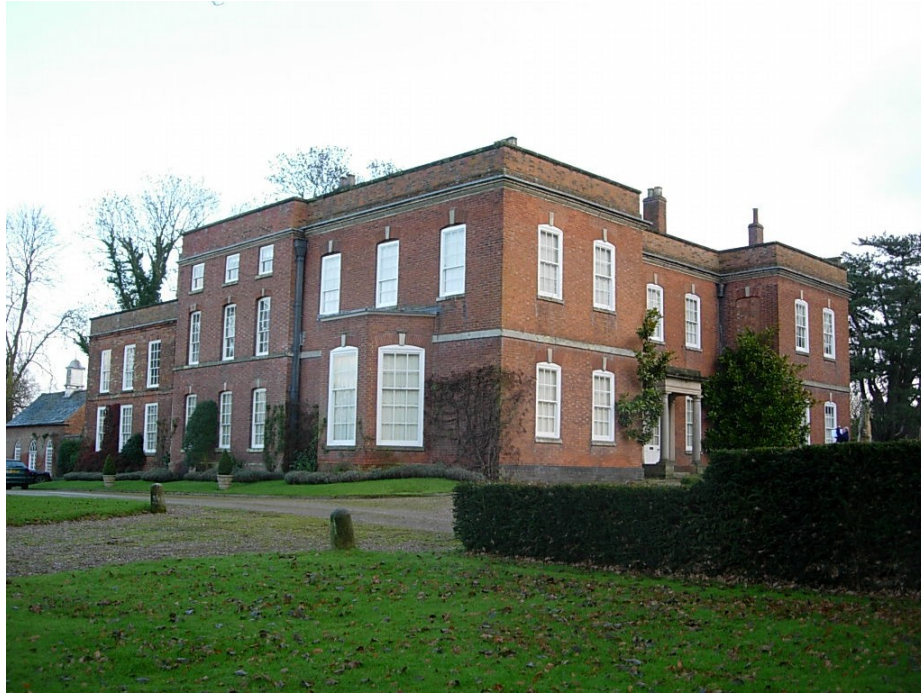
The grade 2* listed Osbaston Hall circa 1720 with some later alterations. A brick country house with stone dressings and plain tiled roof recessed behind a parapet wall located in a parkland setting.

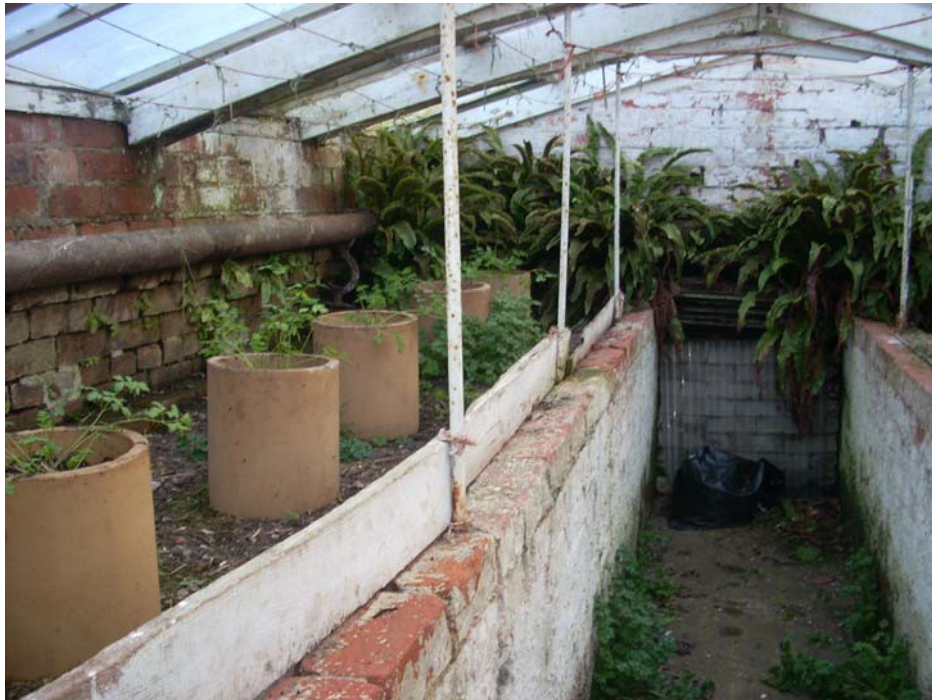
The sunken Victorian greenhouse situated in the walled Garden at Osbaston Hall is in urgent need of restoration.

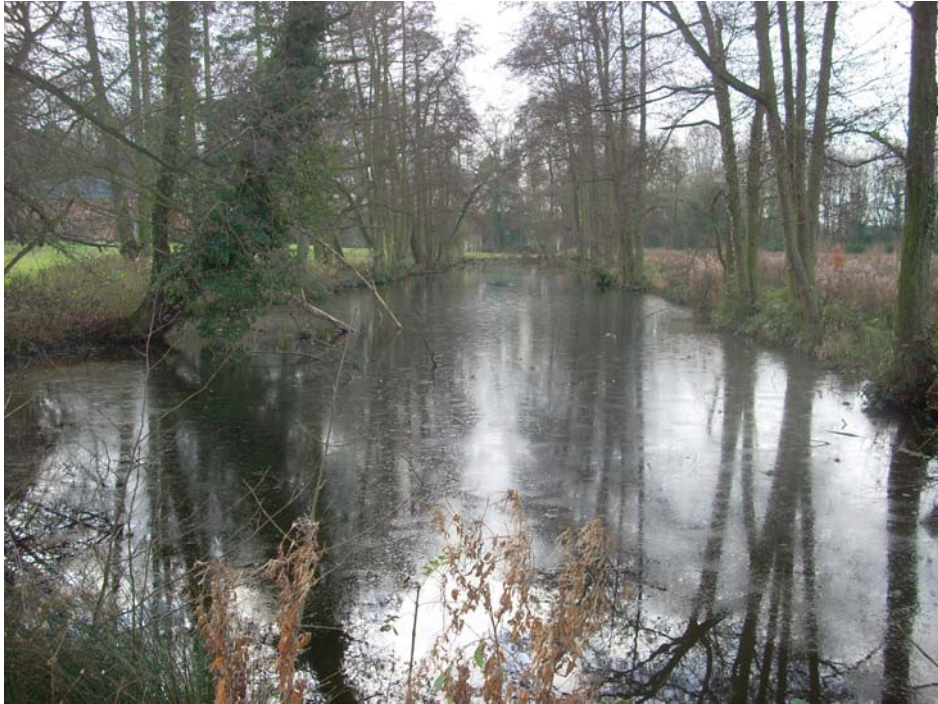
The lake situated in the grounds of Osbaston Hall provides an excellent setting to the Hall

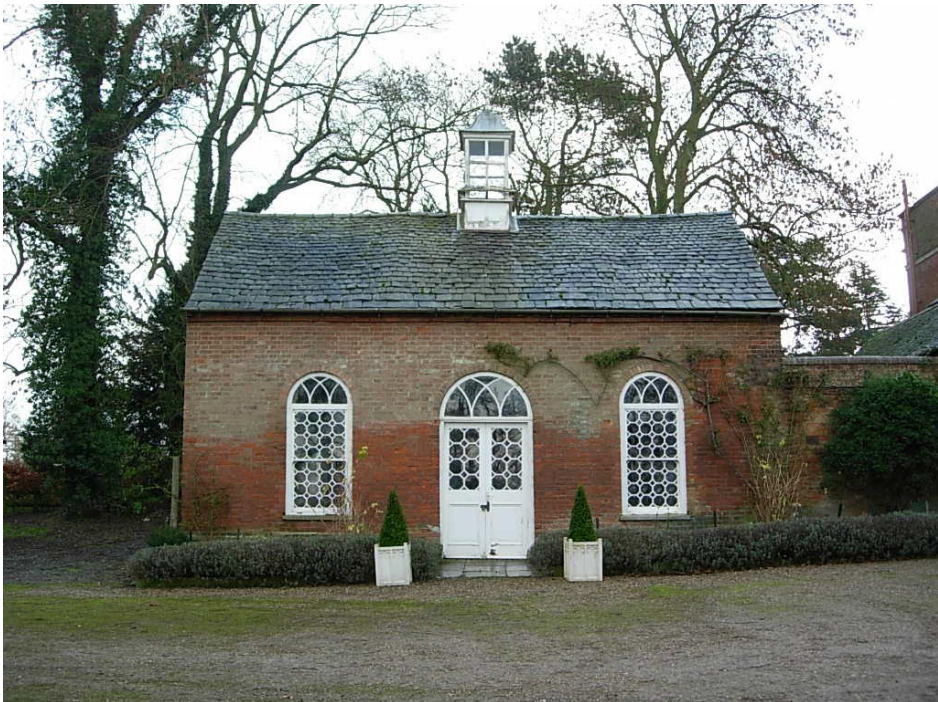
A quaint 19th century pavilion attached to Osbaston Hall showing Gothic detailing.

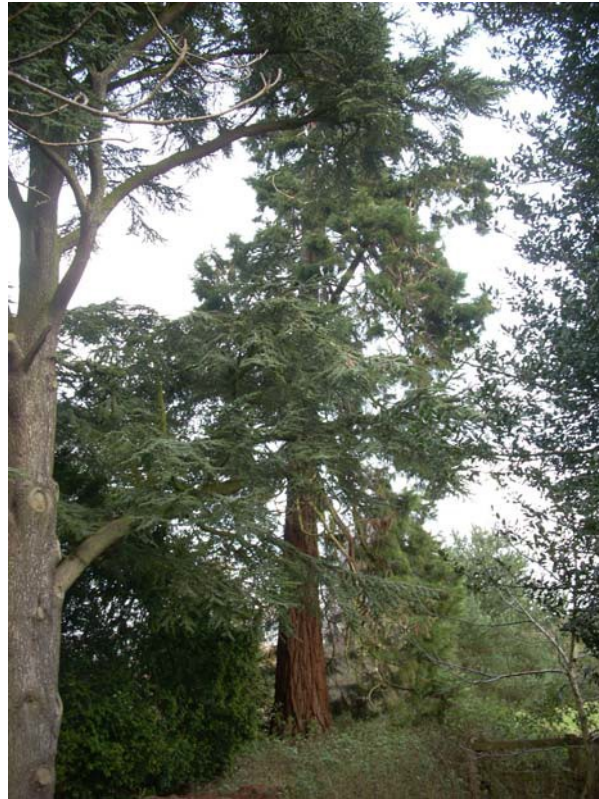
This giant sequoia is one of numerous fine mature trees growing in grounds of Osbaston Hall.

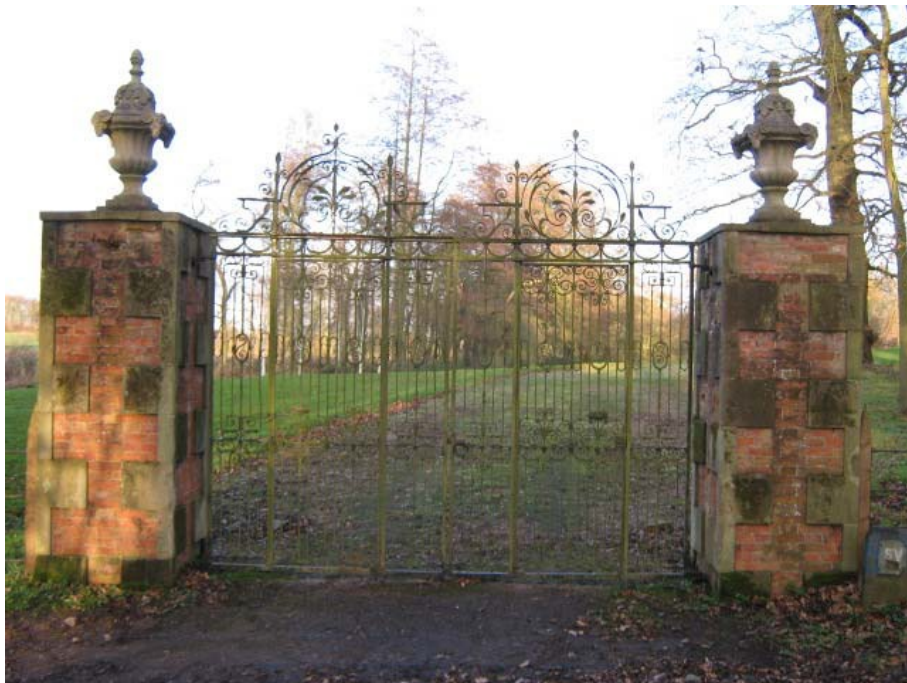
The entrance gates to Osbaston Hall are an imposing feature on Hall Lane in need of decoration.

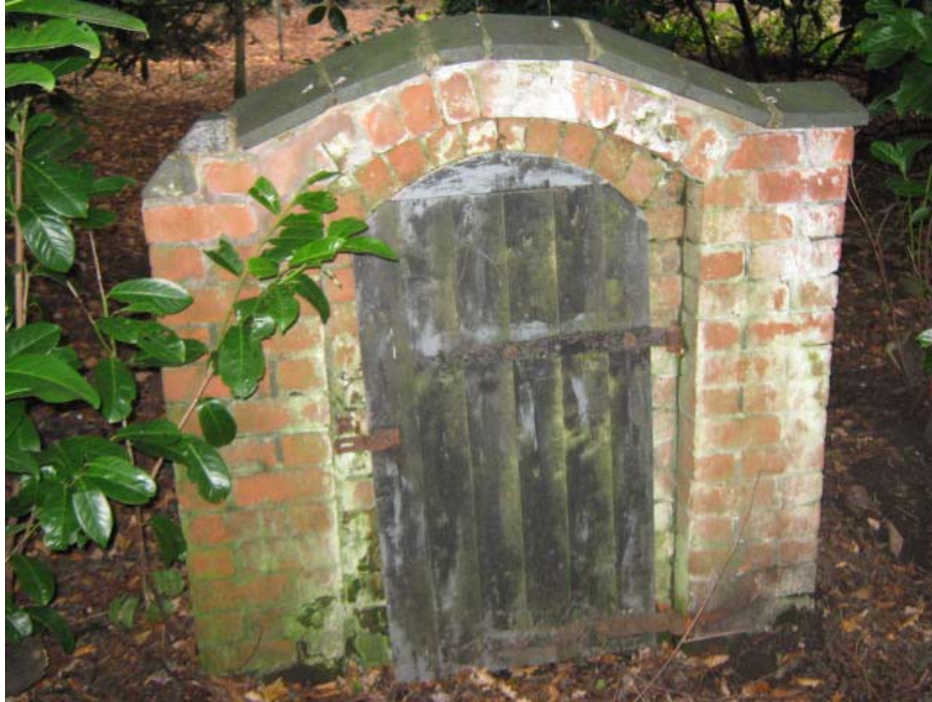
The water pump sited in Rookery Spinney is an interesting feature that was built in 1890 to pump water to the fountain sited in the inner courtyard at Osbaston Hall.

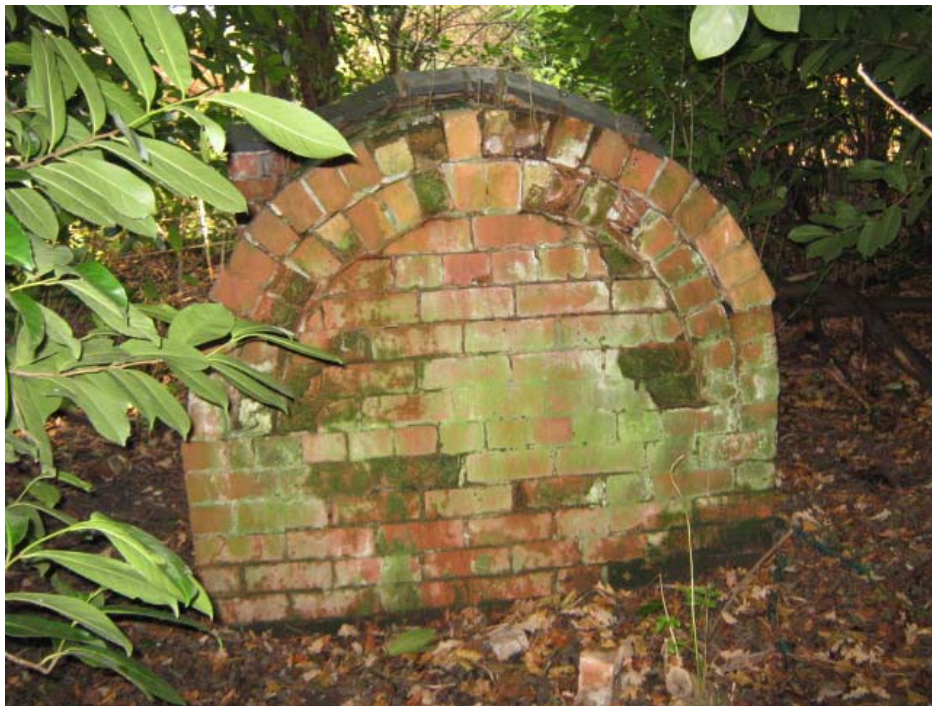
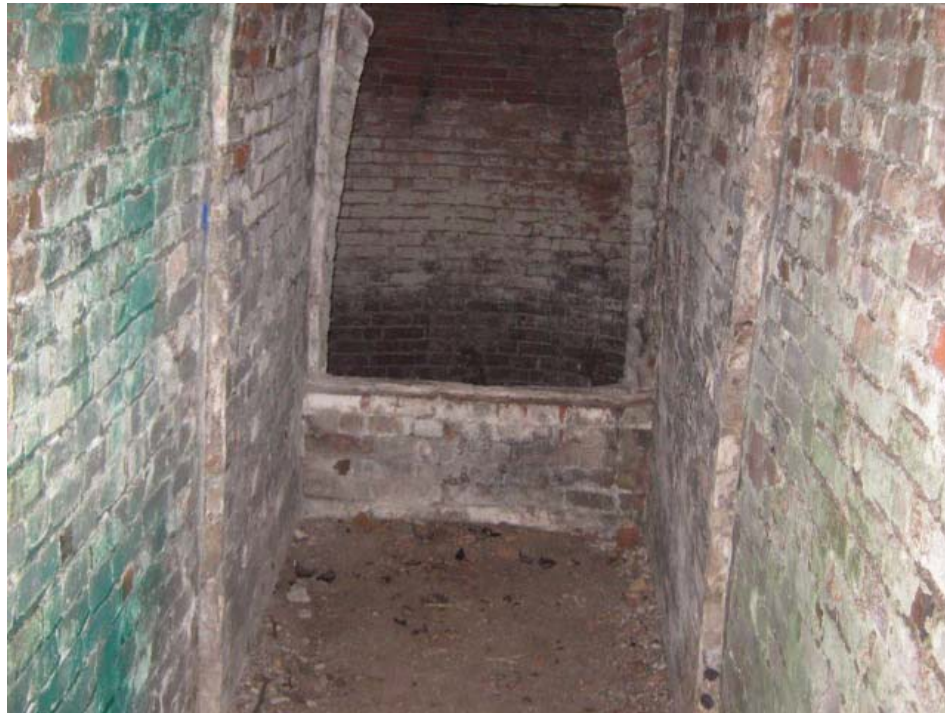
The C18 ice house sited in Rookery Spinney appears to be in excellent condition internally, however, some repair work is needed to its entrance. There is potential to open this feature up to public access, however, a metal grill is required at the inner opening for safety reasons. Debris also needs removing from the bottom of the structure.

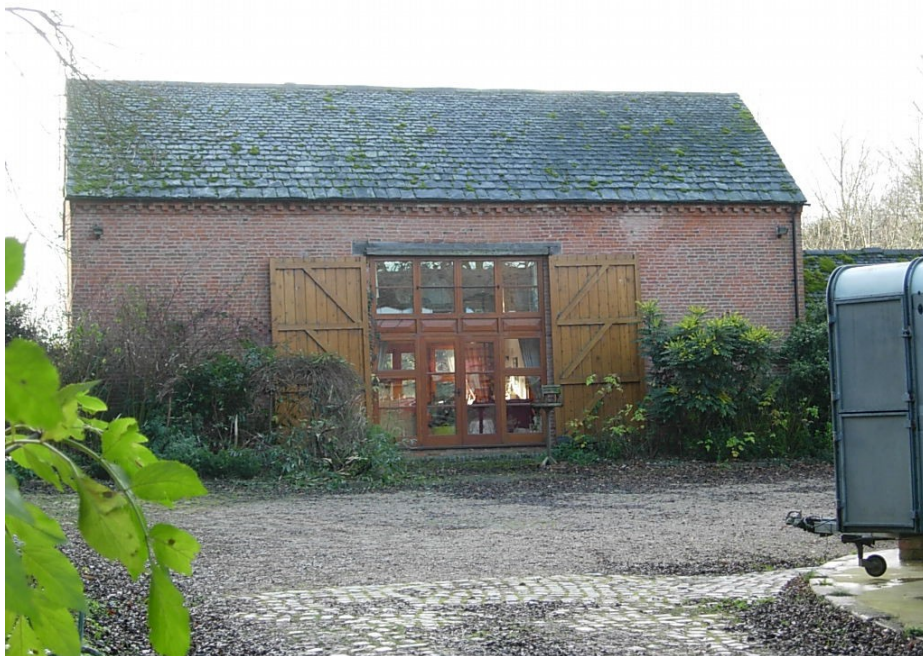
Rookery Barn, like many barns in Osbaston, has been converted into a dwelling. Granite setts have been utilised to surface the courtyard.

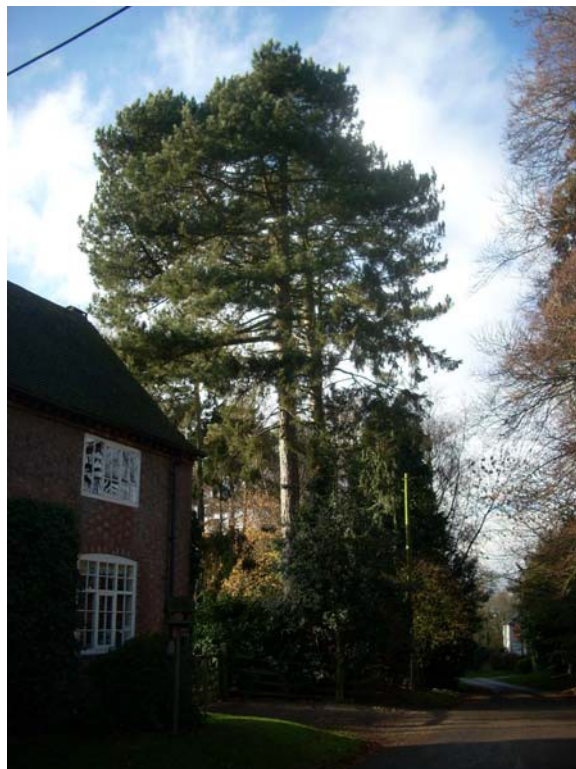
Pines are prominent features within the conservation area.

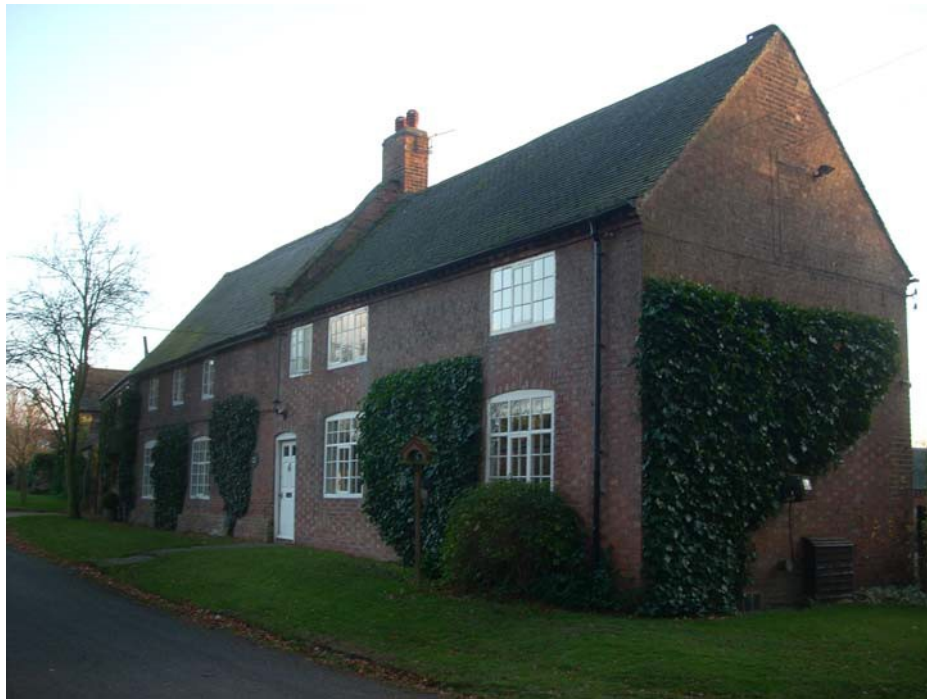
Hall Farm still has one of its original parapet walls that runs up to its chimney stack. The photograph shows how the original farm dwelling has been extended along its frontage.

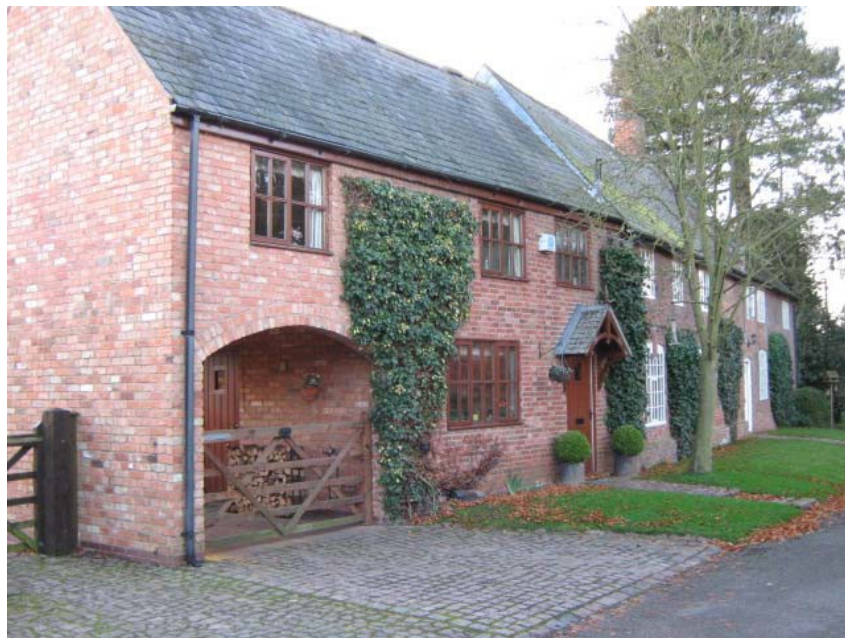
Hall Farm Cottage, once a barn attached to the eastern gable of Hall Farm, has almost been rebuilt into a 2 storey dwelling. Similar to several other dwellings in Osbaston, granite setts, have been utilized to surface its vehicular access.

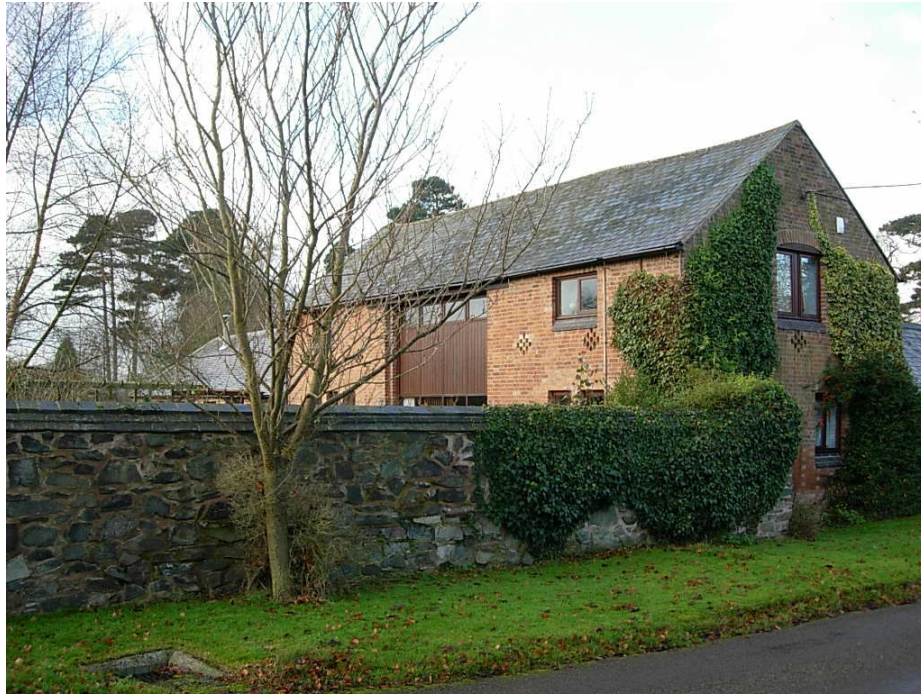
Hall Barn has been converted from a hay barn into a dwelling. The barn's ventilation openings in its side walls are still evident at first floor level

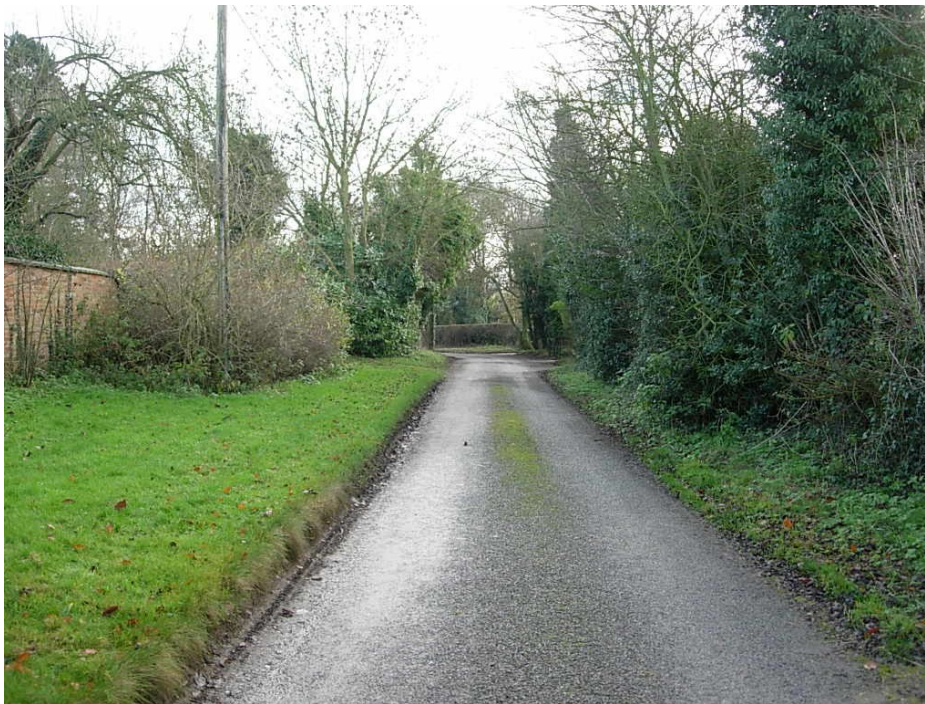
Hall Lane looking eastwards showing its wide verge on the northern side and high brick wall running along the boundary of Osbaston Hall's walled garden.

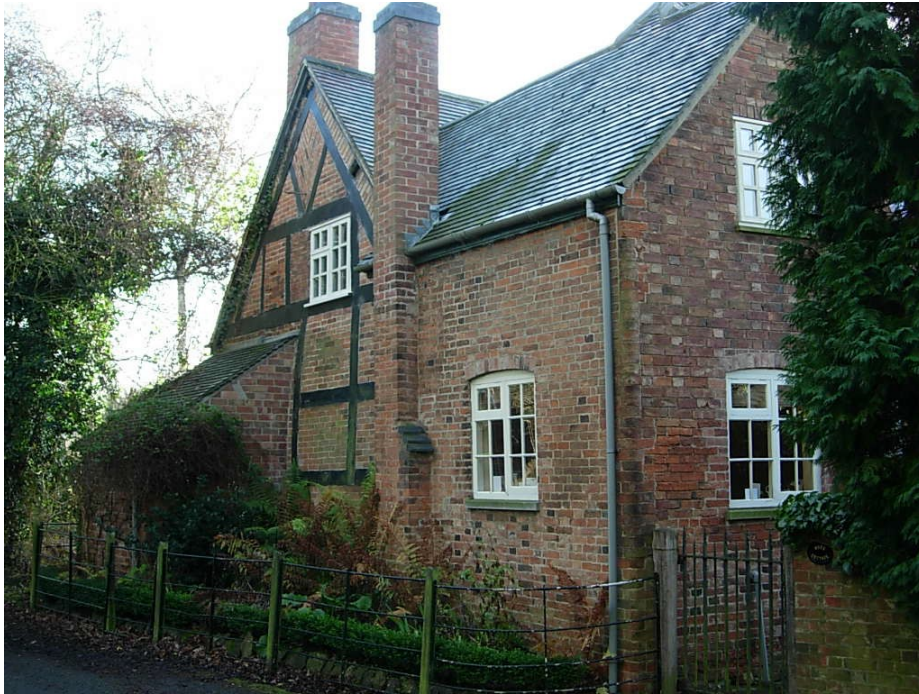
Moss Cottage has been considerably extended with dormers added on both side elevations.

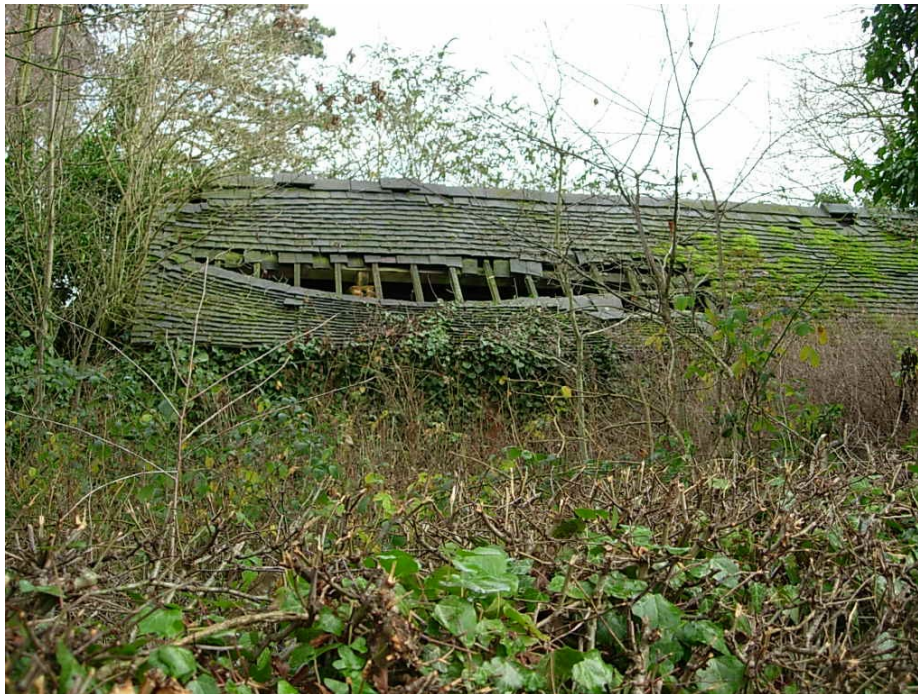
Every effort should be made to retain the derelict vernacular barn at Home Farm.

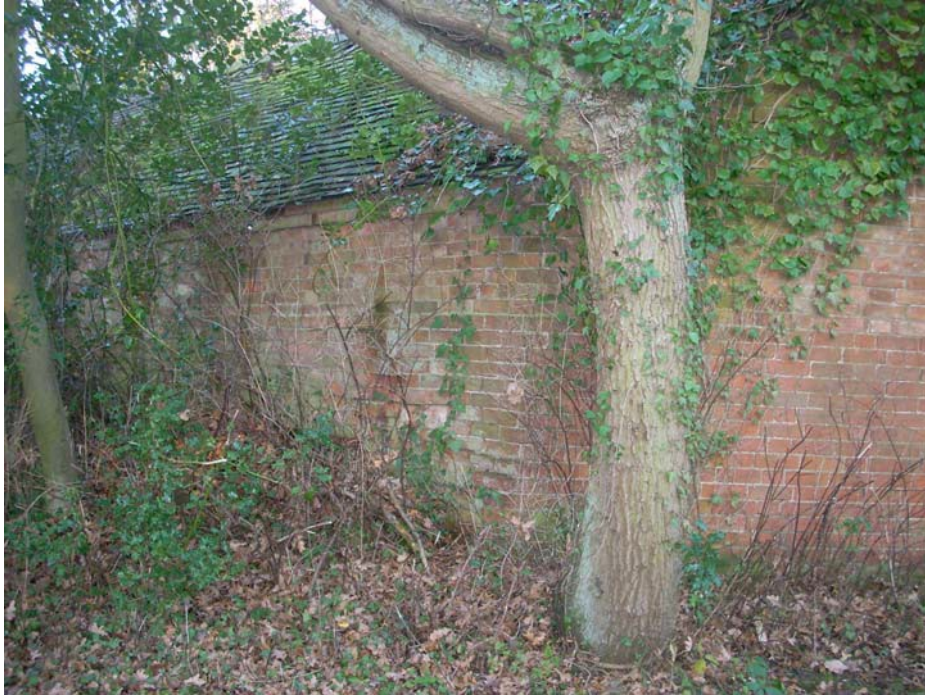
The tree growing adjacent to the derelict barn on Hall Lane should be removed as it is starting to damage the walls.

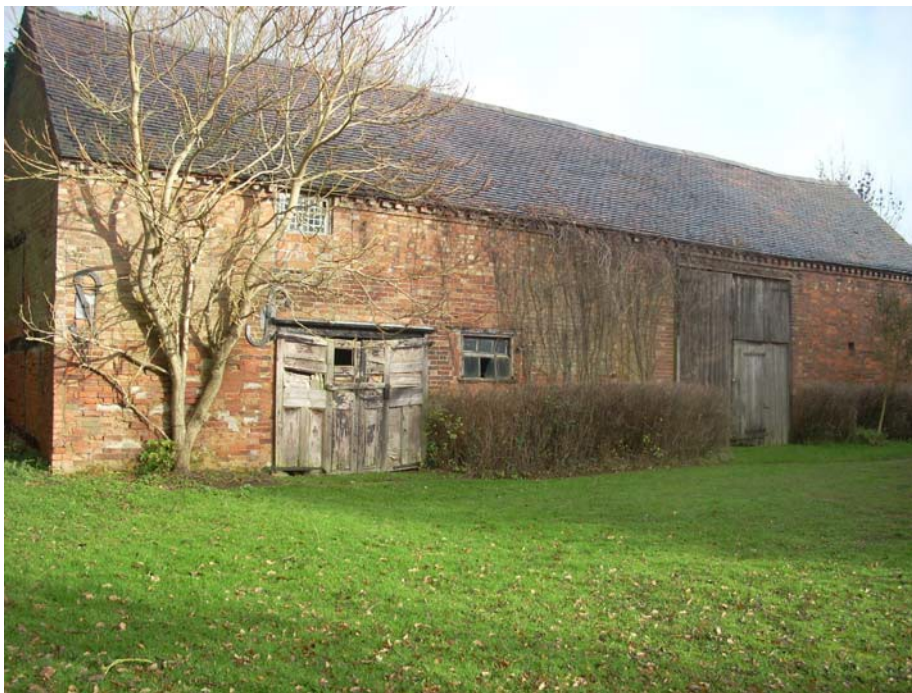
The large barn to the rear of Home Farm is an excellent building with a Rosemary tiled roof and dental course running along its eaves. It has timber framing, the residue of an earlier building, incorporated in its gable wall.

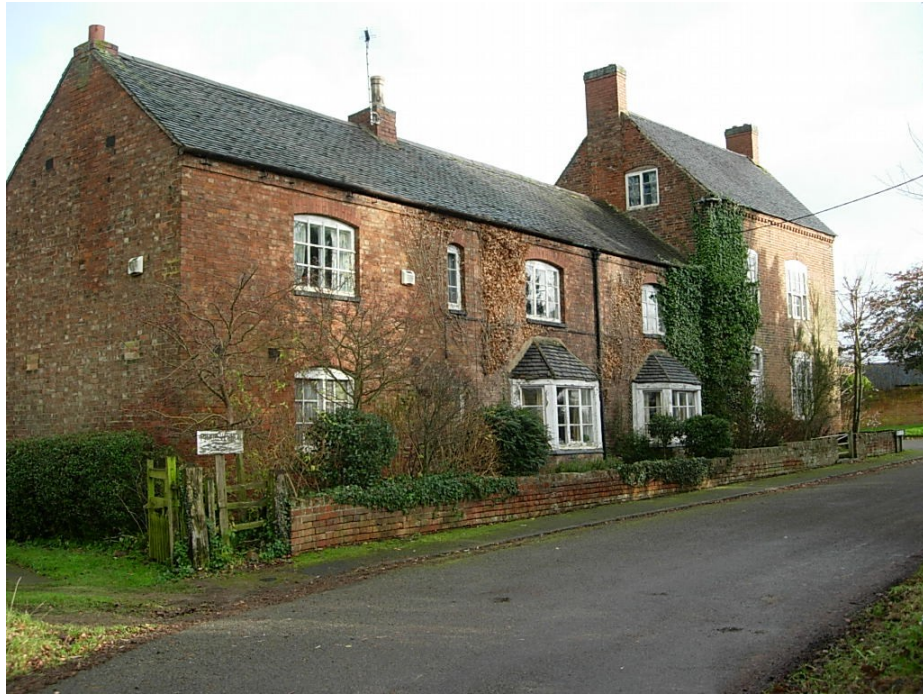
Home Farm is a typical two storey farmhouse with a two and a half storey building sited at the junction of Hall Lane and Goatham Lane. The whole farm complex appears to be in need of financial investment.

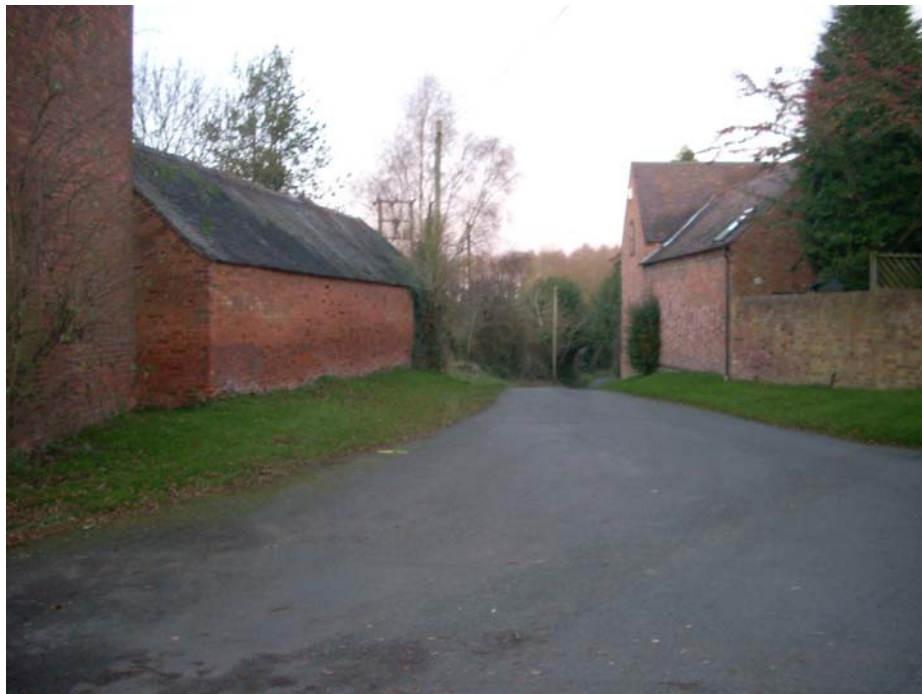
The Home Farm outbuilding and White Boar Barn help to funnel views down Goatham Lane.

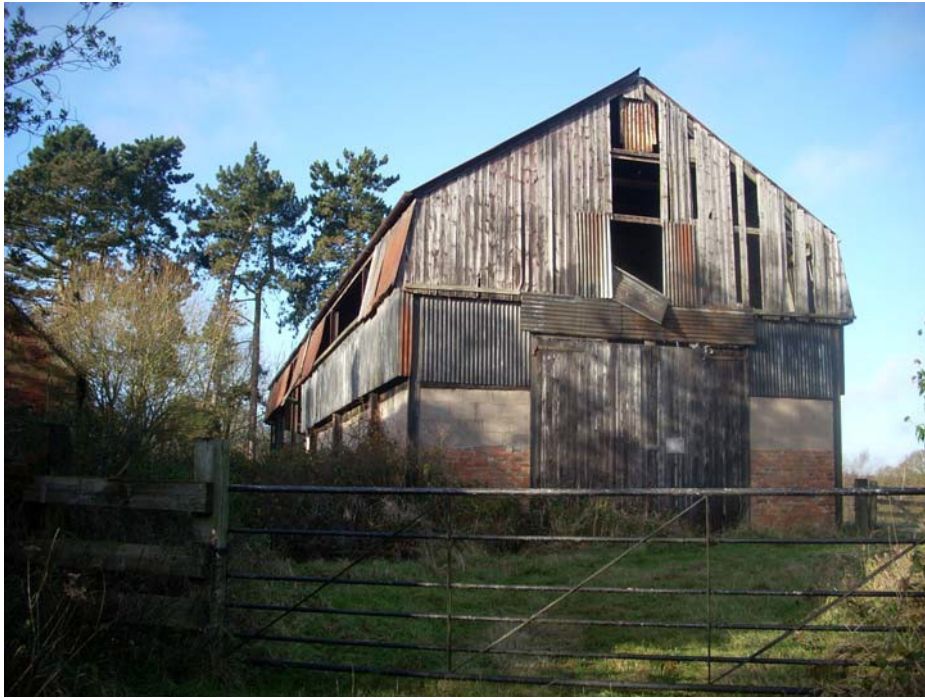
This excellent barn at Home Farm is in urgent need of maintenance.

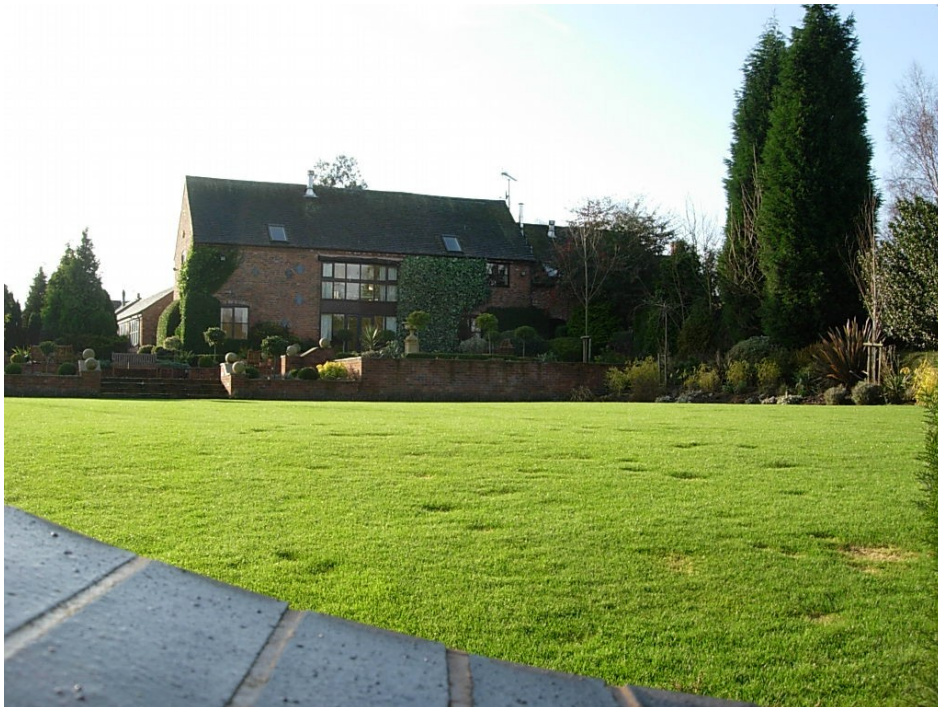
White Boar Barn has been improved to such an extent that it now resembles a modern dwelling set in well manicured gardens. The planting of leylandii trees tend to reinforce its urban character.

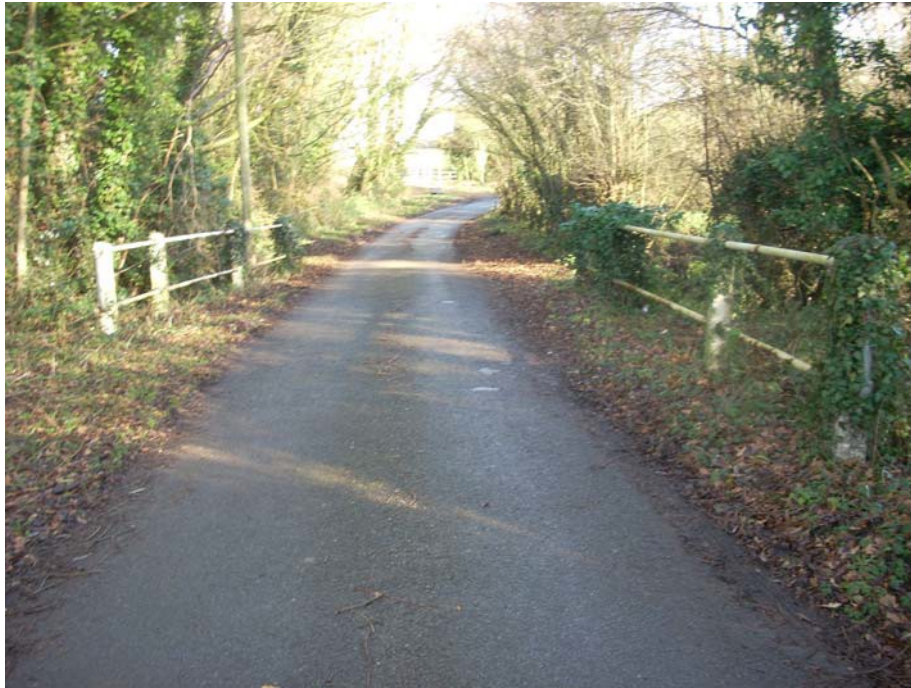
Just beyond White Boar Barn, Gotham Lane becomes rural in character with coppiced woodland either side of the brook.

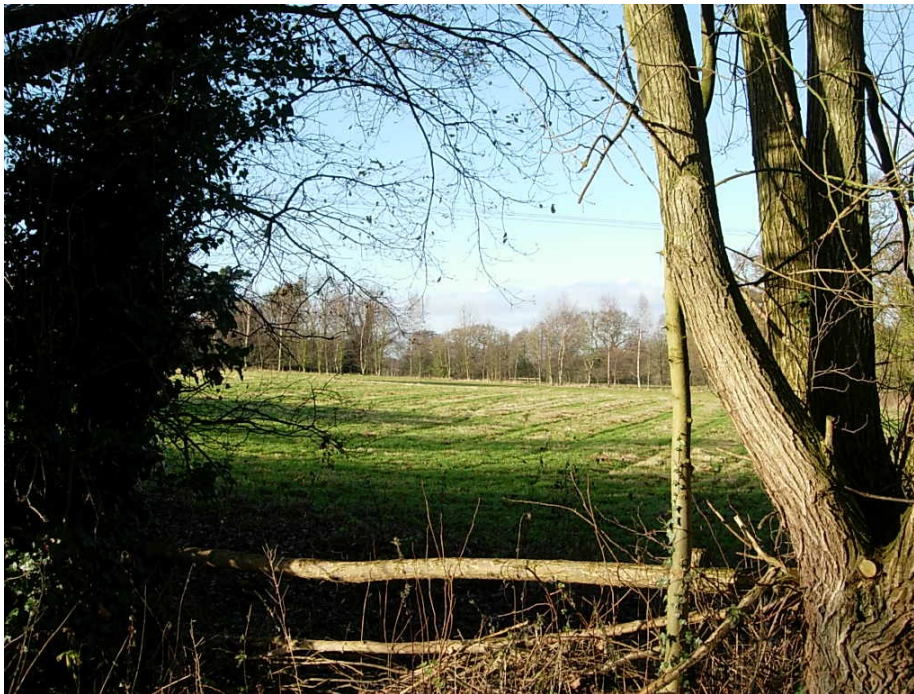
A length of Gotham Lane tends to be enclosed with high hedgerows. However, small gaps in the hedge give rise to pleasant views.

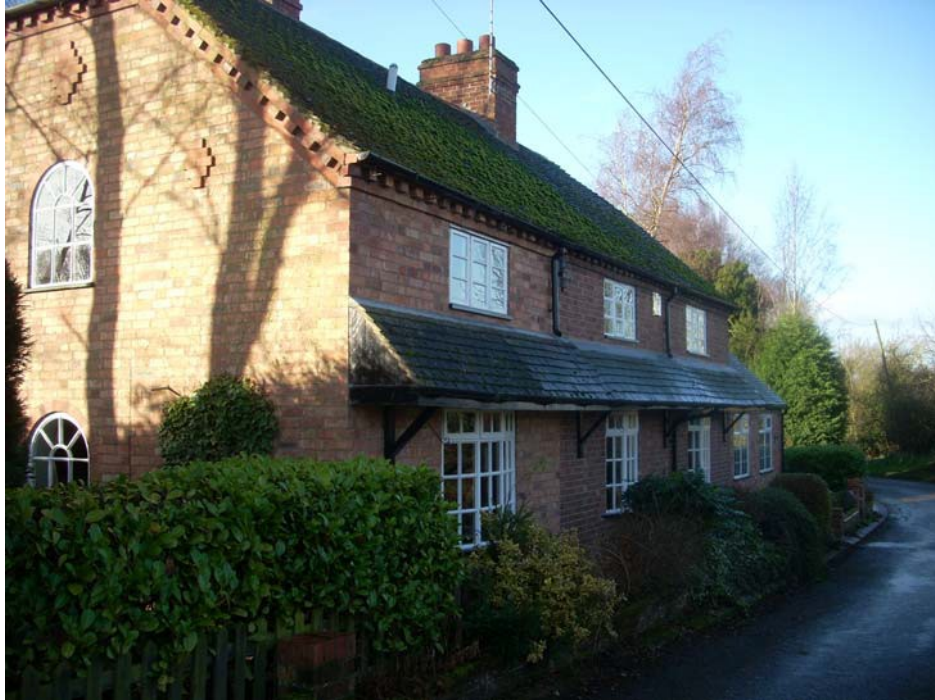
Brookside has been extended both sides of the original building. The properties in this area of Goatham Lane were once small agricultural dwellings that have since been improved incorporating none traditional features now resembling modern dwellings sited in a rural setting.

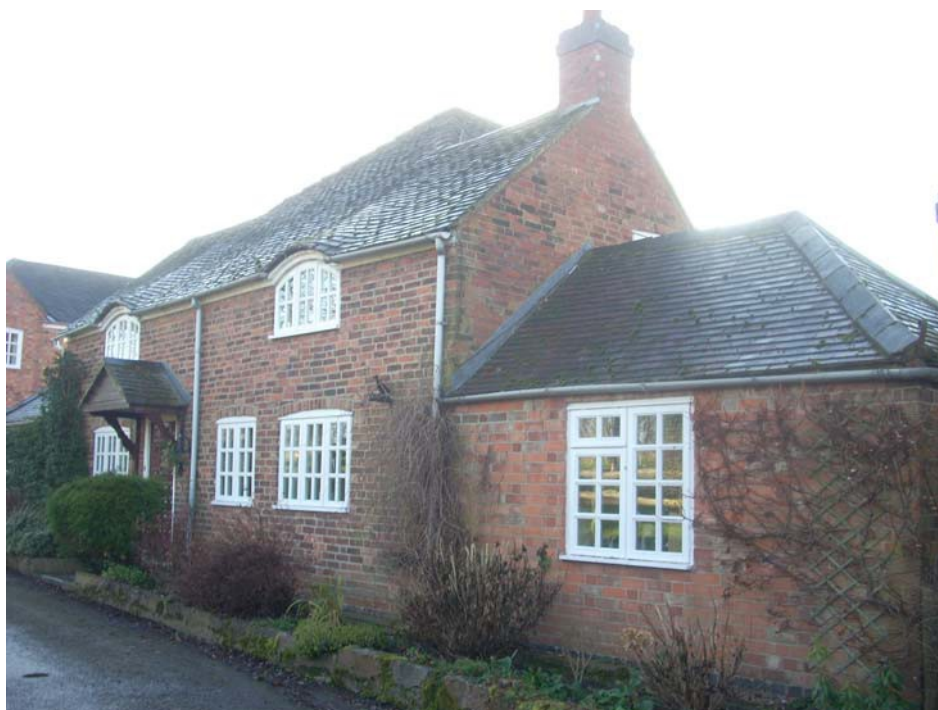
The property, Swallows, showing eyebrow dormers and single storey extension.

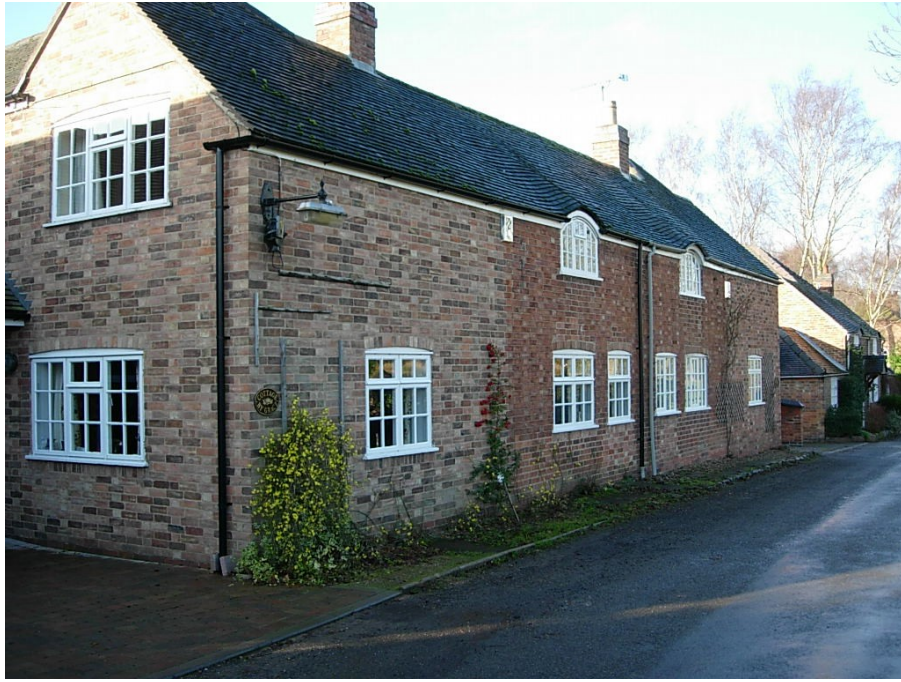
The pair of semi-detached dwellings, Bramble and Cottage by Grace. Both these small agricultural cottages have virtually been doubled in size and have now lost their traditional character.

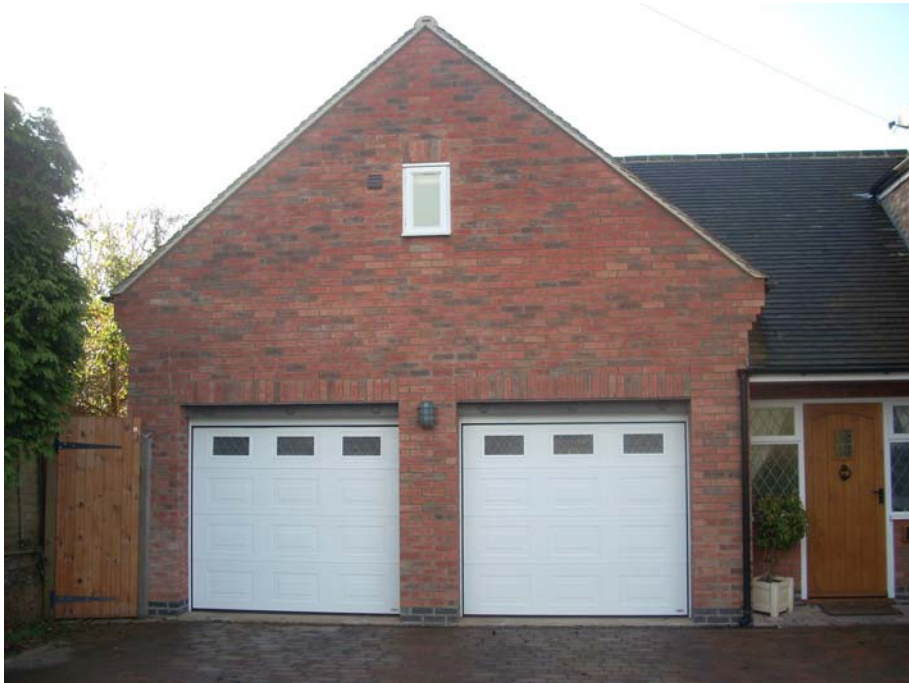
The large gable end of this double garage with white doors is a rather prominent feature when compared with the double garage at Meadow View Cottage.

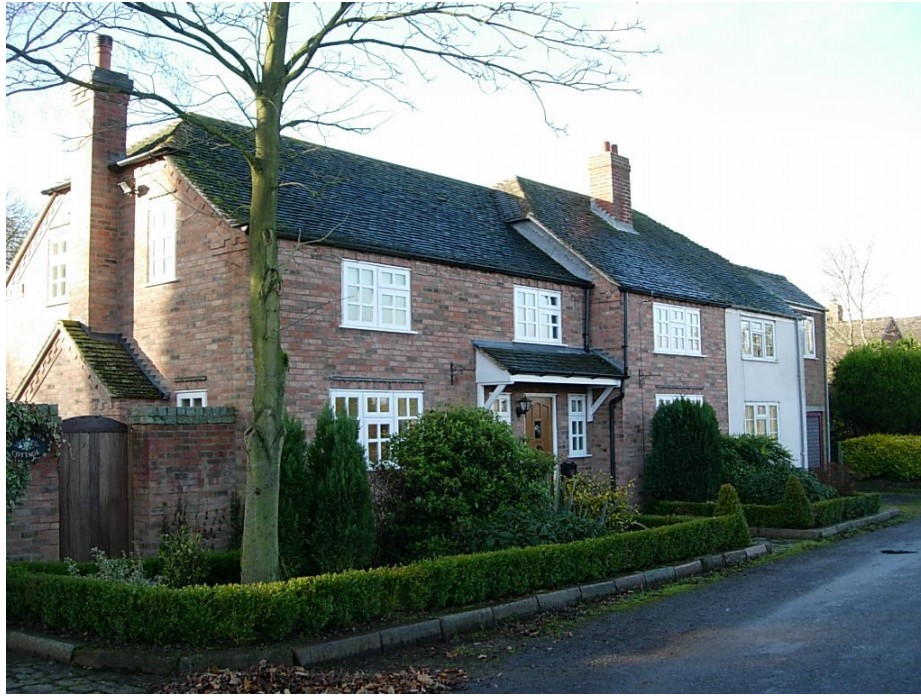
Meadow View Cottage & Coppice Cottage have lost their rustic charm as a result of their modernization and extensions.

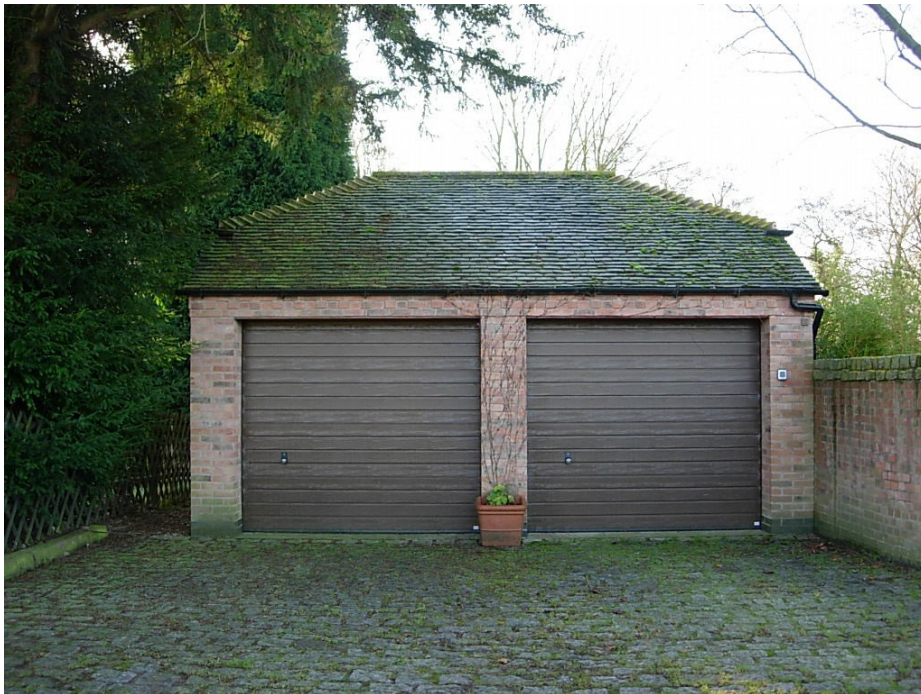
The visual impact this double garage on Gotham Lane is considerably reduced as a result of its roof being hipped and doors painted a darker colour. Granite sets have been sensitively incorporated as a surface material.

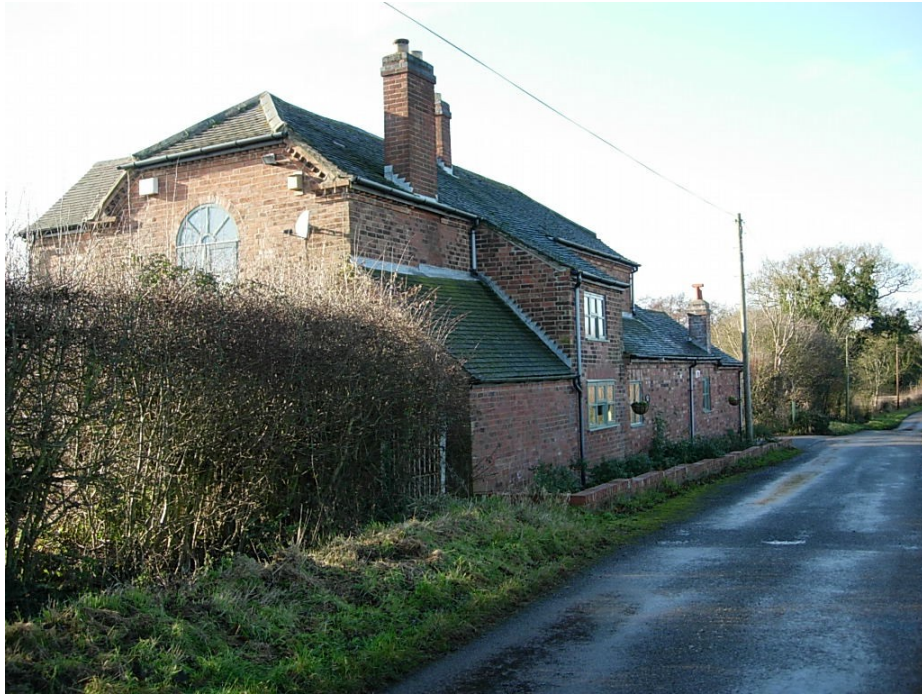
The architectural integrity of Gotham Cottage has unfortunately been lost due to numerous extensions being carried out on the property producing a complex elevation to the street scene.
