**OSBASTON CONSERVATION
AREA MANAGEMENT PLAN**

PHOTOGRAPHIC RECORD OF OSBASTON

January 2009

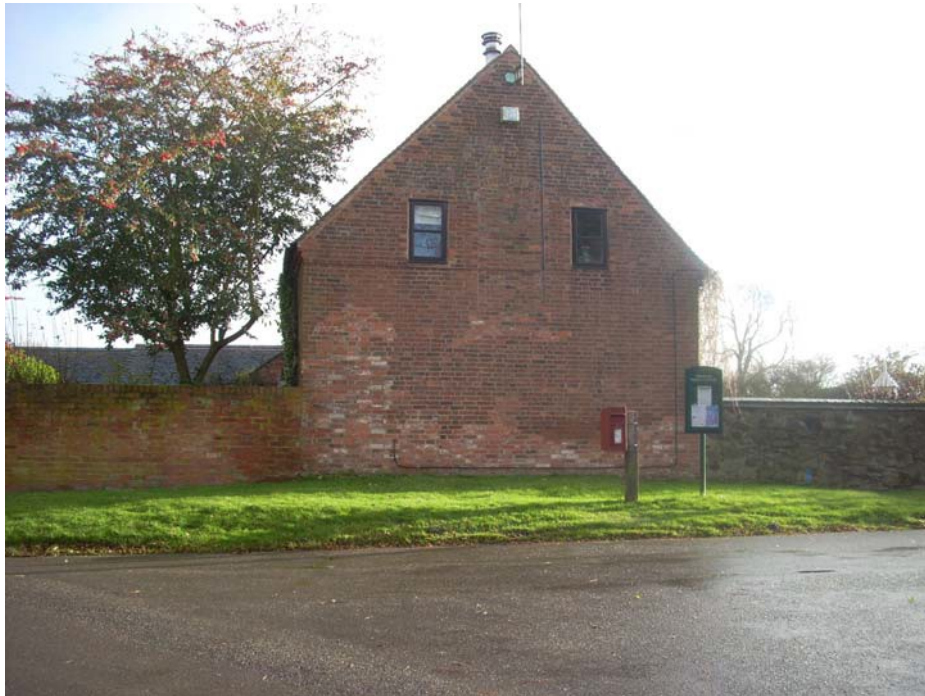
The Gotham Lane and Hall Lane junction is an interesting space with a large grassed verge, post box and parish notice board. The buildings sited at the junction also make a pleasant group.

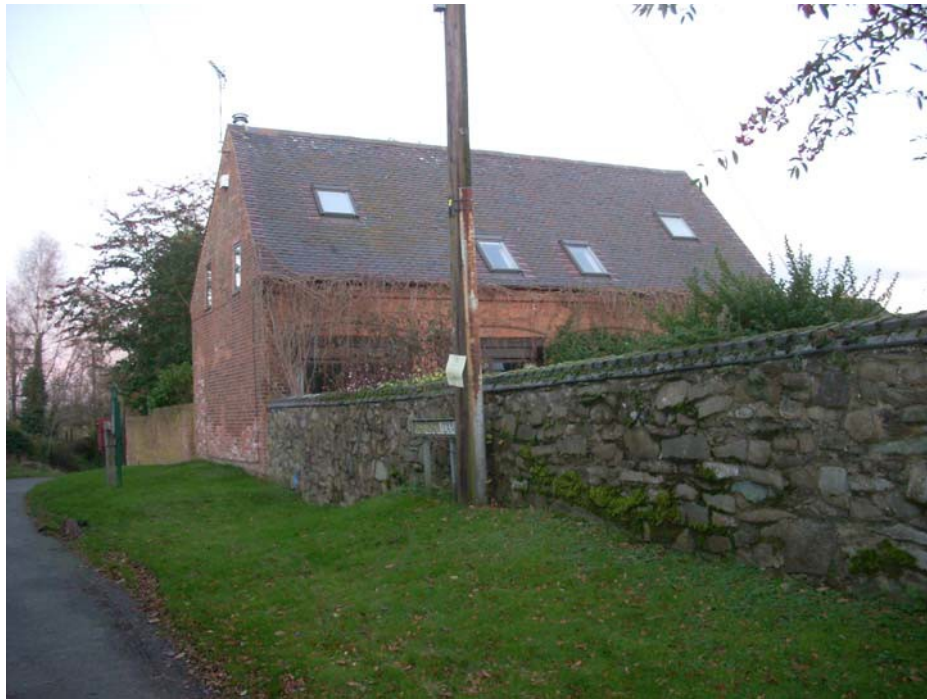
The roof lights on Bloomfield Barn are features that are at discord with its traditional character. The property however, is bounded by an excellent stone wall and wide grass verge.

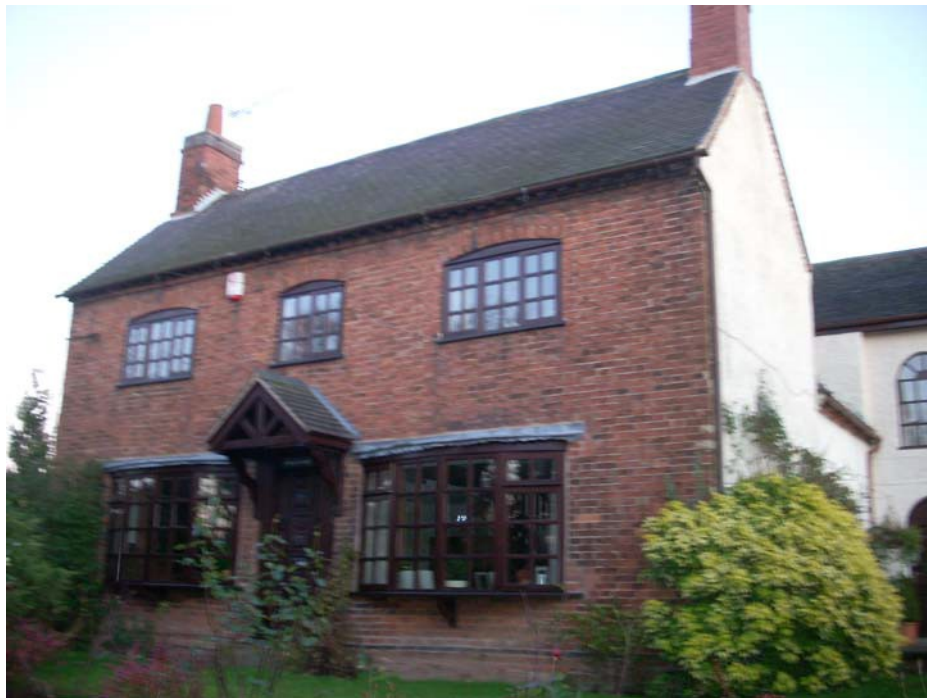
The bow windows in Rose Cottage and canopy over the front door are incongruent features on what is a typical Leicestershire farm house.
