Hinckley & Bosworth  
Borough Council

**BARWELL (ARTHUR STREET)  
CONSERVATION AREA APPRAISAL &  
MANAGEMENT PLAN**

**PHOTOGRAPHIC SURVEY OF  
CONSERVATION AREA**

**September 2010**

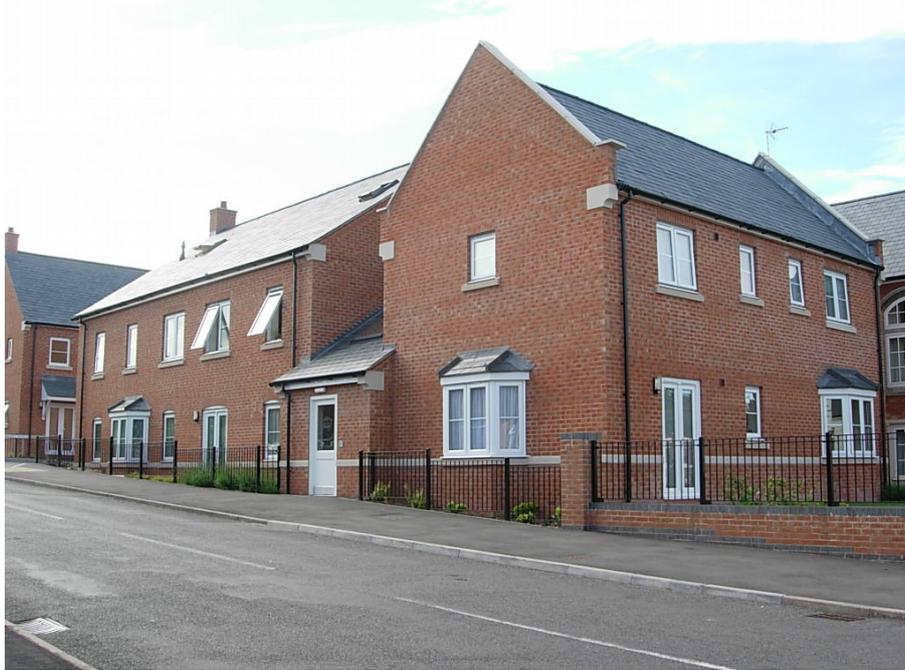
The materials and features used on this new development are in keeping with the adjacent former factory that has been retained and converted into flats as part of the overall scheme.

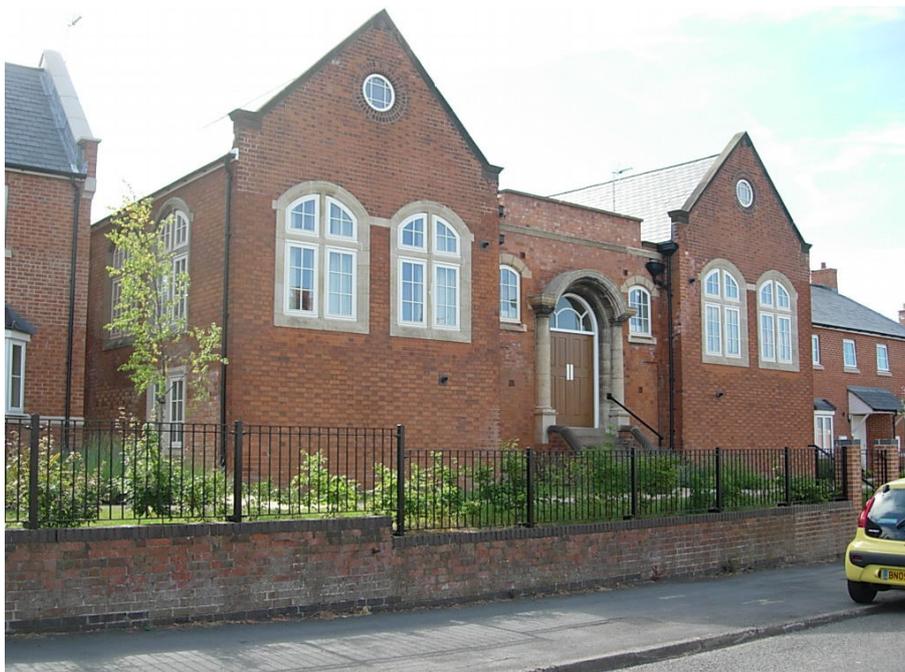
This residential development incorporates the former offices of the Hall and Geary factory on Kirby Road. This company specialised in boots and shoes for girls and boys. The company went bankrupt in the 1950's.

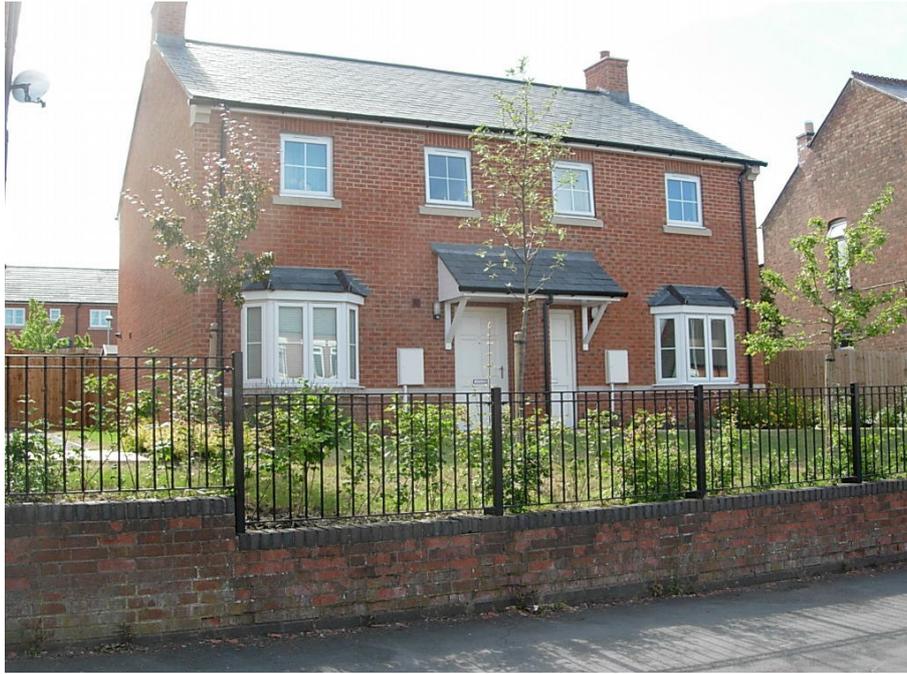
This property front in Kirby Road is part of the development on the former Hall and Geary site. This building incorporates bay windows, chimneys and stone sills which are local features. It also includes a natural slate roof covering.

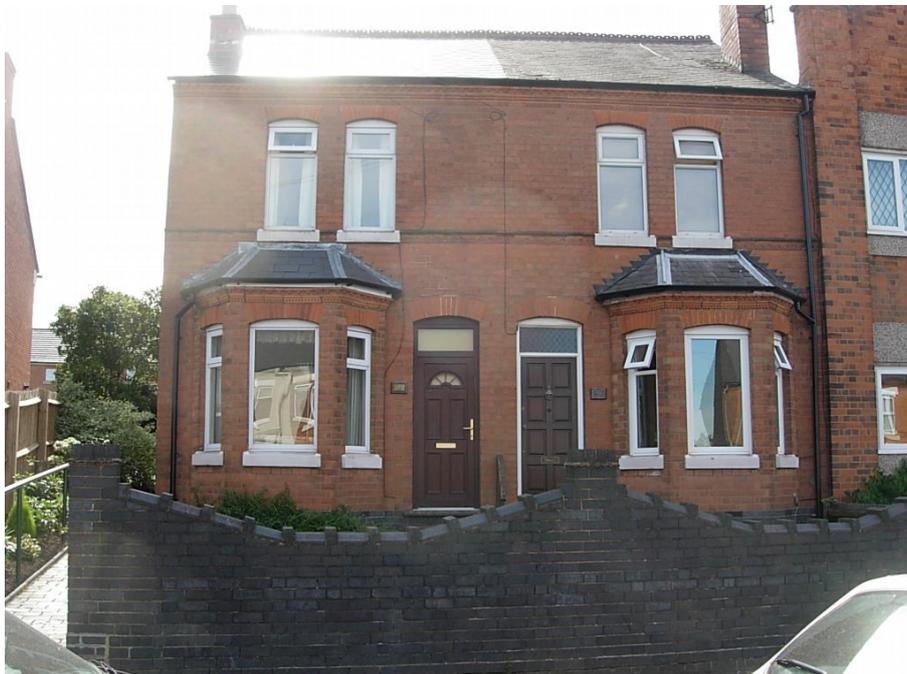
The adjacent Victorian properties have retained their original chimneys and roof covering but unfortunately not the original doors or windows.

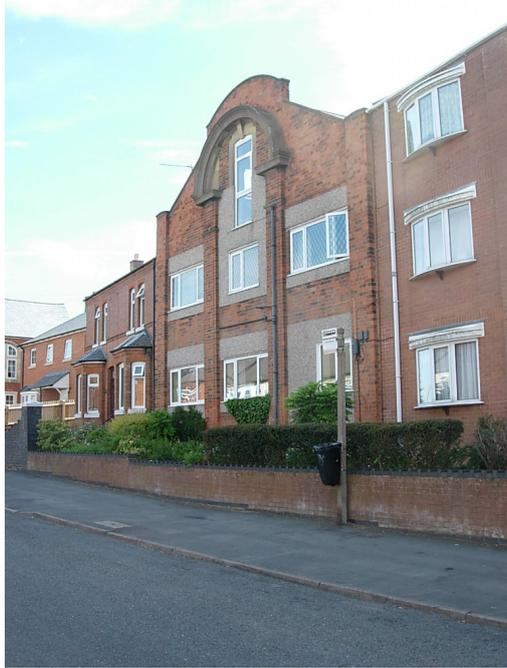
These are the former offices of the Sperope Boot Manufacturing Company, now part of a residential development which fronts Kirby Road. The company was founded as a co-operative in the 1890's when it was known as the Barwell Productive Society. It was taken over in the 1950's.

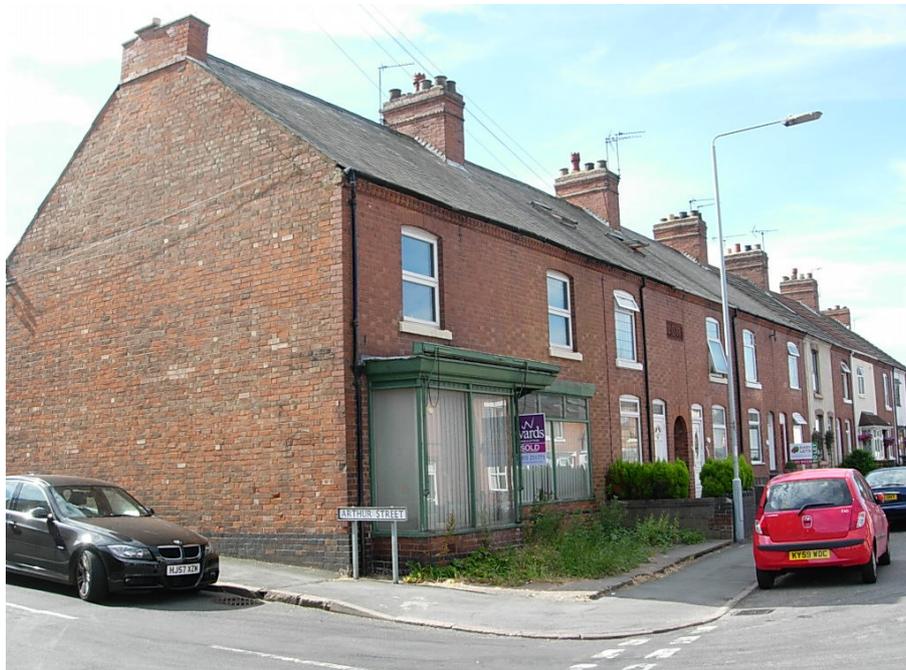
These are former boot and shoe workers cottages on Kirby Road which stand at the entrance to the conservation area. The end of the terrace includes a fine Victorian shop-front.

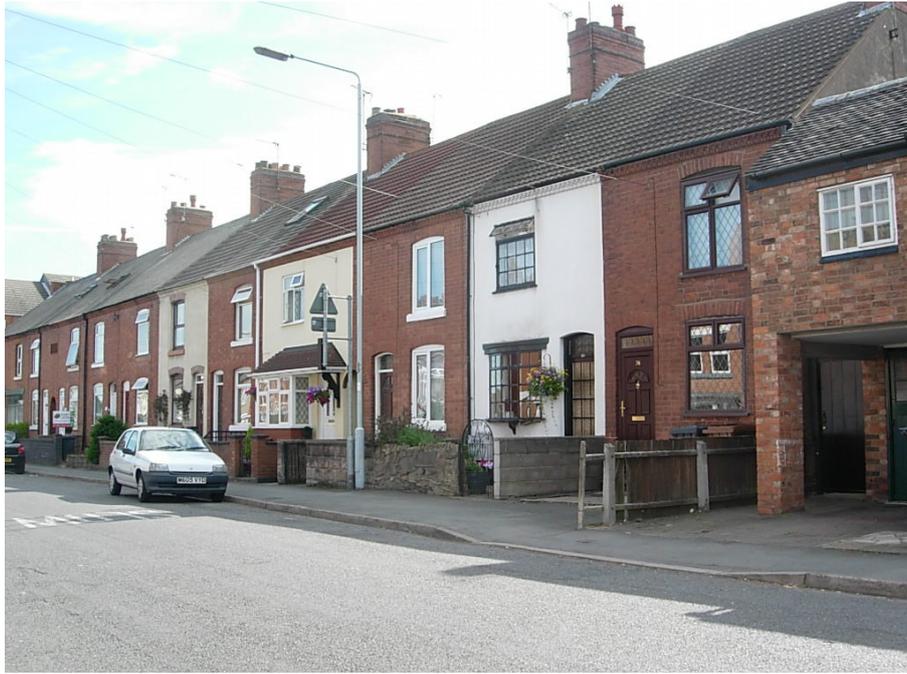
The southern end of the same terrace which has suffered from inappropriate features such as concrete roof tiles and bow windows.

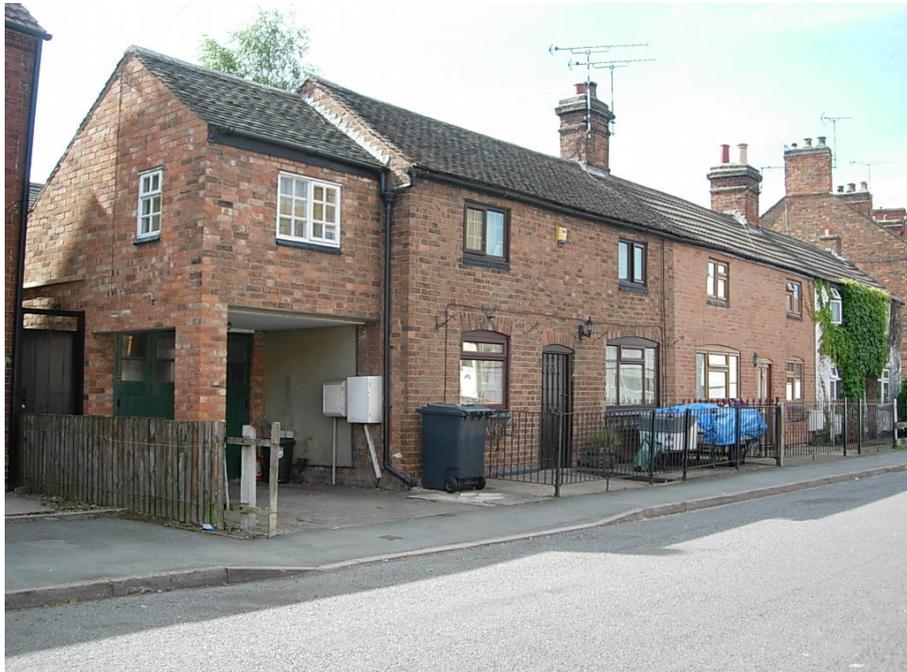
To the south of the boot & shoe workers terrace are three framework knitters cottages. These are recognised by their long ground floor window (originally 5 lights) and small first floor windows which are characteristic of this type of building. The scale of the cottages is much lower than the Victorian terrace.

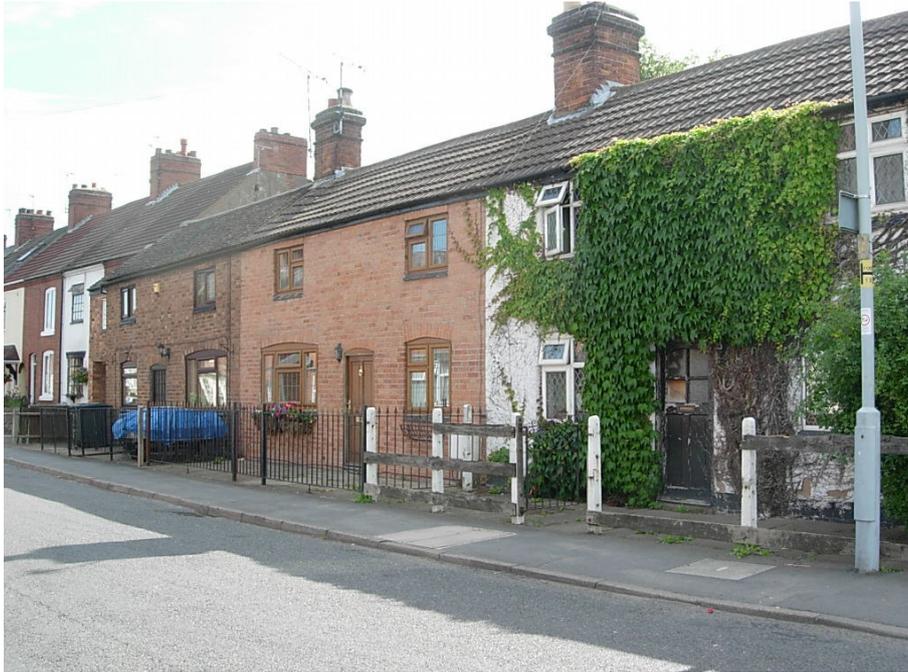
A further view of the framework knitters' cottages. It is unfortunate that they have been modernised with concrete roof tiles plastic windows and render. A standardised boundary treatment would also improve the appearance of this important group of buildings.

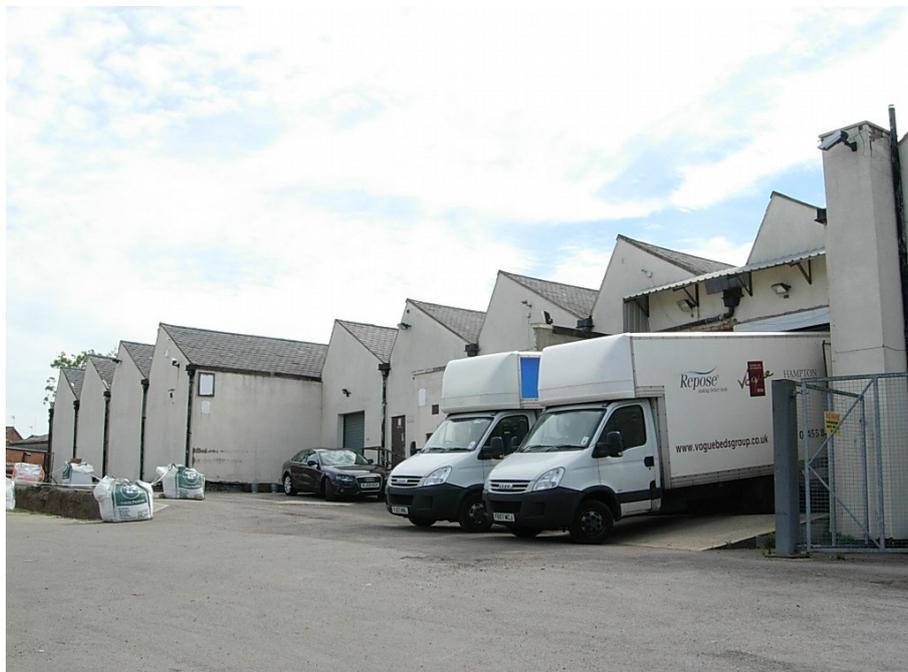
The rear view of the former Grewcock's factory on Arthur Street. This shows the distinctive roof profile of north light factory units.

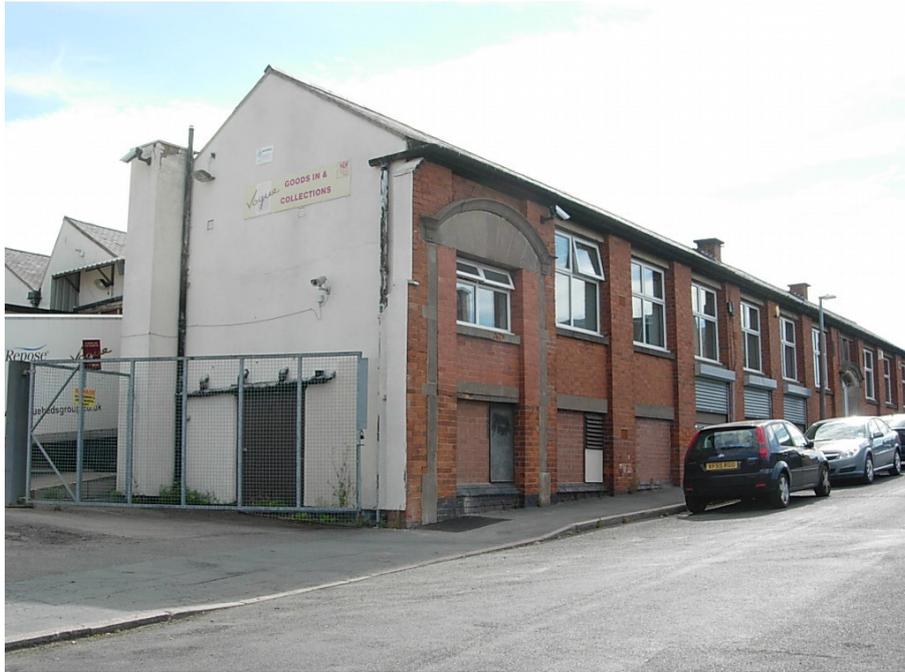
The street elevation of the former Grewcock factory. Founded by Harry Grewcock, the factory specialised in boys and girls shoes. This frontage is particularly fine but unfortunately has had inappropriate roller shutters fitted to ground floor openings.

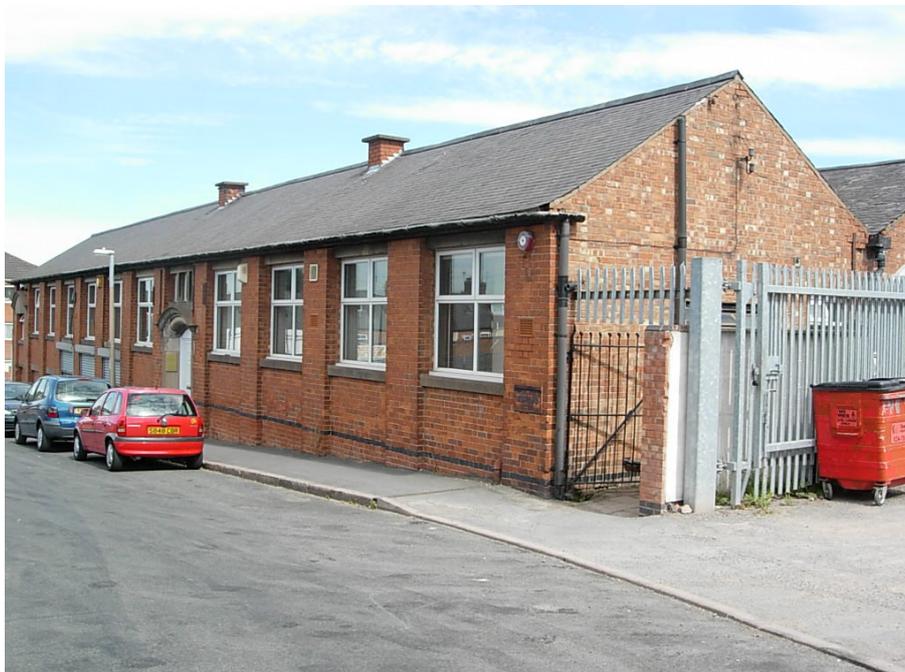
The eastern end of the Grewcock factory.

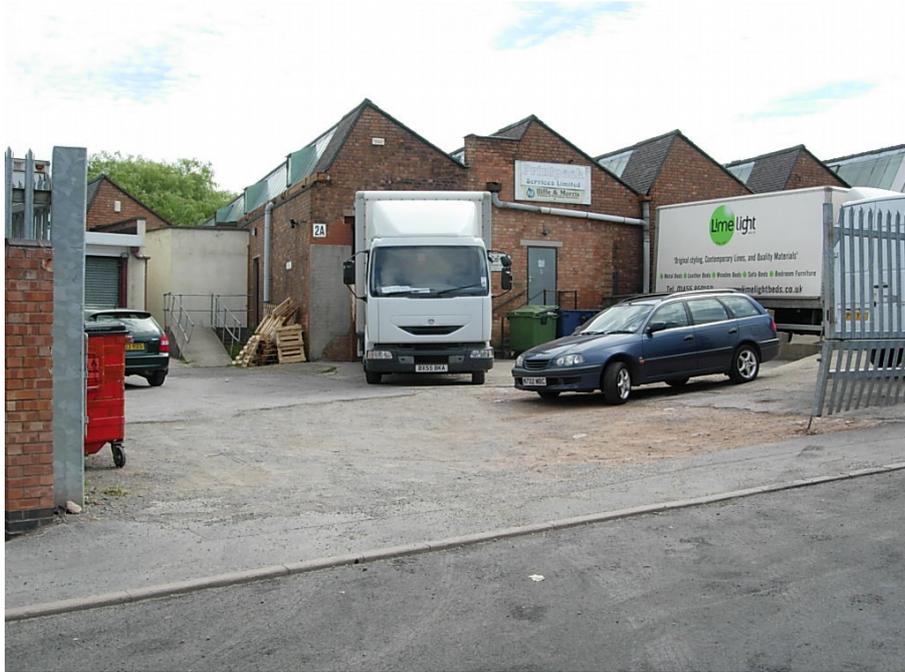
The service yard of the former H Garner factory on Arthur Street. The modern security fencing detracts from its appearance.

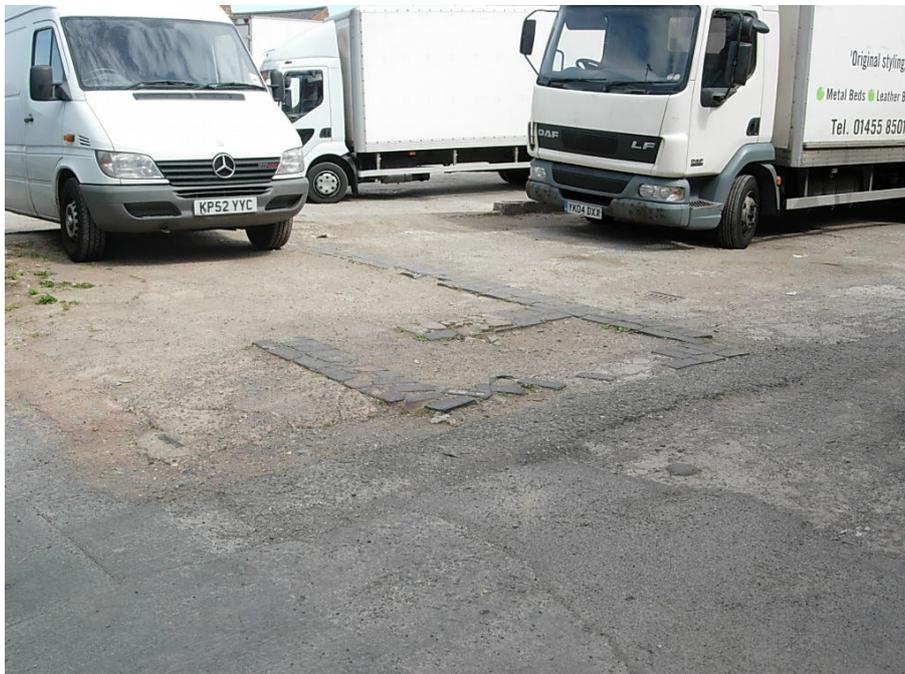
Detail view of the same service yard. The area suffers from poor surfacing and inadequate maintenance.

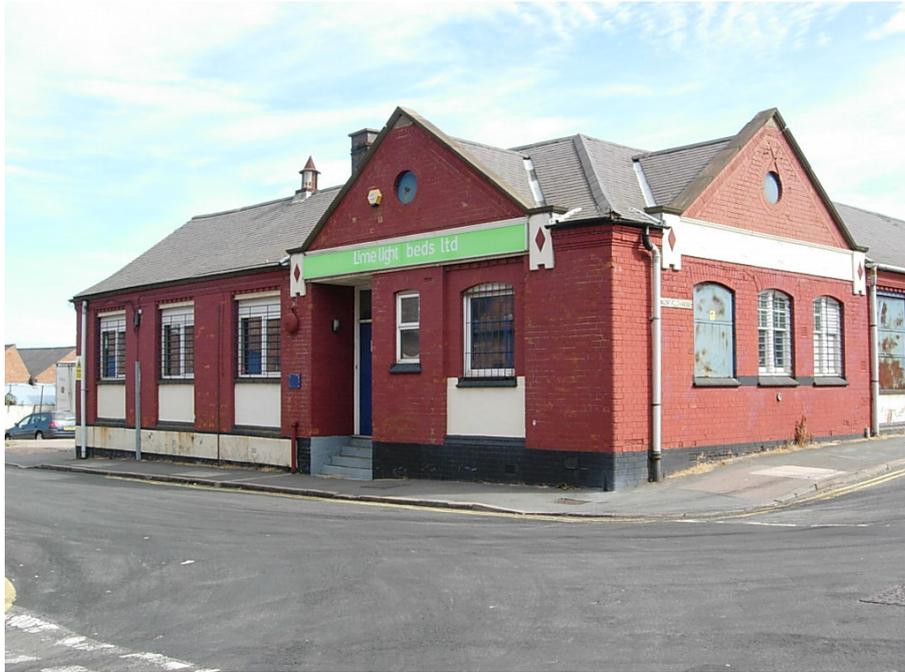
The former offices of the Garner factory at the junction of Arthur Street and Kingsfield Road. This interesting frontage has had its brickwork painted in the recent past which detracts from its appearance.

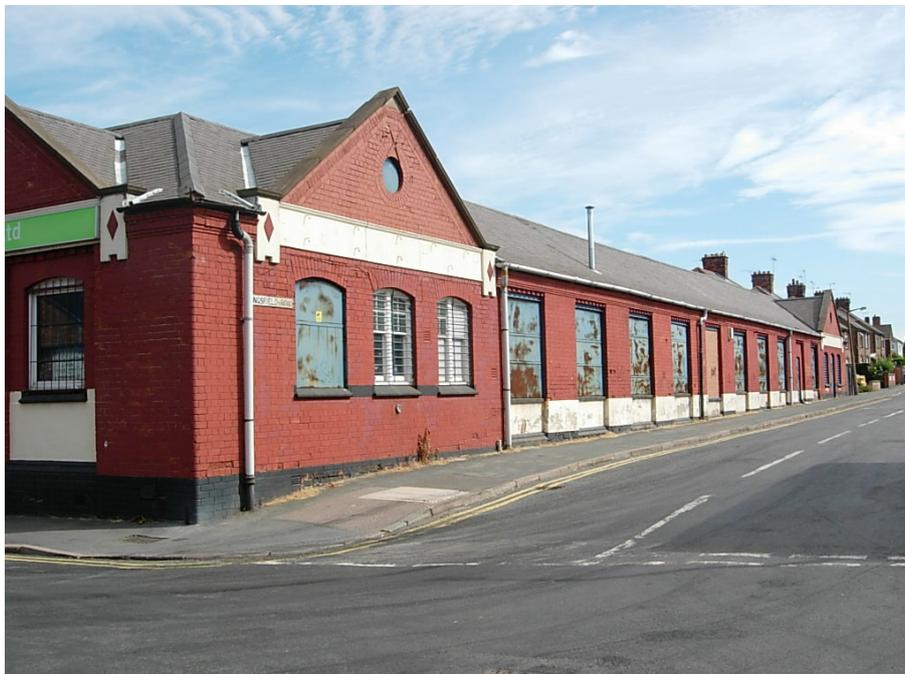
The former Garner factory fronting Kingsfield Road. Again this elevation has been painted which is peeling because of poor maintenance. This has a detrimental impact on the street scene.

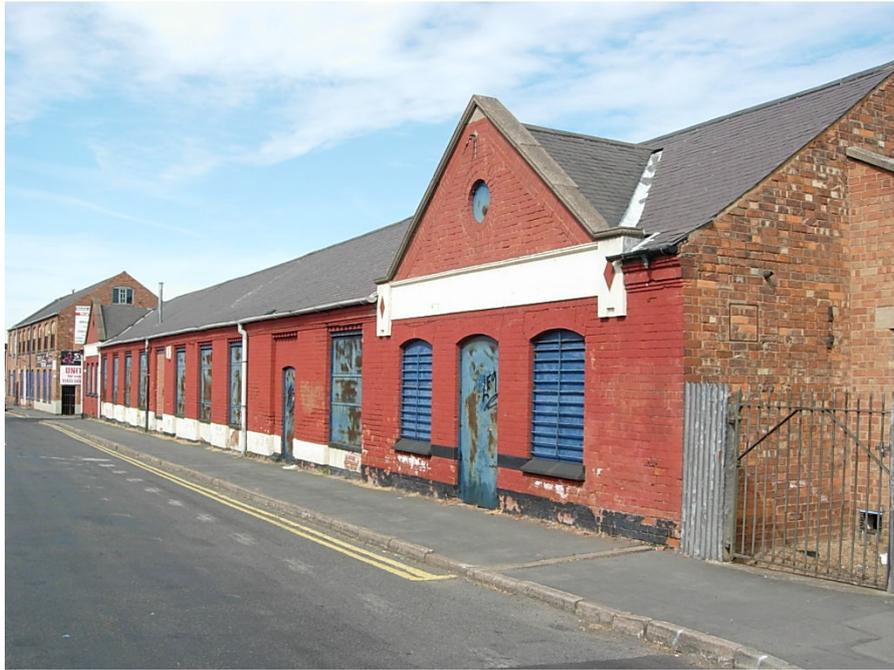
Inadequate maintenance in the conservation area is a major problem which needs to be overcome.

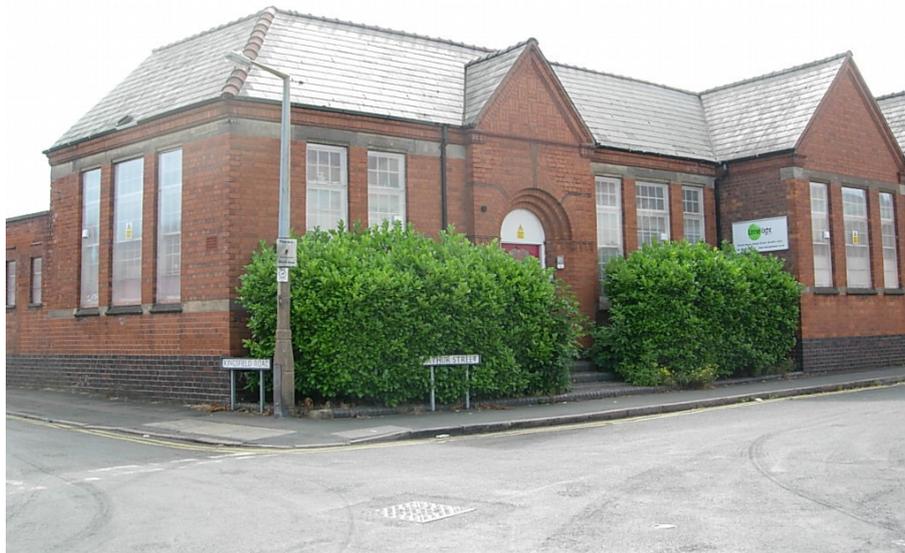
The offices of the former George Ward factory on Arthur Street. This is a high quality building which is suffering from poor maintenance. Regular pruning of the street planting would have a significant improvement on the appearance of the area.

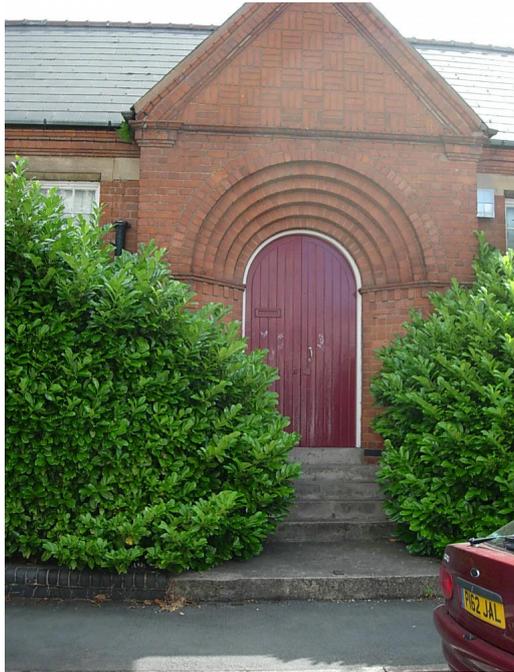
The fine detailing around the street entrance door and the edge of the gable reinforces the importance of the factory to the former owner George Ward.

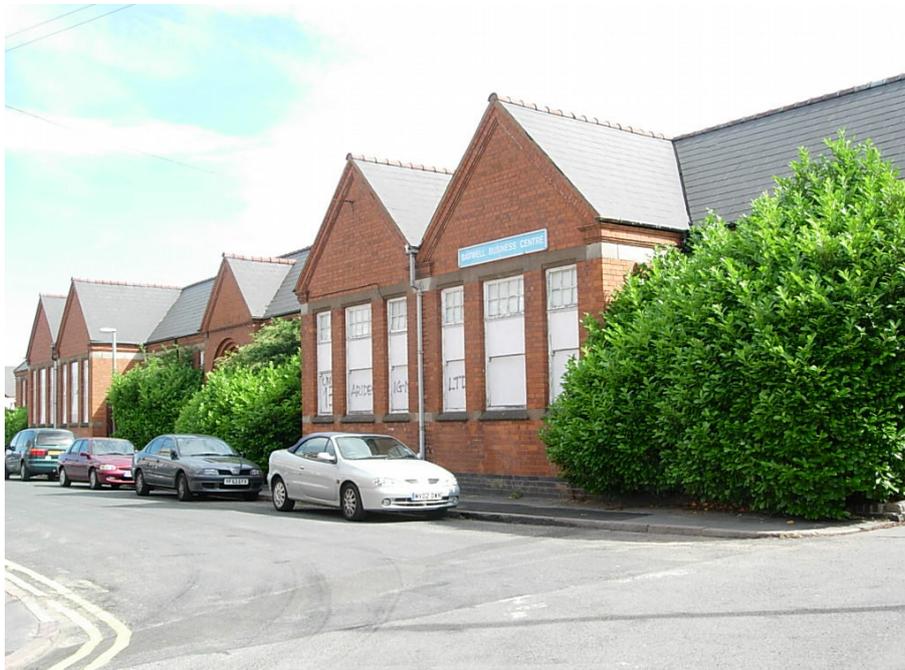
George Ward set up his business in 1894 which expanded and he eventually became one of the country's largest shoe manufacturers. The factory closed in 1989.

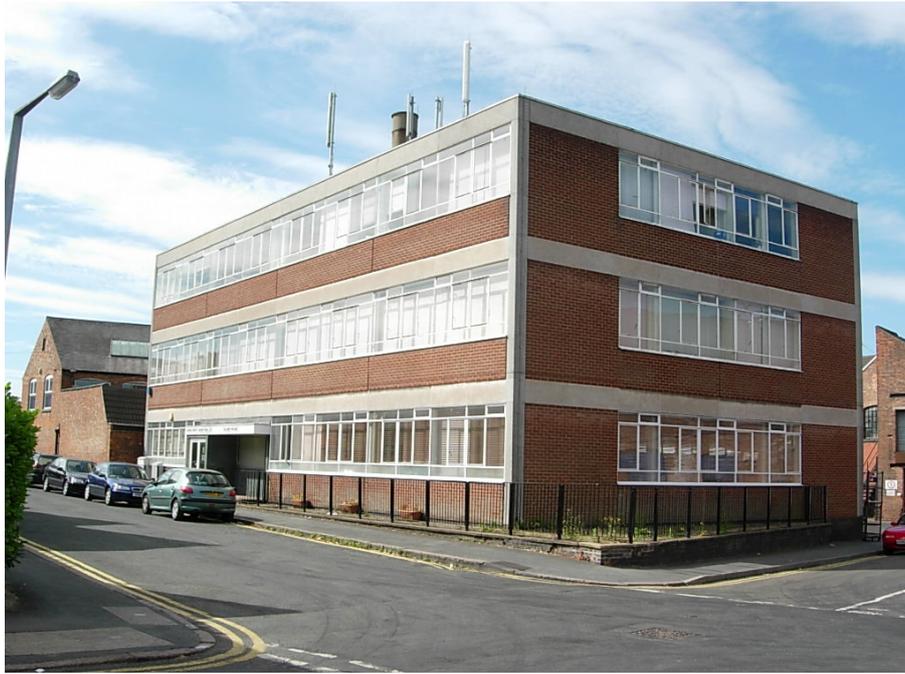
This office building stands at the junction of King Street and Arthur Street on the former Harvey, Harvey & Company factory site. Its design is completely inappropriate in the conservation area.

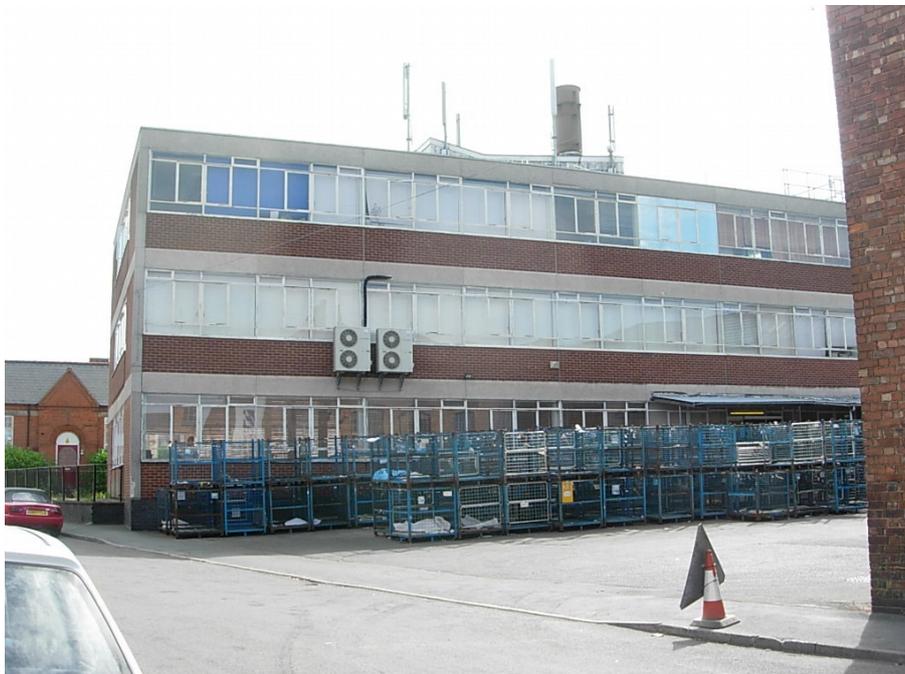
The flat roof and continuous windows contrast sharply with the pitched roofs and individual windows of every other factory in this part of the conservation area.

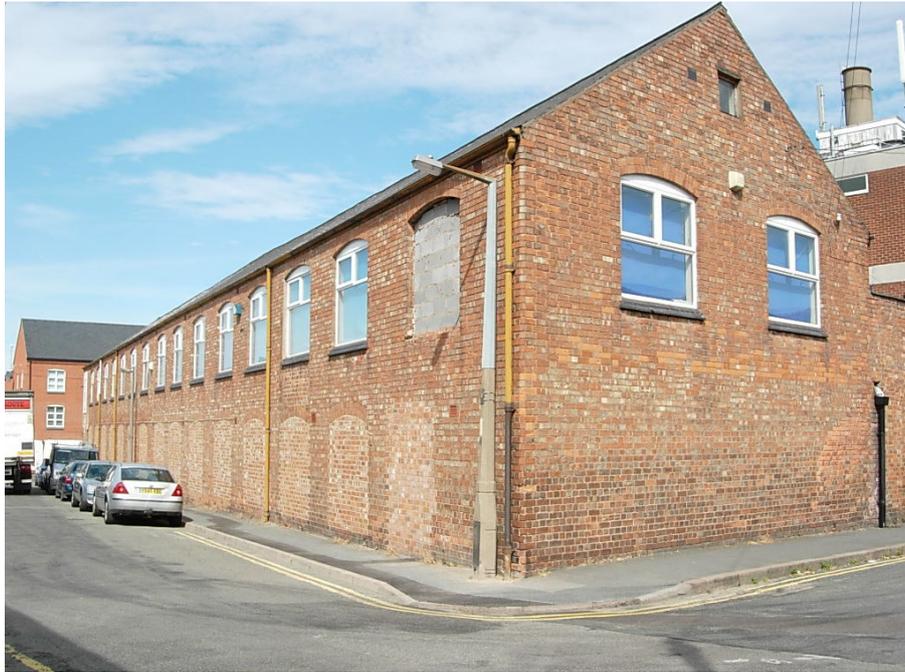
This part of the Harvey, Harvey & Company factory fronts George Street. Unfortunately its original cast iron windows have been replaced with plastic of inappropriate design. Those on the ground floor have been blocked up. This has a detrimental appearance on the conservation area.

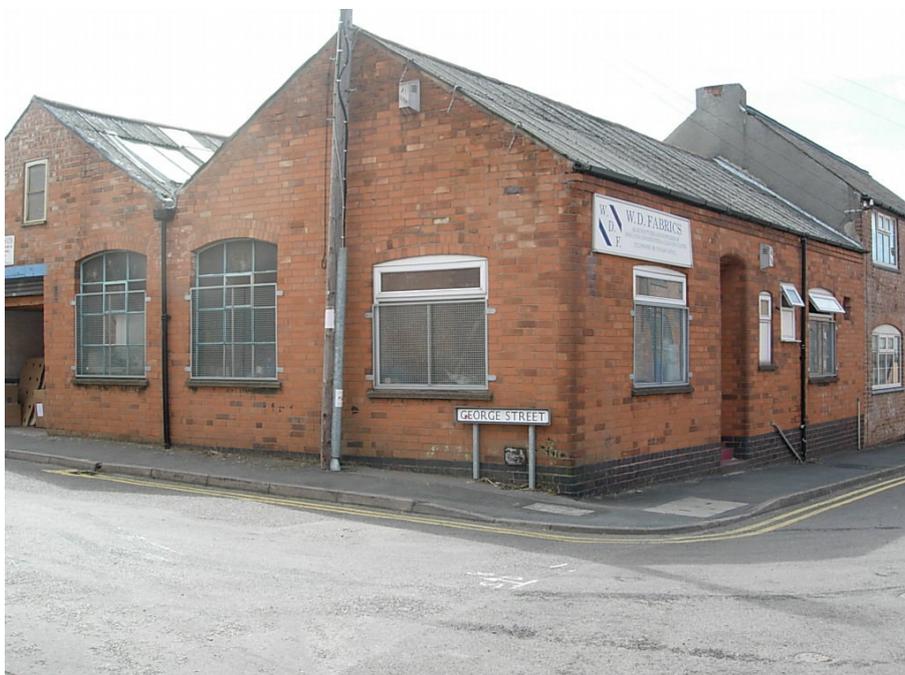
The origin of this small factory at the junction of George Street and King Street is not known. In common with many other factories in the area it has suffered from inappropriate changes to its windows.

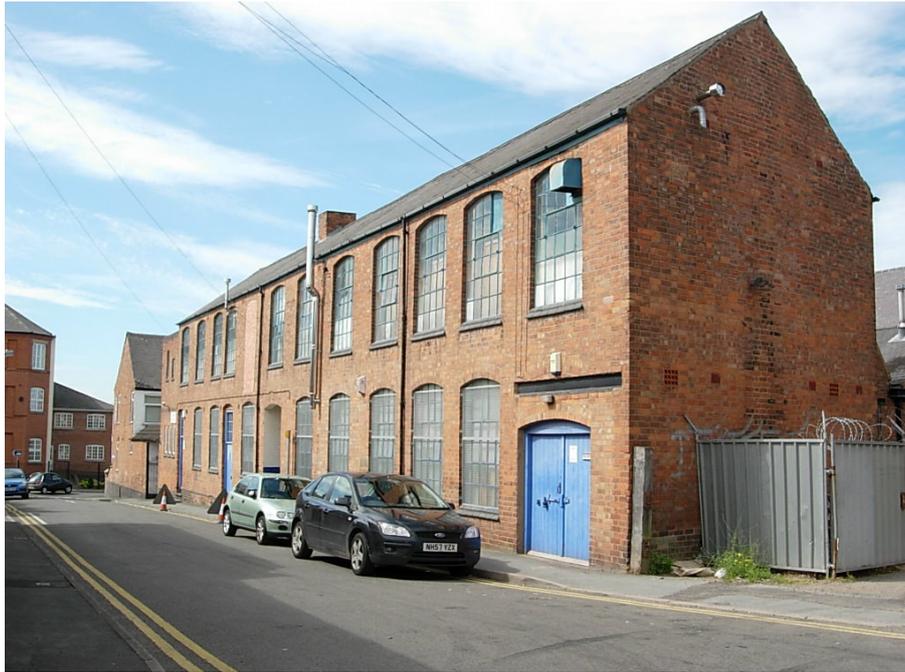
The former Amos Moore factory is one of the better examples of boot and shoe factories in the area. It has retained its original cast iron windows and slate roof covering. This company was one of the earliest shoe manufacturers in Barwell.

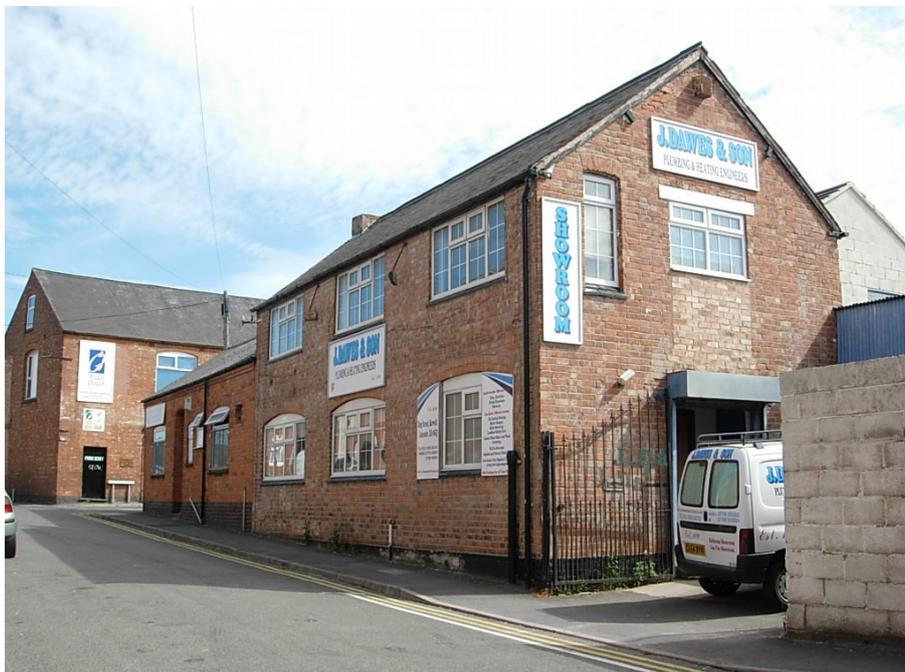
This former workshop has also suffered badly from inappropriate signage and insensitive changes to its windows.

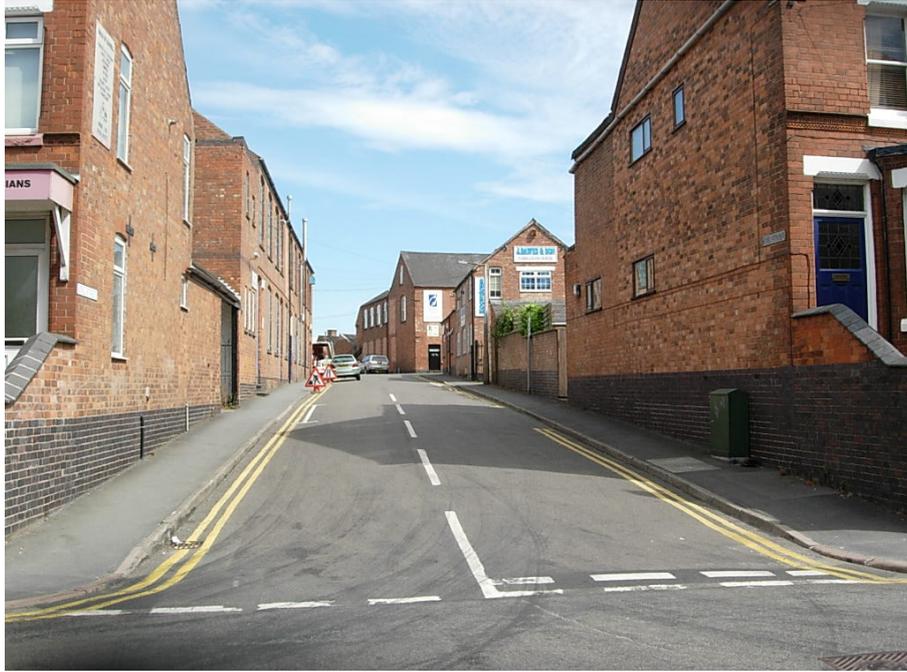
The view from the eastern end of King Street. This classic industrial landscape highlights the many boot and shoe factories in Barwell.

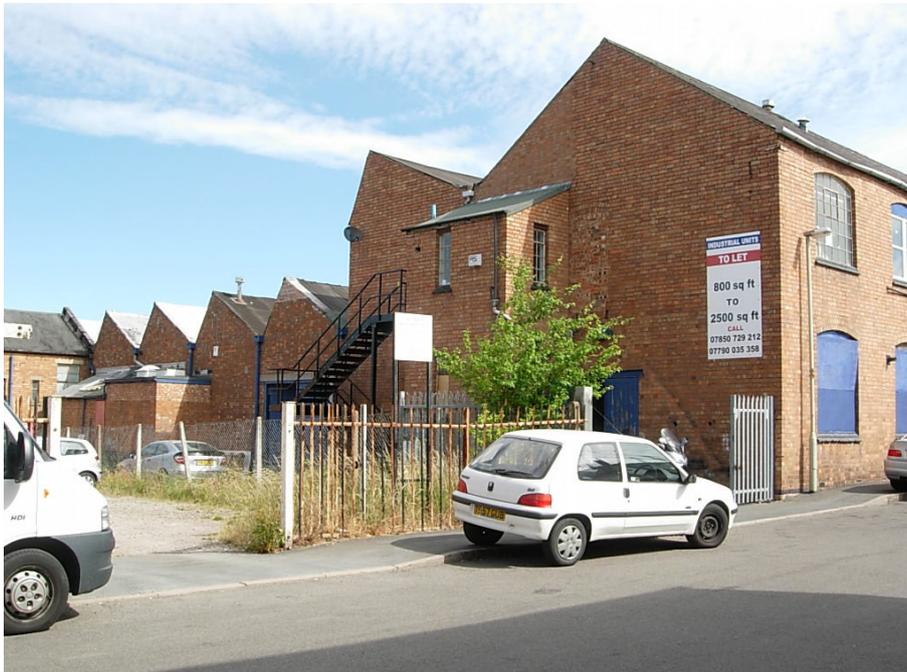
Spaces between the factories are generally ignored by current factory owners. This area at the rear of the Konfidence Works would be improved with regular maintenance and improved boundary treatment.

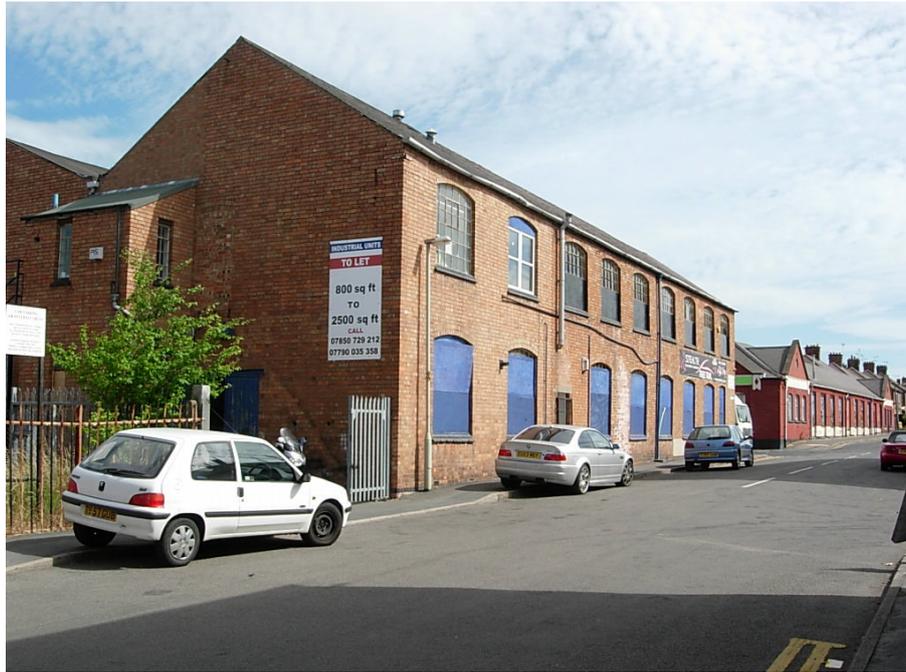
The original simple elegance of the Konfidence factory's elevations is still obvious despite inappropriate changes and signage.

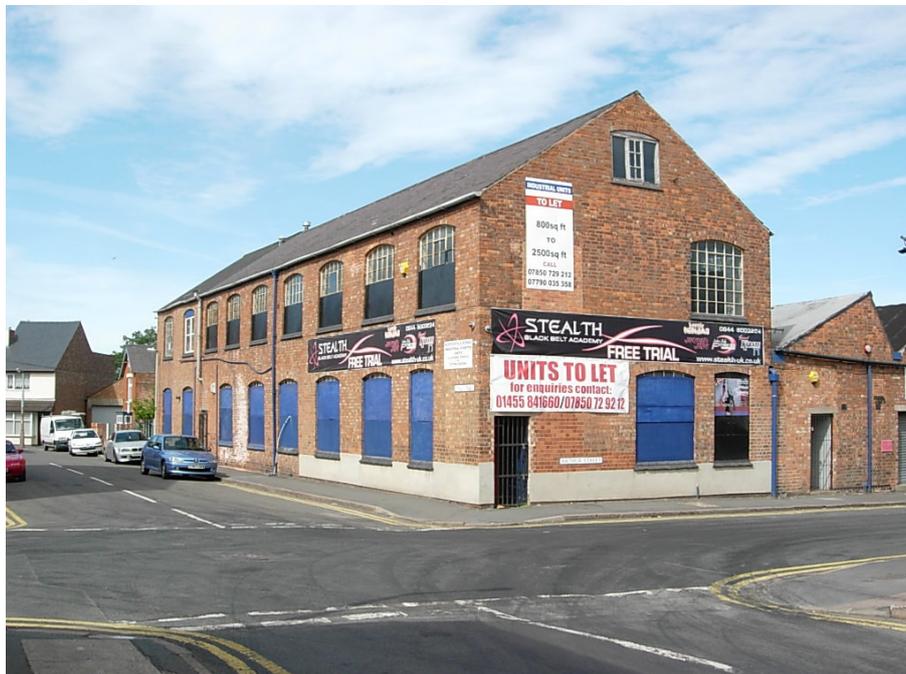
This view of the Konfidence factory highlights the detrimental impact that inappropriate signage, poor maintenance and other ill-considered changes are having on the conservation area.

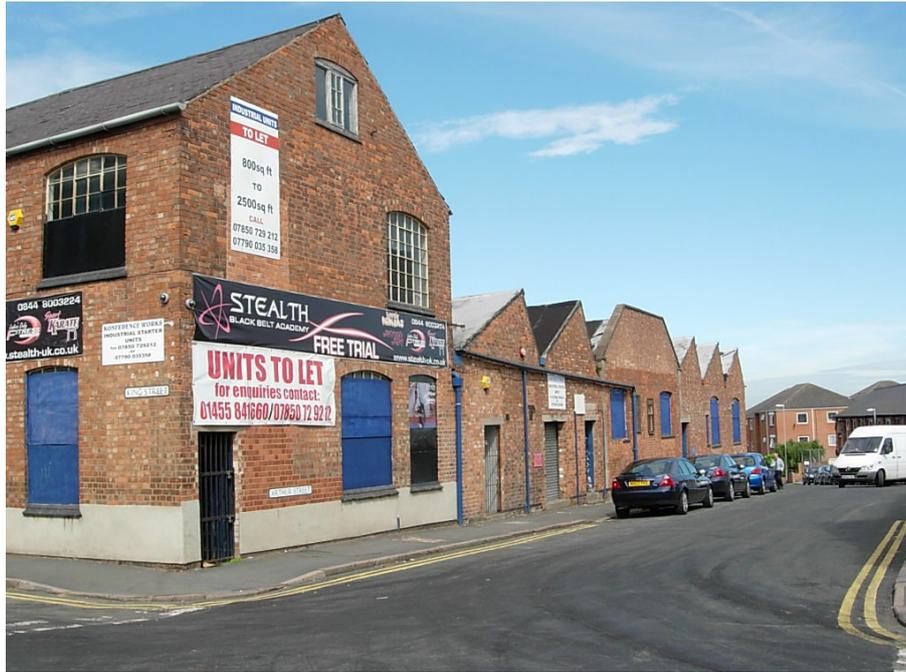
A detail view of the poor condition of this fine group of industrial buildings.

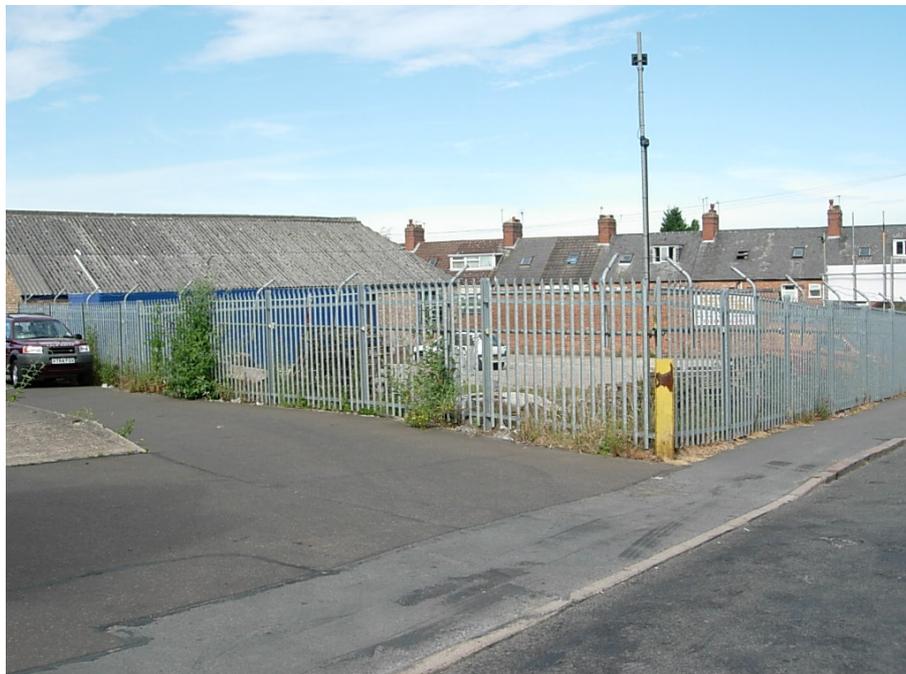
The service area of the Konfidence factory would be improved with a consistent traditional boundary treatment.

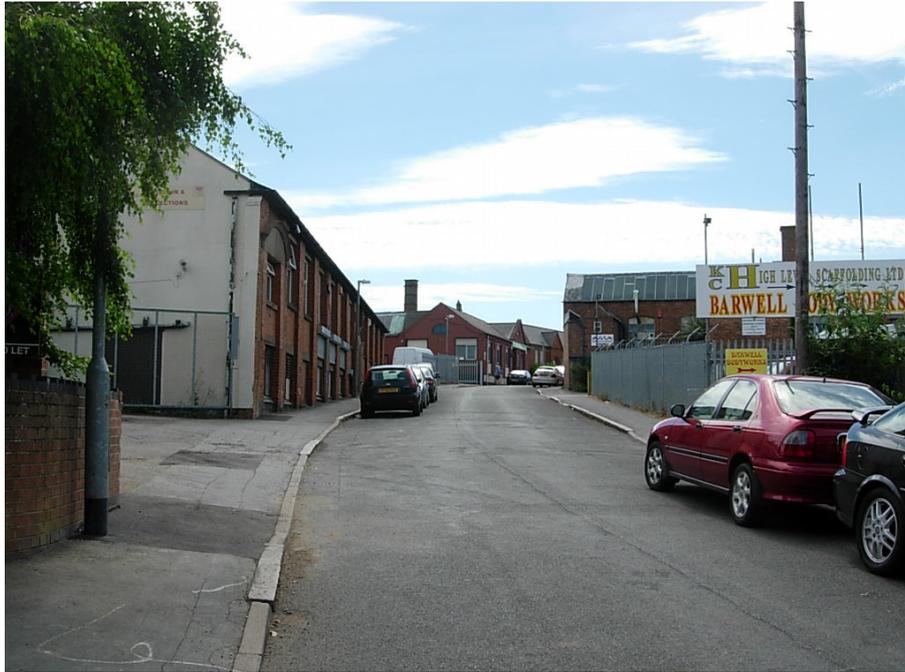
The view eastwards along Arthur Street which has retained many lengths of granite kerbs.

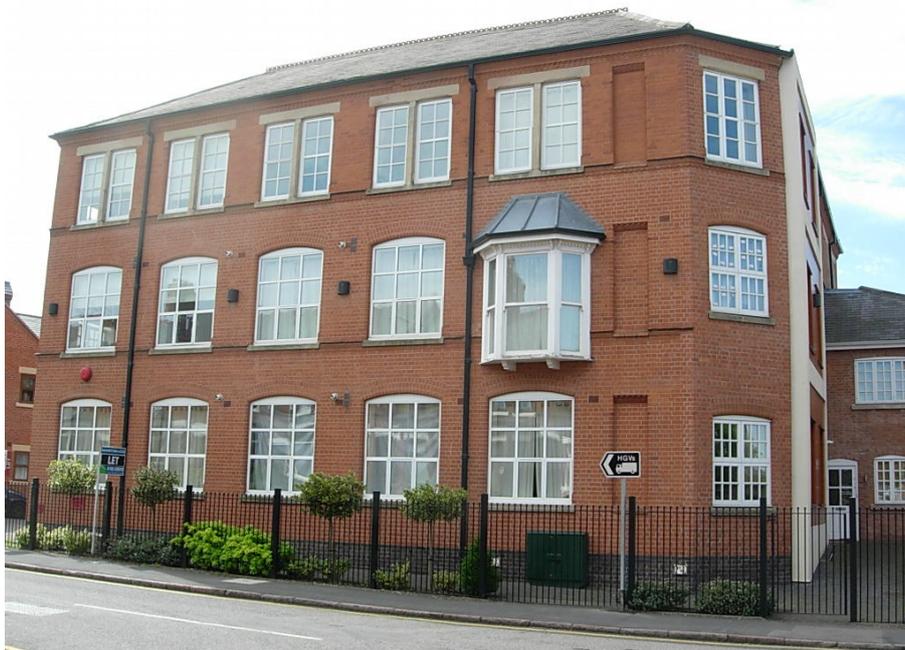
The former Moulds & Moore factory on Shilton Road which has been successfully converted into apartments.

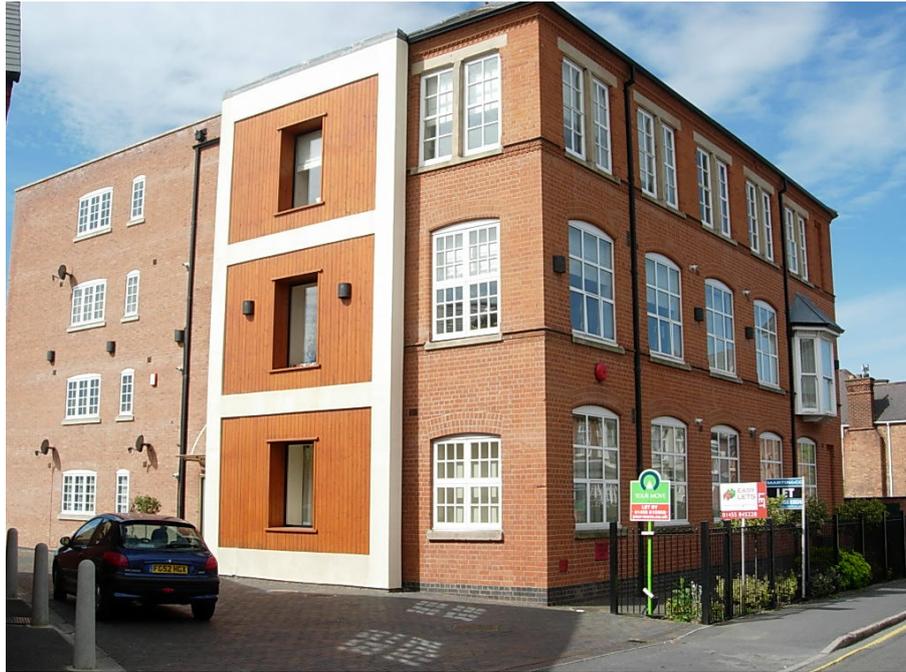
The northern elevation of the former factory with its distinctive loading bay treatment.

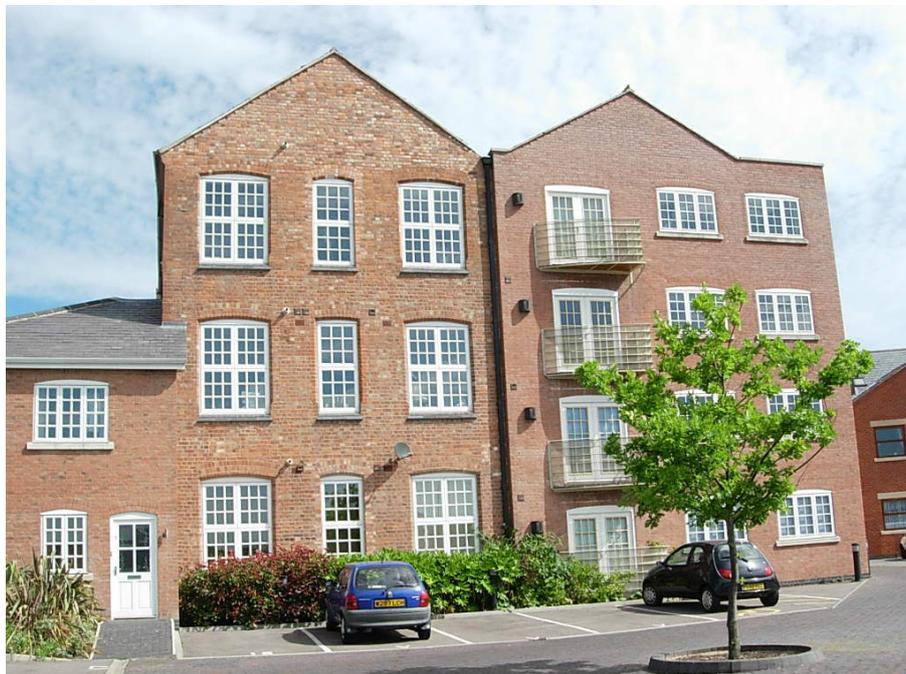
The east elevation of this factory highlights that former boot and shoe factories can readily be converted into residential use.
