**Hinckley Town Centre Conservation Area  
Appraisal and Management Plan**

**Photographic Record 1 - Castle Street, Hill Street, Wood  
Street, New Buildings and Church Walk**

**February 2013**

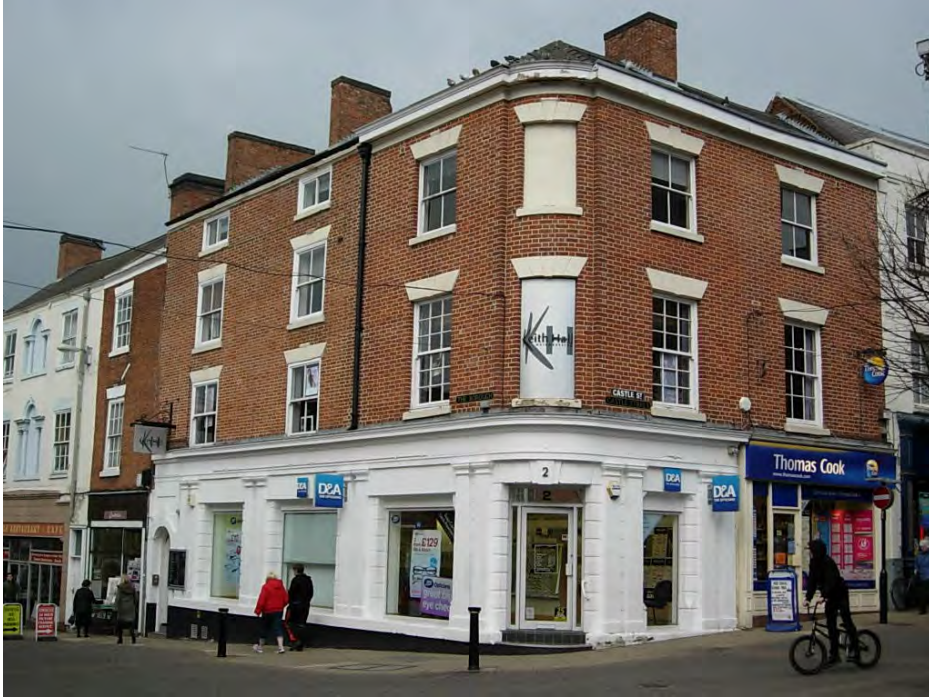
2 & 2a Castle Street is an early C19 Grade II listed building that stands at the edge of the Market Place and although the shop fronts have been extended and the pilasters and windows changed during the C20, the building is a fine landmark structure.

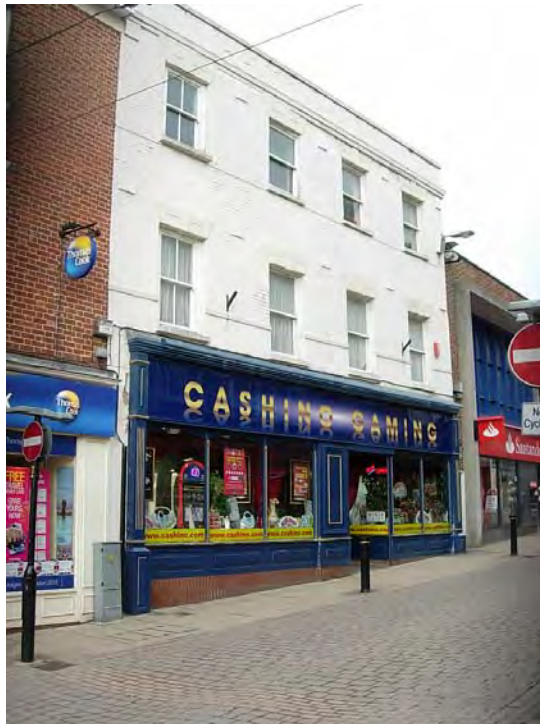
This Grade II listed building, 4 Castle Street, unfortunately has had its frontage painted, and string courses and a presumptuous shop front added during the late C20. Despite this, it is an important heritage asset in the Market Place.

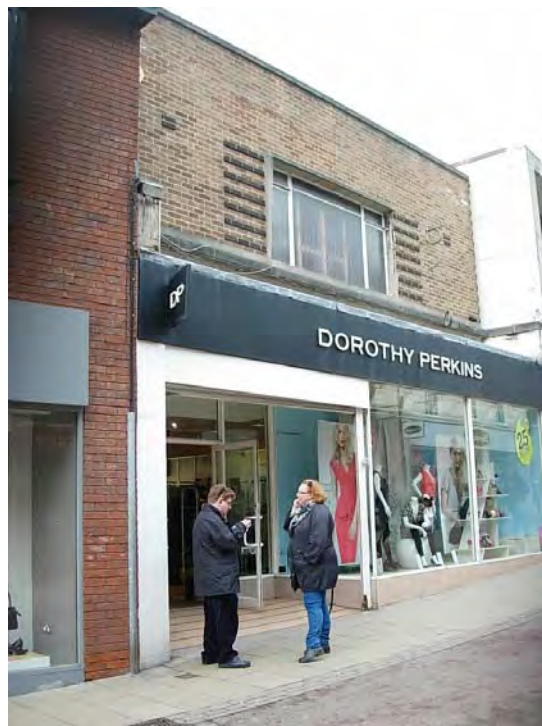
6-8 Castle Street formed part of the Britannia development that replaced earlier buildings during the late C20.

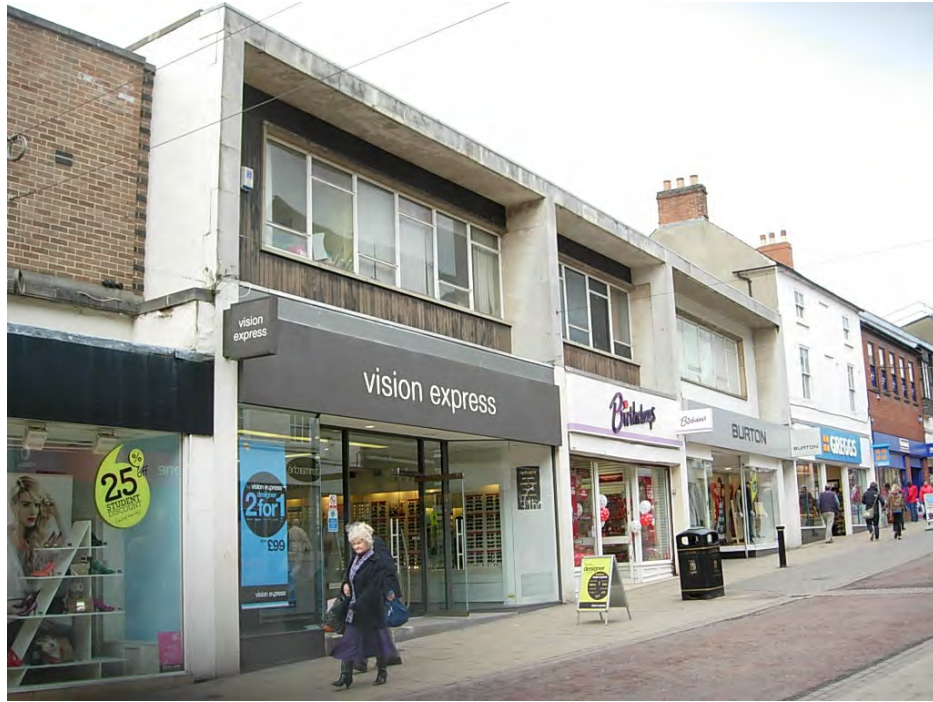
10 & 12 Castle Street has a 1950's style frontage. Its modern shop front is in keeping with other parts of the Britannia development.

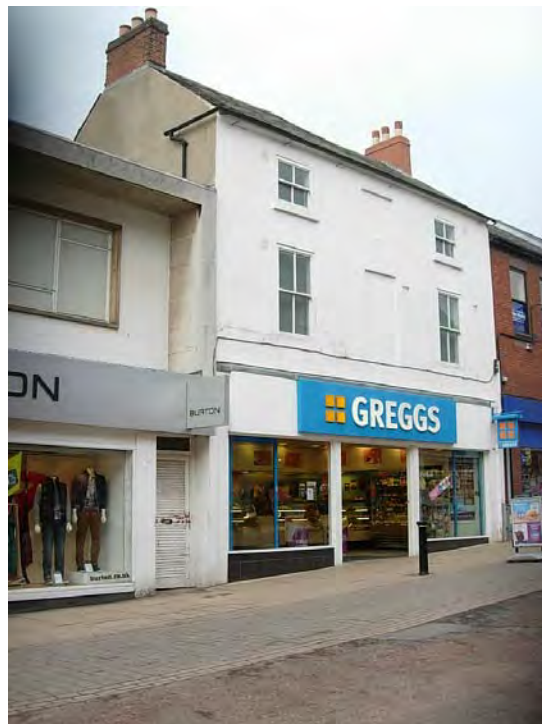
22 Castle Street is probably an early C19 building with a late C20 shop front. It has unfortunately, had its street façade painted although it has retained its chimneys and traditional style windows on the upper floors.

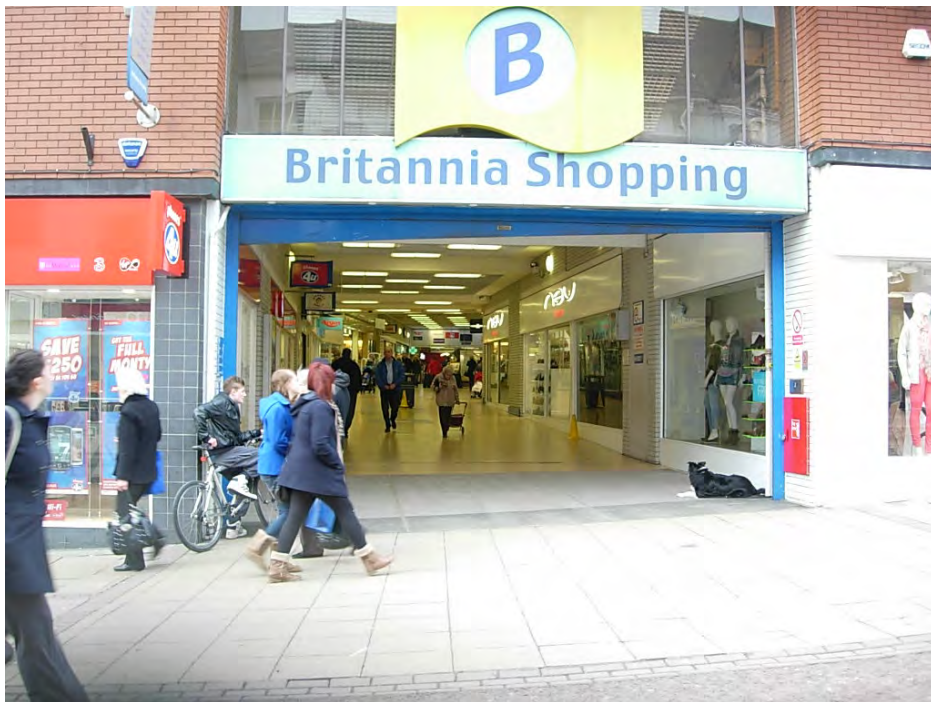
The entrance to the Britannia Centre is typical of similar centres of the same period.

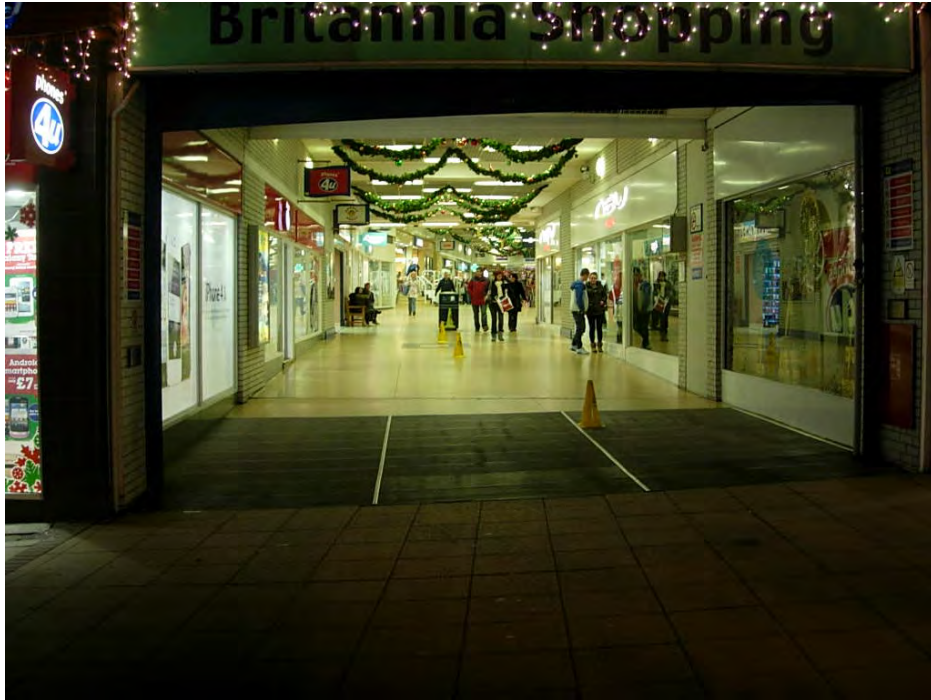
The mall is relatively attractive but has limited impact on the street scene.

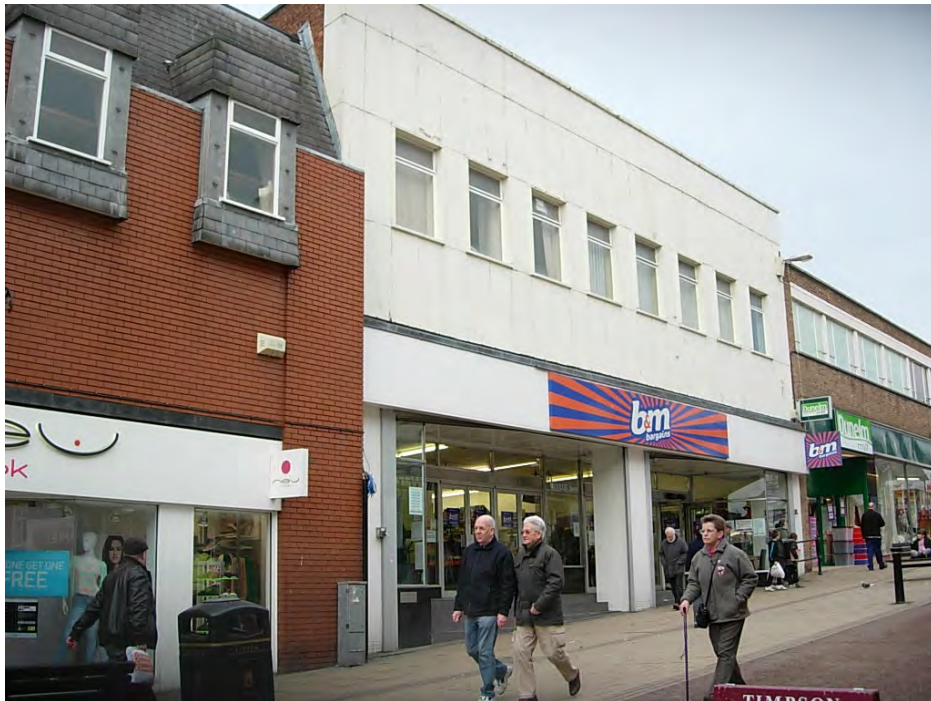
36 & 38 Castle Street lacks interest and has limited impact on the street scene.

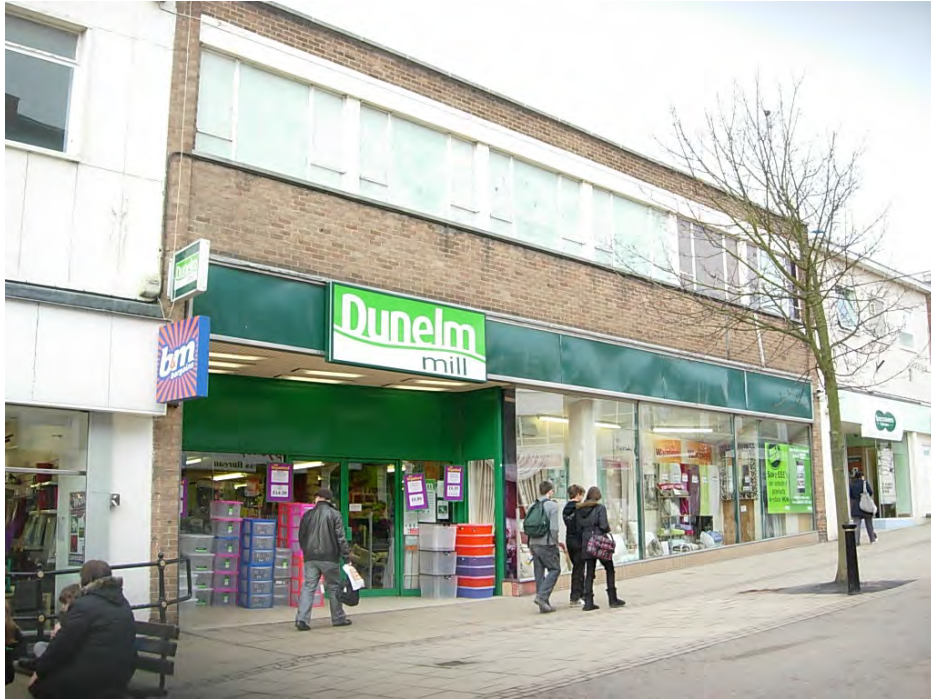
40-44 Castle Street is rather bland and has limited impact on the character of the street. The continuous form adopted for the windows is particularly inappropriate and not in keeping with the traditional character of Castle Street.

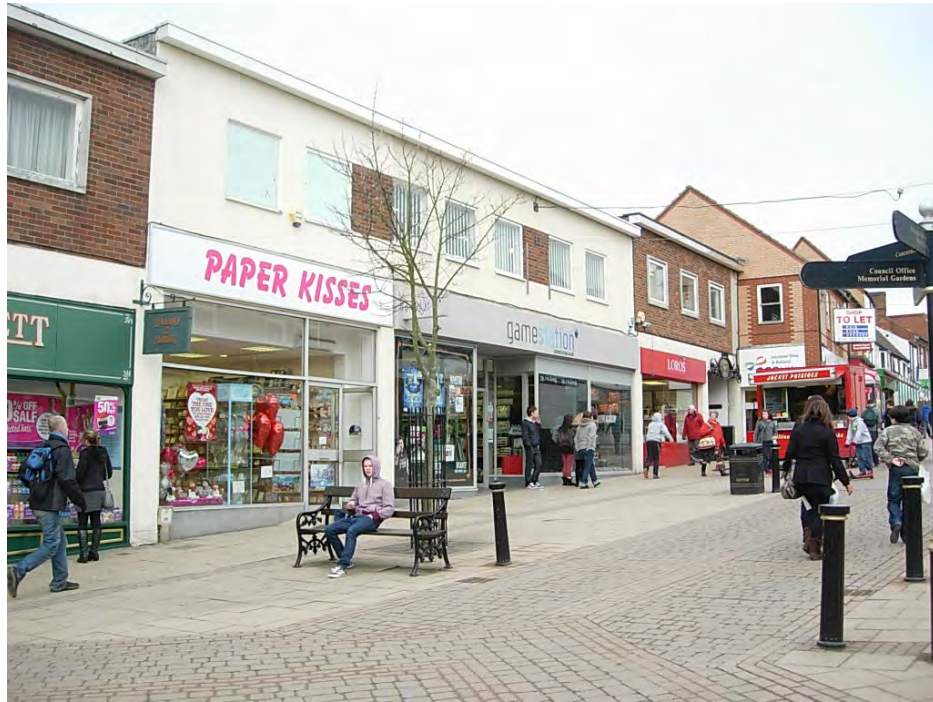
46-52 Castle Street are modern 2 storey buildings economically designed with a flat roof construction which although popular in the 1970's is out of character with traditional buildings in the street.

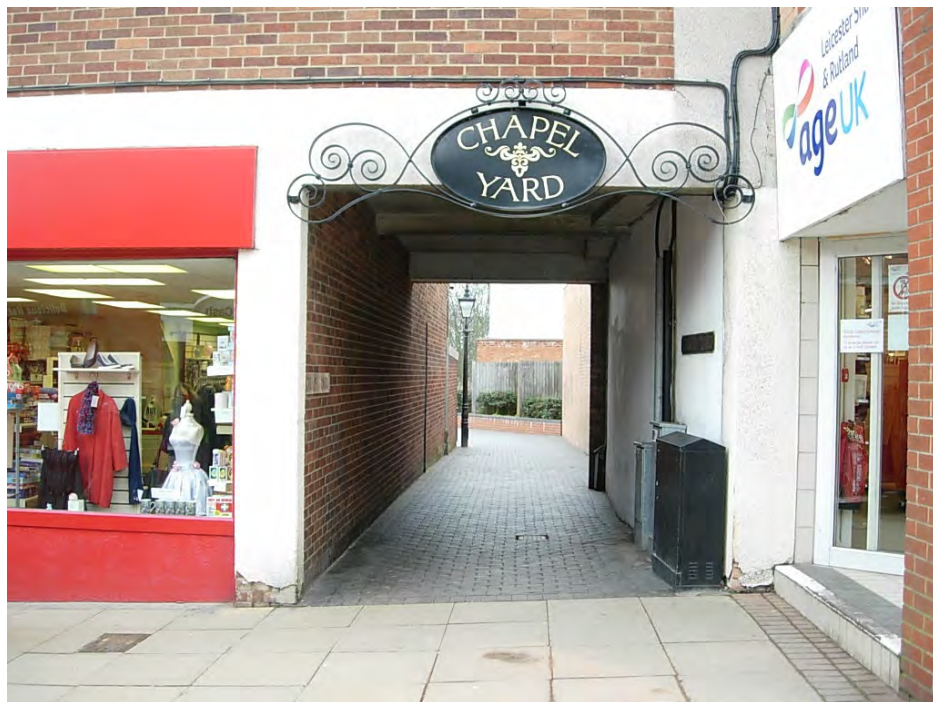
Chapel Yard is a principal jitty in the town centre but its form lacks interest when compared with other C19 jittys.

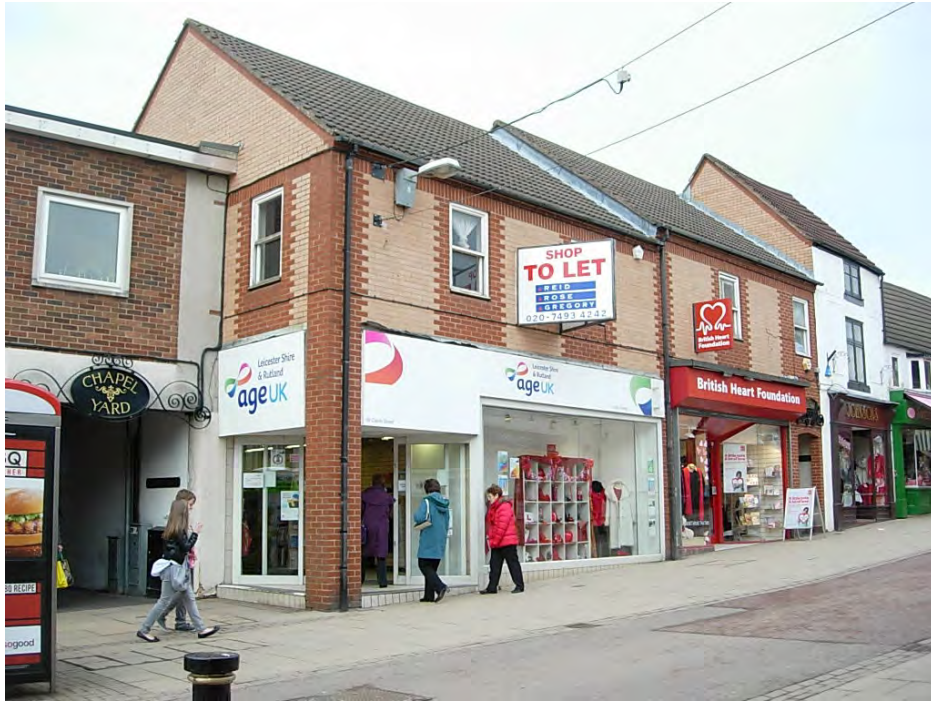
The original serpentine form of Castle Street with continuous frontages was lost with the construction of 56 & 58 Castle Street and a set-back in the frontage introduced.

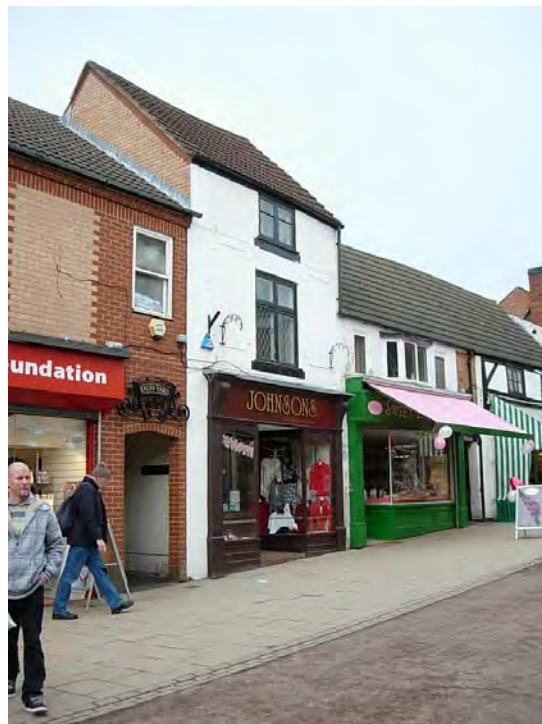
60 Castle Street, originally C17 and remodeled in the C18, has unfortunately had its roof recovered with concrete tiles and its frontage rendered and painted. Its rear wing is very important and forms the sides of both Lilley's Yard and Eales Yard

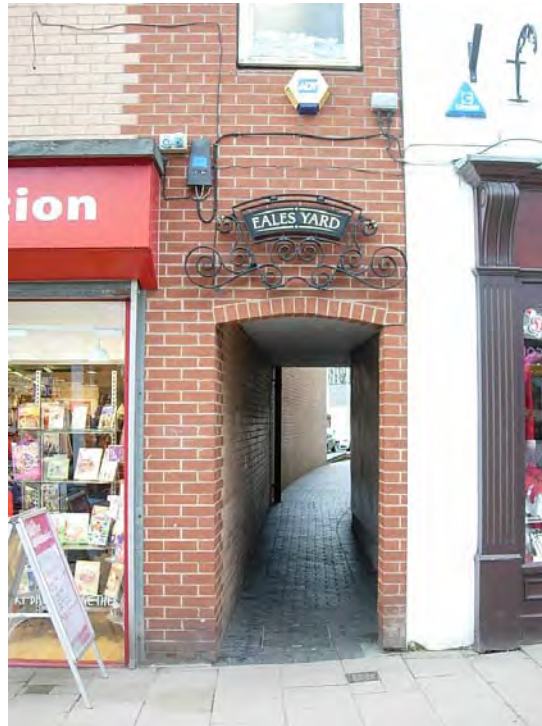
This is the entrance to Eales Yard from Castle Street which although reconstructed in the 1970's incorporates a traditional arch lintel and Victorian diamond pattern pavers. The surface mounted wiring; junction and alarm boxes are clutter that do not improve its appearance.

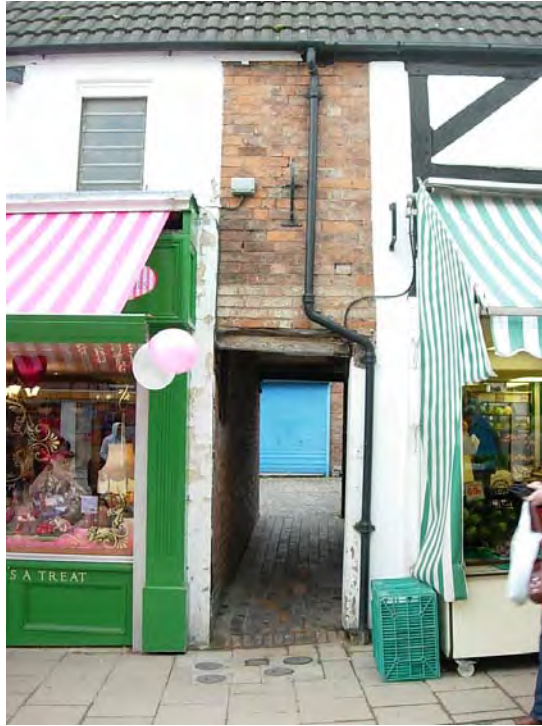
The entrance into Lilley's Yard is very low and incorporates an old timber lintel. The old brick pavers covering the floor add character to this entrance.

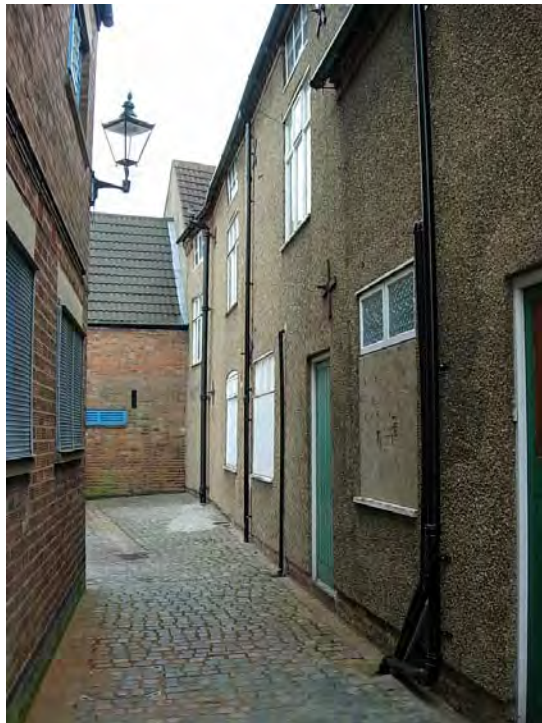
Lilley's Yard itself has a floor surfaced with granite setts and its narrow width and wall surfaces offer the viewer an experience of a traditional jitty.

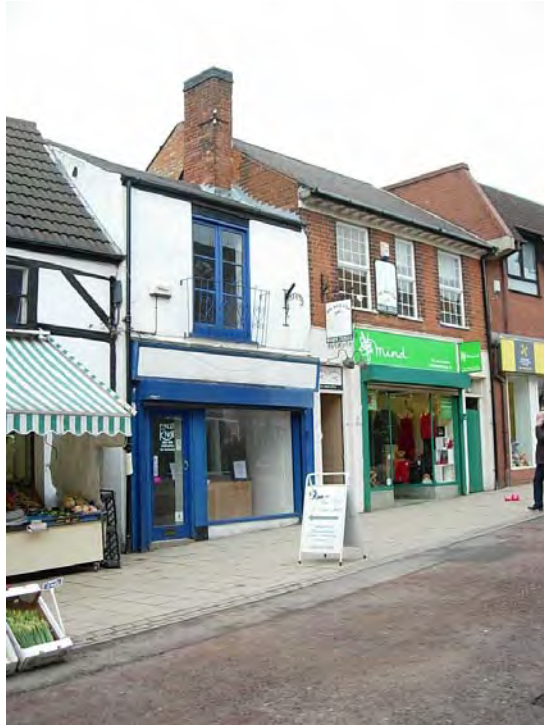
66 & 68 Castle Street. The left hand building is thought to be early C19

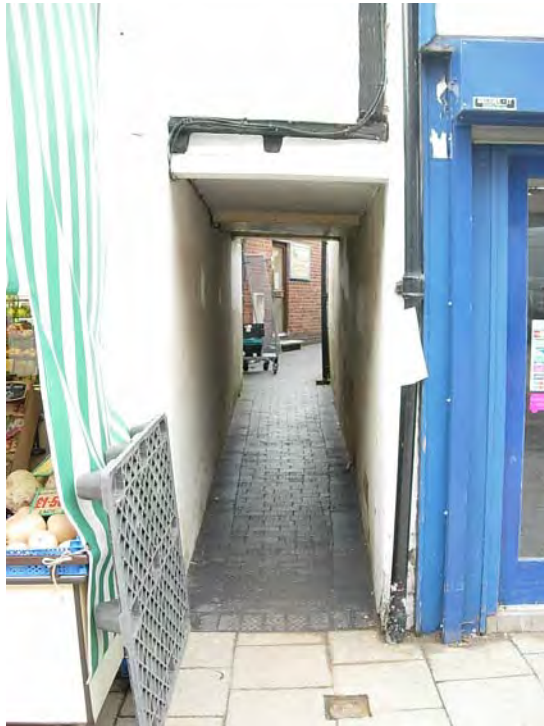
The narrow Vernon's Yard entrance leads into a large open car park which has destroyed the tight enclosed nature of the original jitty.

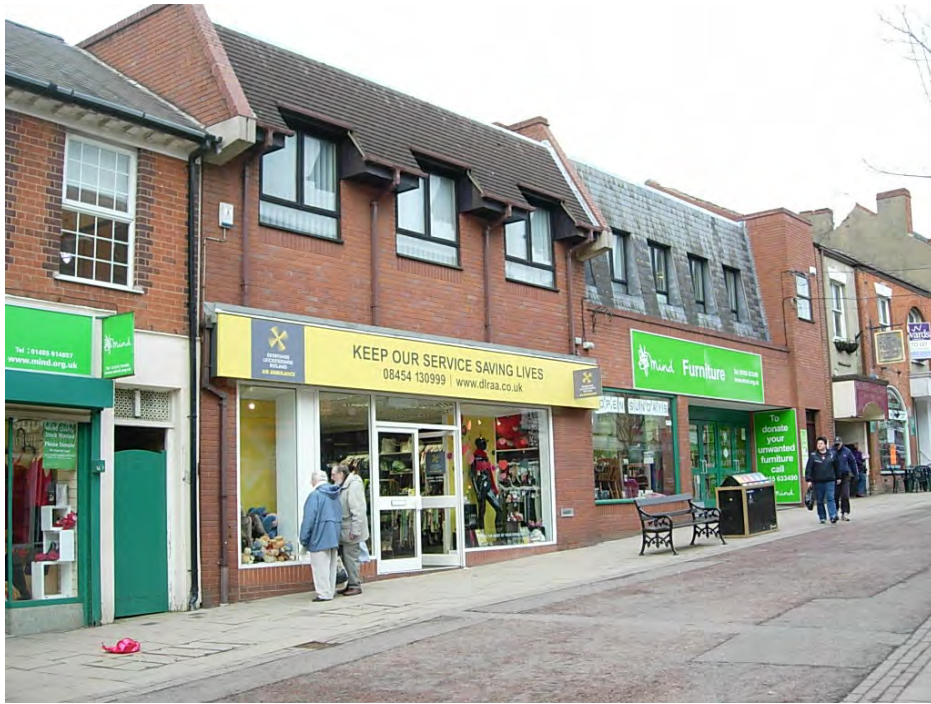
70 – 76 Castle Street is a modern development that unfortunately has destroyed the appearance of the traditional flat fronted buildings with continuous eaves lines which were a feature of Castle Street.

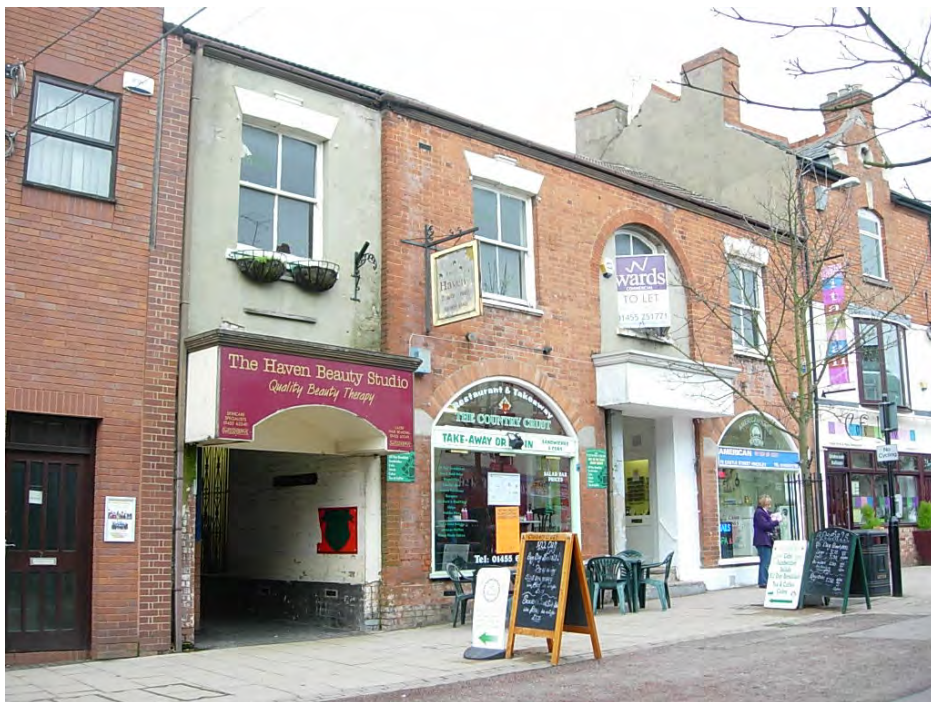
1 Crown Court & 78 Castle Street has a fine building elevation dating from the early C19, would be vastly improved if the projecting canopies were removed.

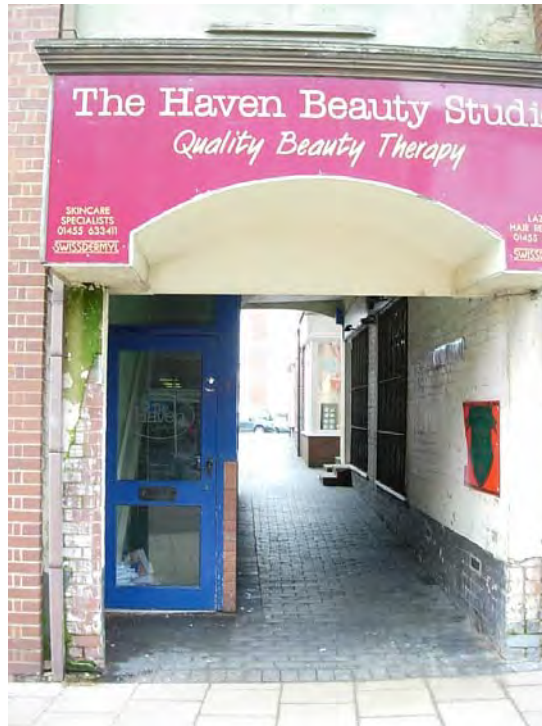
Entrance into Crown Court. Regular maintenance would considerably improve the appearance of this jitty.

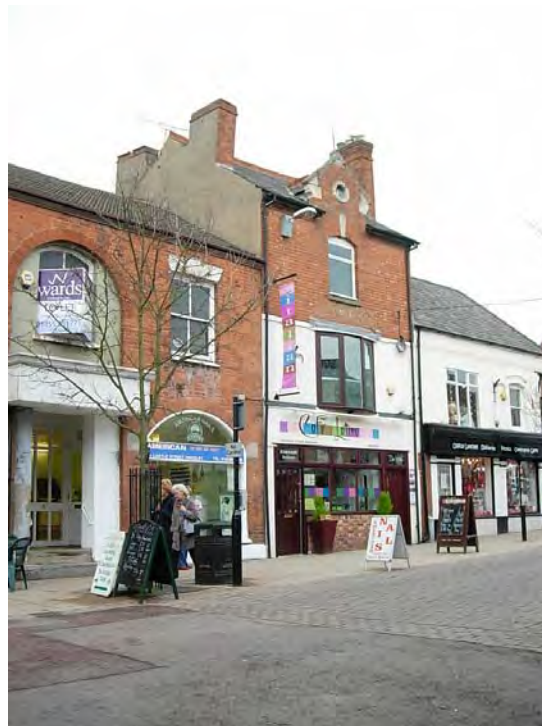
The quality of 80 Castle Street can still be seen despite the modern bay and shop front which have been added.

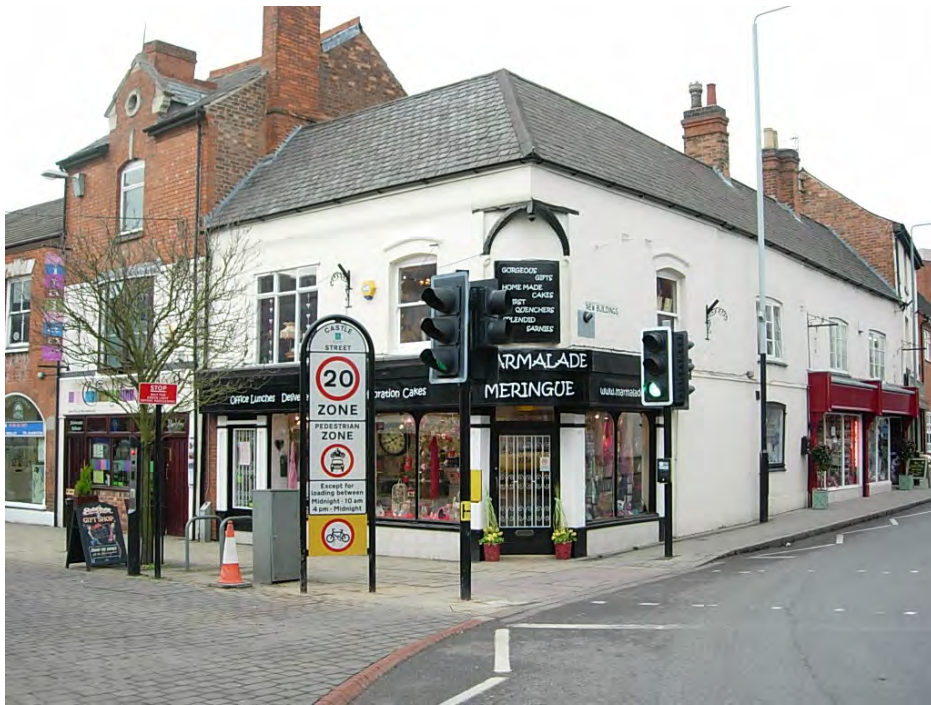
Although 82 Castle Street has lost an entrance on its eastern façade and its shop front has been changed, it remains a good corner building and a significant heritage asset on this important corner of Castle Street.

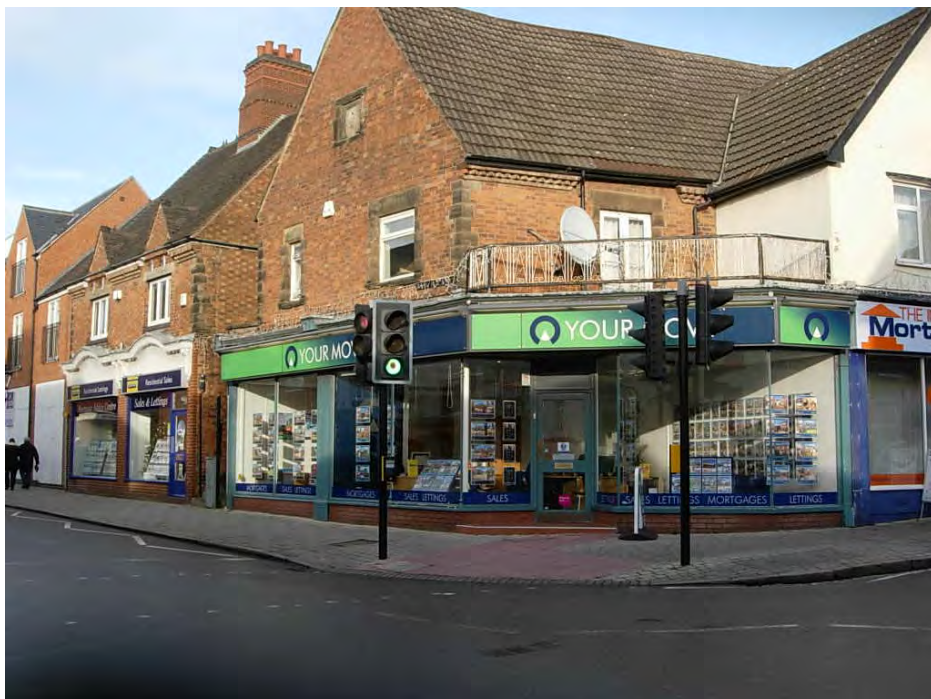
84/86 was constructed in 1874 as part of a group of buildings. With the exception of the modern shop fronts and windows, most of the original features can still be seen. It is unfortunate that some of the original decorative clay tiled roofs have also been replaced with concrete.

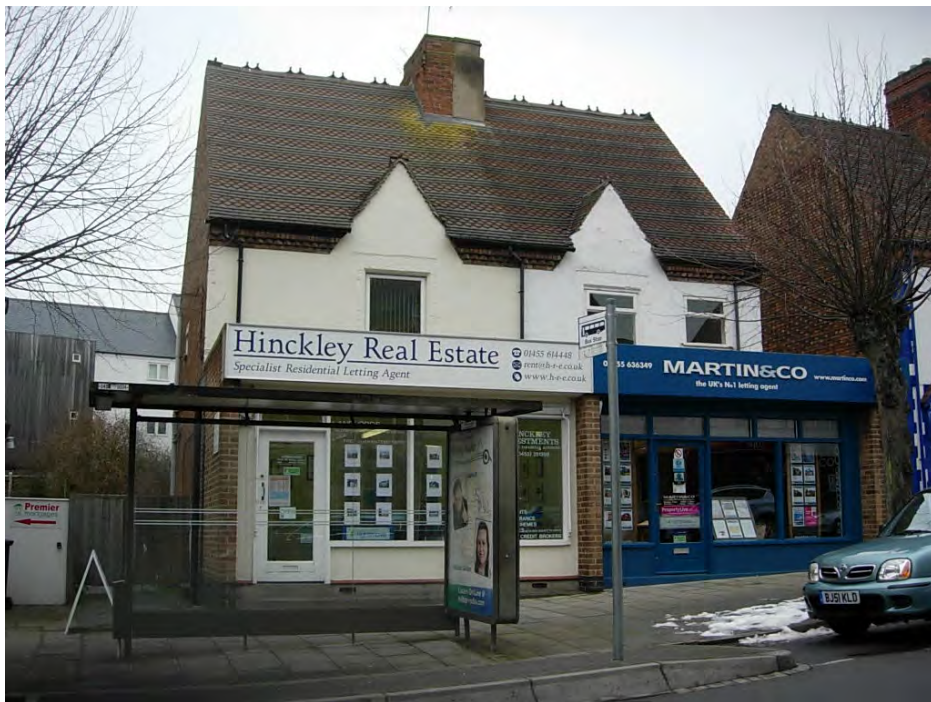
92/94 Castle Street were originally constructed with short front gardens and low boundary walls. These were later lost by the incorporation of front flat roofed extensions. These properties still display their original decorative tiled roof covering.

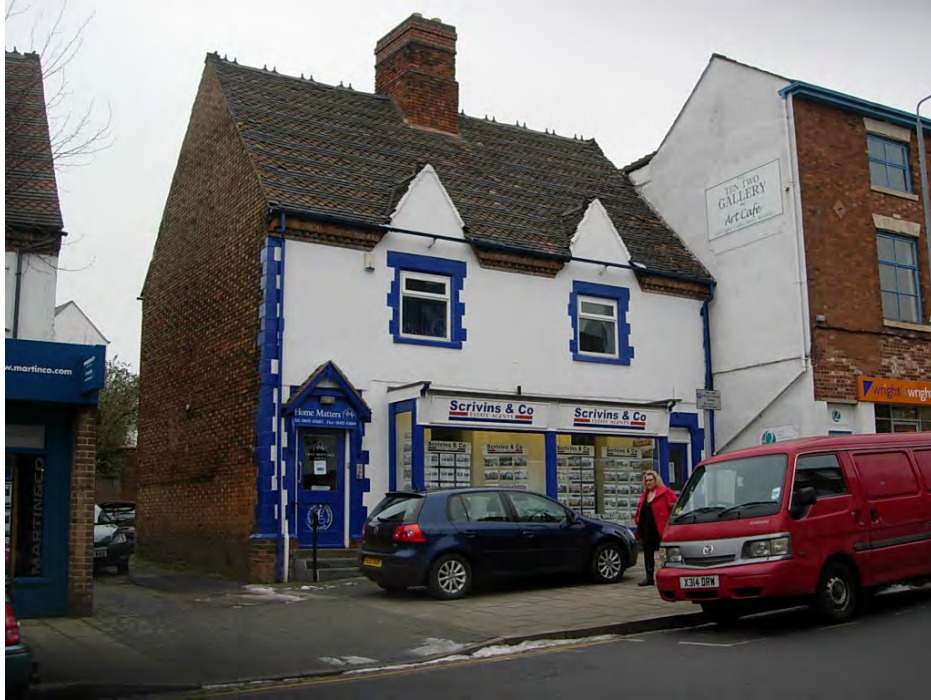
It is unfortunate that the frontage to 96/98 Castle Street has been rendered and a flat roofed front extension has been added.

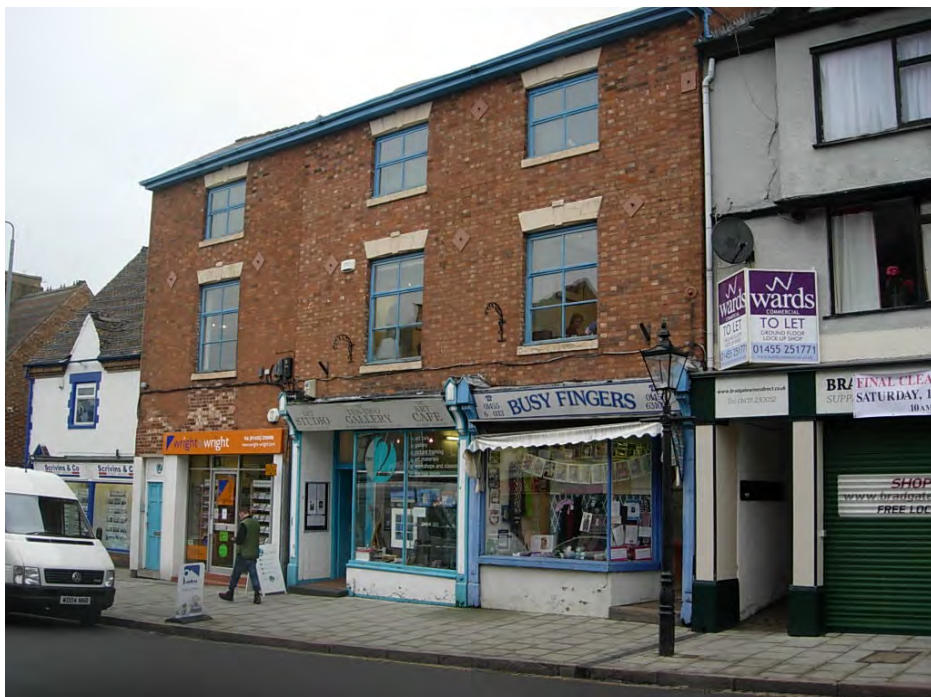
100-104 Castle St were formerly the offices of Ginns Son and Moore, a hosiery manufacturer whose factory premises extended as far as Wood Street at the rear.

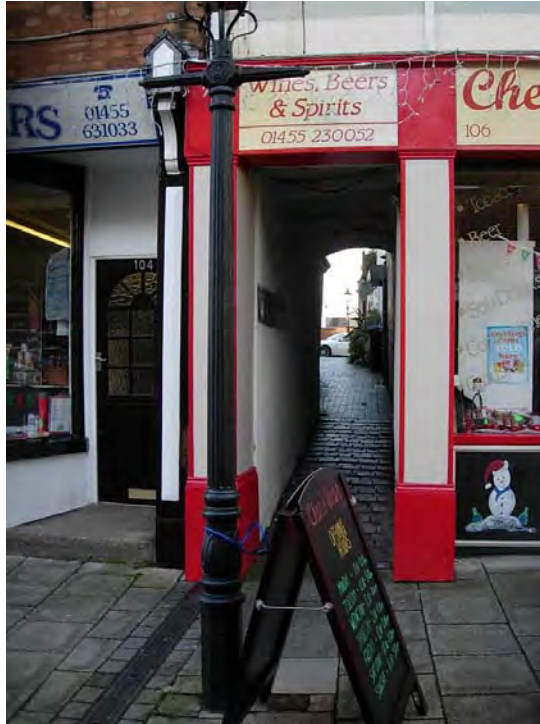
Although the Crown & Anchor entrance has been incorporated into the shop front, it still provides a fine view along the jitty.

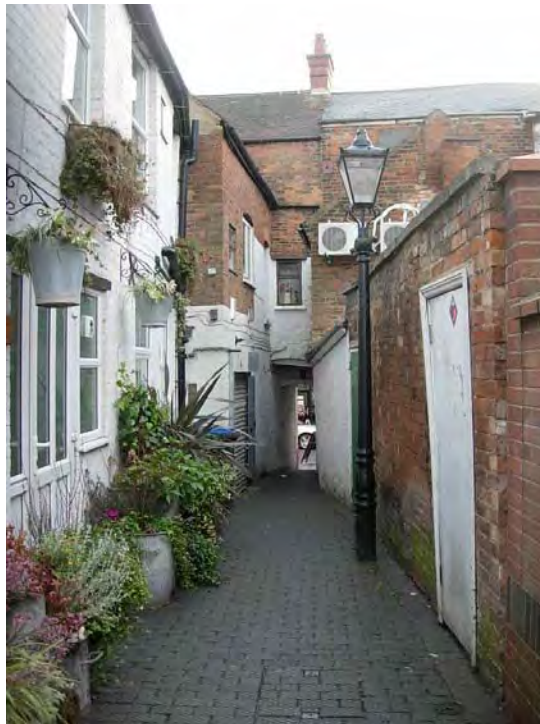
The Crown and Anchor Yard has the appearance of a traditional jitty which is flanked by residential properties. It is an important heritage asset in the Conservation Area and should not be considered as the rear of buildings. Greater consideration should be given to the siting of features such as air conditioning units which detract from the appearance of these very pleasant spaces.

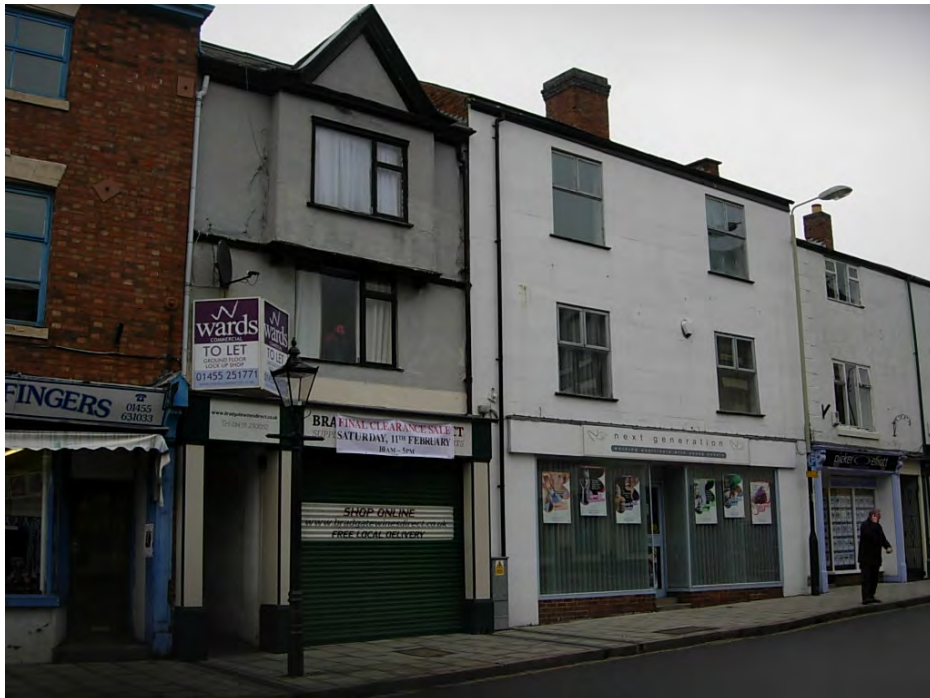
106/108 Castle Street is a C18 building that during the late C19, was the Crown and Anchor public house. The frontage includes the yard entry and is unusual in including a small roof gable and projecting bay at second floor. The rear range is probably C19.

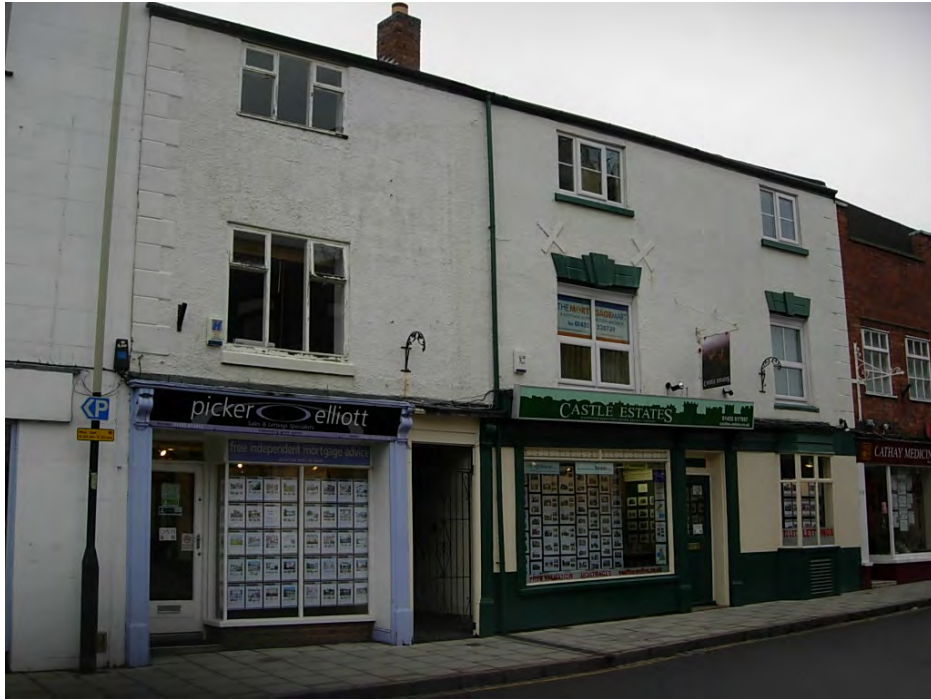
110/112 Castle Street is largely a C18 building that incorporates earlier fabric. The frontage includes a yard entry between two late C19 or early C20 shop fronts. Unfortunately the left hand bay has lost its keyed and grooved lintels which has had a significantly detrimental impact on the appearance of the short terrace.

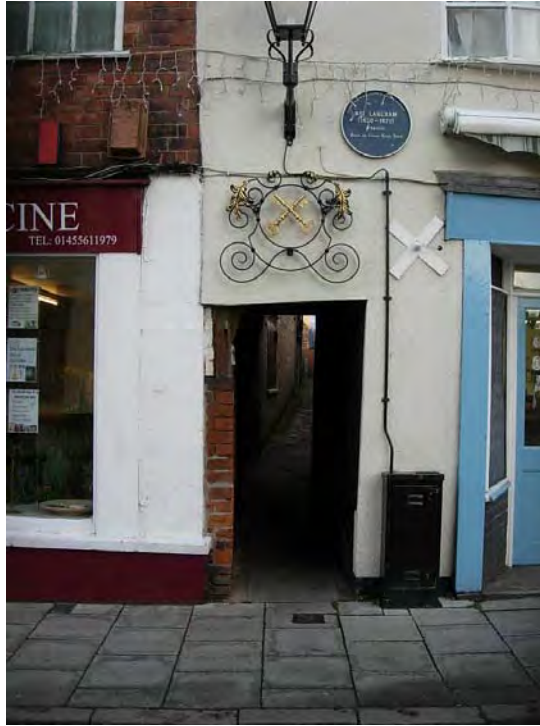
Cross Keys Yard includes some timber framing exposed on the left side of the jitty.

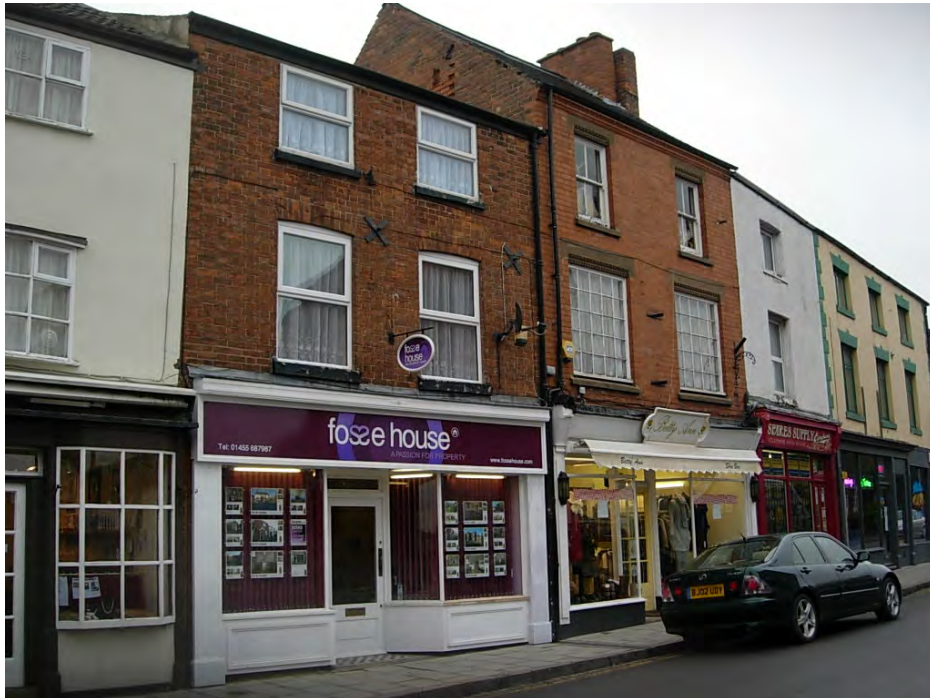
120/122 Castle Street is mid C19 in origin although it has C20 casements and shop front with a recessed entrance.

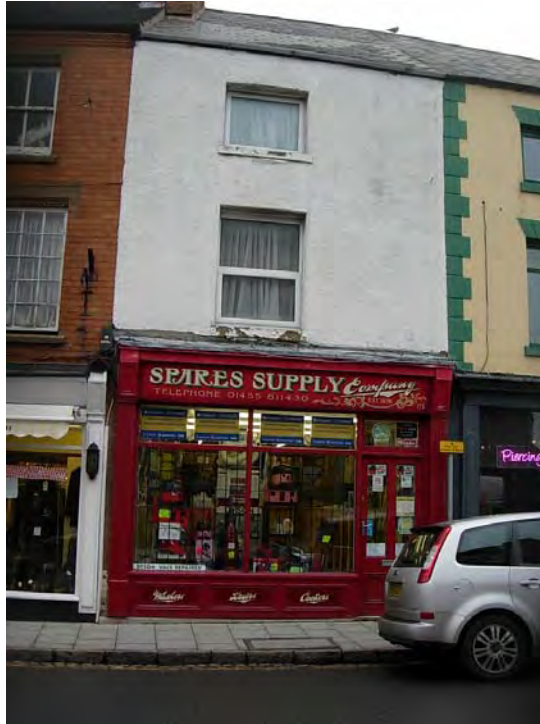
124 Castle Street is probably early C19 but with C20 windows and shop front. The rear elevation includes a classic blocked up 5 light window on an upper floor which signifies its use as a framework knitters workshop.

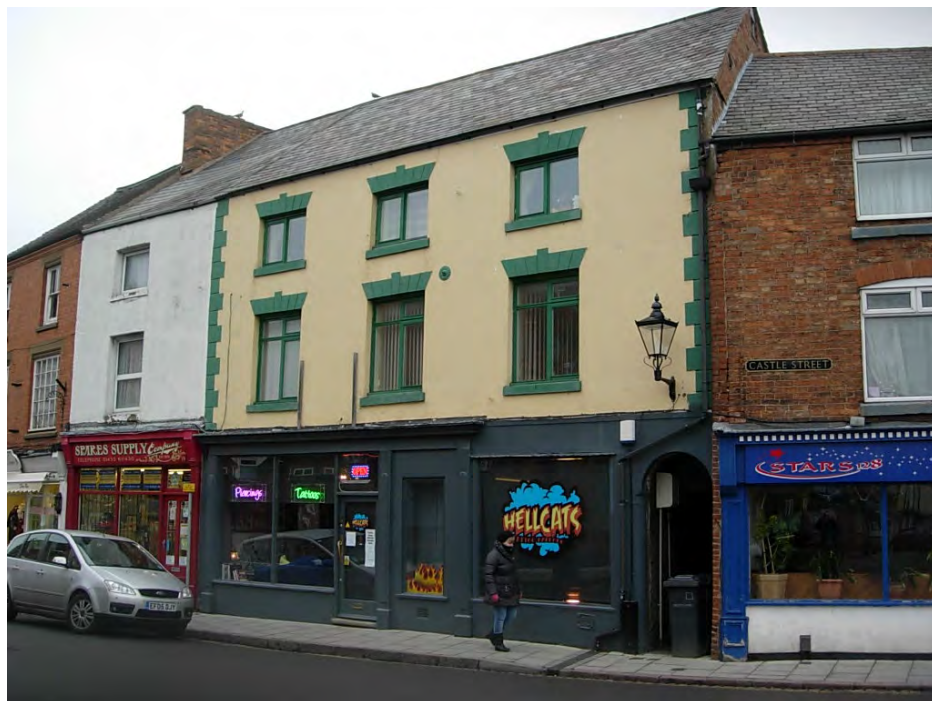
126 Castle Street was constructed in the early C18 and includes an arched yard entry and a C20 shop front. The colour scheme adopted for the building is unfortunate.

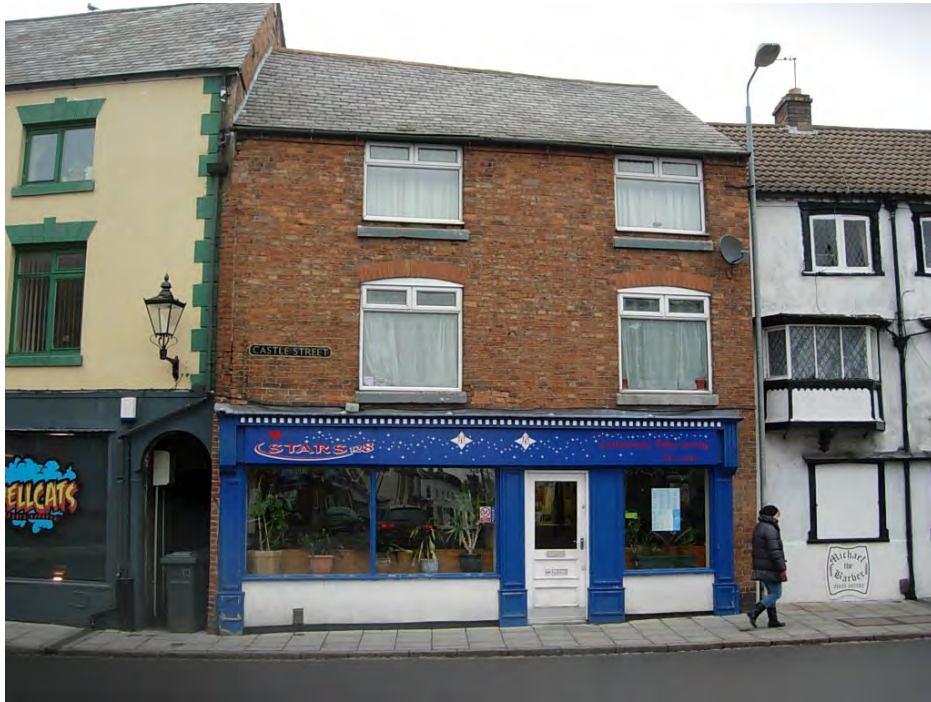
128 Castle St is an early C19 building with brick segmental arch lintels and C20 shop front and windows.

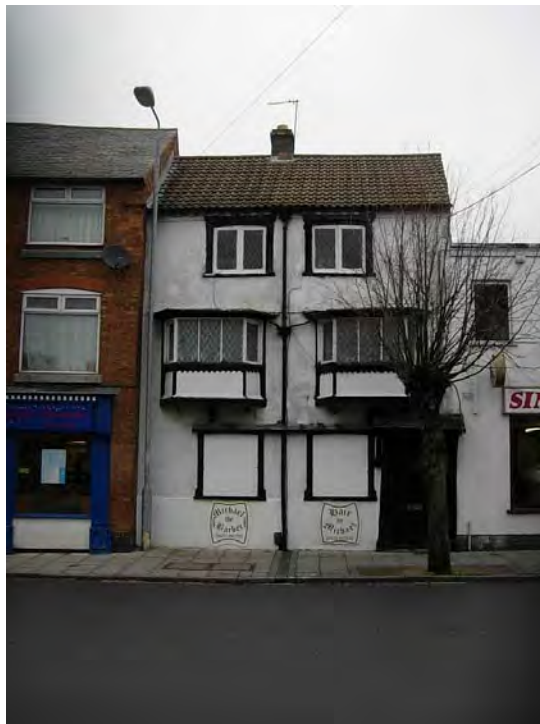
130 Castle Street is probably C19 with C20 glazing and canted bays at first floor.

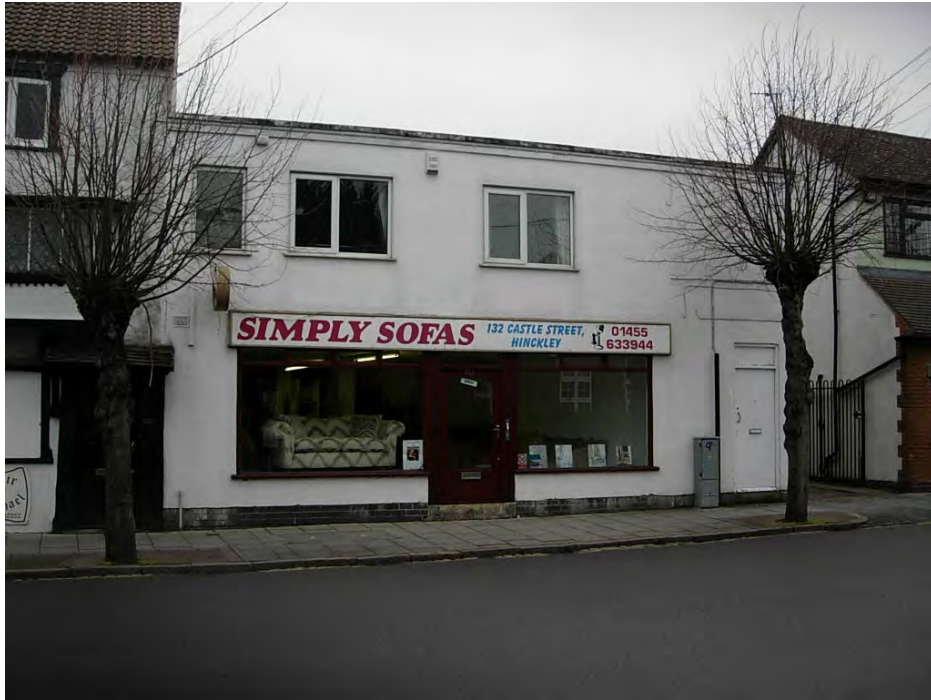
132 Castle Street is a late C20 building of limited interest.

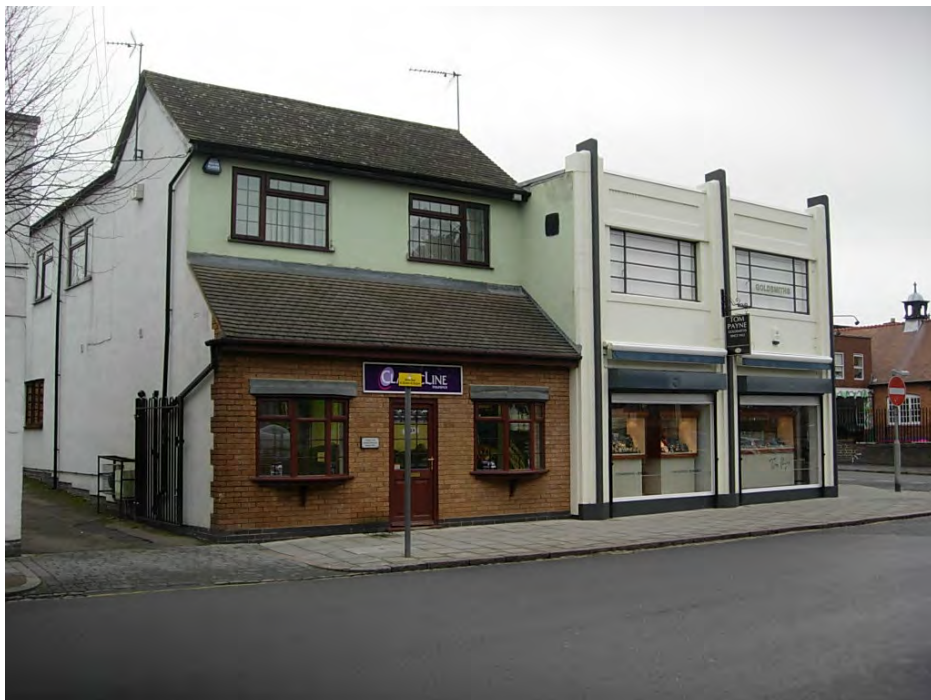
136 -144 Castle Street is also a building of limited interest which has been extended in the late C20
