**Hinckley Town Centre Conservation Area  
Appraisal and Management Plan**

**Photographic Record 1 - Castle Street, Hill Street, Wood  
Street, New Buildings and Church Walk**

**February 2013**

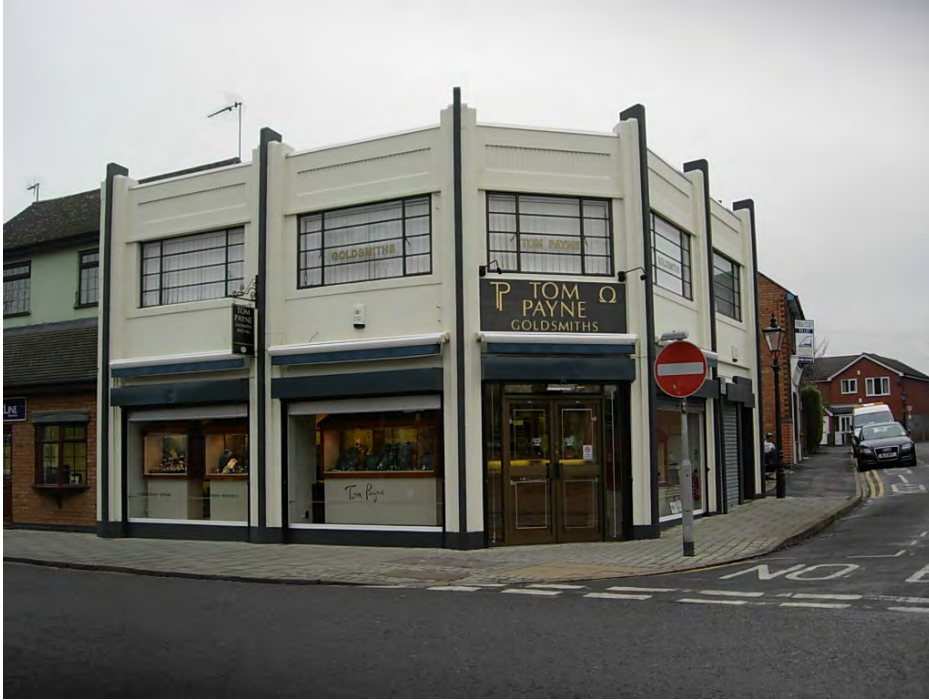
140-144 Castle Street was constructed in the 1930's in the Art Decoratif style and is a very interesting heritage asset that completes the commercial centre.

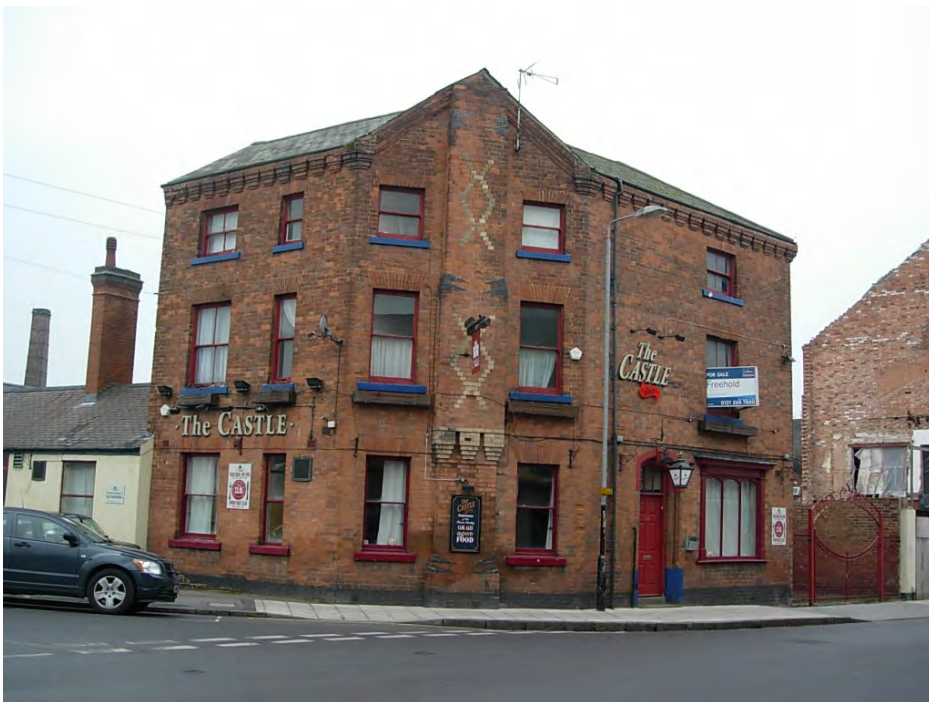
113 Castle Street is a landmark building constructed in the late C19 that has an interesting projecting stack on the centre bay and polychromatic brickwork.

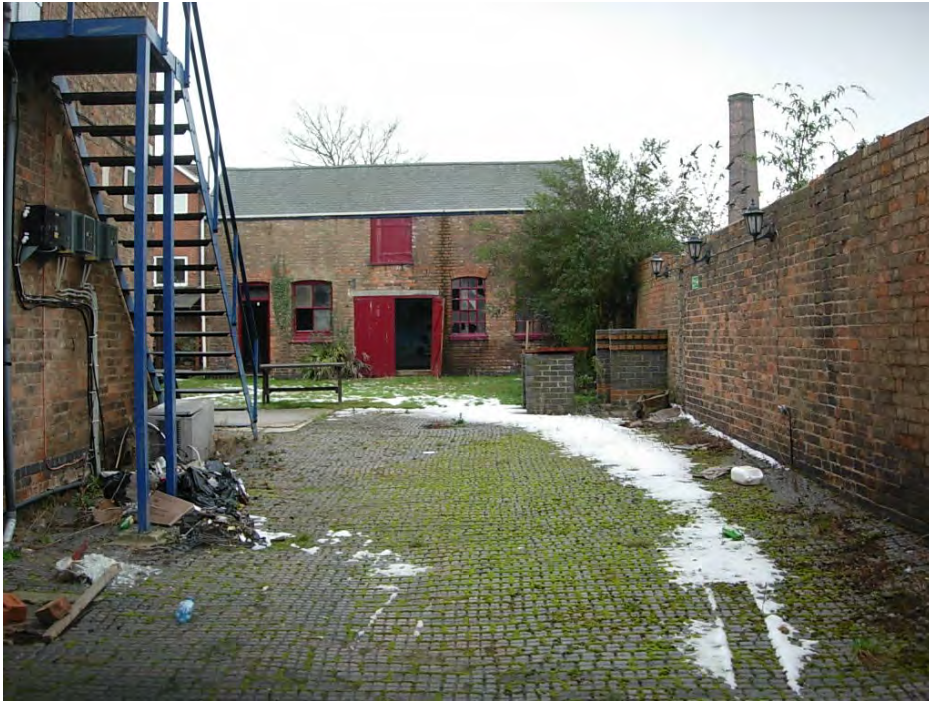
This yard at 113 Castle Street has retained its original setts and two interesting outbuildings.

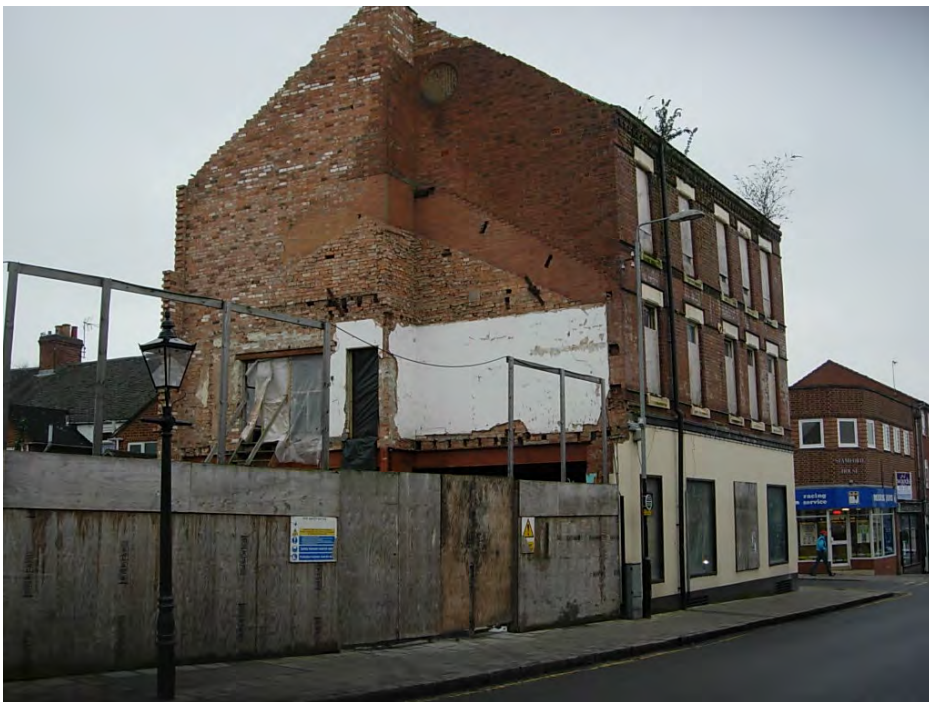
The property 109 Castle Street has recently been demolished. The vacant site is an eyesore and in urgent need of re-development

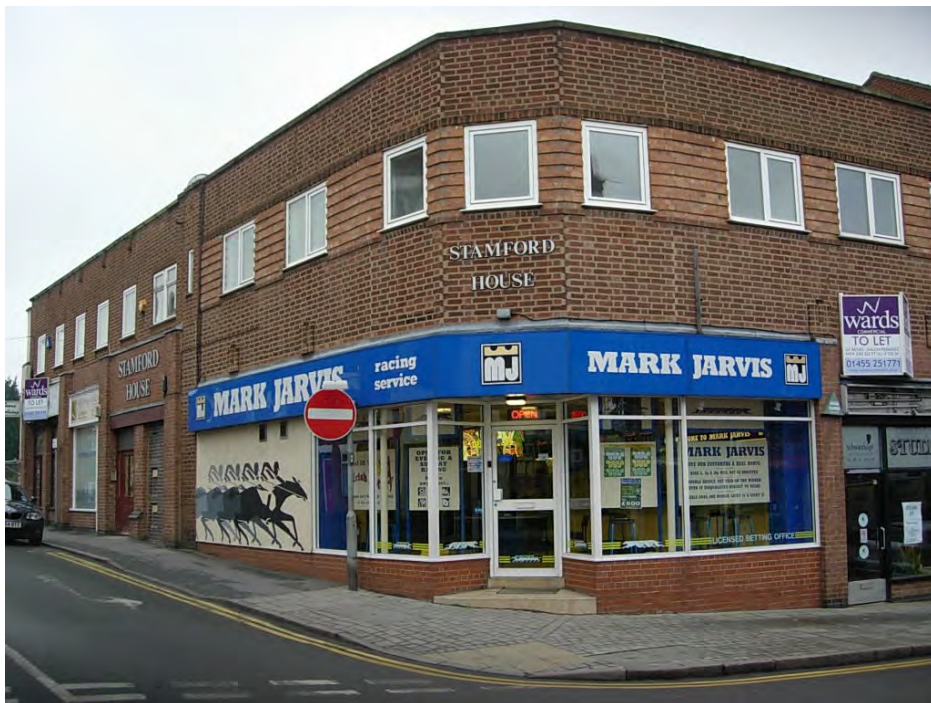
On the opposite corner of Hill Street is 97 & 97a Castle Street which is an unmemorable mid C20 building.

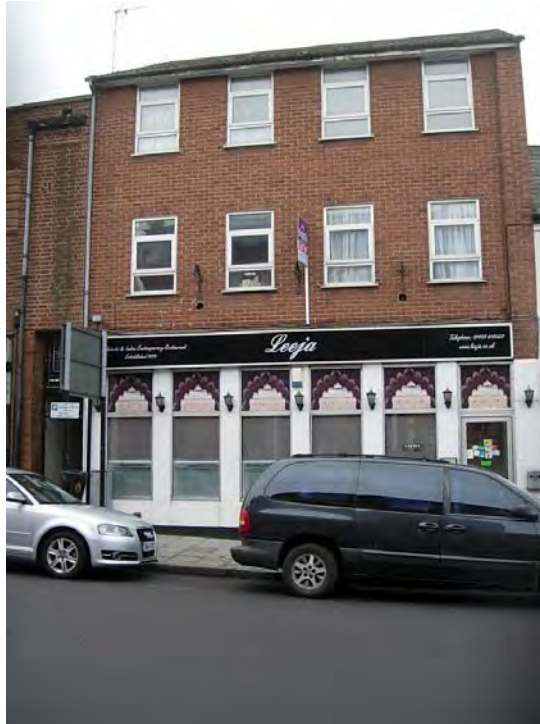
93-95 Castle Street is a late C20 building that although incorporates vertically proportioned windows, is rather plain and lacks interest.

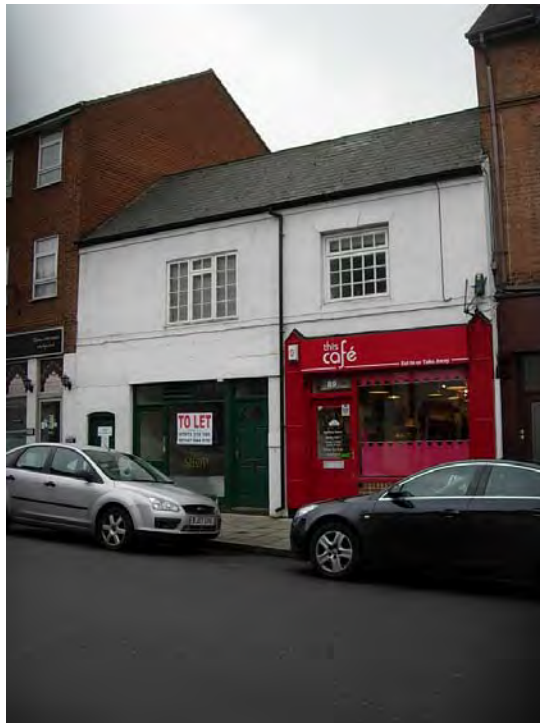
89-91 Castle Street is probably a C18 building with splayed and grooved lintels, C20 shop fronts and segmental arched opening to form a yard entrance.

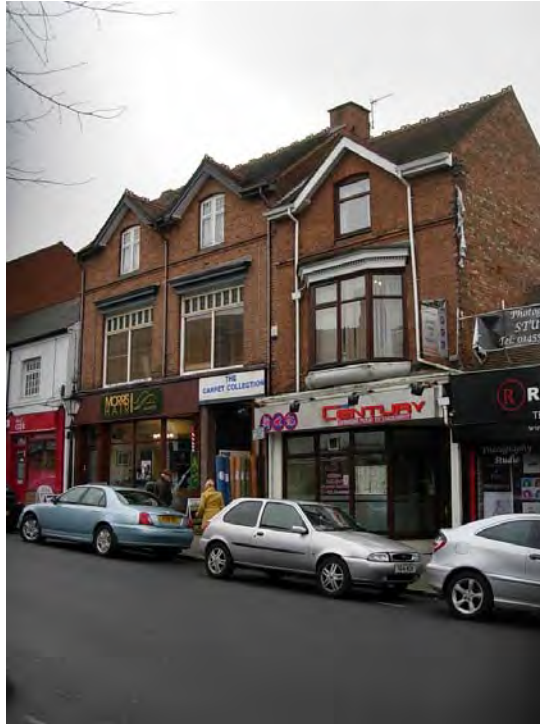
83-87 Castle Street is a late C19 building with a canted bay at first floor. Eastern large first floor windows may have replaced original bays.

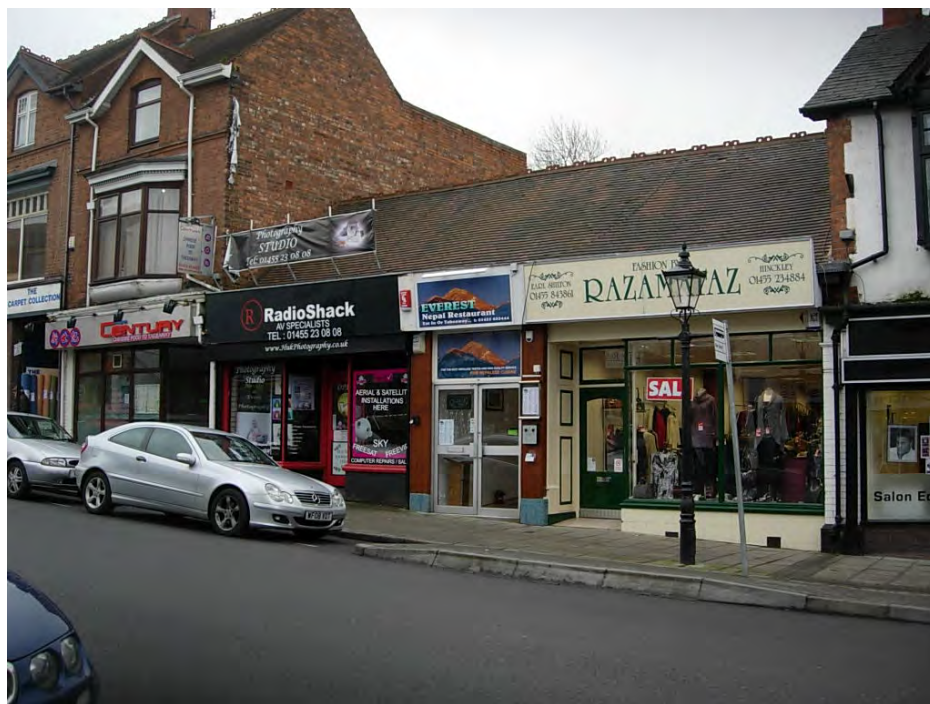
75-81 Castle Street is an early C20 building with C20 shop fronts, both of which have recessed entrances.

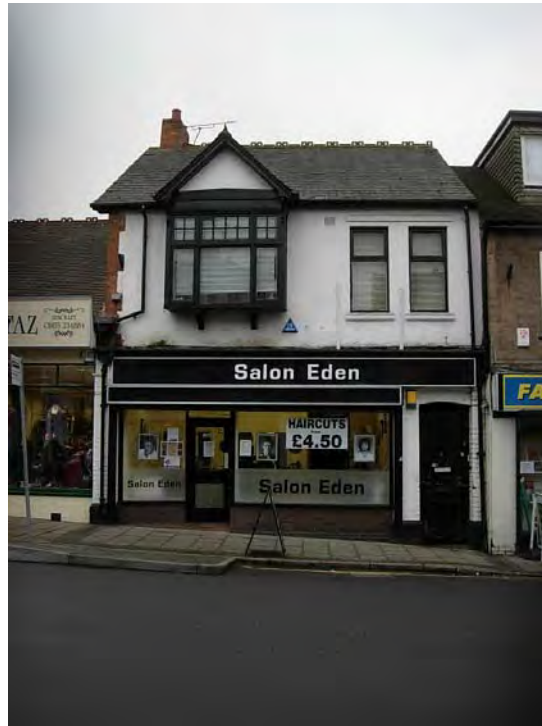
73 Castle Street is probably an early C20 building with a pendent bay at first floor.

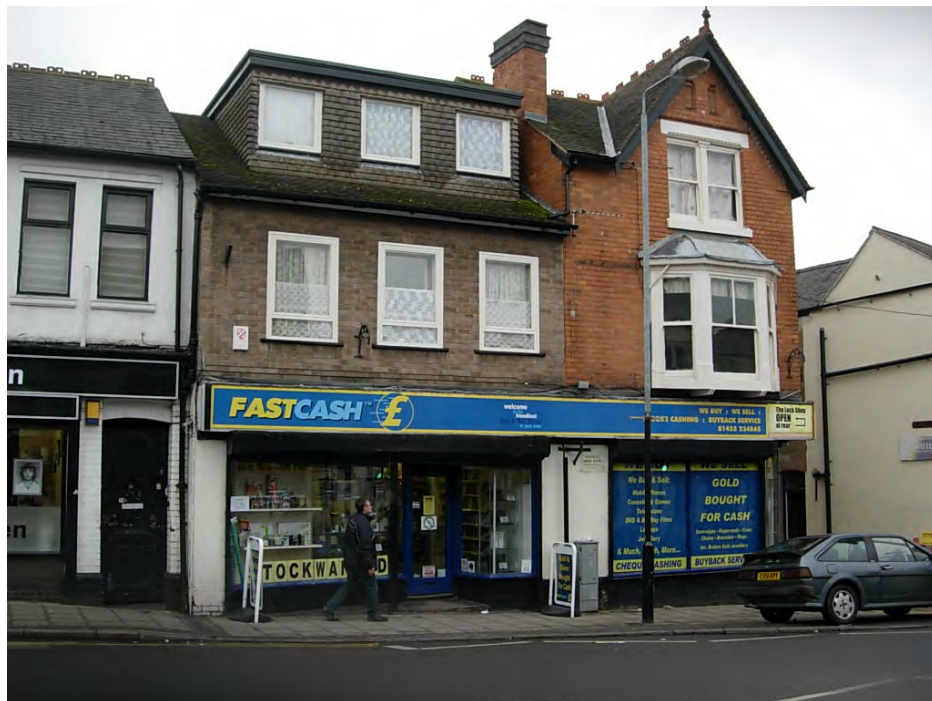
69-71 Castle Street is a combination of two buildings. The right hand side is late C19 with a canted bay at first floor. The left hand building is mid C20 with a recessed entrance and an overly dominant flat roofed dormer.

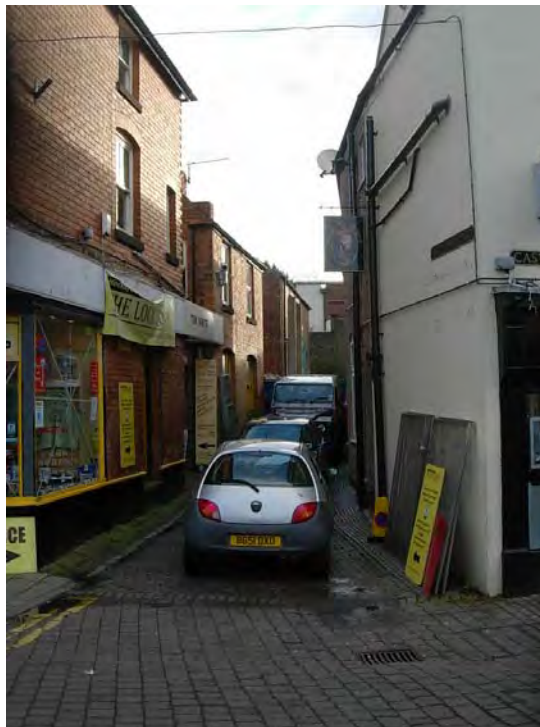
Kings Head Yard has a traditional granite sett floor finish with late C19 buildings flanking the jitty.

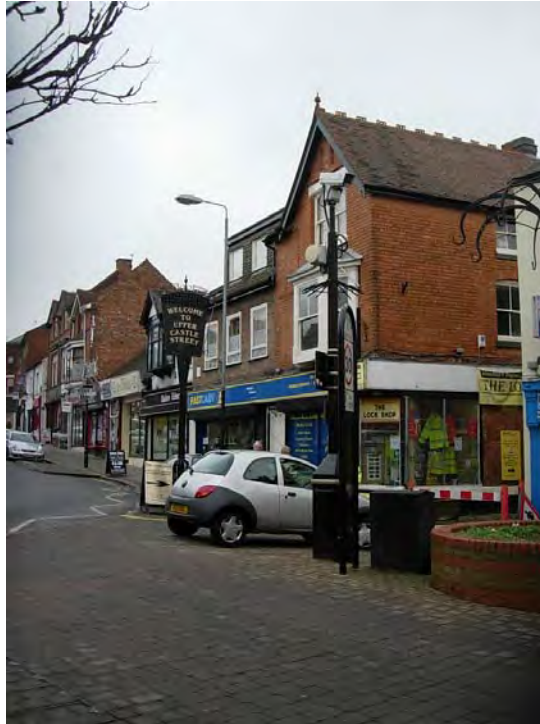
The street clutter around the entrance into the pedestrianised section of Castle Street has a major detrimental impact on the appearance of the Conservation Area.

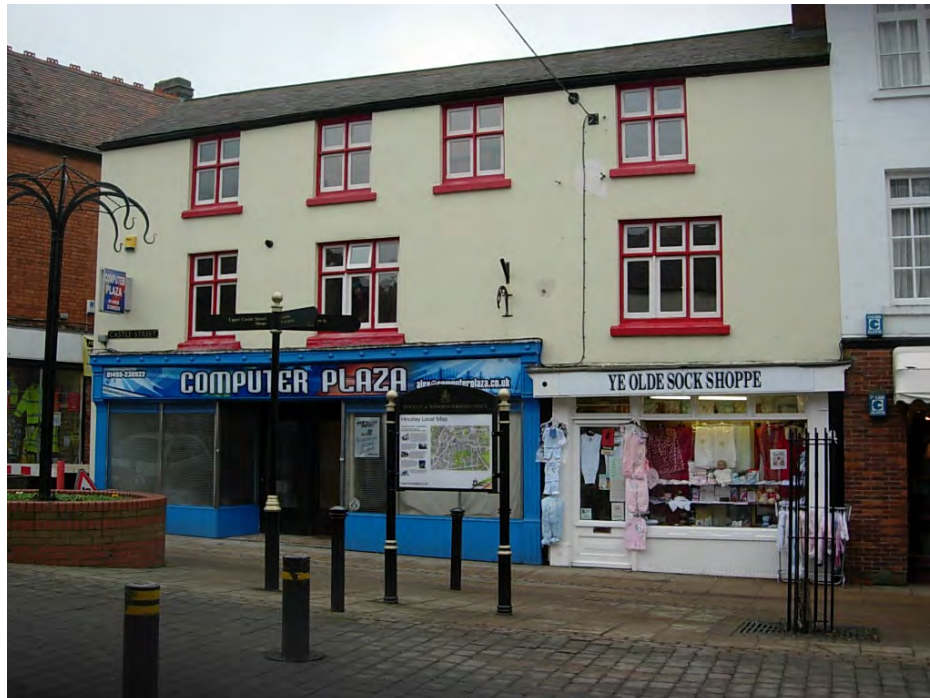
67 Castle Street is a C19 building that has recently been refurbished and although the C20 shop fronts are traditional in appearance, the colour scheme needs reconsideration.

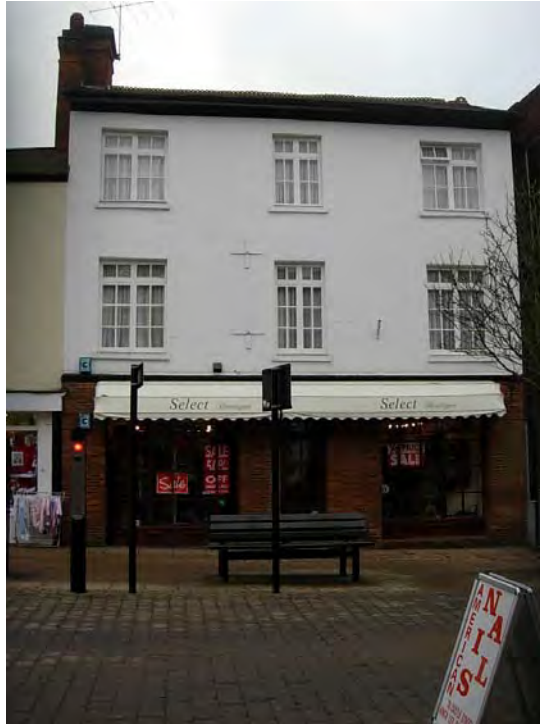
This C19 building, 65 Castle Street, is spoiled to a degree by the plastic canopy. It stands on the site of the former Red Lion Inn referred to in an 1822 trade directory. At the east of the rear yard is the former brew house, a major historic asset which should be carefully protected.

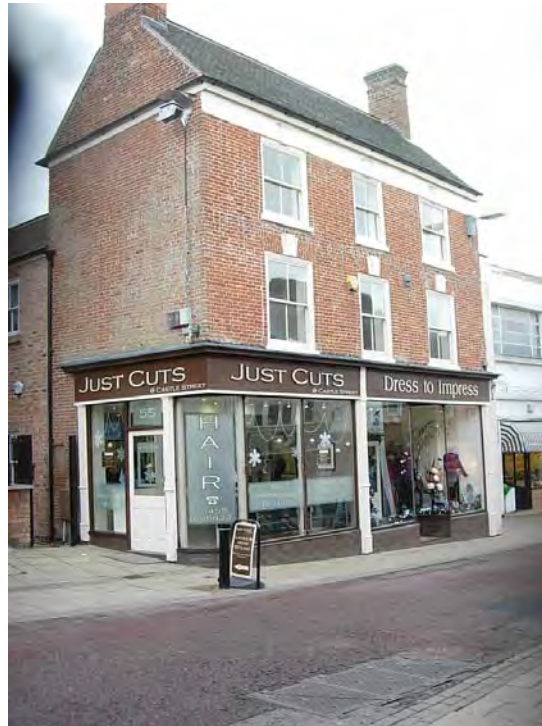
53 Castle Street is a fine late C18 grade II listed building that has some early sash windows and two very fine traditional style shop fronts. Because of its prominent location, it is a key heritage asset on Castle Street.

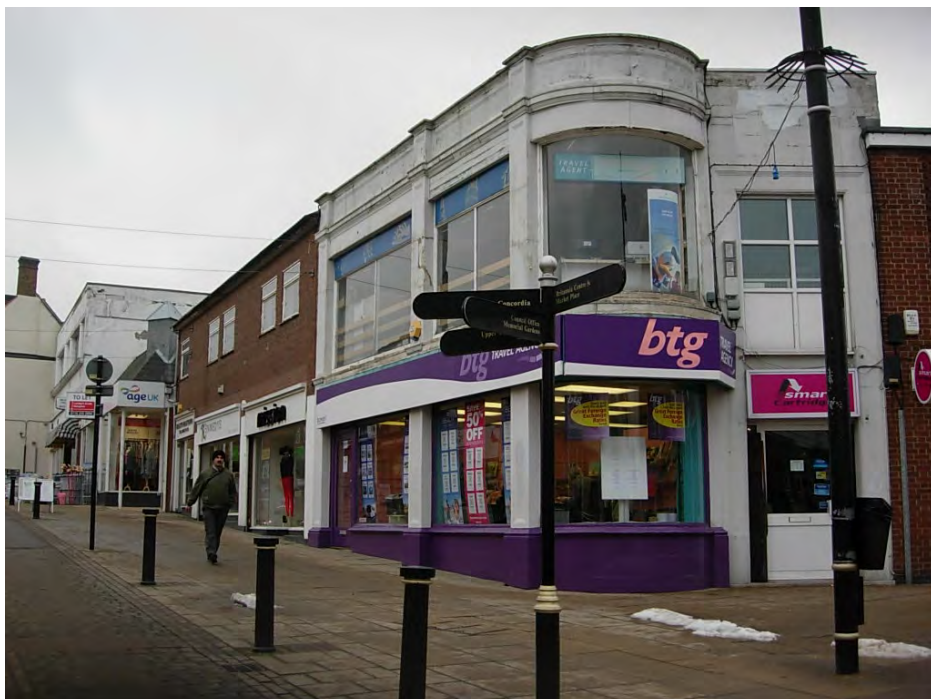
39-43 Castle Street. The corner building was originally the gas showrooms and extended a further 2 bays to the south. Its 2 storey curved corner bay is a landmark on this part of Castle Street. The attached building to the north is late C20 and of no historical interest.

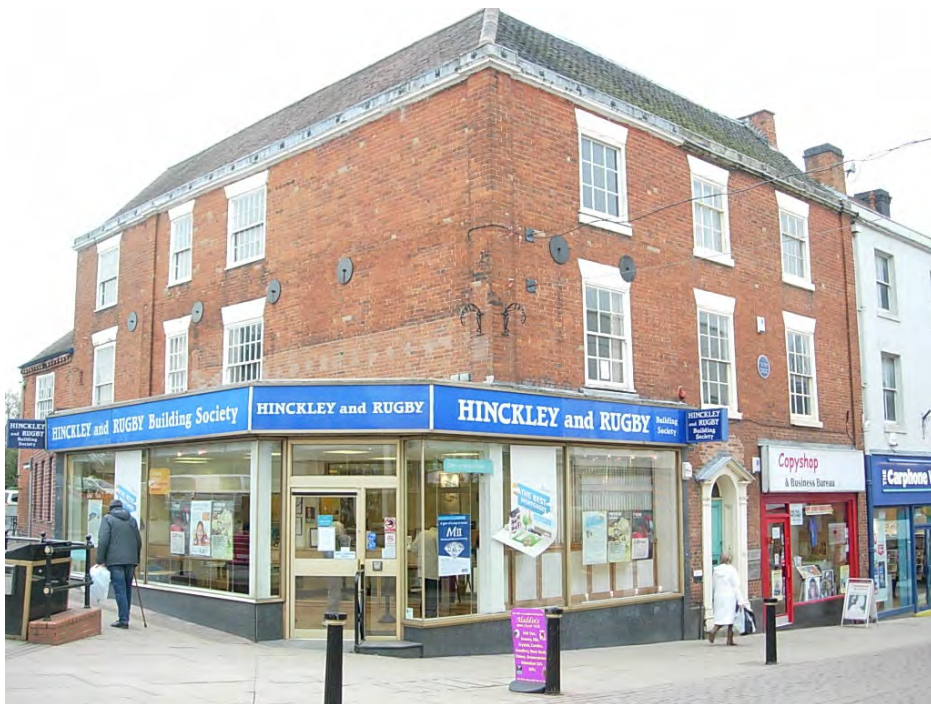
33-35 Castle Street is grade II listed mid C18 three storey building that was for a period the home of Charlotte Mary Brame, a romantic novelist. It has a symmetrical elevation centre on the modified door casing on Castle Street but unfortunately been spoiled by the late C20 addition to the eastern side. The staircase linking the eastern half's first and second floors has been lost.

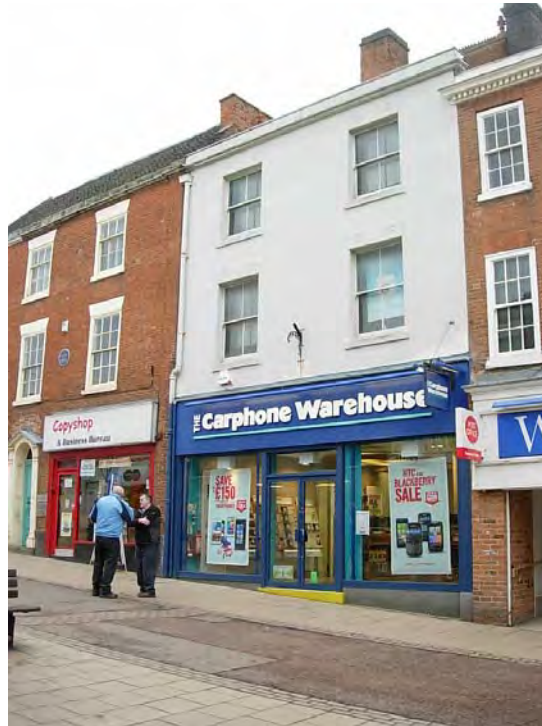
33 Castle Street is a mid C19 building that has unfortunately been rendered and had a late C20 shop front added. The flat roofed building at the rear, although much modified, is said to have been the former Friends Meeting House built in 1736 and closed in 1841. It is an important heritage asset.

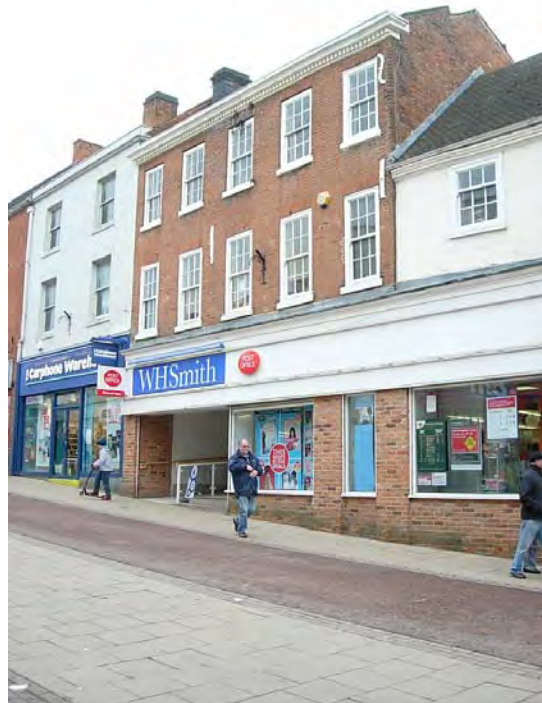
29-31 Castle Street is a mid C18 grade II listed building has unfortunately been rebuilt at ground floor with an overly large shop fascia added which detracts from the appearance of the building. This is reinforced by its continuation across the frontage of the adjacent building.

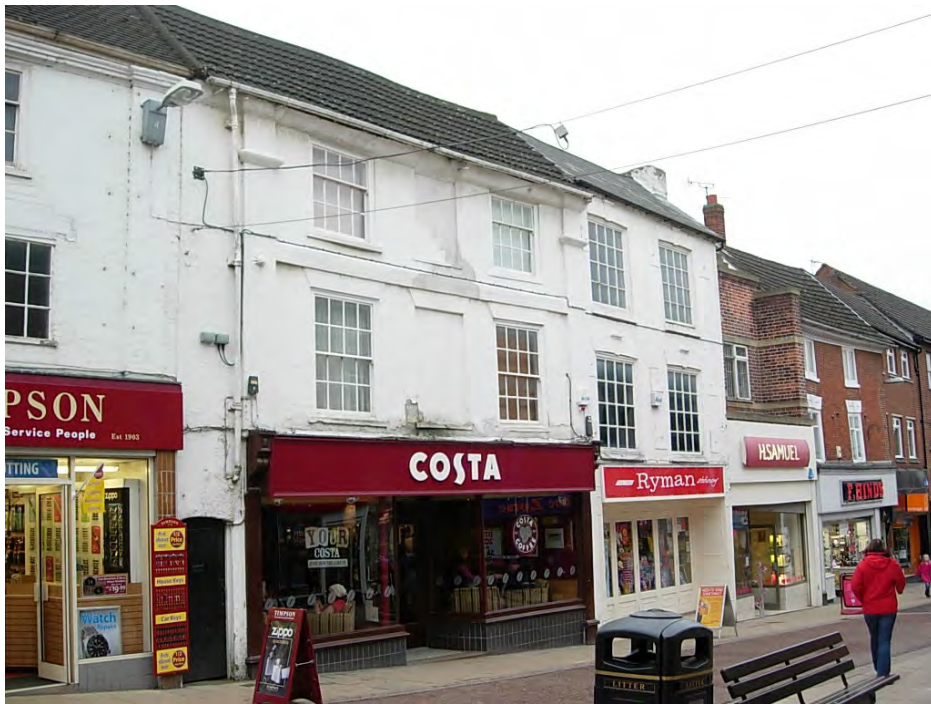
The early C18 eastern building, 23-25 Castle Street, has unfortunately been re-roofed with concrete tiles. The ground floor has a segmental headed yard entry to the right of the C20 shop front. The building is in urgent need of some maintenance. The adjoining building is of a similar period but has had the internal staircase removed. Both are important heritage assets.

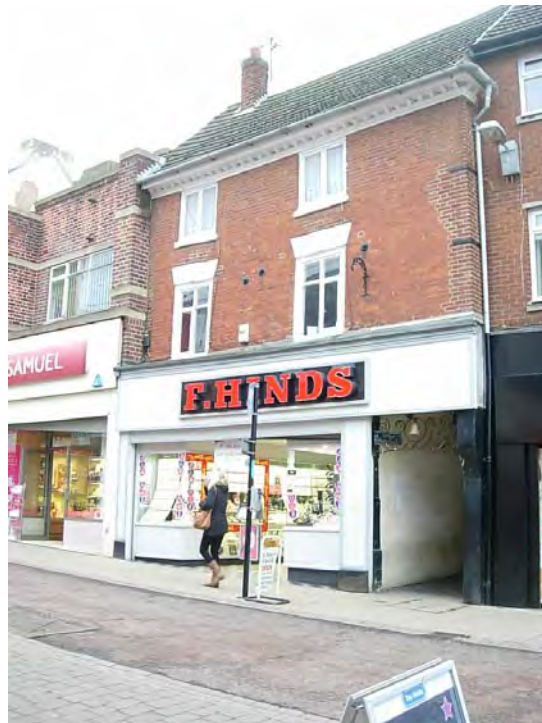
19 Castle Street is a C18 building that incorporates the entrance to Bell Entry, an important jitty which links this street to the church. The C20 shop front incorporates an overly large fascia which detracts from the appearance of this fine building.

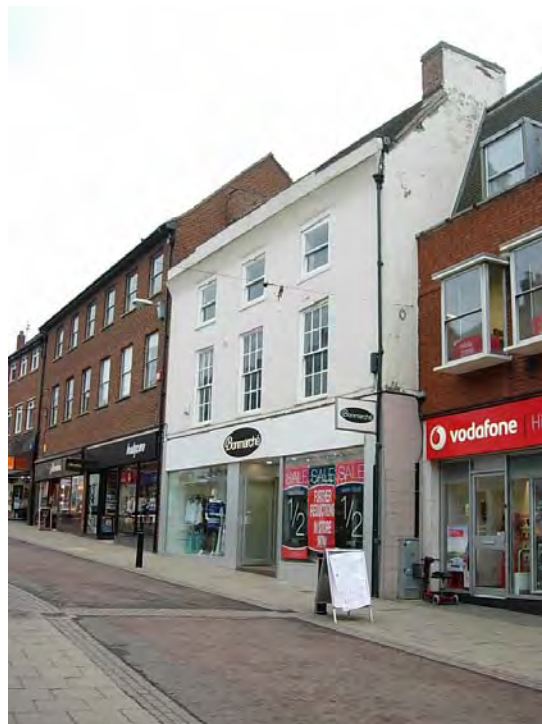
11 Castle Street is a grade II listed building that suffers badly from a lack of maintenance.

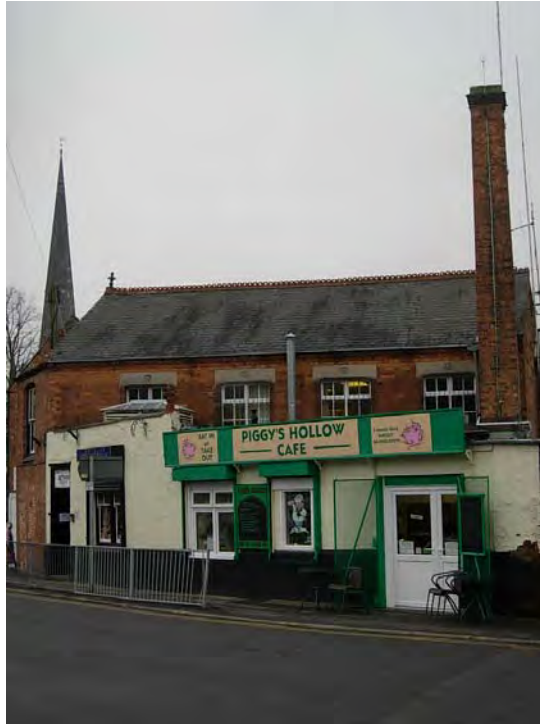
This view of 5-7 Church Walk shows one of the few brick factory chimneys remaining in the town centre. These are important relics of the hosiery industry which must be retained.

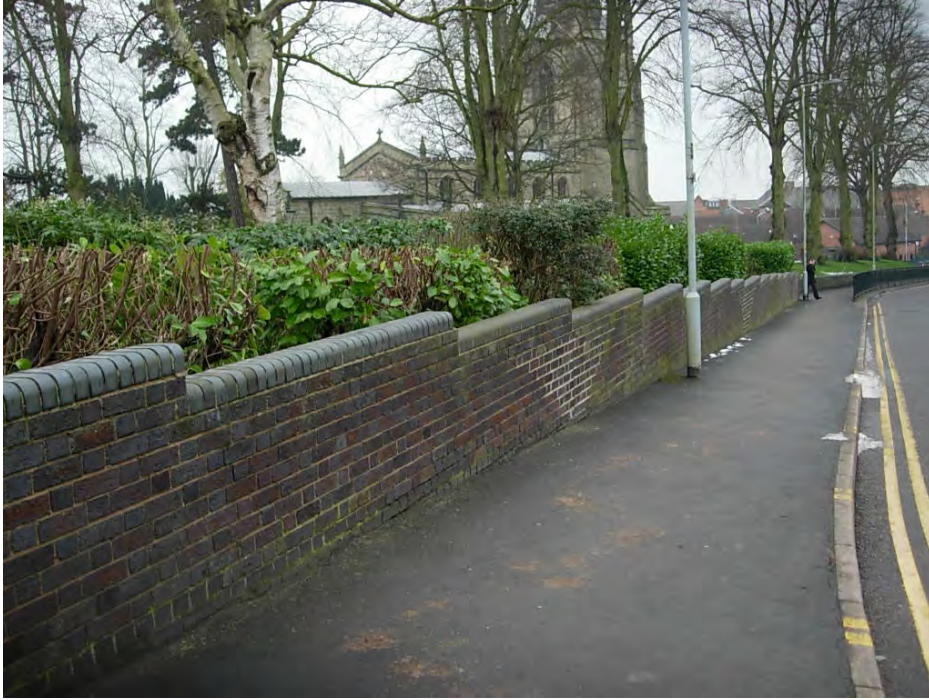
The blue brick boundary wall on the south side of Church Walk with its saddleback copings defines the extent of the churchyard and is a very important historic feature and an asset in the Conservation Area.

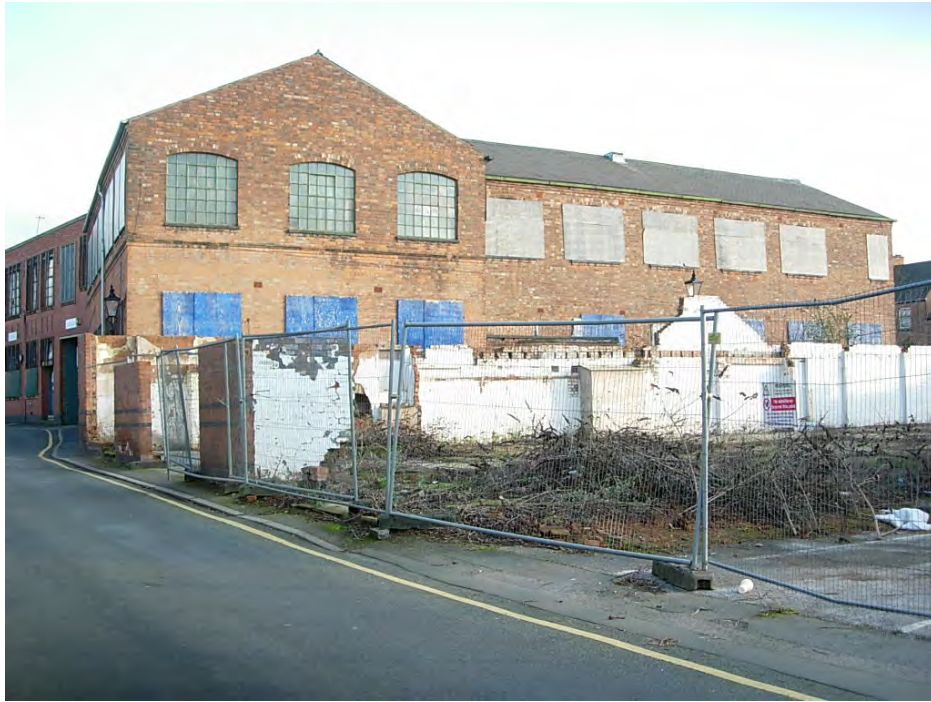
The recent demolition of 21 Wood Street detracts from the appearance of important heritage assets.

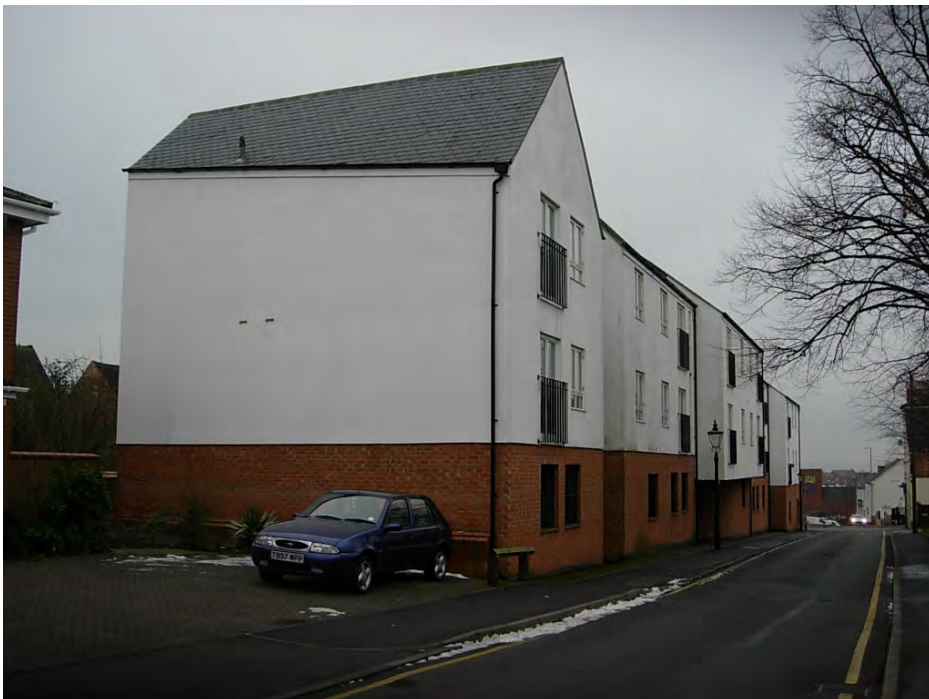
Castle Point sited at the western end of Wood Street that is set at the back of the pavement, extends the same factory style as those factories at the head of Wood Street.

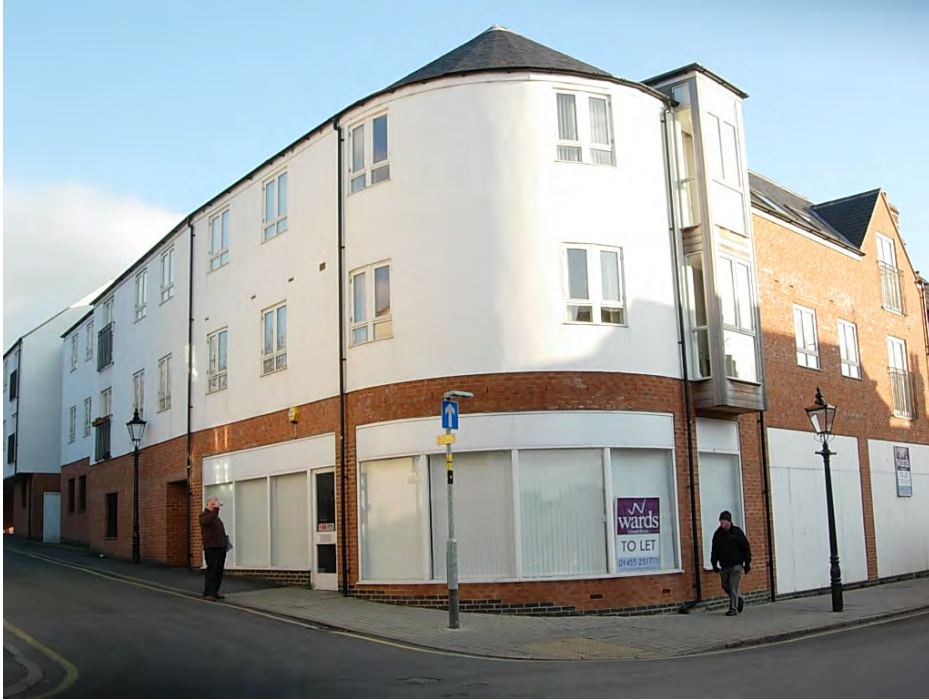
The curved corner on this new building at 1 Wood Street reflects a similar treatment to the building opposite. The 2 storey bay window creates an interesting feature on a relatively plain elevation.

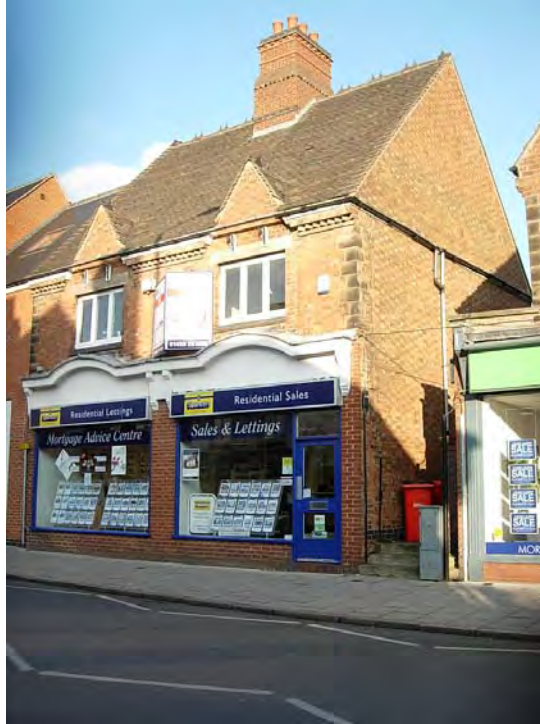
1 New Buildings was constructed in 1874 as part of a group of buildings which extends into Castle Street. Each had two tone tiled roofs which some buildings have lost. The central massive brick chimney, decorative ridge tiles, gables and herring bone eaves details are important characteristics of these buildings.

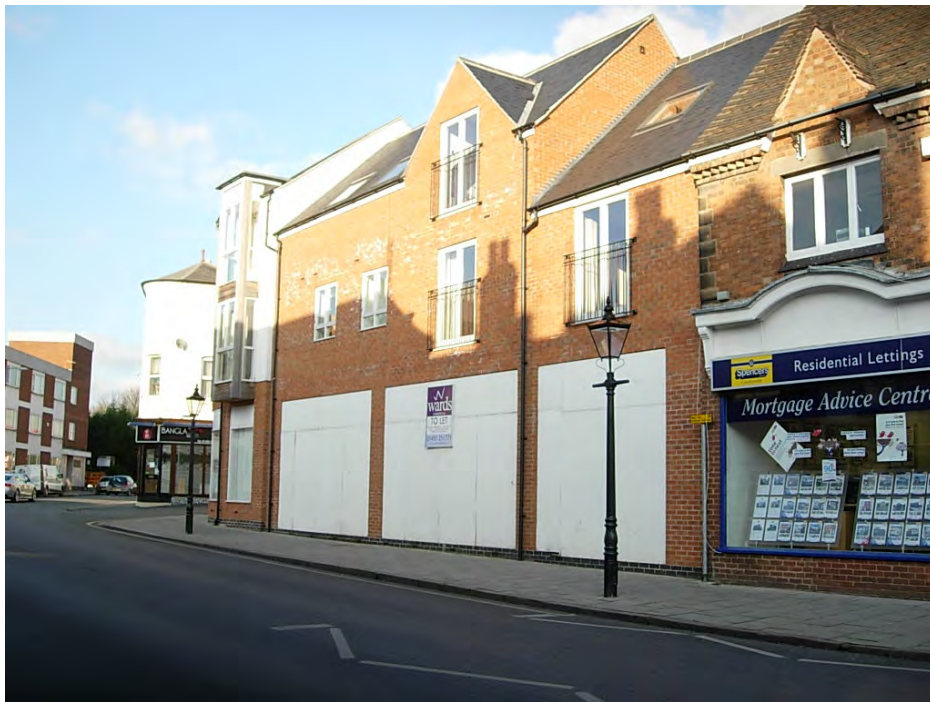
This modern frontage at 1 Wood Street highlights the importance of introducing locally common features onto plain elevations.

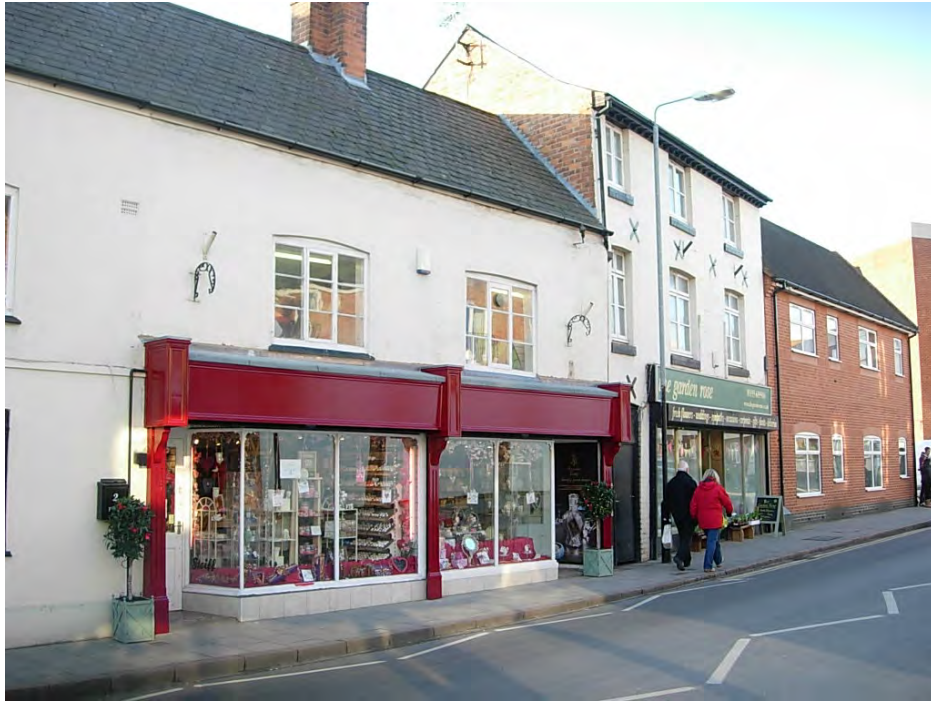
These new shop fronts in a traditional form at 2 New Buildings enhance the street scene.

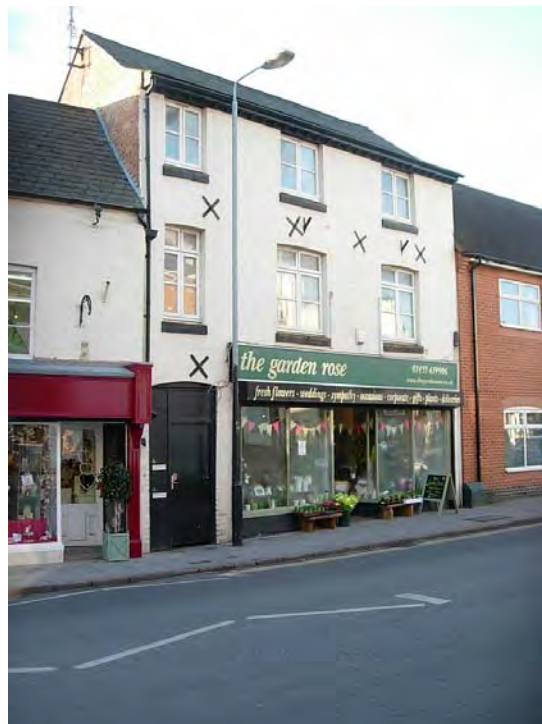
4 New Buildings is a late C19 building with a Welsh slate roof which has been rendered. It has a separate yard entrance on the frontage.

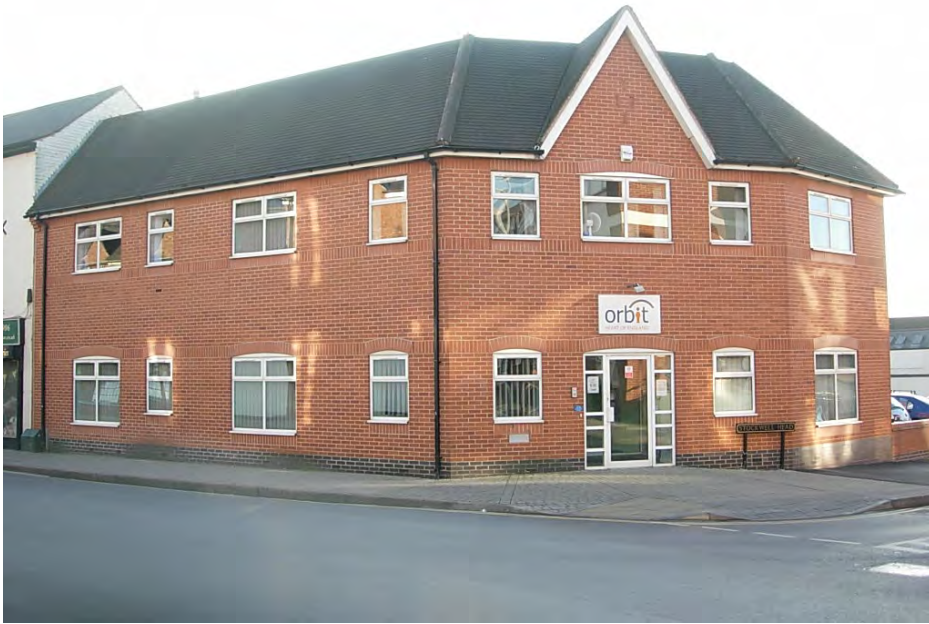
6 New Buildings is a modern building that has plain frontages and a simple gable on the corner which helps to add a little interest.

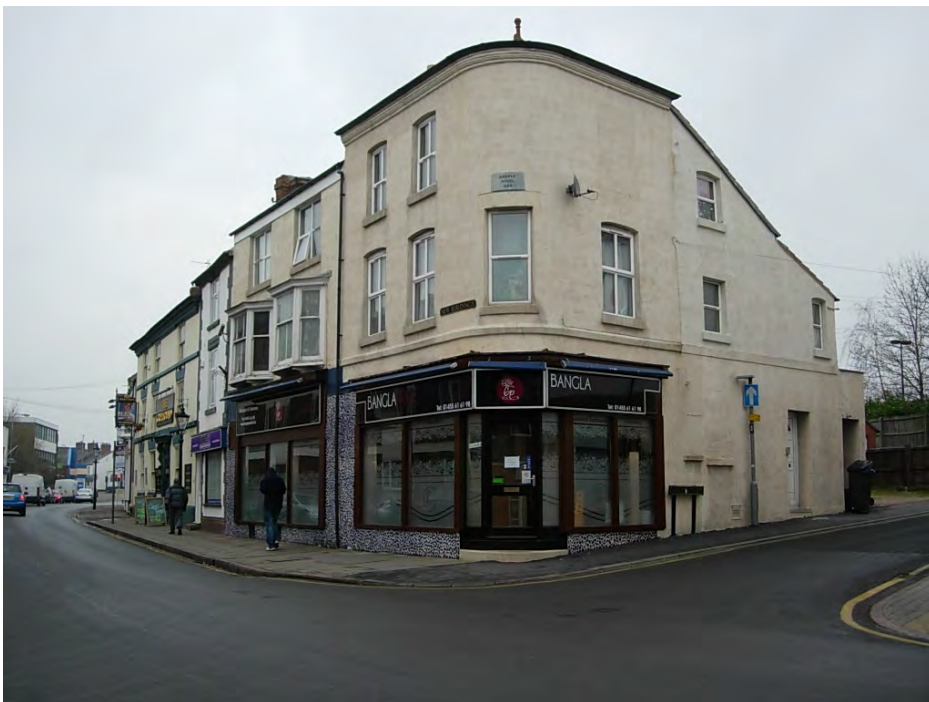
The tablet above the entrance door to 3-5 New Buildings indicates this building was constructed in 1884 as Argyle House. It has a feature curved corner and sash windows to the upper floors. The mosaic tiles detract from its appearance.

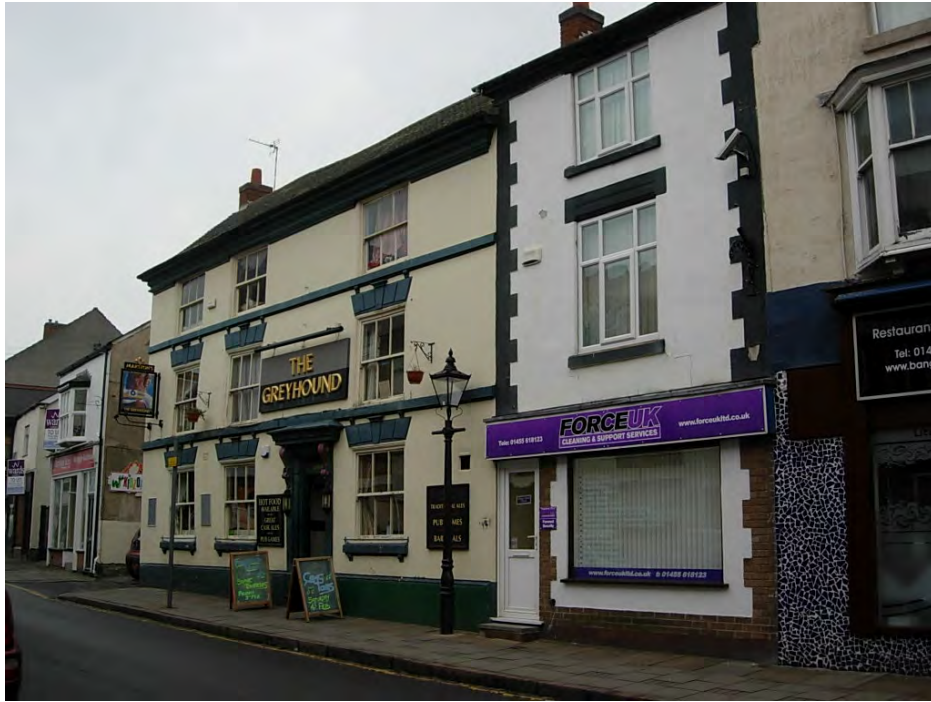
7-9 New Buildings were constructed in the mid-late C19. The Greyhound public house is a particularly attractive building and an important heritage asset. Its street elevation has a concrete tiled roof covering and the sash windows are crude modern replacements.

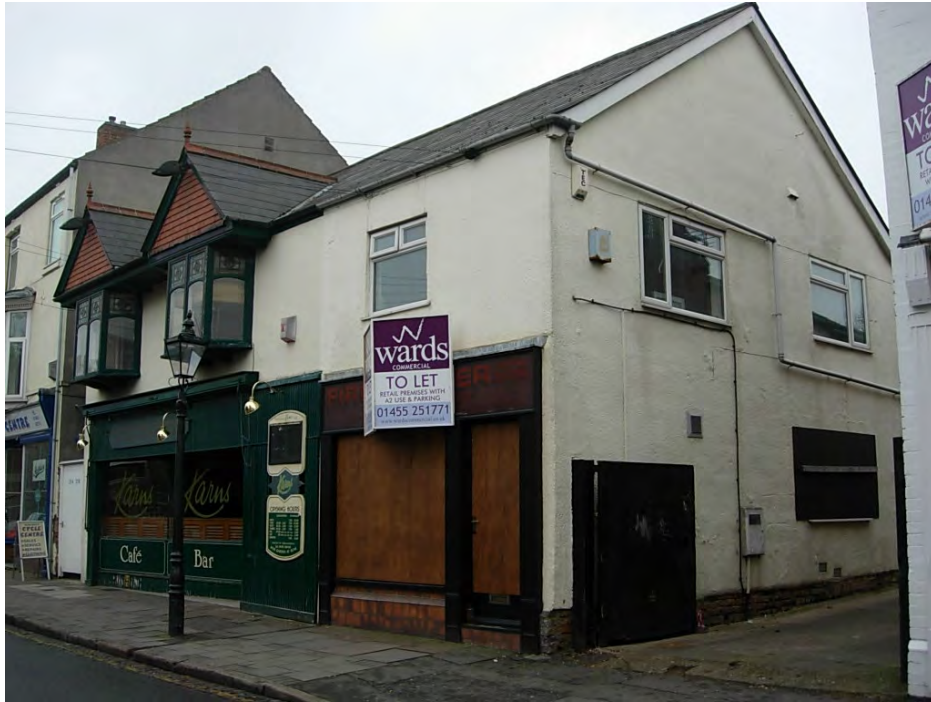
15-19 New Buildings are mid C19 buildings that have been heavily modified by the addition of bay windows and projecting gables. These add to the group's significance as do the traditionally designed shop fronts.

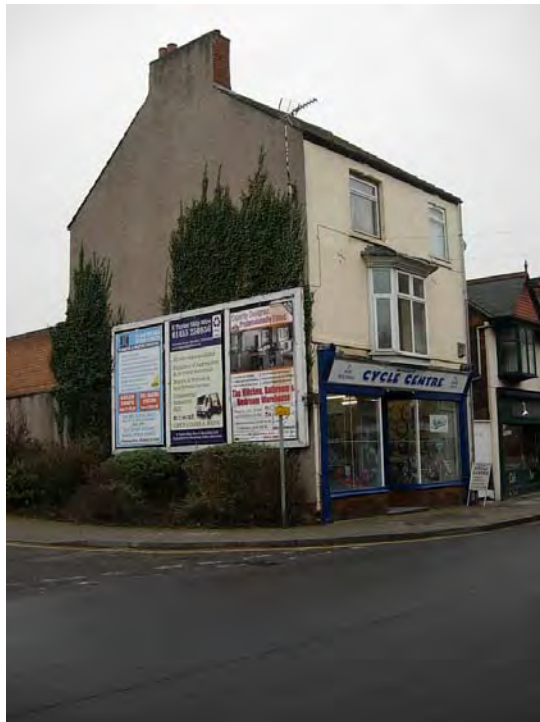
21 New Buildings is a late C19 building that has retained its early C20 shop front and bay window at first floor. The large posters on its gable end detract from the street scene.

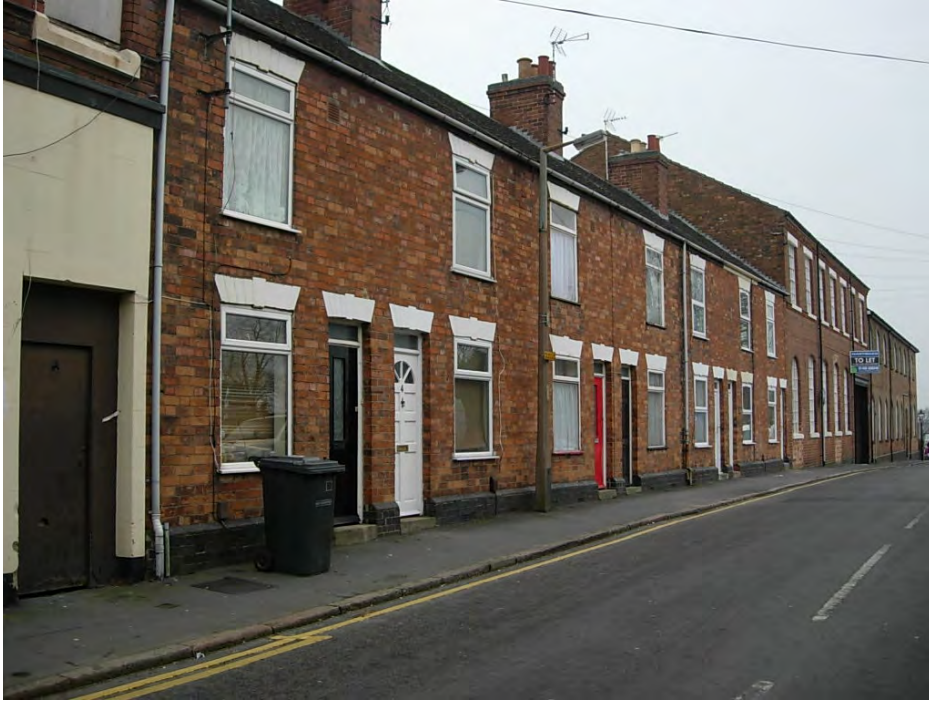
This terrace, 2-14 Hill Street, probably constructed in the third quarter of the C19, links the former Abticom factory with Castle Street. Its projecting lintels, massive ridge chimneys and blue brick plinth are important features on the street elevation. It is unfortunate that the windows and doors have been changed although the proportions of the openings are unchanged
