**Hinckley Town Centre Conservation Area  
Appraisal and Management Plan**

**Photographic Record 1 - Castle Street, Hill Street, Wood  
Street, New Buildings and Church Walk**

**February 2013**

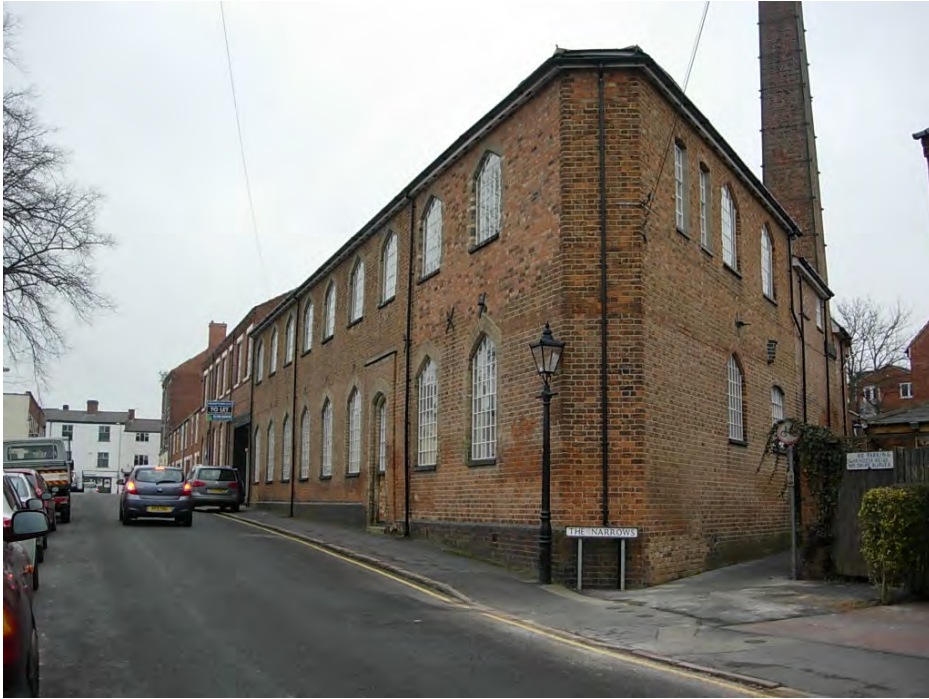
The chimney has been retained on this C19 shoe factory conversion which together with the lancet style metal windows adds character to the conservation area. The Narrows jitty that runs at the side of the building linking Hill Street to The Lawns has had heritage street lights installed along its length.

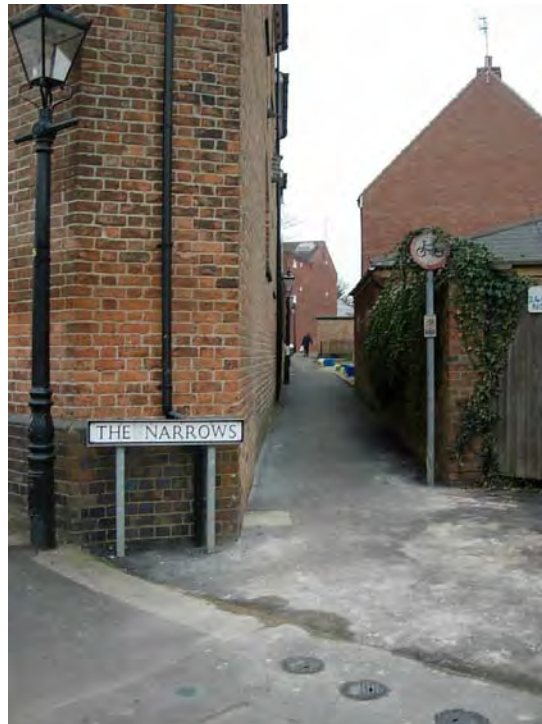
This view highlights the traditional narrow form of The Narrows jitty with routes between factories and high brick walls.

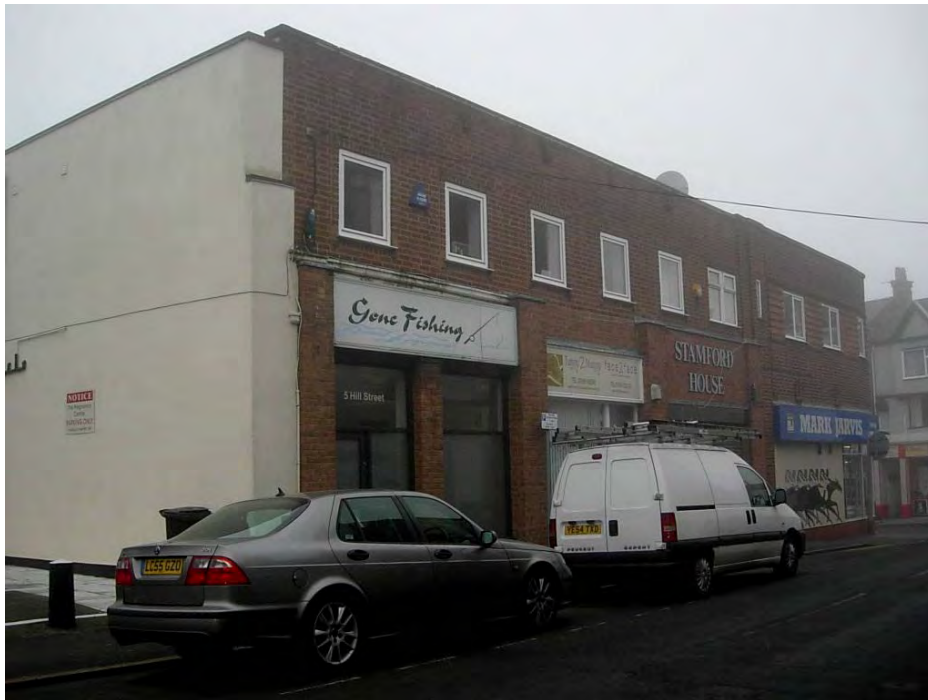
1-5 Hill Street is a modern building that has limited impact on the street scene because of its very plain frontage.

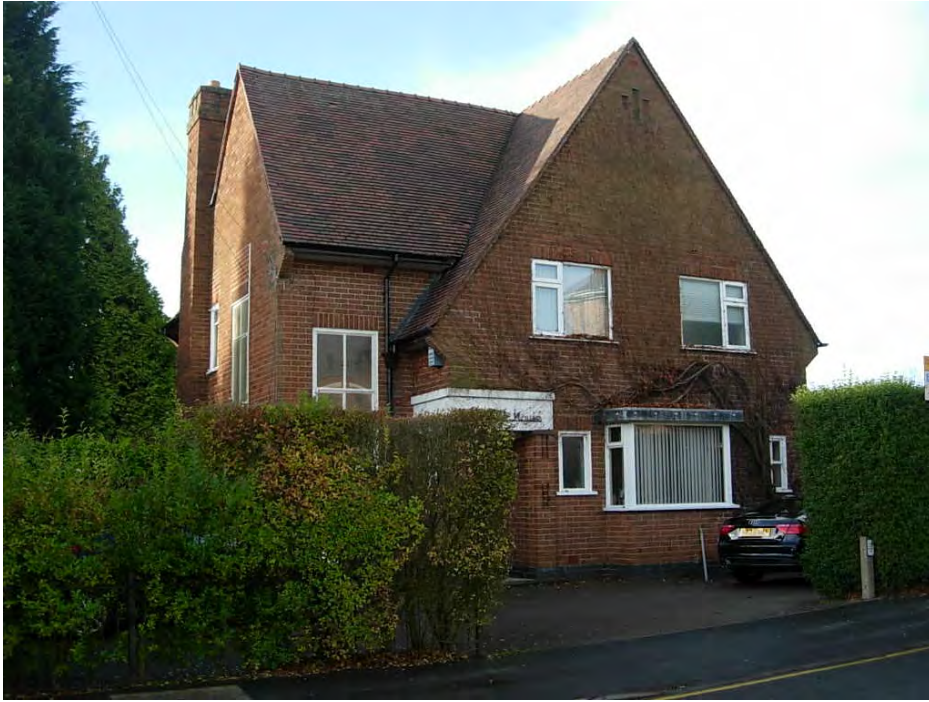
The western side of Hill Street was developed in the 1930's and has several interesting properties similar to The Mead on Hill Street

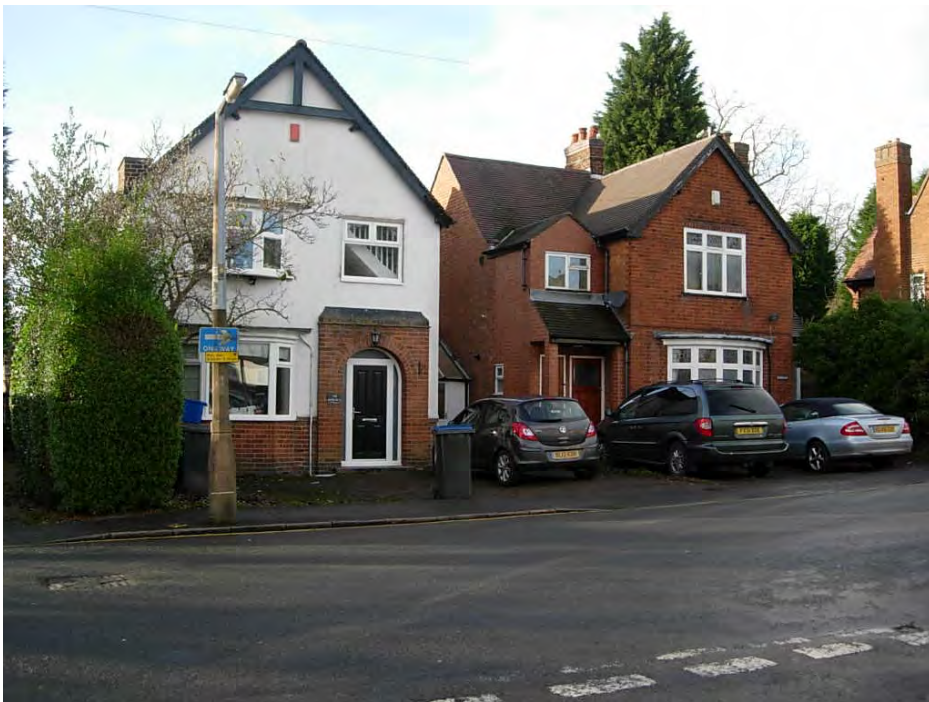
Rose Mead & the White House on Hill Street are early C20 properties that back onto Argents Mead public park.

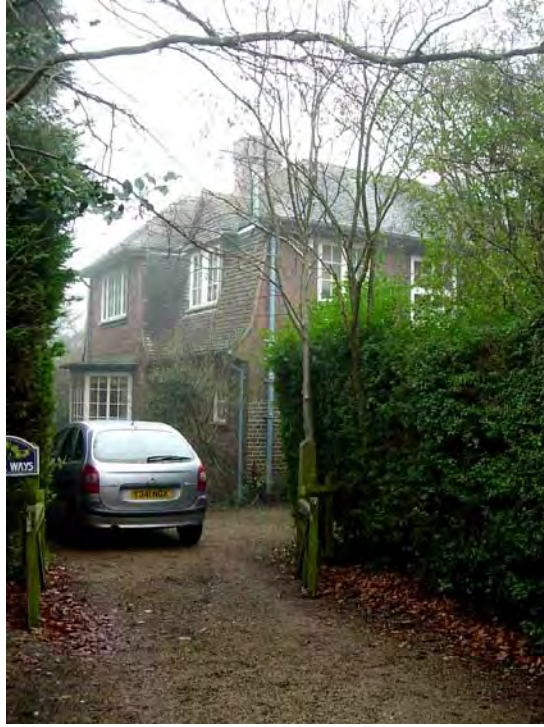
Threeways on Hill Street is a further property dating from the early C20.
