**Hinckley Town Centre  
Conservation Area Appraisal and Management Plan**

**Photographic Record 2 - Market Place, Regent Street,  
The Borough, King Street and Lower Bond Street**

**February 2013**

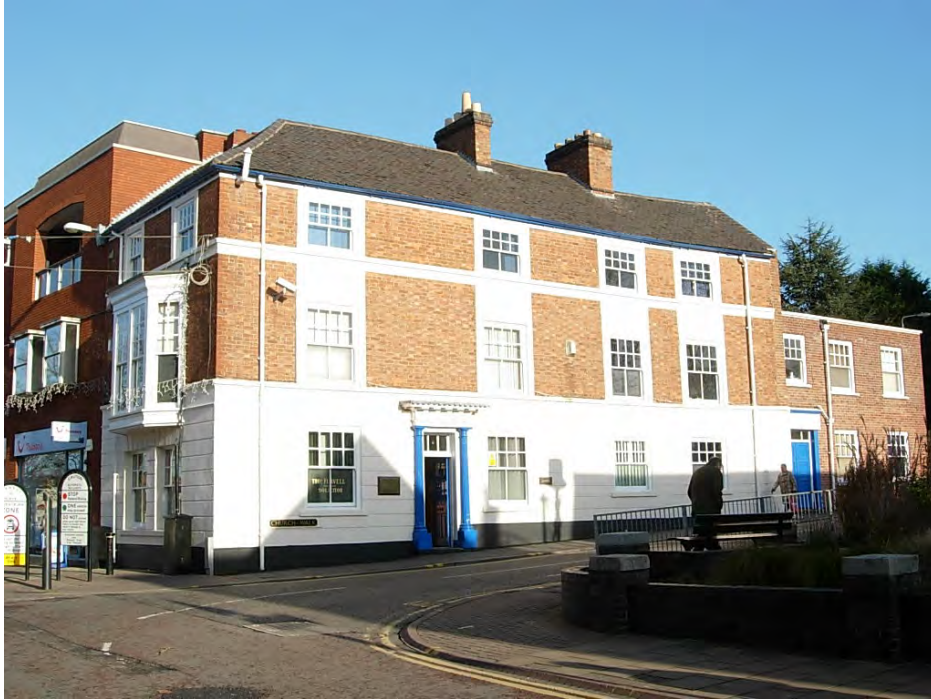
2 Market Place. This listed building is a very elegant structure and an important heritage asset. The first floor bay window adds significant character to both the Market Place and Station Road.

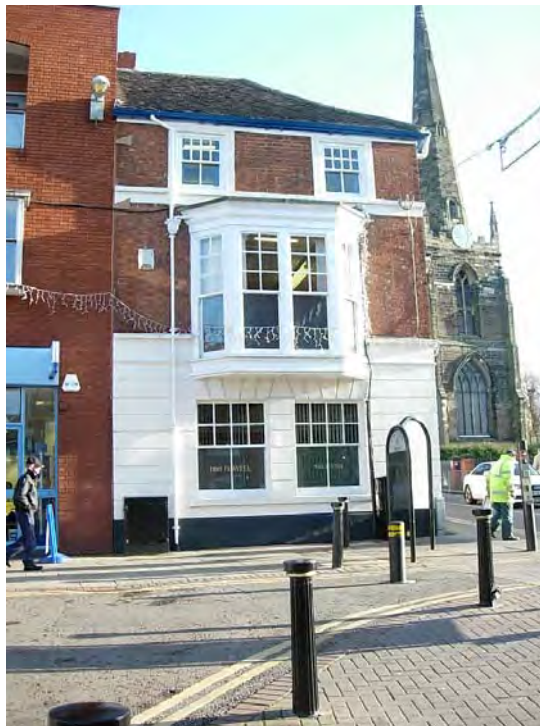
2 Market Place. The view of this building from the Market Place is interesting in that the bay window was a later addition to the property which considerably improved the appearance of the building.

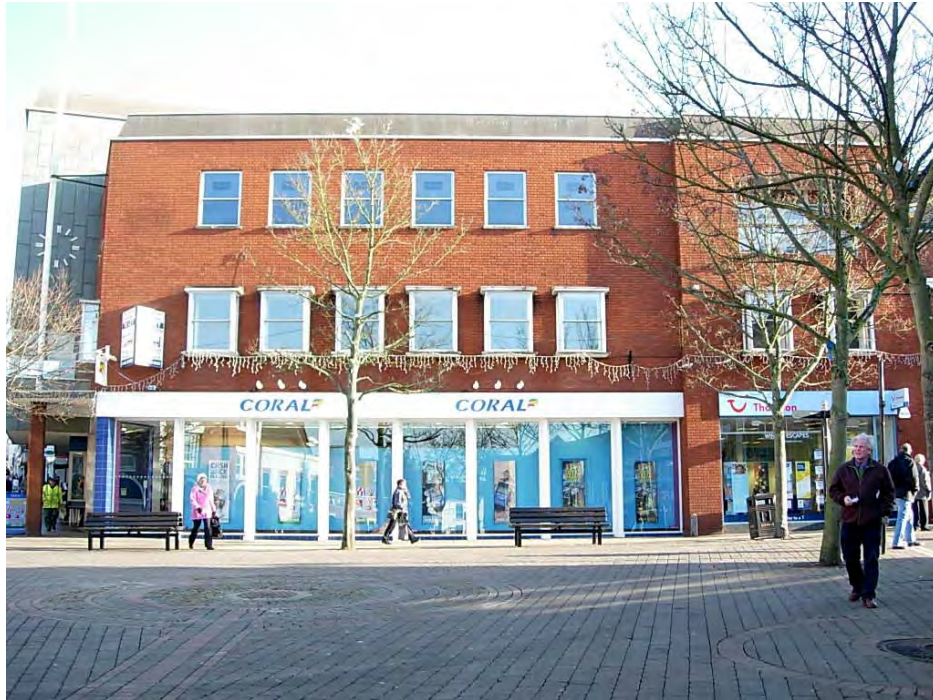
1 Castle Street presents a low key unremarkable elevation to the end of the Market Place which does not draw attention away from the adjacent listed building.

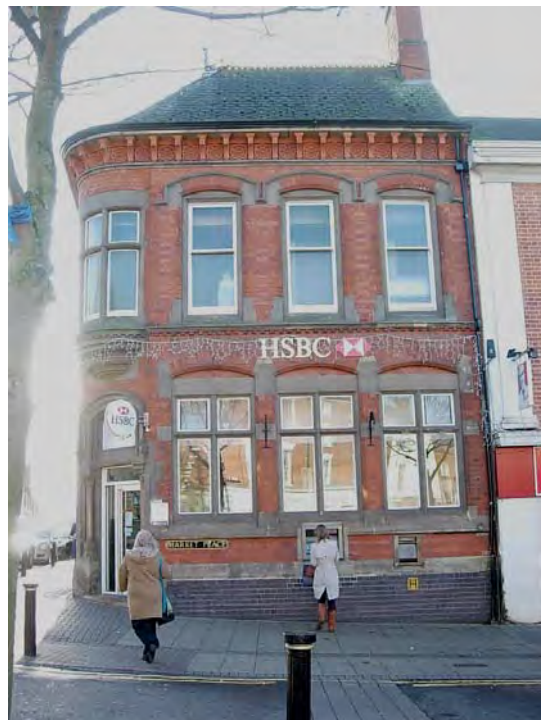
10 Market Place presents a very interesting frontage to the Market Place and successfully turns the corner with Station Road with a notable entrance and a hanging bay at first floor.

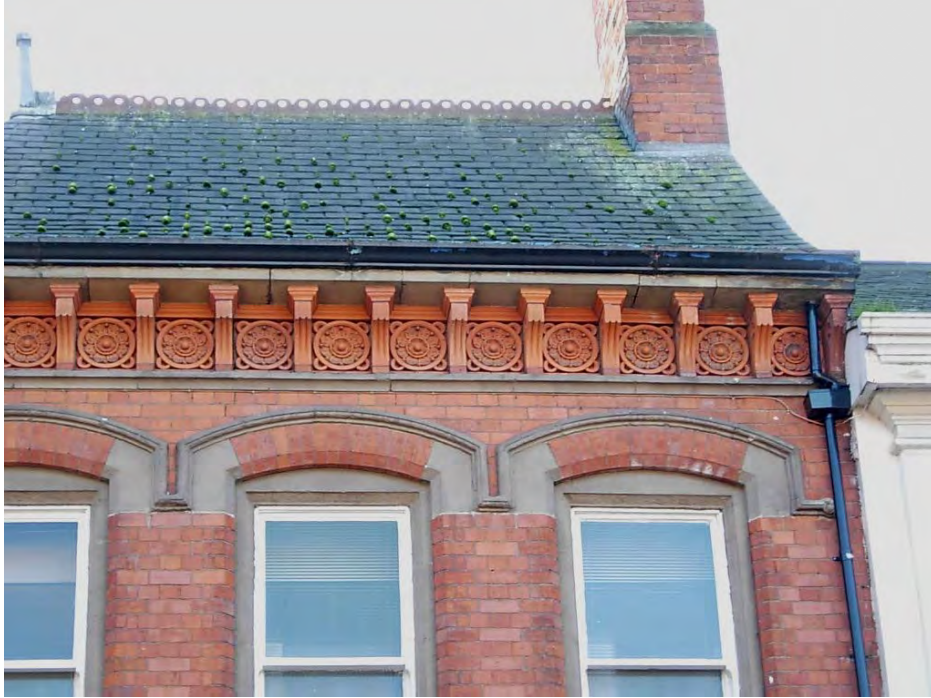
HSBC bank has particularly noteworthy details which includes a terracotta cornice, brick/stone lintels and timber sash windows.

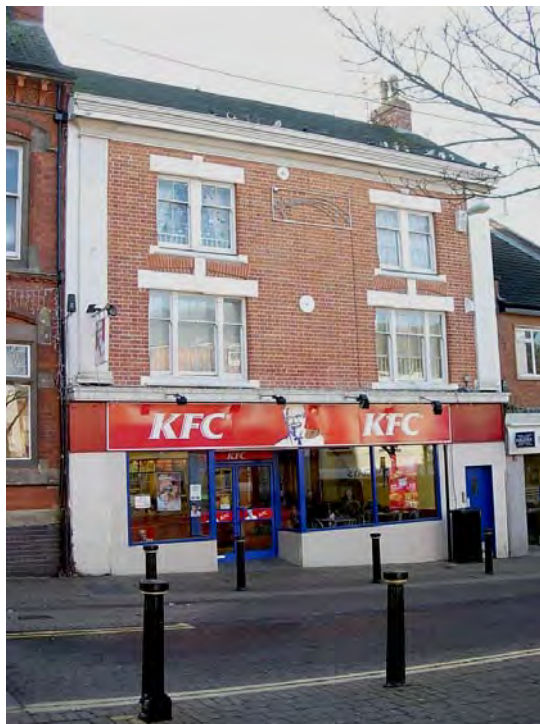
12 Market Place. The upper floors of this building have been carefully restored and add interest to the Market Place. It is unfortunate that the shop fascia is overly large and the colours of this and the shop front are not in keeping with the Conservation Area.

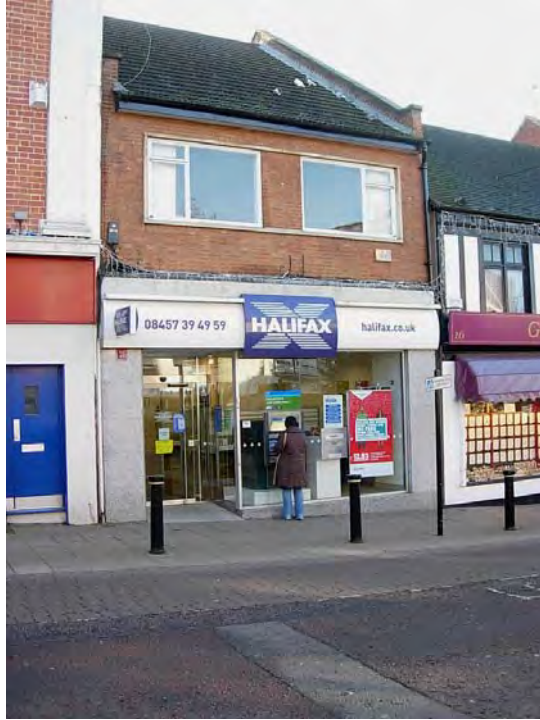
14 Market Place. This unremarkable mid C20 building occupies a significant location in the Market Place. The design has retained a traditional recessed entrance although the window proportions do not reflect the vertical proportions of most other traditional buildings facing into the Market Place.

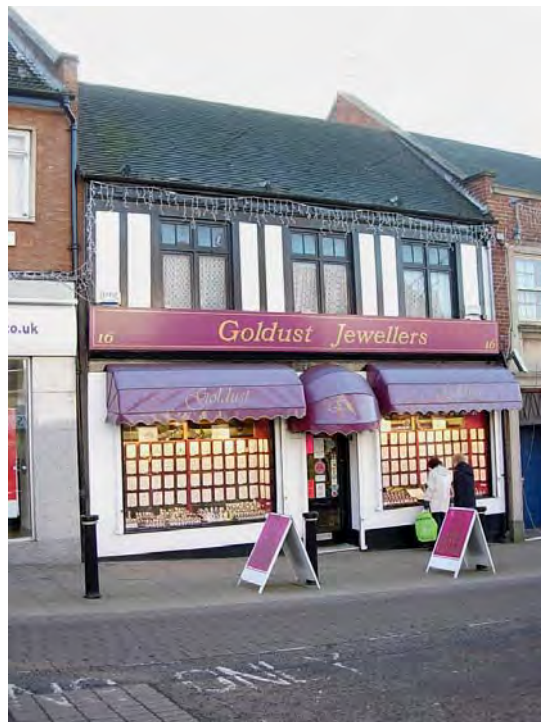
16 Market Place. Although this building suggests a traditional appearance, it is mid C20. The signage is overly large and the plastic canopies detract from its appearance.

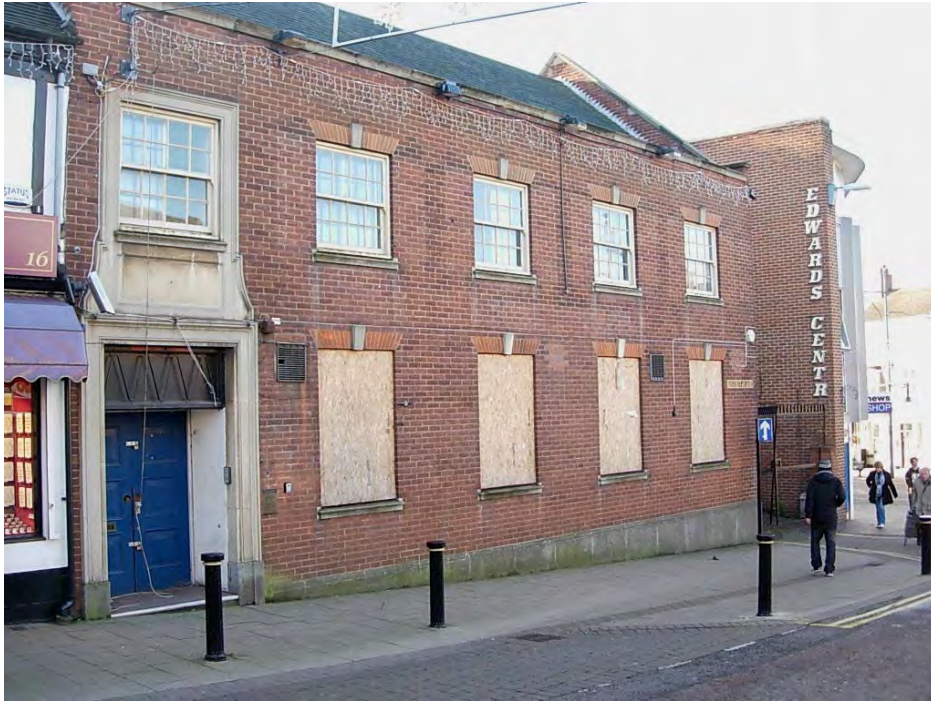
18 Market Place. This building which replaced the George Inn, forms part of a very large club building which has been vacant and boarded up for a long period. The proportions and stone details around the windows and doorway have given the mid C20 building, a semi traditional appearance.

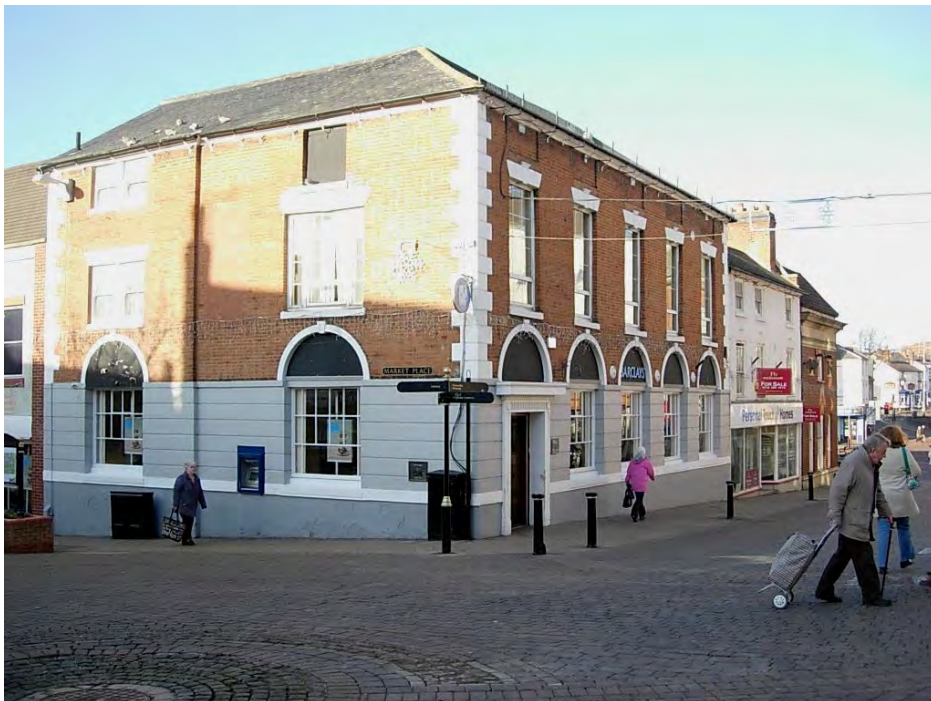
This elegant listed building suffers from the installation of plastic double glazed windows at first floor which detract from its appearance. These were unfortunately granted consent by the local authority in the late 1980's. However it remains an important heritage asset in the Conservation Area.

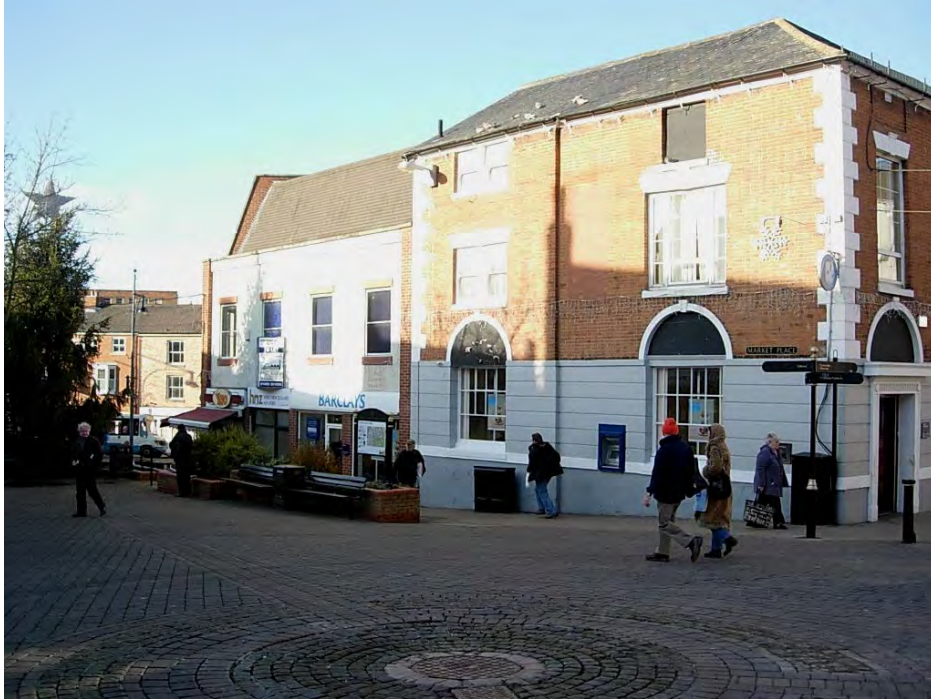
The Market place is traditionally the most important space in the town centre and has a very interesting plan form but it suffers from the lack of a focal point and mainly poor quality shop fronts in the surrounding frontages.

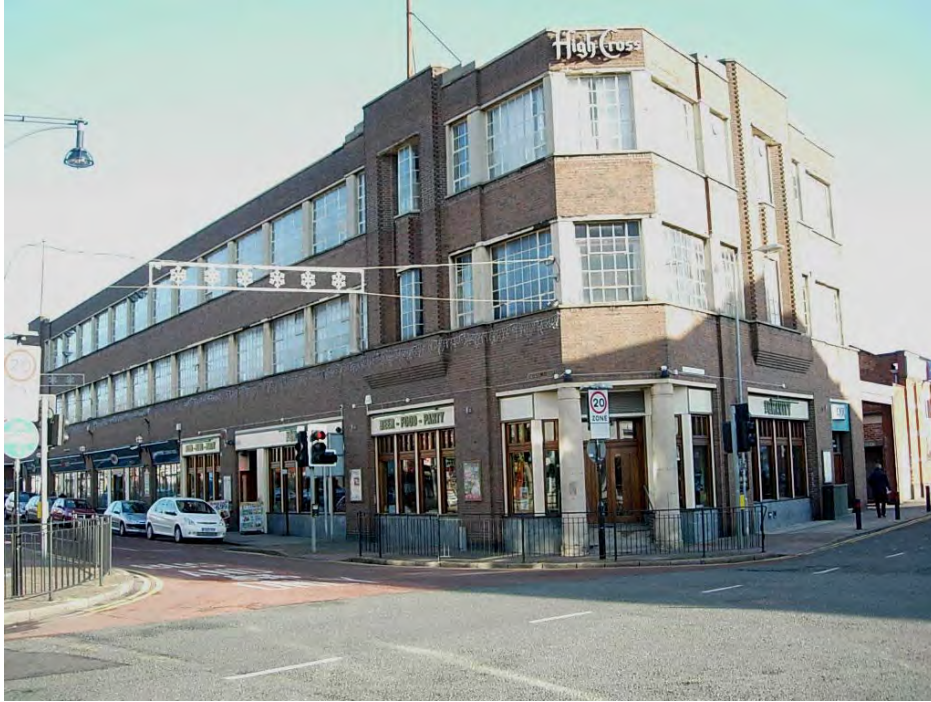
The High Cross building, a former hosiery building, was originally two stories high and had an arcade on the street frontage. It forms a significant memory of the town's hosiery industry and is an important heritage asset. Again its form makes an important play around the corner of the building.

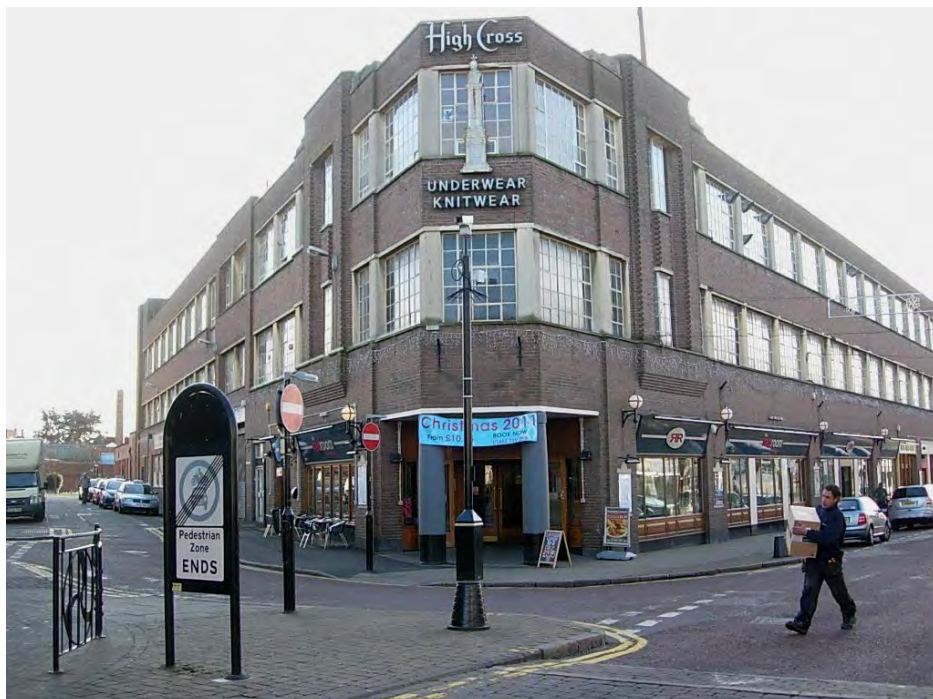
The importance of the corner entrance to the Highcross building at the junction of George Street and Regent Street is being affected by the proliferation of street signage and other clutter in the vicinity.

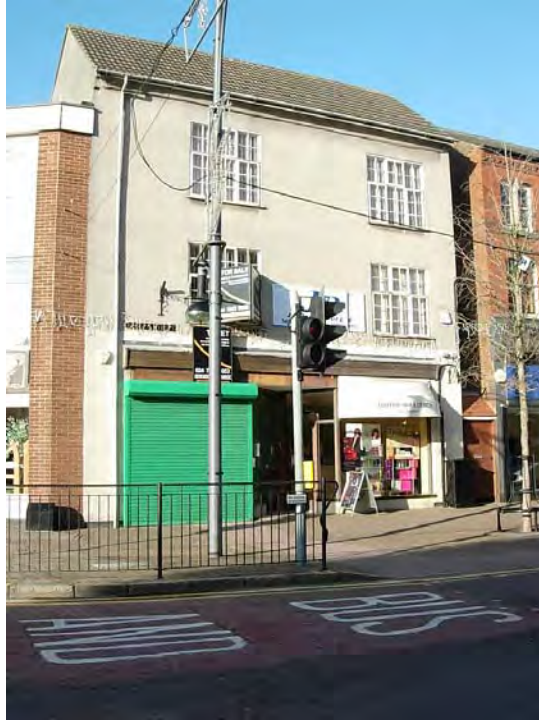
The green roller shutter, the render, the plastic canopy, the concrete roof tiles and the street clutter on 45 Regent Street have had a major detrimental impact on the appearance of this simple traditional building.

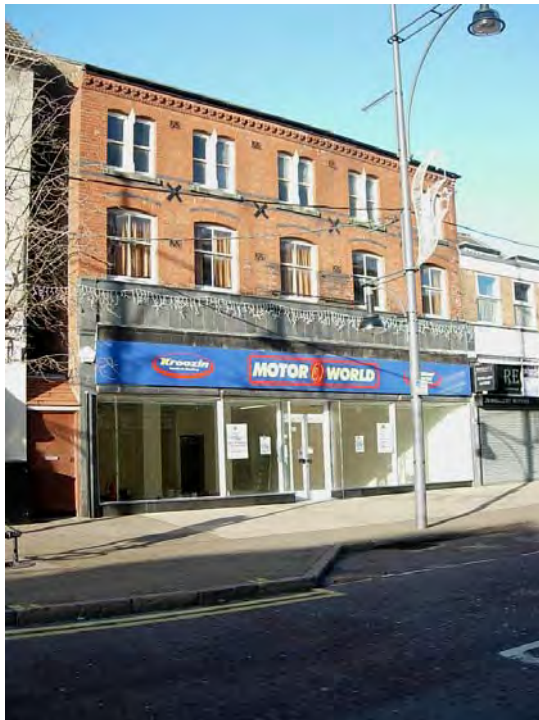
43 Regent Street is a late C19 building with an attractive elevation, traditionally proportioned windows and a brick dentil course. The overly large fascia signage and modern shop front however detracts from its appearance. When new signage is added to a traditional frontage, great care should be taken to ensure the proposal is proportionate.

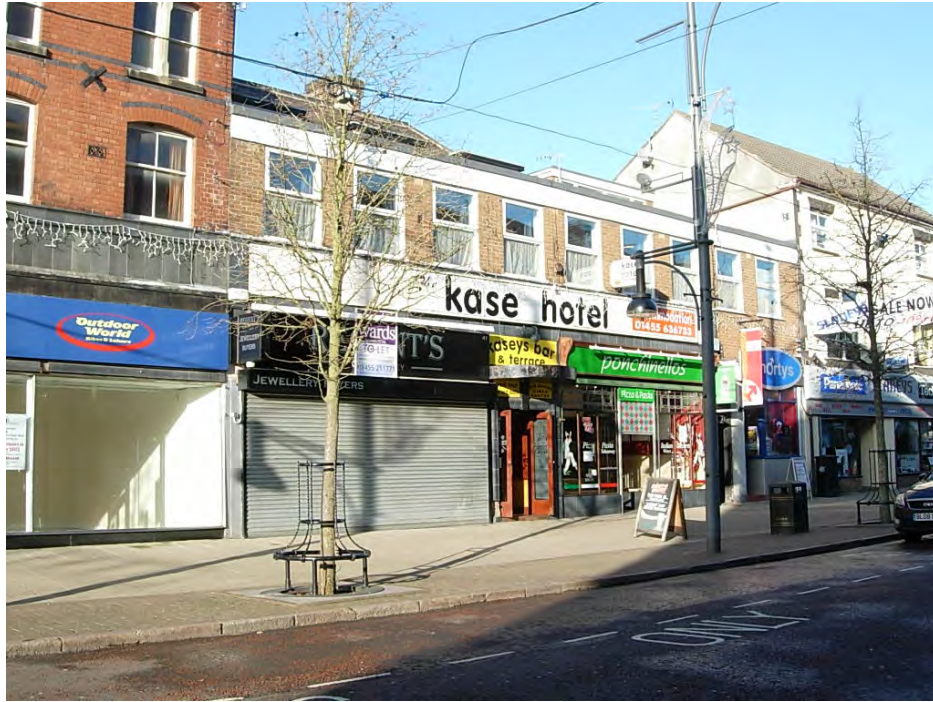
The modern frontage on 39-41 Regent Street conceals a very interesting medieval house which for a period was the home of the Atkins family. It is hoped that at some point the frontage will be removed to reveal one of the Conservation Areas hidden gems.

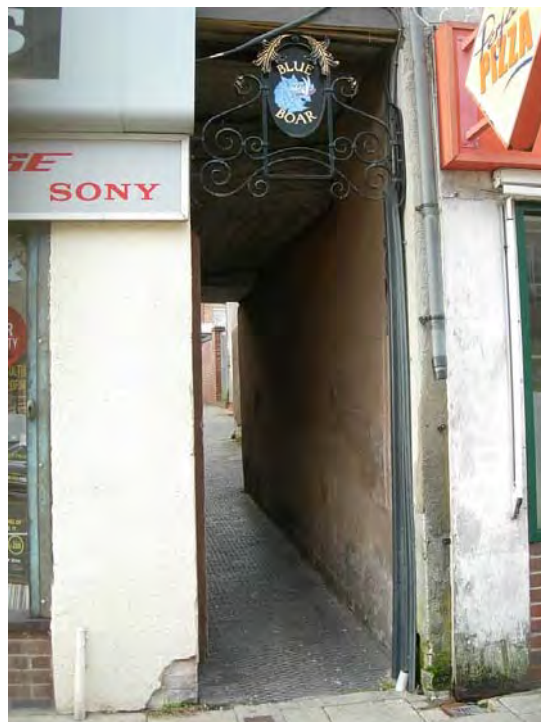
Blue Boar Yard is one of the traditional jitties which run throughout the town centre. It is thought that upon the death of Richard at Bosworth Field, its original name White Boar Yard, was changed to Blue Boar, to avoid any possible retribution by the new King, Henry Tudor. This jitty like several in the town centre is an important heritage asset but suffers from a lack of adequate maintenance.

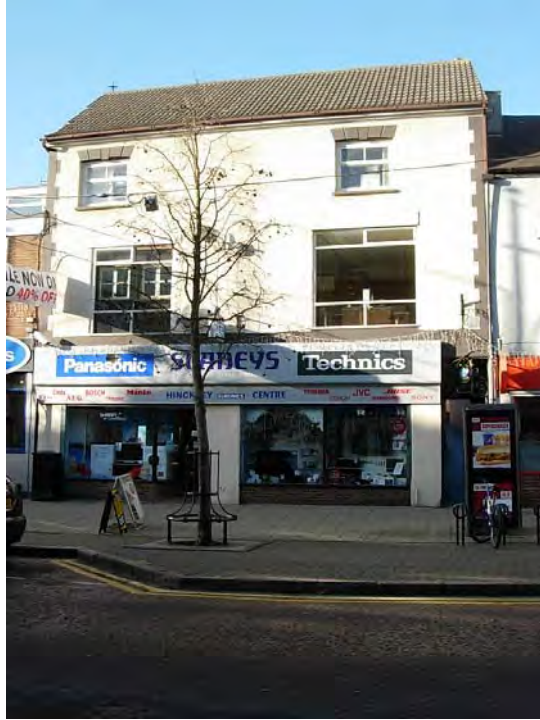
35-37 Regent Street is a C18 building that has been badly altered by its current owners. Unfortunately it now has a concrete tiled roof, over large first floor windows which may have been bay windows in an earlier period, and an inappropriate shop front. It has also lost its brick chimneys.

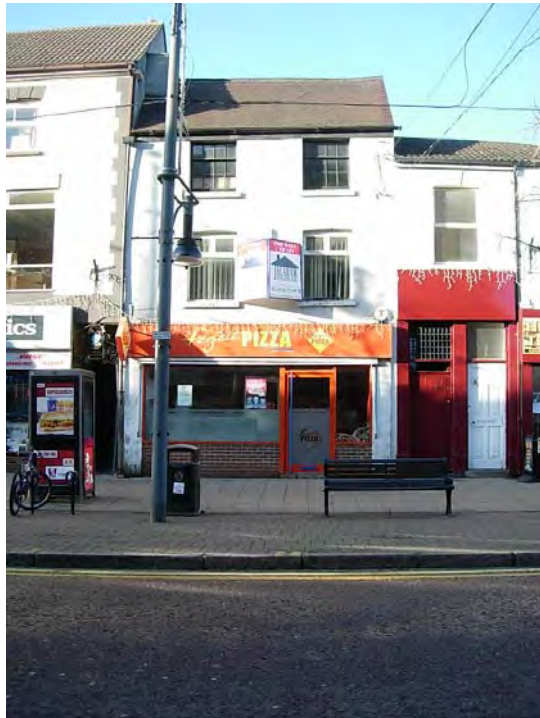
This early C18 building, 33 Regent Street, has been much altered in both the C19 and C20's. The shop fascia and colour scheme are particularly destructive to its traditional appearance.

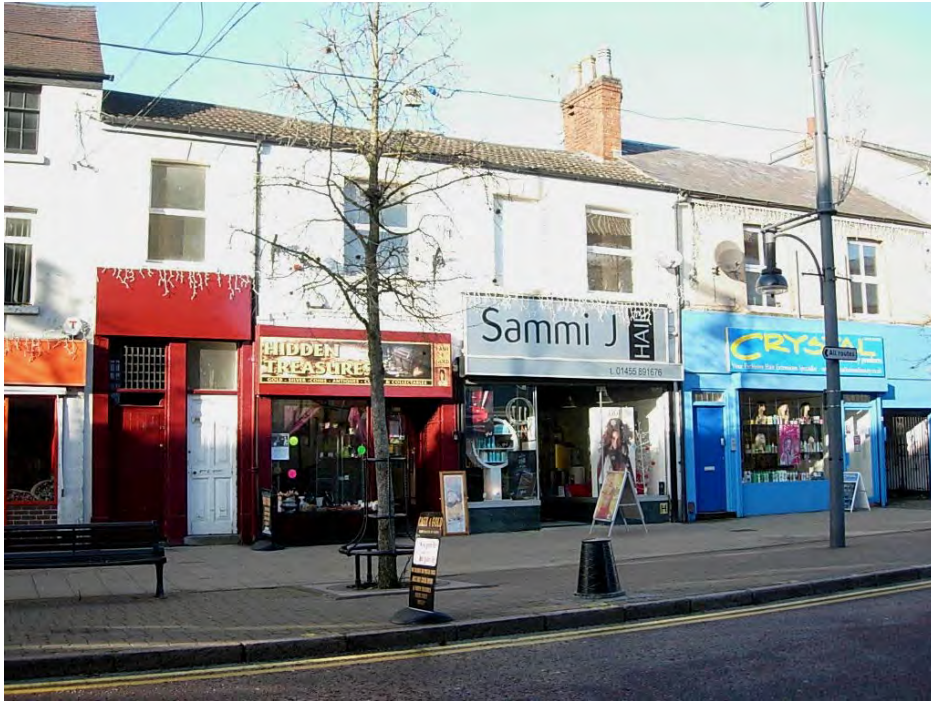
All of the shop fascias on this group of properties, 29-3A Regent Street, are excessively large and badly detract from the appearance of the buildings. They should be replaced with traditional sized fascias and more appropriate colour schemes.

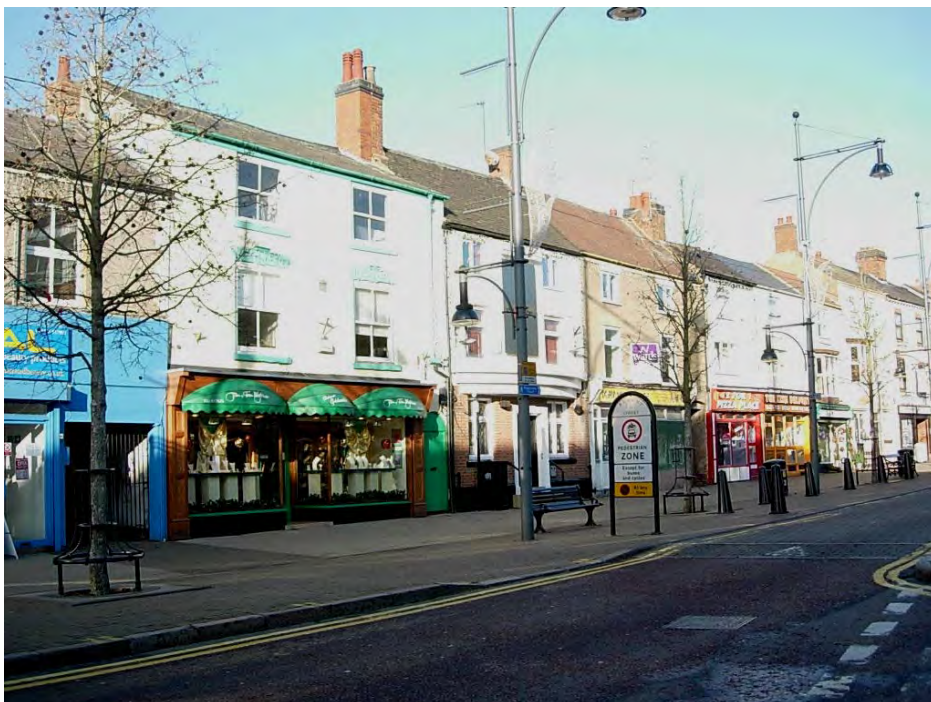
23 & 27 Regent Street are C18 buildings that have retained their slate roofs, chimneys and timber windows. It is unfortunate that plastic canopies have been introduced onto both properties. This has had a detrimental impact on their appearance, particularly No. 23 Regent Street.

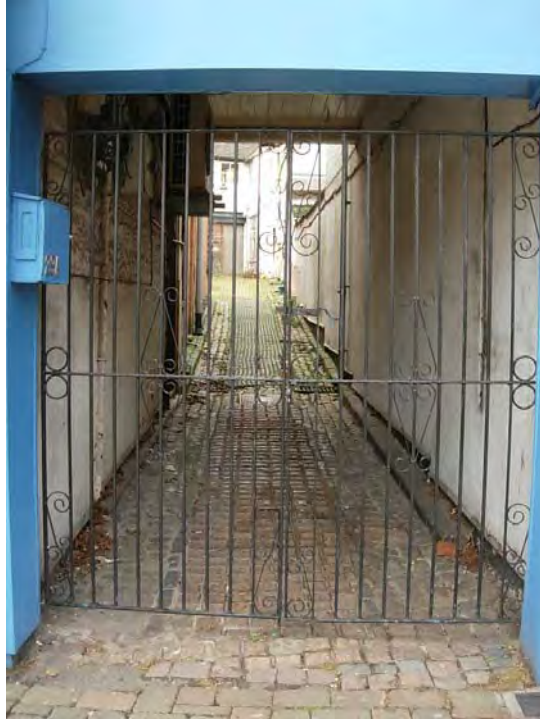
The entrance to this heritage asset, Slaughter House Yard, is surfaced with traditional granite sets and leads into one of the few remaining fully enclosed yards in the Conservation Area. Within the yard, two sides were the slaughterhouse, one of which holds a lifting wheel.

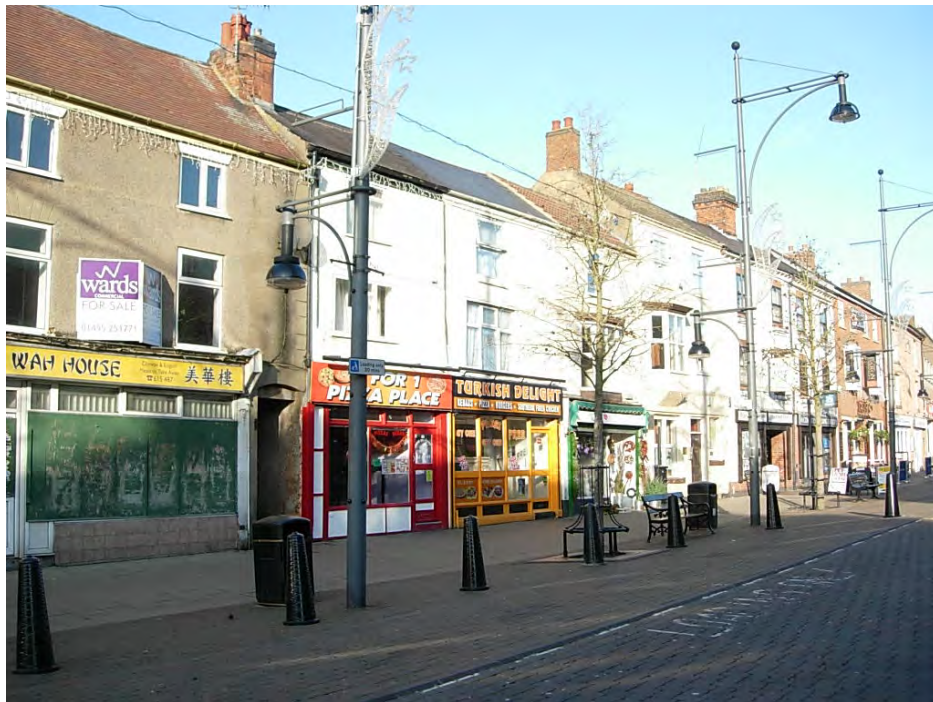
17 – 21 Regent Street are C18 properties which have had significant changes to the roof finishes which has divided the original continuous roof. Unfortunately, the modern shop fronts with their bold colours detract from the appearance of the buildings.

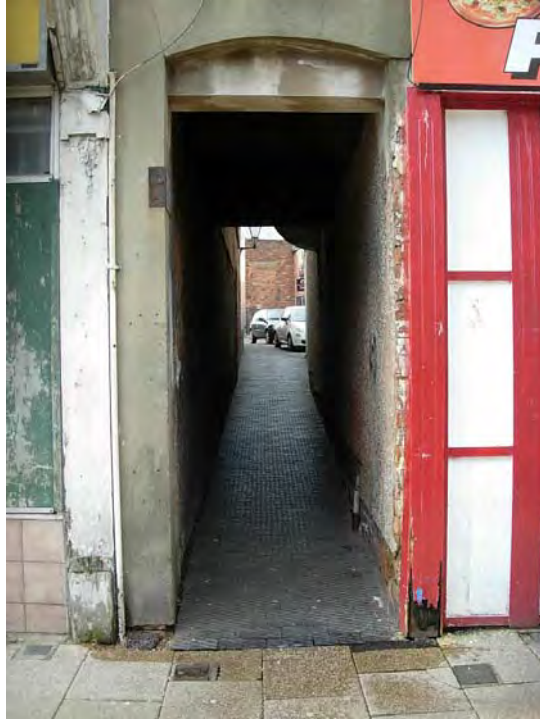
The jitty through 21 Regent Street has diamond pattern Victorian blue pavers. Jitties are important heritage assets in the Conservation Area and they should be protected and enhanced. These passageways are important entrances into the commercial centre of the town and need to be adequately maintained.

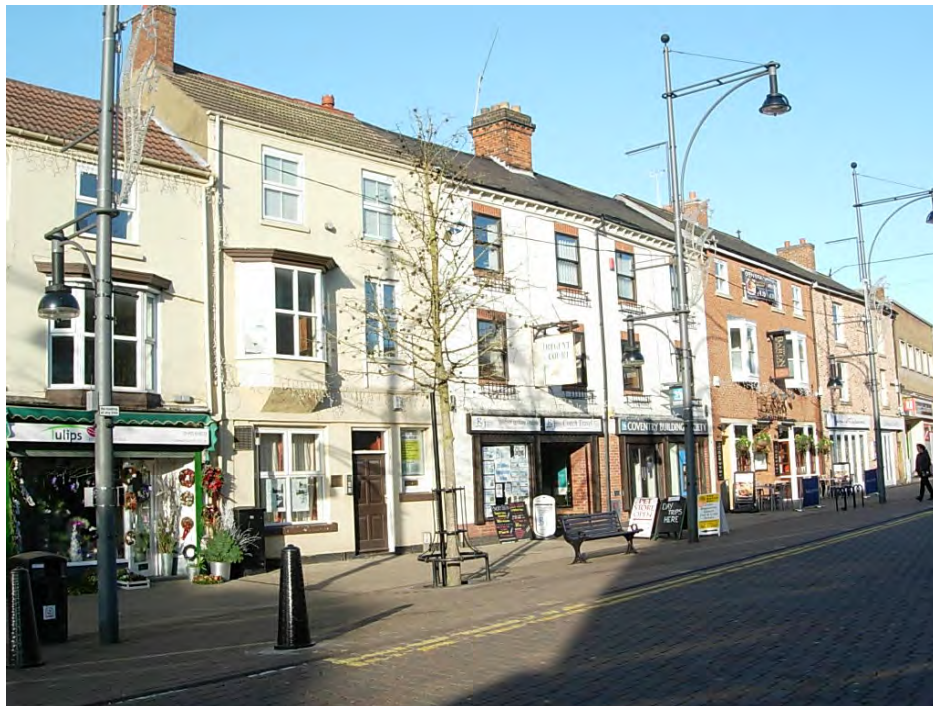
Although the frontages to nos. 9 and 11 Regent Street have largely been rebuilt, their interiors have timber framing dating from C16. The slate roof, massive central chimney and Victorian window proportions have been retained. No.13 and 15 Regent Street are pleasant buildings with a feature bay window at first floor. No.15 has a traditional retractable canopy over an acceptable shop front whereas no 13 has a domestic style ground floor window.

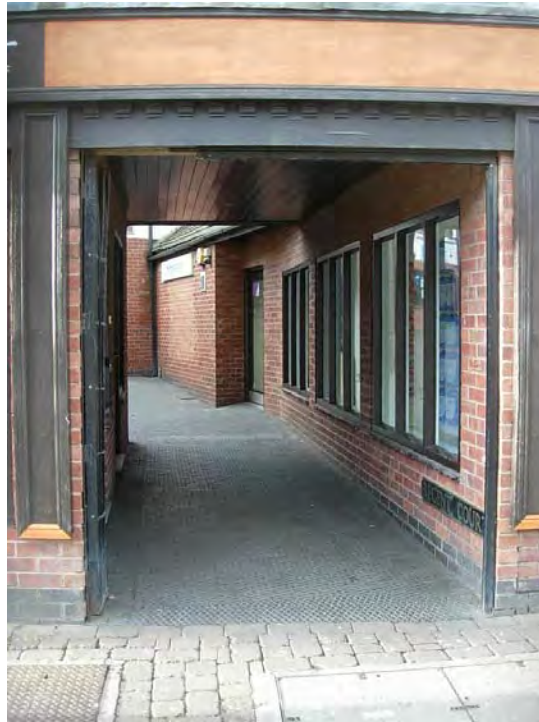
The entrance into Regent Court is completely modern and much wider than traditional jitty routes. However, it is in keeping with others in the town centre having blue diamond pattern pavers, is well maintained and it is very well used by the public.

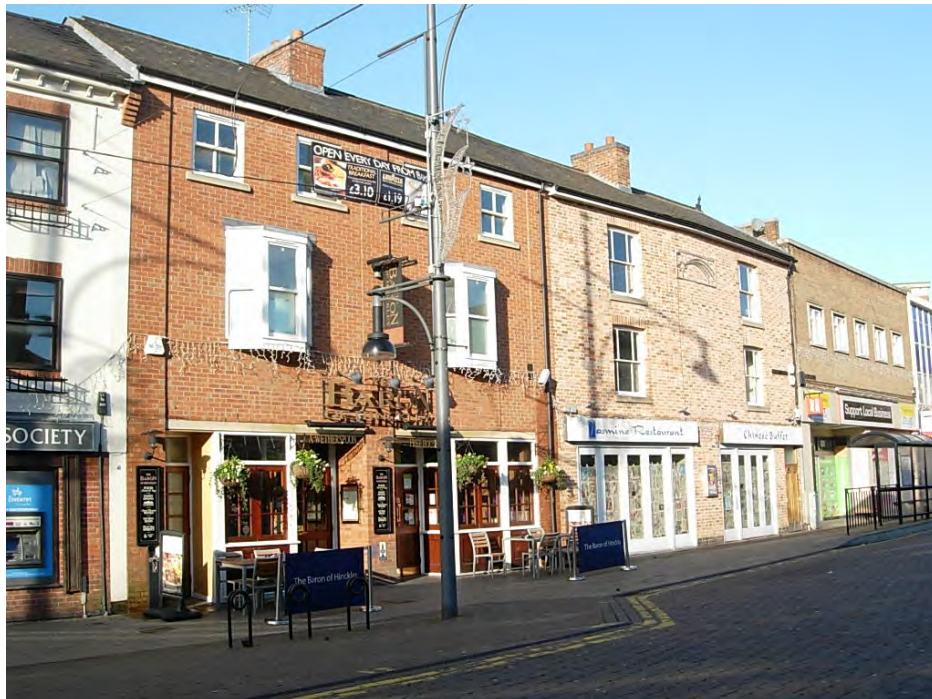
Although the street frontages to 1 & 7 Regent Street have largely been rebuilt in the C20, they have retained the Victorian vertically proportioned windows on the upper floors, facing brickwork and a slate roof. The first floor bay windows are important features in the street scene.

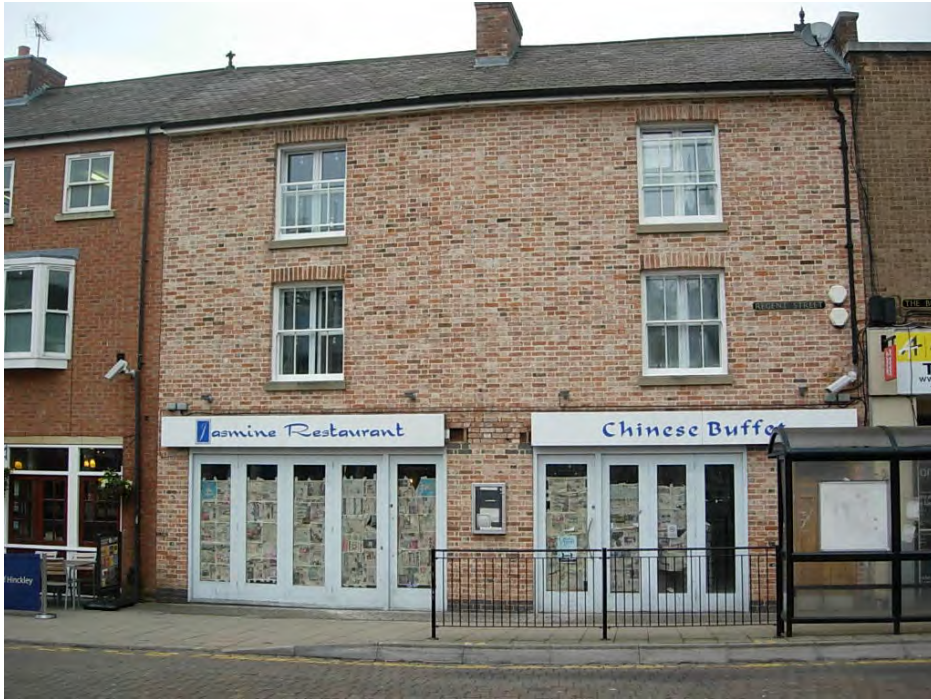
1 Regent Street, although recently rebuilt, includes a slate roof covering, central chimney stack, and sash windows at first and second floors with brick soldier course lintols.

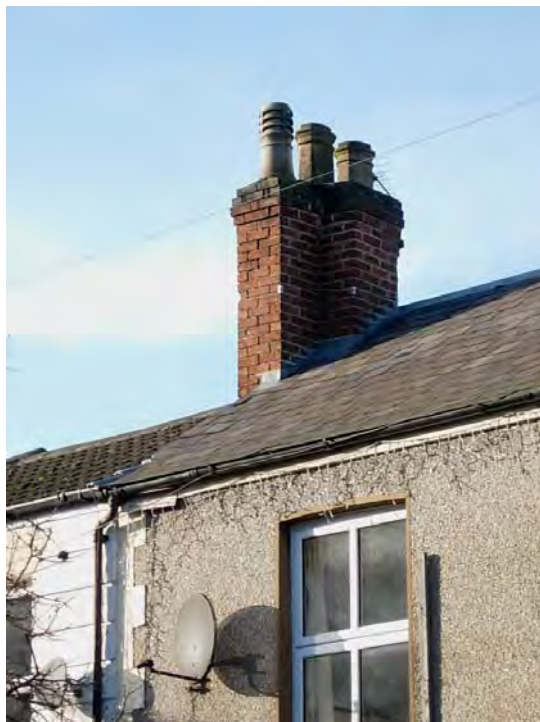
One of the few remaining properties on Regent Street that has retained its traditional chimney stack and pots. However this must be set against the detrimental impact of the street facing satellite dish and the plastic window.

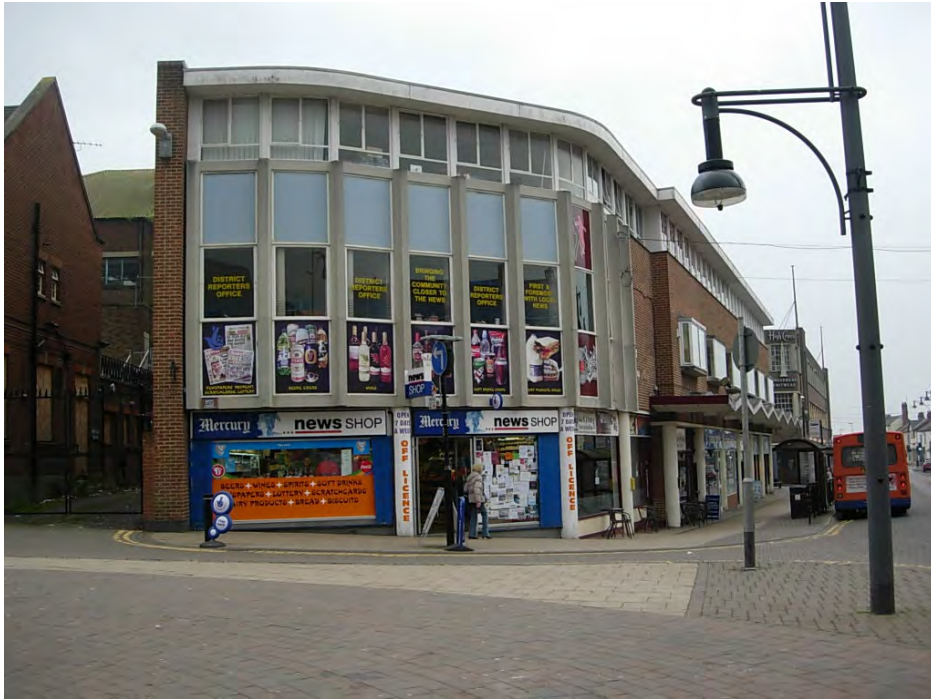
Northern end of the Edwards Centre reflects a style of design common during the 1960s and the 1970s. It is unfortunate that the small development blocks of earlier periods, has been lost.

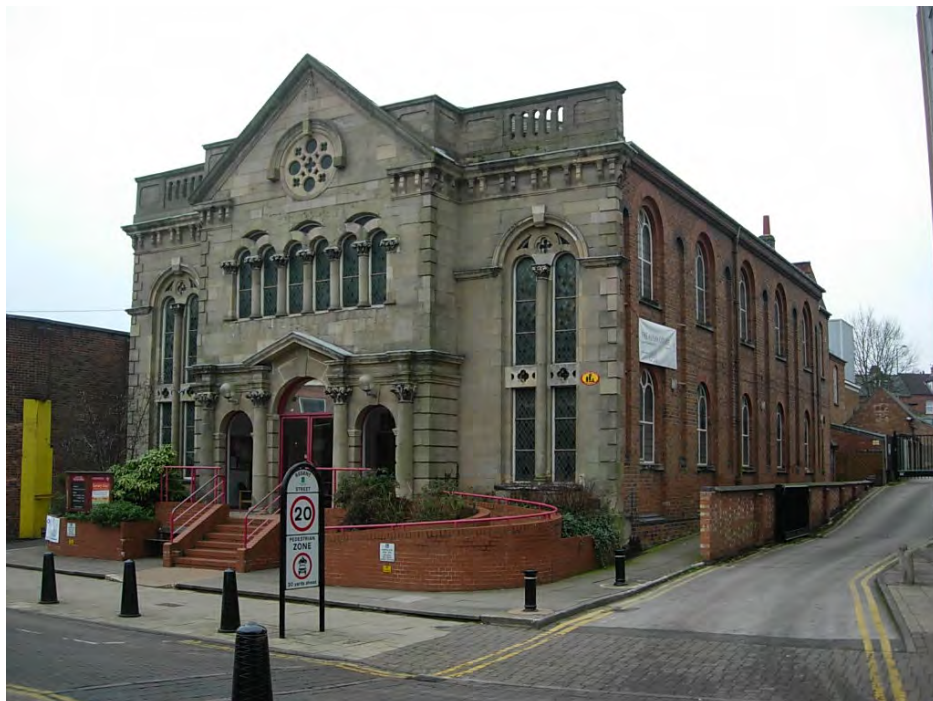
The United Reform Church is a very distinctive Grade II listed Non-conformist Church designed by F. Drake that has a street frontage of ashlar stone in the Italianate style. The remainder of the structure and the attached school rooms are of brickwork with slate roofs.

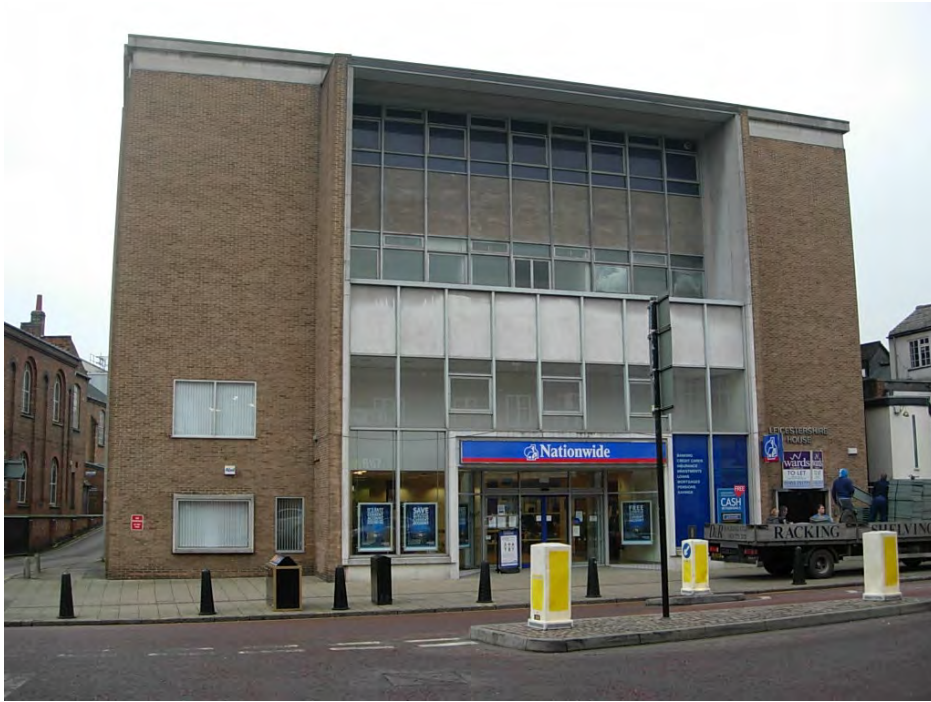
The Nationwide Building Society building on The Borough, although of a style common when it was constructed, is completely out of scale with the nearby buildings. Its appearance is also out of character with this part of the Conservation Area.

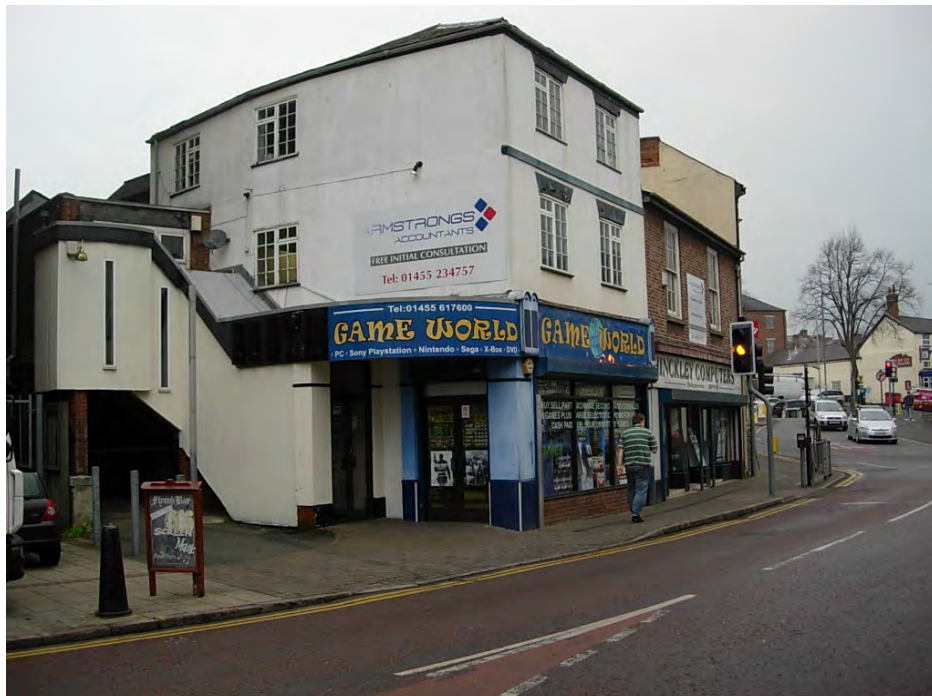
18 The Borough is probably late C18 although since the 1960's it has suffered from inappropriate extensions, rendering and the loss of its sash windows at first and second floors.

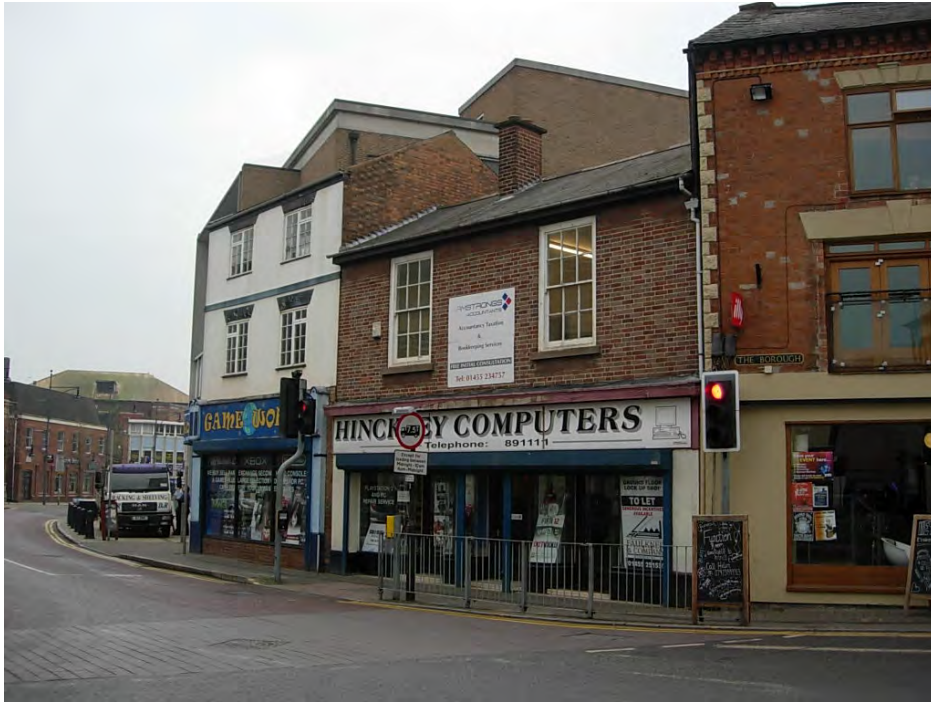
20 The Borough has been reconstructed in the mid C20 but does retain vertically proportioned windows, a slate roof and a central brick chimney. Its appearance, however, is spoiled by the projecting roller shutter and its housing.

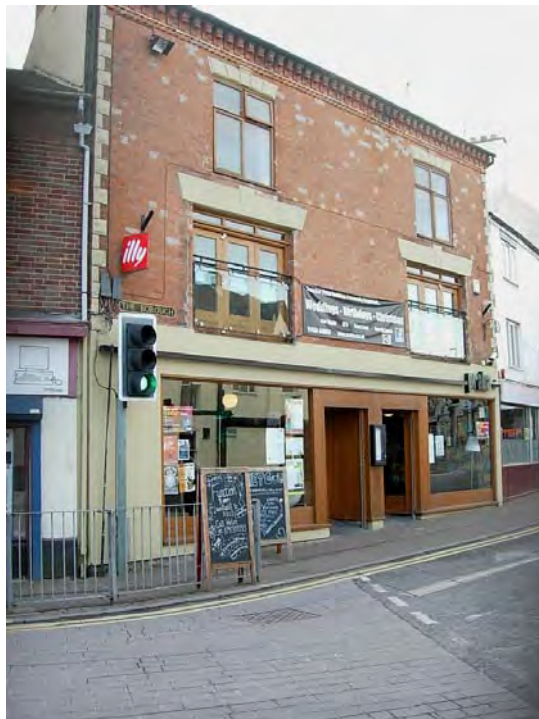
22/24 The Borough is predominantly a mid C19 building that has overly large openings at first floor which may have been originally intended for bay windows. Should these features be added in the future, they will significantly improve the buildings appearance.

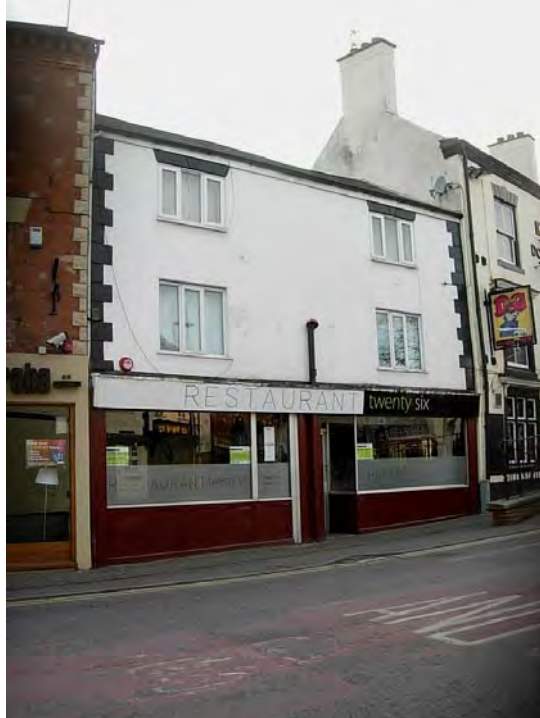
26 The Borough is a late C18 building that has a simple façade with a C20 shop front and windows which unfortunately detract from its appearance.

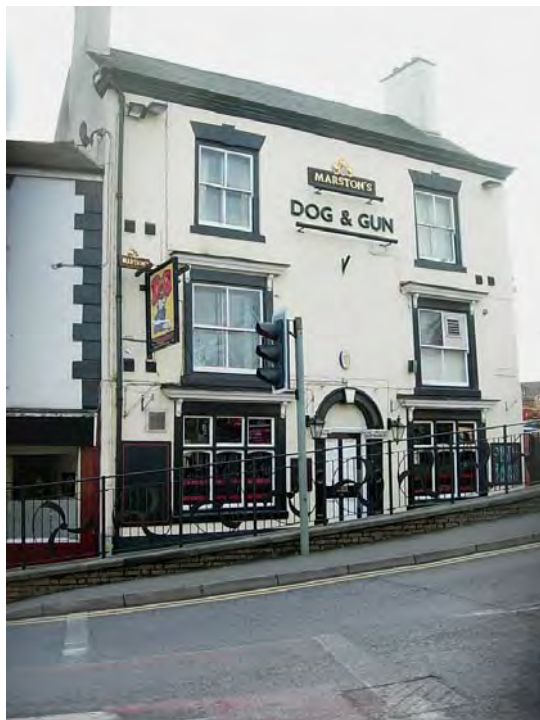
28 The Borough is largely a mid C19 property with a rendered frontage and a rear courtyard. Its street elevation sparkles and considerably adds to the character of this part of the street. It is an important heritage asset to the Conservation Area.

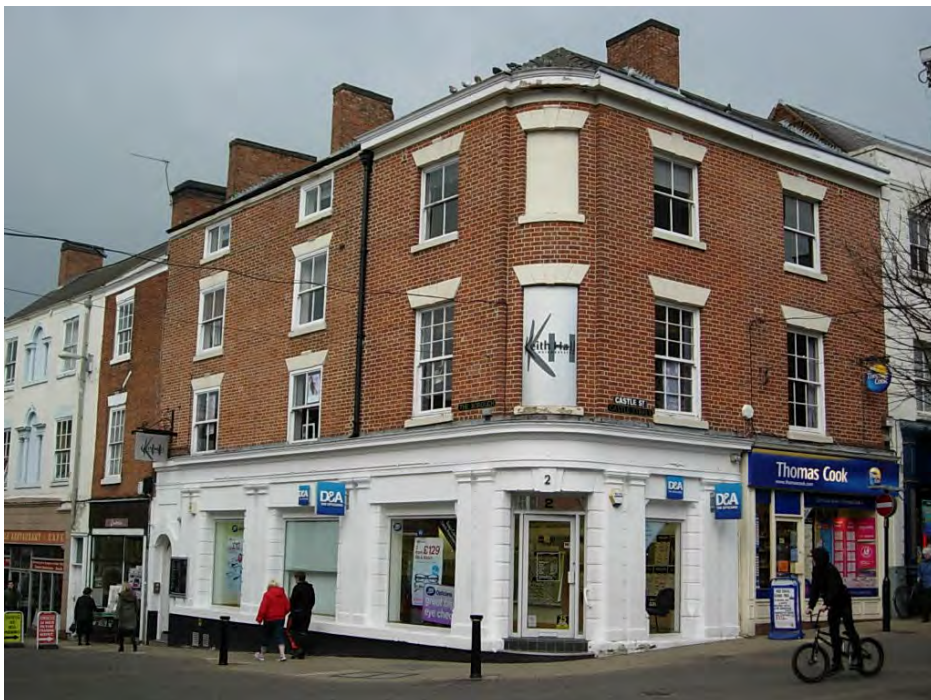
2 Castle Street has part of its frontage along The Borough. This listed early C19 building forms an impressive corner building at the junction of Castle Street and The Borough. Although the shop fronts have been extended and significantly simplified from their original form, they still present good examples to the rest of the town centre.
