**Hinckley Town Centre  
Conservation Area Appraisal and Management Plan**

**Photographic Record 2 - Market Place, Regent Street,  
The Borough, King Street and Lower Bond Street**

**February 2013**

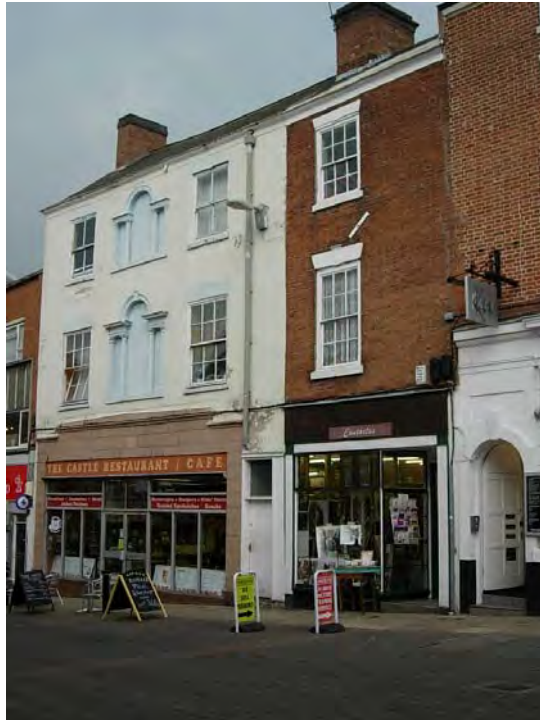
3 & 5 The Borough are late C18 structures that form a grand frontage on the street. Although 5 The Borough has lost its 2 bay windows at first floor which existed until the late 1960's, the two blind Venetian windows at first and second floors help retain its impressive character. The C20 shop fronts however, do not reflect the quality of the upper floors.

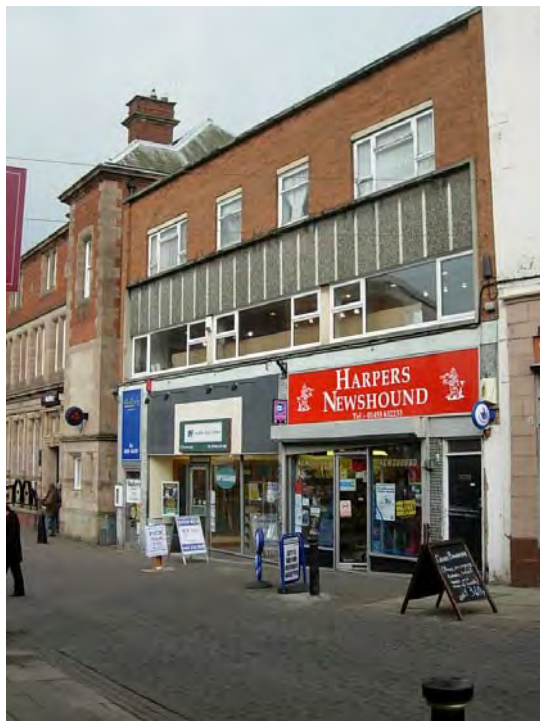
This modern infill development, 7 & 9 The Borough, has a highly complex street elevation with features that are out of character with other buildings in the area.

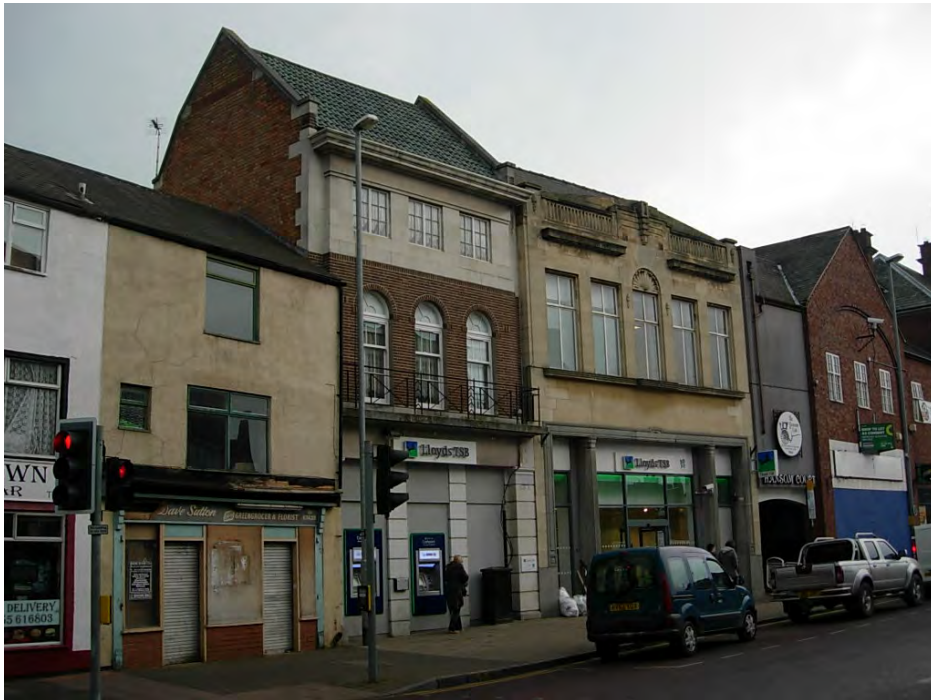
Although both bank buildings on The Borough are interesting, the earlier frontages had bay windows at first floor and one had additional bays at second floor. The windows to 25 The Borough unfortunately have been modified from pleasant vertically rectangular openings with soldier course lintols and projecting brick sills to the current very bland openings.

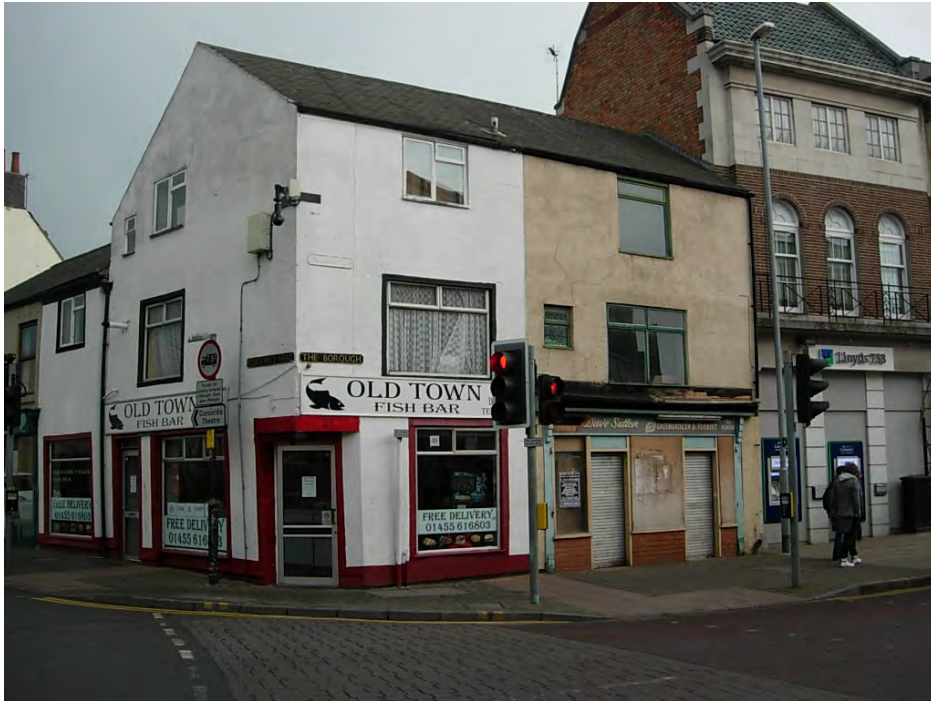
23 – 27 The Borough are 2 buildings that previously had vertically rectangular windows which were better proportioned than the current openings. Any changes to return them to their original form would be supported.

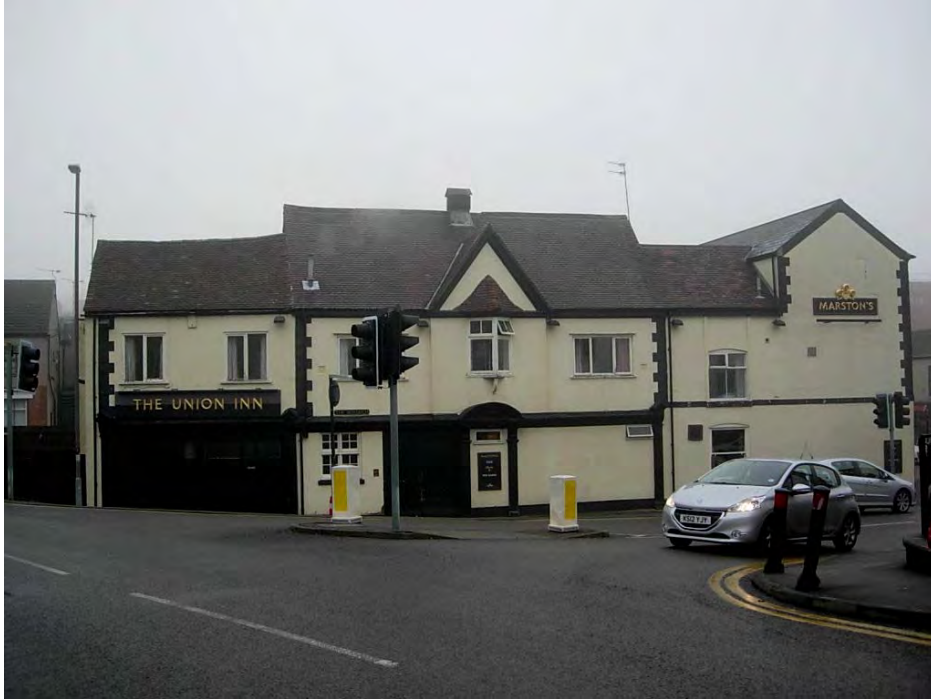
The Union Inn viewed from Trinity Lane. This façade has been reconstructed and has seen significant changes including the loss of a parade of shops. In this case the replacement frontage has retained some interest which adds to the quality of the building.

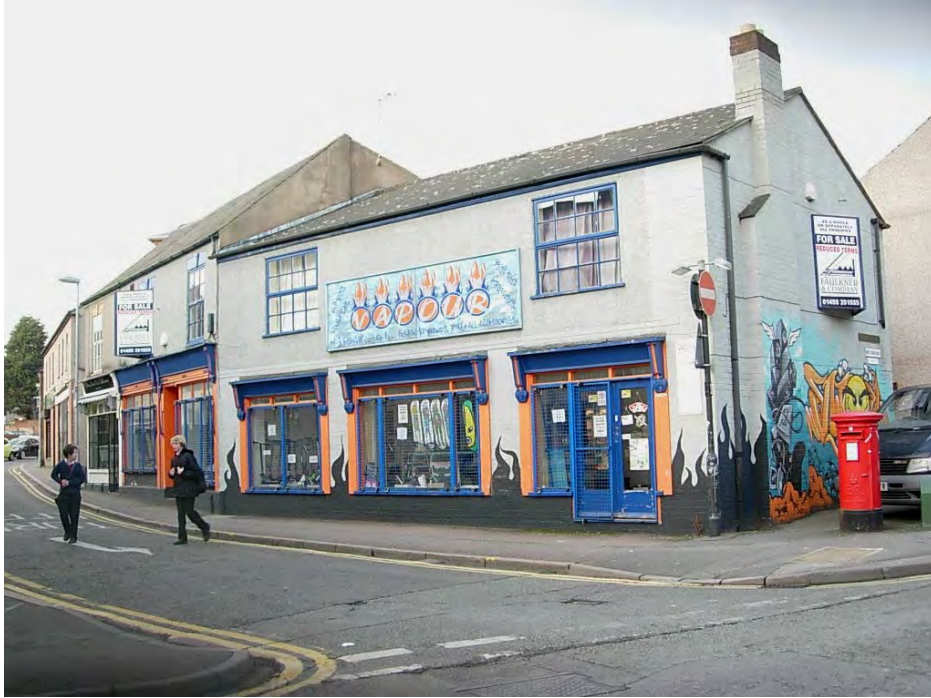
This block of properties, 1- 5 King Street, replaced the original buildings in the 1980's. Although similar in appearance, the proportions and appearance of the first floor windows and the shop fronts are of a lower quality. The colour scheme and the signage also detract from the appearance of the building.

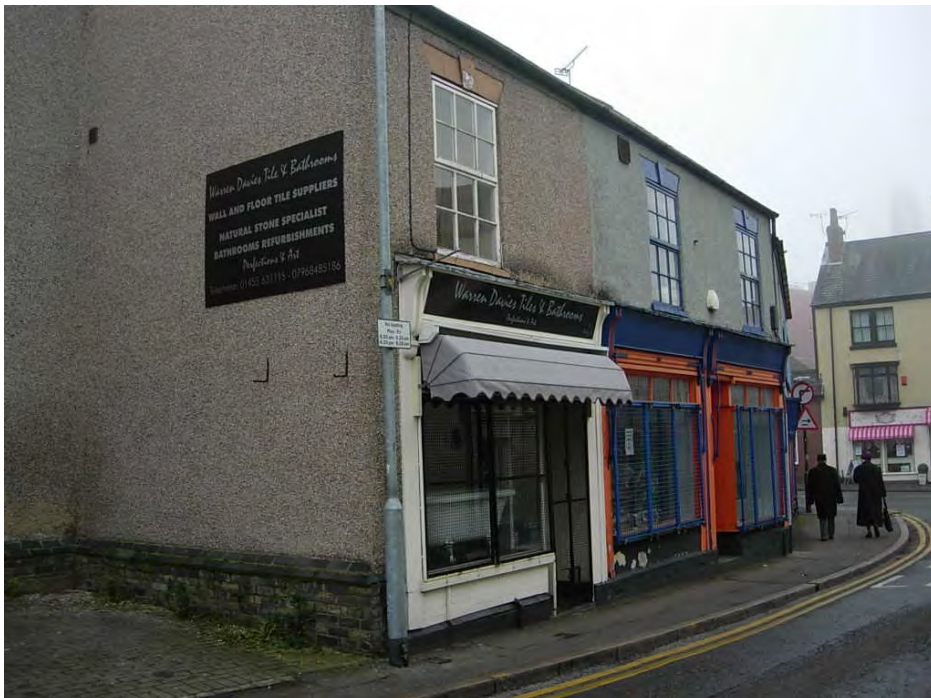
The shop fronts at 7-9 King Street would be improved if painted in a more appropriate colour.

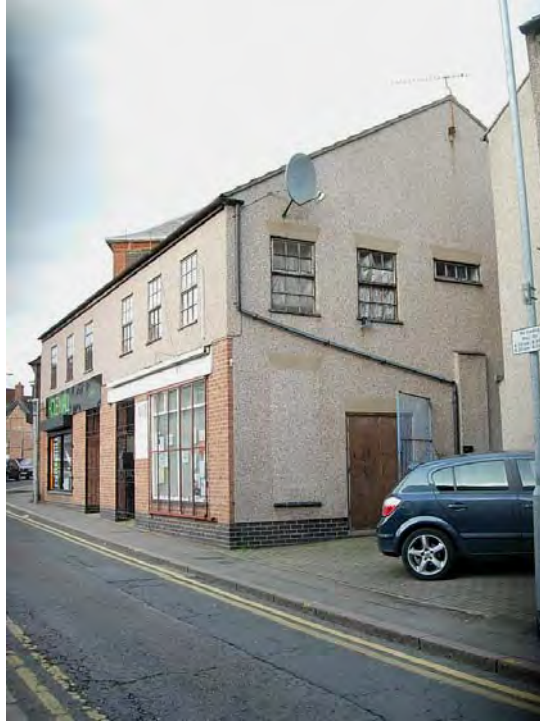
13 King Street was also re-constructed in the 1980's and has lost much of its traditional character.

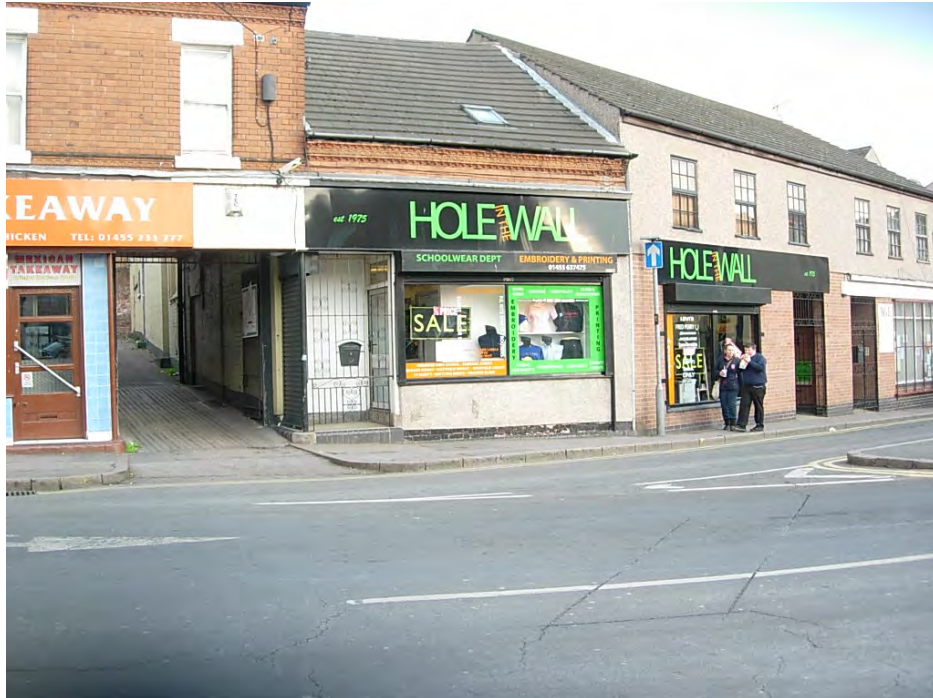
Although the original recessed entrance in this shop front has been retained, the oversized shop fascia and the concrete roof tiles detract from the appearance of this building.

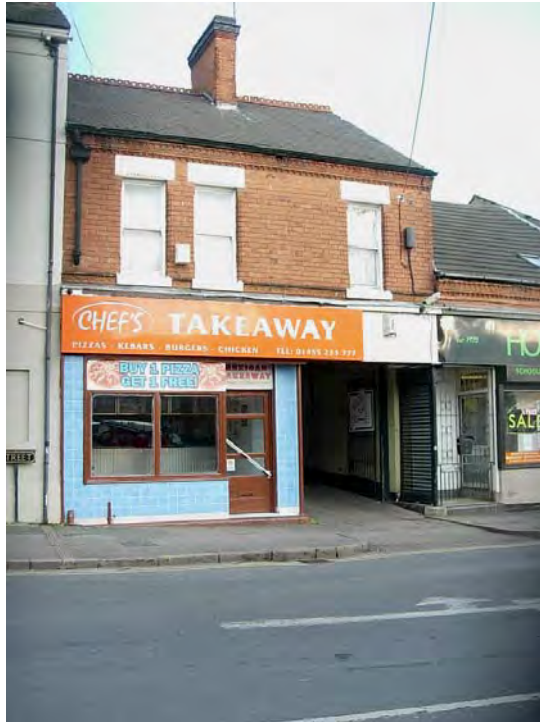
The original cart entrance, chimney, ridge tiles, slate roof covering and timber sash windows have survived on this building. It is unfortunate that the signage is overly large and bright blue tiles have been added to the ground floor, which detract from the appearance of the building.

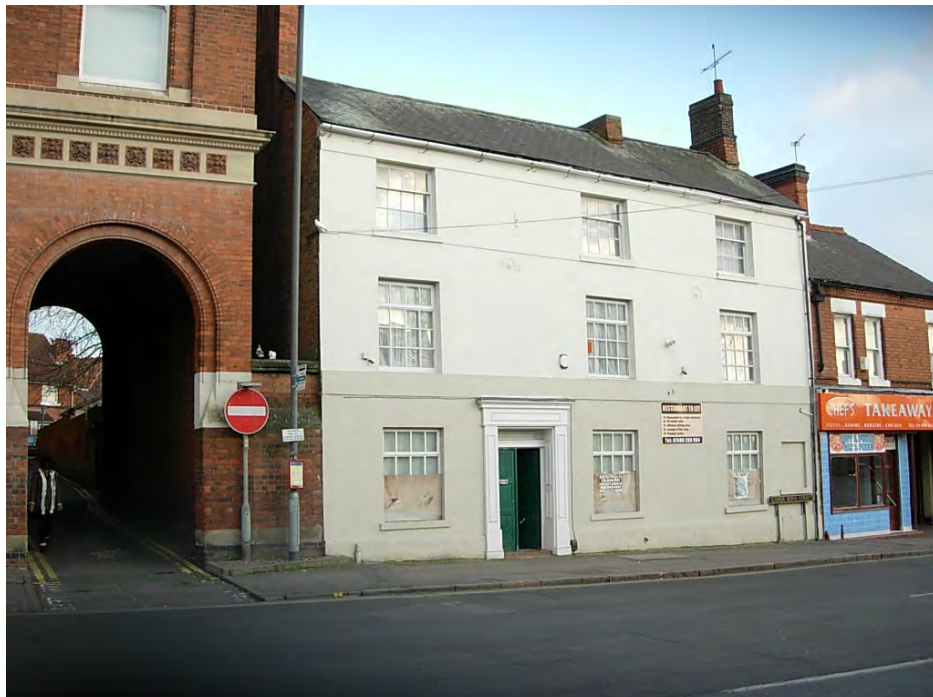
Although the central chimney has been shortened at the now vacant Barley Sheaf Pub, the windows changed from sash to top hung casements and the original projecting hanging sign lost, this mid C19 public house still retains a strong presence in the street and is an important heritage asset.

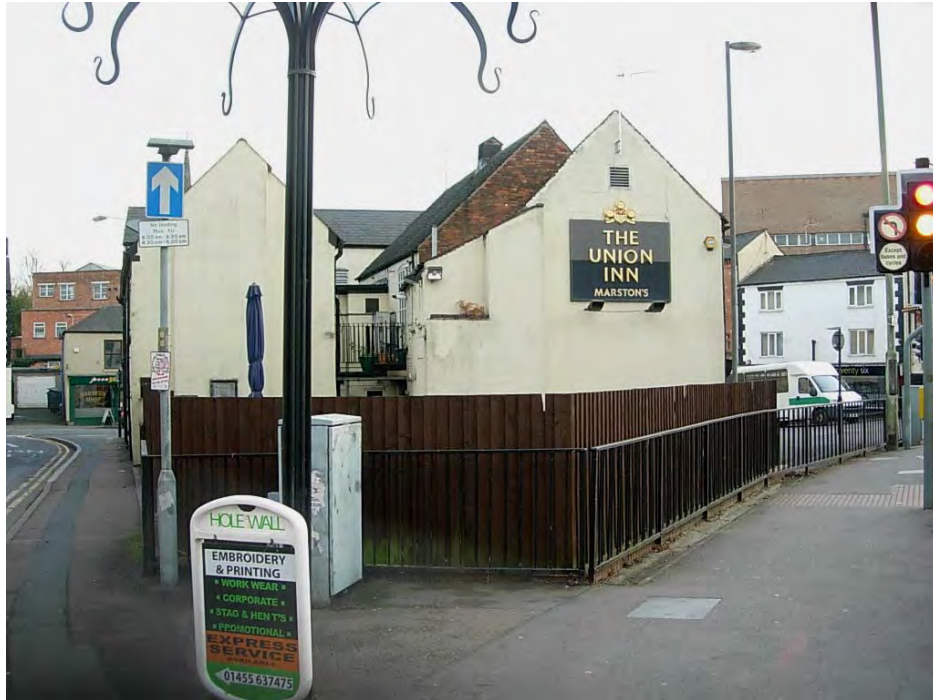
This vacant site was previously occupied by a 3 storey building with a shop at ground floor. The vacant site would benefit from redevelopment.

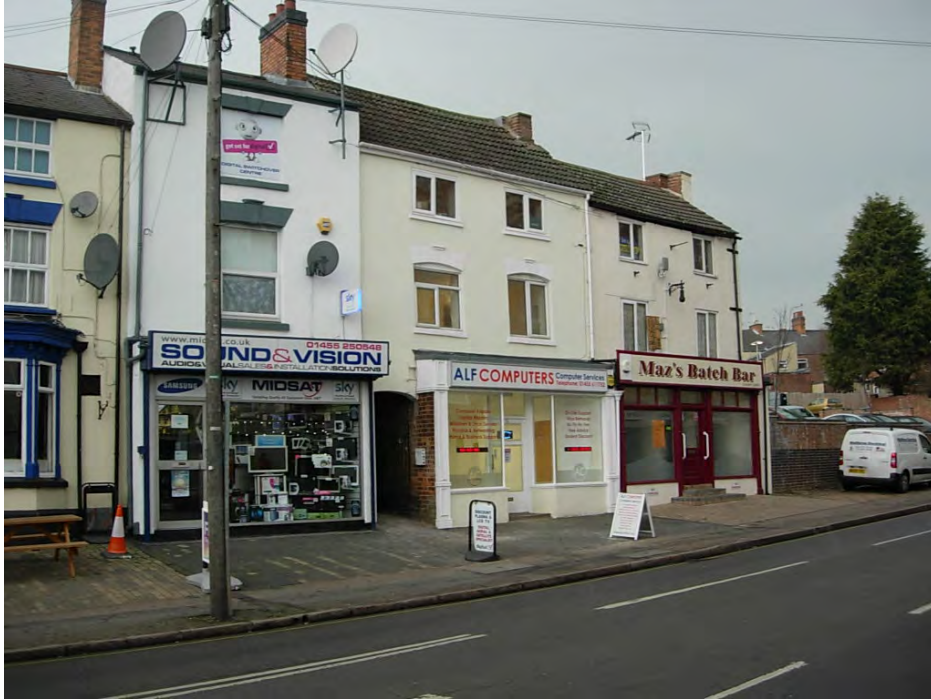
This group of late C18 buildings, 12-16 Lower Bond Street, has unfortunately been modernised by the installation of concrete roof tiles, inappropriate windows and except for the centre unit, poor quality shop fascias. The large numbers of satellite dishes are also unacceptable and detract from the street scene.

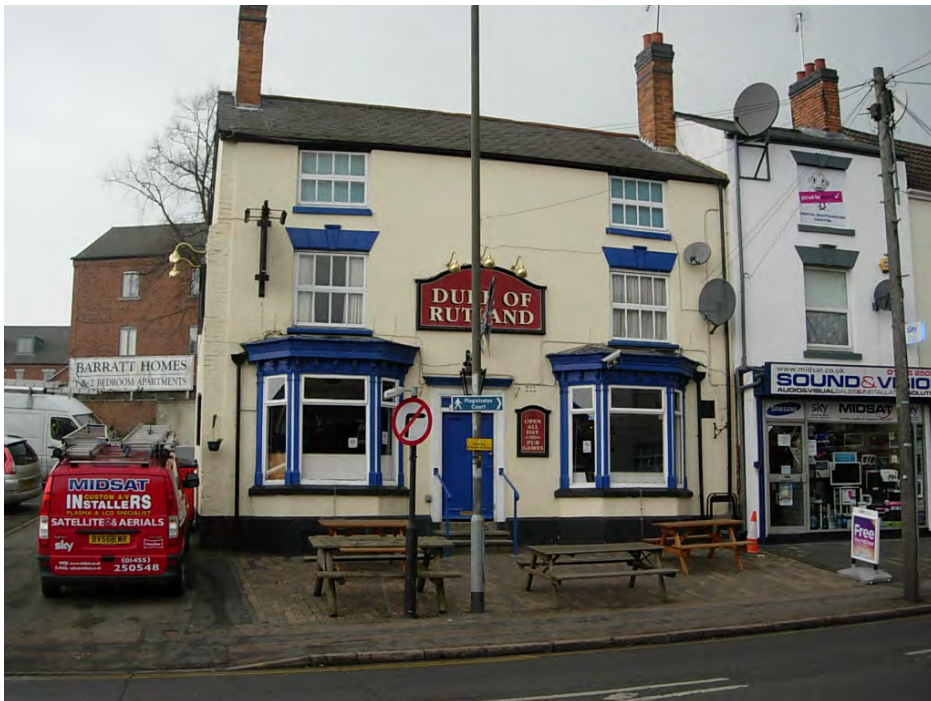
The Duke of Rutland Public House on Lower Bond Street, is an impressive heritage asset in the street scene and is a fine property despite having its windows replaced by top hung lights.

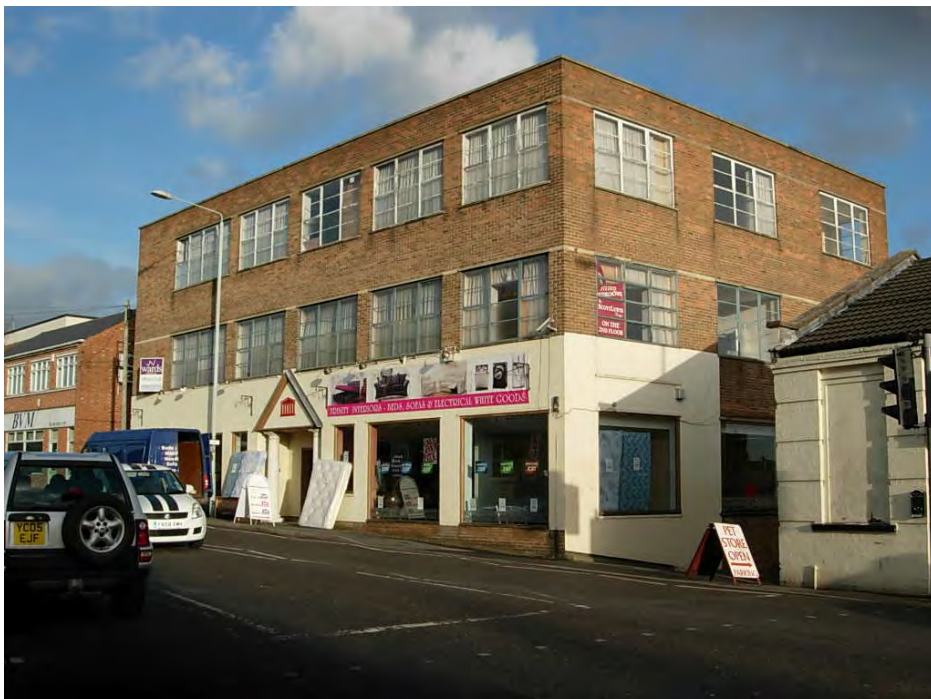
Abbott House, Trinity Lane. This former factory has been converted into retail space. It stands at the entrance to Blockleys Yard. The signage and the timber pediment sit uncomfortably on the face of the building. These features are out of character with the simple rectangular form of the building.

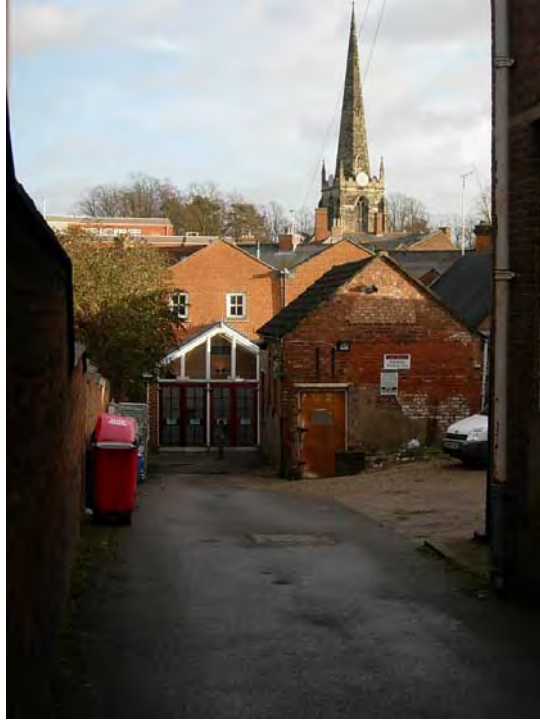
Trinity Yard. This jitty has a fine view of St Mary's Church. The buildings in the foreground require improved maintenance.

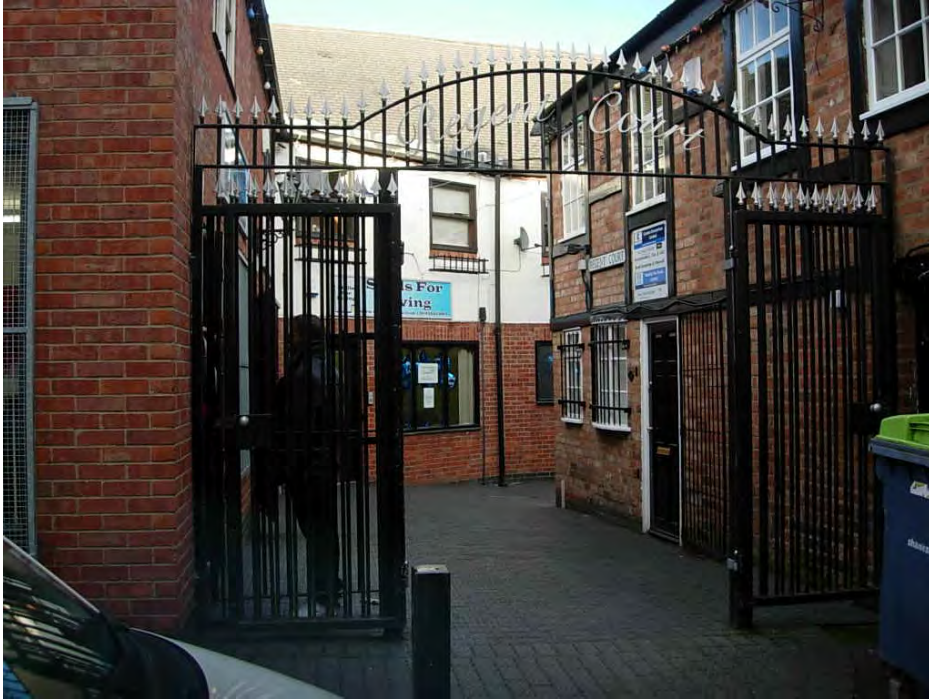
Entrance into Regent Court from the Blockleys Yard. Regent Court is a private jitty and, as with other similar yards, it is gated off at night.

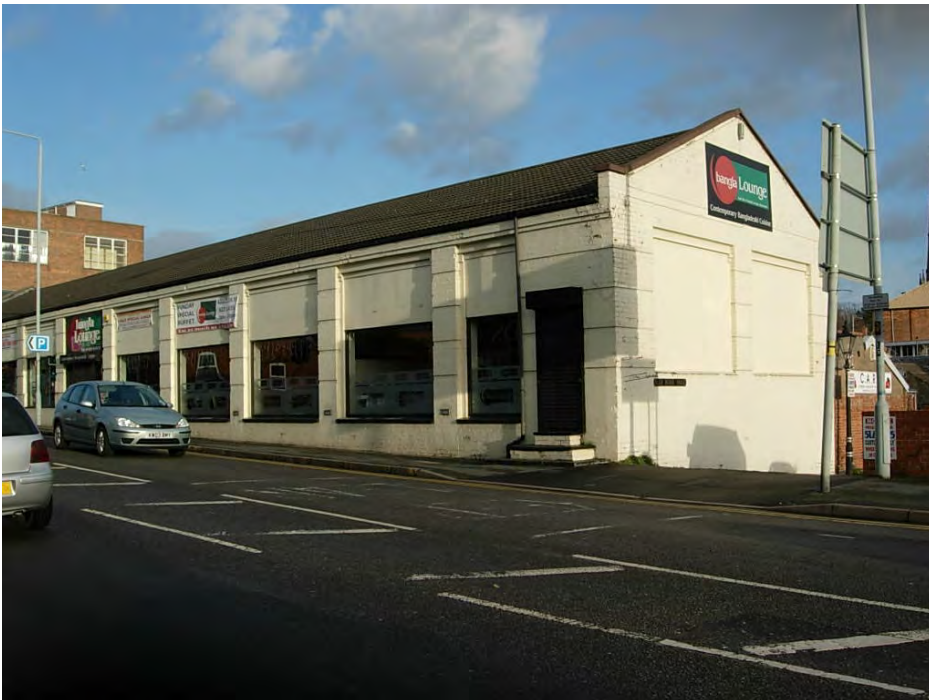
91 Trinity Lane and the entrance into Blue Boar Yard. This was a factory until recently when it was converted into a restaurant.

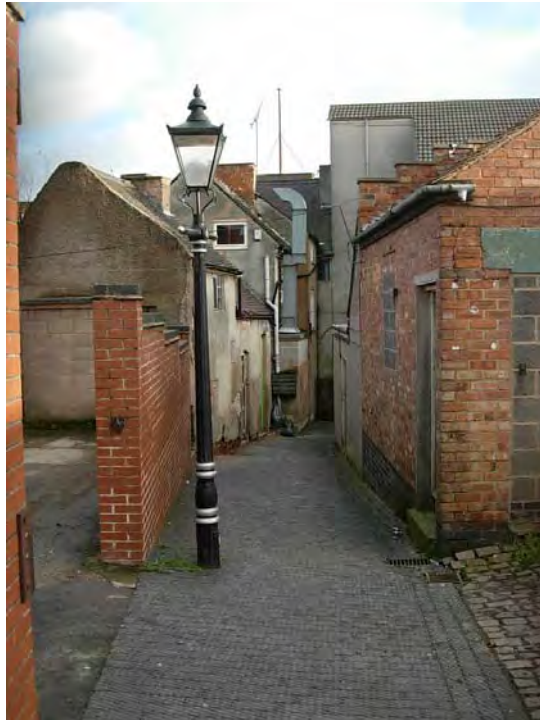
Blue Boar Yard. The floor has been resurfaced and heritage lamp posts have recently been installed by the Council. It is unfortunate that the flanking buildings are not being adequately maintained. Town centre jitties are important features in the Conservation Area and buildings which flank them should be given as much consideration and care as those on the main shopping streets.

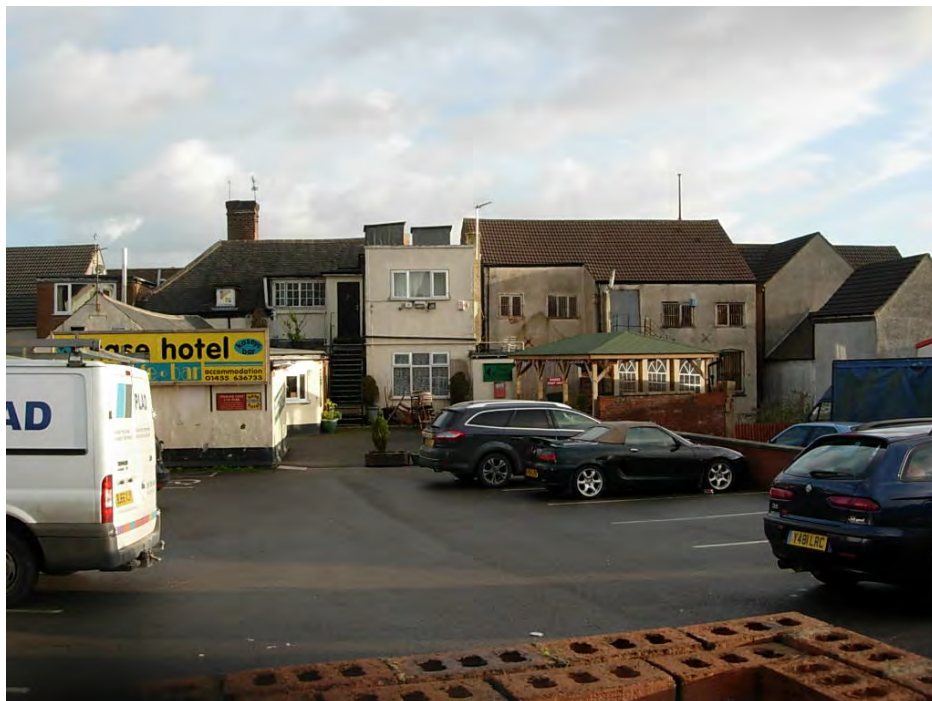
Rear of the Kase Hotel viewed from Trinity Lane. The open frontage of the car park and the poorly maintained rear elevations of Regent Street properties do not present a good quality image for the visitor.
