**Hinckley Town Centre Conservation Area
Appraisal and Management Plan**

**Photographic Record 4 - Stockwell Head, Baptist Walk,
Council Road, Hollier's Walk and Baines Lane**

February 2013

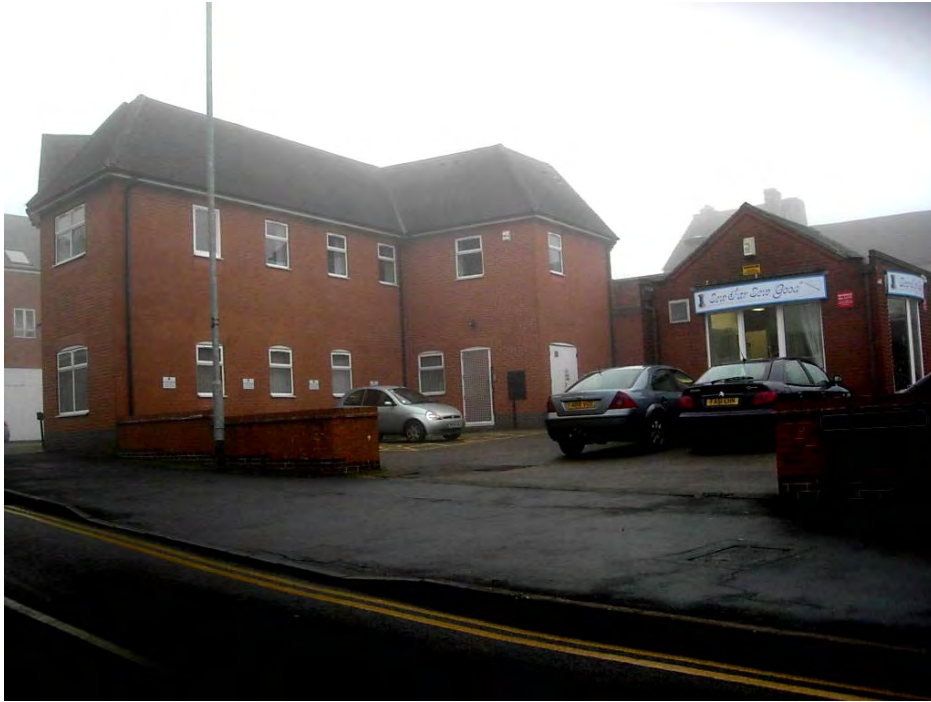
The rear of 6 New Buildings is a plain structure highly visible from Stockwell Head that adds almost nothing to the street scene.

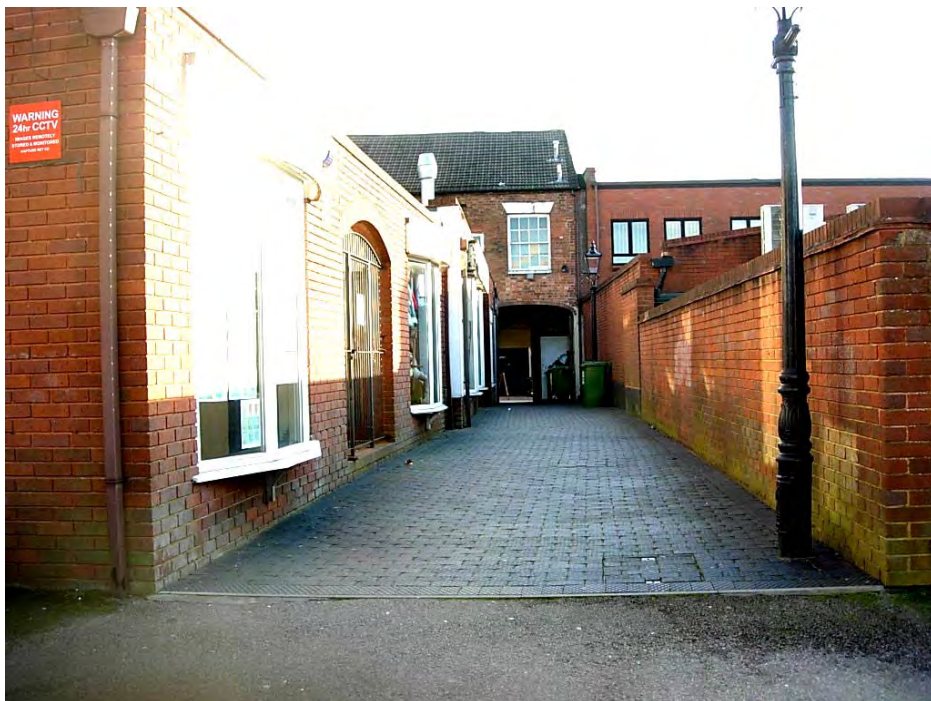
Entrance to Regents Court from Stockwell Head. This jitty has recently been resurfaced and has had heritage lamp posts installed by the Council.

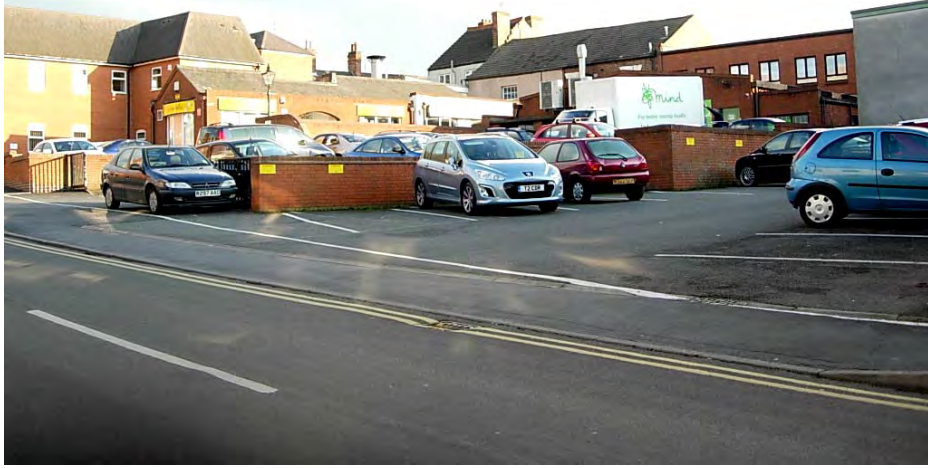
Stockwell Head is characterised by open frontage car parks and the rear facades of Castle Street properties. This is not an attractive environment for the visitor.

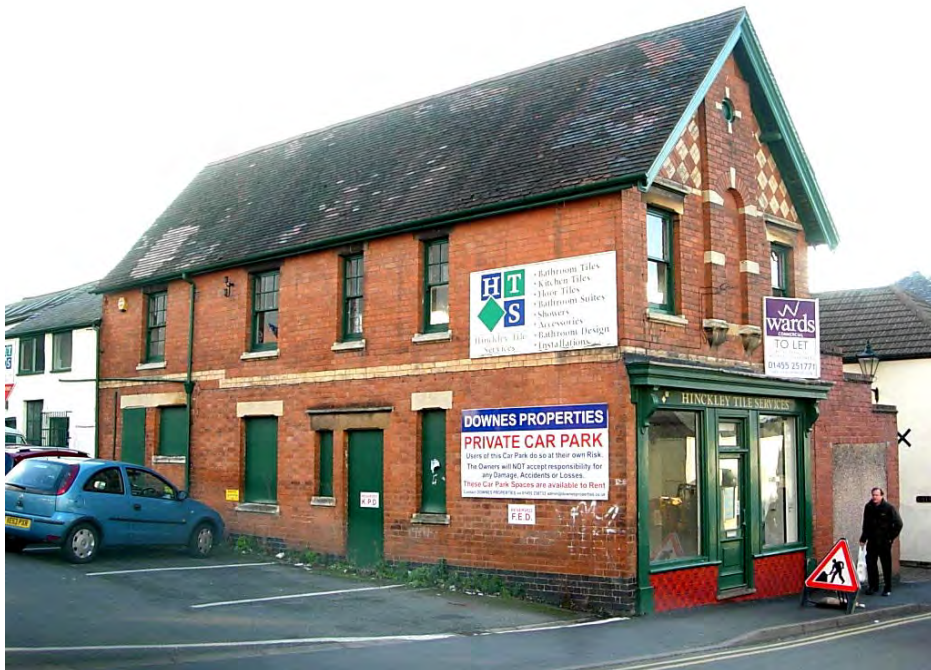
67 Stockwell Head is one of the few buildings on the street with character and is a fine heritage asset. It has a traditional shop front. The signage however has a detrimental impact on the building and the street.

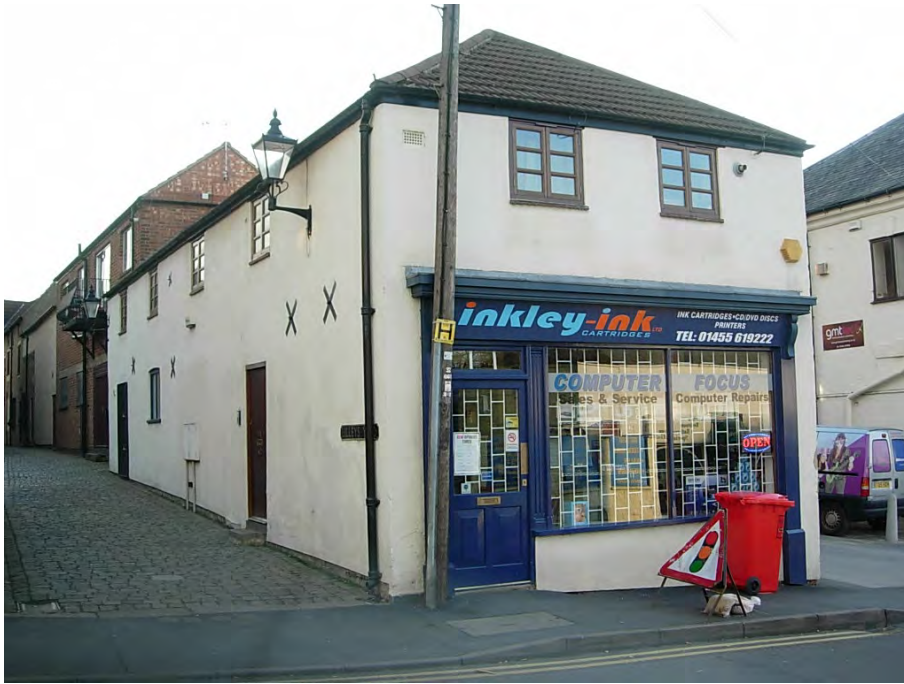
65 Stockwell Head is a simple building with a fine traditional shop front and stands in front of a former small factory unit, now converted into residential use. It flanks Lilley's Yard, one of the few remaining jitties on this part of Castle Street.

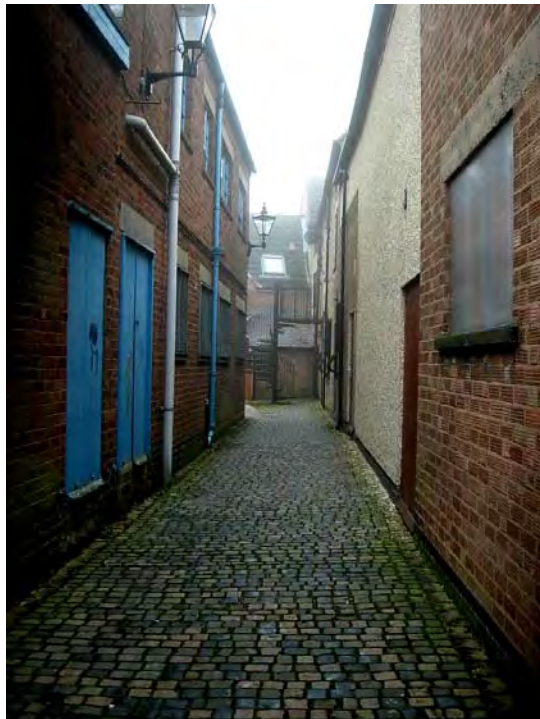
Lilley's Yard is typical of Hinckley's original passageways that were squeezed between small factories. The floor surface has recently been improved by the Council through the addition of granite sets and new heritage lighting.

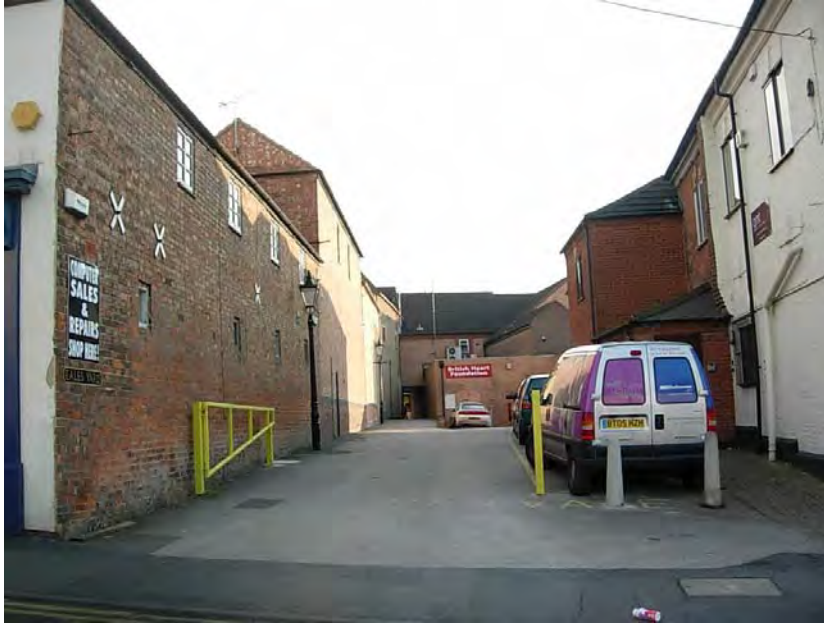
Eales Yard links Stockwell Head with Castle Street. Its entrance is flanked by a shop and the former Methodist chapel which is now a photographers Studio.

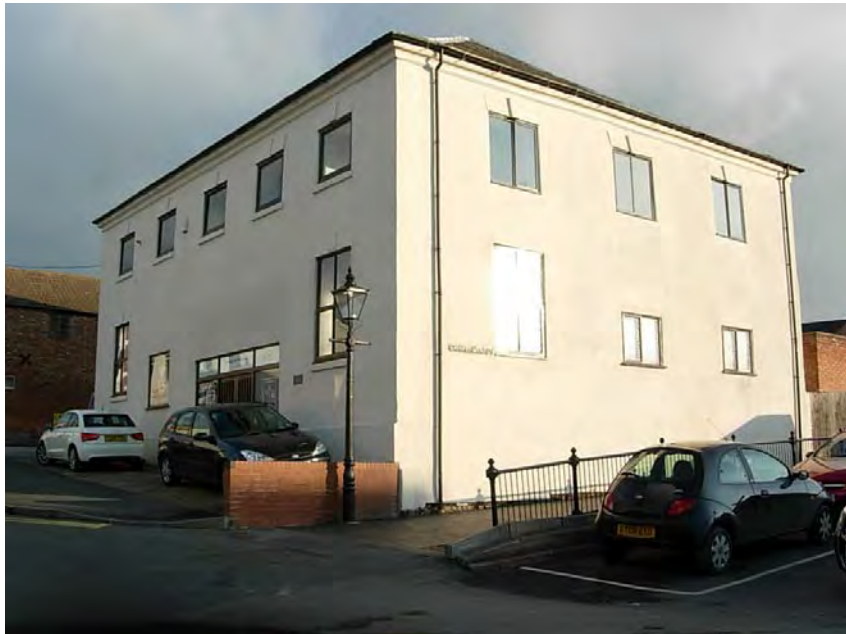
61 Stockwell Head is a former Wesleyan chapel, 1782, where John Westley preached to the local population. It is now a photographer's studio and its frontage unfortunately has been rendered and its window and door openings altered. However it remains an important heritage asset in the Conservation Area.

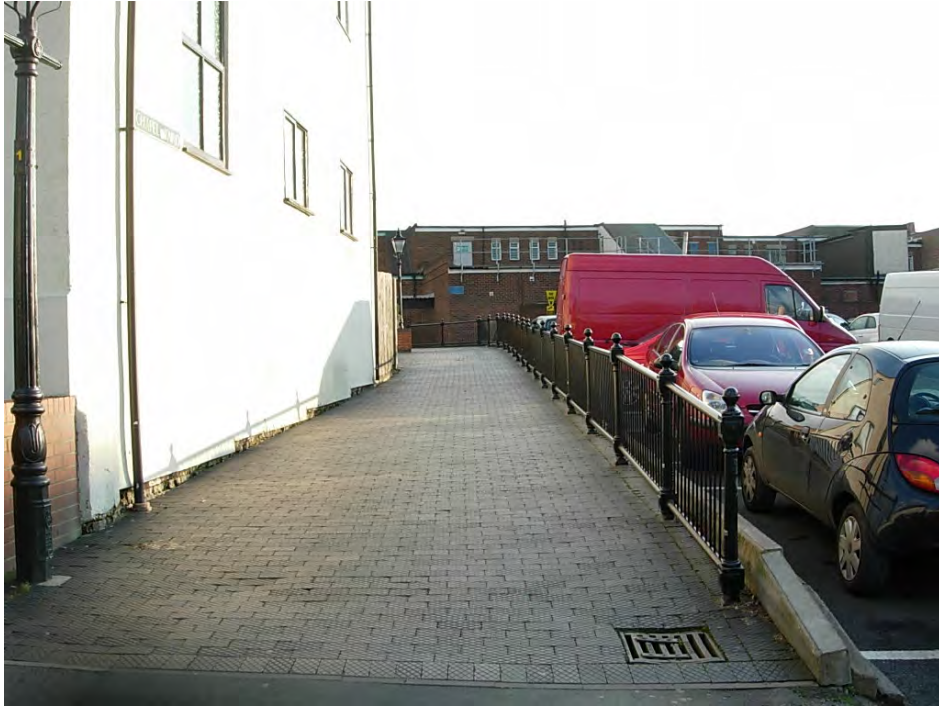
Chapel Yard jitty was recently surfaced with diamond pattern pavers and heritage lighting and the balustrade added.

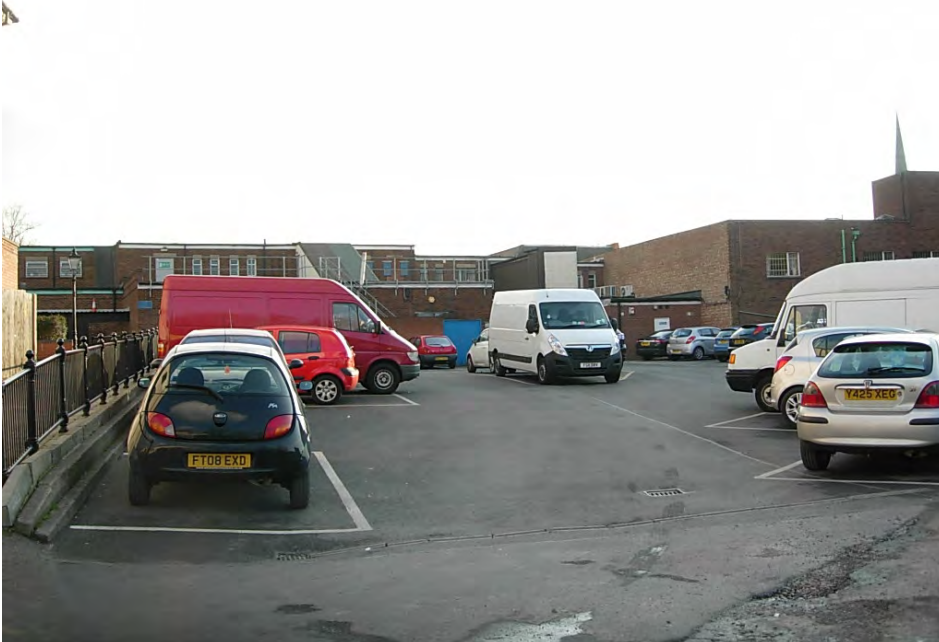
Stockwell Head looking towards the rear of 40-54 Castle St. The open frontage to this area of parking would be improved if a wall or railings were added to the street frontage.

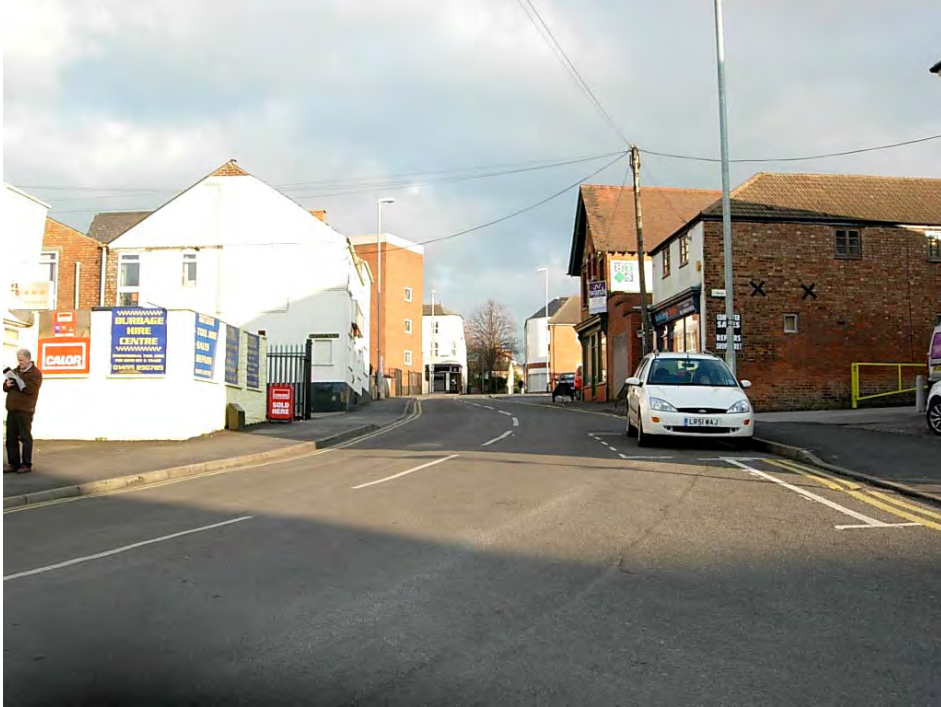
Stockwell Head looking east. This street has suffered in the recent past through inappropriate demolition and the construction of poor quality frontages.

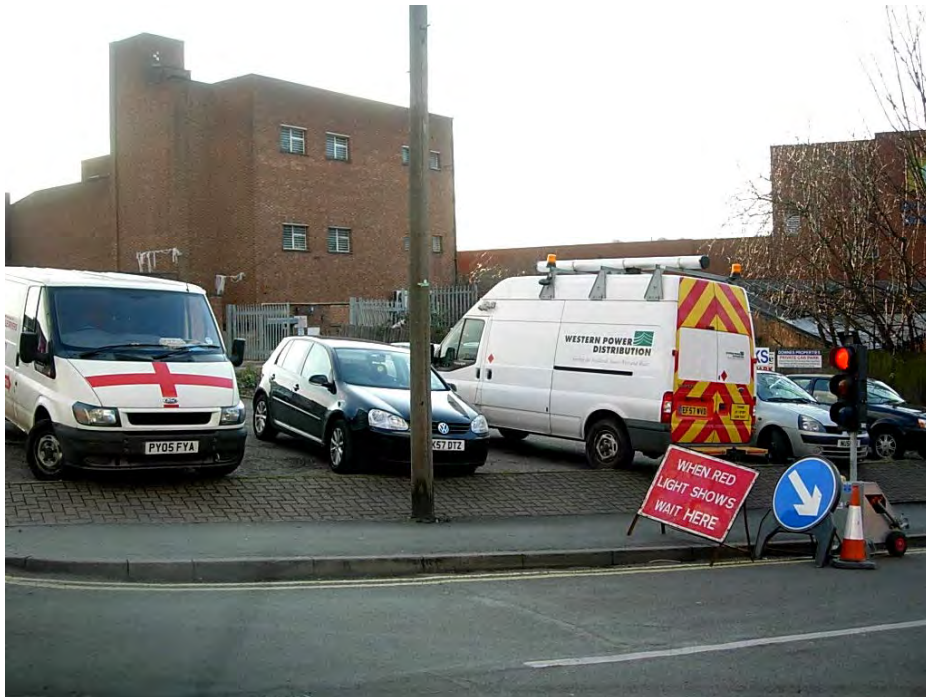
A further section of open car park facing onto Stockwell Head.

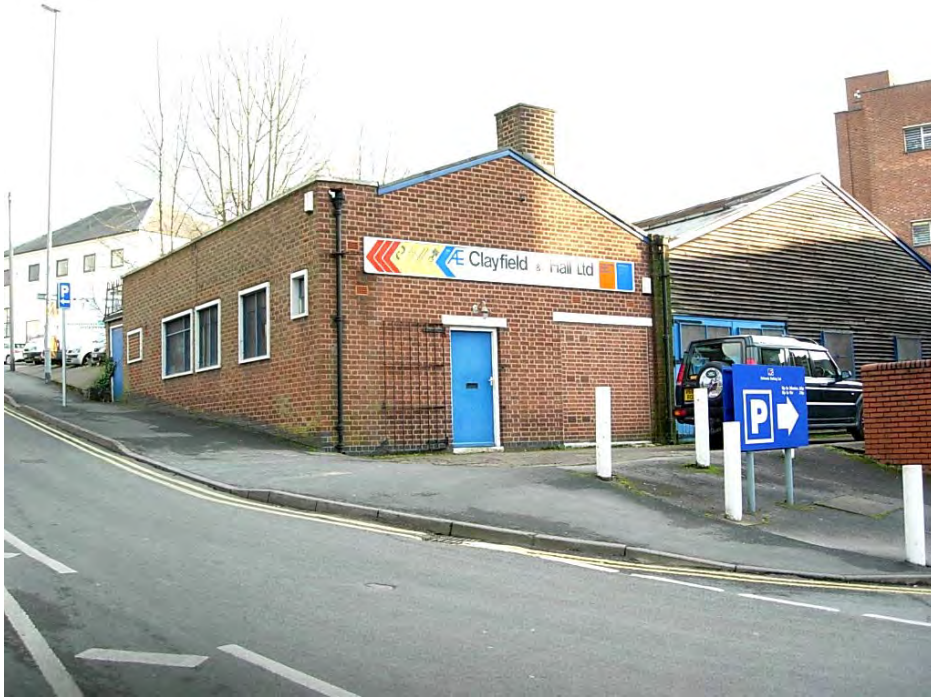
51 Stockwell Head is a former factory building with a timber clad extension dating from the 1950's.

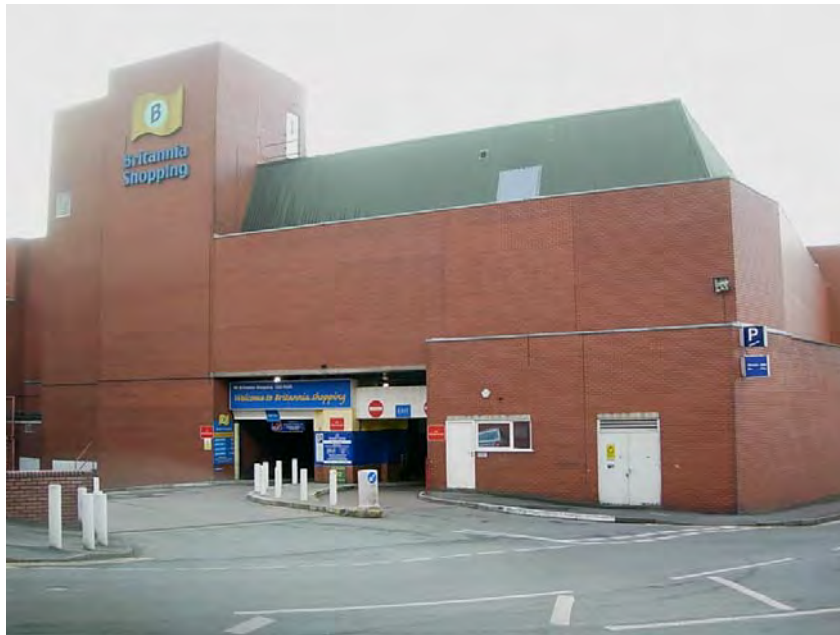
Britannia Centre Car Park although providing an important area of car parking for the commercial centre, has elevations that lack interest.

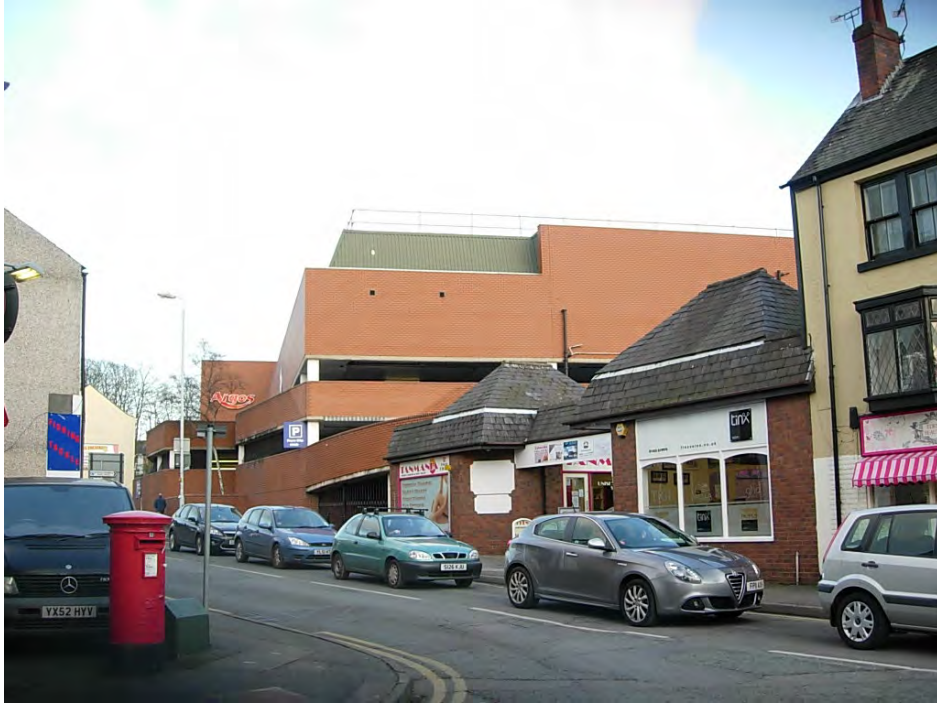
Britannia Centre, 1 & 10 Hansom Court fronting Stockwell Head. The blank walls of the car park dominate this part of the street.

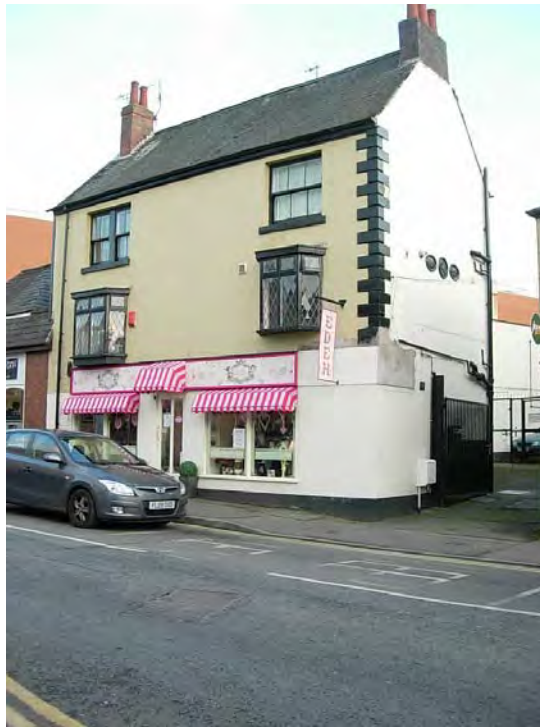
7 Stockwell Head was rebuilt in 1887. This building originally had a corner shop front which regrettably has been lost.

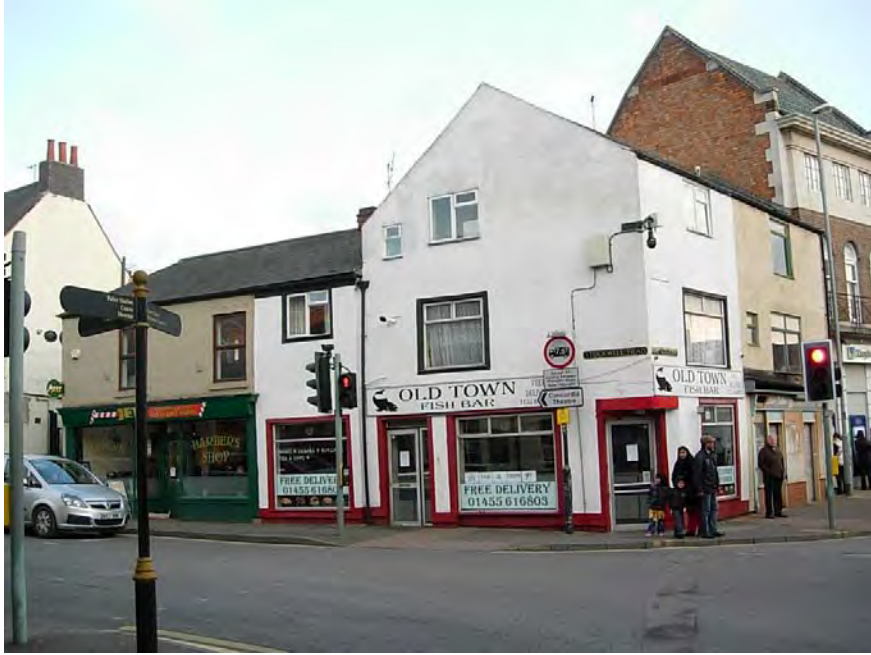
27 The Borough & 5 Stockwell Head have retained their slate roofs and some of their former sash window openings.

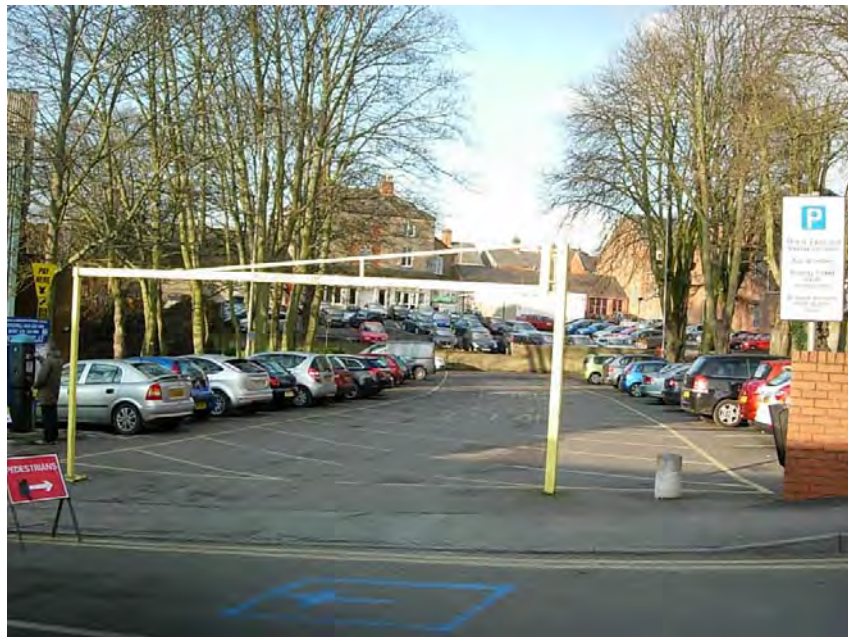
This car park was the Italianate garden of the former Atkins family home. It still retains two significant rows of trees.

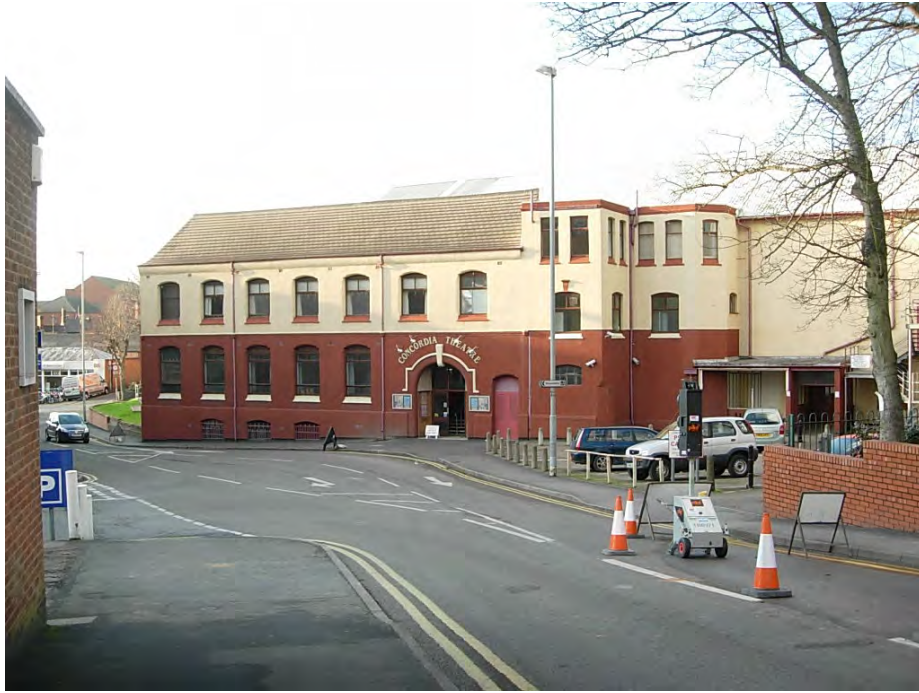
The Concordia Theatre was formerly the late C19 hosiery factory of Moore, Eady & Murcott Goode. It has been partly rendered but is still an important heritage asset which terminates this part of the street.

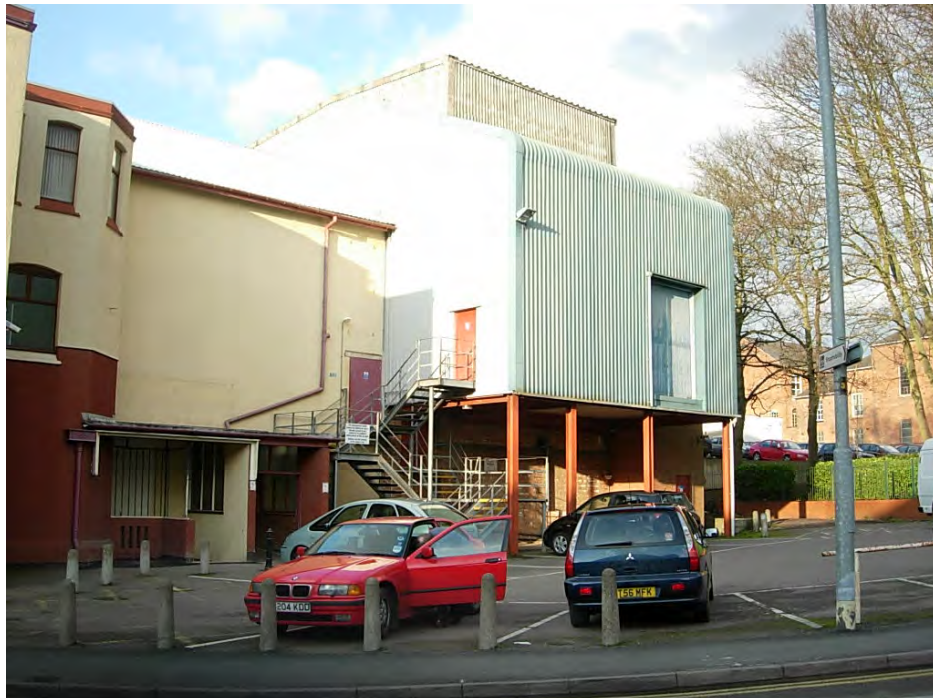
This extension to the theatre in a modern factory style sits uncomfortably with the original brick design. Again open fronted car parking fronts the site and has a detrimental impact on the street.

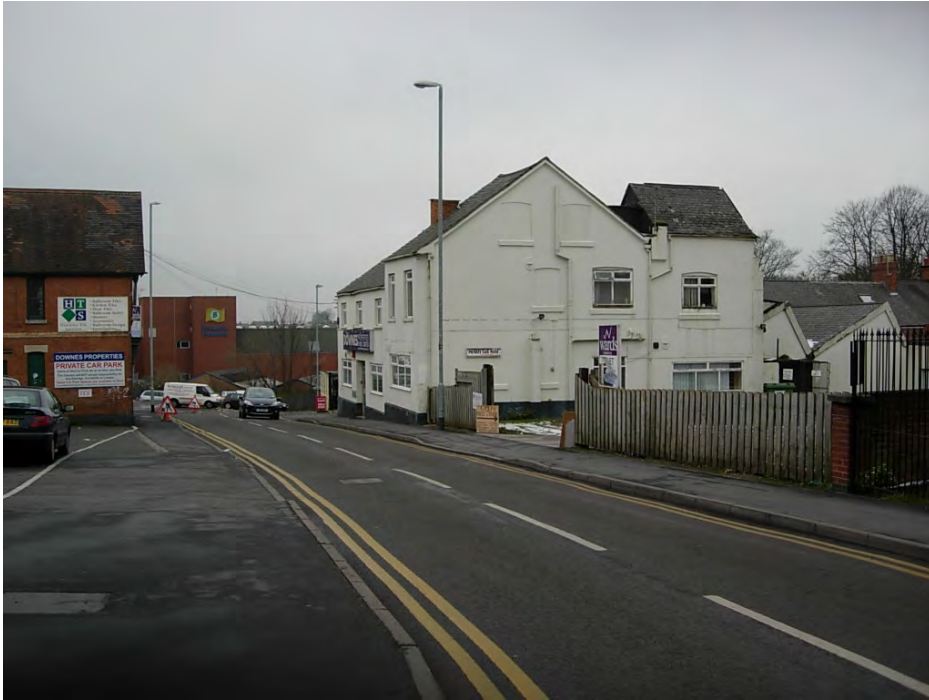
This view of Stockwell Head looking westwards, highlights the many open frontages which have a major detrimental impact on the street and the visitor experience.

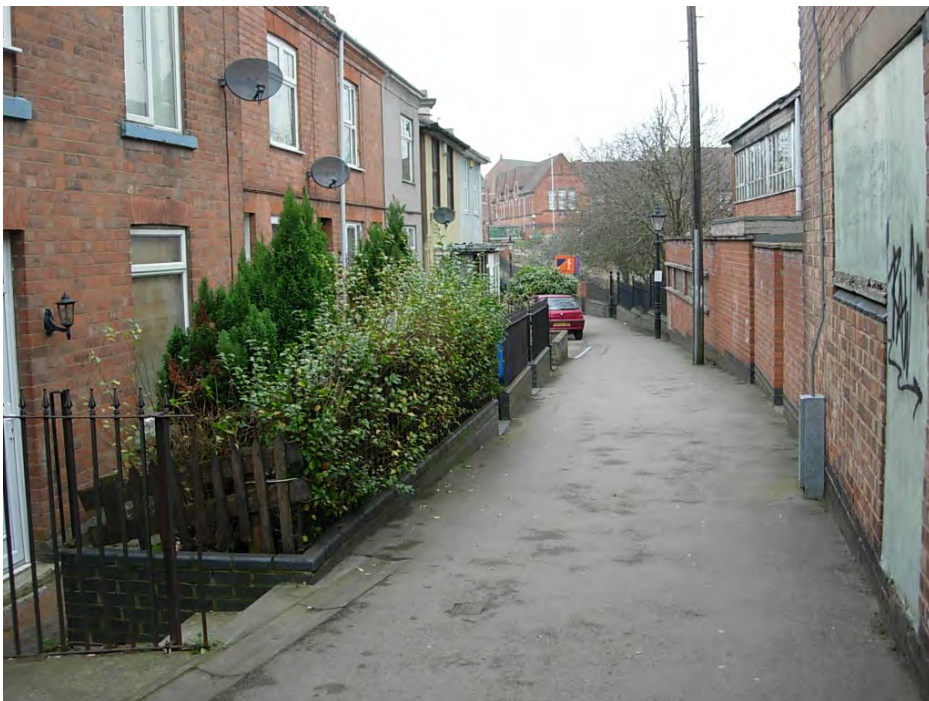
Baptist Walk has seen several frontage improvements in recent years, mainly new low brick walls, railings and heritage lighting.

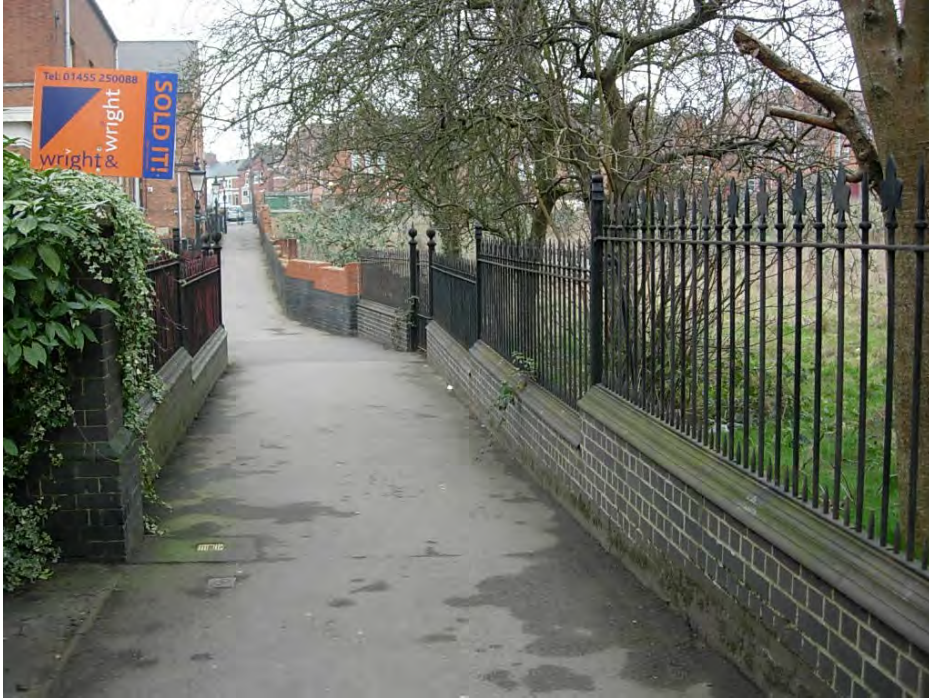
Baptist Walk showing the new low brick boundary wall with cast iron coping and decorative railings which formed the boundary to the former Bodycote factory. This is a most important jitty and heritage asset.

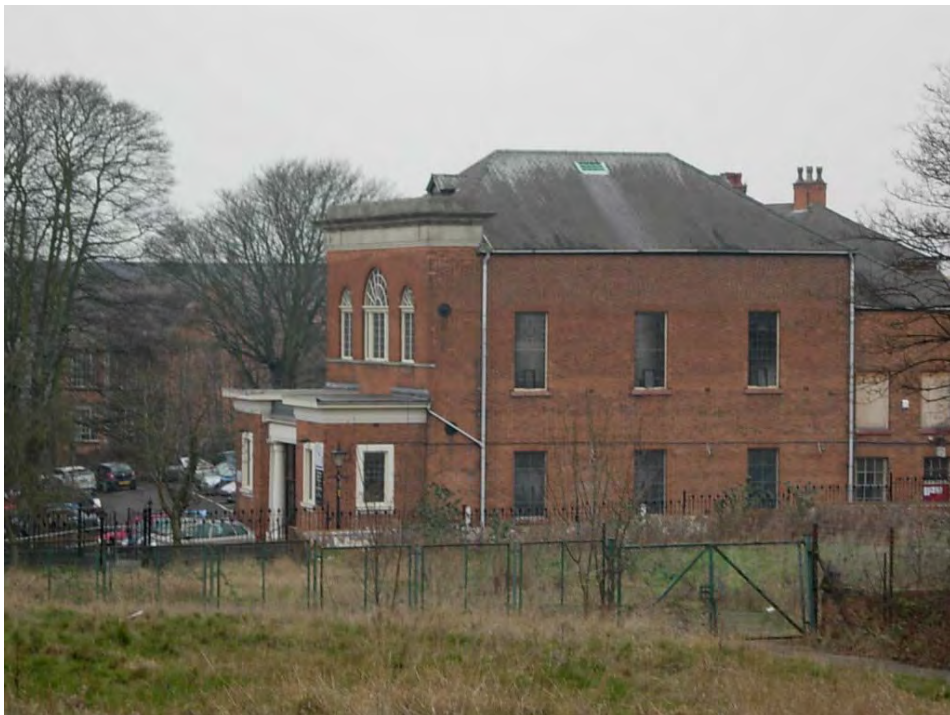
The flat roofed south porch built 1920-21 was constructed as a First World War Memorial at the Hinckley Baptist Chapel (built 1806-7)

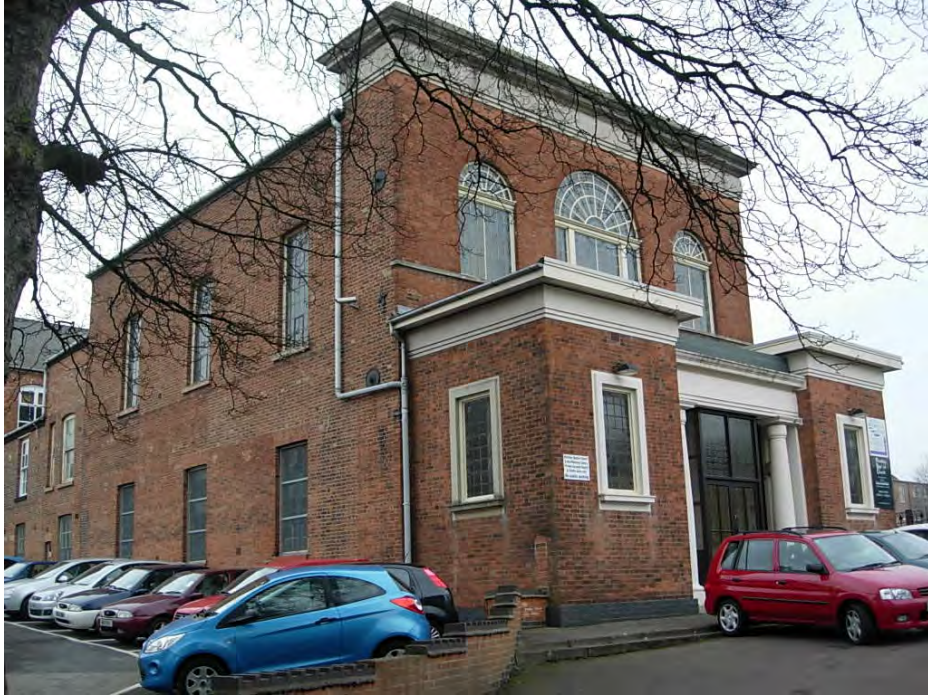
The southern elevation of the Hinckley Baptist Chapel surrounded by car parking.

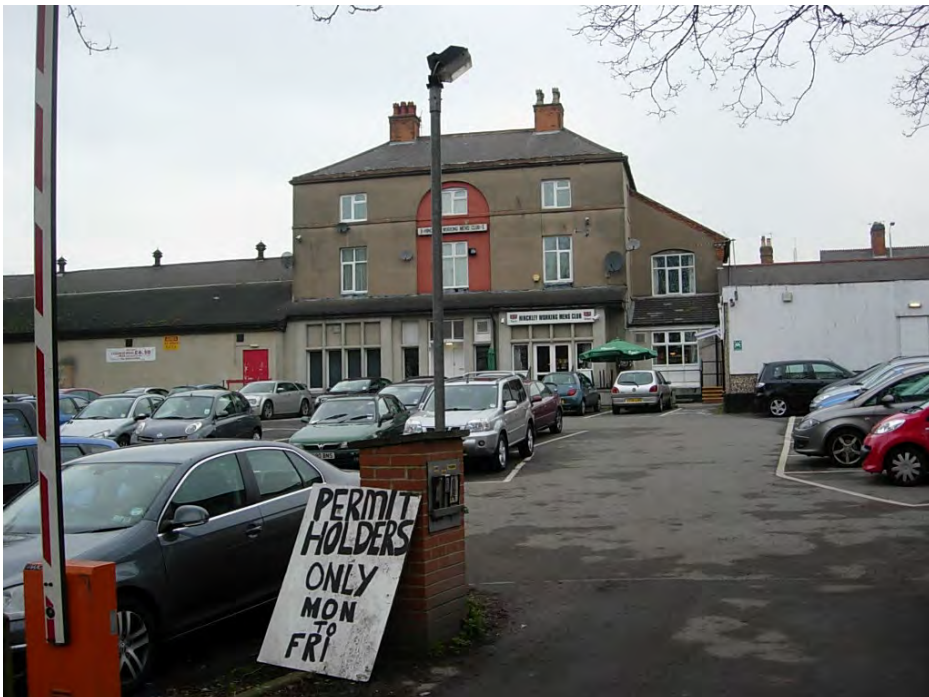
Hinckley Working Men's Club was formerly an Atkins family home. The building has been substantially altered in the C20 and its gardens covered with tar macadam to form car parking.

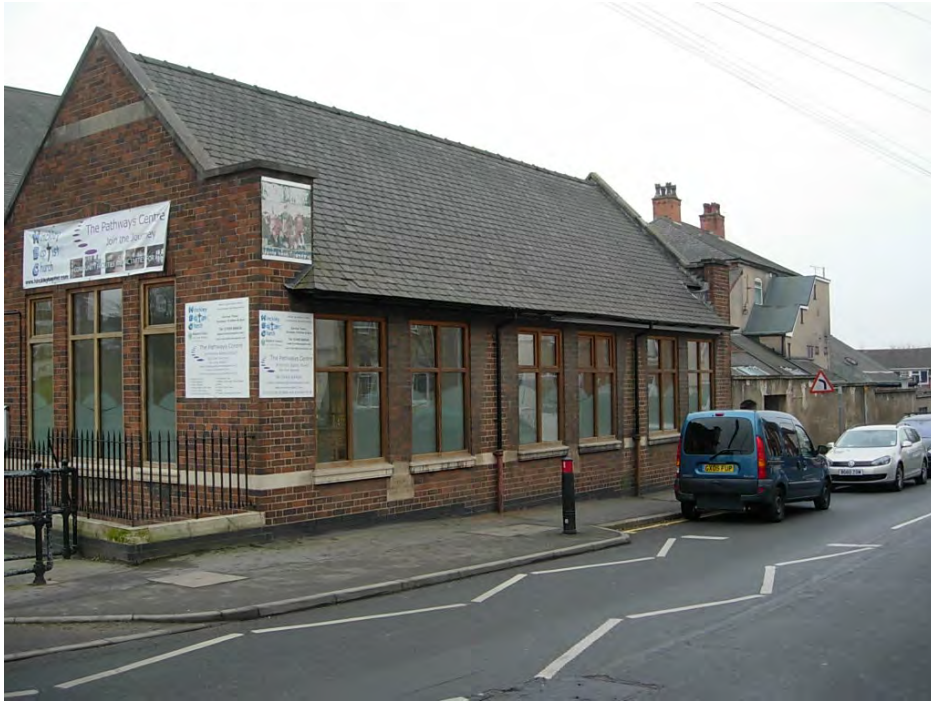
The former Sunday School on Hollier's Walk is part of Hinckley Baptist Chapel. The posters on the faces of the building do not enhance its appearance.

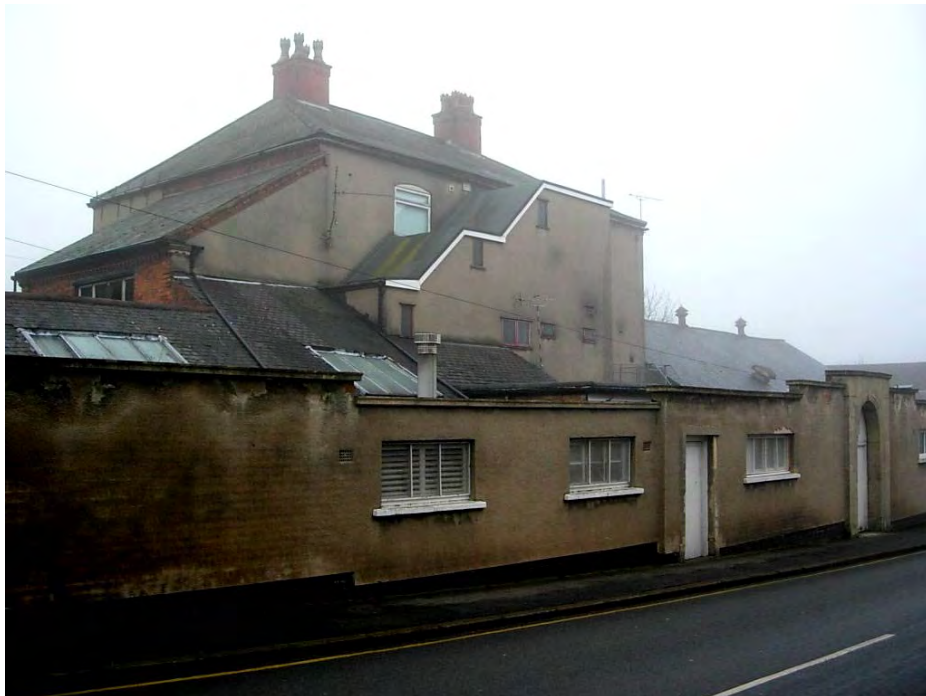
The rear of Hinckley Working Men's Club, viewed from Hollier's Walk, highlights the detrimental impact that inappropriate changes have had on its appearance.

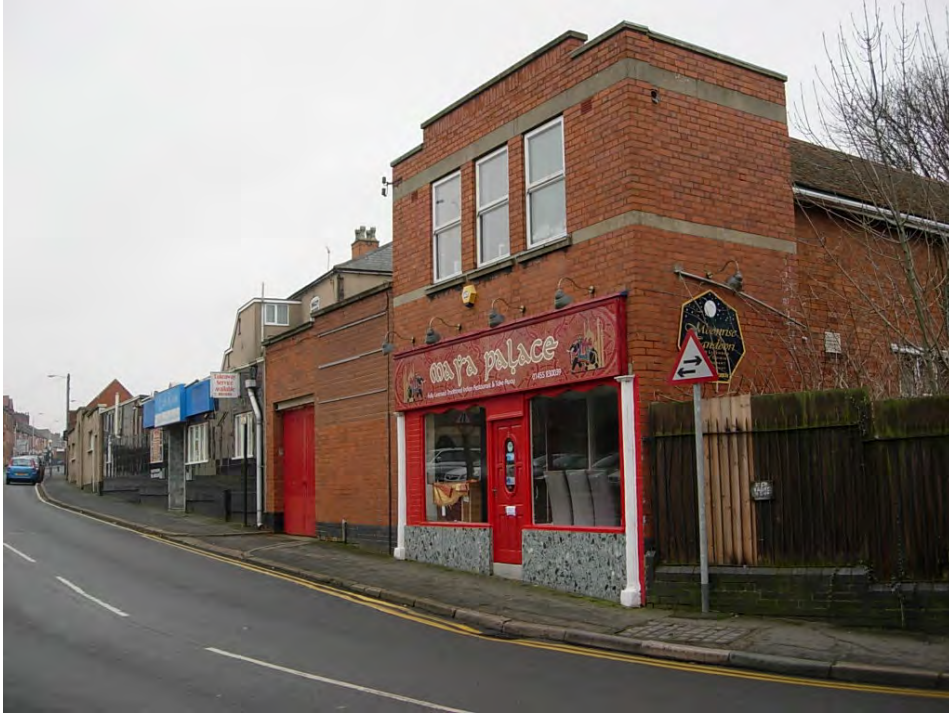
8 Holliers Walk is one of several poor quality buildings on this part of Holliers Walk.

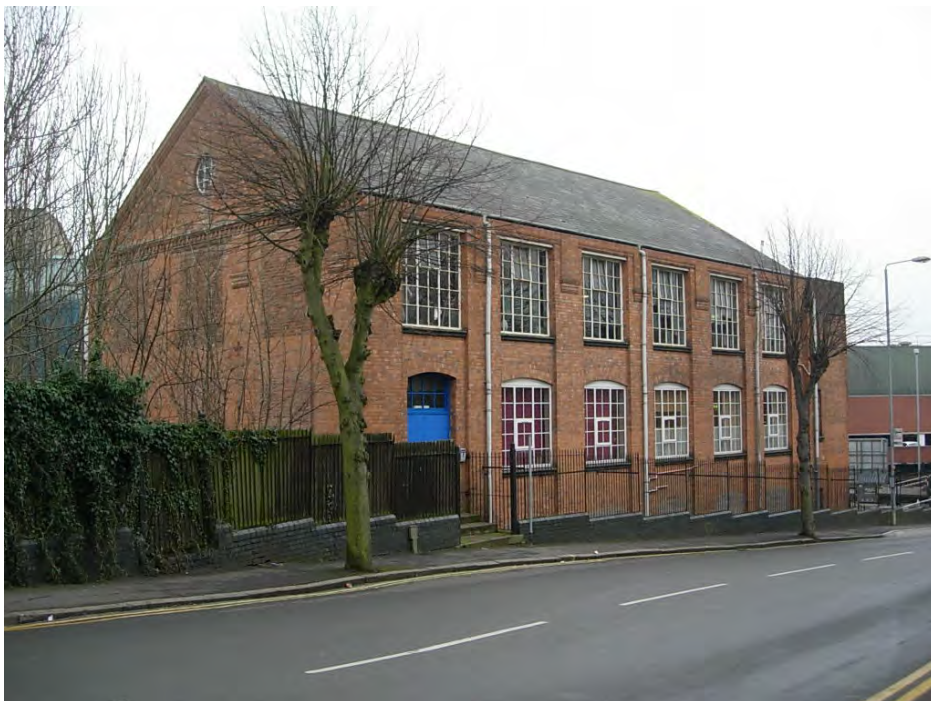
The north west elevation of the Concordia Theatre which unfortunately has had plastic windows inserted at ground floor. It was formerly part of the hosiery factory.

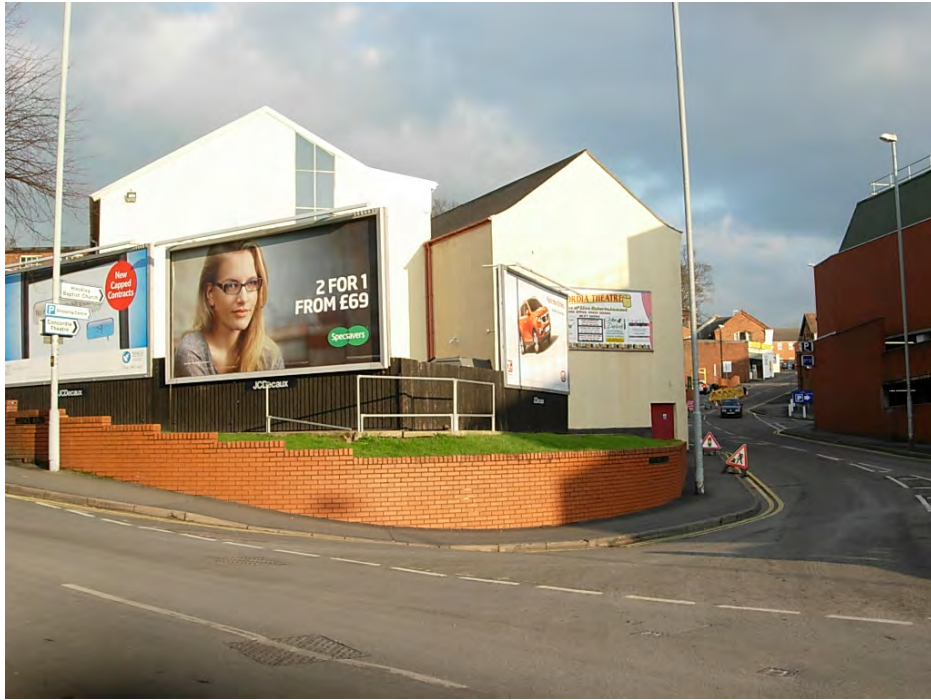
The close boarded fencing and advertising hoardings sited at the Junction of Council Road & Stockwell Head detract at this important intersection.

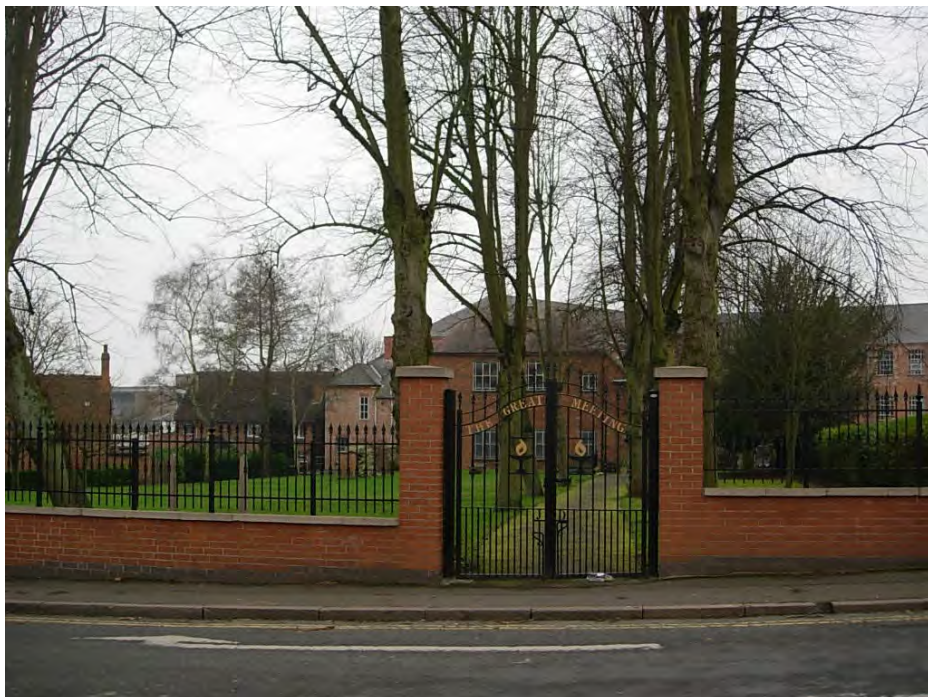
The rear access to the Great Meeting Unitarian Chapel yard. Although the yard has been cleared of grave stones, the space with its fine avenue of trees, is a key green area in the town centre and is very important for the setting of the Church.

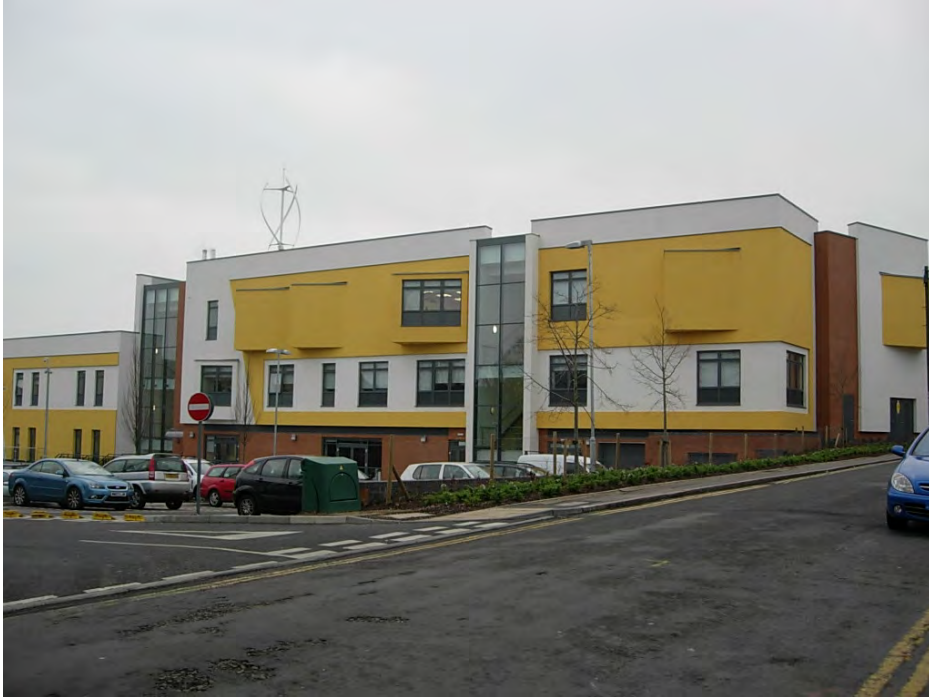
The new Hinckley and North Warwickshire College building is very unusual in that it completely ignores the form and features in the surrounding area.

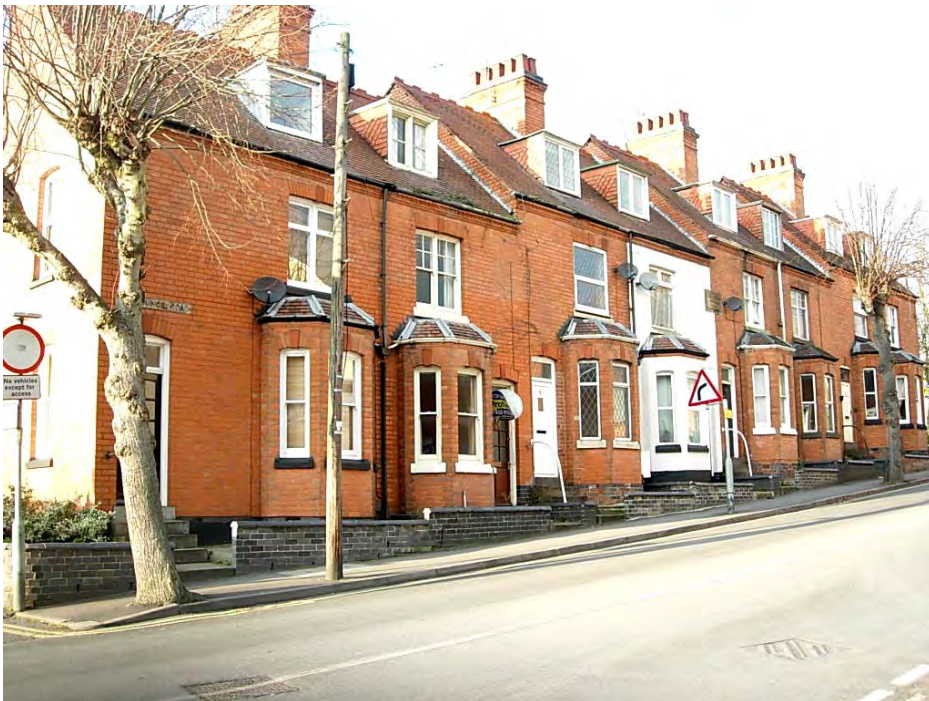
The brick bay windows on 1-15 Council Road are attractive features in the street scene. The brick garden walls however need partly rebuilding in places.

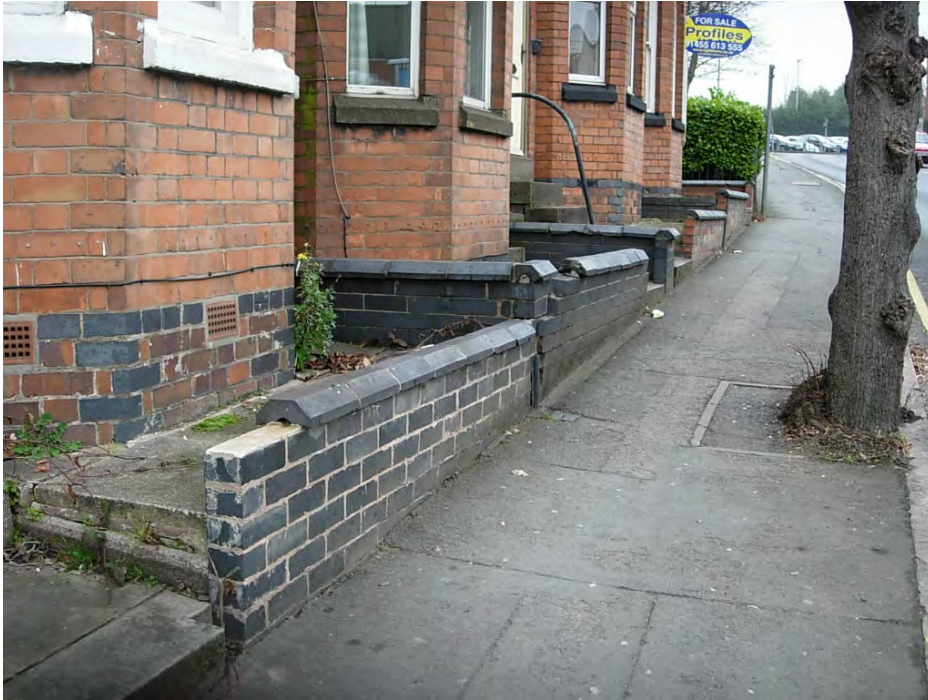
These garden walls fronting 1-15 Council Road are important features that should be retained to help to define the edge of the street. This view highlights the need for adequate maintenance.
