**Hinckley Town Centre Conservation Area
Appraisal and Management Plan**

**Photographic Record 4 - Stockwell Head, Baptist Walk,
Council Road, Hollier's Walk and Baines Lane**

February 2013

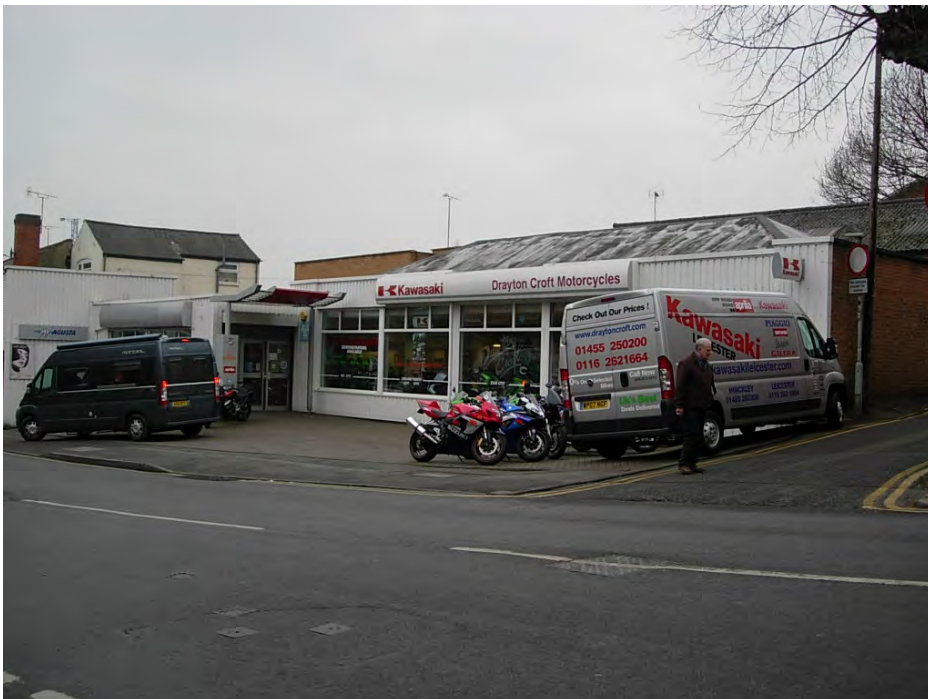
The open frontage at 14-20 Stockwell Head, although providing car parking and a vehicle display area, does not enhance the street scene.

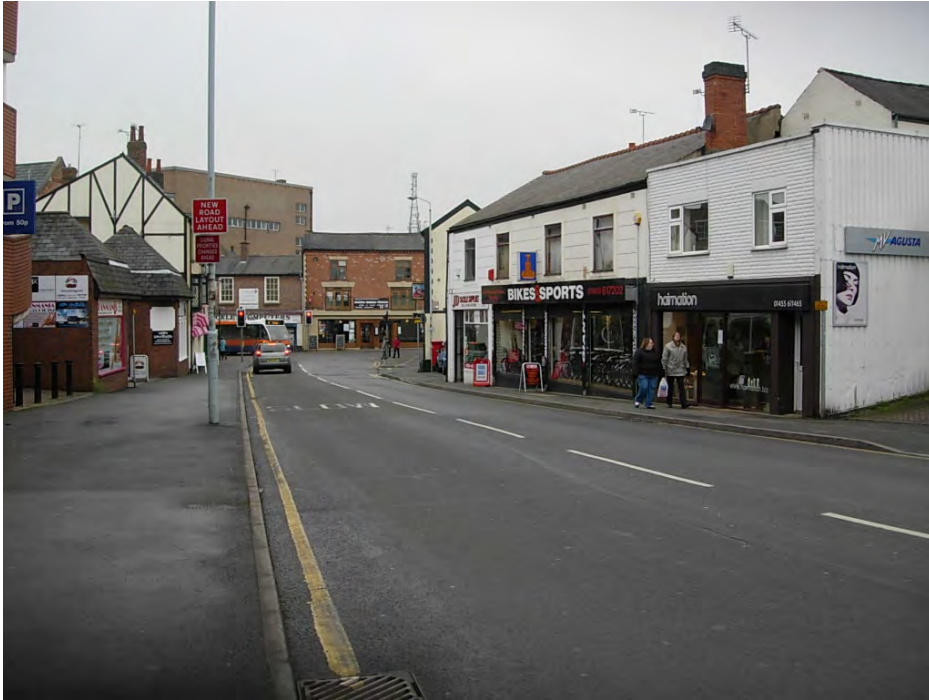
This view highlights the poor appearance of the Nationwide Building Society building which could be an important landmark building in the town centre.

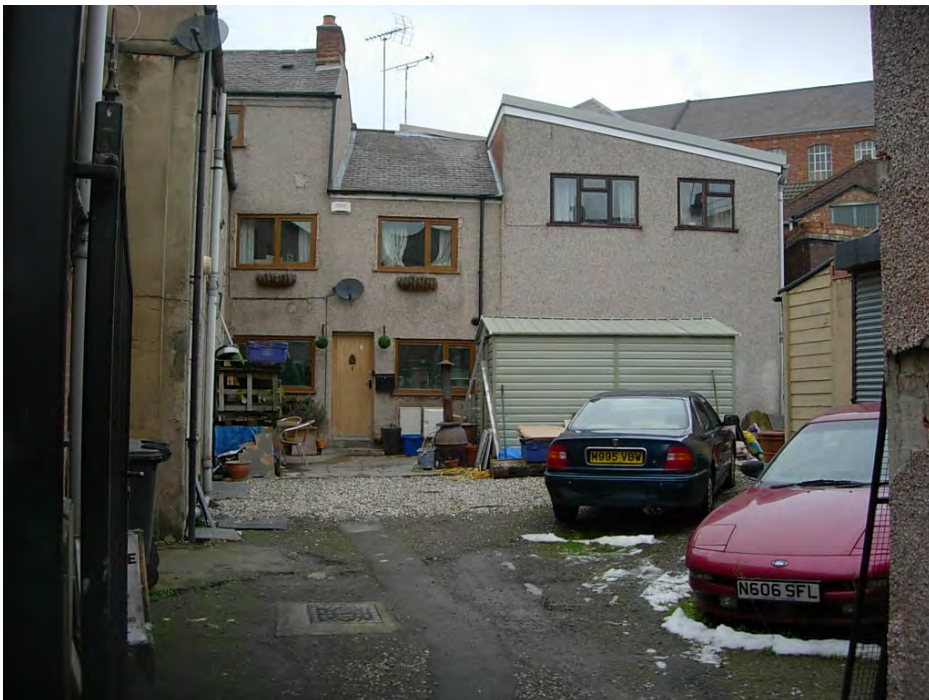
Brooke's Yard was the original location of the manufacturer of Brooks bicycle saddles. Unfortunately the poor ground surfacing, the clutter and the incongruous built form detracts from the appearance of this important historic yard.

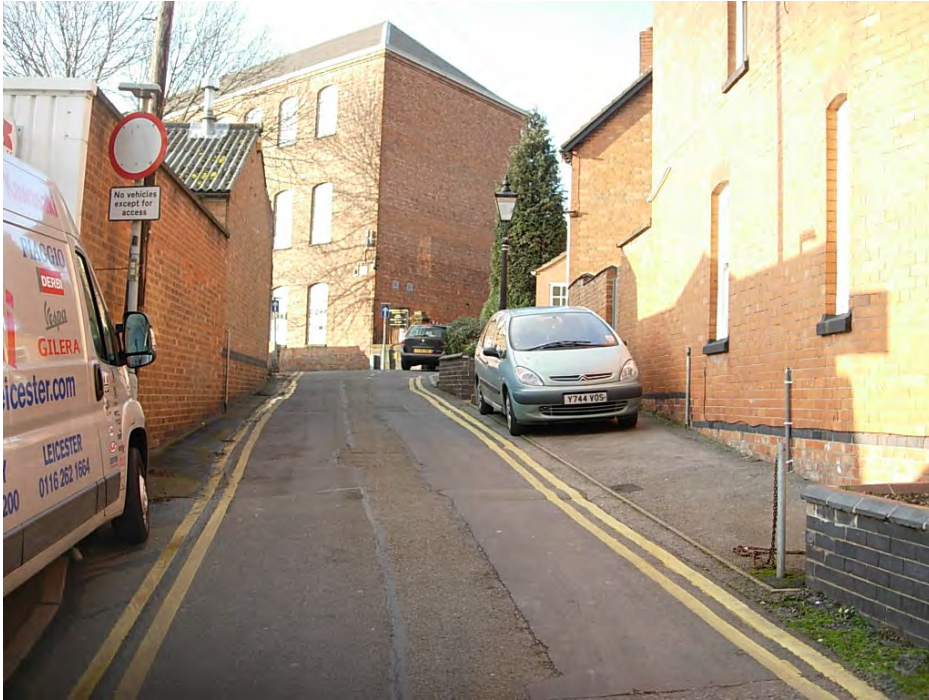
Baines Lane provides an important view of the listed former Atkins factory.

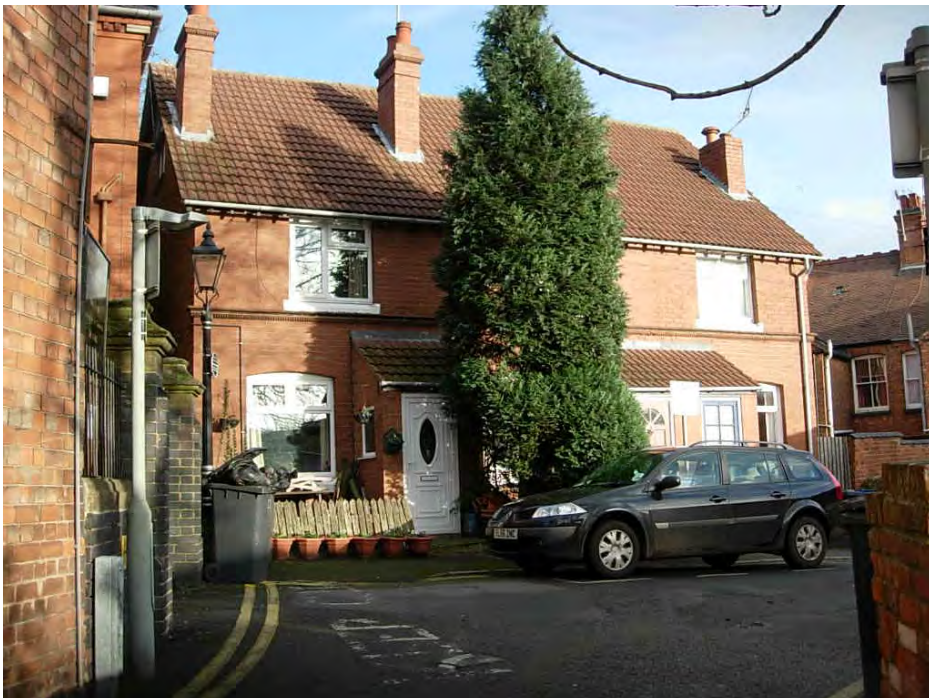
The terrace, 2-6 Baines Lane, was originally constructed by the trustees of the Unitarian Chapel. The partial loss of the end chimney stack is unfortunate.

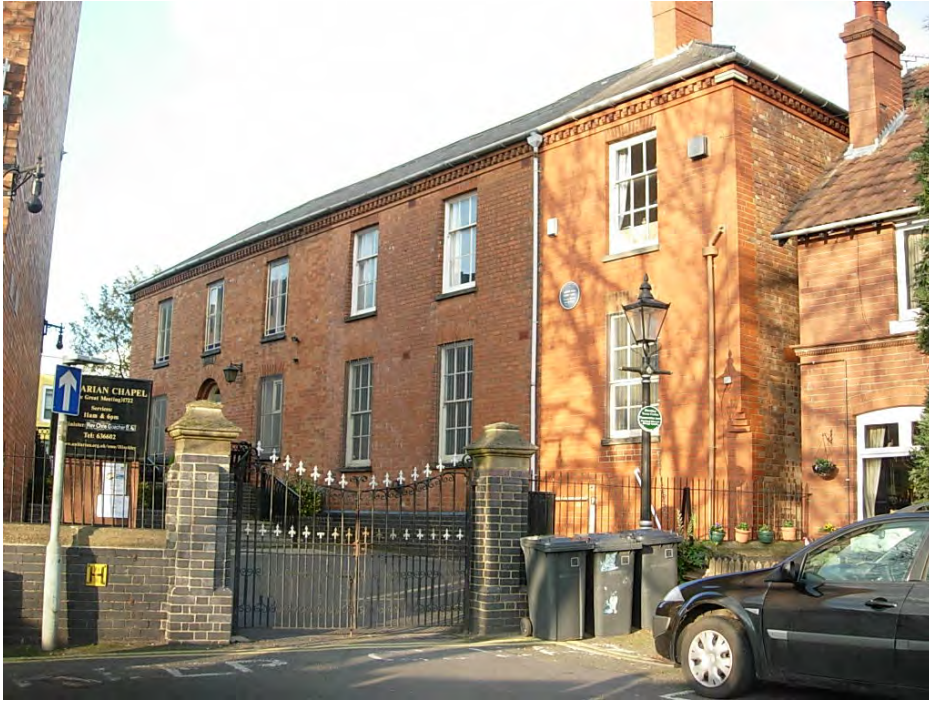
The Great Meeting Unitarian Chapel is a fine Grade II* listed building closely associated with Hinckley's hosiery manufacturers many of whom were Unitarians. The simple elevation conceals a magnificent interior space.

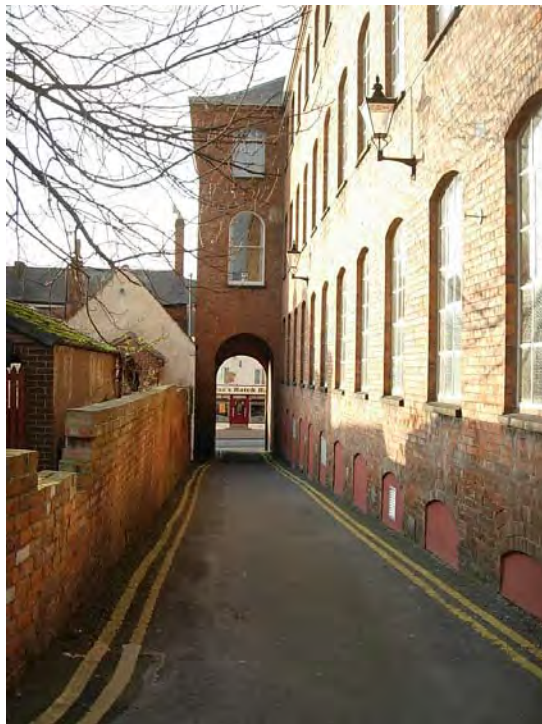
View looking down Baines Lane towards Lower Bond Street. The towering height of the Atkins factory compared to the adjacent buildings highlights the power of the hosiery families.
