**Ratby Conservation Area Appraisal and Management
Plan**

**Photographic Record 1 – Main Street, Burroughs Road,
Stamford Street & Station Road**

**December 2013
(Adopted February 2014)**

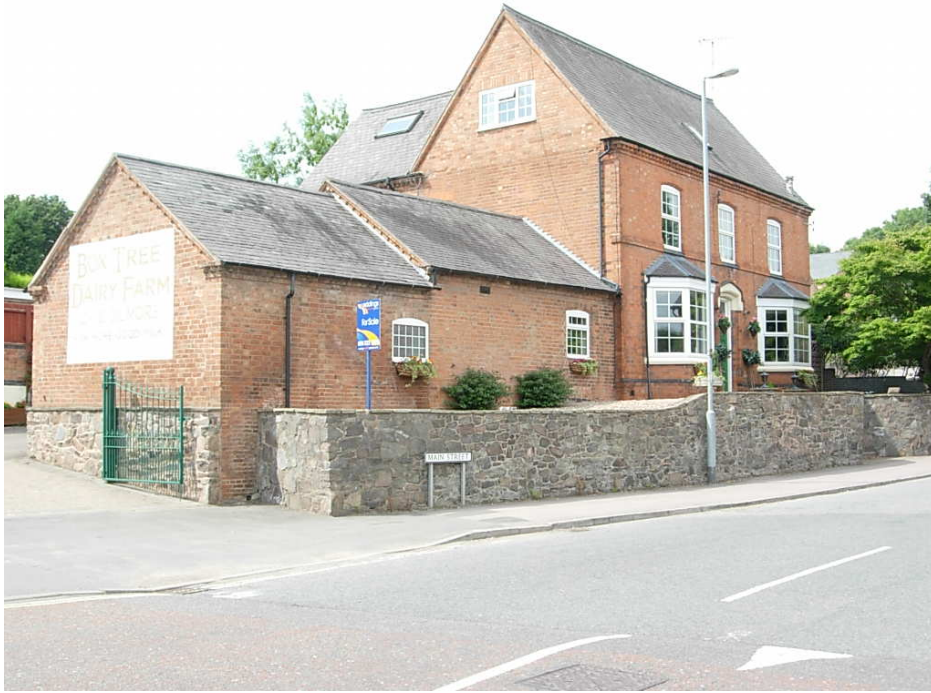
Box Tree Farm and its outbuildings are important features sited at the junction of Main Street and Desford Lane. The property has ceased to be a farm and unfortunately, it has lost its previously dominant chimneys and been restored using plastic windows and prominent roof lights.

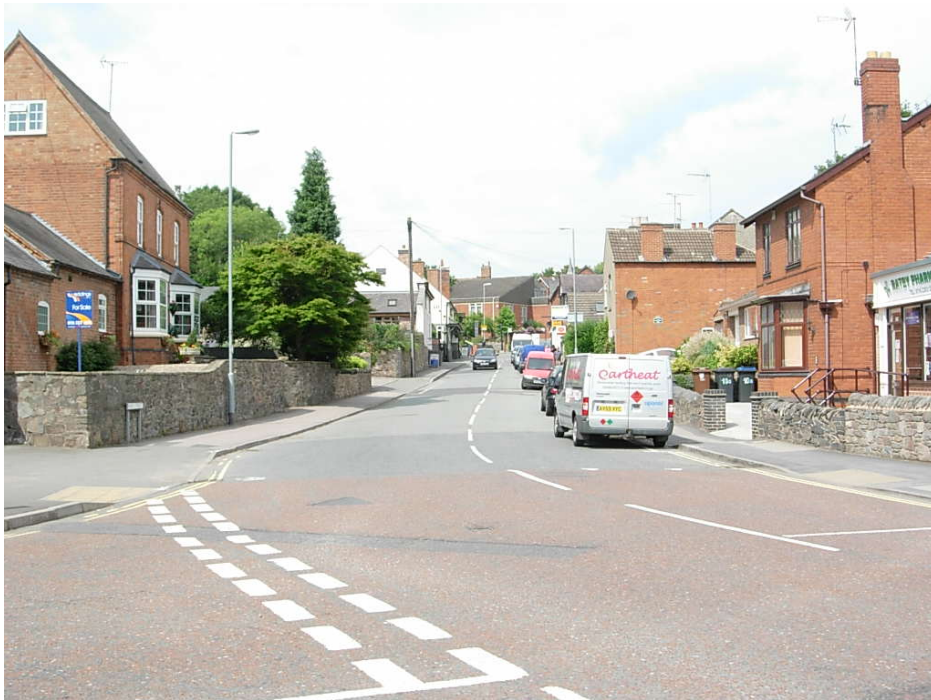
Ratby Primary School terminates views looking northwards up Main Street. Red/orange brick is a prominent building material in Ratby.

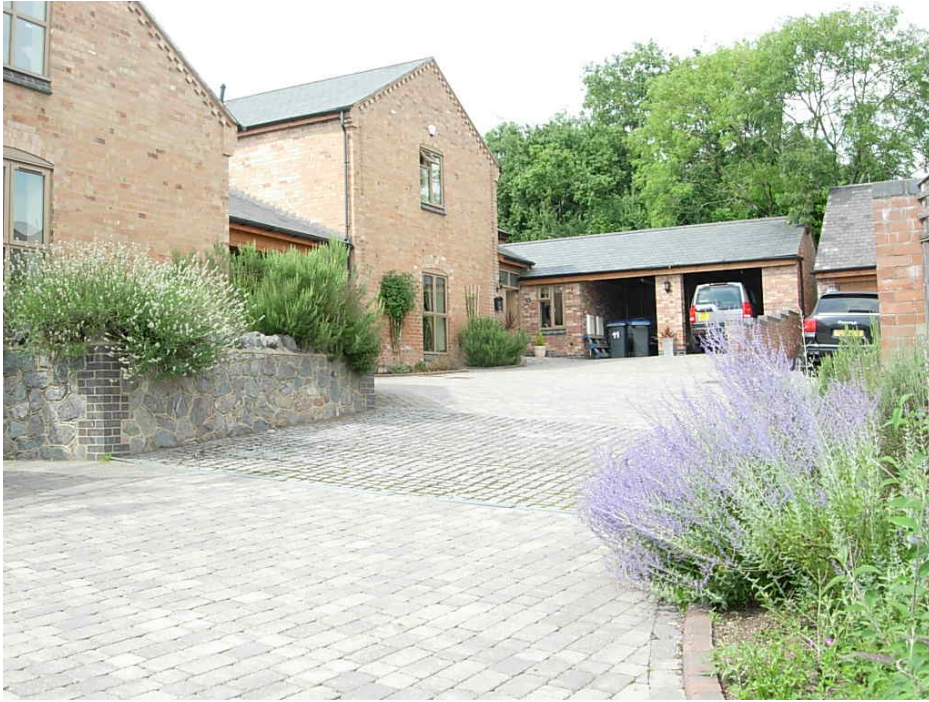
9 and 11 Main Street have been converted from barns into two large dwellings.

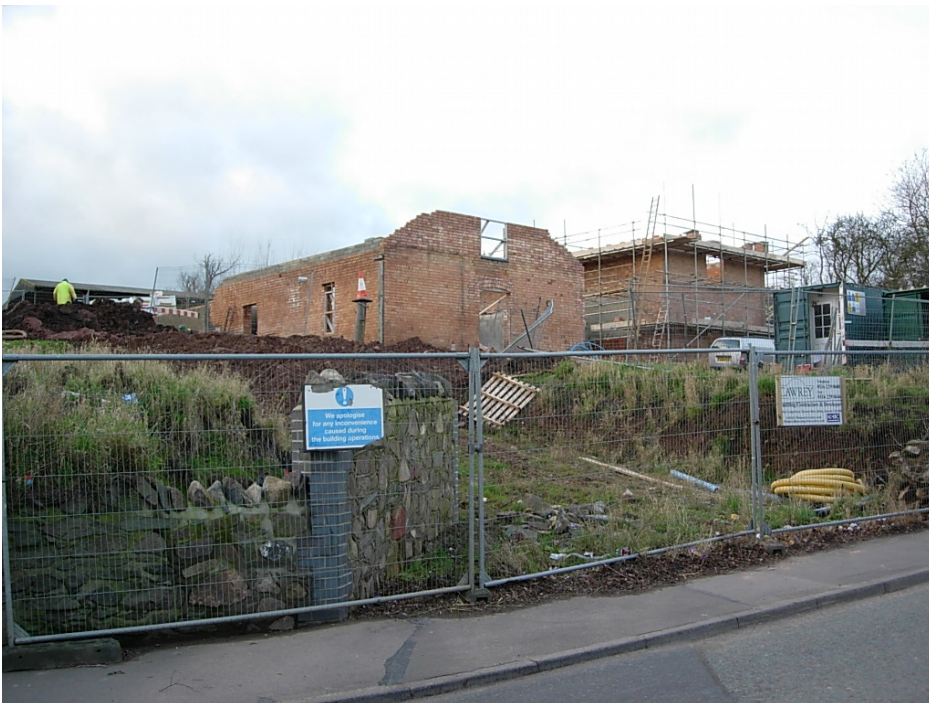
9 and 11 Main Street during their conversion work into residential properties.

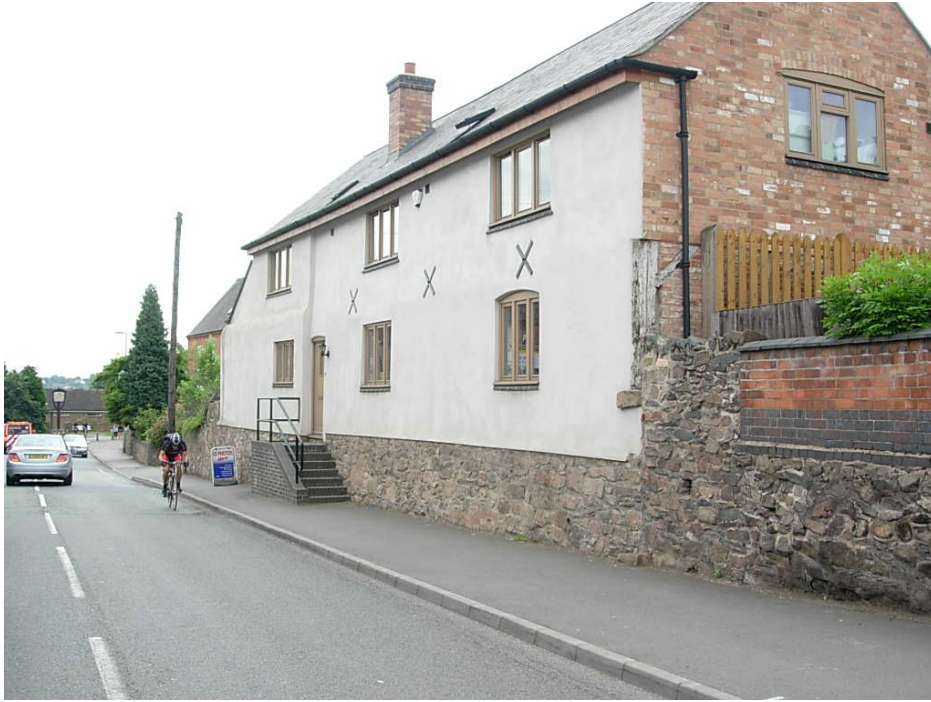
Pear Tree Farm is now a private dwelling that has been modernised. The front elevation of the property has been rendered but its stone plinth has been retained as a feature.

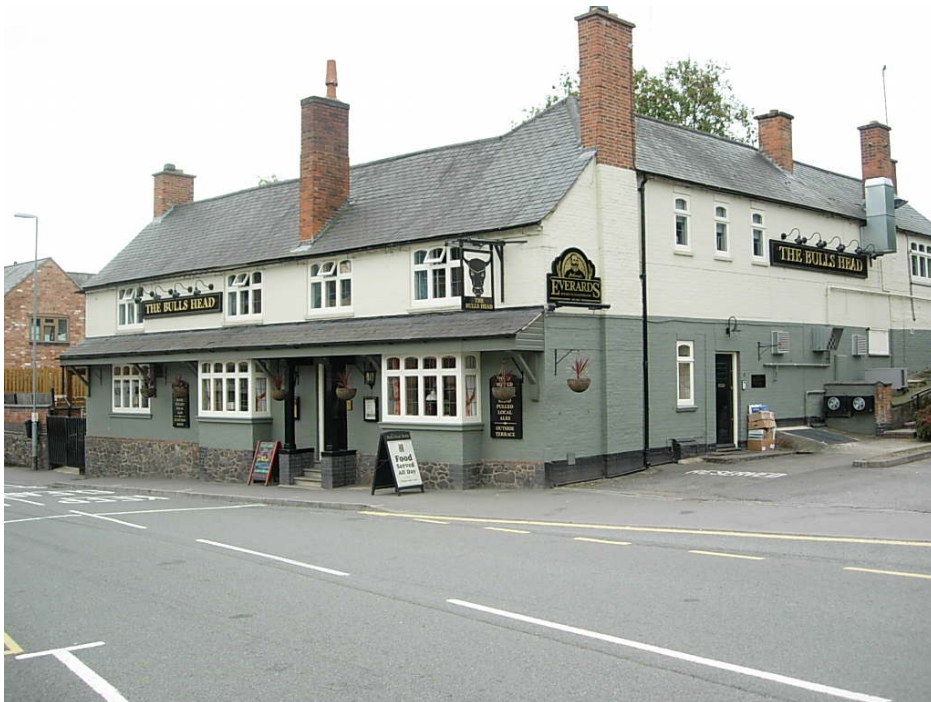
Bulls Head Public House, originally a farmhouse, is a large prominent building on Main Street that has been considerably extended and modernised. The extension on its northern elevation is built at a greater height to the original property due to the topography of the ground and this is reflected in different roof heights. The property still retains its stone plinth and prominent chimney stacks.

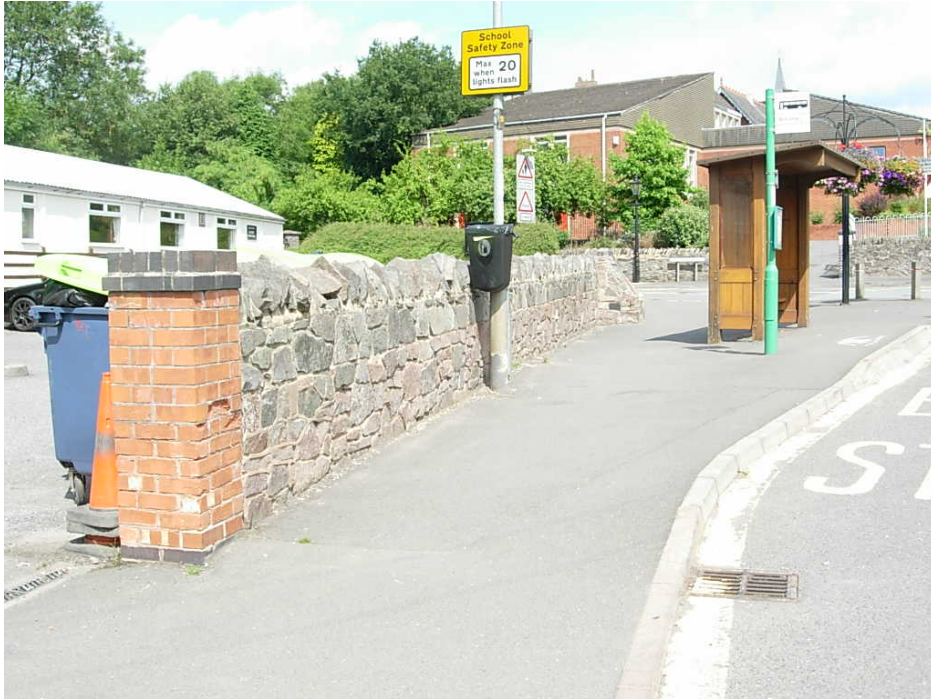
The granite wall fronting the Bulls Head now provides enclosure to the car park and was built as part of the Hinckley and Bosworth Borough Council's Environmental Programme. Everards Brewery subsequently increased the height of the wall.

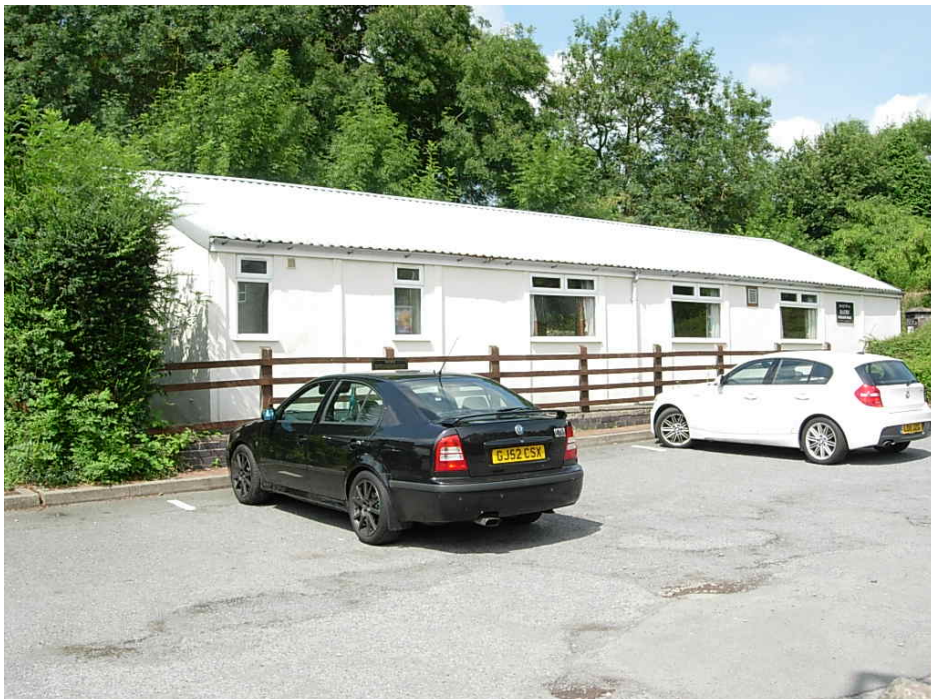
The Village Hall is not a particularly attractive building in the Conservation Area, however it serves as an important community facility.

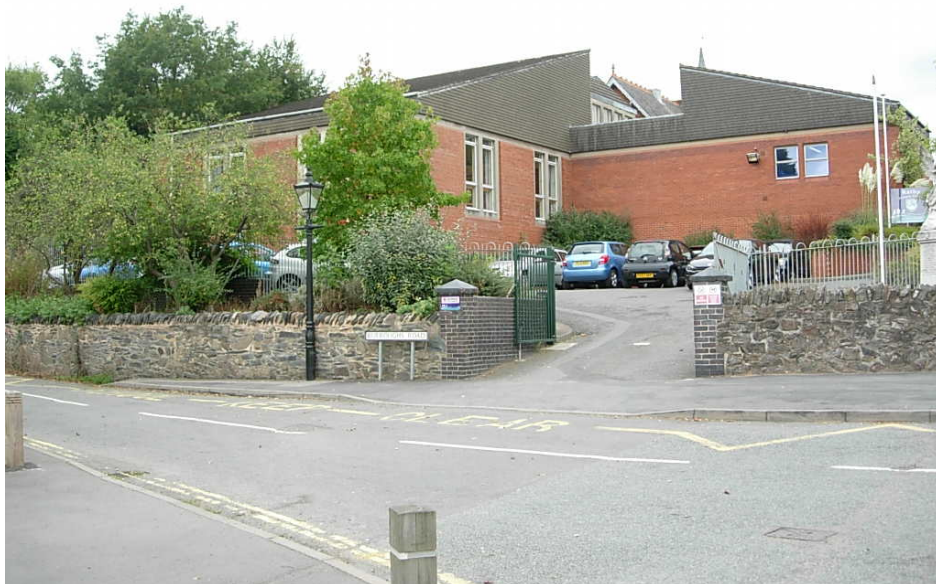
The modern extension to Ratby Primary School is built in red brick with mono-pitched roofs. It is unfortunate that the modern extension has now obscured the excellent side elevation of the Victorian school.

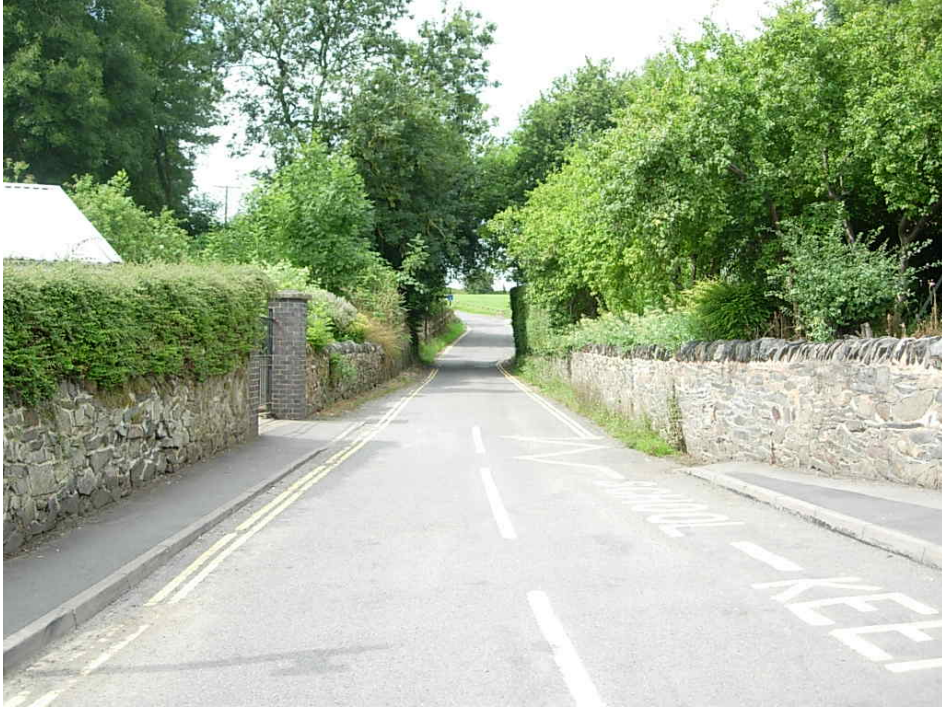
Excellent view looking westwards along Burroughs Road. This narrow lane that was originally an old coaching road is flanked by granite walls softened by foliage

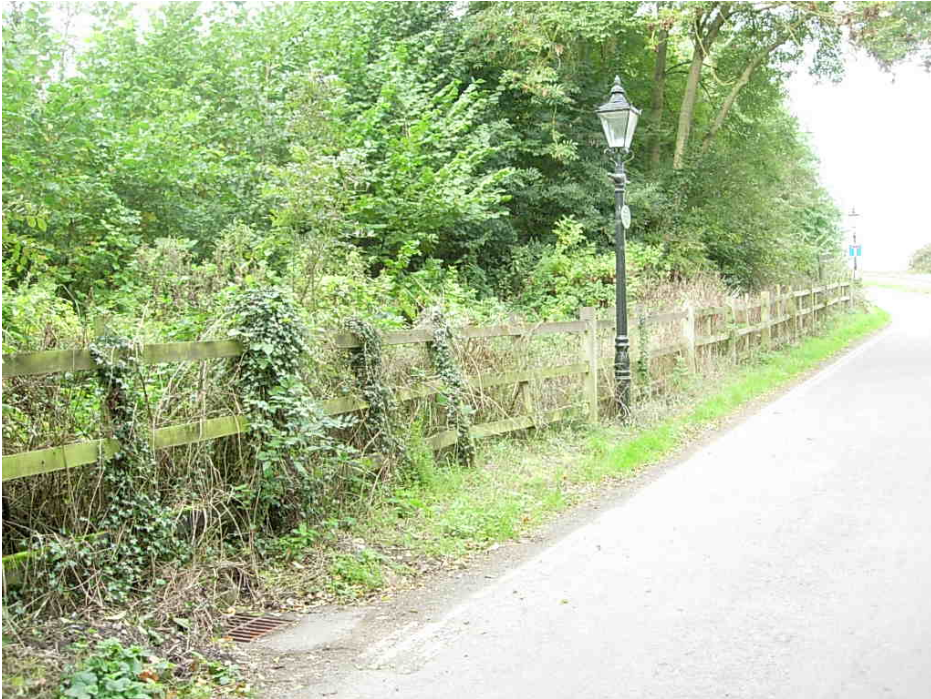
This site was where the Ratby Fish and Chip Shop once stood. The corrugated building was demolished and the timber fence erected by the Borough Council. The area now provides a small haven for wildlife. The timber fencing needs repairing.

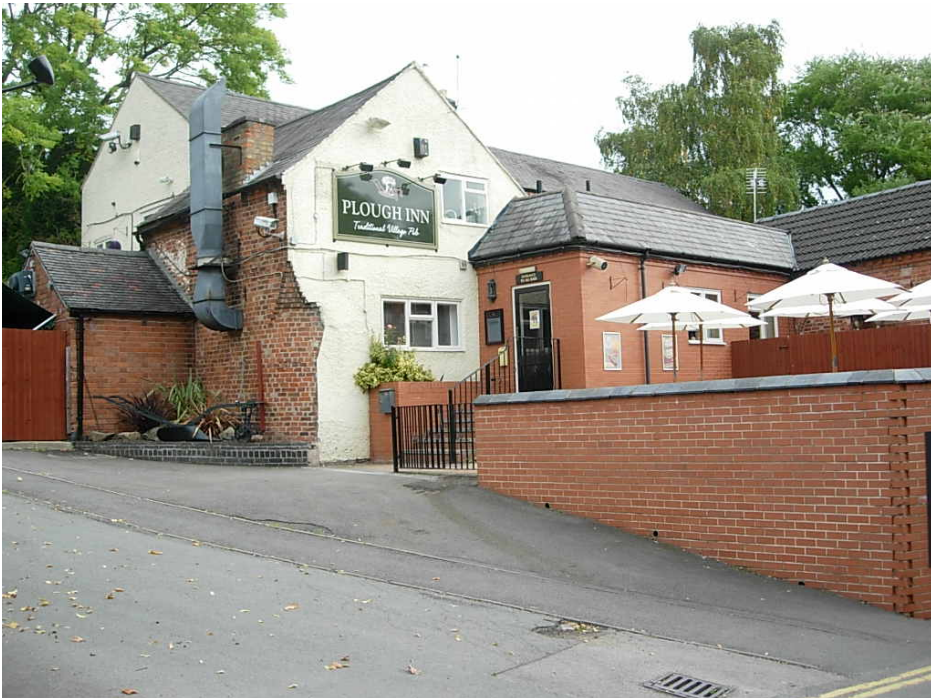
The Plough Inn is an interesting property that has been considerably extended and modernised over the years. Part of the brick building has been rendered and the large metal flue is a particularly unsightly feature.

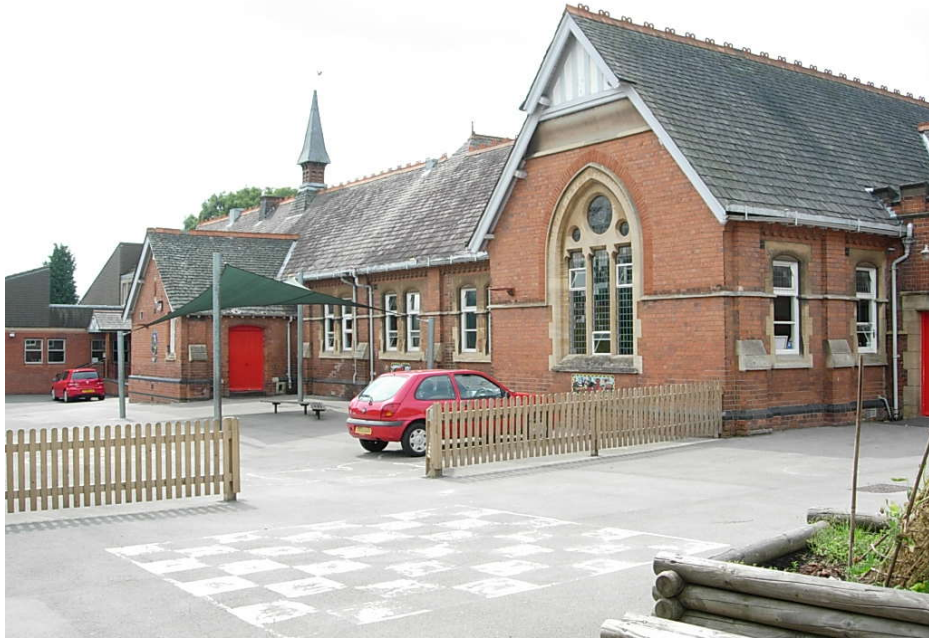
Ratby Primary School opened in 1873 is typical in design to many other village schools built at the time. The building with its gable ends and large mullioned windows is an impressive property on Main Street which enhances the street scene.

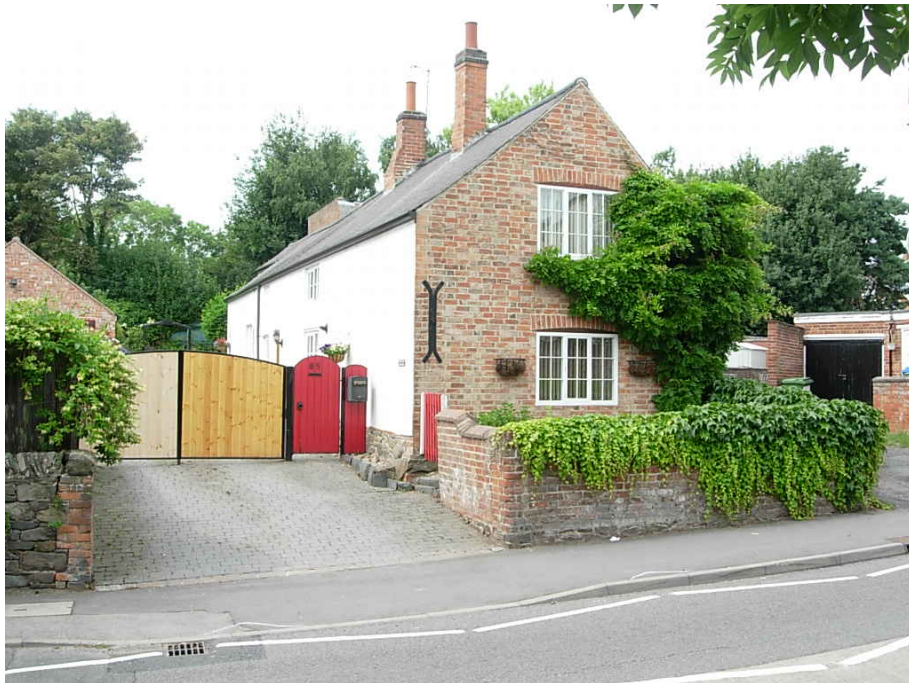
The Grade II listed building, 85 Main Street, is a large cruck-framed dwelling probably built early in the C17. The property is built in red brick, although its southern elevation has since been rendered, and has a plain tiled roof which replaced the original thatch roof covering. It has retained its brick ridge chimney stacks.

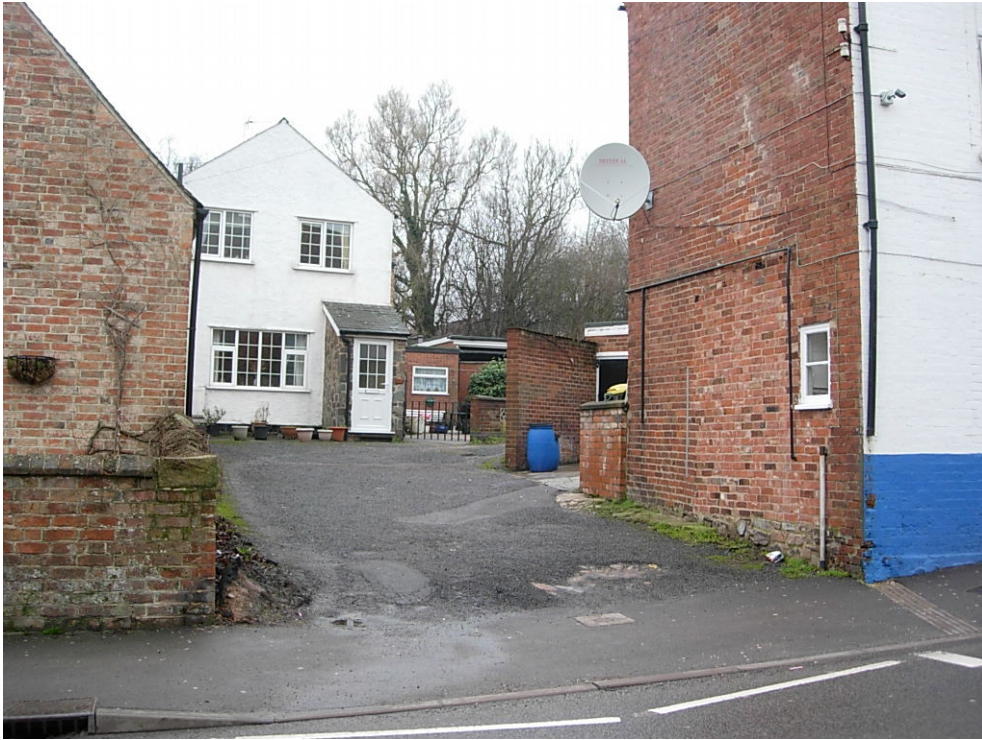
Stamford Arms yard was once a farmyard that took its name from the Earl of Stamford Arms Public House which once fronted Main Street. The farm outbuildings were converted into cottages in the C19 and on the western boundary stood a group of three-storey dwellings known locally as the 'Garrett Houses'. The large satellite dish mounted on the side of 93 Main Street is an unsightly feature and the access needs re-surfacing.

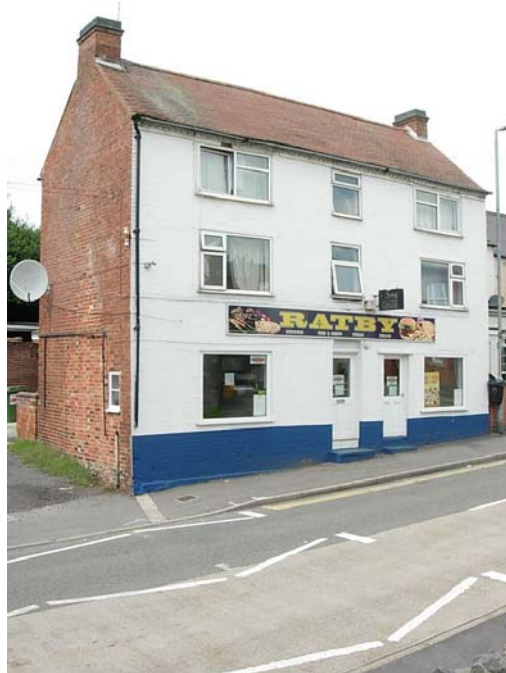
The fish and chip shop, 93 Main Street, is the only 3 storey dwelling in the Conservation Area. Unfortunately the property has been significantly altered with its front elevation painted, window openings enlarged, plastic windows inserted and chimney pots removed.

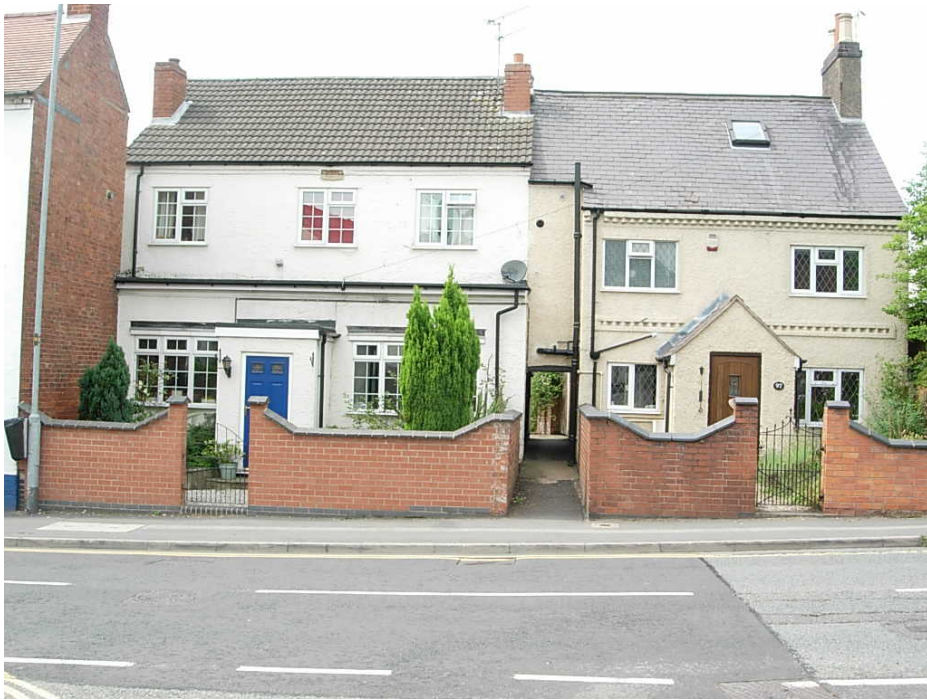
The property 95 Main Street was once the Earl of Stamford Arms Public House. The property has been considerably modernised with bow windows, concrete roof tiles and the chimney stacks reduced in height. The front of 97 Main Street has been painted and a roof light installed. The central passageway between the two properties once accessed Stamford Arms Yard.

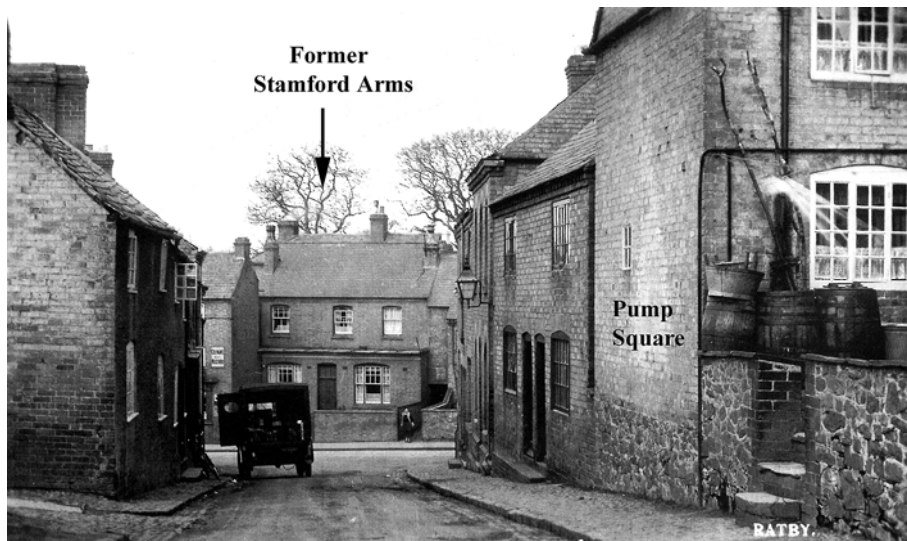
This old photograph, taken around 1930, shows the Church Lane/Main Street road junction and how the buildings on Church Lane helped enclosure and direct views down the carriageway.

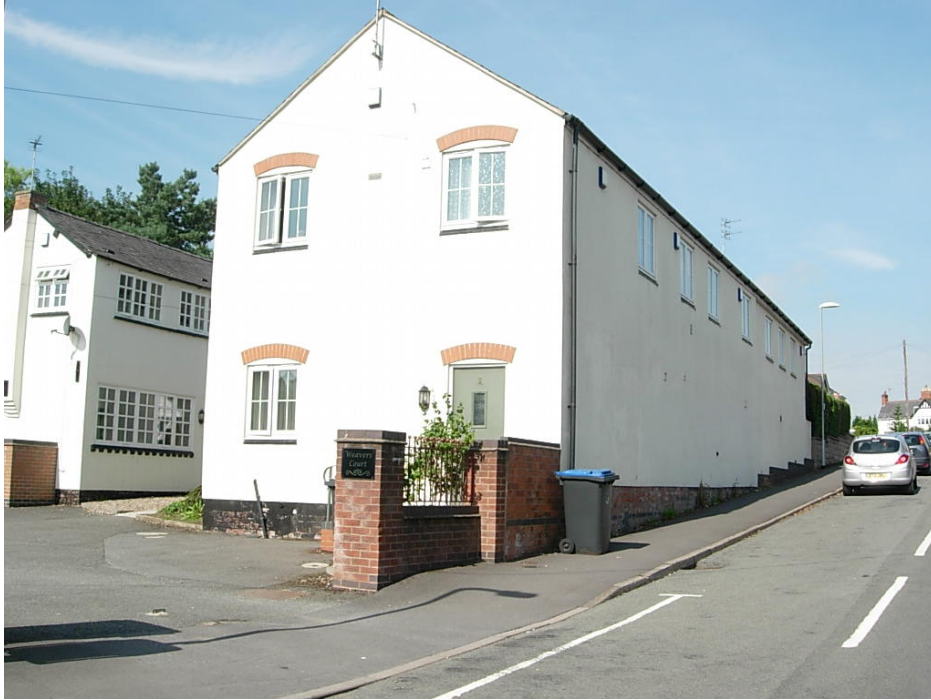
This former hosiery workshop on Stamford Street, built around 1875 has now been converted into residential dwellings.

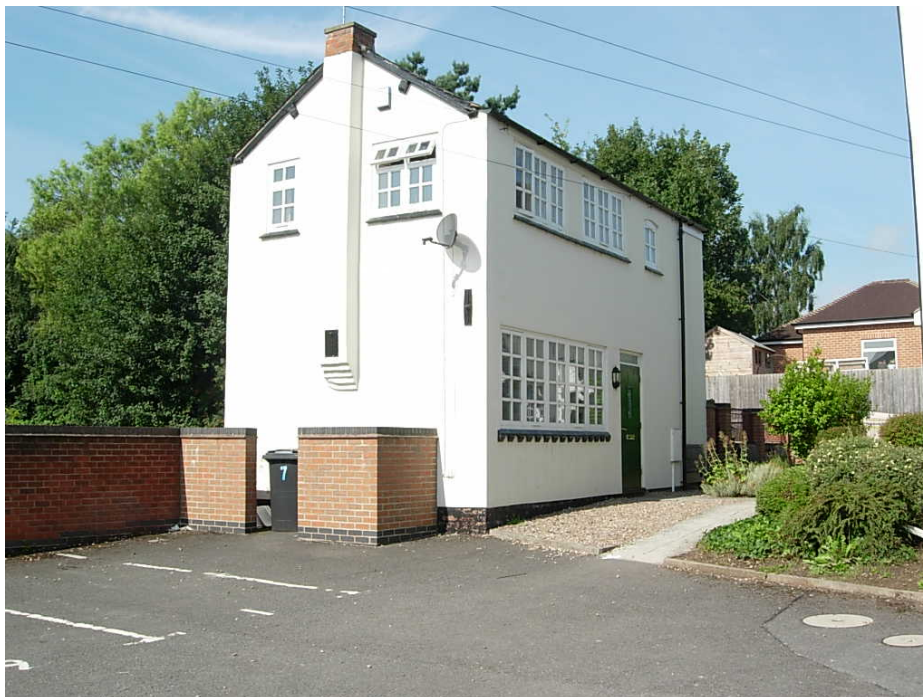
This former hosiery workshop on Stamford Street, mentioned in Pevsner's 'Buildings of England', was removed from the List of Buildings of Special Architectural or Historic Interest due to unsympathetic improvements. The building however, still retains its charm from when it was a Framework Knitter's cottage.

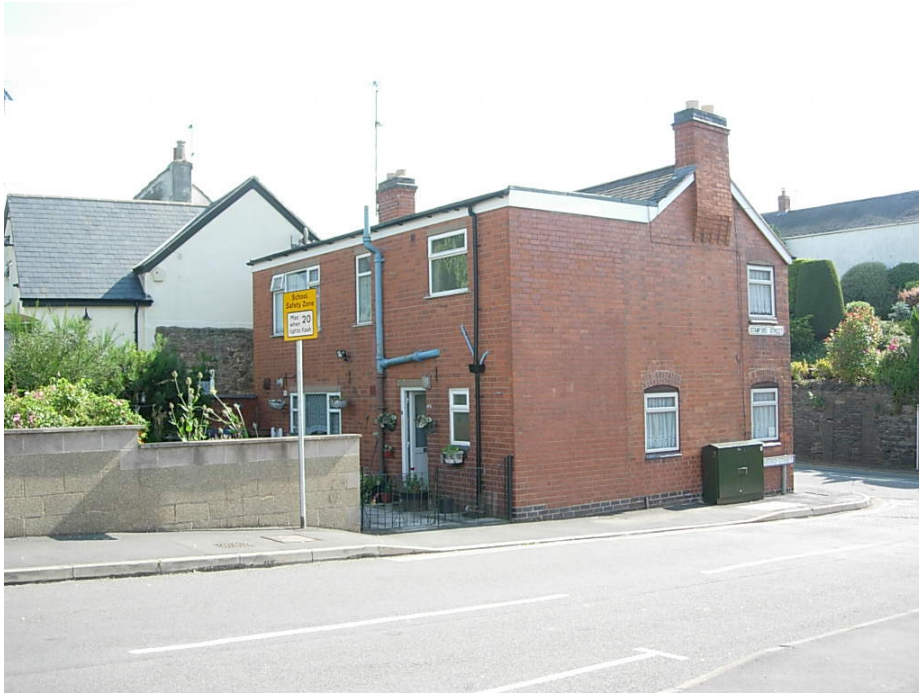
This view of 103 Main Street is unattractive due to the scale of its rear extension and flat roof. The block wall running up Stamford Street is also an unsympathetic building material in the Conservation Area.

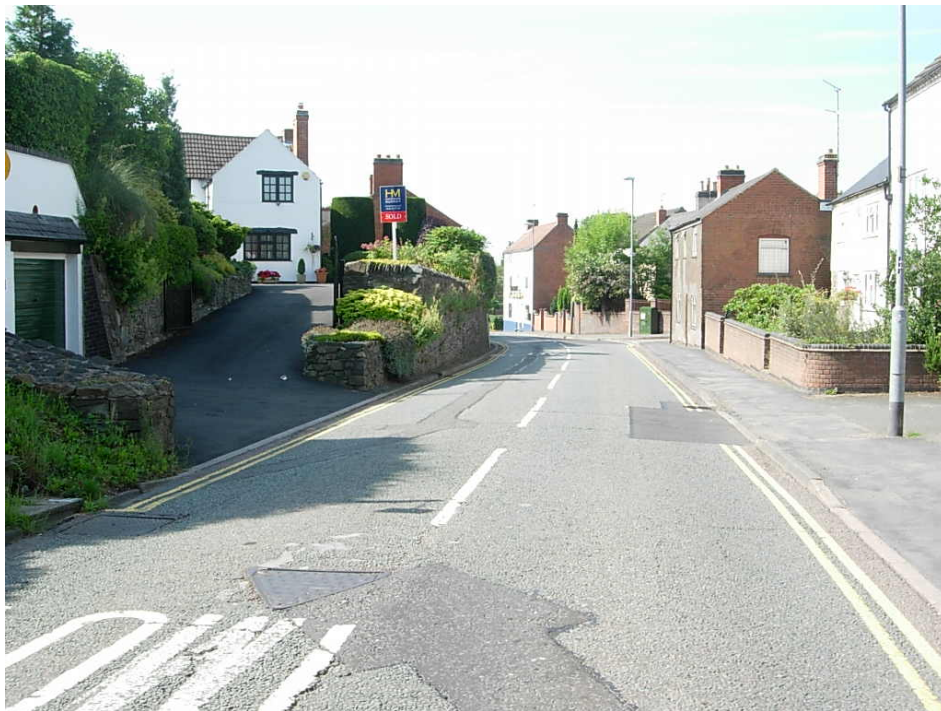
View looking southwards down Main Street showing how the high stone wall helps to direct views along the road. There is no public footpath on the eastern side of the road at this entry into the conservation area. The fish and chip shop helps to terminate views on Main Street.

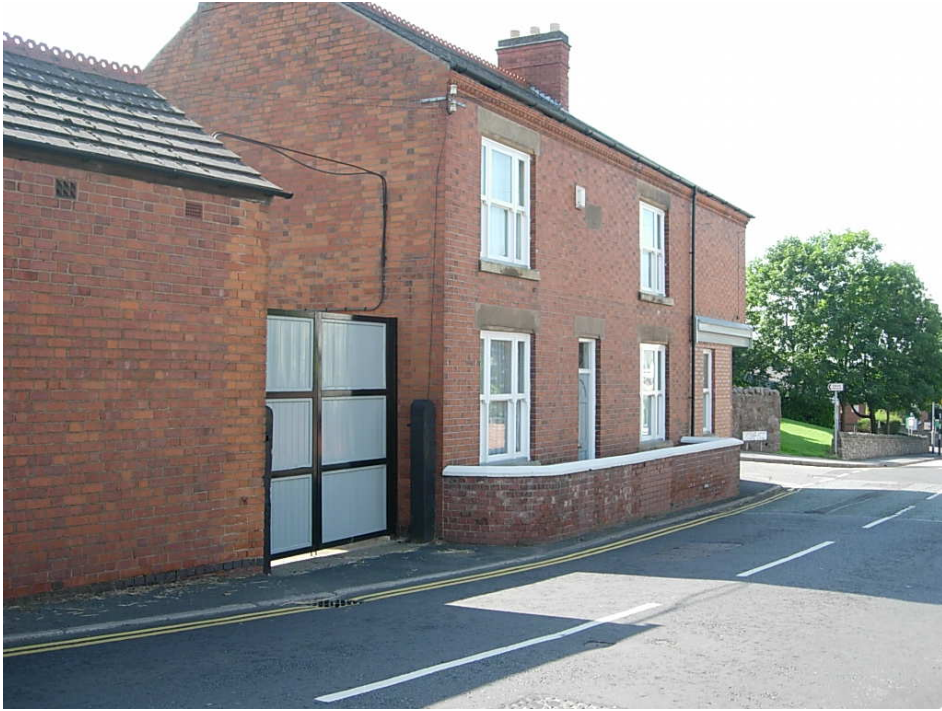
88 Main Street is fine brick property with sash windows, a pair of large chimney stacks and ornamental ridge tiles. Its front entrance door has been blocked off with the construction of a brick wall. The property was once the village butchers shop. The single storey building to the left was once its abattoir.

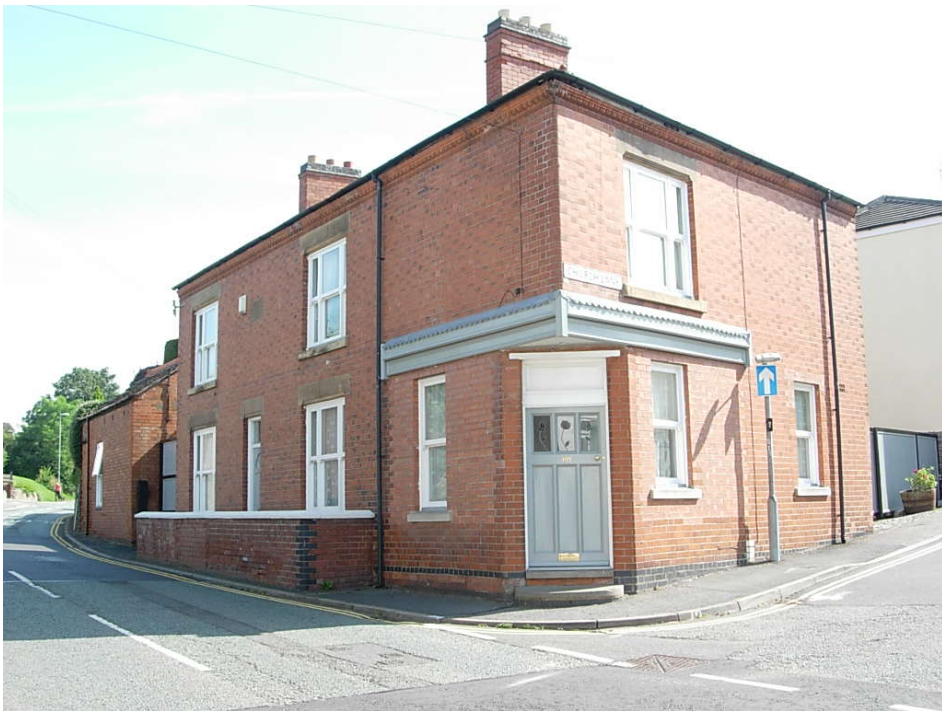
The door on the corner of the property was constructed to provide access to the butcher's shop. The shop windows have been replaced with smaller windows.

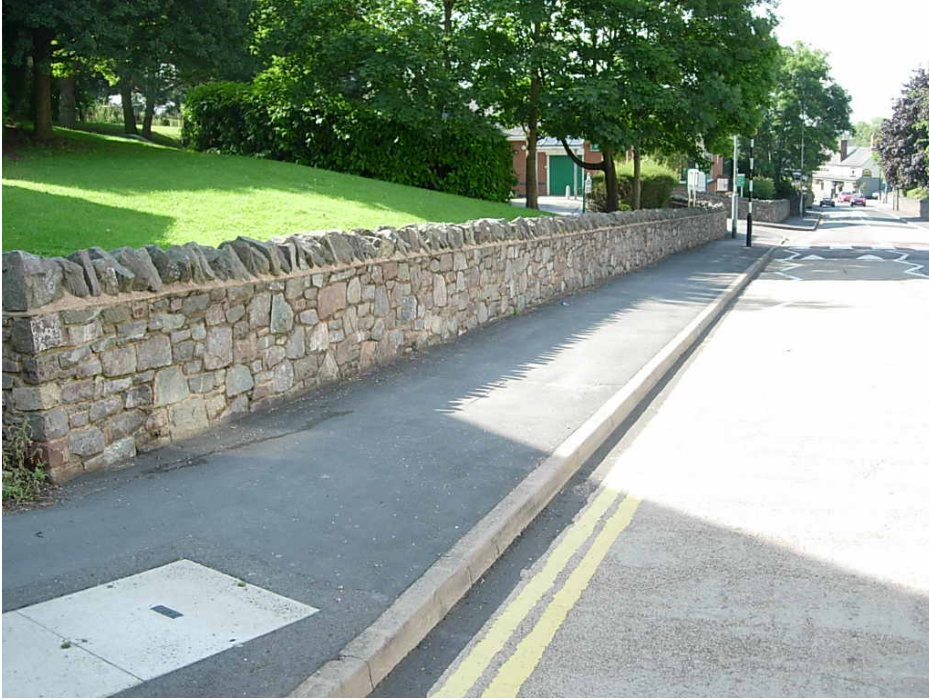
This excellent granite wall was built to replace a line of unsightly concrete paving slabs. The land to the rear was the site of Ratby Workhouse and Workhouse Yard. Ratby embraced a number of yards that were built to house the increasing population during the 19th Century. The location of several of these yards have been identified with plaques displayed throughout the Conservation Area and are the subject of the leaflet 'The Lost Yards of Ratby' that can be seen on the Borough Council's web site.

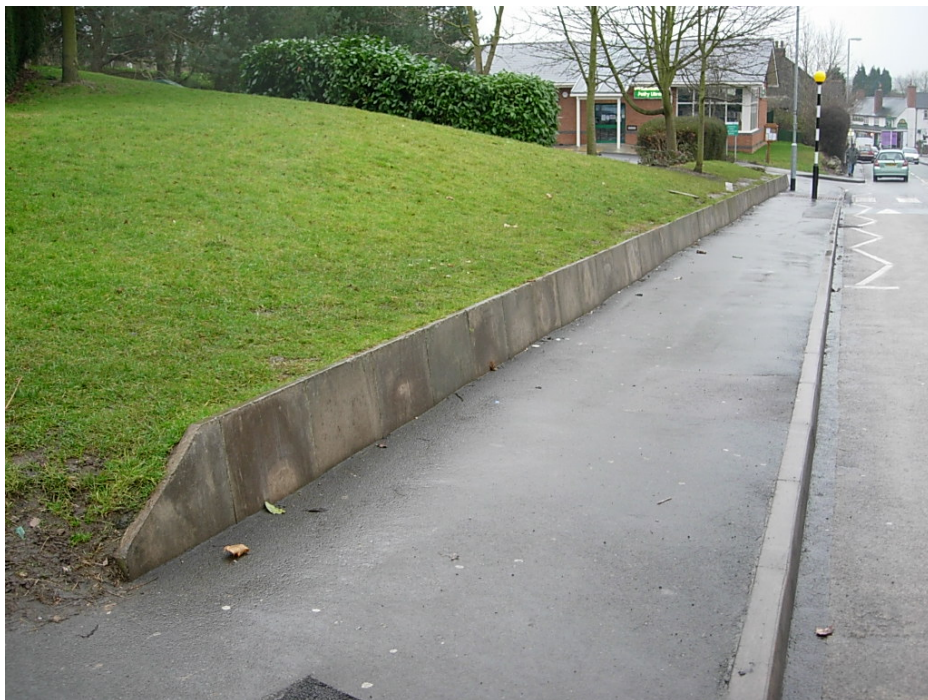
These unattractive concrete paving slabs were identified in the previous management plan as a potential improvement scheme and subsequently have now been replaced with a granite wall.

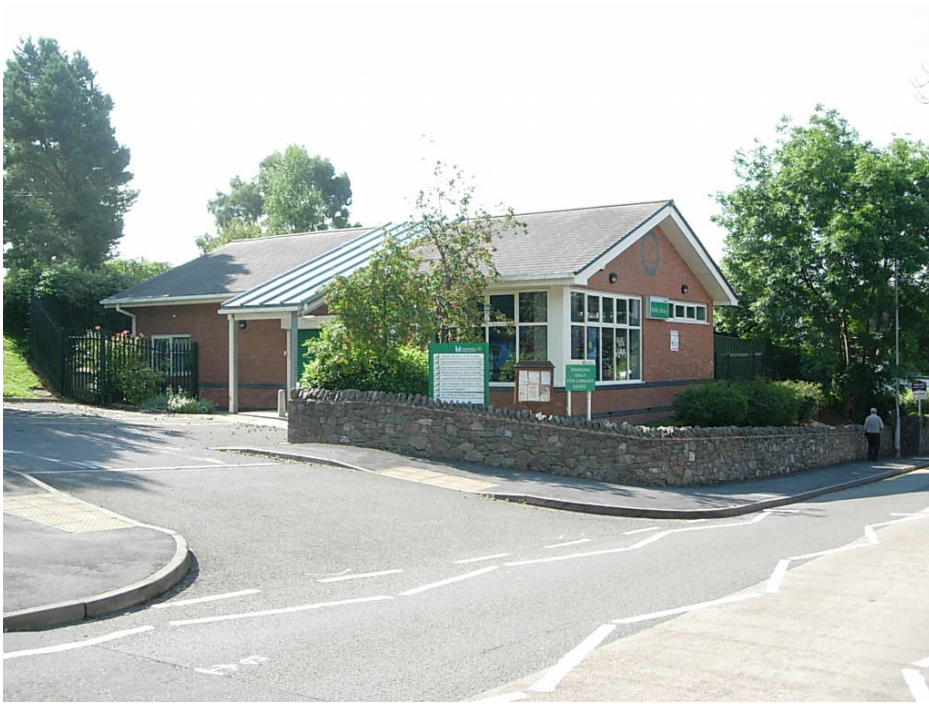
Although Ratby Library is an important community building, its design and use of materials does little to enhance the Conservation Area. The granite wall built along the library frontage was also continued on the southern side of the car park access.

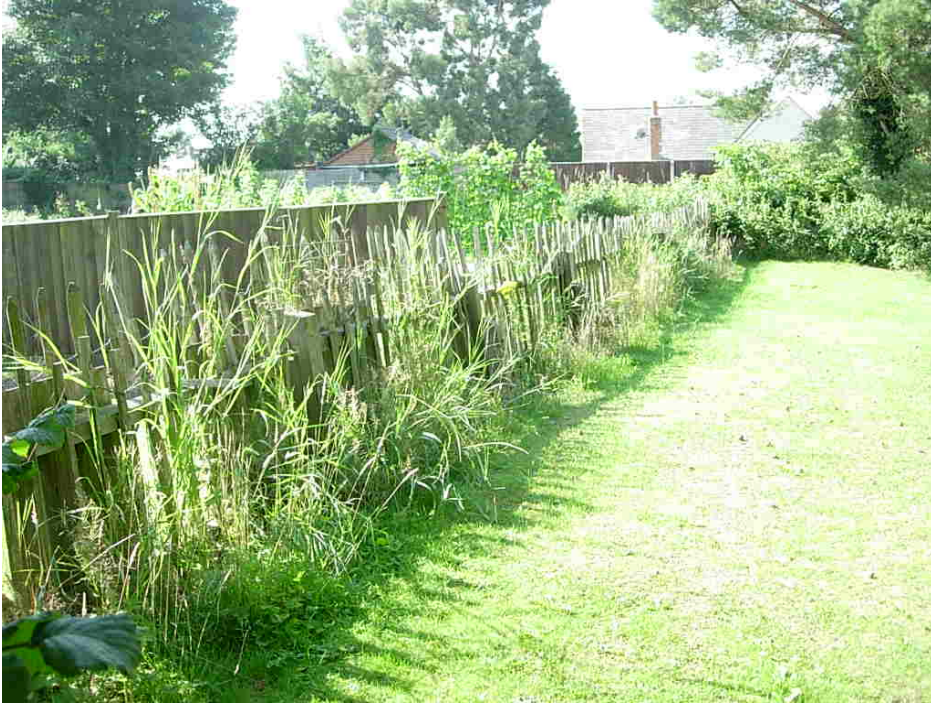
The timber fence running along the rear boundary to the Ratby Library is a poor feature that would benefit by being replaced with a traditional granite wall.

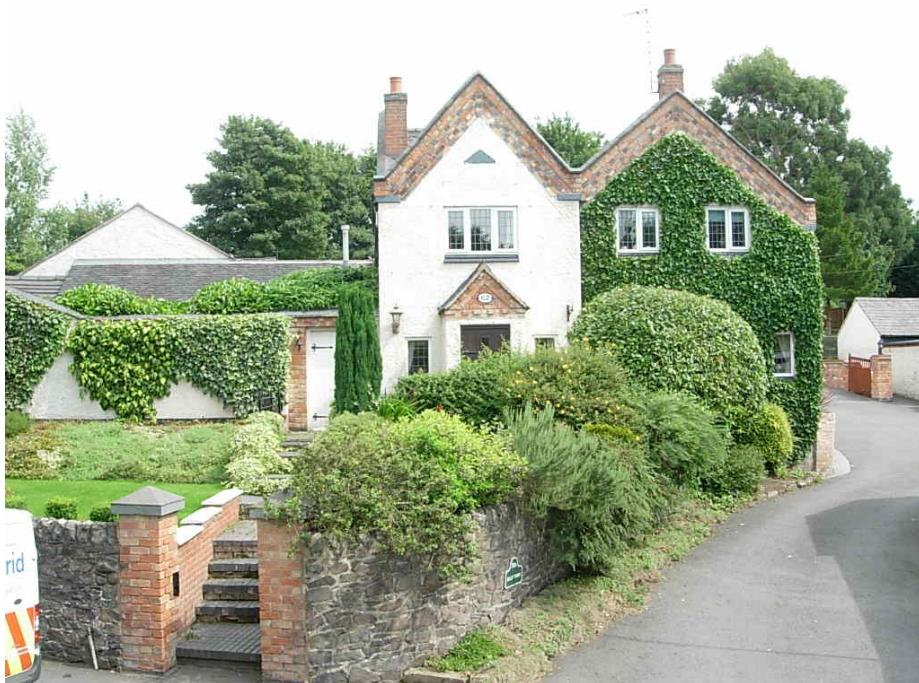
This imposing property with its twin gables that was built in 1859 was once a licensed premise in the 1970's. It is sited at the entrance to Sills' Yard named after the Sills Family that lived there during the 20th century.

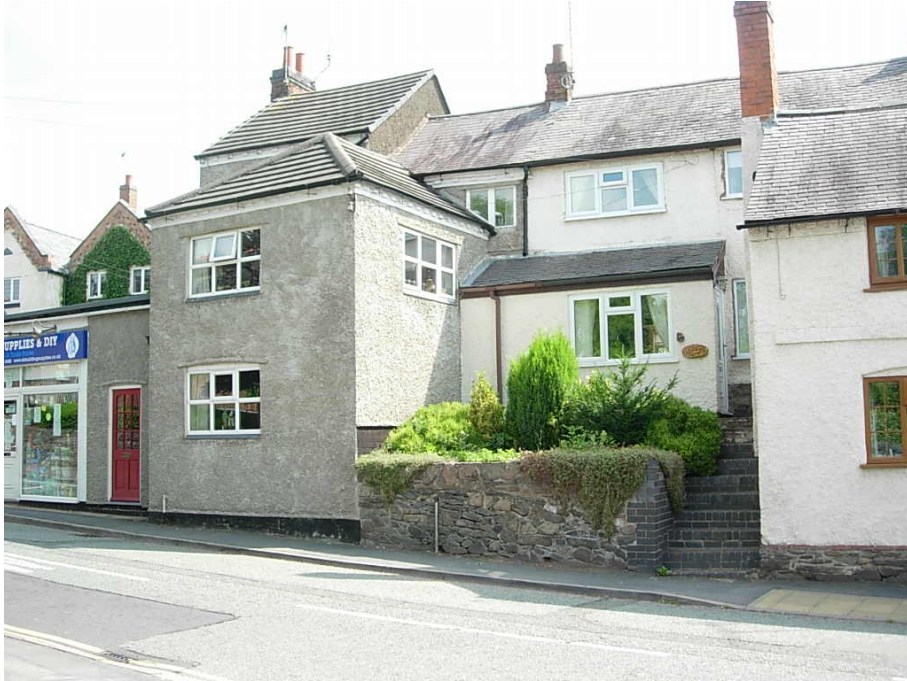
54 and 56 Main Street are an early example of how Ratby developed during the 19th century where development in the village was restricted to the core area and where the yards were developed.

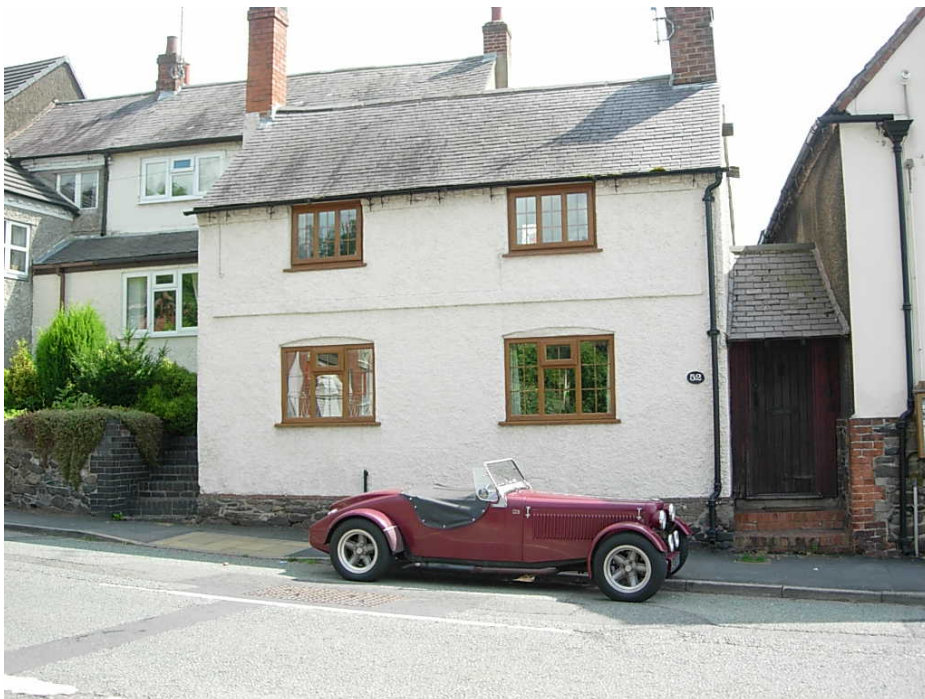
52 Main Street is a detached property that is sited on the back edge of the pavement. The dwelling that has been rendered still retains its stone plinth and gable chimney stacks.

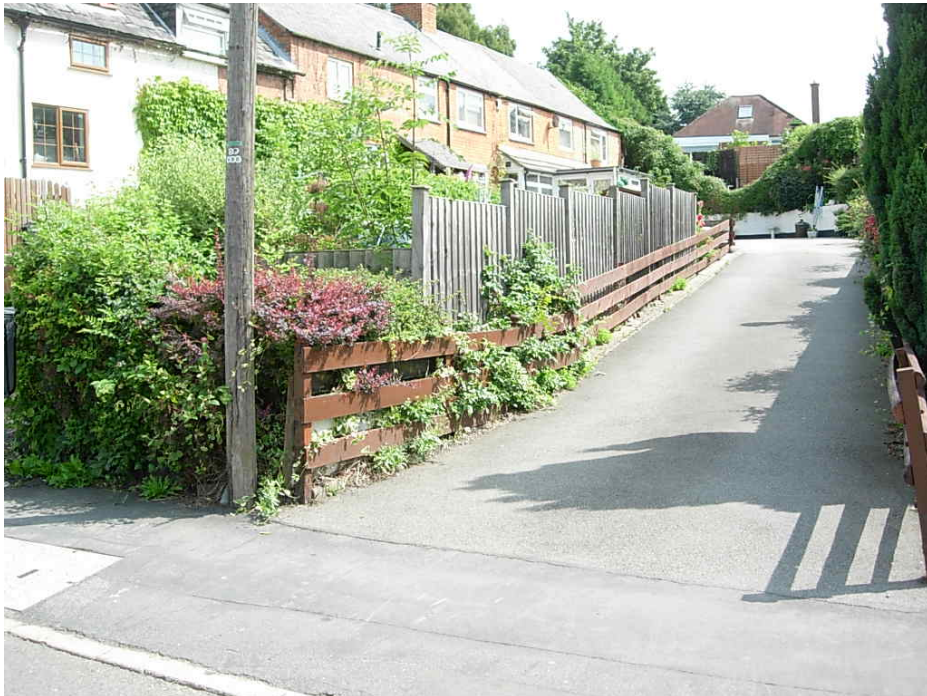
The timber fencing running up the rear gardens to 48 and 50 Main Street is not a particularly attractive feature and would benefit by being replaced with a traditional stone wall.

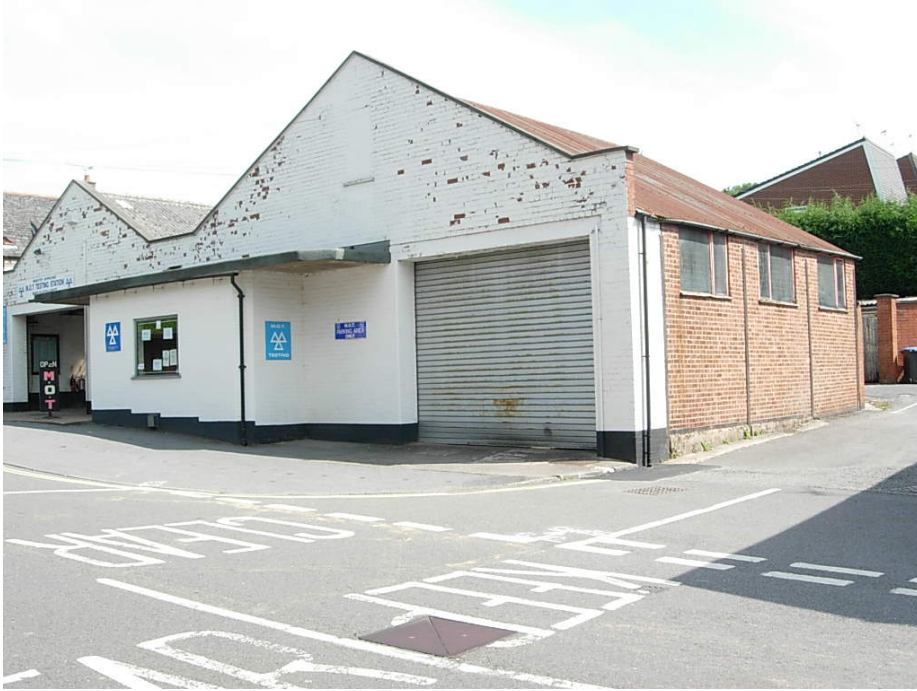
Although the MOT and vehicle repair garage does little to enhance the Conservation Area at the junction of Main Street and Berrys Lane, it does provide an important facility for the village. The property once had planning permission for the building of new houses.
