**Ratby Conservation Area Appraisal and Management
Plan**

**Photographic Record 1 – Main Street, Burroughs Road,
Stamford Street & Station Road**

**December 2013
(Adopted February 2014)**

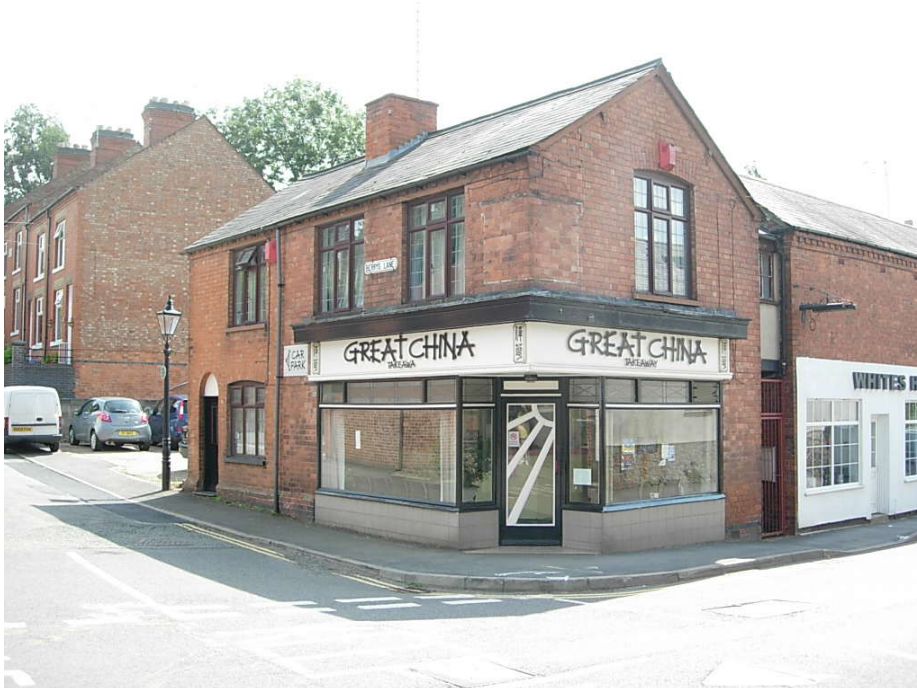
The 'Great China' take-away sited on the corner of Main Street and Berry's Lane has lost some of its traditional character with the construction of a large modern shop front and fascia. The property has also lost its chimney pots.

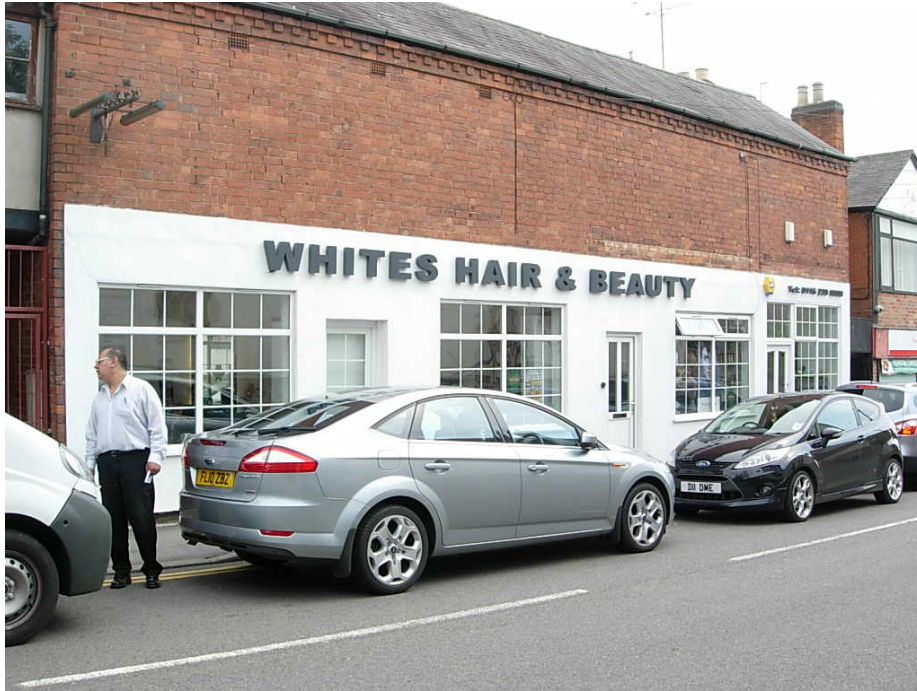
The stretch of Main Street running from Berry's Lane to the Co-op has lost its traditional charm due to out of character improvements. The frontage to the hairdresser's has been rendered and plastic window and doors installed.

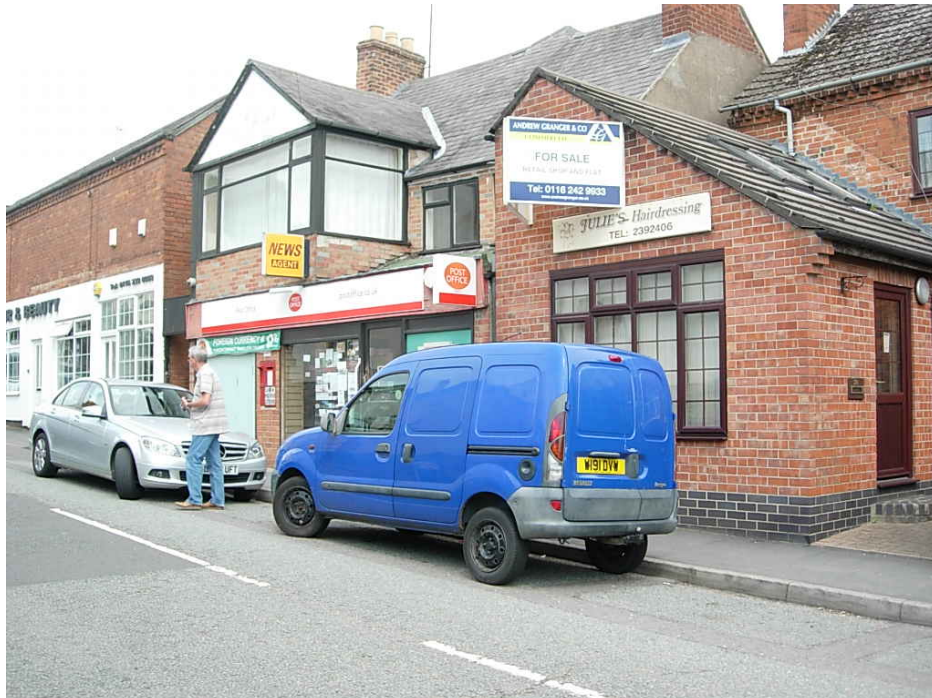
The extensions to the post office and 26 Main Street do nothing to enhance the character of the Conservation Area with large modern windows, fascia and building materials.

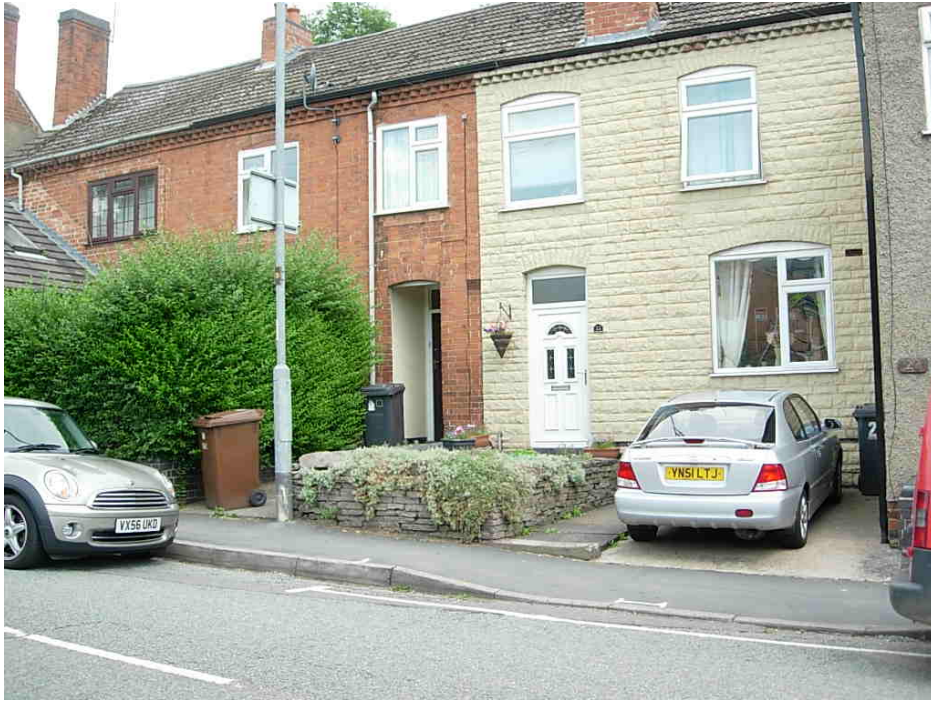
The concrete cladding and roof tiles used at 22 Main Street are a poor substitute to the original materials and breakup the uniformity of the terrace.

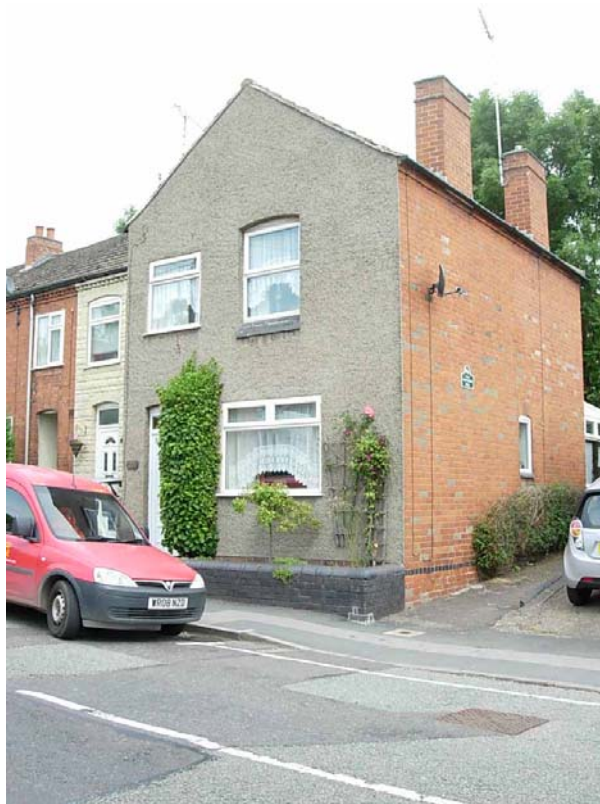
The front room to the large dwelling 20 Main Street was once the village post office. No doubt when the property was fully converted to residential, its frontage was rendered to conceal the conversion work.

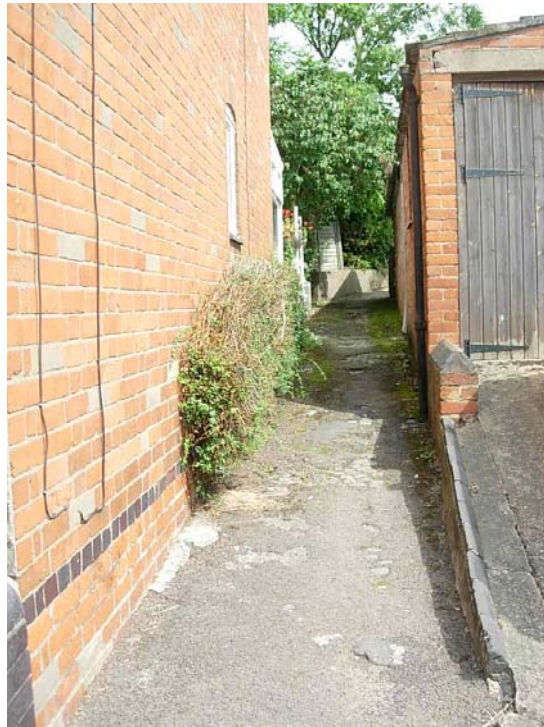
This jitty led to Post Office Yard sited at the rear of the old post office that comprised a group of five cottages built in the early 19th Century. The footpath used to link to Berry's Lane and was surfaced with cobbles some of which can still be seen showing through the tarmac. The jitty would be improved if the setts were re-laid.

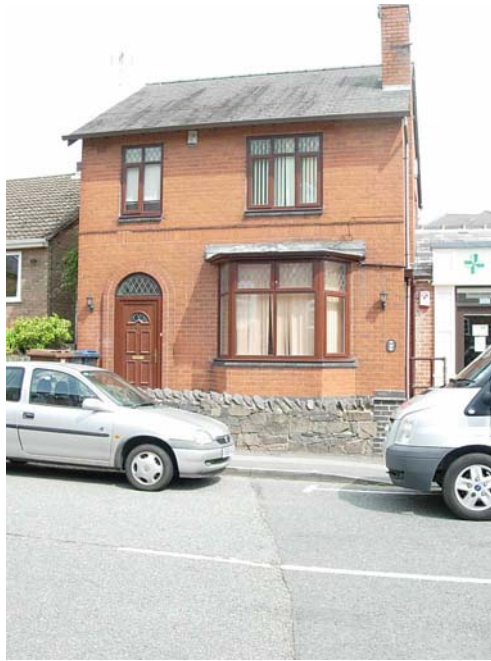
Unfortunately, 10 Main Street has been modernised with the windows replaced with plastic.

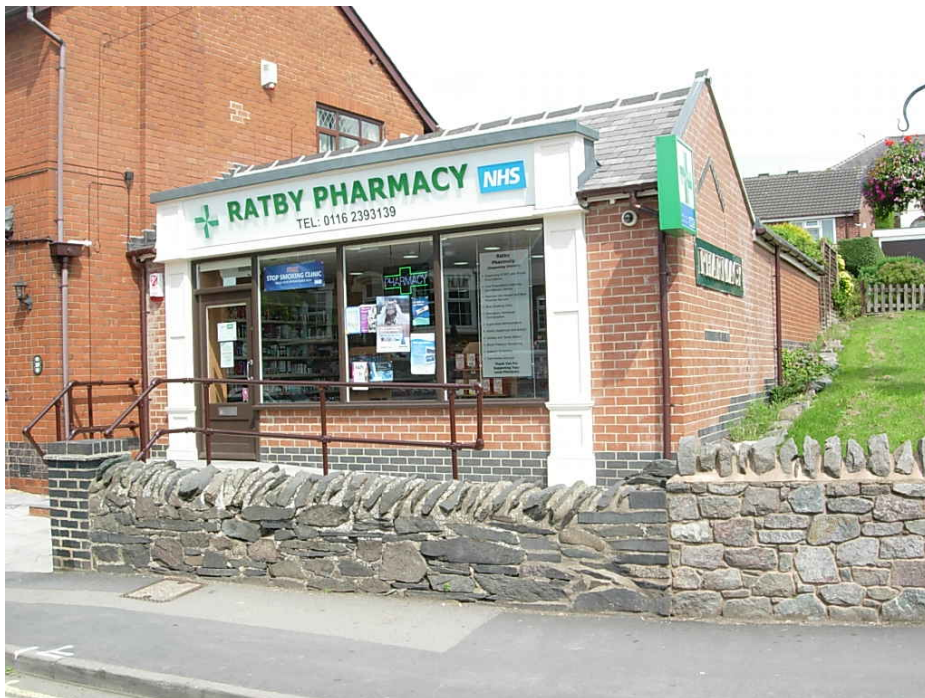
The new chemist shop is a recent extension to 10 Main Street. The existing stone wall has been retained.

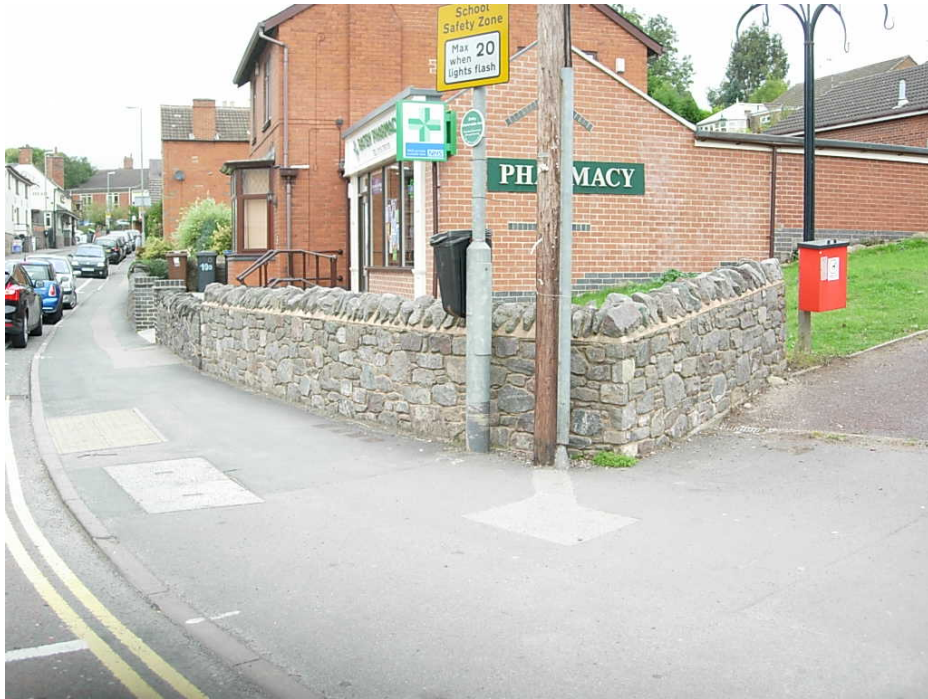
The granite wall fronting the Parish Council's public amenity open space helps enclosure at this important road junction.

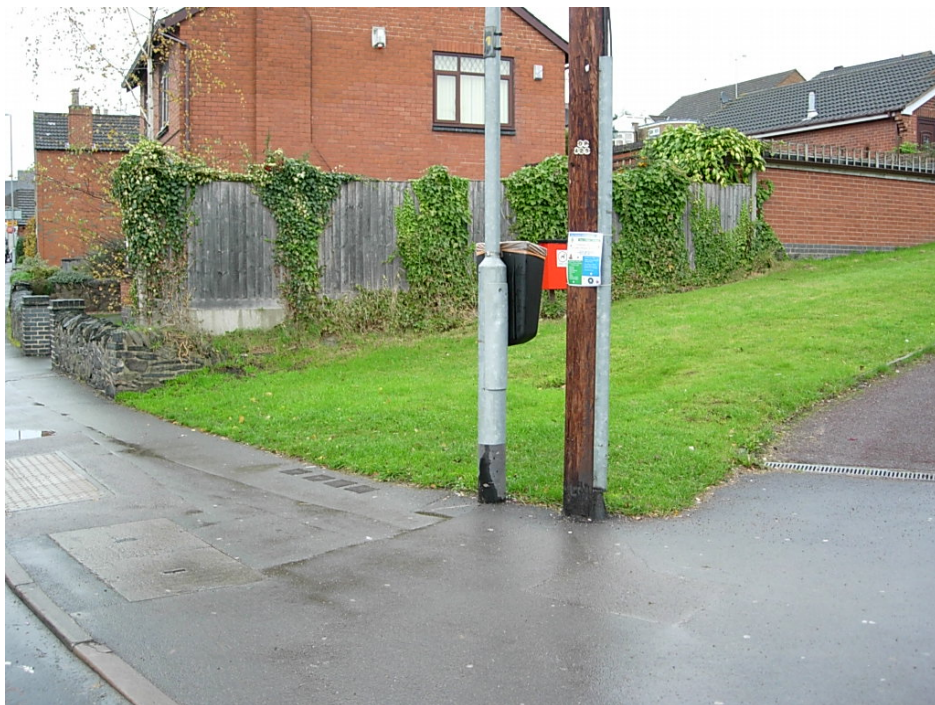
The sense of enclosure was lost when properties were demolished at this site. A granite wall has since been built as a project put forward in the previous management plan.

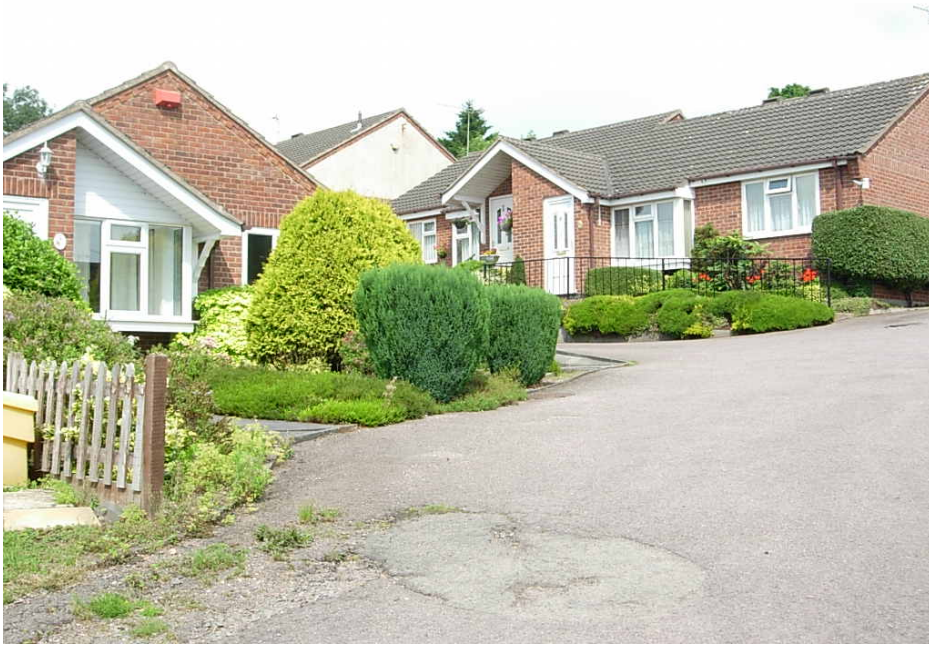
The land this modern housing development occupies was once the site of the village's 'Majestic' Cinema. This large amorphous area of macadam needs visually reducing possibly with a strip of granite setts laid across the entrance.

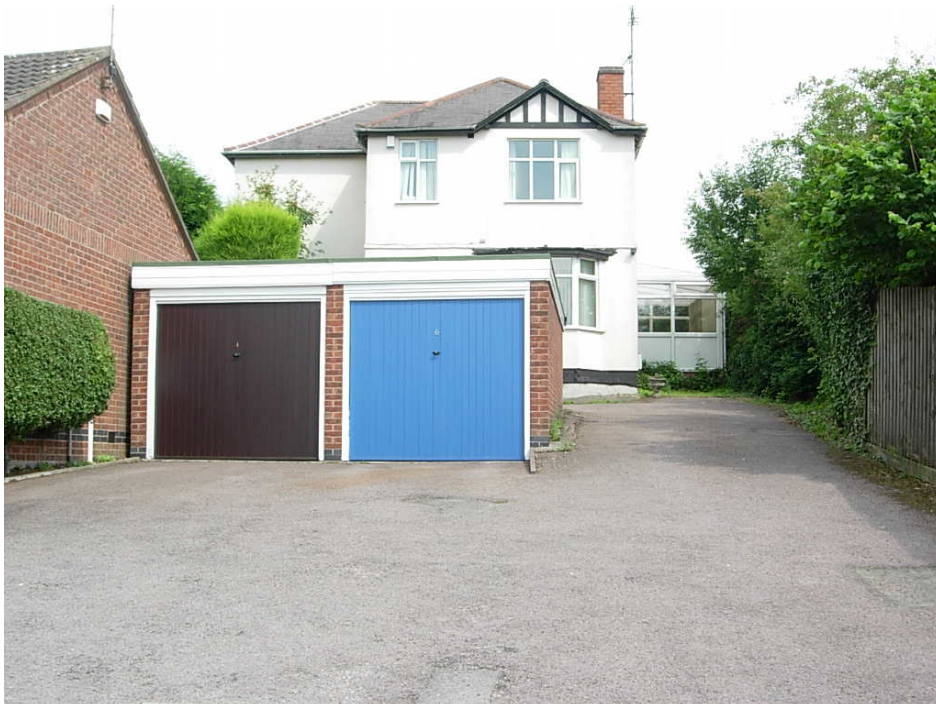
The view would be improved if the garage doors were both painted in the same colour.

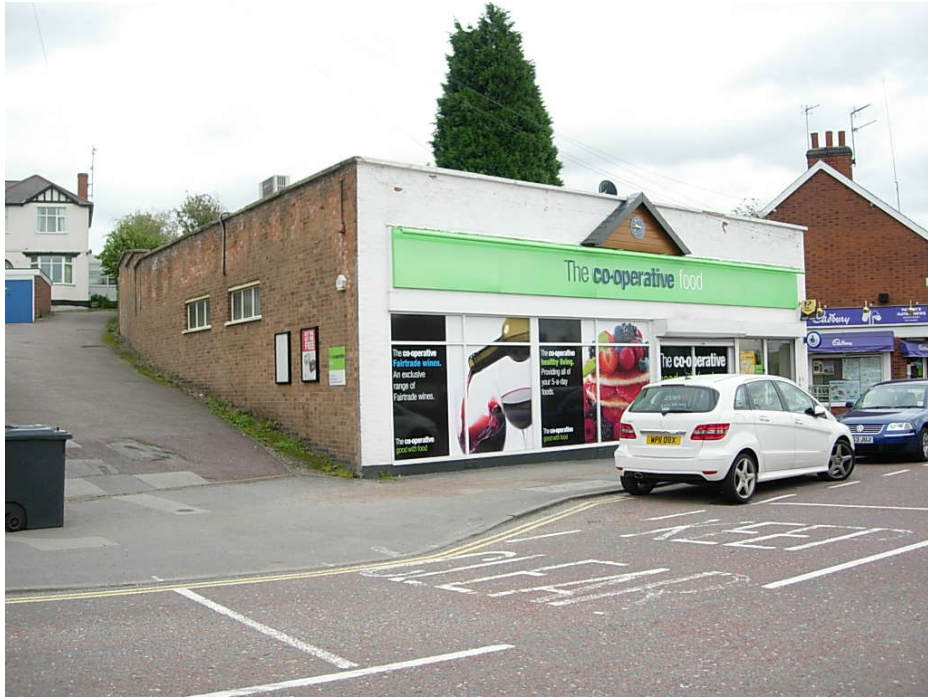
The Co-Operative store is an important village facility, however its design and dominant shop front treatment is a poor closing feature standing at the junction of Main Street/Station Road/Desford Lane.

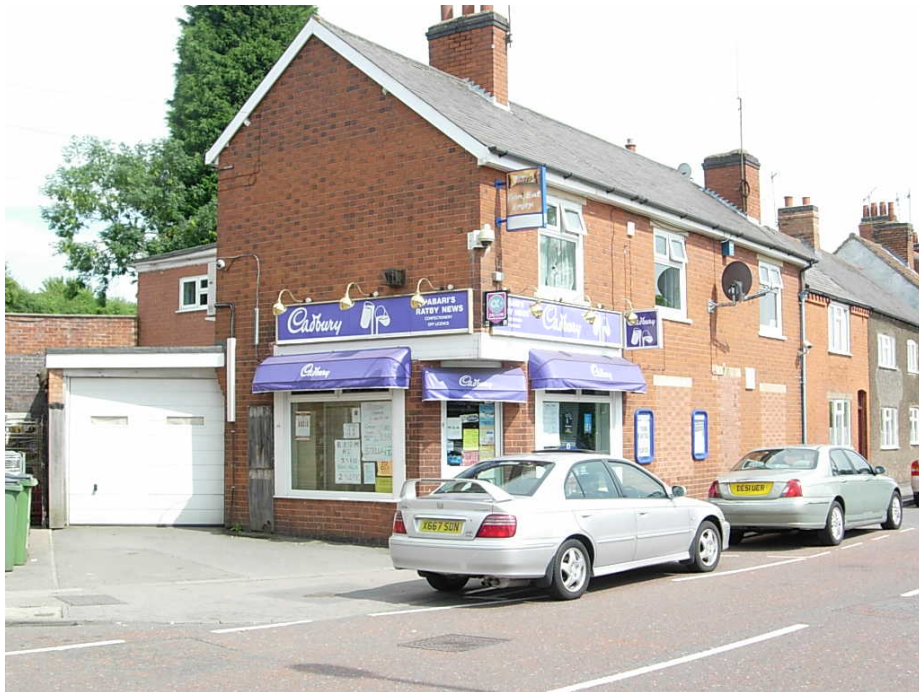
The property, 3 Station Road, has been considerably modified when it was converted to a shop with its windows and door bricked up along its frontage. The property would be improved if the fixed canopies and advertisement boards were removed and the size of the fascia's reduced. The large satellite dish also detracts from the visual amenity.

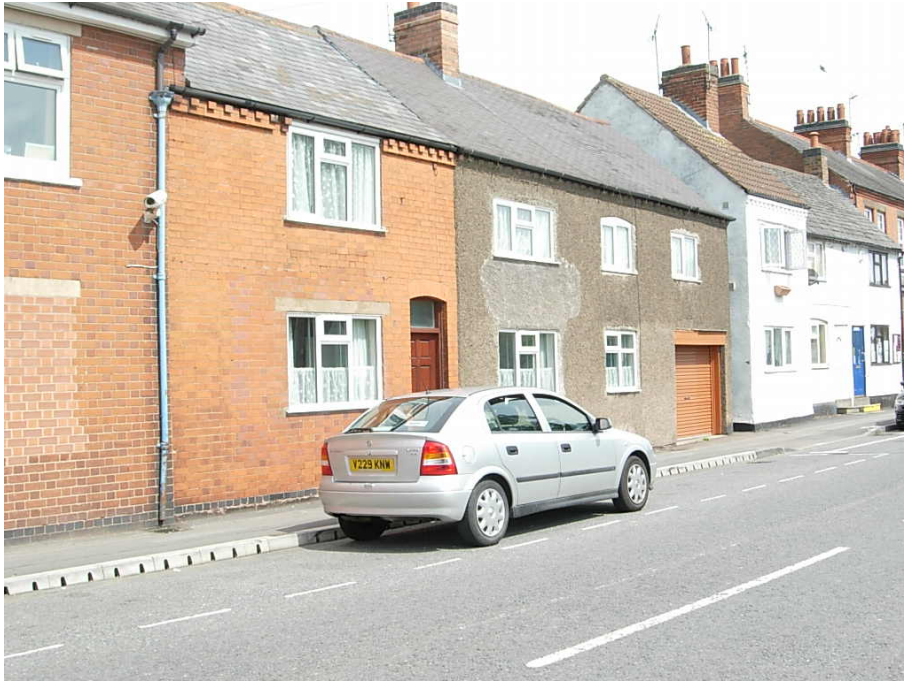
5 Station Road is built in red brick with a slate roof and has a fine dental course. The dwelling, 7 Station Road, has had its window openings altered and an integral garage constructed which is the reason why the front of the property has been rendered.

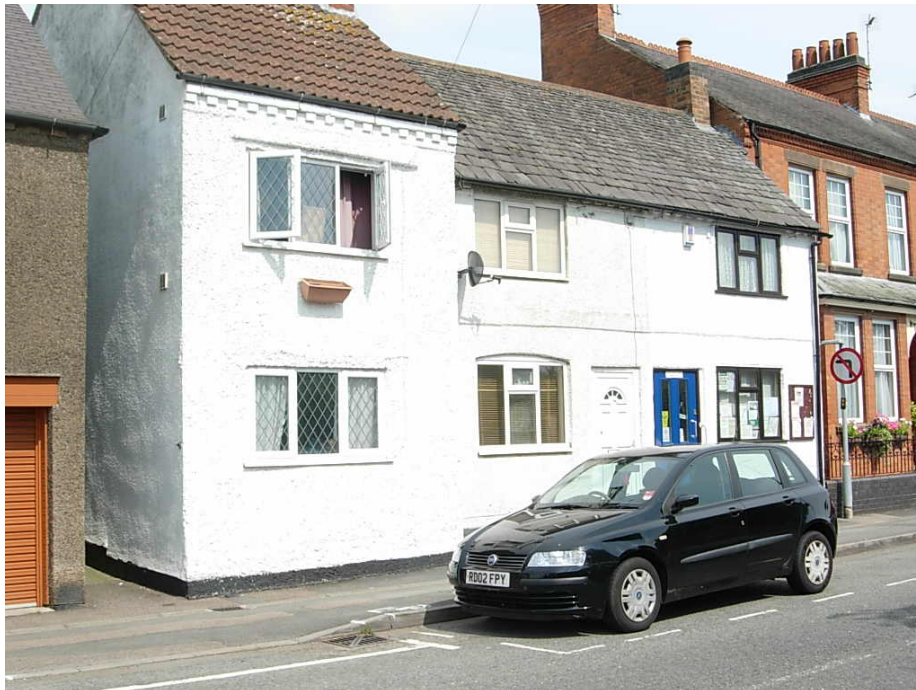
The cottages 9-13 Station Road have been modernised with plastic windows and in part with concrete roof tiles. 13 Station Road is now the Ratby Parish Council Offices.

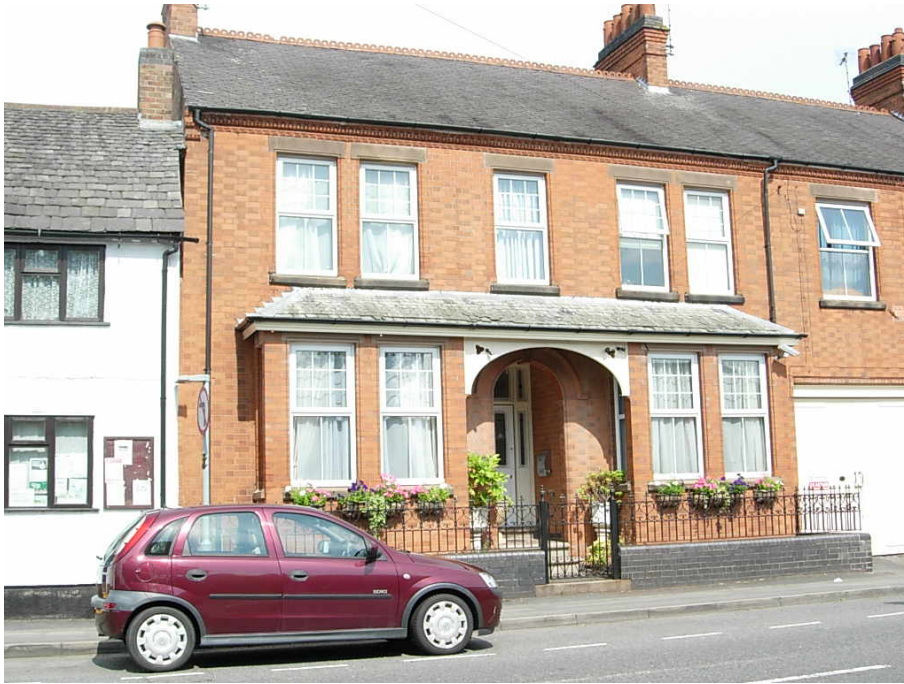
The dwelling, 15 Station Road, is part of a fine red brick terrace that has retained its original window openings, slate roof and terracotta ridge tiles. Its low blue brick wall topped with metal railings and prominent chimney stacks and pots are also excellent features.

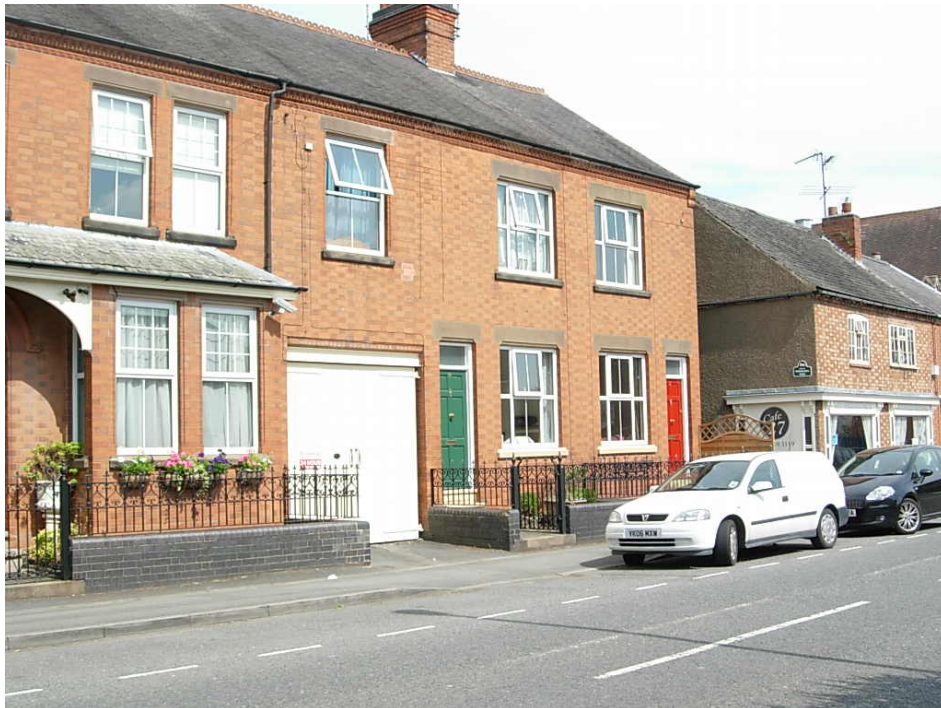
The gate to the rear yard at 15 – 21 Station Road would benefit visually if it was painted in a darker colour and the two front doors painted in the same colour.

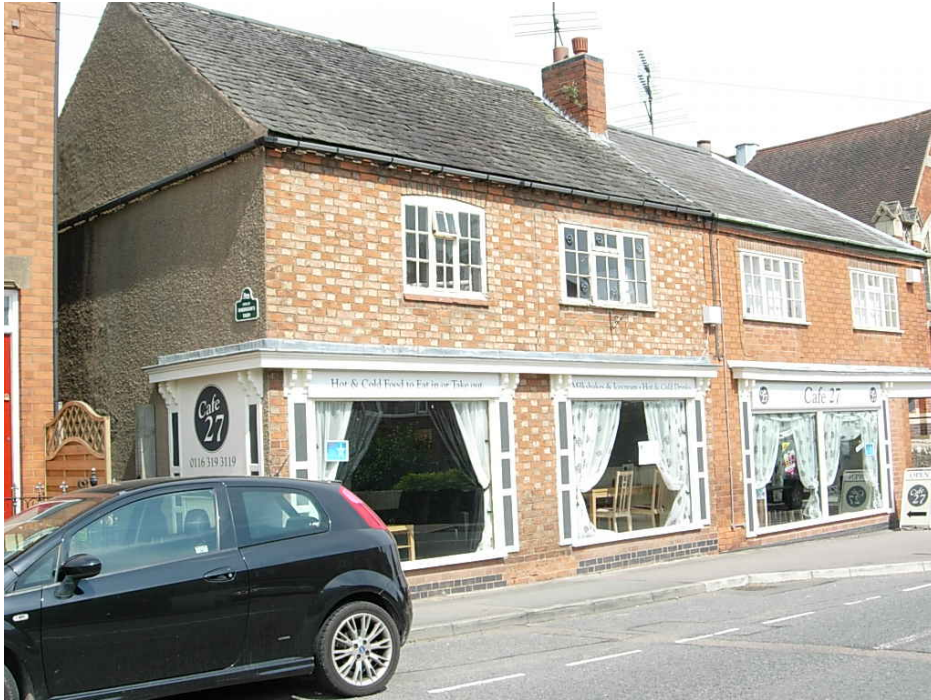
This property, 21 Station Road, has recently been converted into a café.

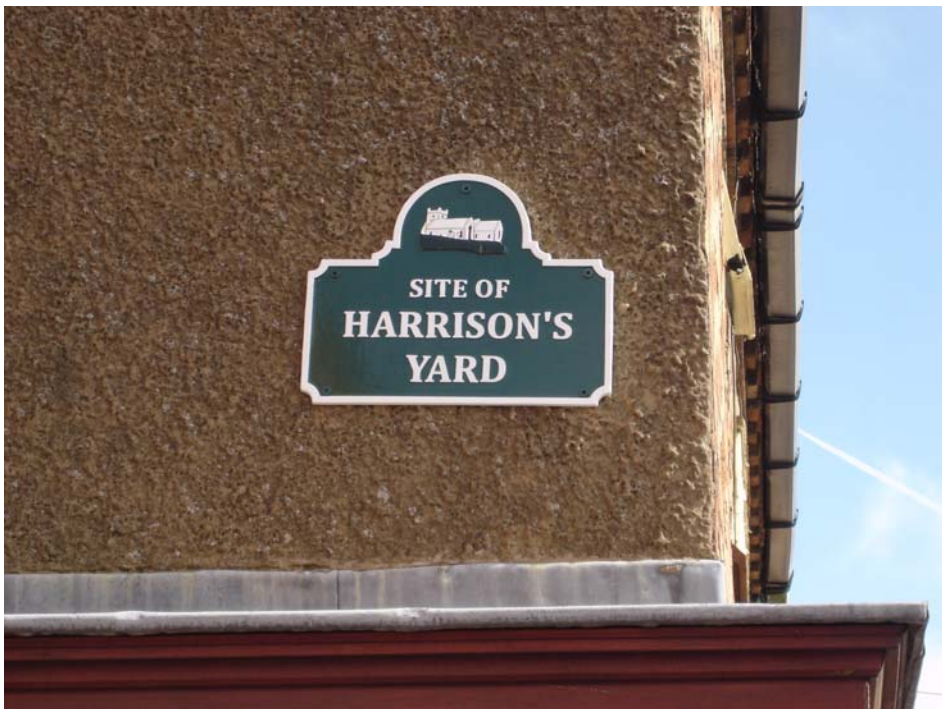
The jitty to the side of 21 Station Road was used to gain access to Harrison's Yard that took its name from Harrison's Drapery Shop. The yard was first created by the conversion of farm outbuildings into six residences during the early 19th century.

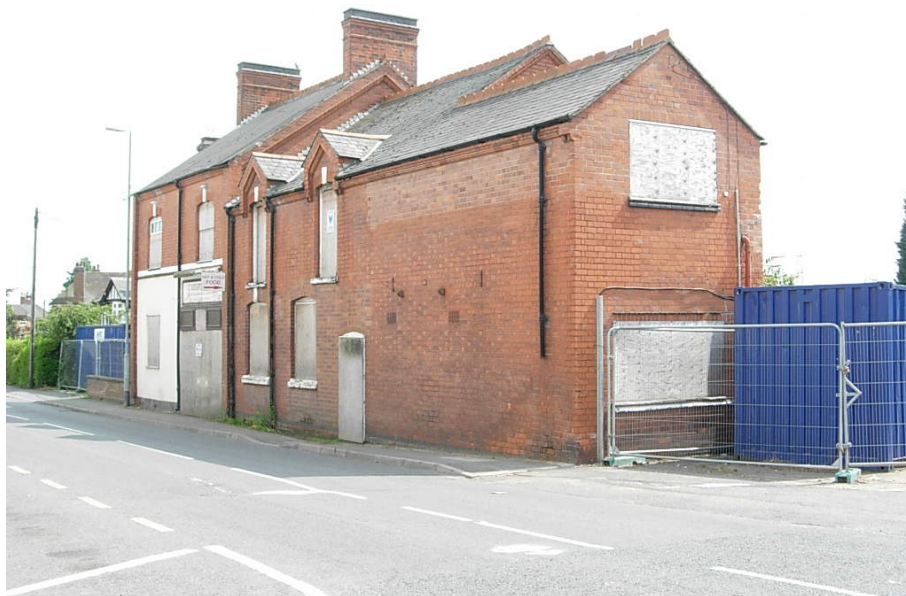
The former Geary's bakery shop, although not situated in the Conservation Area, is an important building as it provides enclosure at the entrance into the Conservation Area. Every effort should be made to retain this property.

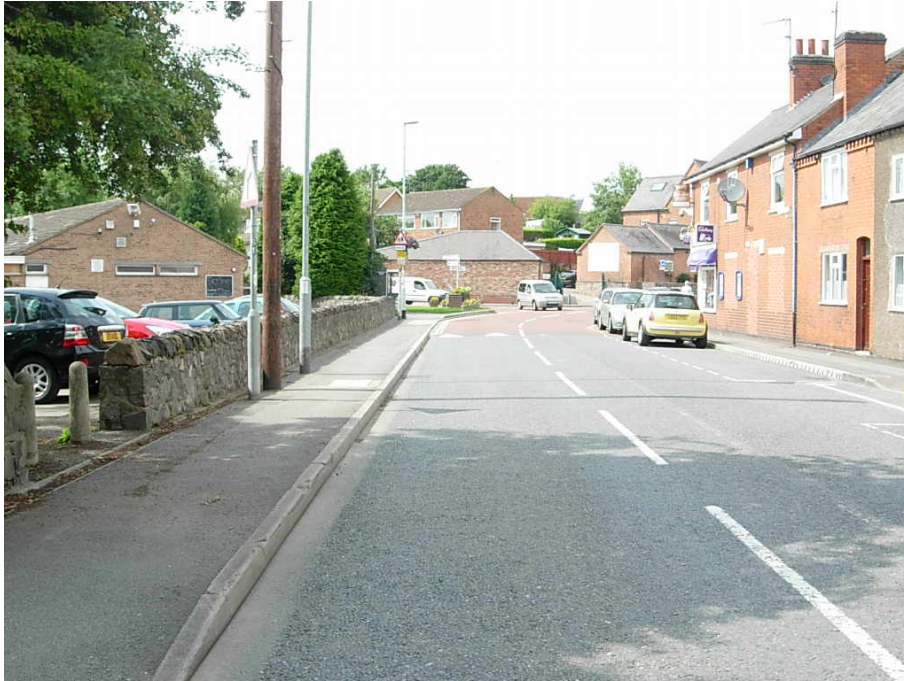
View looking westwards along Station Road. The stone wall running down the southern side of the road was built to replace an existing stone wall that was demolished when the footpath was provided.
