**HIGHAM ON THE HILL
CONSERVATION AREA
MANAGEMENT PLAN**

**PHOTOGRAPHIC RECORD OF HIGHAM
ON THE HILL CONSERVATION AREA**

October 2009

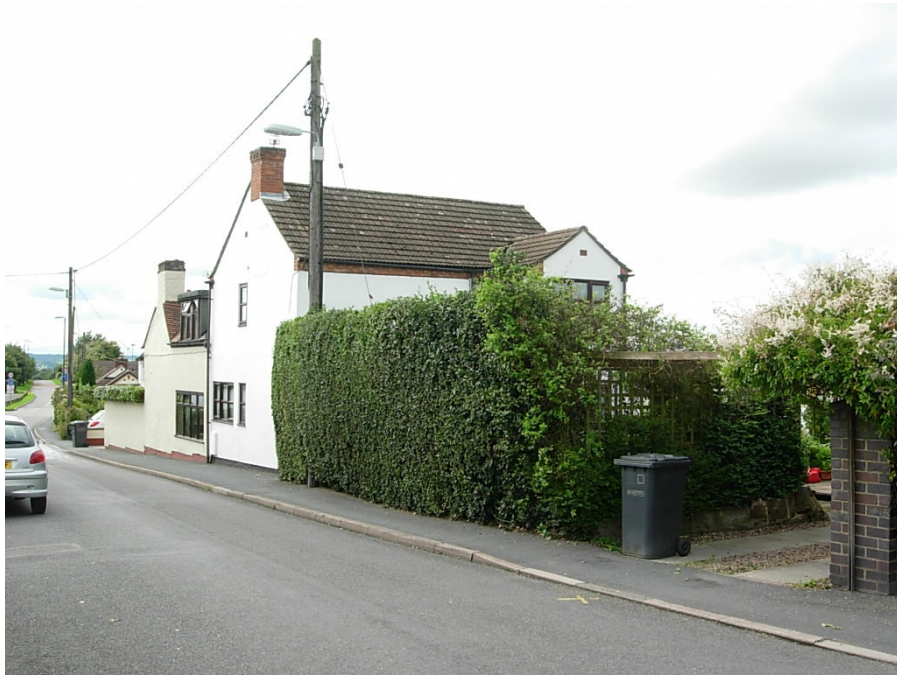
The tall hedge fronting 23 Main Street is a dominant feature that helps to soften the street scene.

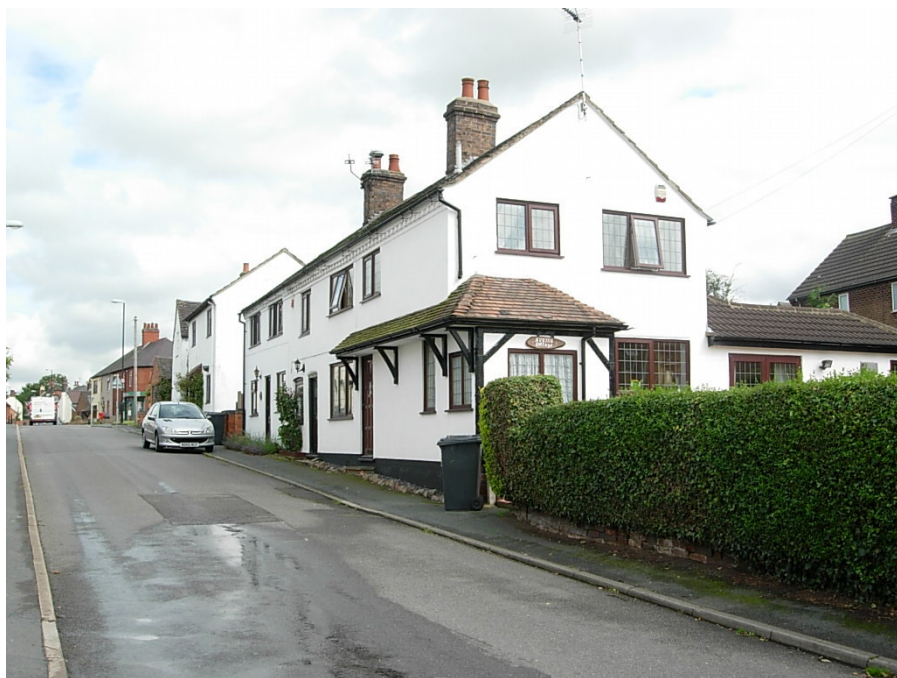
26 – 30 Main Street is a pleasant terrace that has retained its chimneys.

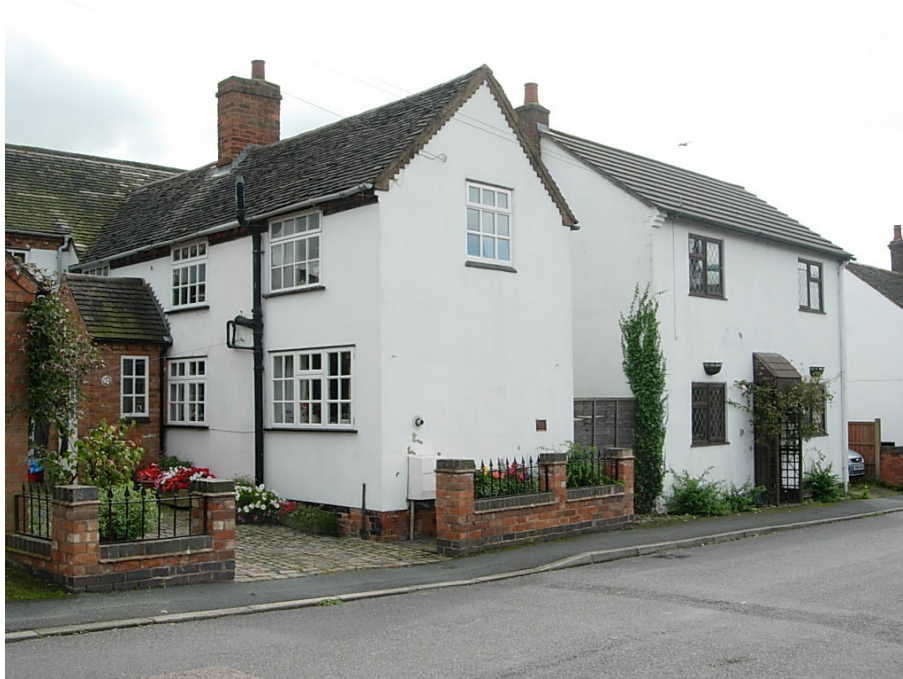
32 & 34 Main Street are an interesting group with 34 having its gable end fronting the road with small pane windows.

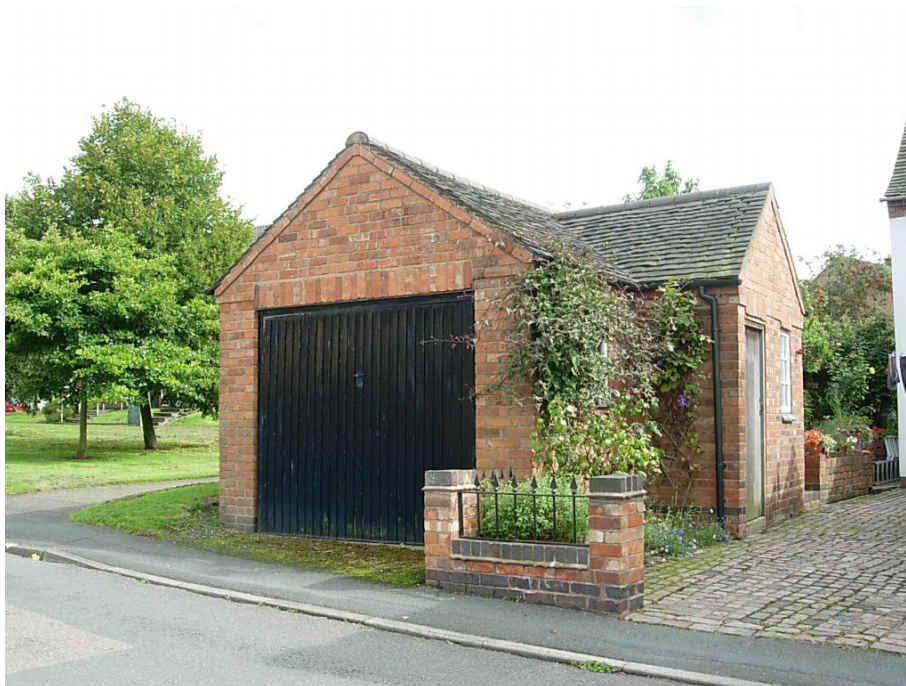
The garage and outbuildings at 34 Main Street are more in keeping with the traditional street scene having pitched roofs and the door painted a dark colour. The granite surfacing is particularly attractive.

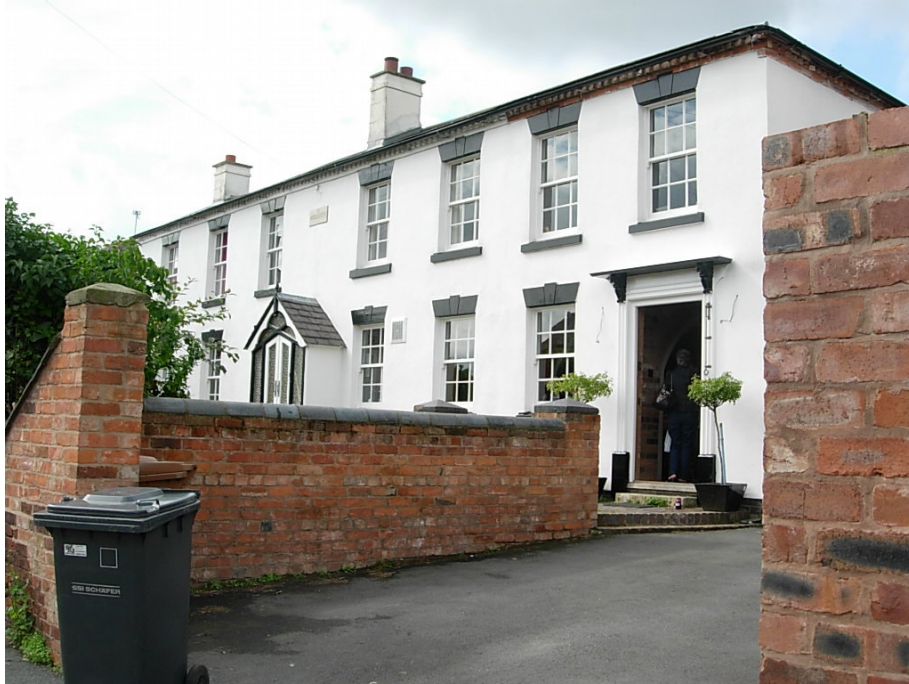
33 Main Street is an excellent vernacular dwelling rendered white with sash windows, sills, traditional walls and copings.

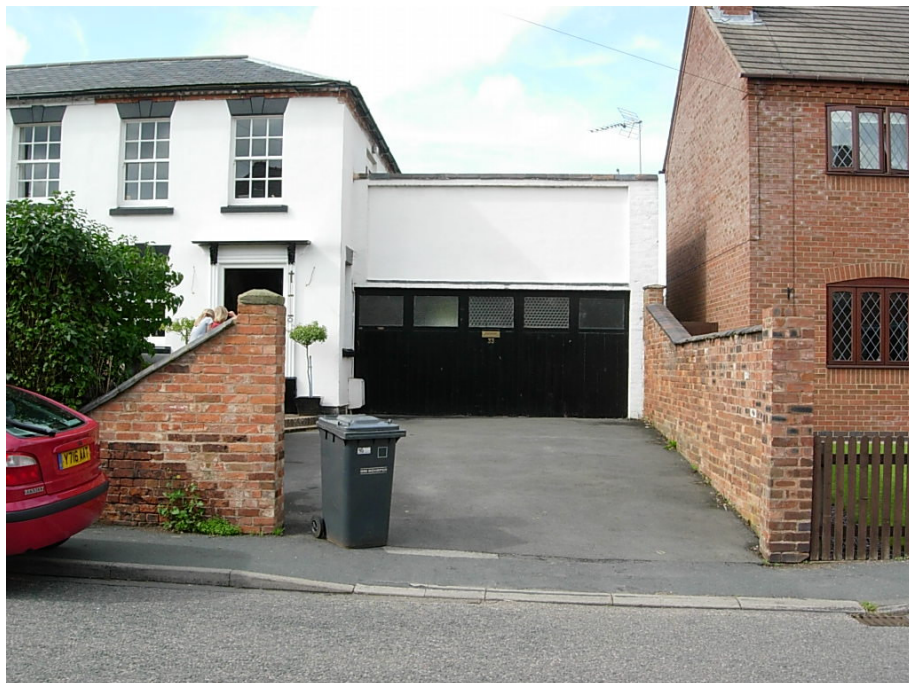
The garage adjoining 33 Main Street compliments the dwelling by way of design, scale and timber door.

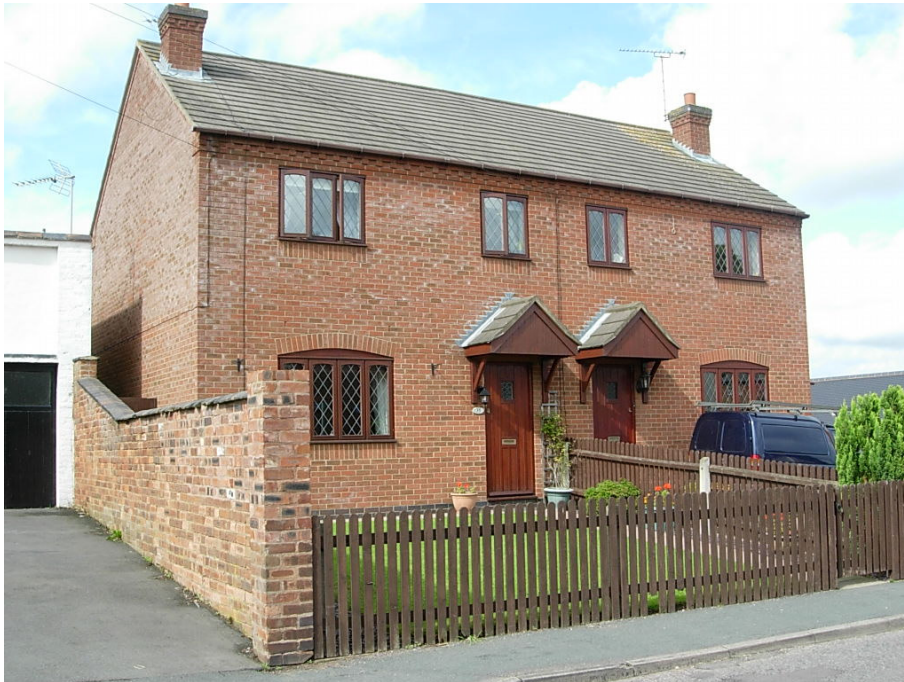
The recently built semi detached dwellings, 35/37 Main Street, are of simple design with small front canopies and picket fence.

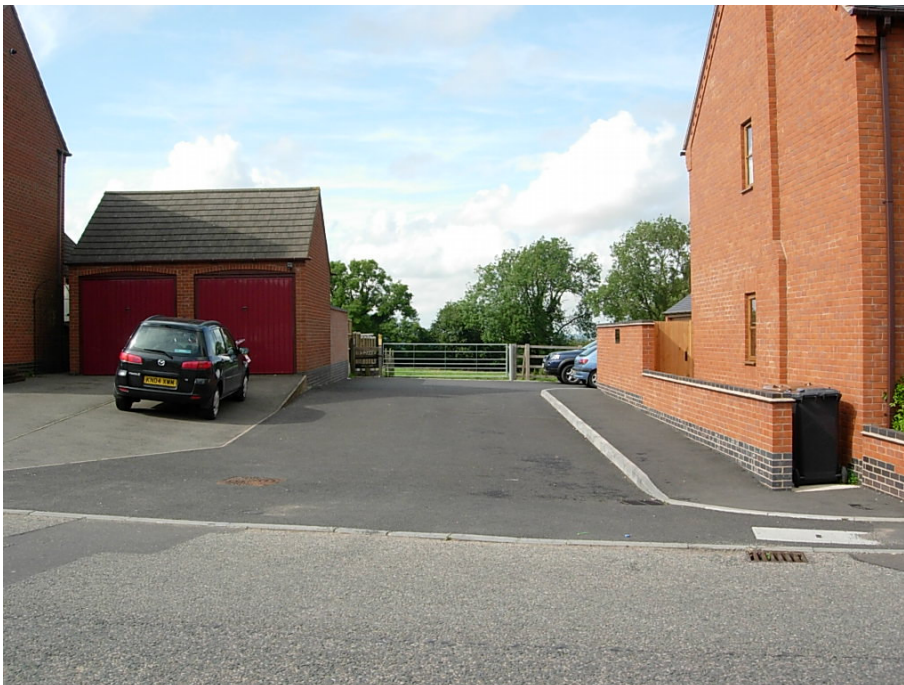
The access road adjacent to 37 Main Street allows views to the countryside.

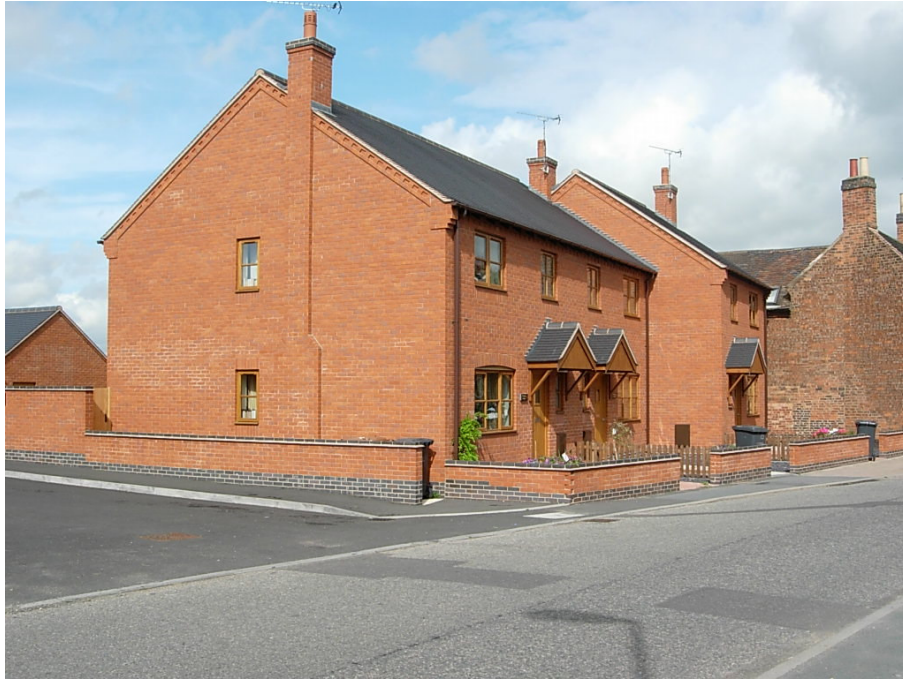
The modern dwellings built on the former garage site are also of simple design complimenting the semi detached dwellings on the opposite side of the access drive.

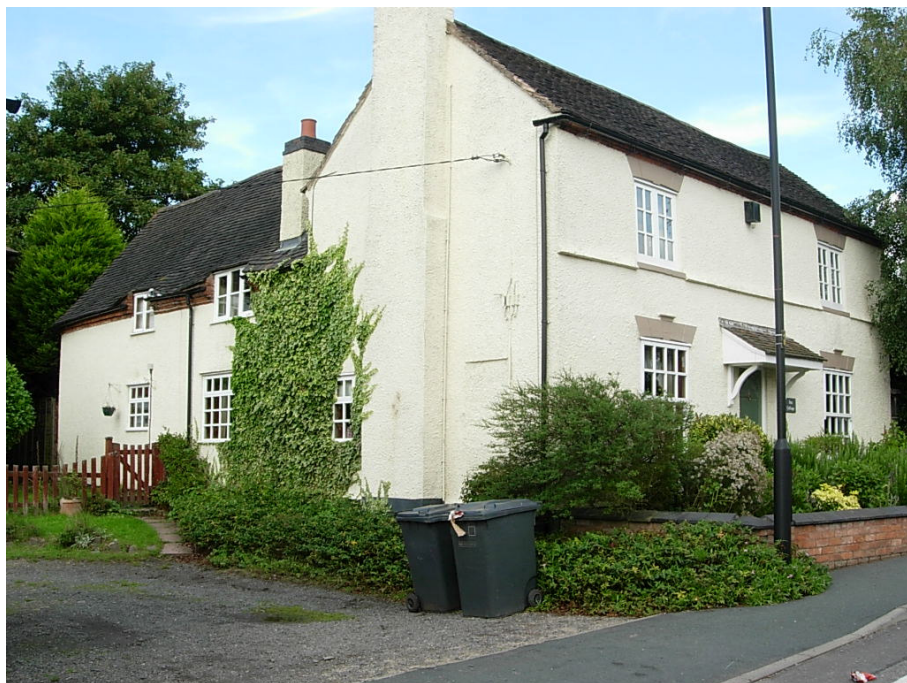
Fox Cottage is a well maintained rendered property with rosemary roof tiles and a pleasant front garden and wall.

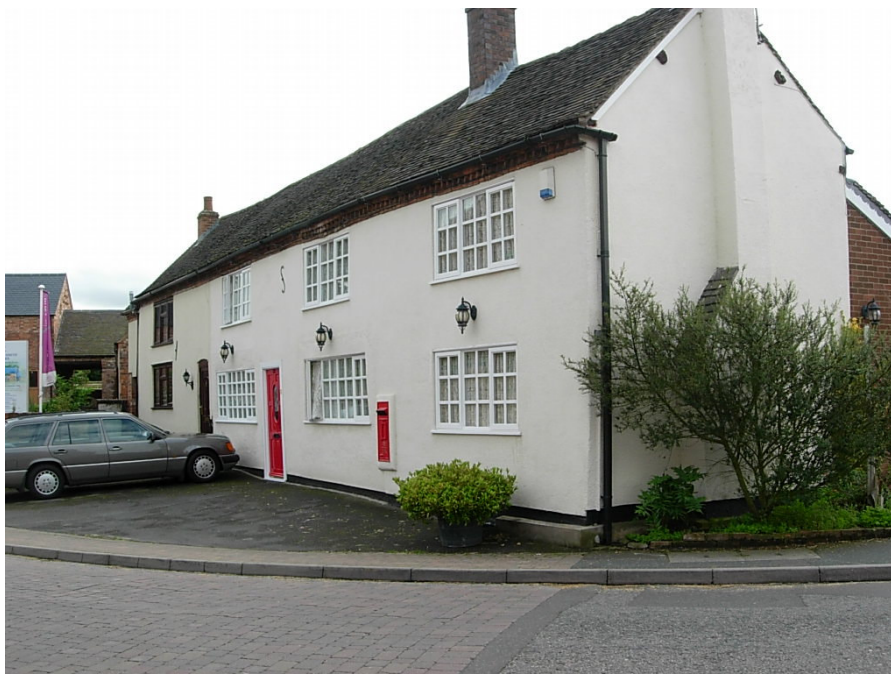
The old post office is sited in a prominent location in the conservation area. The rendered property that has timber windows and rosemary roof tiles has retained its original wall post box.

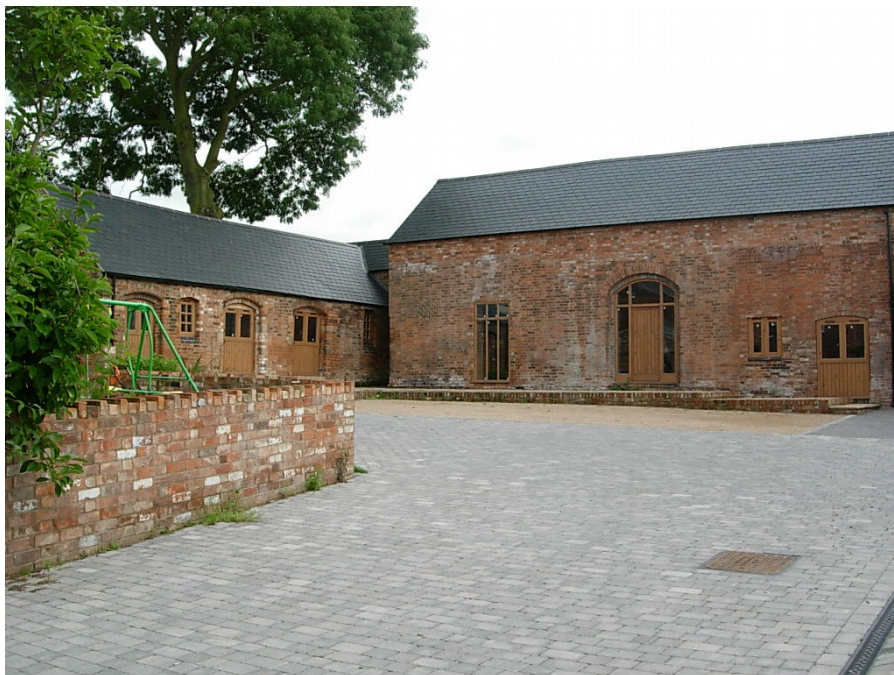
The out buildings at Ravenstone Farm have recently been sympathetically converted into dwellings.

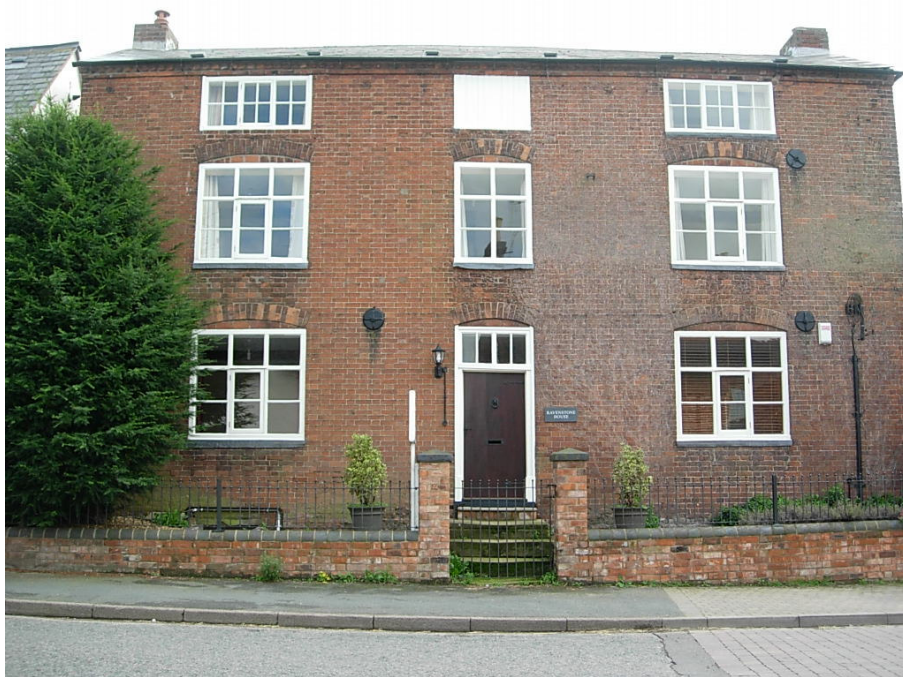
The 3 storey late C18 Grade 2 listed dwelling is one of Higham's important vernacular buildings. The red brick property with slate roof, end chimney stacks and large window casements has steps leading to a flush panel door.

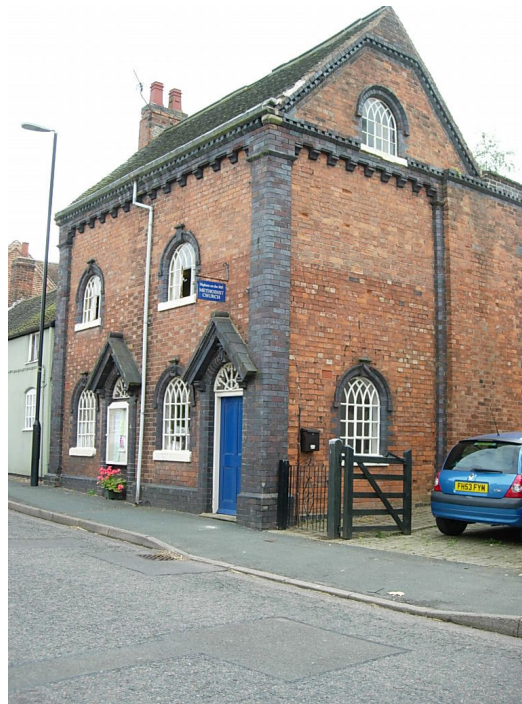
The Grade 2 Listed Methodist Church was originally 'the house that Jack built'. The building which is built of red brick with a purple brick detailing and plain tile roof is a prominent landmark building in the village.

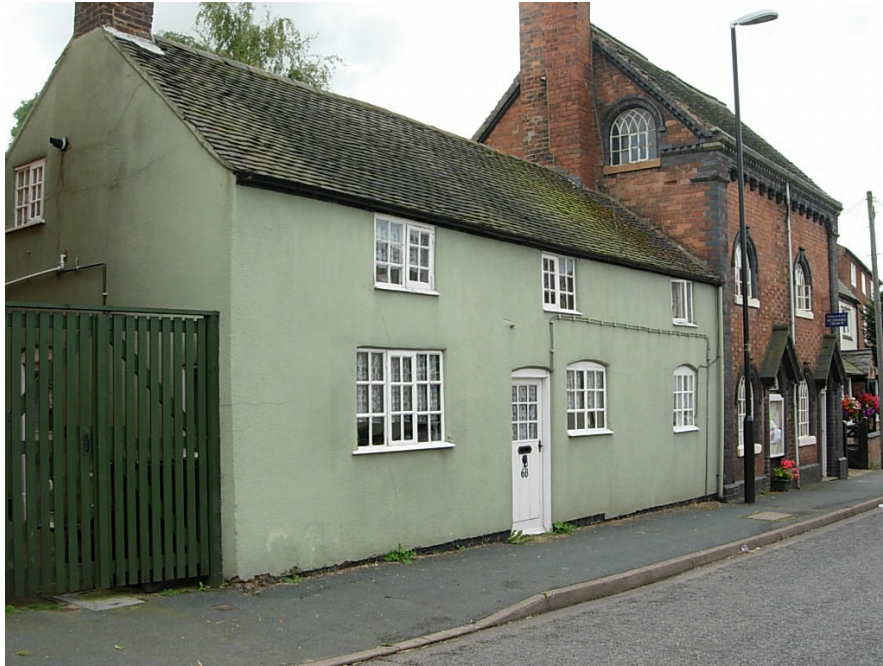
The Grade 2 Listed C18 cottages painted roughcast with plain tile roof have been listed for their group value.

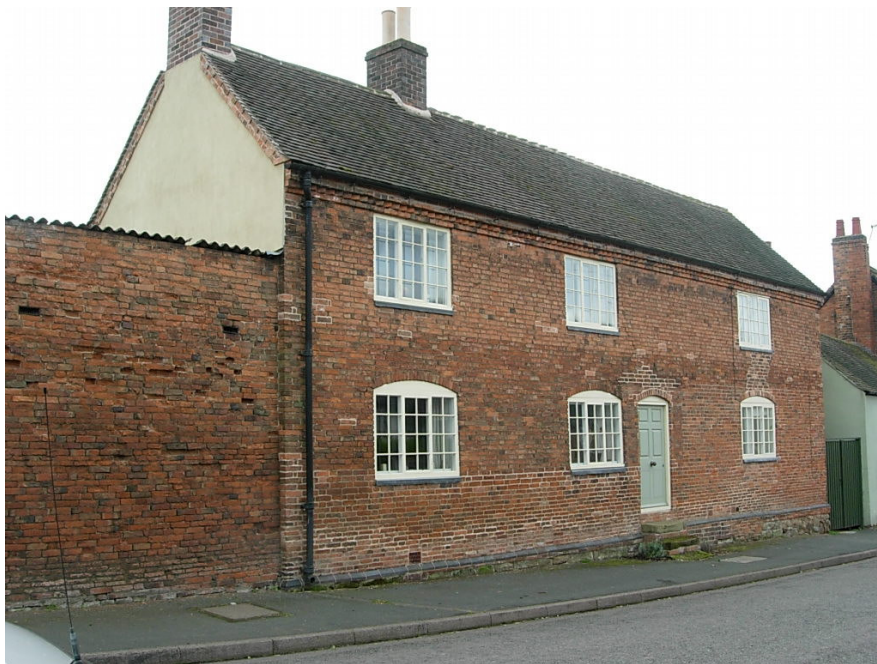
The Grade 2 early to mid-C18 Listed Elms Farmhouse is red brick dwelling built on a Charnwood rubblestone plinth with plain tile roof and steps leading to a central 6 panel door. The farm is now a riding school.

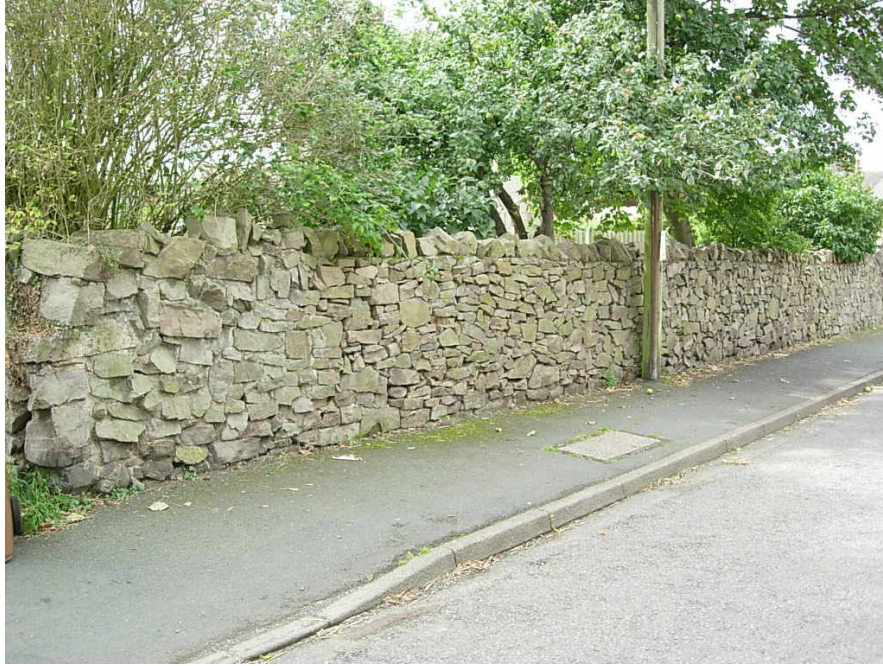
The stone wall fronting Ivy House Farm was rebuilt with a grant from the Borough Council's Environmental Improvement Programme in order to help retain these important features. It is an important historic continuous feature in the conservation area where its impact is strengthened by its continuity

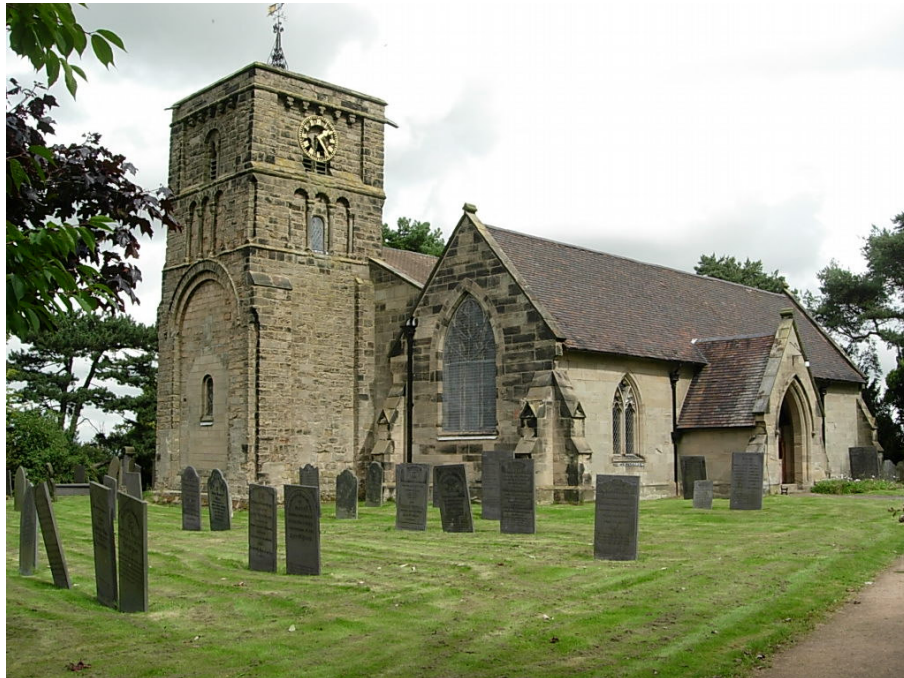
Grade 2* Listed St Peter's Church with its C12 tower. The steeple was removed in the last war as it was considered a danger to aircraft flying from Higham Airfield.

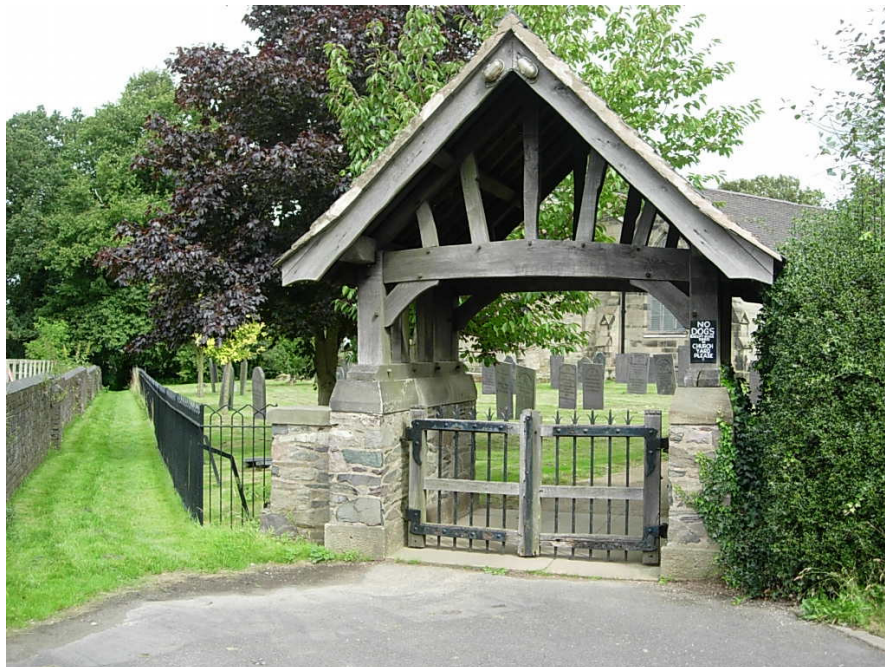
The lychgate built in 1939 is an impressive entrance to St Peter's Churchyard. The Borough Council has replaced the church yard railings using its Environmental Improvement Programme.
