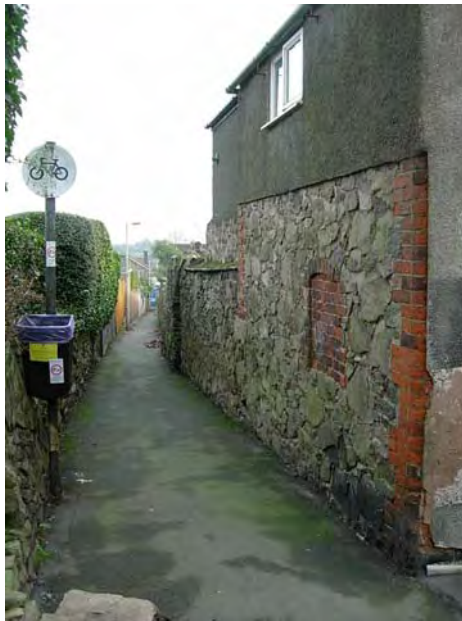
The jitty that runs from the northern end of The Green to Main Street is one of several jitties often flanked by important granite walls. These pedestrian routes traditionally linked Main Street to the ambient farmland.
