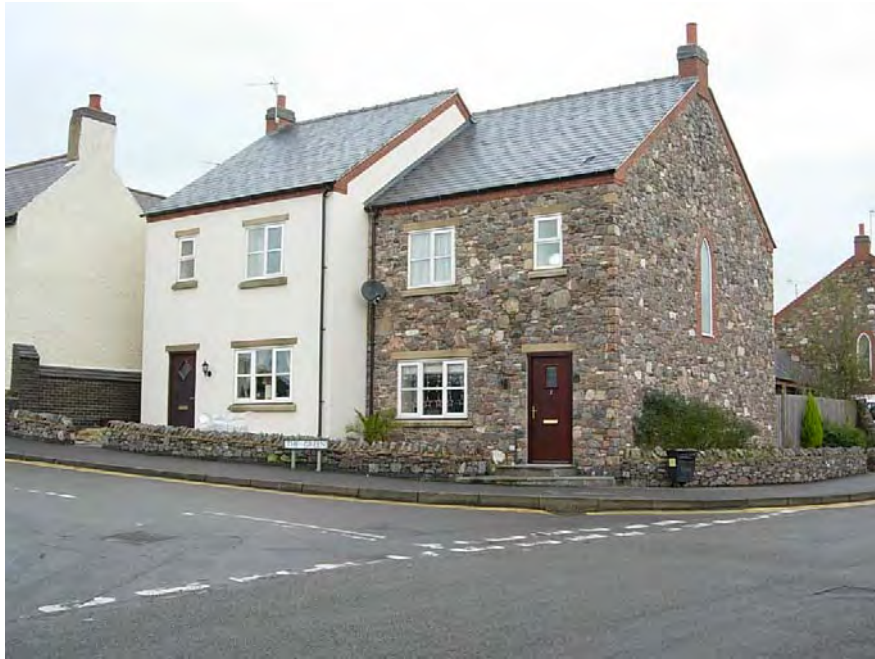
The recently erected semi-detached dwellings at the junction of The Green and Main Street provide a fine setting fronting Saw Pit Green.

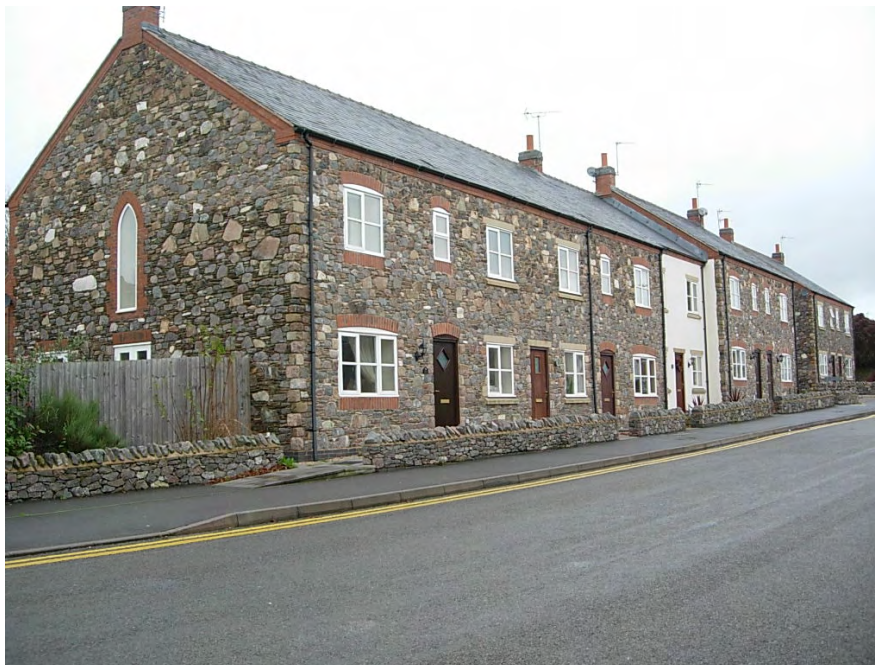
The recent development on Main Street successfully blends with the traditional character of the village by way of design and use of natural materials.

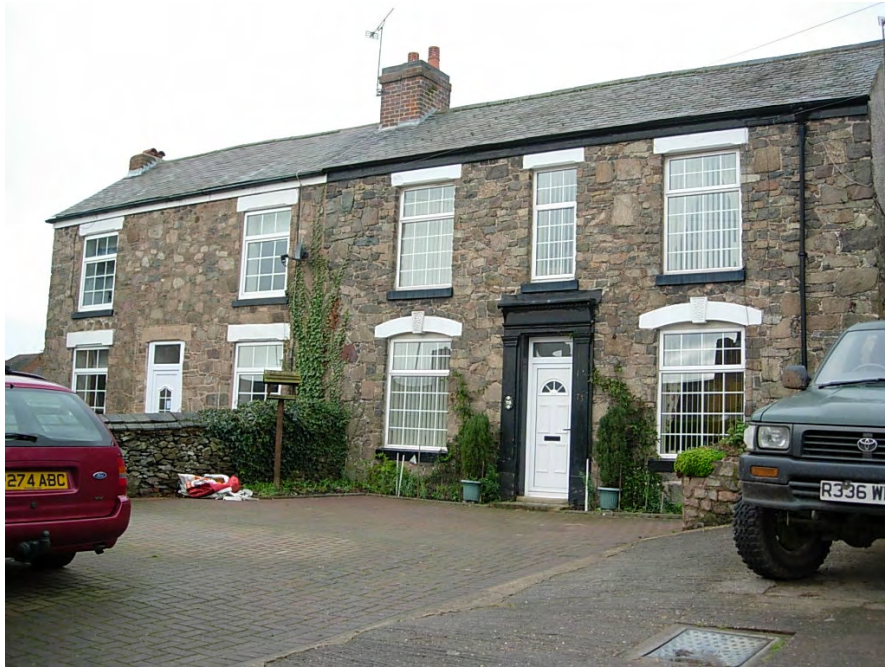
The two semi-detached dwellings 71 & 73 have generally retained their unity although some artificial materials have been introduced.

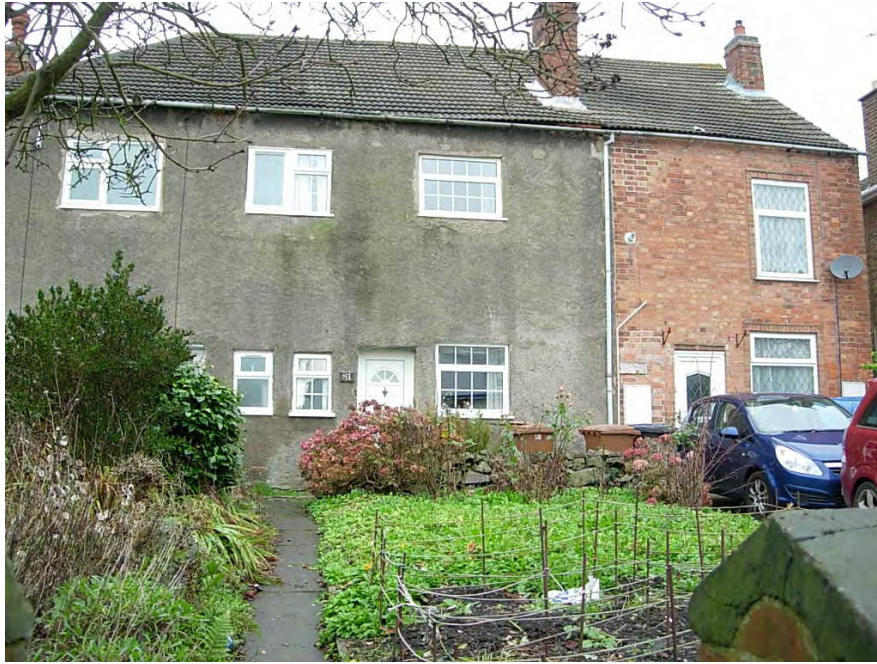
The rendered dwellings 79 – 81 Main Street that have a hipped roof were the first chapel to have been built in the village. This is a very important building in the conservation area. The end property, 83 Main Street appears to have been built at a later date.

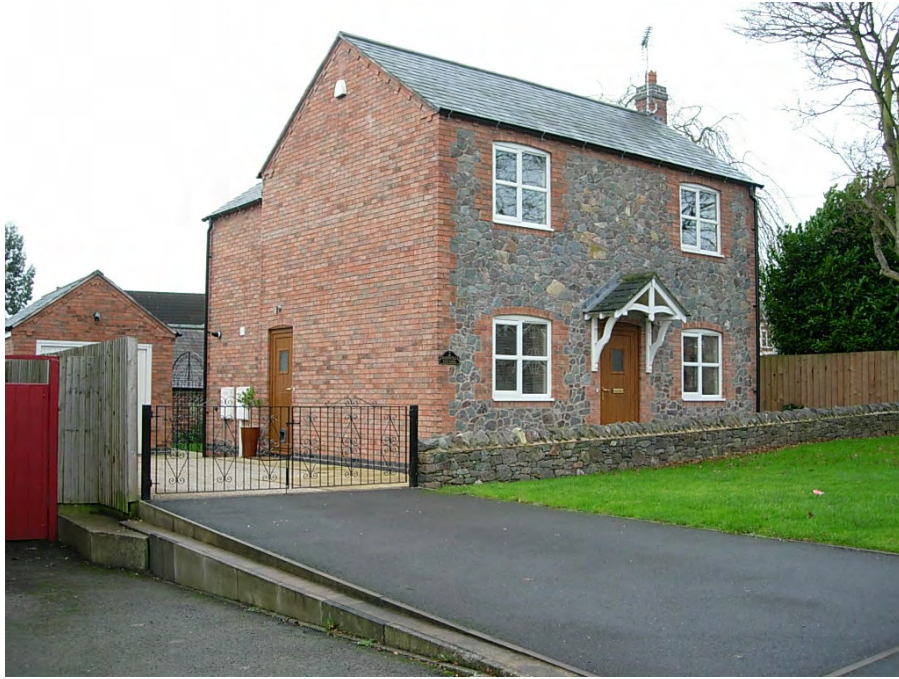
This dwelling on the corner of Neville Drive has only recently been erected and generally has a neutral impact on the conservation area.

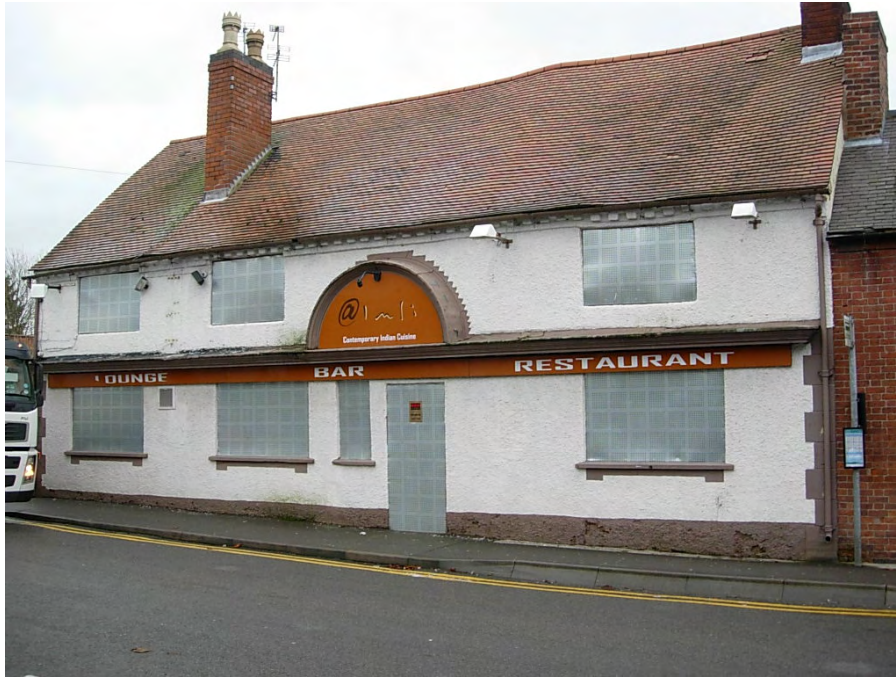
The George Pub is now closed. The land to the rear has development potential but it is important the pub premises front Main Street is retained.

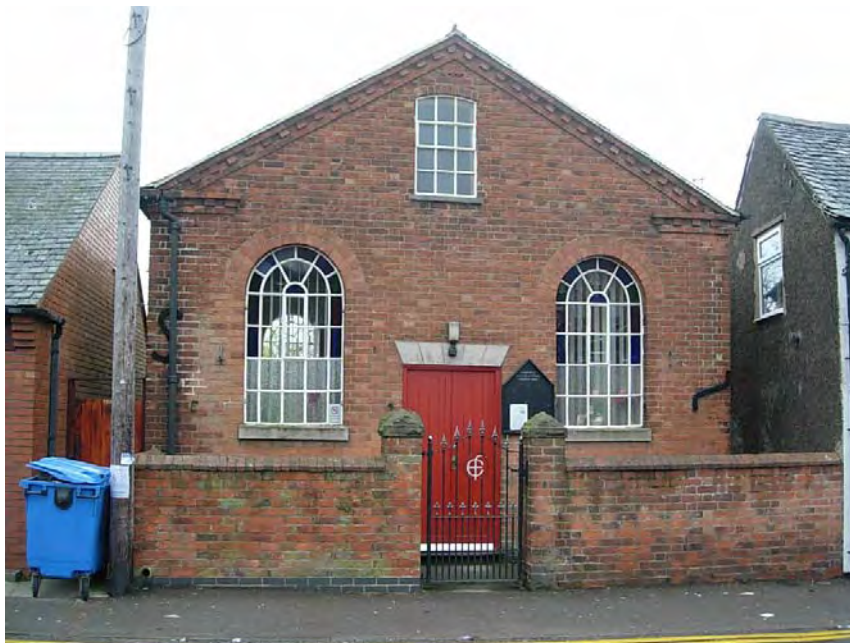
Markfield Congregational Chapel with its rounded cast iron windows and brick wall is an attractive building on Main Street.

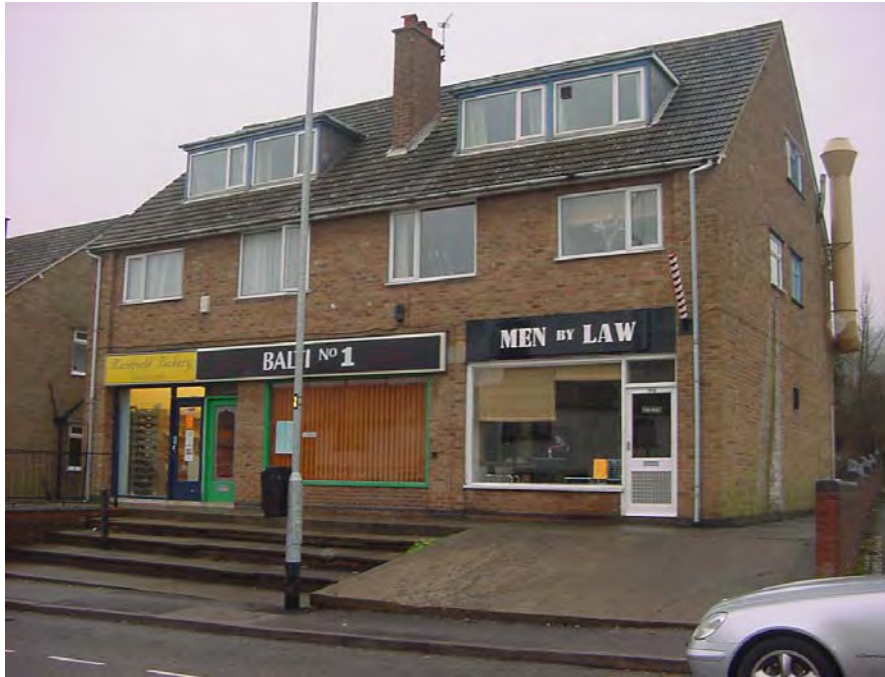
99 Main Street before an enhancement scheme to improve the front of the building was carried out by the owner and the Borough Council. Although the premises are not in the conservation area, it has a considerable visual impact.

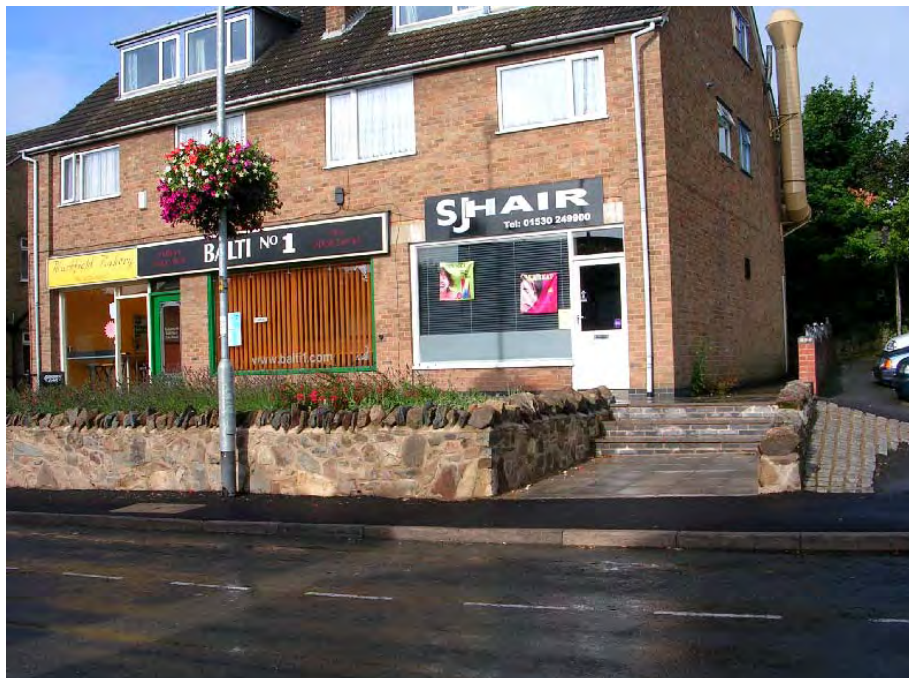
99 Main Street after completion of an enhancement scheme. The scheme comprised the construction of a granite wall fronting Main Street with a planting bed behind and disabled access provided from the adjacent council car park.

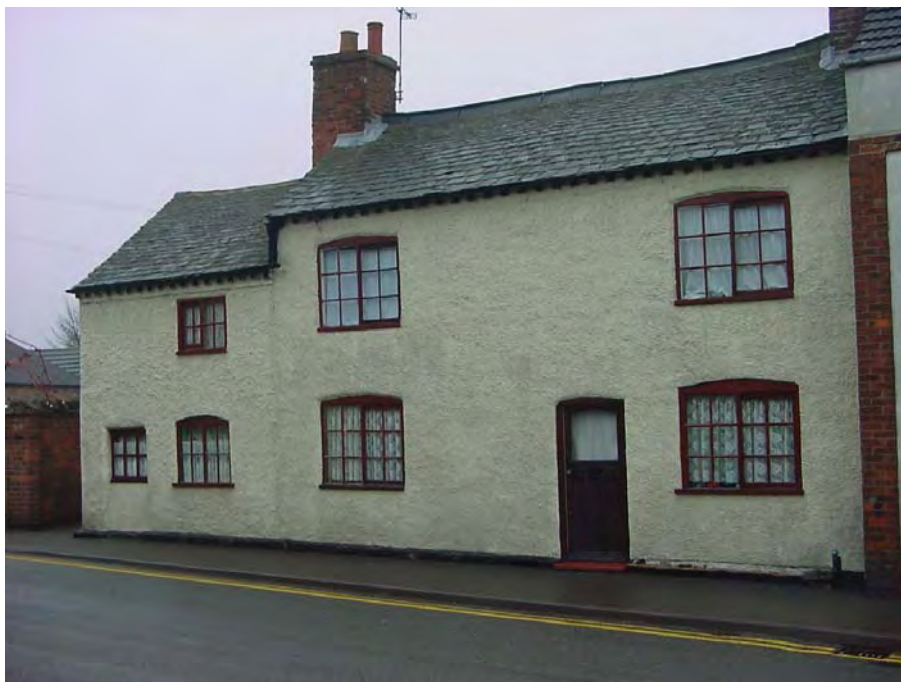
116/118 Main Street is a rendered property with a slate roof.

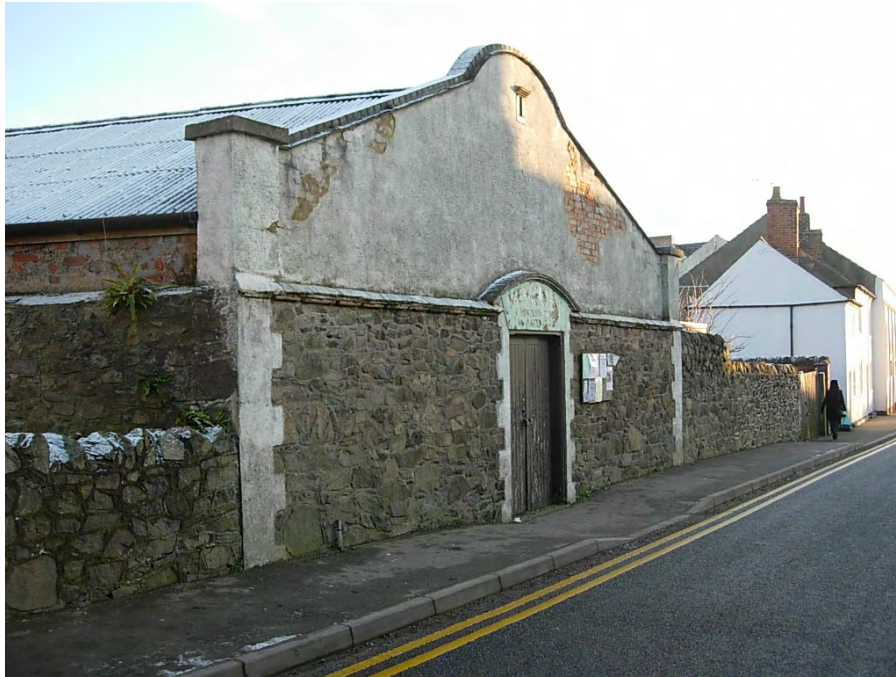
There are proposals to demolish the Miners Welfare Hall on Main Street that was once the village cinema. Redevelopment of the site should respect traditional design elements of the village and materials.
