Markfield conservation area photographic survey part 4

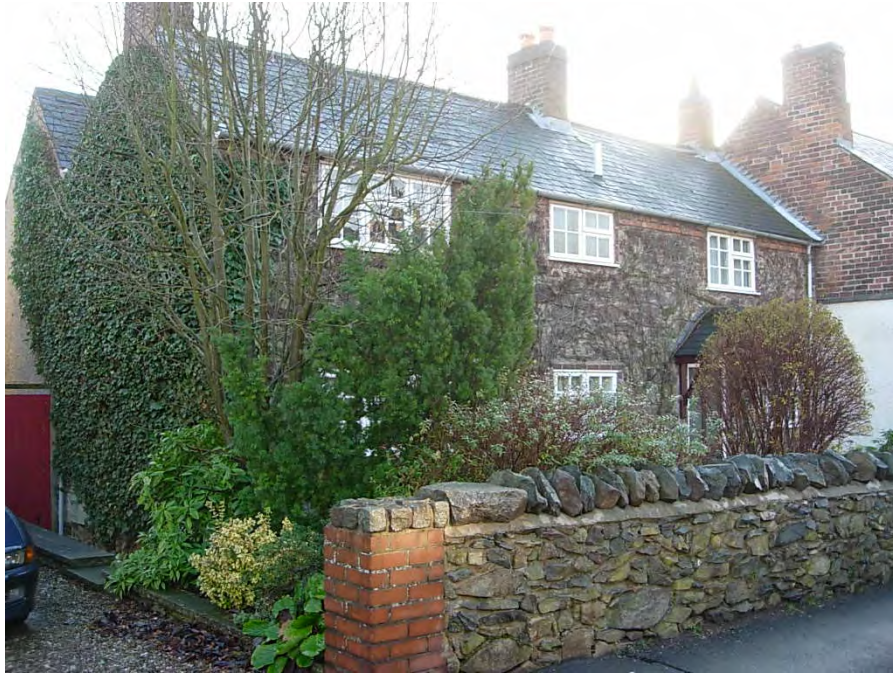
168 Main Street is an excellent stone cottage that has a fine granite wall along its frontage. The property has a slate roof, timber windows and has retained its chimneys.

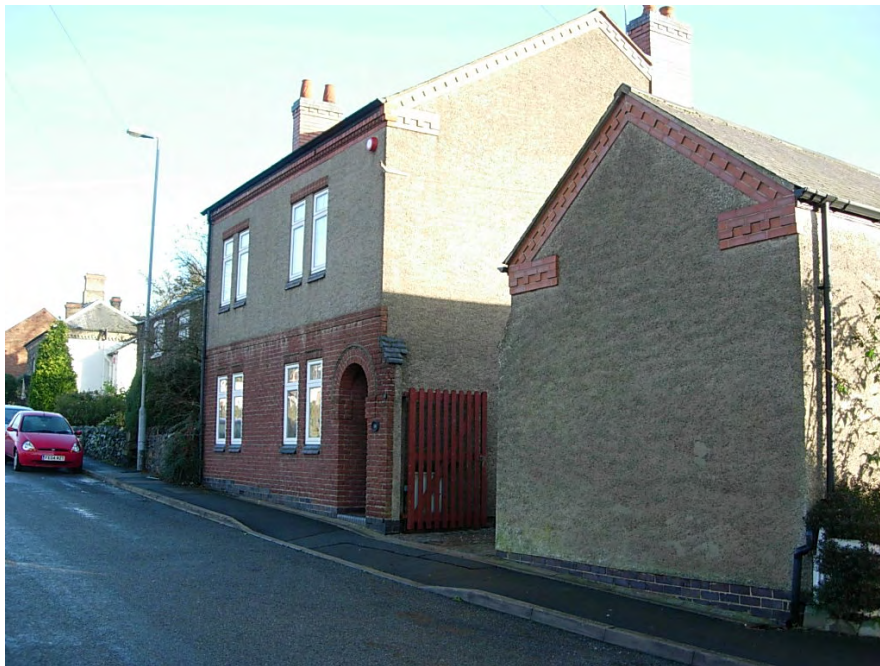
180 Main Street has a brick finish on its front elevation at ground floor level with the rest of the property rendered.

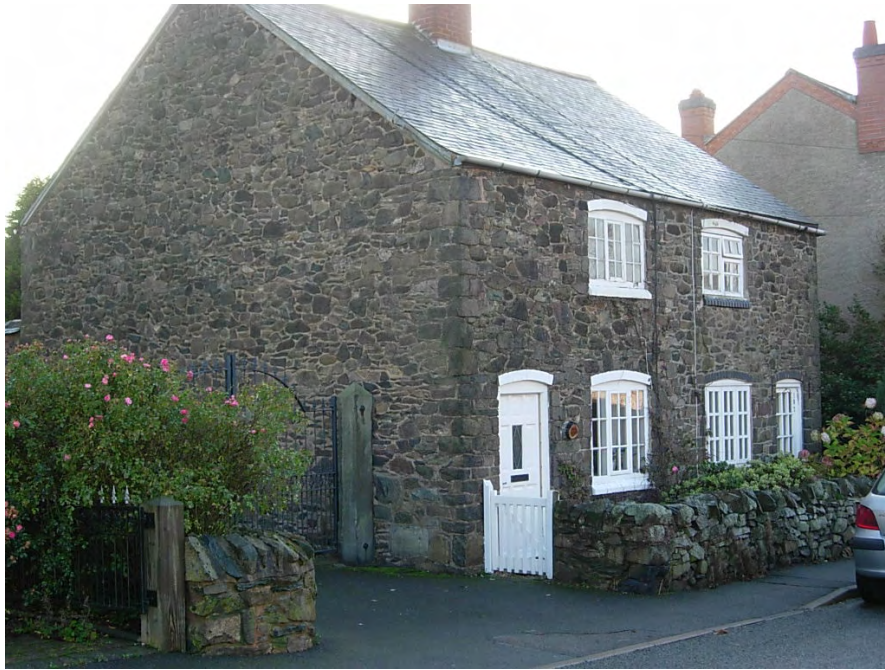
182 & 184 Main Street, a charming pair of granite cottages that have generally retained their traditional character.

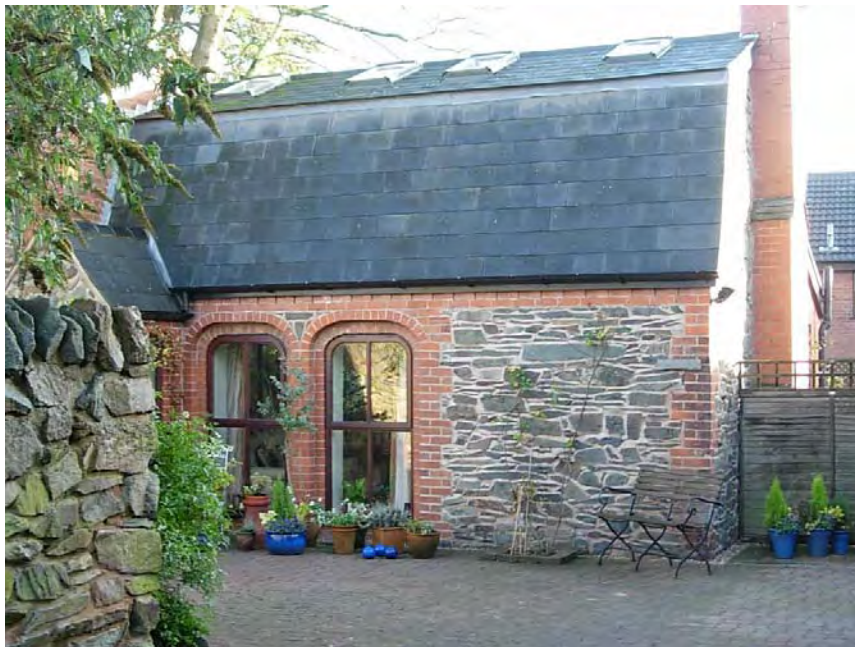
The modern dwelling 186 Main Street is unusual in having a Mansard roof.

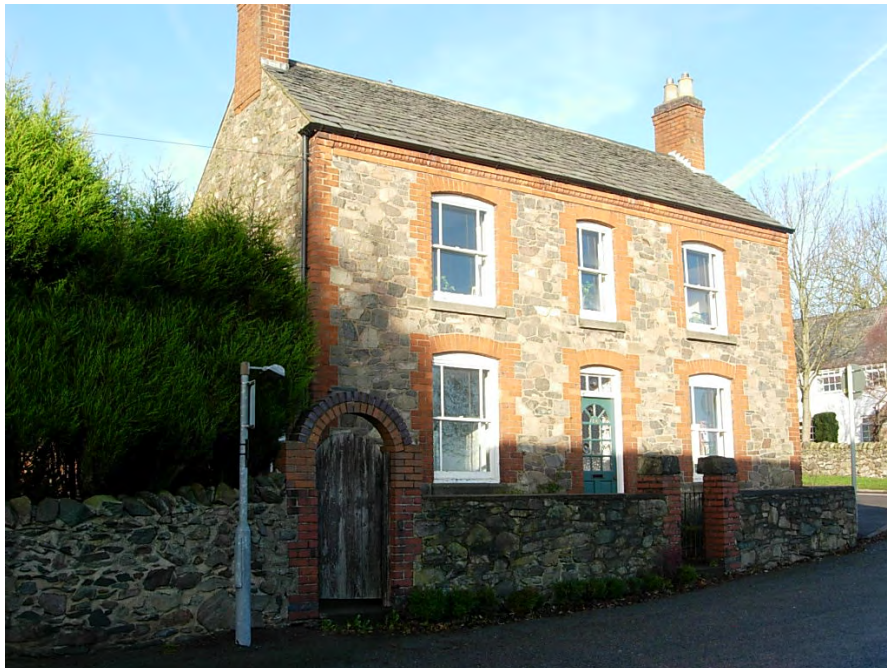
196 Main Street, the village's old police house occupies an important position at the road junction with Leicester Road and Ashby Road. The property has retained its sash windows which are currently being refurbished.

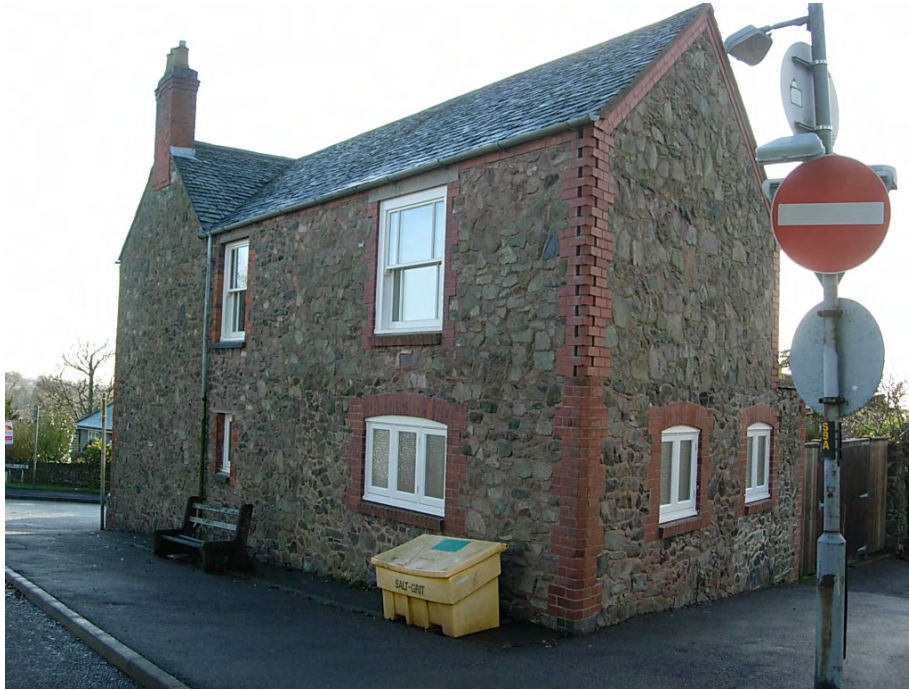
View of the old Police House from Ashby Road. The windows of the property are being replaced with traditional sash windows.

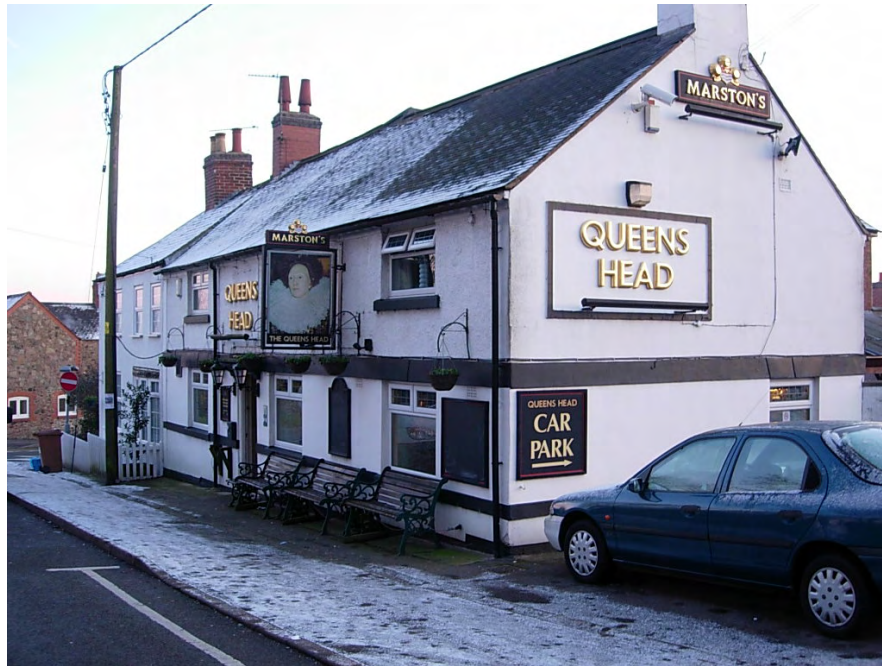
The Queens Head Pub is an interesting property sited on Ashby Road which is enhanced by the advertising of the pub's name at first floor level.

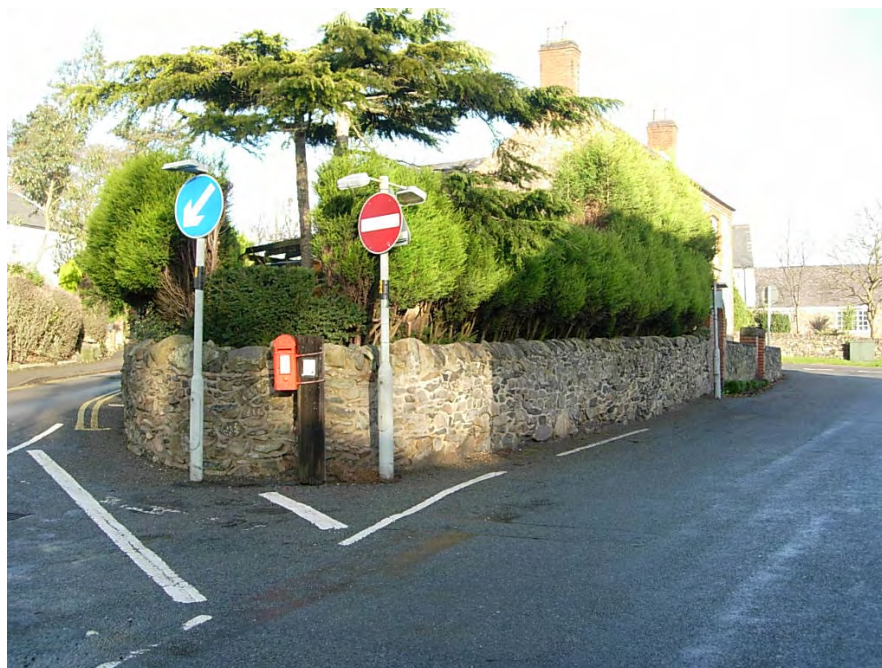
The rear garden to 196 Main Street is flanked by a granite wall. The fir trees in the garden provide colour helping to soften the northern end of Main Street.

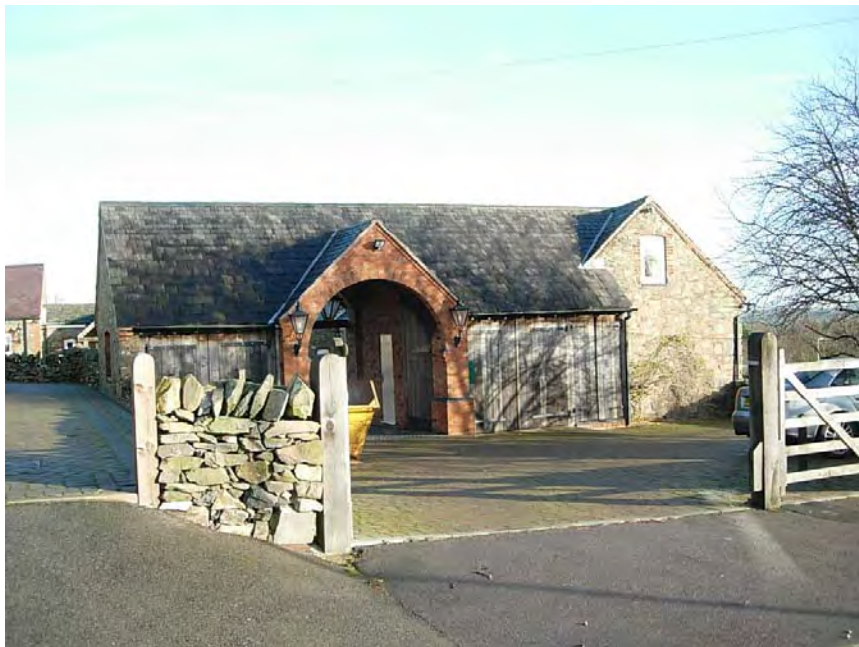
The outbuildings to Townhead Farm have been successfully converted to residential. The access to the inner courtyard is gained through an impressive archway.

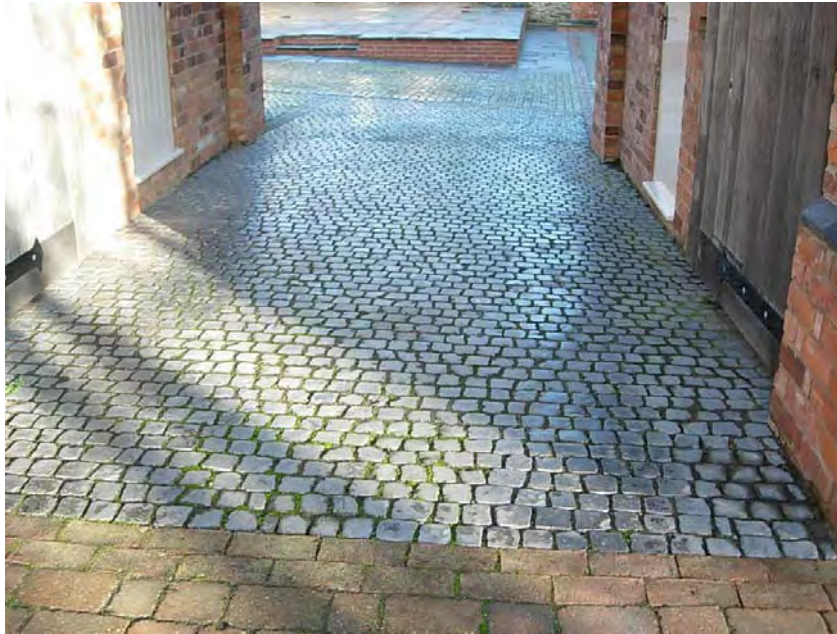
The entrance to Townhead Farm's inner court yard is surfaced with granite setts that makes an attractive feature.

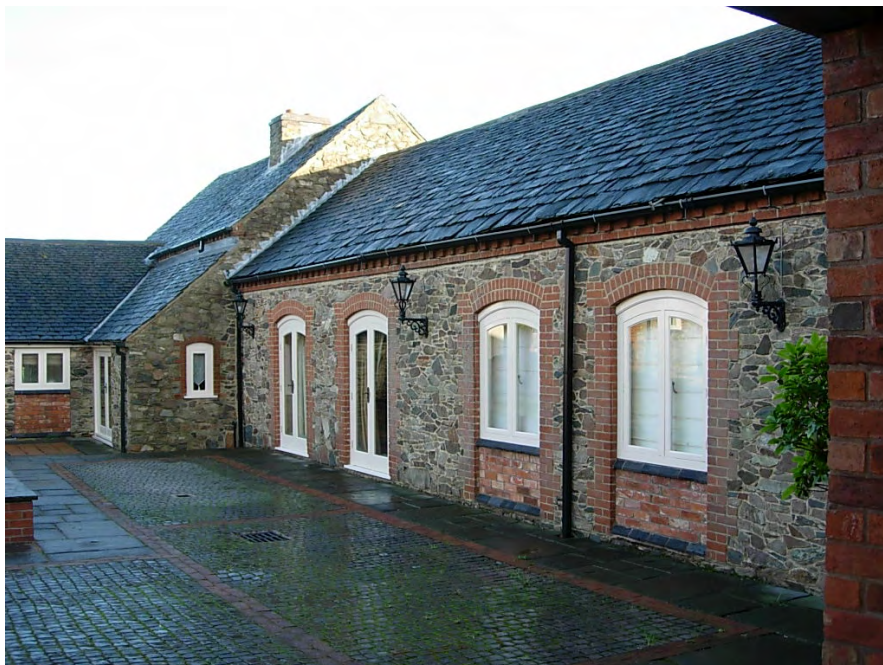
The outbuildings to Townhead farm that surround an inner courtyard have sensitively been converted to residential use.

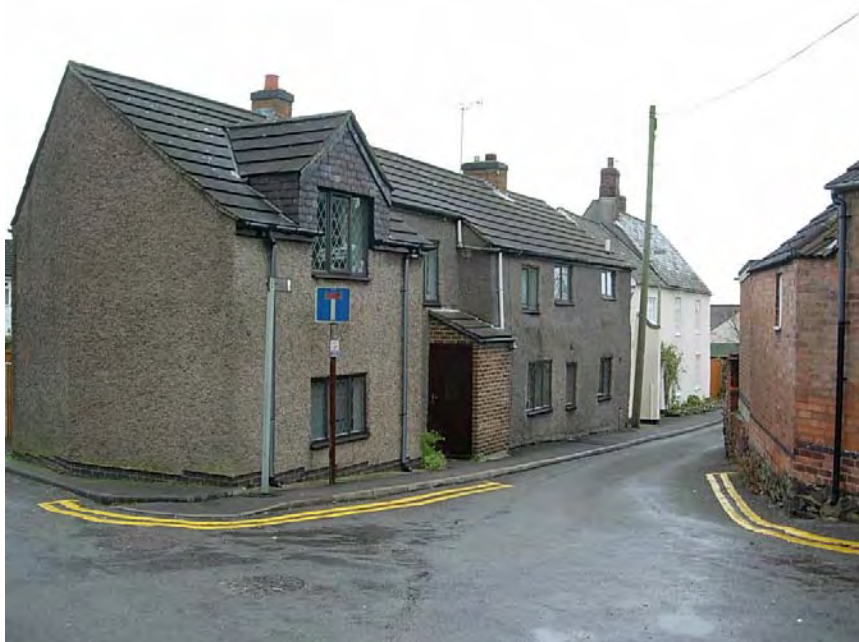
The Nook is an attractive narrow cul de sac.

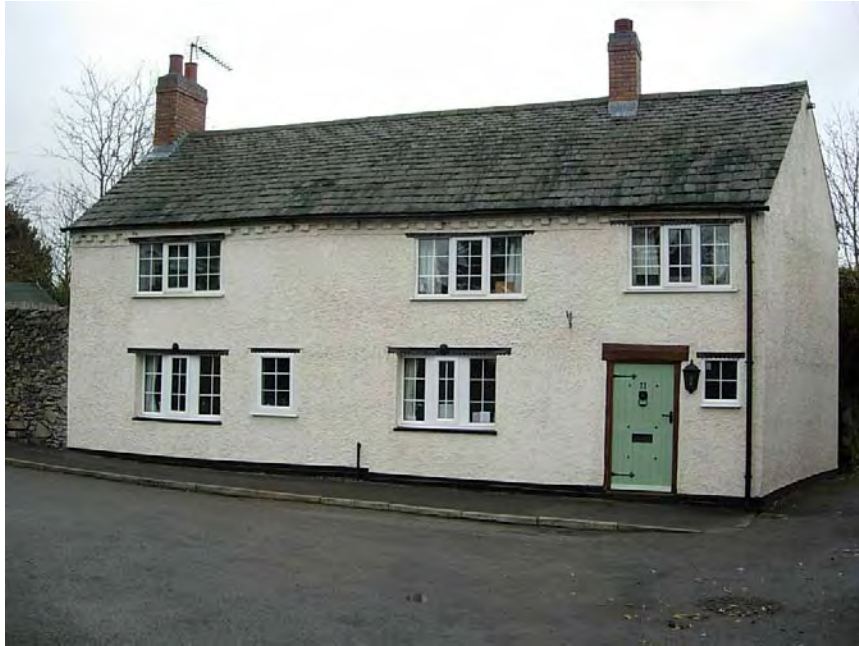
11 The Nook is an attractive rendered dwelling that has been renovated and although its windows have been modernised they have retained their original proportions. The property still has its slate roof and chimneys.

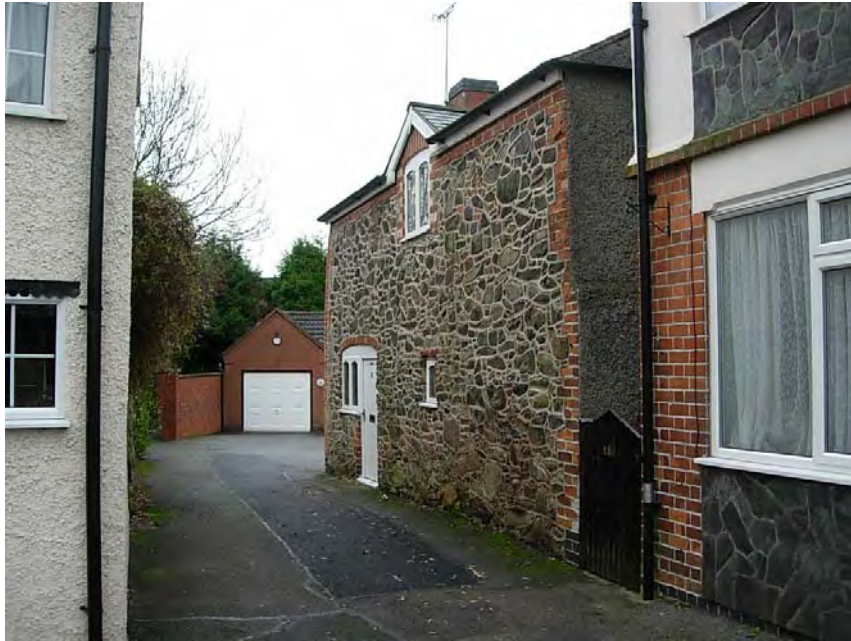
15 The Nook is a stone cottage whose appearance has been altered. The recent addition of a fine stone gable has provided a new feature in the street scene.
