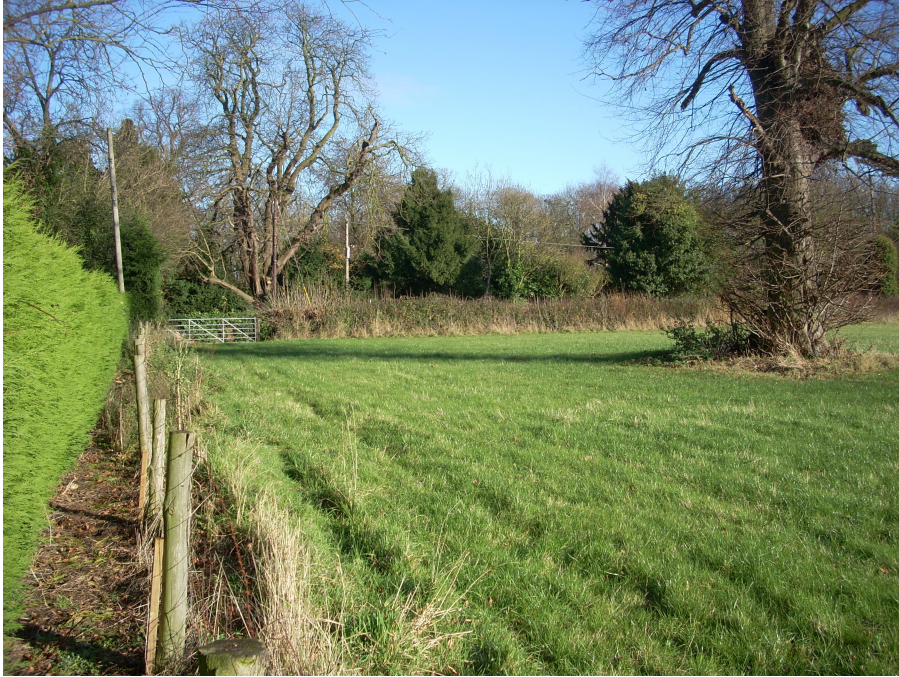
The large paddock that fronts The Green is important in visual terms. In the vicinity the Green, buildings tend to be dispersed being sited in large gardens or adjacent large tracts of open land.

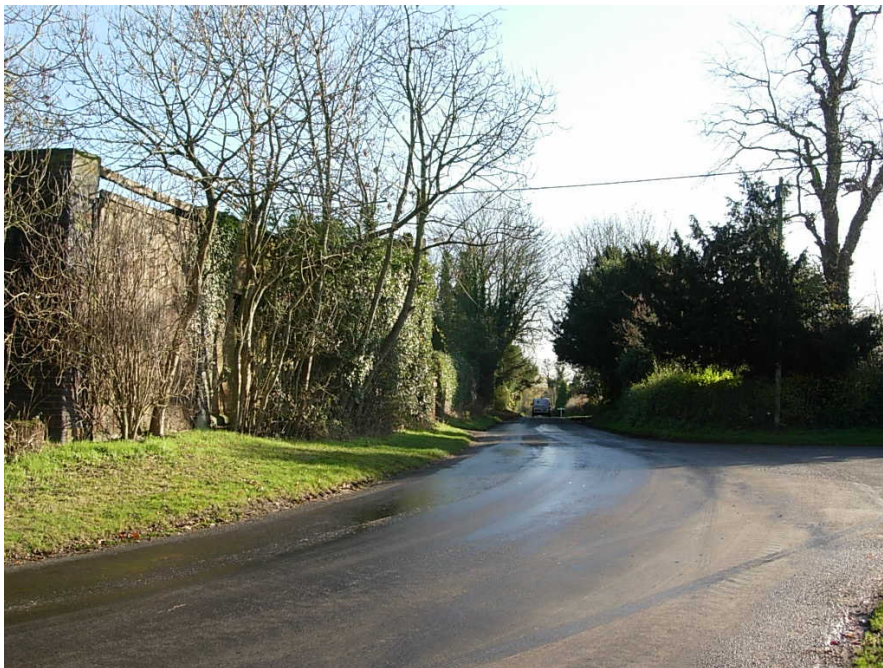
The eastern end of The Green has the character of a narrow rural lane flanked with mature trees and no footpaths or buildings.

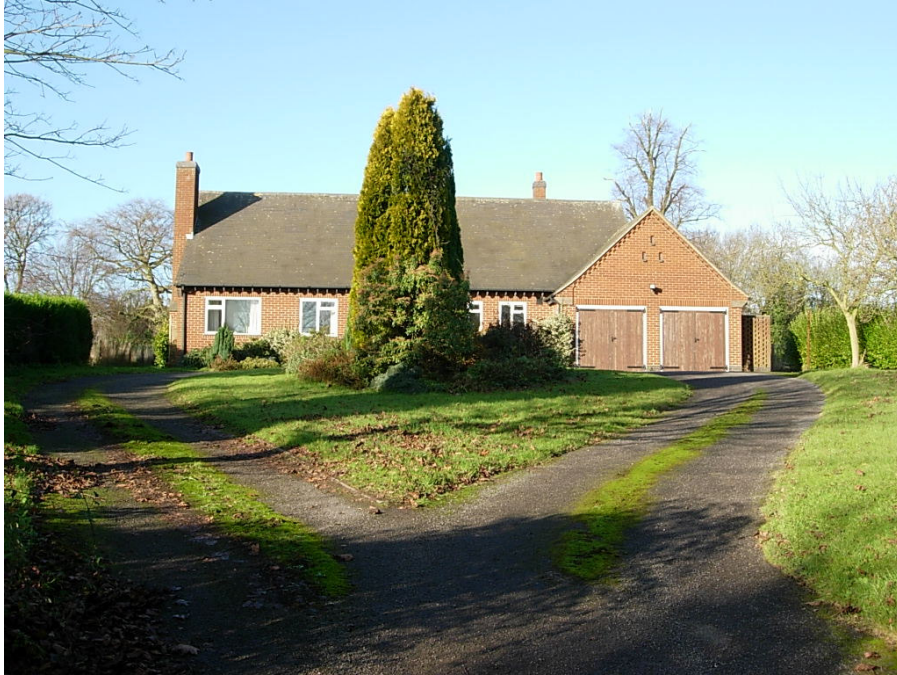
No 4 Pipe Lane is a modern bungalow set well back from the road surrounded by a large paddock area .

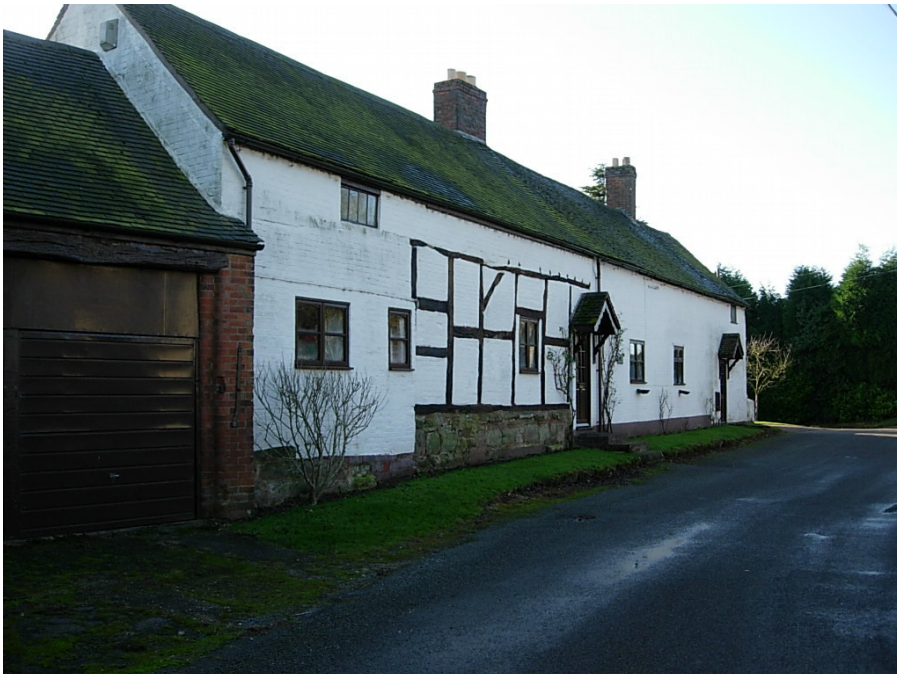
Lower Farmhouse is an excellent C17 Grade 2 listed property, timber framed on a stone plinth with painted brick infill panels and plain tiled roof. The property forms part of a picturesque group of dwellings.

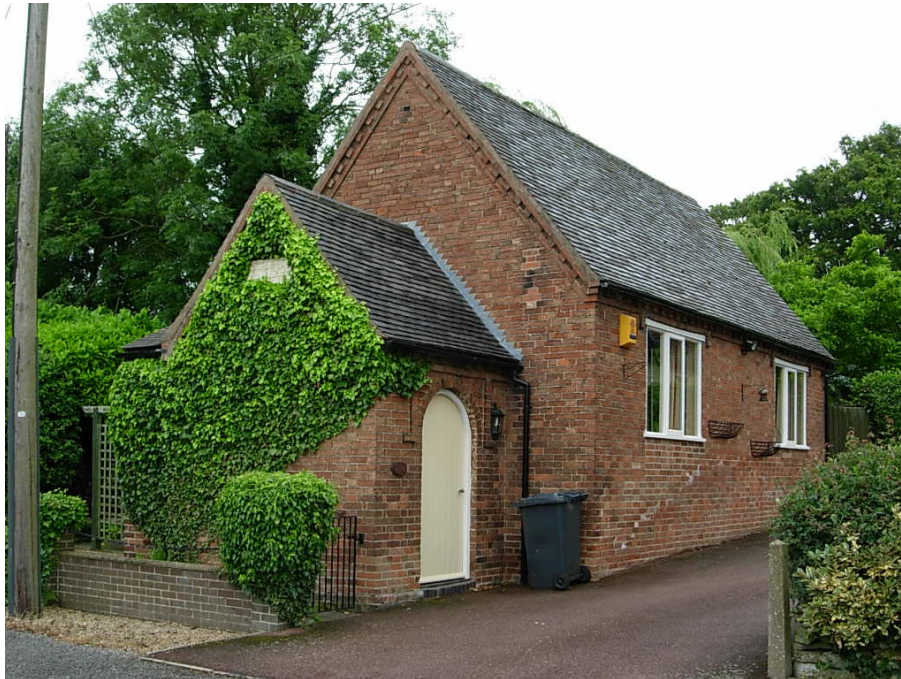
This quaint little property originally built in 1834 that was once the village School has retained its character.

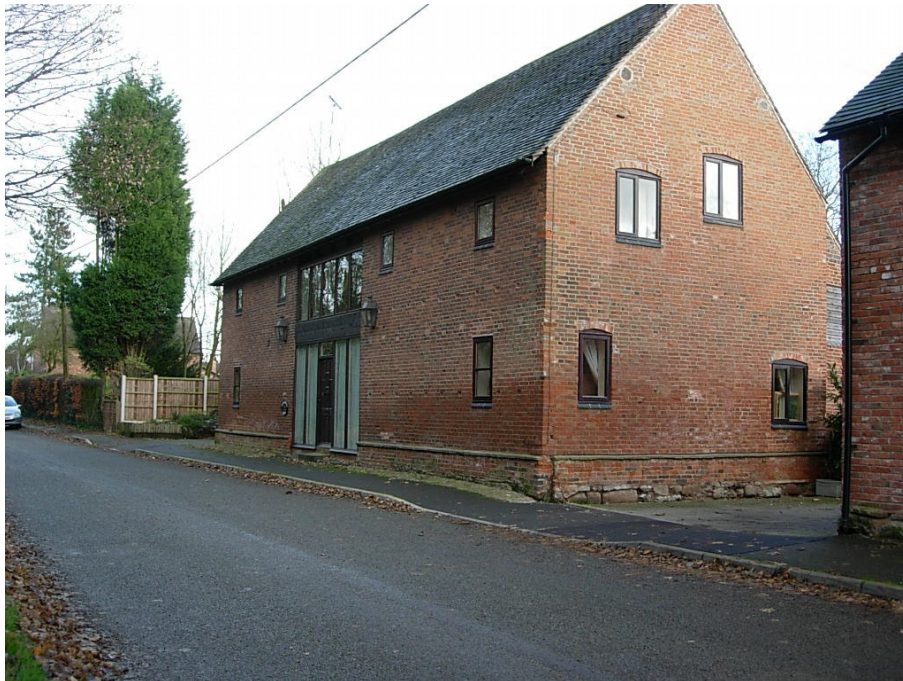
The residential conversion of The Dovecote on Main Street has enabled the retention of this large barn on the street frontage.
