**SHENTON CONSERVATION
AREA MANAGEMENT PLAN**

**PHOTOGRAPHIC RECORD OF
SHENTON CONSERVATION AREA**

December 2007

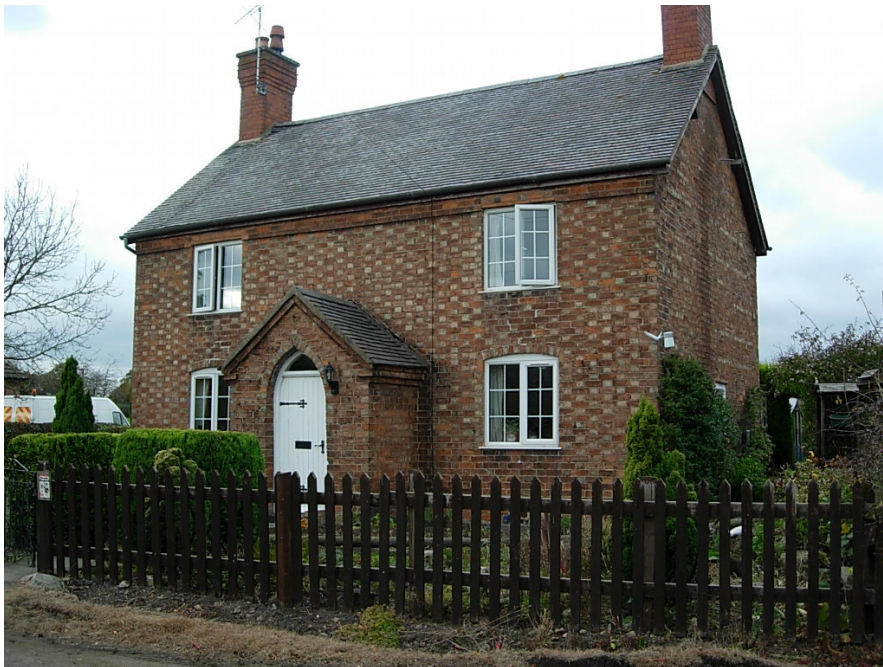
The Poplars, an attractive period cottage located on the bend on Sibson Road which displays diaper brickwork.

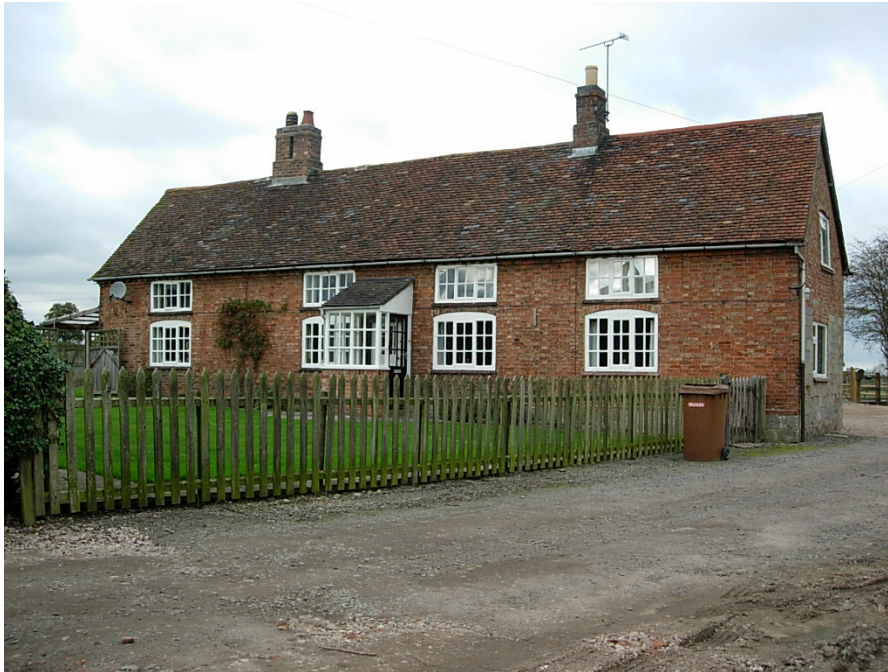
Woodyard Cottage is accessed from Sibson Lane via a private drive

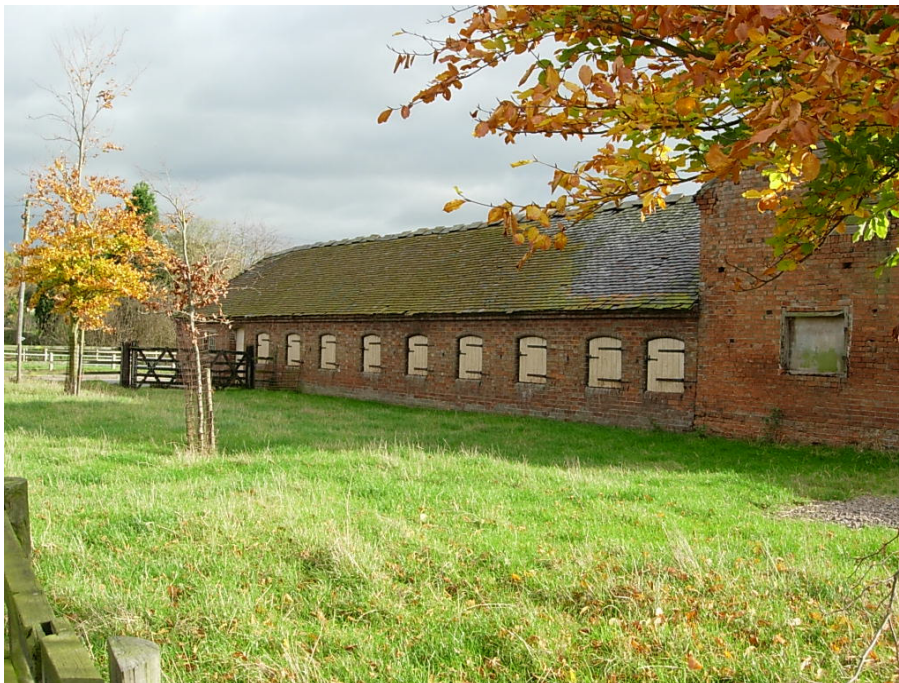
The listed cattle barn at Stud farm built in the 'Shenton Estate' style is an excellent building strategically located at the bend on Sibson Road.

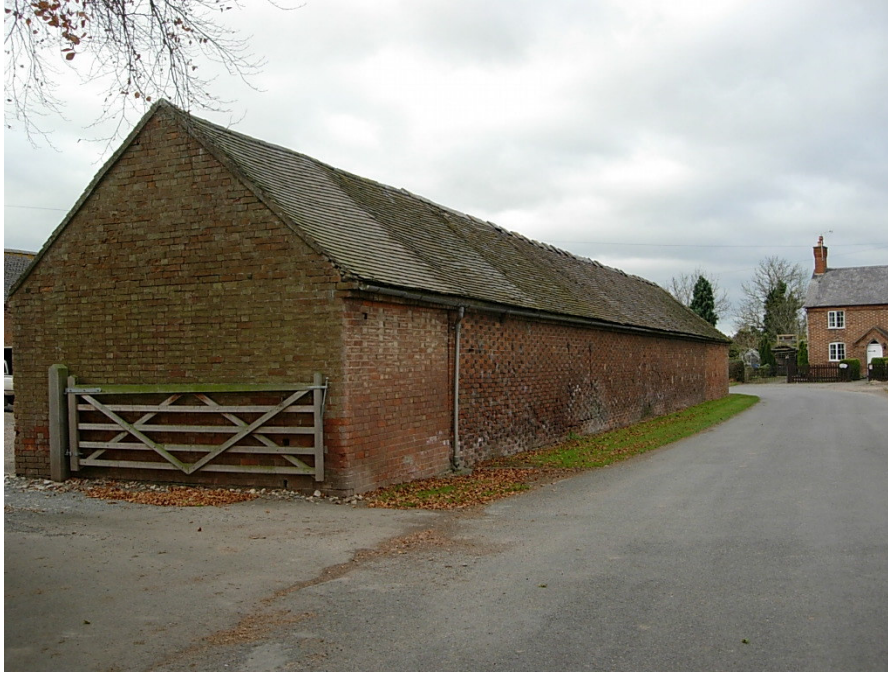
Another view of the Stud Farm cattle barn showing diaper brickwork on its north-eastern elevation. 'The Poplars' can be seen in the distance closing views up Sibson Lane towards the start of the bend.

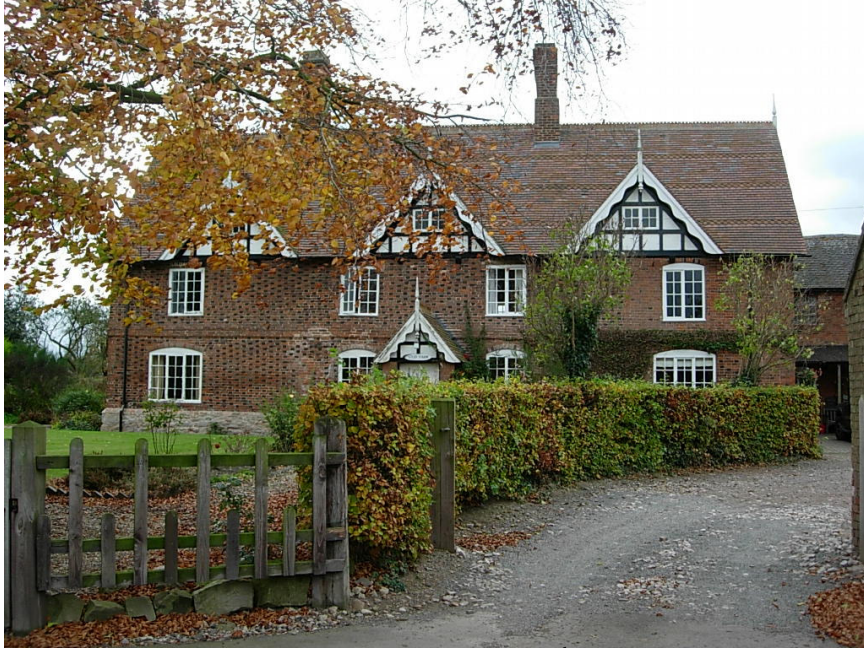
The listed Grade 2 Stud Farmhouse is a late 18th century dwelling modernized in the mid 19th century that has two axial chimney stacks and three half-timbered gablet dormers on the front elevation.

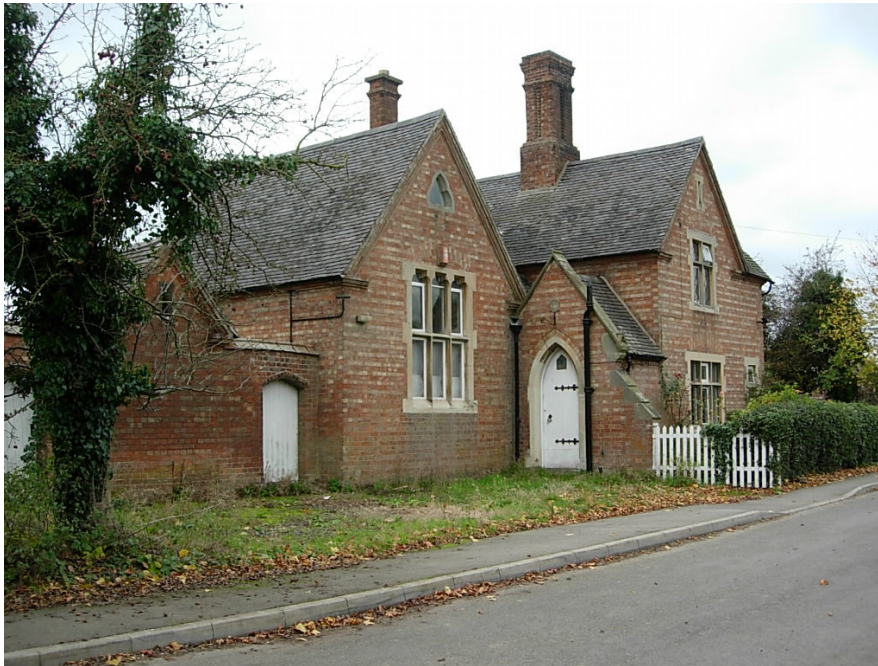
The Old School House on Main Street built in 1858 has now been converted into a dwelling

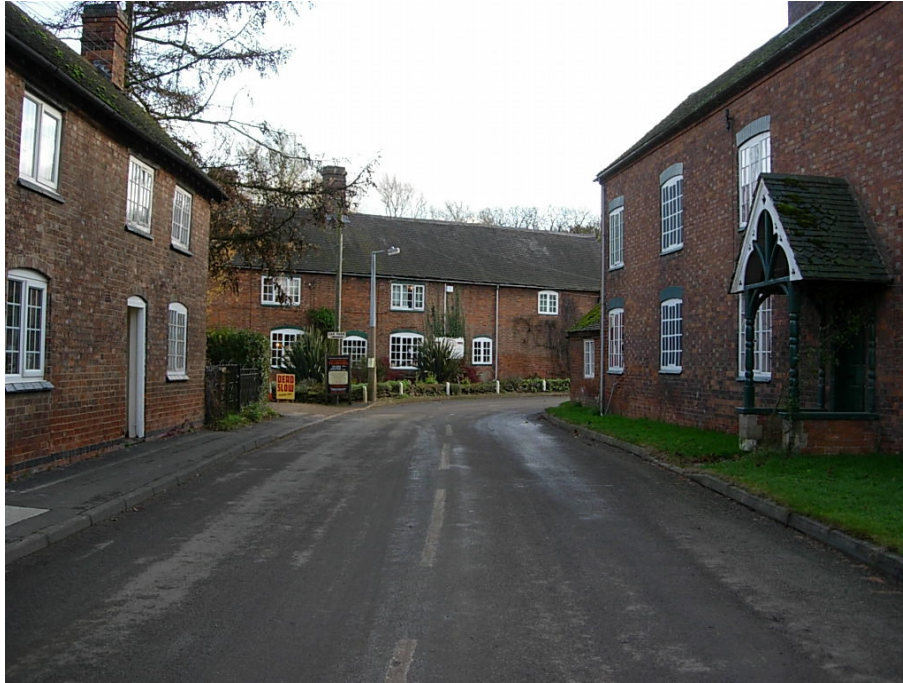
Views directed down Main Street with White Moors closing views

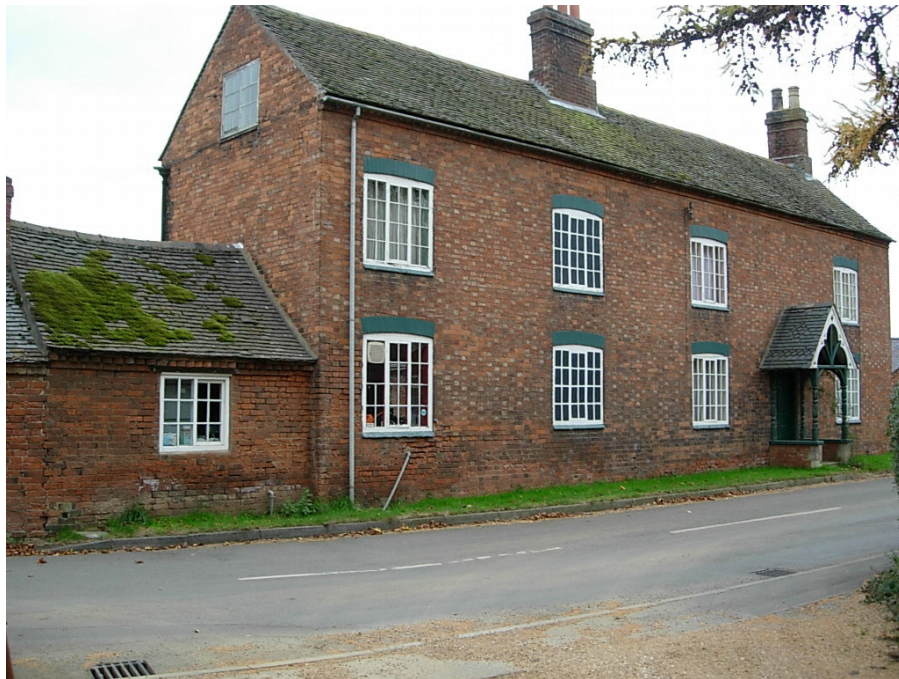
The listed late 18th century Fomer Farm on Mill Lane showing its 'two blind' windows which comprise the middle windows of the group of three.

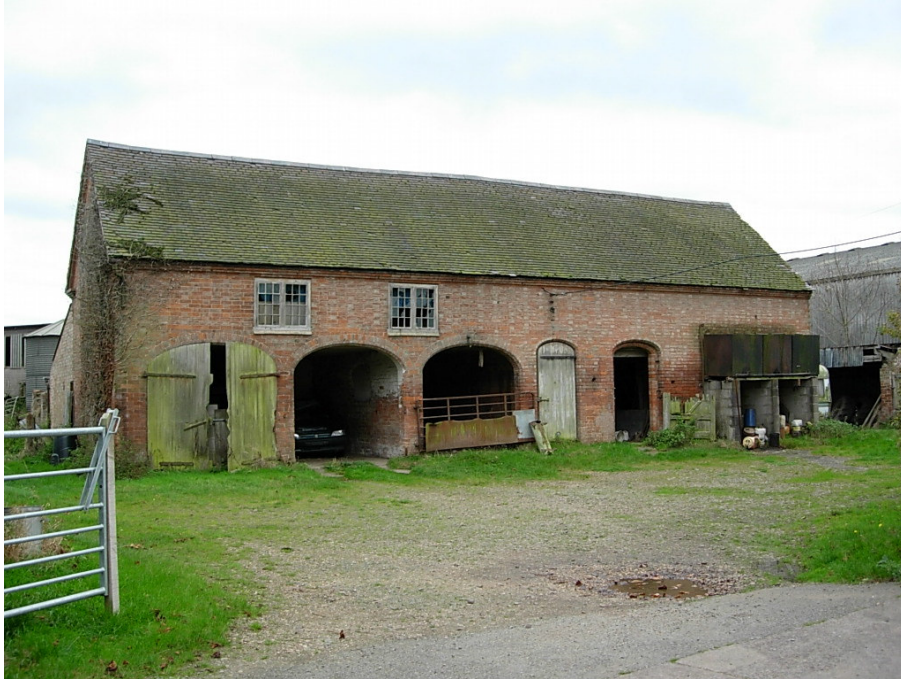
The mid 19th century cart shed with loft above situated to the rear of Fomer Farm is a Grade 2 listed building built in the ‘Shenton Estate’ style.

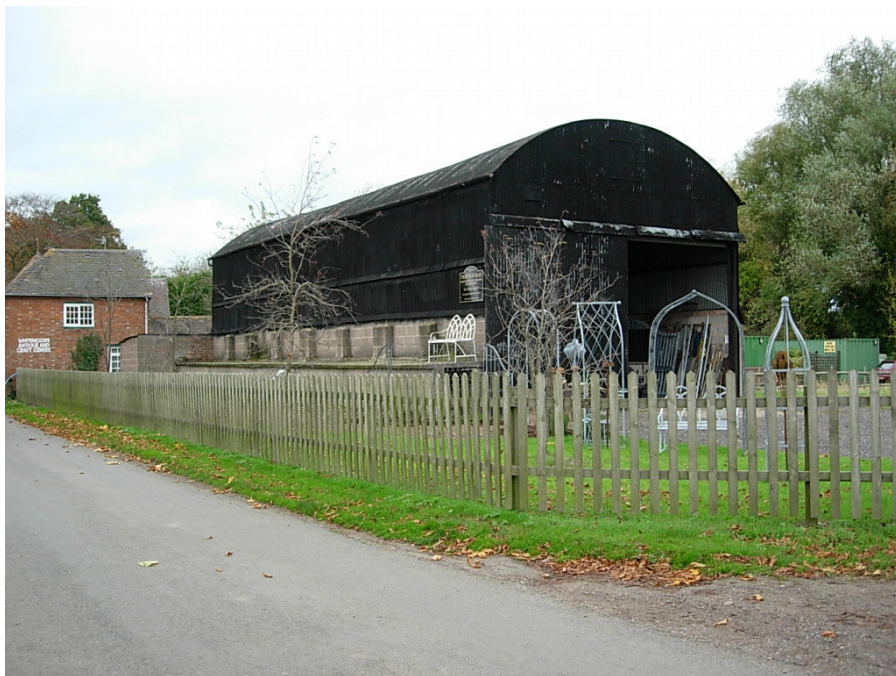
The large Dutch Barn on Mill Lane is currently used to make garden furniture. The barn mainly built with corrugated iron is a fine imposing structure at the entrance into Shenton.

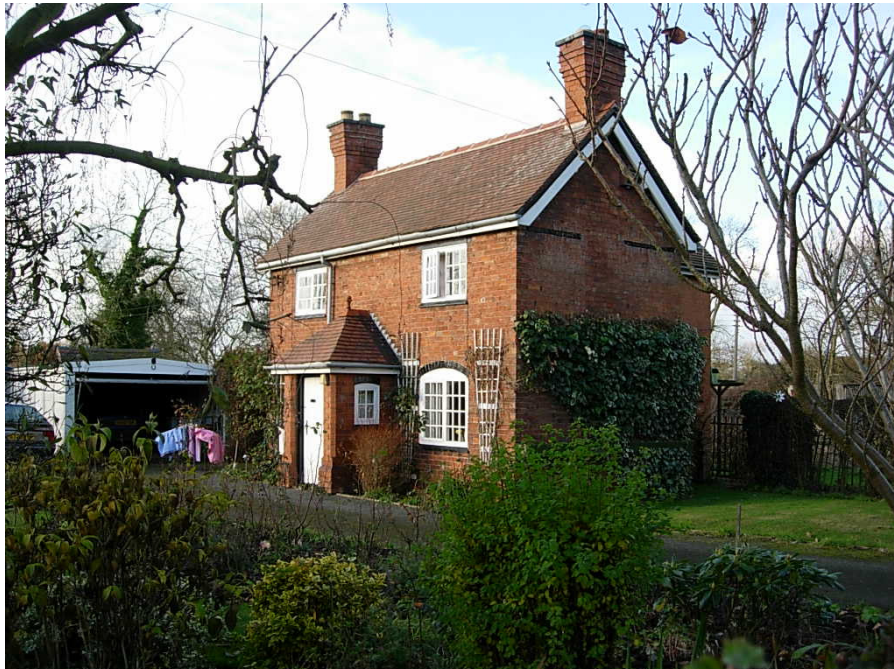
22 Mill Lane has its gable end facing the carriageway.

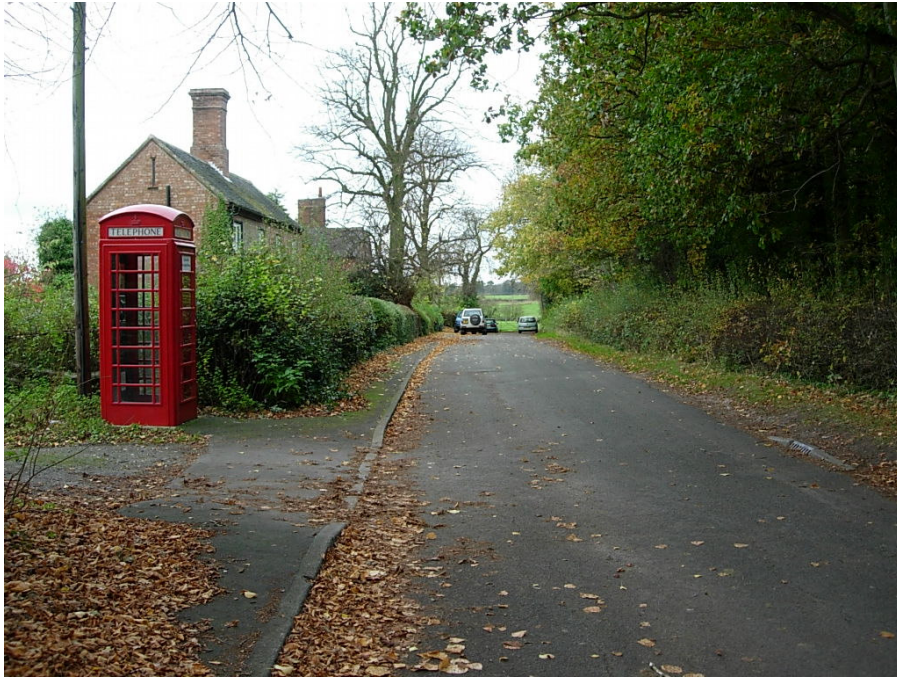
View looking down Pump Lane from Bosworth Road. The type K6 telephone kiosk although not listed is an important feature on the lane.

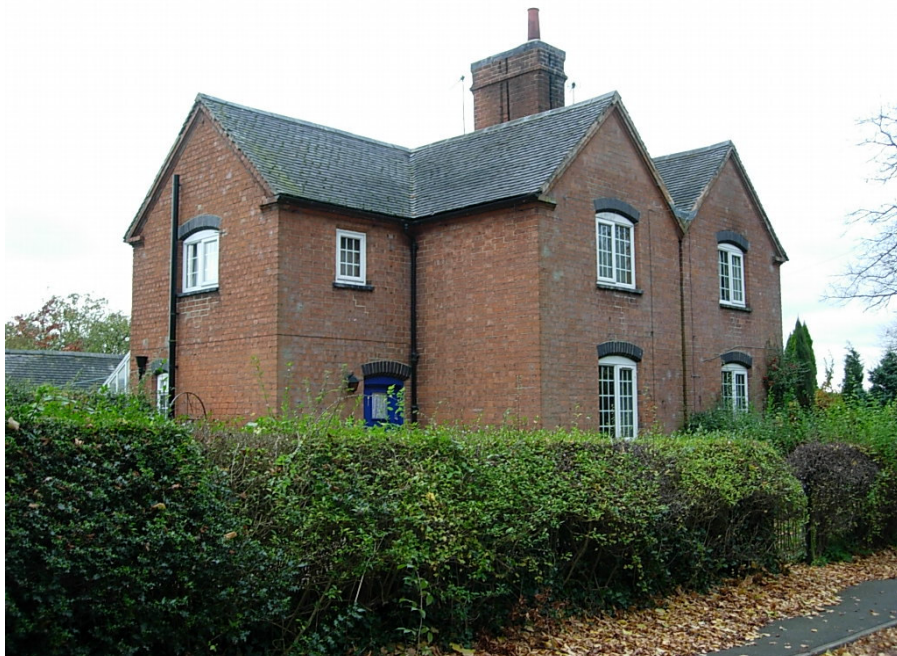
The properties 5 and 6 Pump Lane, are typical 'Shenton Estate' semi-detached dwellings that benefit from the hedge boundary treatment.

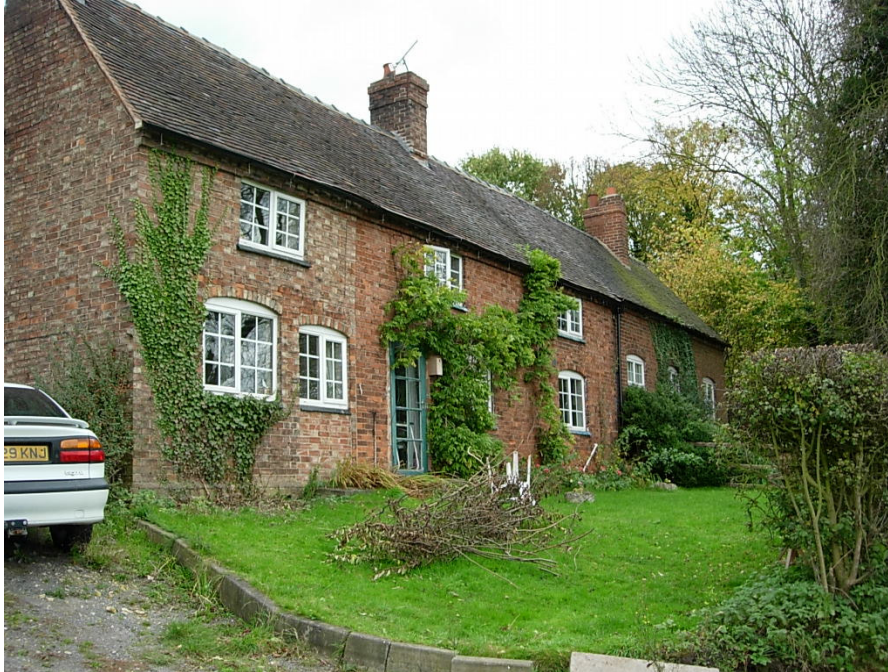
The terrace of three dwellings, 7-9 Pump Lane, are located at the end of the Lane.

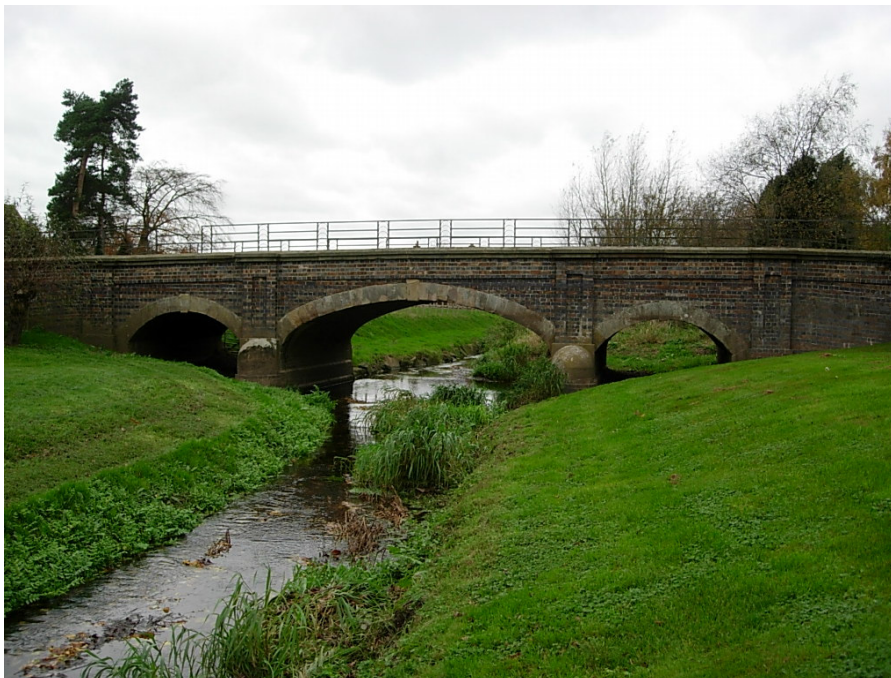
The picturesque road bridge that spans the River Tweed on Bosworth Road is flanked by low parapet walls with iron railings running along their top. The bridge and adjacent marshes are important features in the conservation area.

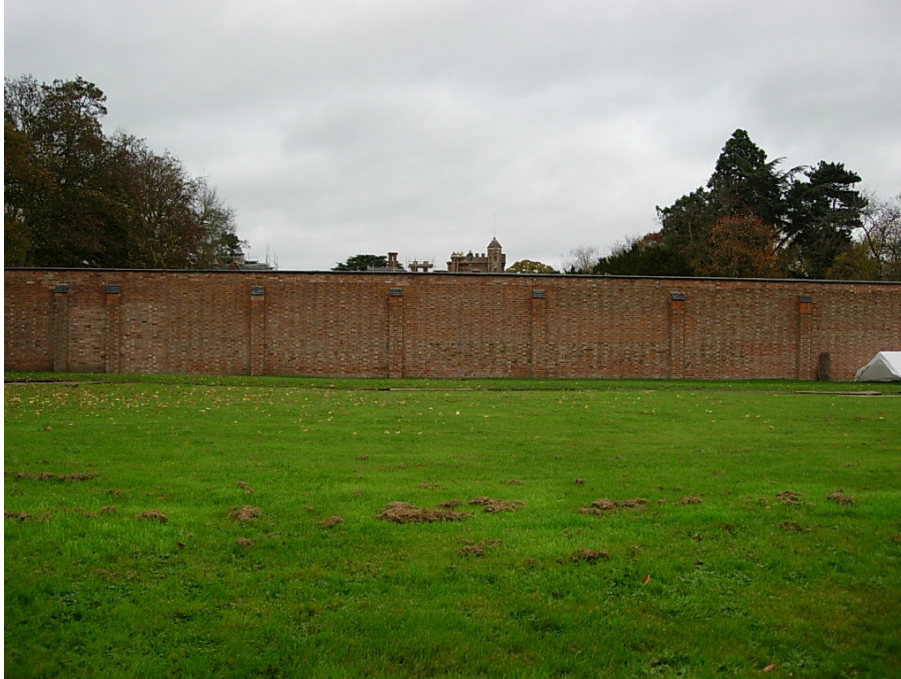
The high boundary wall that runs around Shenton Hall adds to the Settlement's charm and character.

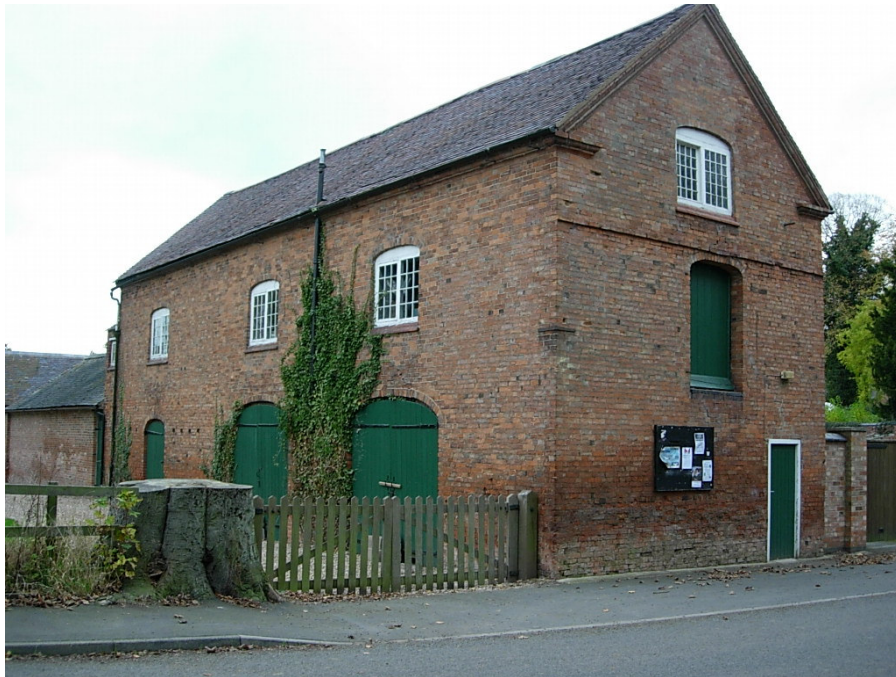
The building on Bosworth Road that is being used for storage has retained its traditional agricultural character.

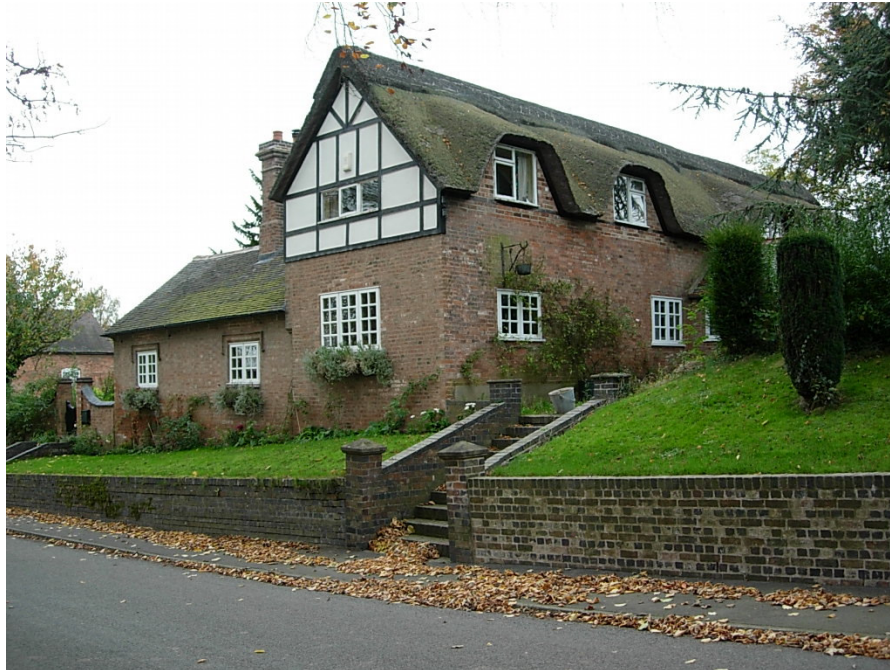
Thatched Cottage on Bosworth Road with its half-timber feature and eyebrow dormers. The blue brick boundary wall together with the high wall to Shenton Hall opposite, define the heart of the settlement.

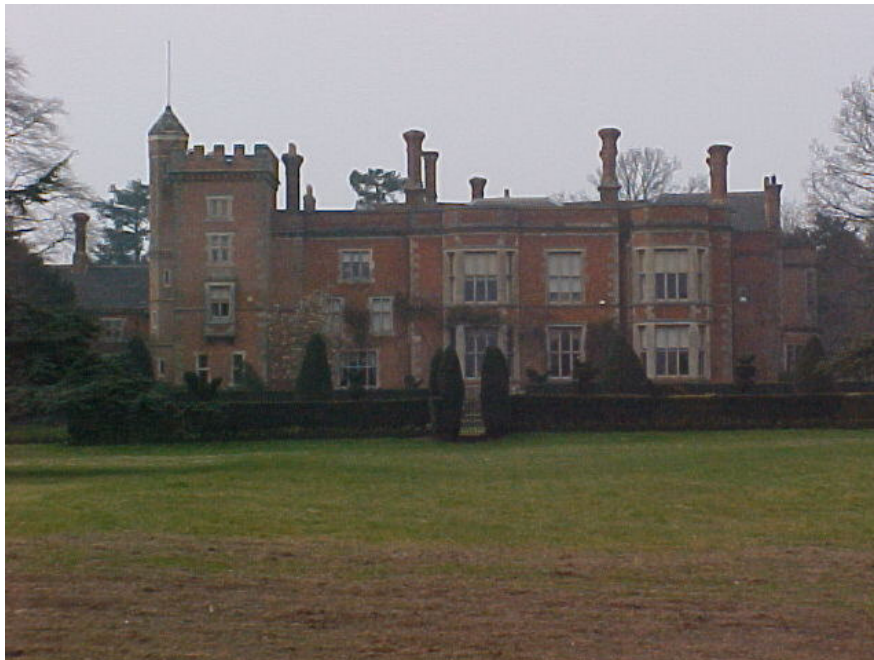
South eastern elevation of Shenton Hall. Although building work started in the 1620's, the Hall had doubled in size by the mid 19th century. The property is listed Grade 2* built in brick with stone dressings and plain tiled roof.

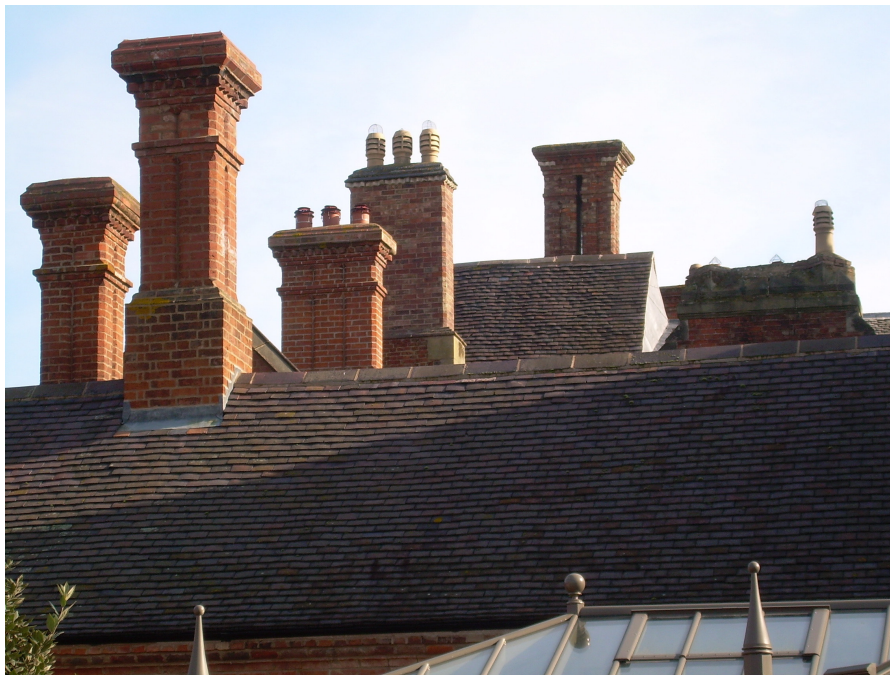
Shenton Hall showing a number of its embellished chimney stacks. These are important 'roofscape' features in the village.

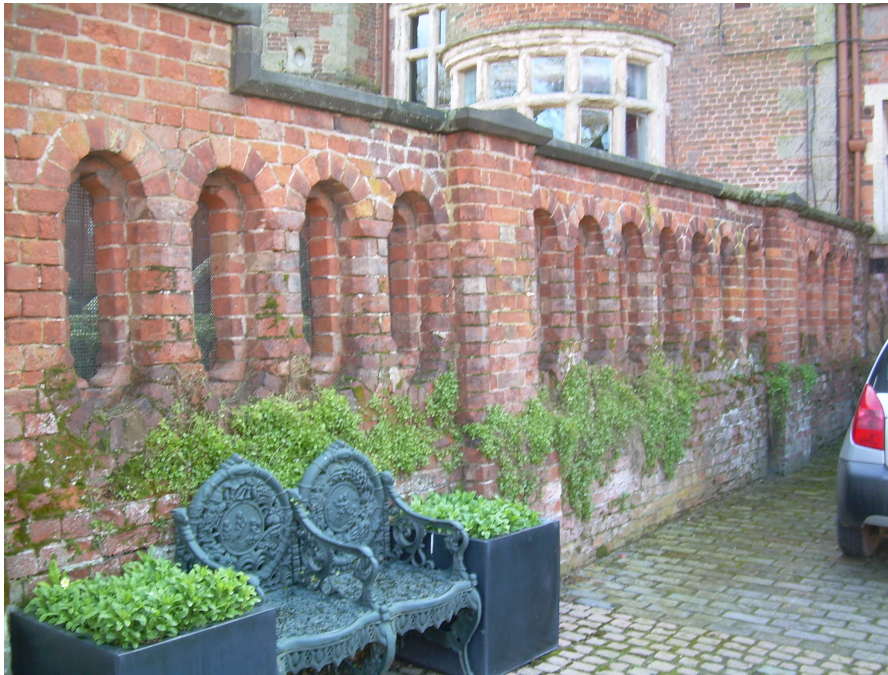
One of the fine decorative walls at Shenton Hall

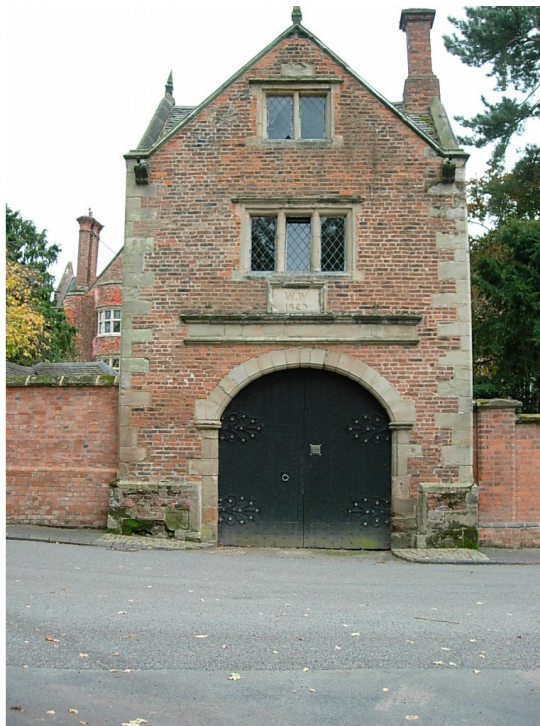
The listed gatehouse at Shenton Hall dated 1629 is an important building fronting Bosworth Road.

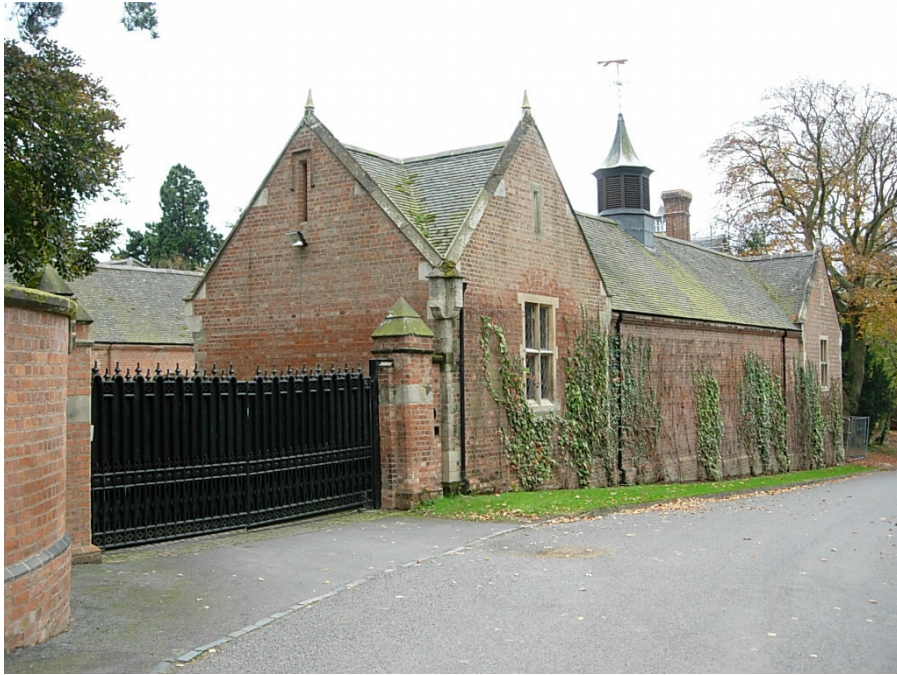
The main vehicular entrance to Shenton Hall off Bosworth Road.

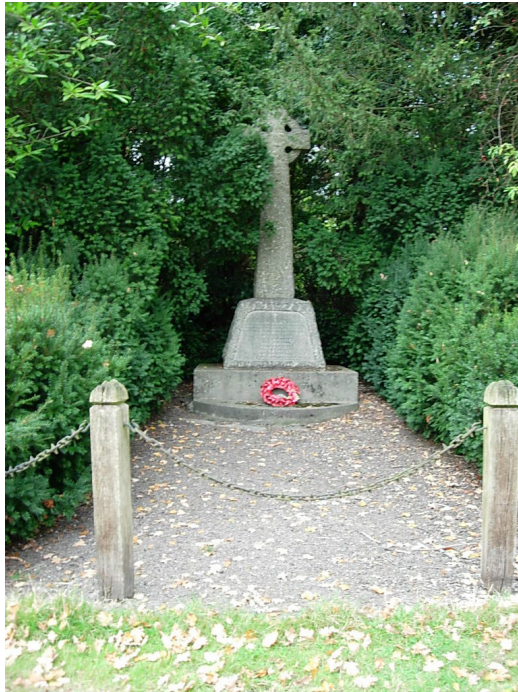
Shenton's War Memorial sited at the junction of Bosworth Road and Pump Lane.

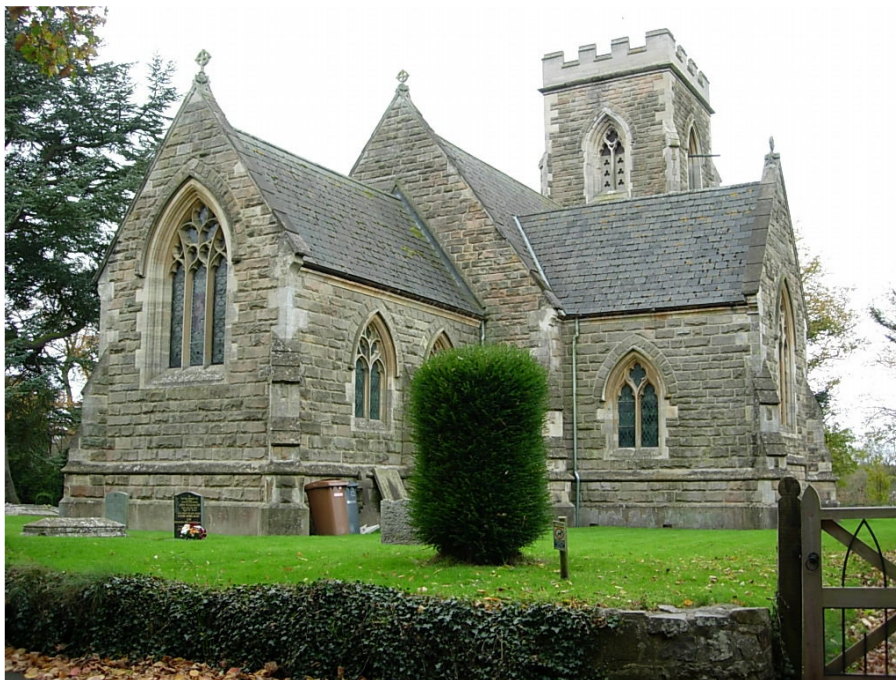
The parish church of St John the Evangelist showing the embattled parapet wall on its tower. The church, which was demolished in 1859 and re-built immediately, underwent restoration in 1875.

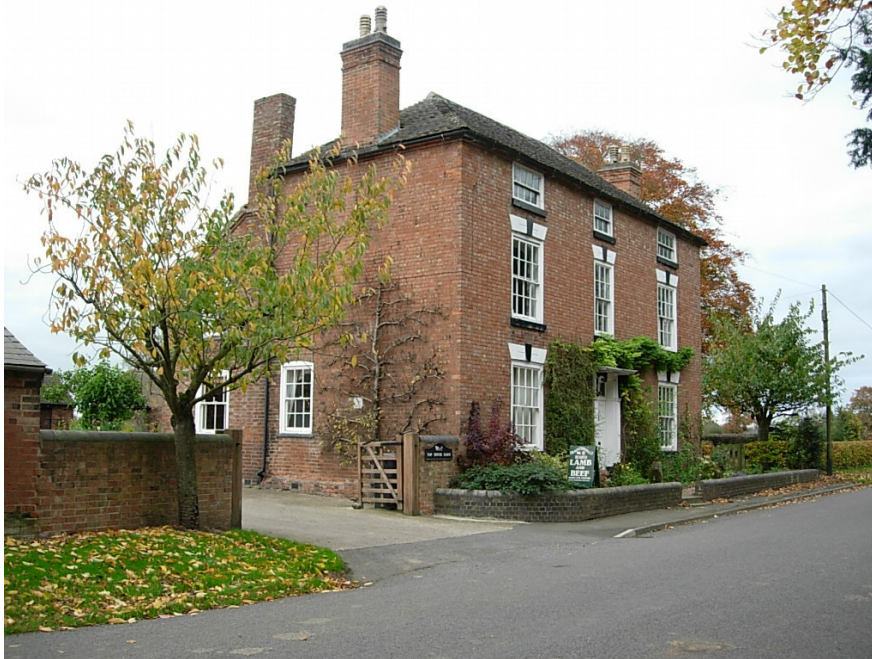
The listed early 19th century Top House Farmhouse, built in brick with a hipped plain tiled roof. There are very few properties in the settlement that are 3 storey.

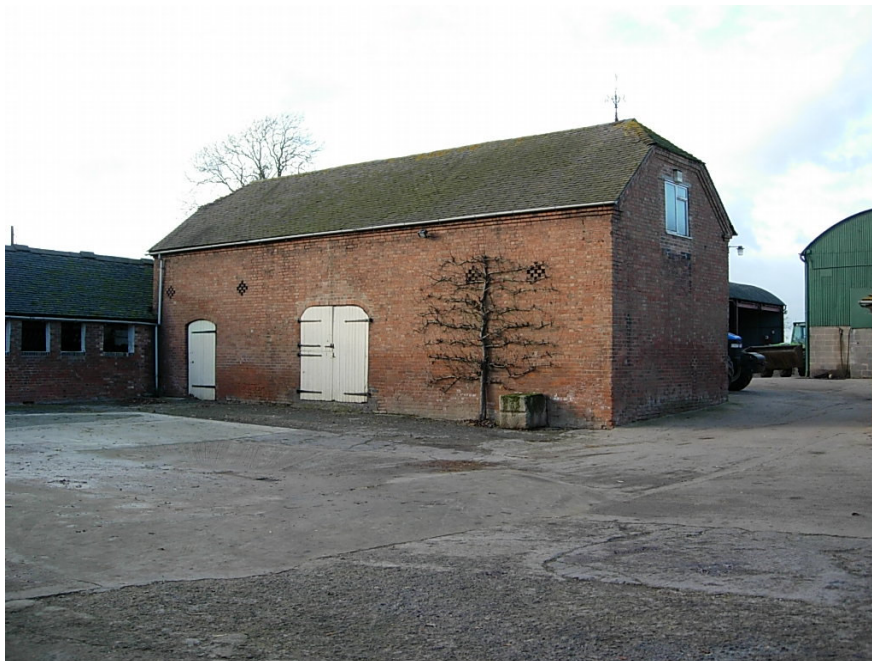
Traditional barn at Top House Farm built with a dental eaves course and tiled roof. A horse mounting block fronts the building.

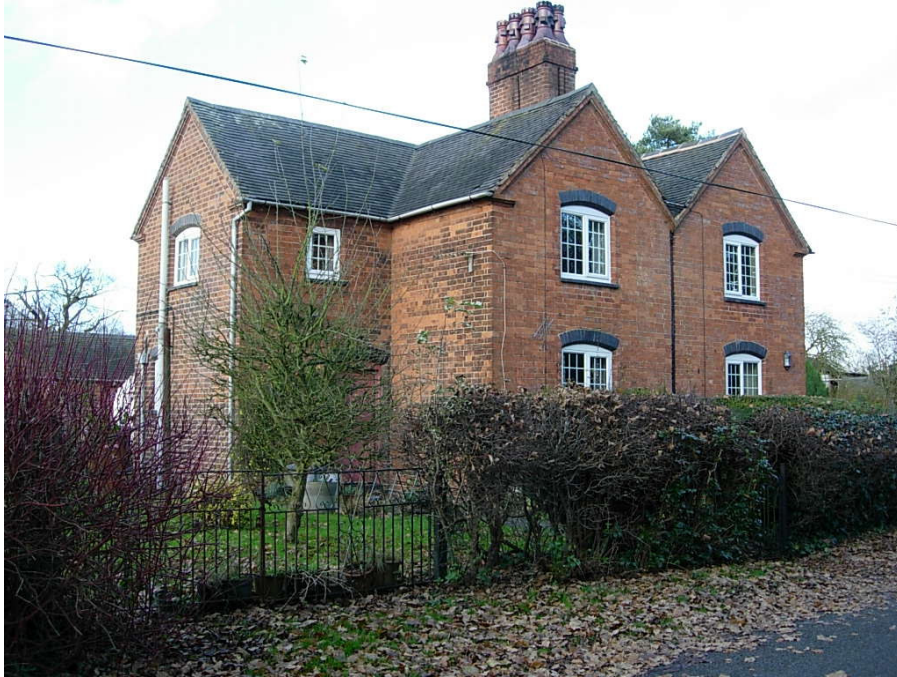
The properties 1 & 2 Bosworth Road are another of the 'Shenton Estates' semi-detached dwellings.

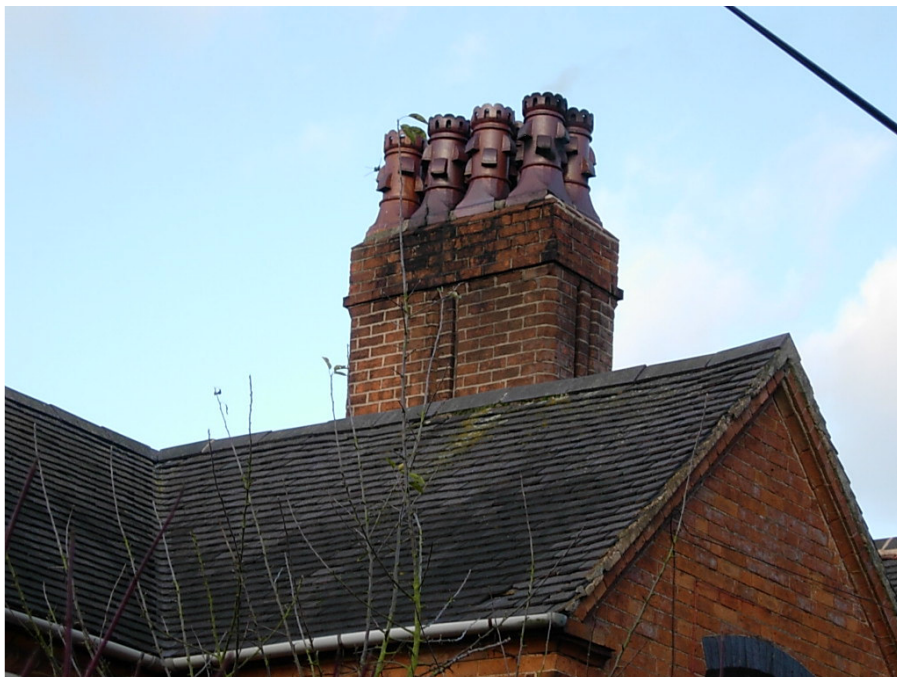
The properties have retained all of their original eight chimney pots.

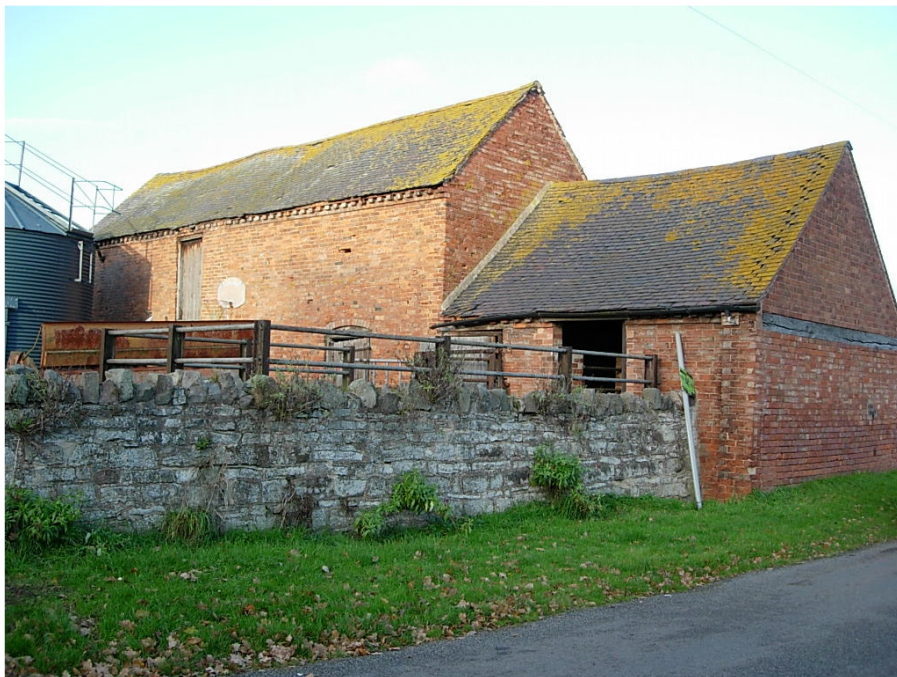
These fine barns at Aqueduct Farm are important buildings in the conservation area which need to be retained

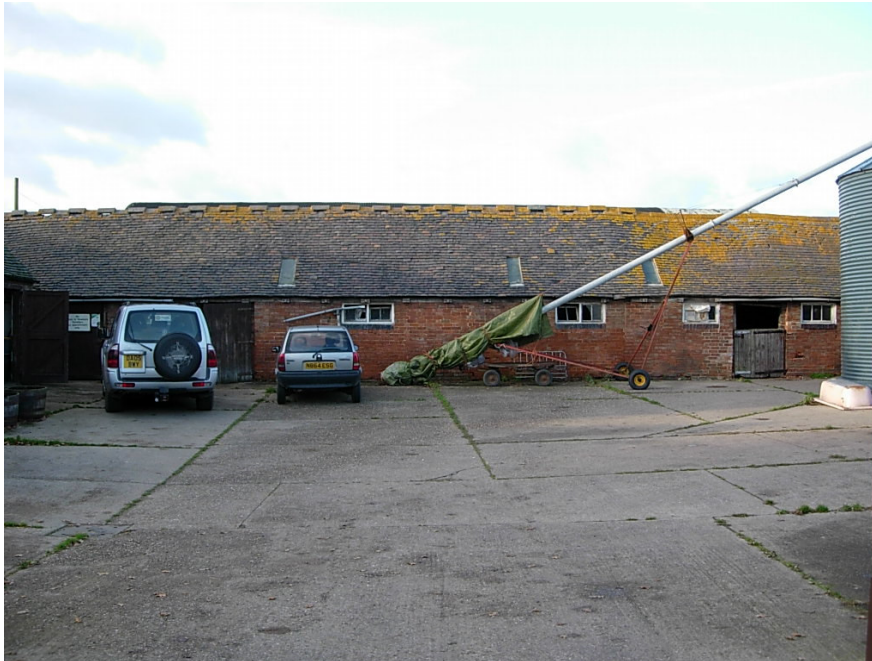
The cattle sheds at Aqueduct farm.

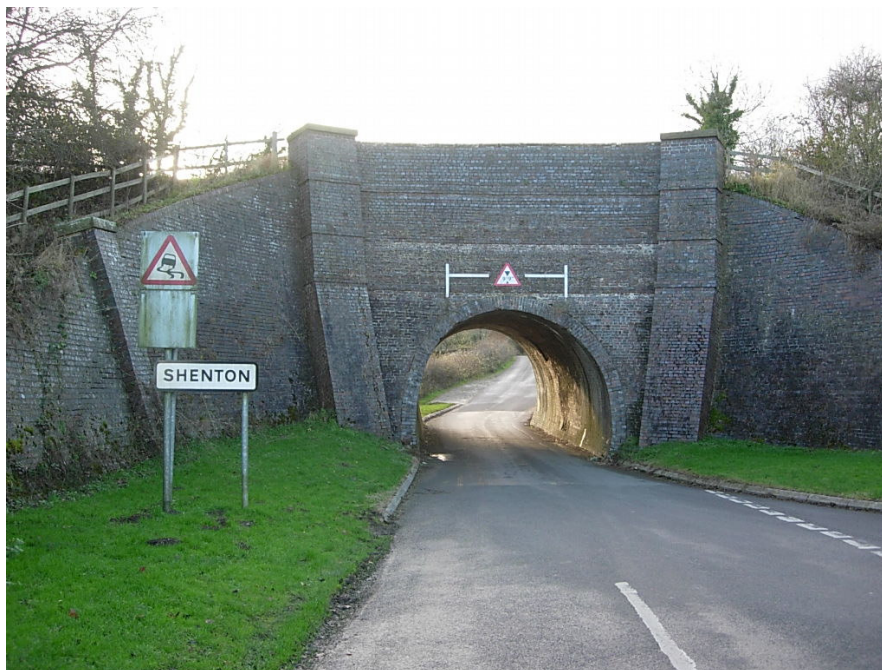
Entrance into Shenton along Bosworth Road is obtain through the narrow archway of an aqueduct on the Ashby Canal. The aqueduct is built with brindle blue bricks with covered parapets flanking the canal.
