## **DESFORD CONSERVATION AREA APPRAISAL & MANAGEMENT PLAN**

**PHOTOGRAPHIC RECORD OF  
DESFORD CONSERVATION AREA**

**March 2010**

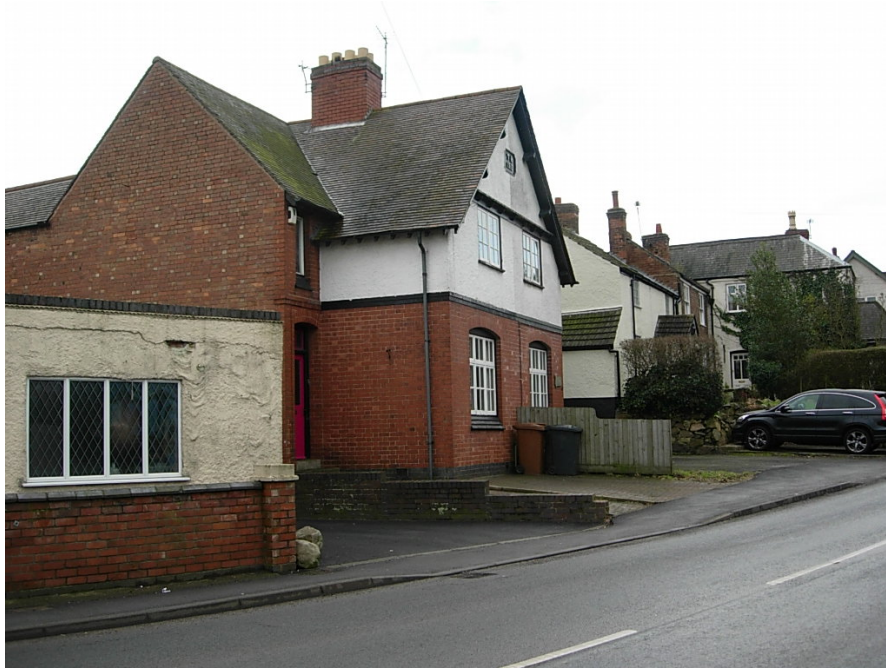
The rendered property 66 High Street has lost some of its traditional character due to the insertion of modern windows although it has retained its traditional brick wall fronting the carriageway.

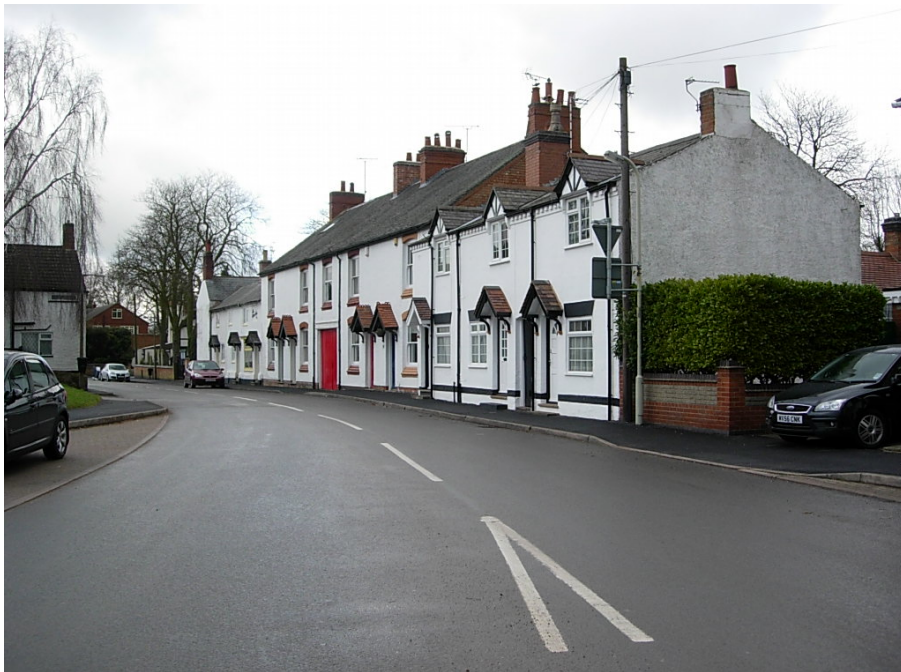
The dwelling, 2 Main Street, does not respect the traditional character of the conservation area by way of its design, materials, and open frontage.

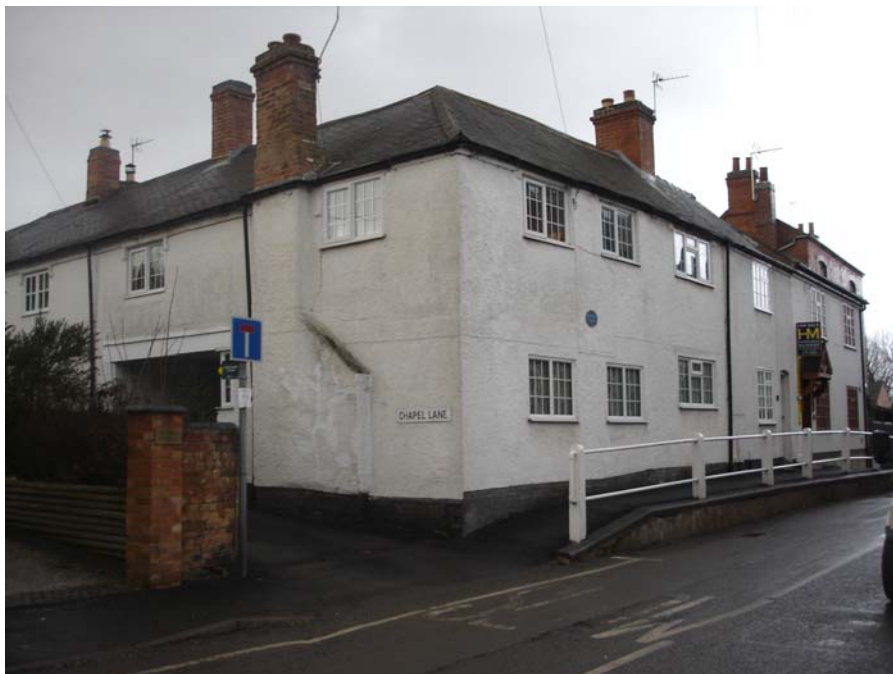
The access to the rear yard of 55-59 Main Street is gained through an impressive archway. Unfortunately, the windows in the properties on either side have been replaced with plastic windows and the bow window to the bedroom is inappropriate.

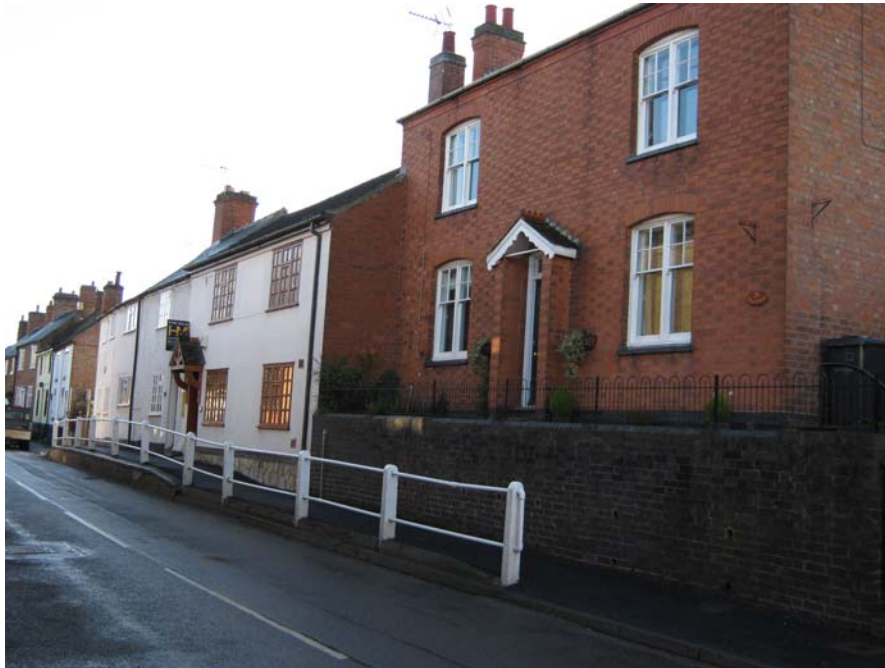
75 Main Street is an attractive property that occupies a prominent position in the street scene sited behind a blue brick retaining wall.

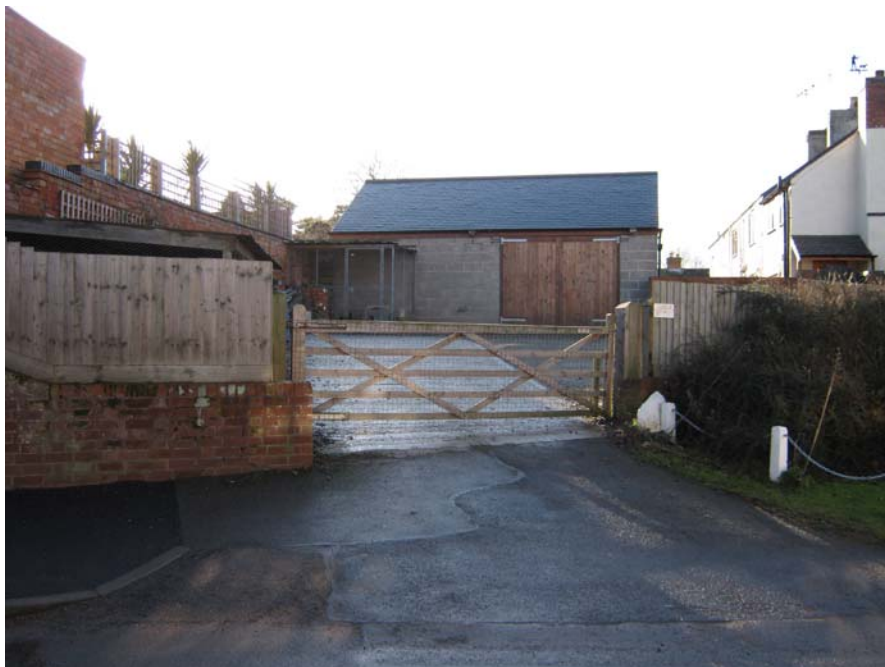
This small holding sited at the northern end of Main Street with its agricultural gate is a remnant of the past. It is unfortunate that the outbuilding has been built with concrete blocks. The site has development potential.

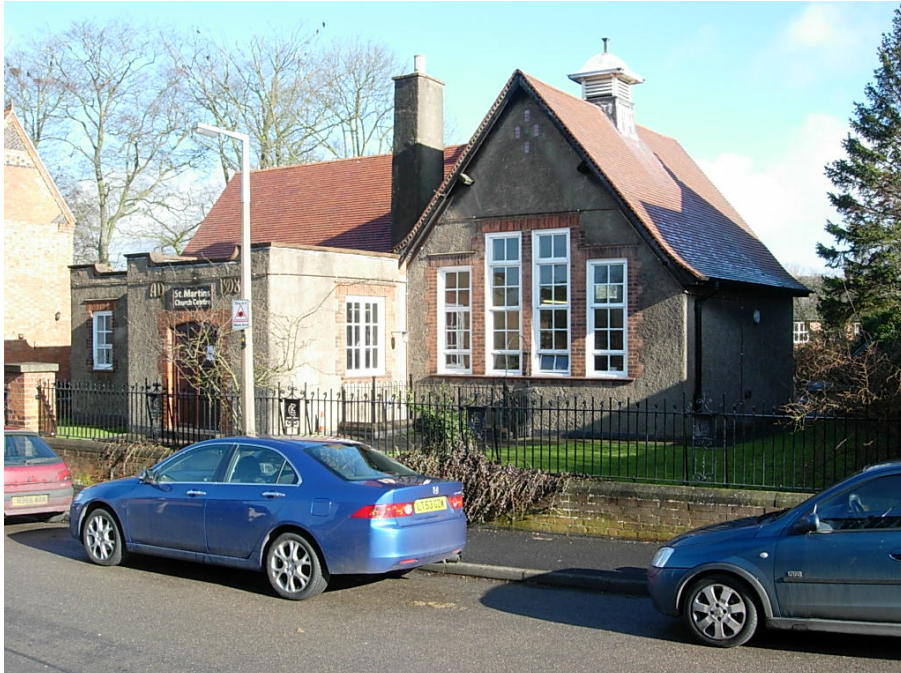
St Martin's Church Hall on Main Street was once the village infant school. The property still retains its appealing metal railings designed and installed by Leicestershire County Council.

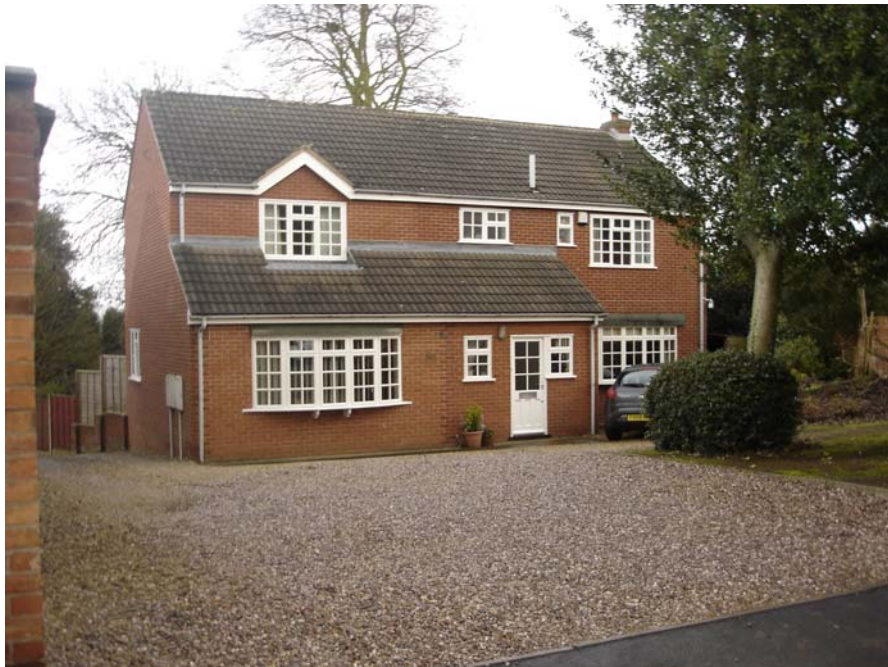
This modern dwelling, 56 Main Street, does not reflect the traditional character of the village by way of design, materials and siting.

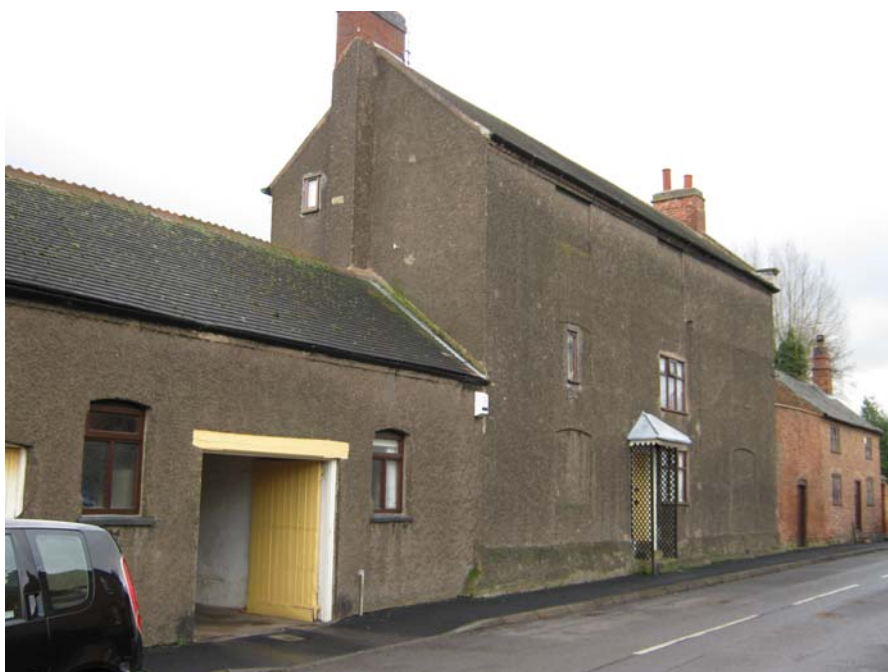
Prior Farm on Main Street is one of only a small number of three storey buildings located in the conservation area. This rendered property that has had several of its windows blocked in on its front elevation, has an attractive rear elevation.

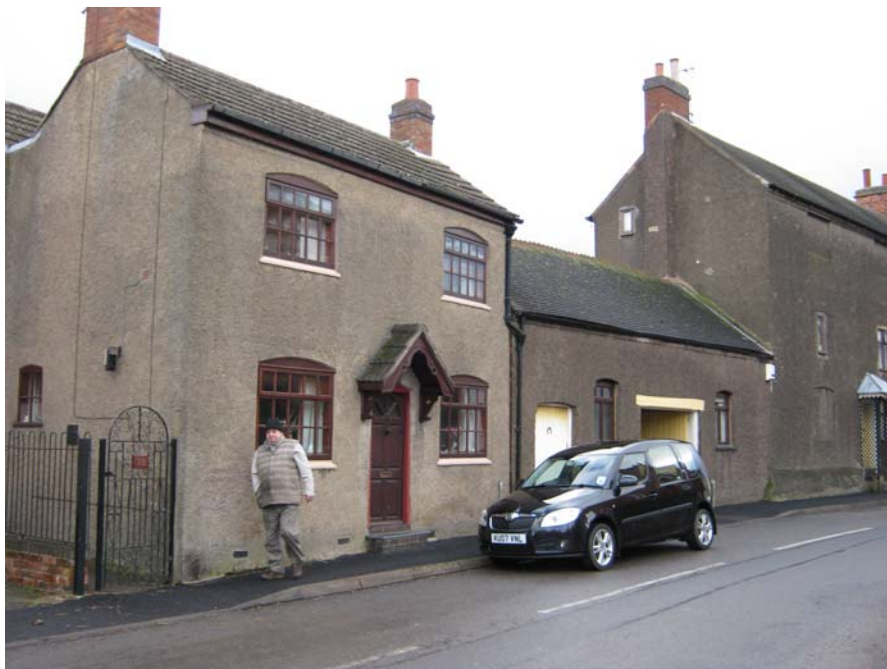
76 Main Street is a small period cottage spoilt by the use of concrete roof tiles.

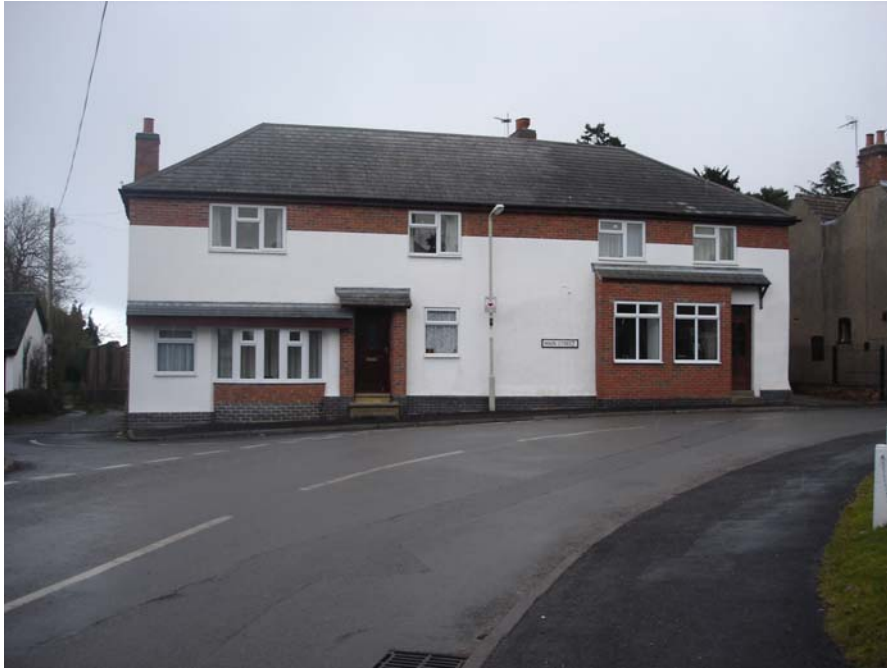
The elevation treatment of 80 Main Street is out of character with the traditional features of the conservation area.

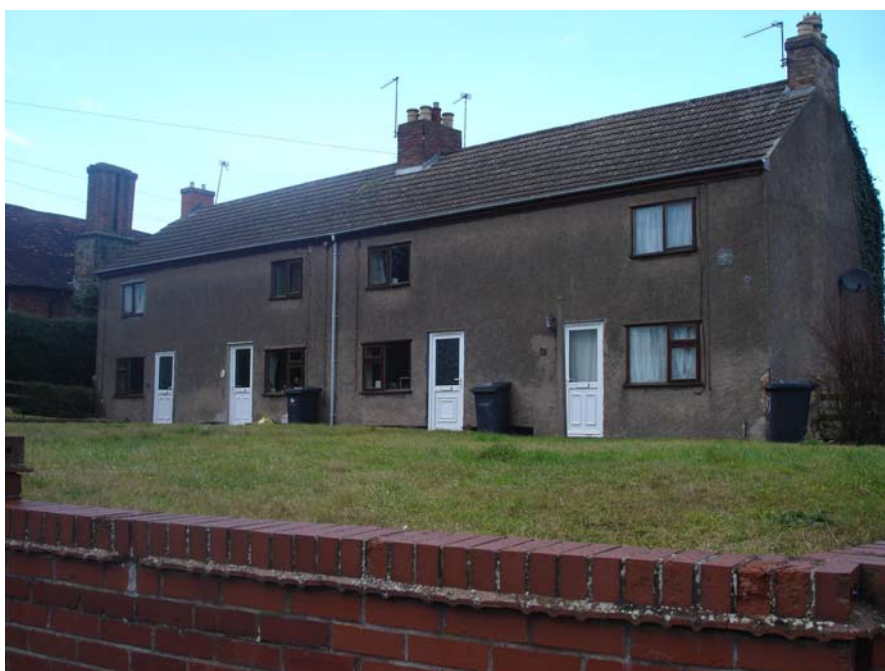
The terrace, 30-36 Newbold Road, has lost some of its traditional character due to insensitive alterations with the installation of plastic window, doors and concrete roof tiles.

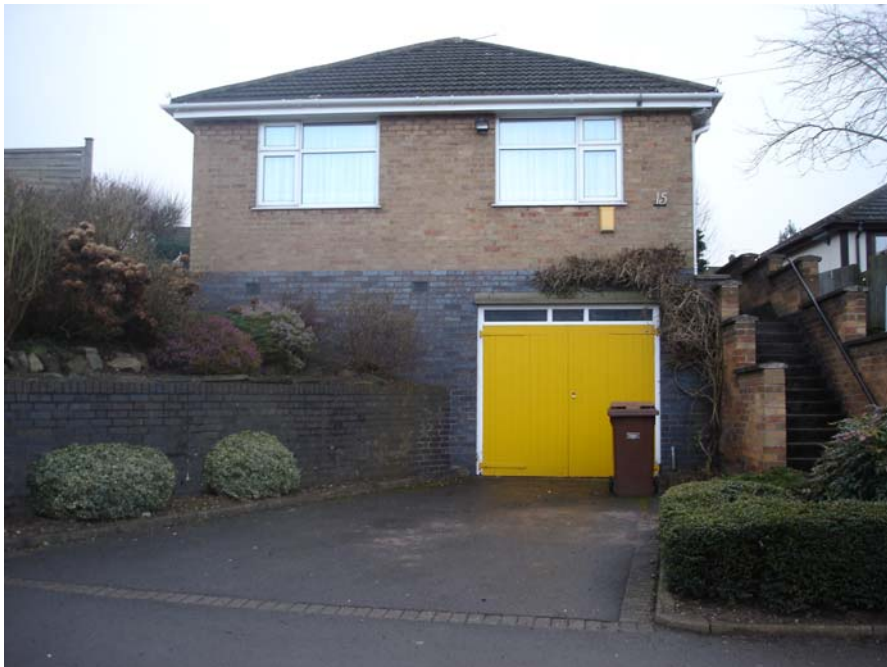
15 Newbold Road is a dwelling of modern design and materials which has a negative impact on the conservation area. The visual impact of the garage doors could be reduced significantly if they were to be painted in a dark colour.

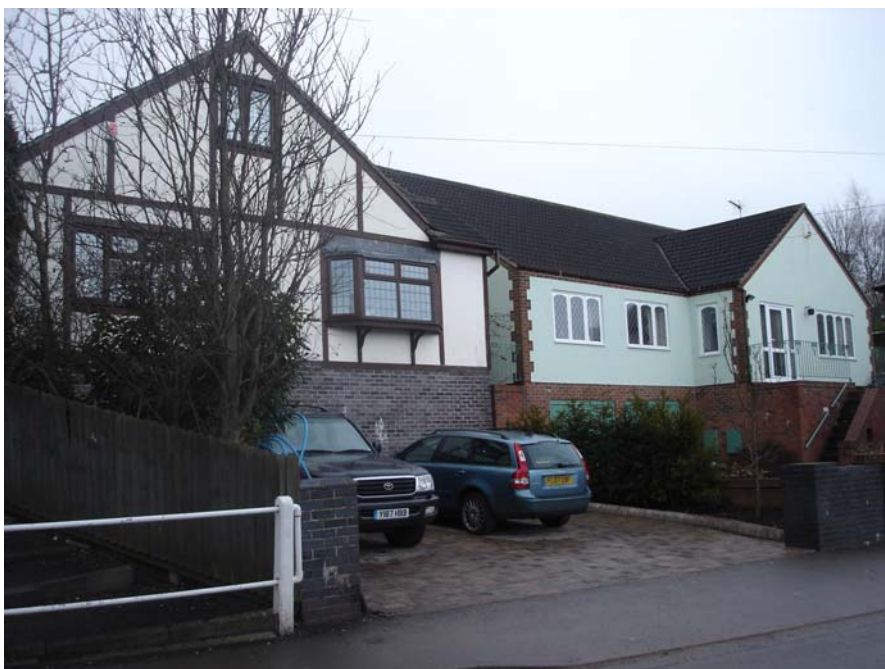
17-19 Newbold Road are two relatively modern properties that do not enhance the traditional character of the conservation area.

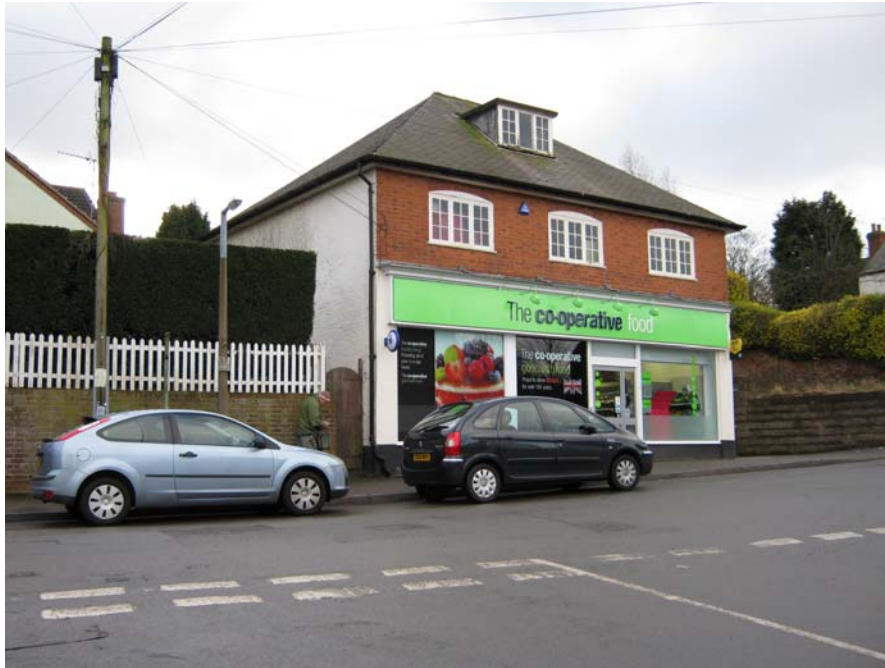
The shop front treatment to the Co-Op store on Newbold Road is too brash and prominent. Consideration needs to be given to reduce its visual impact in the street scene.

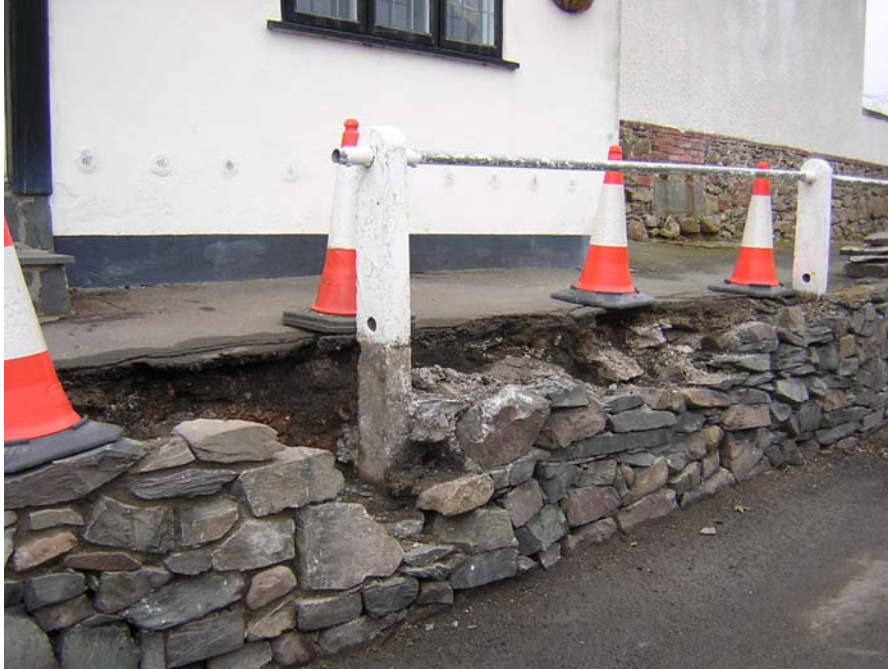
The raised pavement fronting 29 Newbold Road before the stone retaining wall was rebuilt shows the concrete post and rail fence before it was replaced.

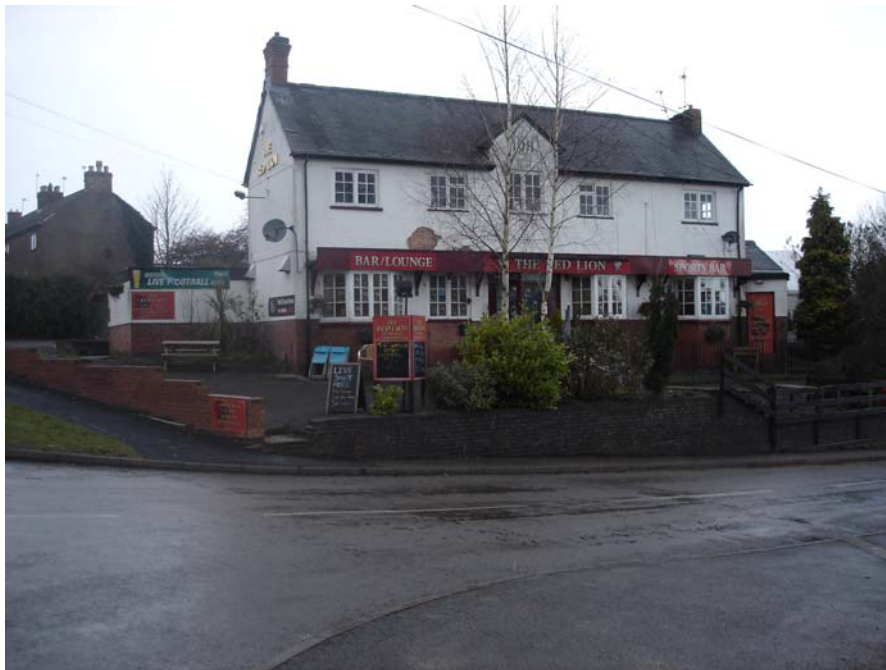
The Red Lion Pub is a prominent landmark sited at the junction of Lindridge Lane and Newbold Road. The pub site has development potential, however, the main building is worthy of retention, although the rear flat roof extension needs to be demolished.

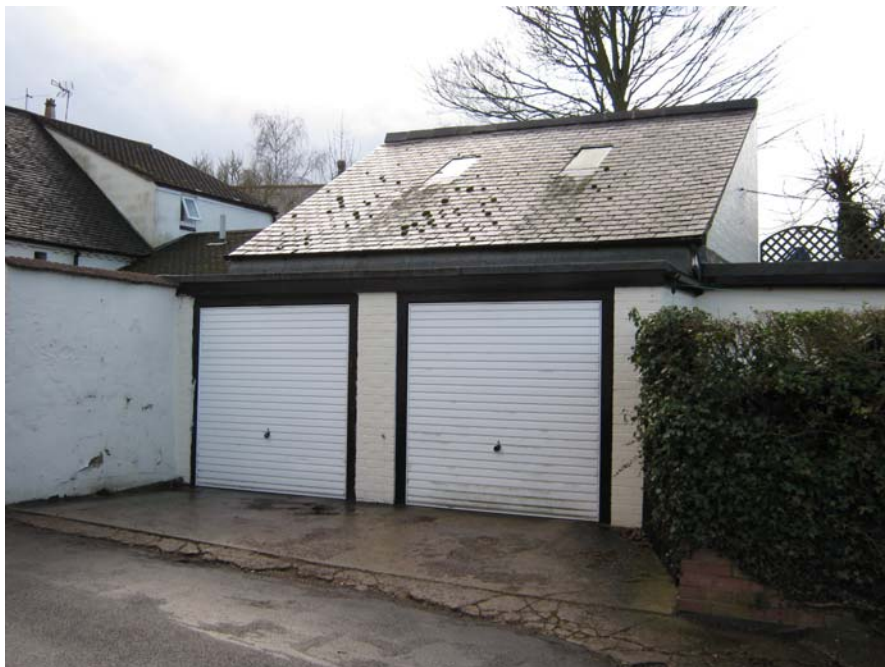
The double garage on Cottage Lane with its up and over doors does not particularly enhance the street scene.

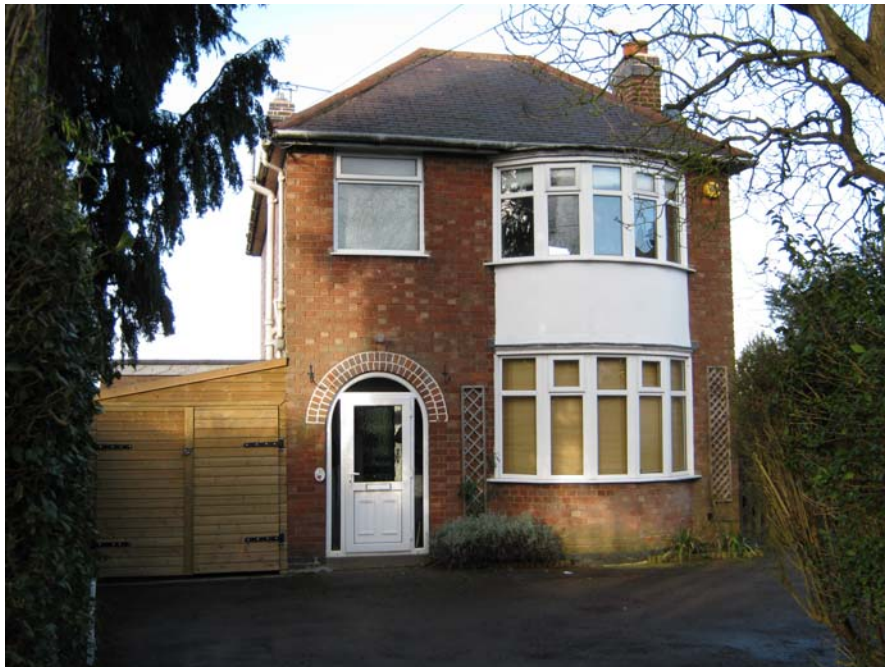
17 Cottage Lane is a classic 1930's property that unfortunately does not reflect the traditional character of the conservation area.

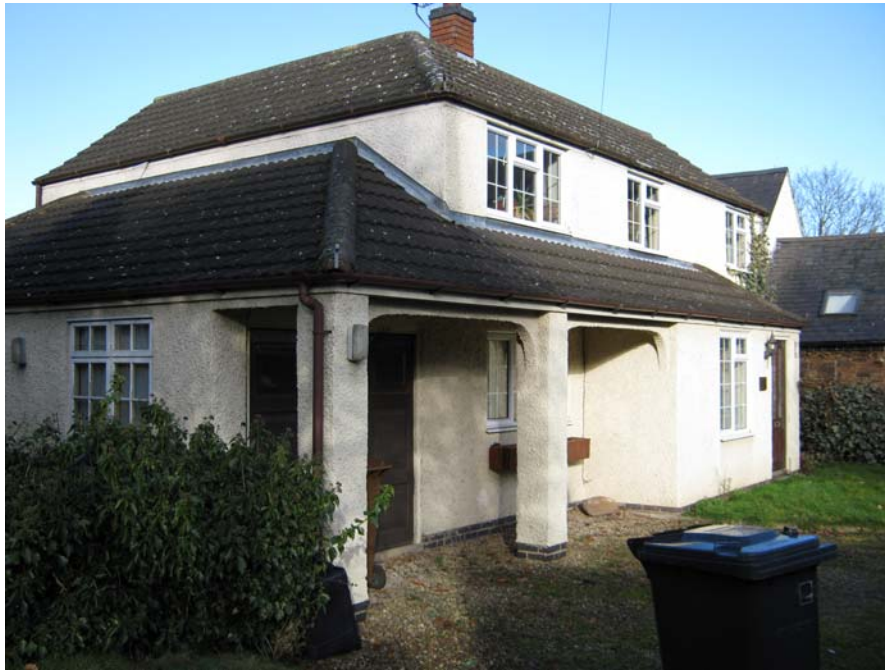
The dwelling, 19 Cottage Lane, does not respect the traditional character of the conservation area by way of its design and choice of materials. The canopy is a particularly incongruous feature.

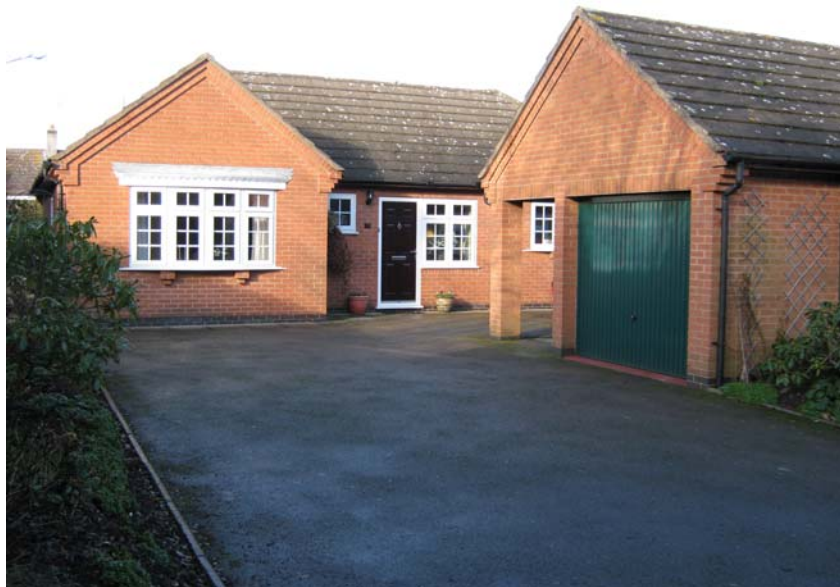
The bungalow, 10 Chapel Lane, does not respect the traditional character of the conservation area by way of its design and choice of materials.

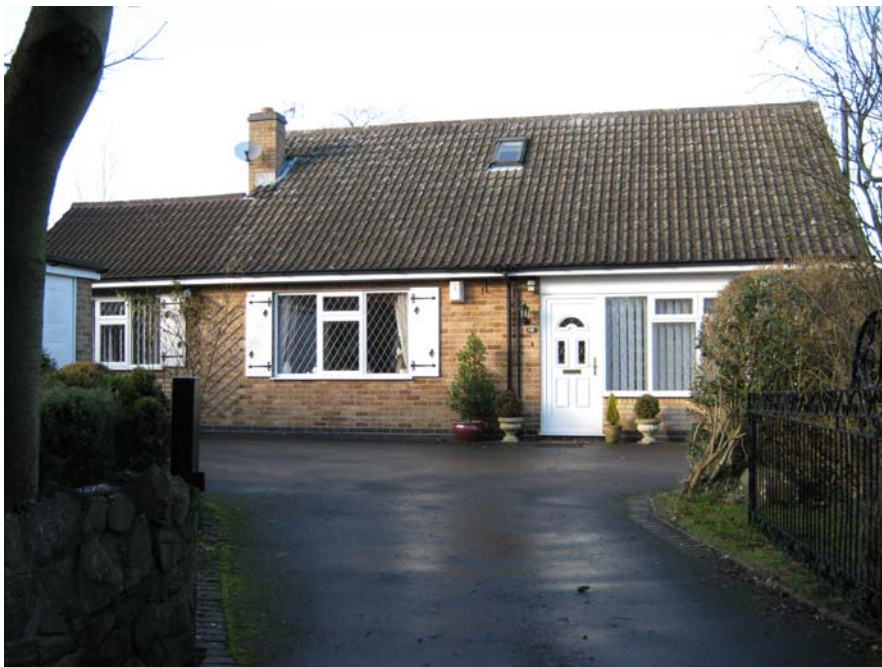
12 Chapel Lane is a dwelling of modern design and materials that has a negative impact on the conservation area.

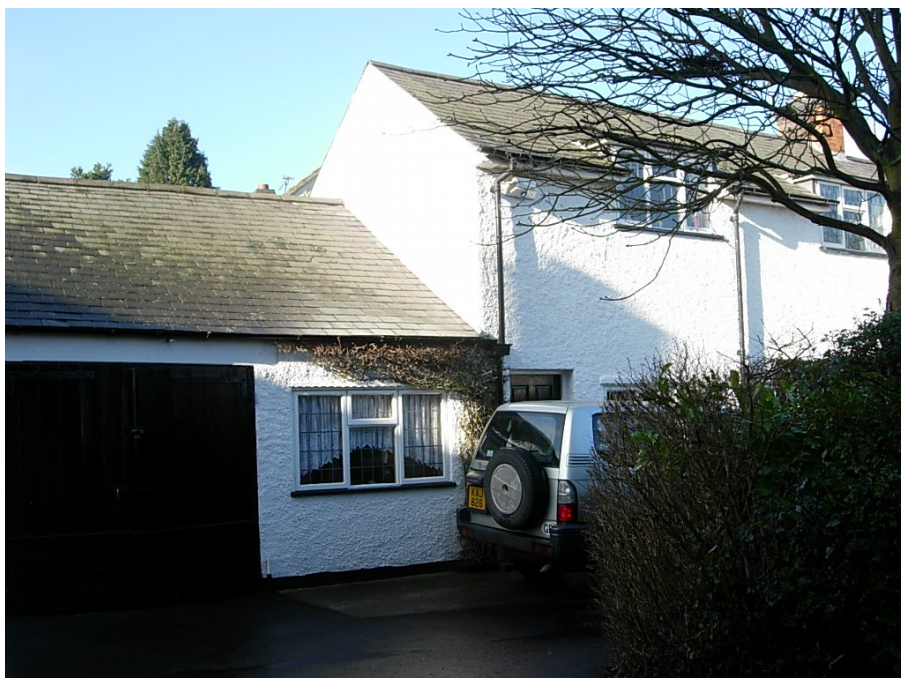
16 Chapel Lane is similar in design and treatment to a number of other dwellings sited at the northern end of Cottage Lane.

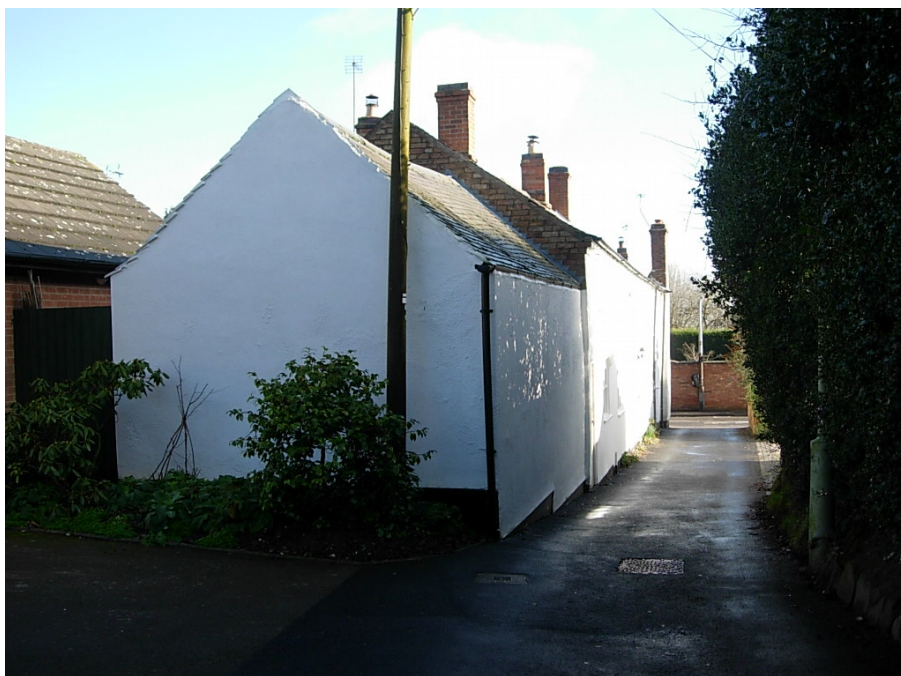
The properties, 2-6 Chapel Lane, were once framework knitters cottages.

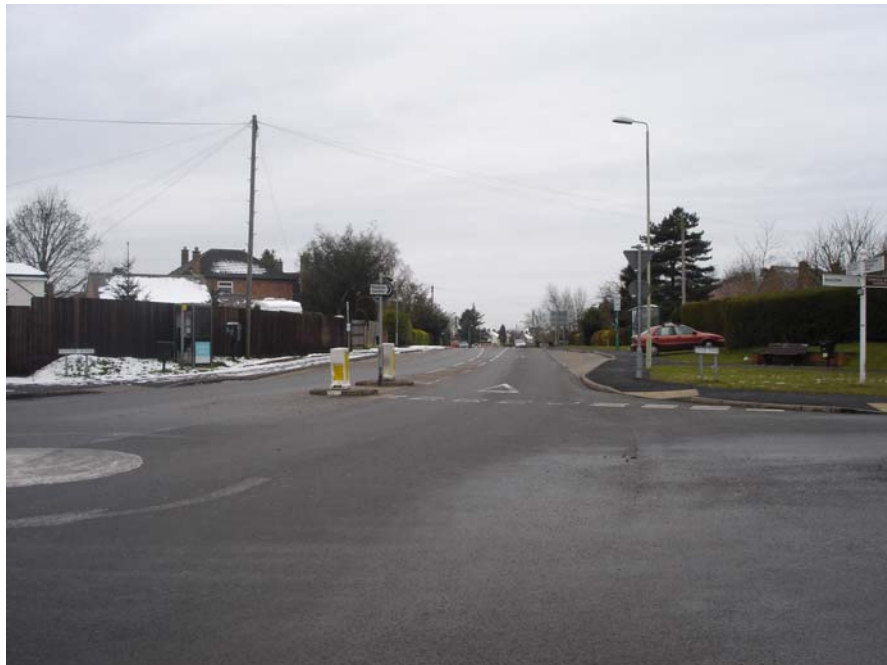
The view looking westwards along Manor Road. The properties sited within the conservation area on Manor Road have all been constructed since the road was built and have no traditional character.

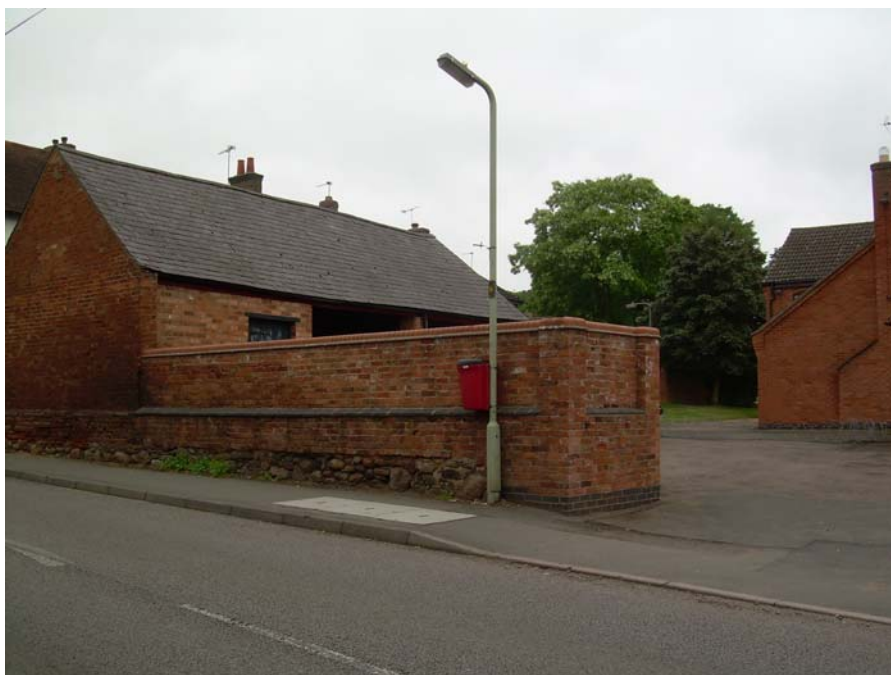
The barn, sited at the junction of Church Lane and High Street, was probably built around the same time as Old Manor Farm. It still has late mediaeval arched foundations. The building was once listed as it was sited within the curtilidge of the adjacent listed property.
