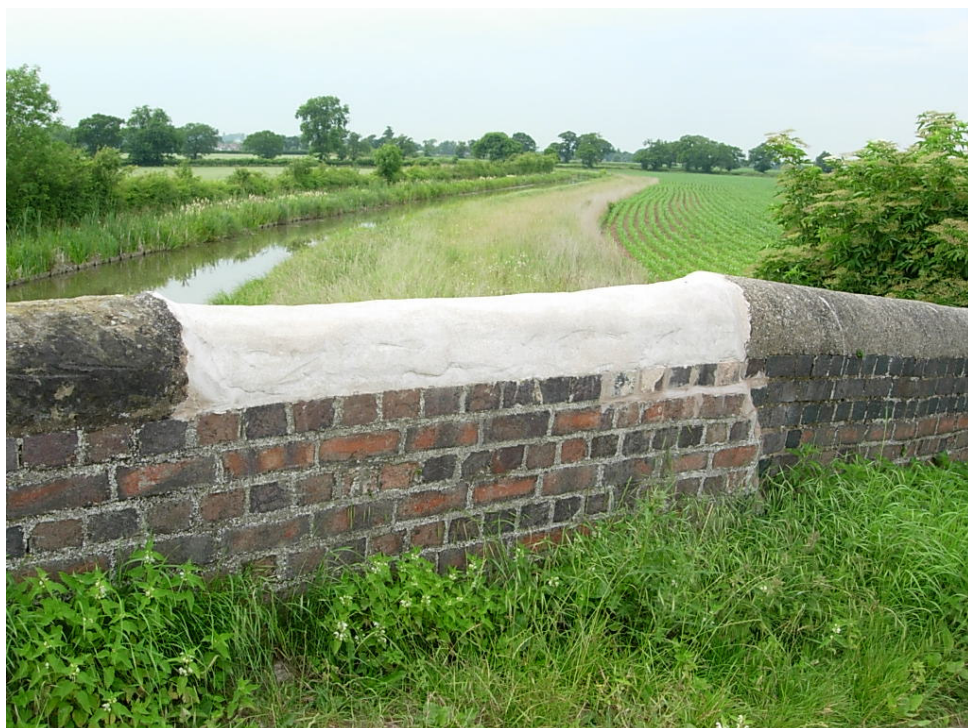
Bridge 46 showing the unsatisfactory repair to the copings. The stone copings have been replaced with sand/cement mortar which has a detrimental impact on its appearance. Work is also needed to repair the open joints on the parapet wall where the brick work has fractured
