BURBAGE CONSERVATION AREA APPRAISAL & MANAGEMENT PLAN

**PHOTOGRAPHIC RECORD OF
BURBAGE CONSERVATION AREA**

November 2011

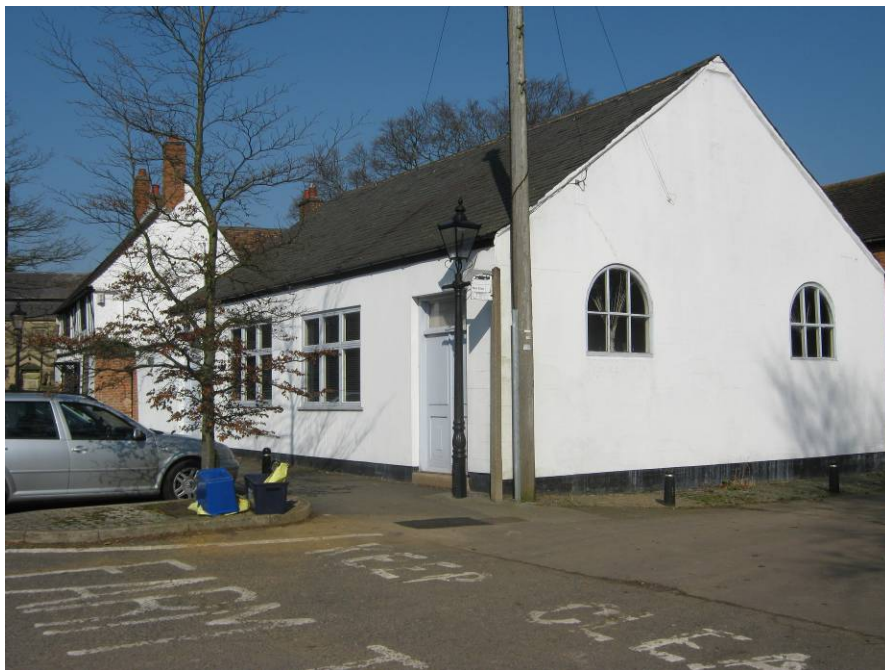
The former church rooms are now used as a shoe showroom. Although the window openings and door locations have been changed, it remains an important historic building in the conservation area. The high chimney adjacent is a key feature which should be retained.

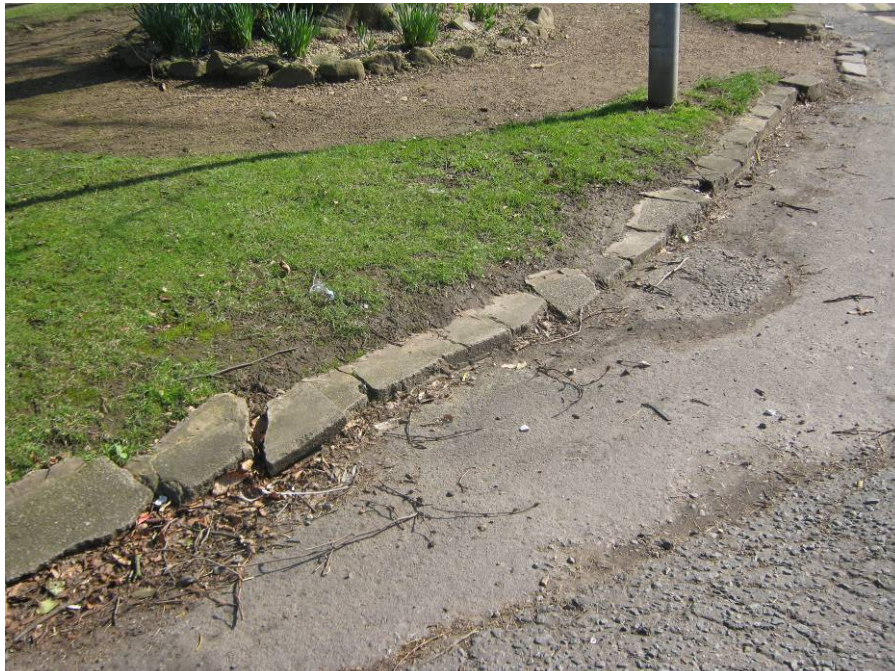
The edge treatment to this attractive open space on Church Street is poor. Consideration should be given to edging the area with granite kerbs.

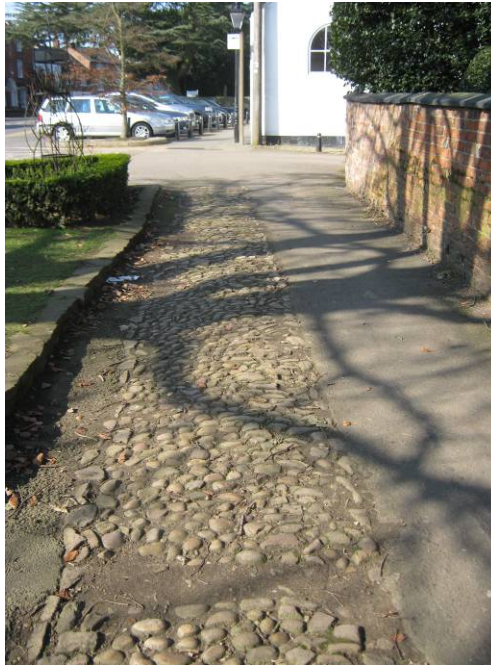
Some areas of this attractive cobbled area on Church Street need attention.

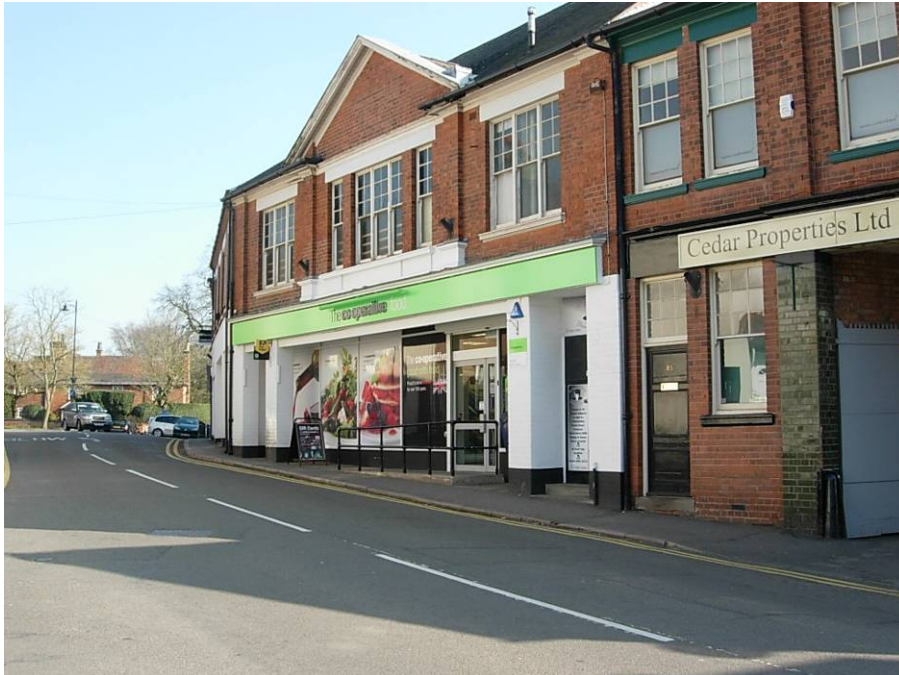
The timber sash windows and gated service entrance have retained the traditional appearance of the Co-operative store on Church Street despite the modern interventions around the shop entrance. The original five bay frontage and glazed tiles around to the entrance piers have been lost.

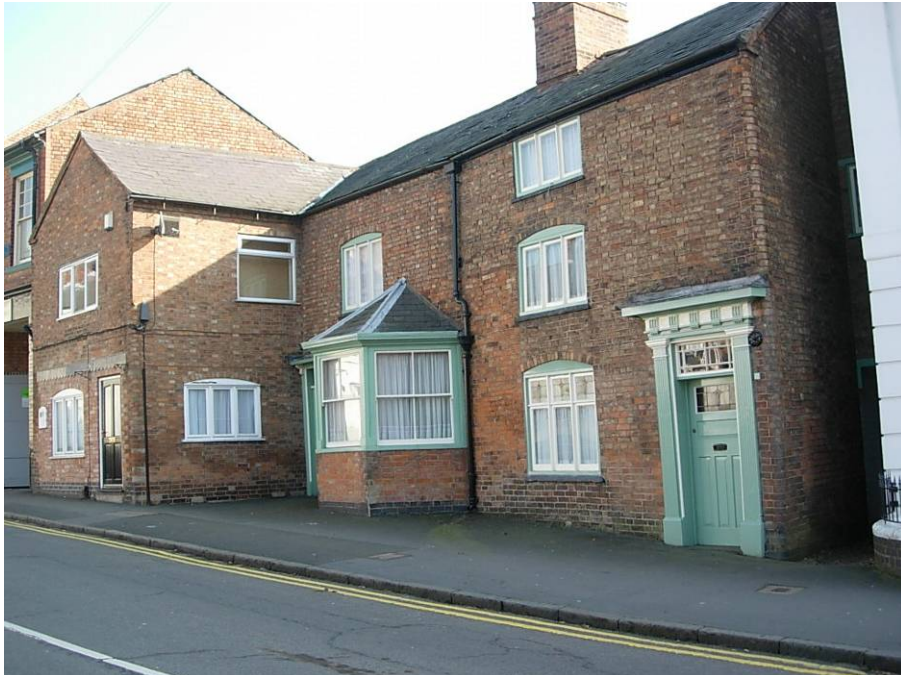
The large bay window built on the front elevation of 79 Church Street tends to disrupt the unity of the block. The entrance doors and surrounds are excellent features. Originally thatched cottages adjoined the Co-op buildings.

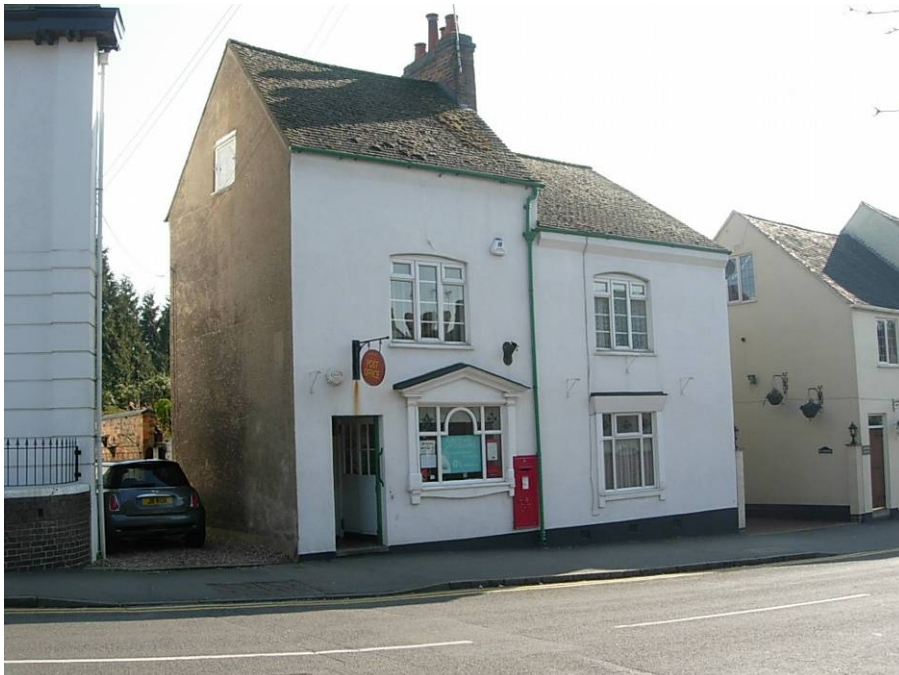
Although 71 Church Street has been converted to a post office and its shop front is overly decorated and it has lost its second floor window. However it is not over prominent in the street scene.

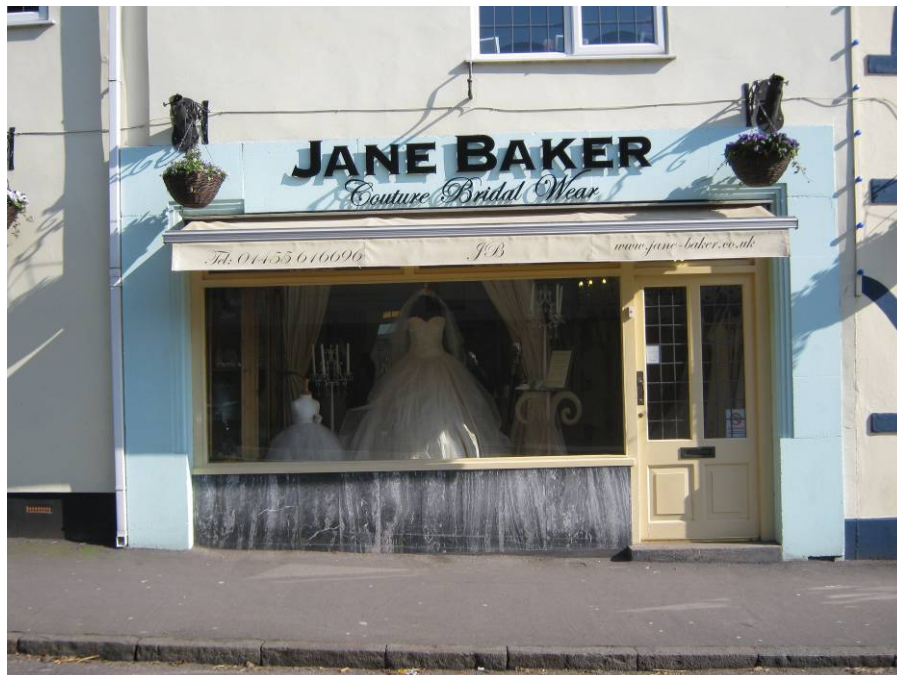
The shop front to these premises has been built in the art-deco style which is in conflict with the appearance of the traditional retractable canopy.

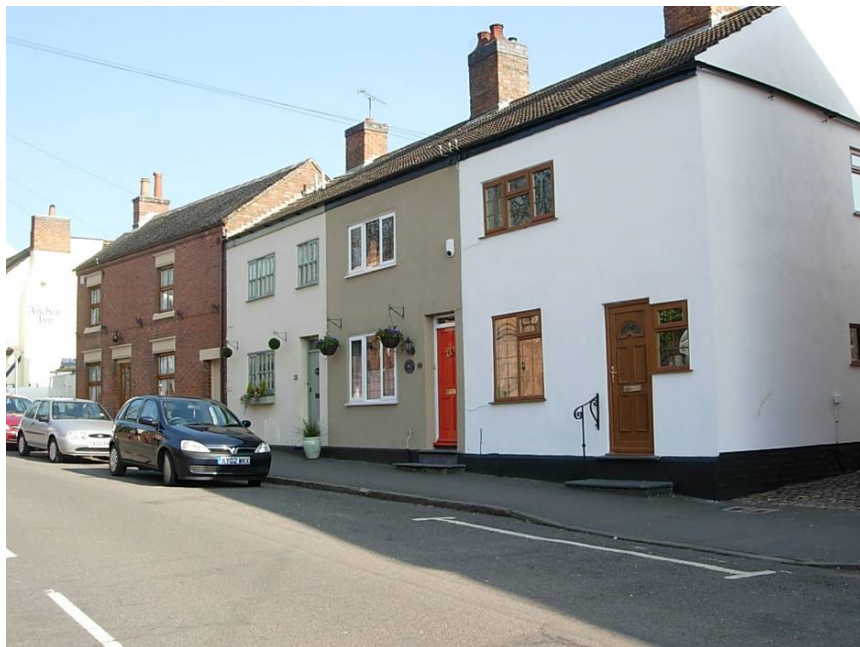
The character of 51-57 Church Street has been lost due to modernization. Chimneys have been rebuilt, window openings altered, lintols & sills lost and the brickwork rendered. A consistent colour would improve the appearance. No. 57 alone has retained its traditional appearance.

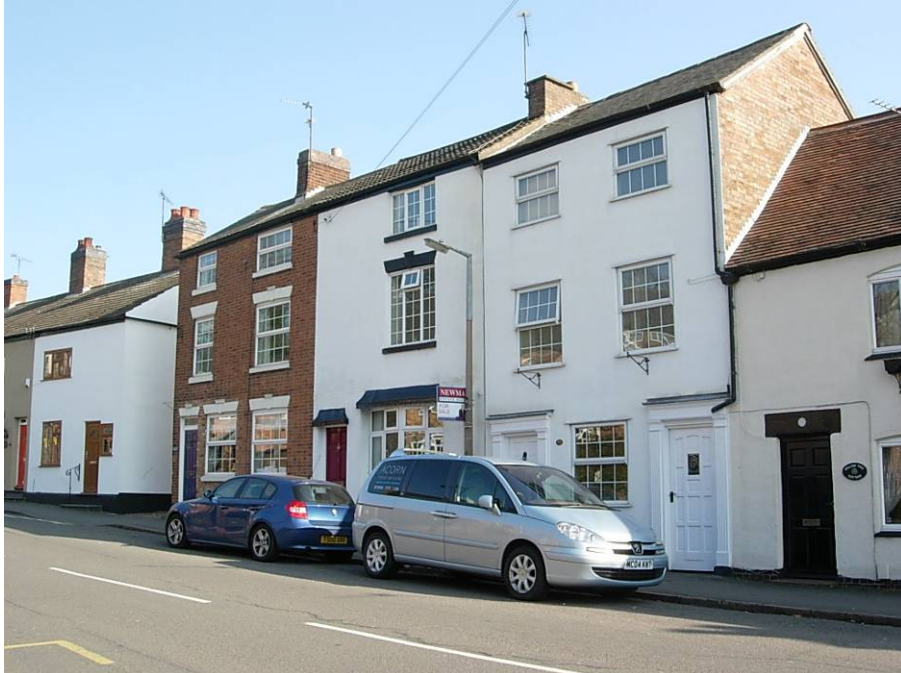
This impressive block of 3 storey properties, 45-49 Church Street, has been spoilt by the introduction of concrete roof tiles, bow window and the loss of lintols. The ground floor of number 45 was originally a shop.

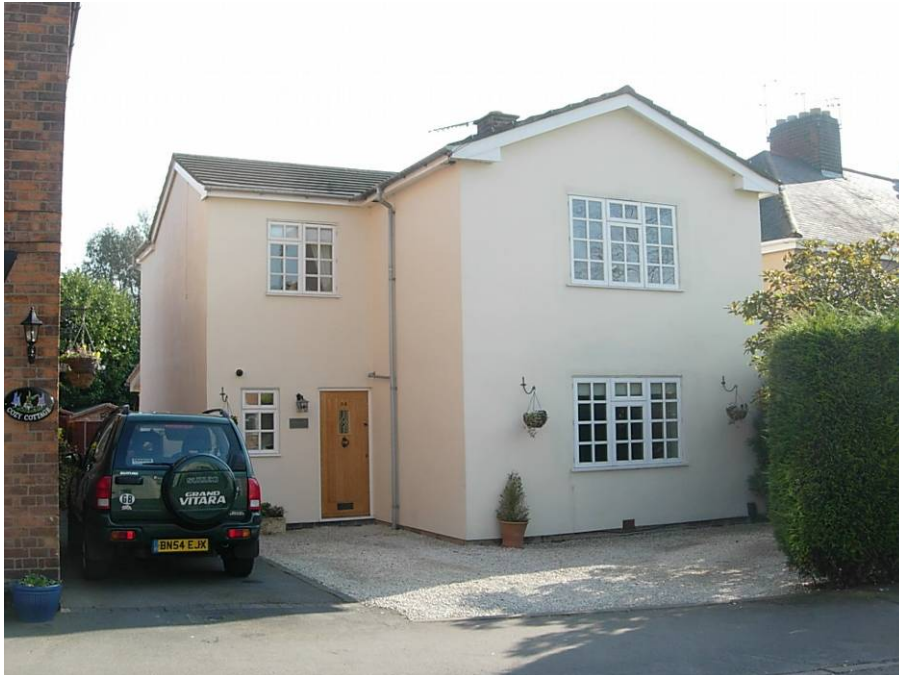
Unfortunately, the detached dwelling 33 Church Street does not reflect the character of the conservation area by way of its modern design, materials of construction, siting and semi-open frontage.

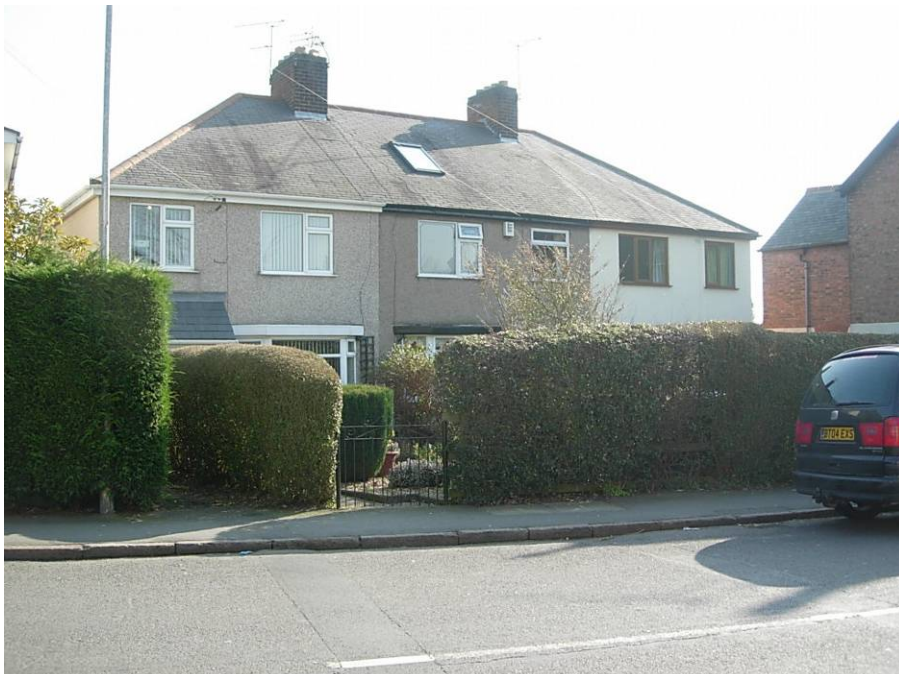
The hedge fronting this block of three dwellings helps to screen the properties. The roof light is a prominent feature which breaks the roof plane and should have been sited on the rear elevation of the dwelling.

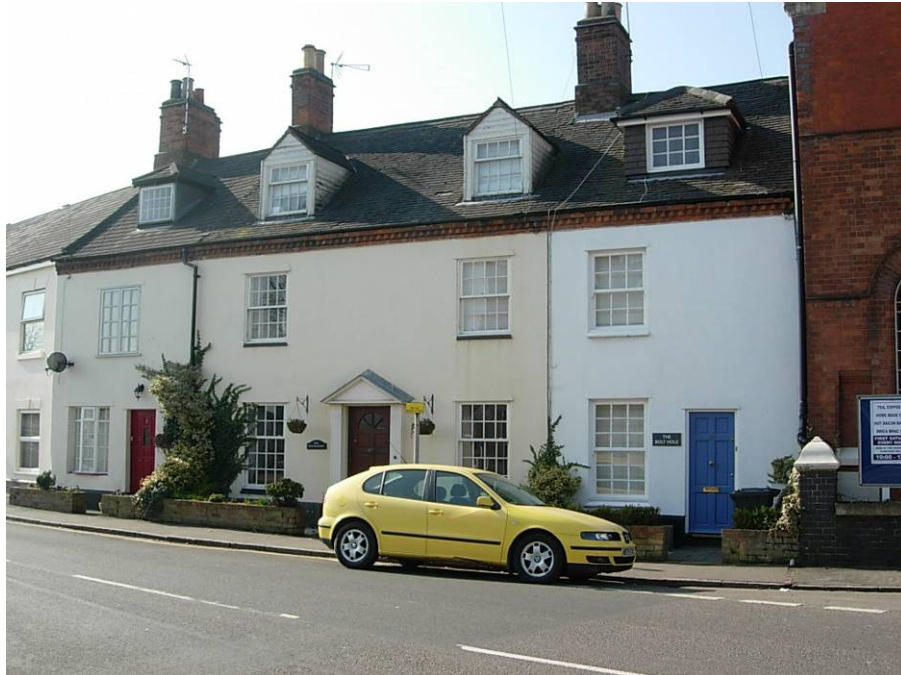
This attractive group of dwellings; 6-10 Church Street still retain their impressive chimney stacks and pots. Unfortunately the original cast iron railing which fronted the properties have been lost.

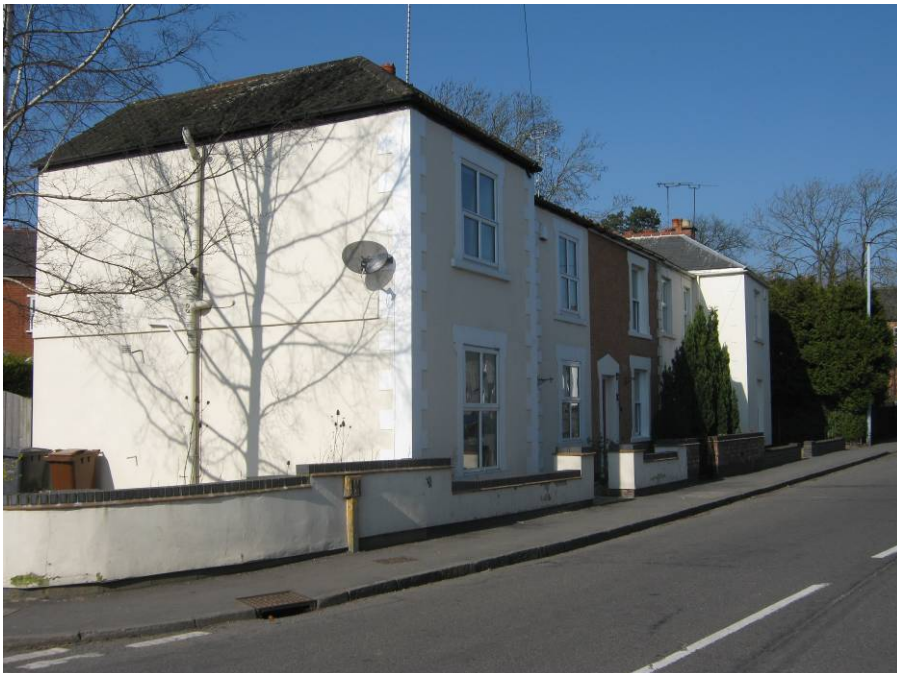
12-16 Church Street is a pleasant block of dwellings that have been rendered and modernised. They originally had railings and a low wall to mark the street boundary. The siting of the satellite dish is unfortunate.

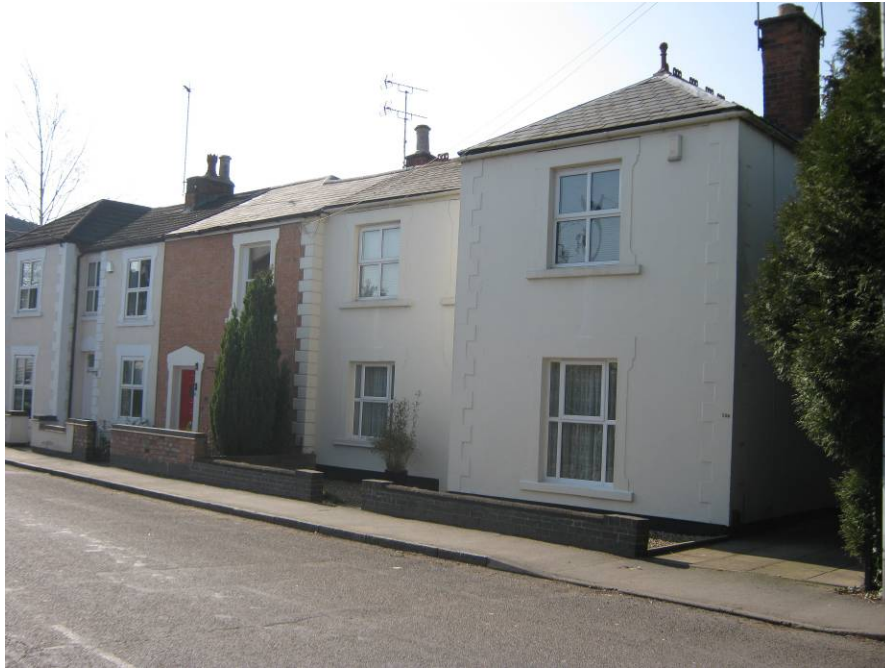
12-16 Church Street looking north westwards. A boundary treatment which was consistent across the whole frontage, would improve their appearance.

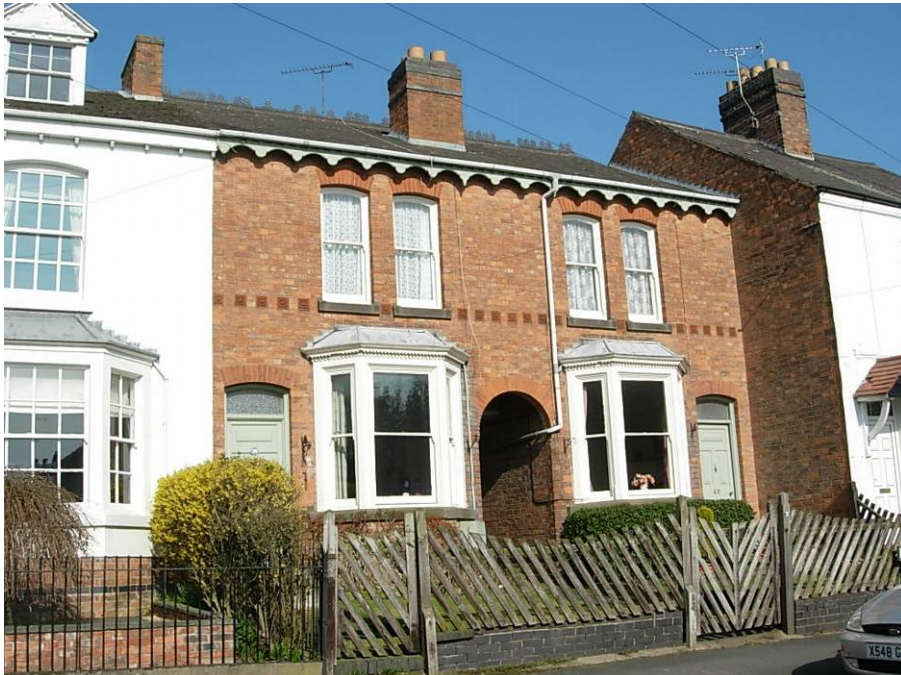
This excellent pair of semi-detached dwellings still retains their traditional character. The boundary treatment could be improved.

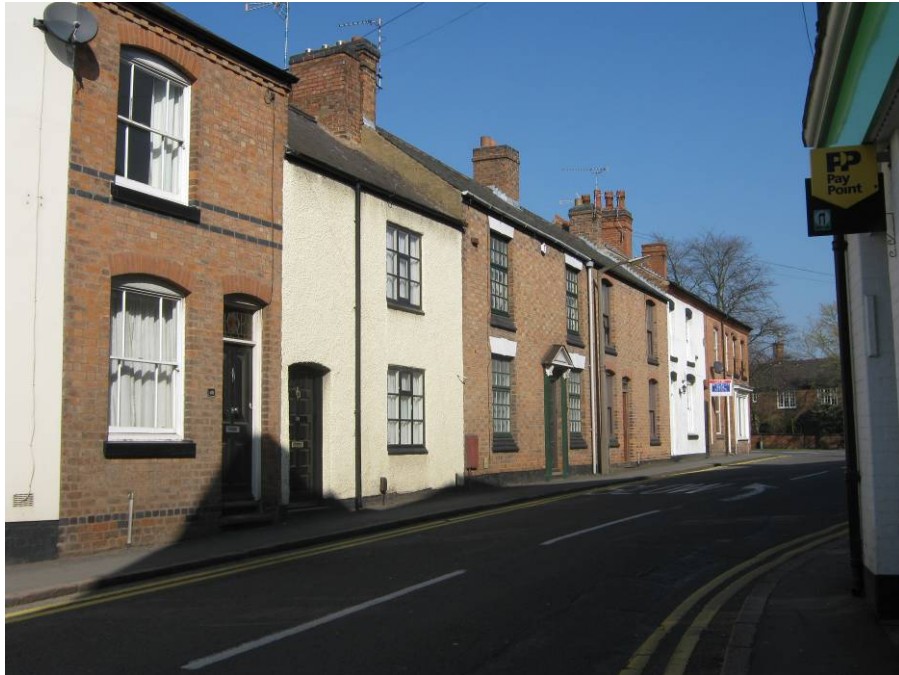
The unity of the terrace on the west side of Church Street has been lost due to the rendering and modernization of several properties. However, this length of the road still retains its granite kerbs.

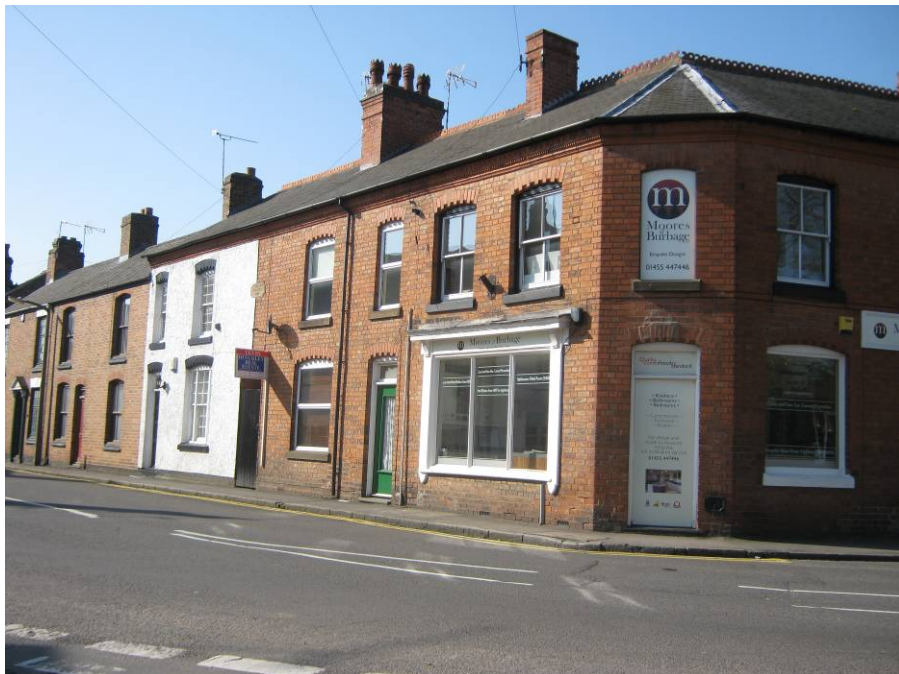
This attractive corner property has unusual saw tooth lintols and decorative ridge tiles. Unfortunately, chimney stack has lost its pots.

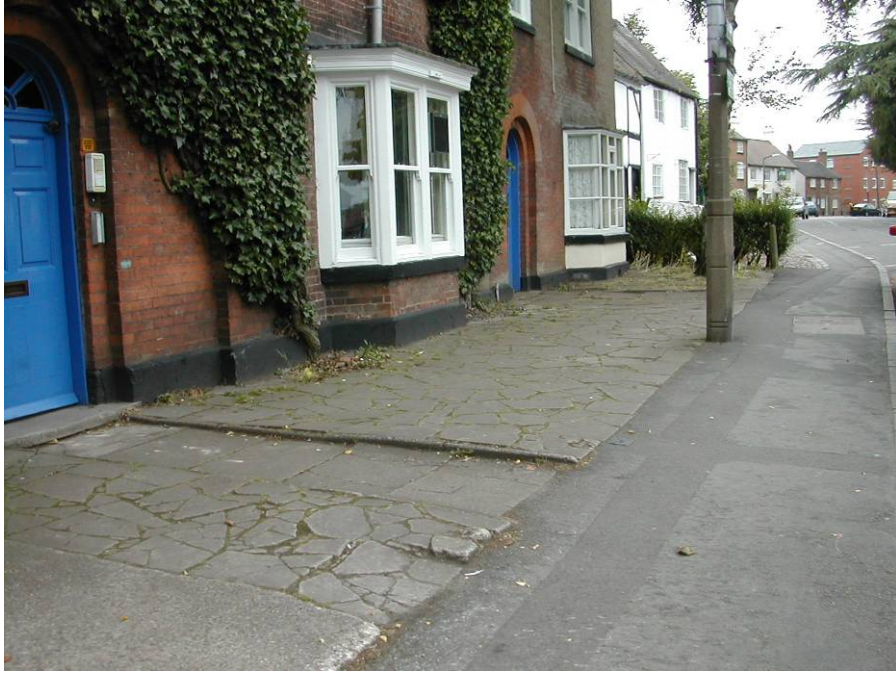
The forecourt to the Constitutional Club would benefit by being re-surfaced in slabs or grassed over to match the opposite side of the road. A low wall with railings along the boundary would also improve its appearance.

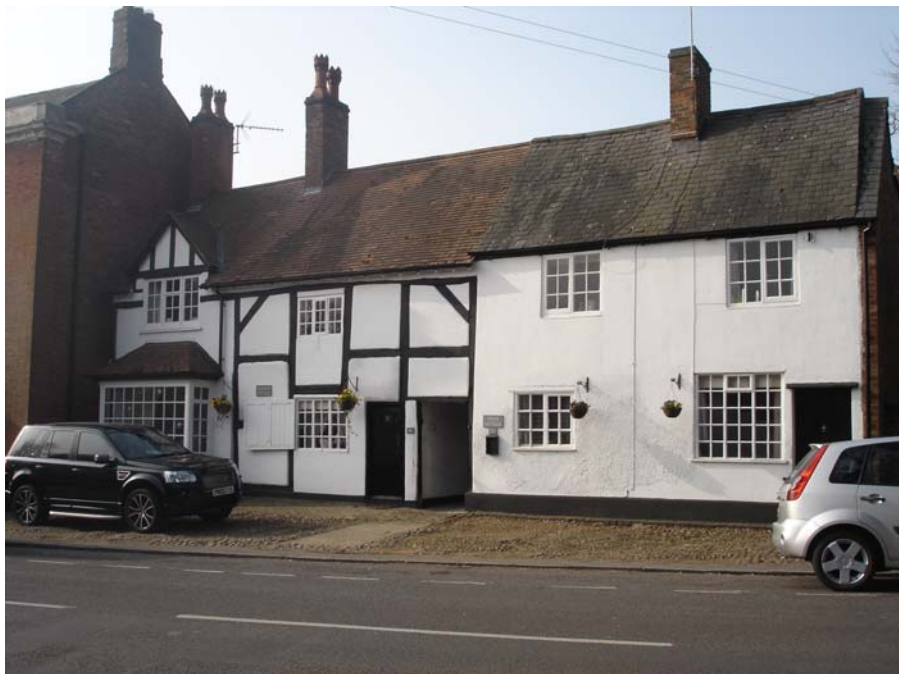
The properties 66 & 72 Church Street are Grade II Listed Buildings. No. 66 is C17, timber framed with roughcast infill. 72 is C19, roughcast with a central chimney stack that has lost its pots.

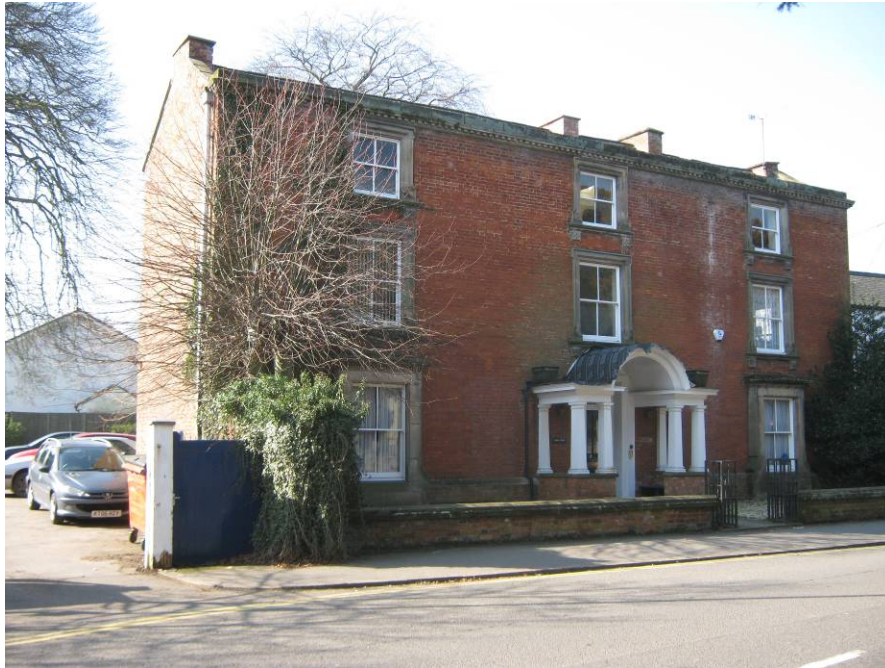
Cedar Lawns is a 3-storey Grade II listed building built in red brick with a Swithland slate roof. The property has a central paneled door with fanlight under a large round-headed hood that was added in the early C20. The building that is now used as offices is fronted by a low brick wall that was once topped with iron railings. The four chimney stacks have lost their pots.

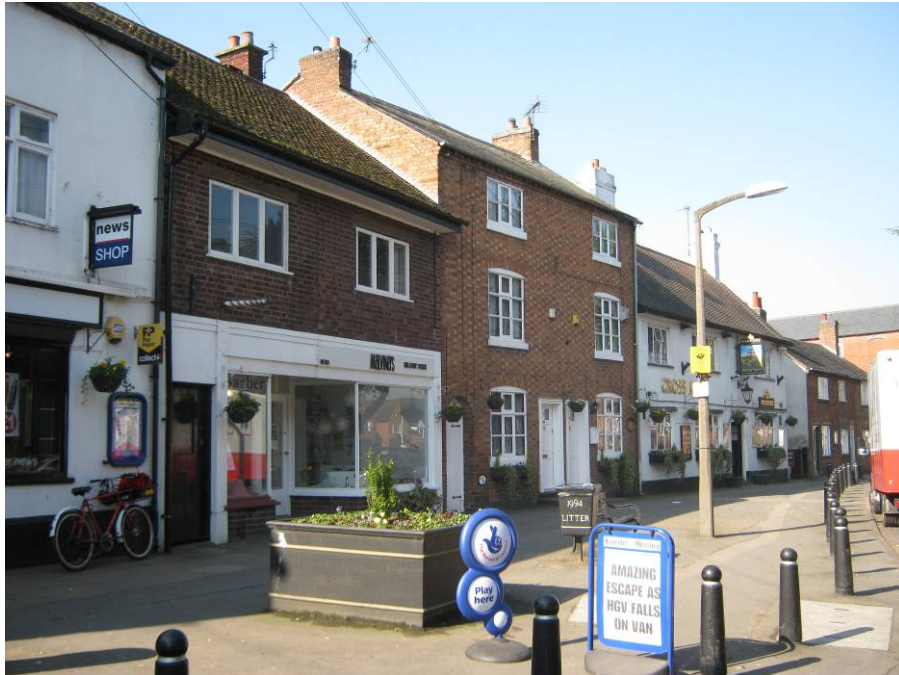
The different ridge heights on this terrace of properties along the west side of Hinckley Road add interest to the street scene. Consideration needs to be given to improving the area fronting the properties with a re-surfacing scheme which would include a heritage lamp post. In Victorian times a village pump was sited on the forecourt.

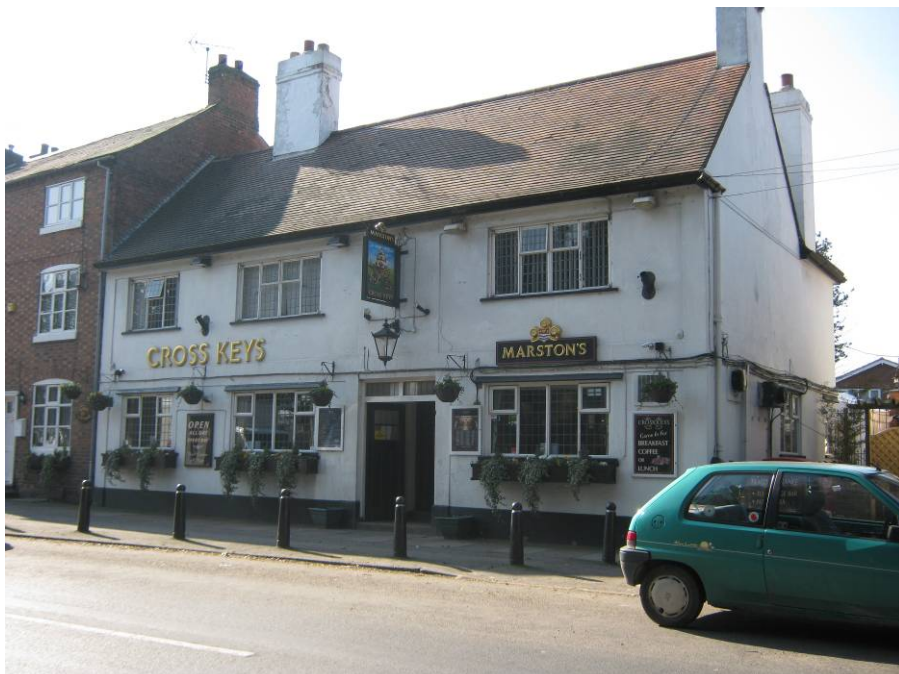
The Cross Keys public house has been modernised with the addition of rendering and the insertion of large windows.

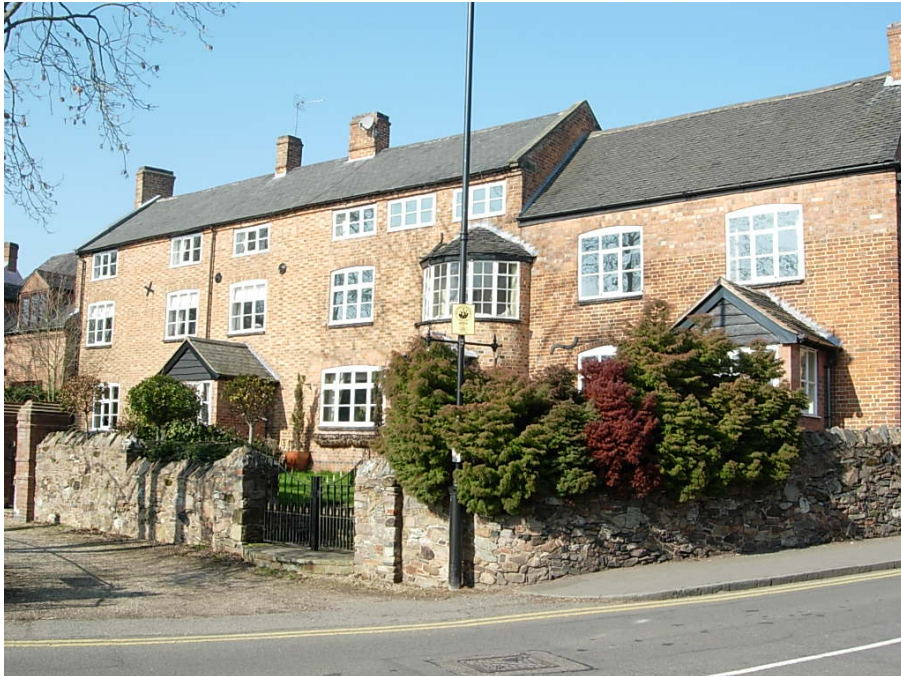
The Croft at the junction of the Horsepool & Church Street has been successfully restored. It is a former framework knitters dwelling. Unfortunately the property has lost its traditional chimney pots.

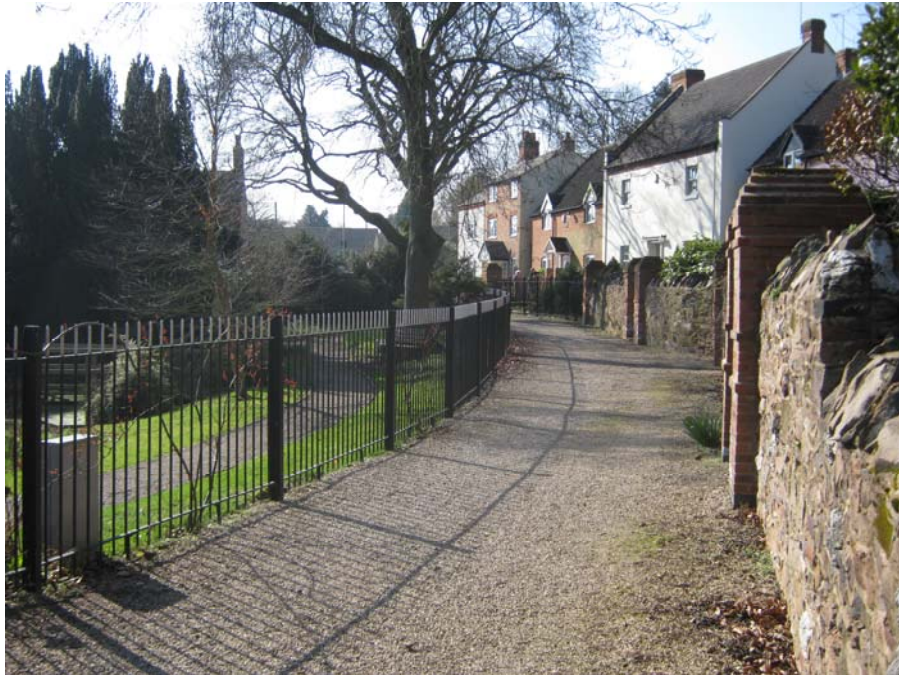
The Horsepool with granite walls one side and open space on the other is an attractive setting. It is suggested that a heritage street lighting column could be installed just inside the open space.

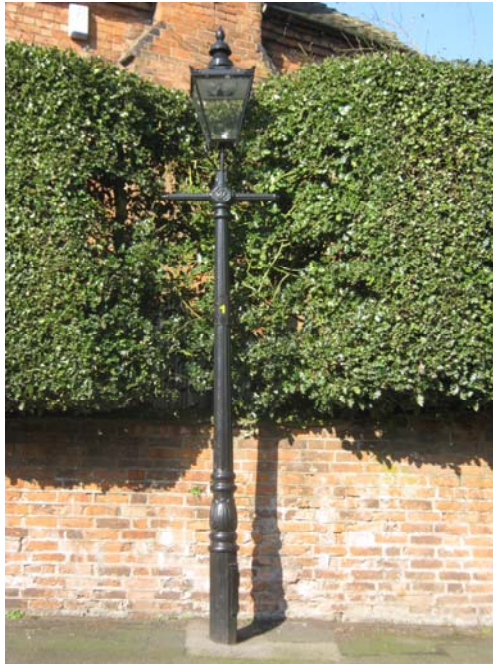
Cast iron street lighting columns have been installed in several locations in the conservation area. It is considered that the Horsepool would benefit with the installation of these columns

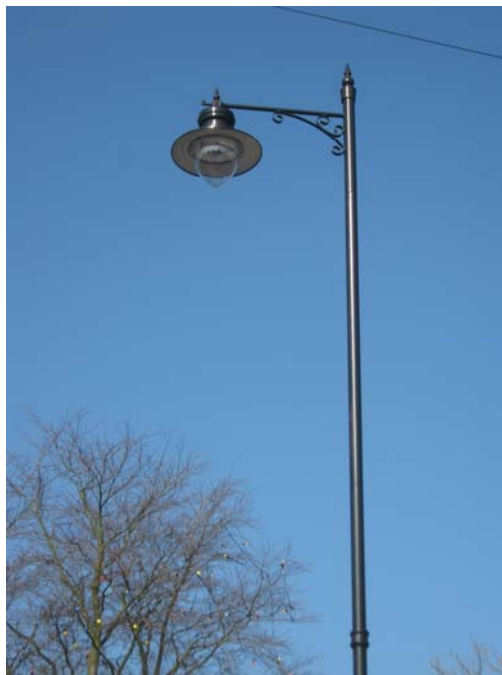
This 8 metres high heritage column has been used on Church Street due to it being a main through road. It is suggested the columns should be installed along the entire length of Church Street and the section of Hinckley Road within the conservation area.

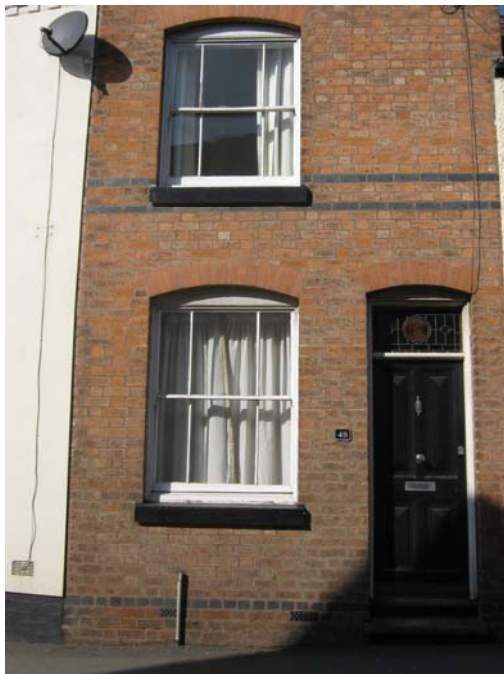
Sash windows are also important features in conservation areas that sadly are being replaced by modern plastic windows.

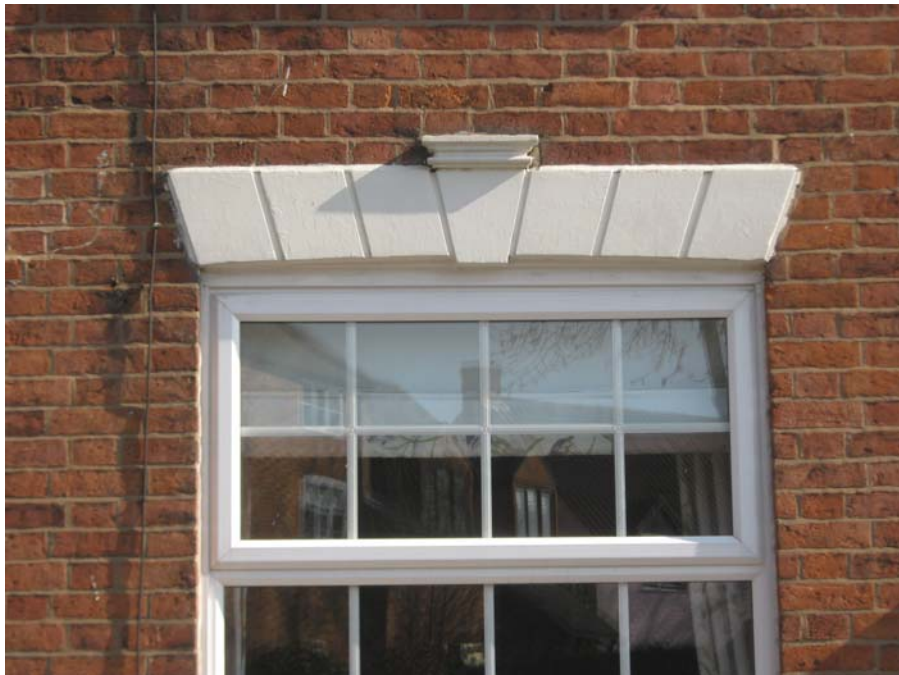
This feature is known as the Hinckley lintol where it is very common. The plastic windows unsuccessfully try to mimic sash windows

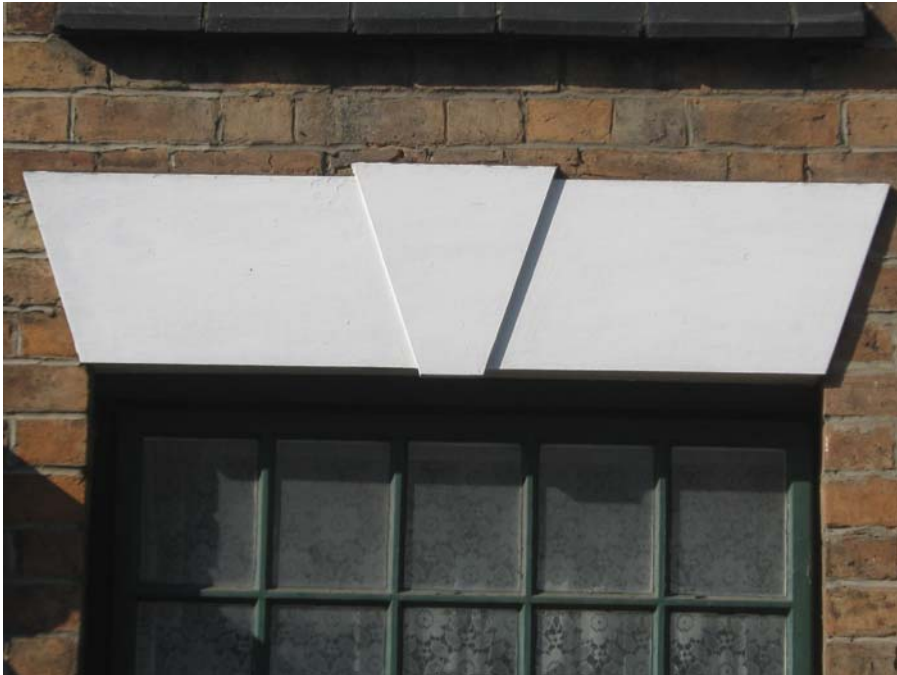
This lintel is a modern attempt to improve the appearance of this dwelling which is out of character with its humble design.

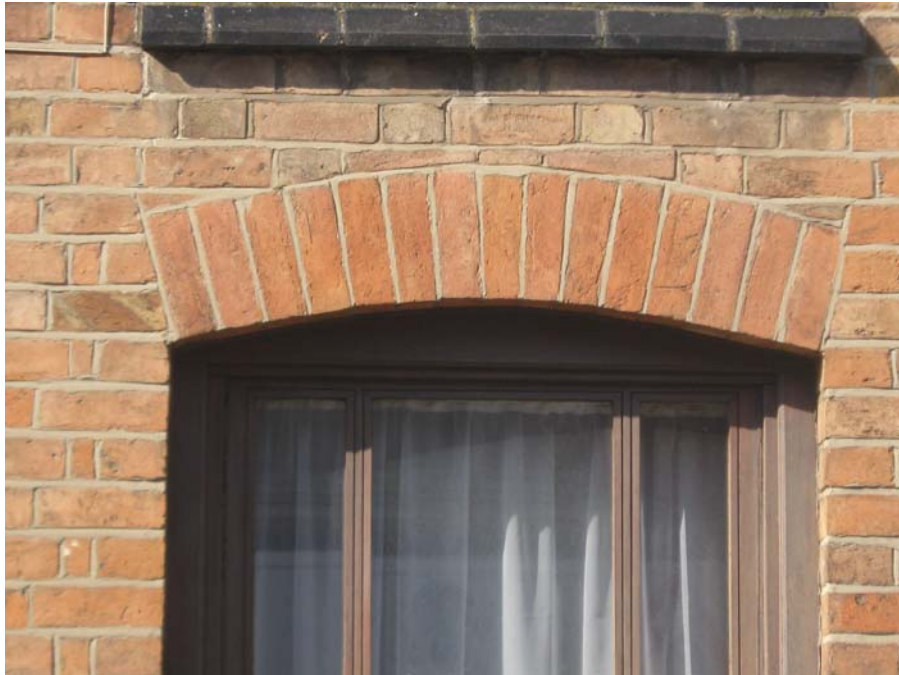
A traditional segmental arch lintol which has been re-pointed.
